PROPERTY INSPECTION REPORT

Any Street, Any City, 44444

Report ID: Example Buyer Inspection Report

Report Summary (Not A Complete List)

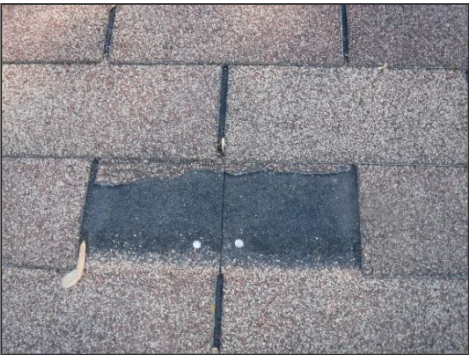
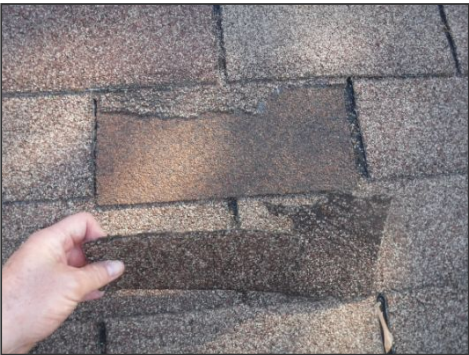
Page 8 Item: 1	Exterior Roof Covering	1.1. Roof covering was nearing end of its useful life. I saw (9) damaged/missing shingles. Recommend contacting a qualified and license roof contractor repair to prolong it useful life. Servicing can also uncover problems not discovered or that are beyond the scope of home inspection standards. Budget for replacement.

Roof Covering Missing Shingles (Front Side)		Roof Covering Missing Shingles (Front Side)	
Exterior

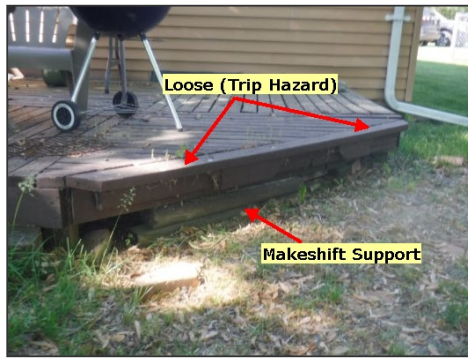
Page 12 Item: 8	Pergola / Deck / Balcony / Walkable Flat Roof Sections	8.2. There was a section of the deck that was not properly supported and edge board was loose. This is a trip hazard. Recommend repair to prevent injury.

Deck not property supported / loose edge board (trip hazard)

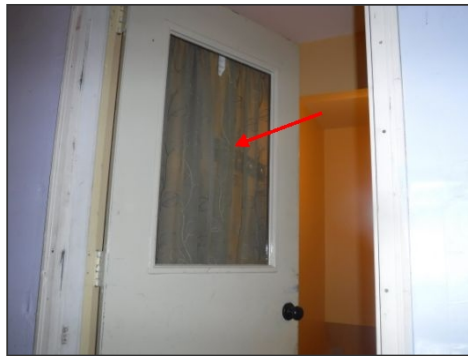
Page 14 Item: 4	Occupant Door (Including Fire Door)	4.1. Garage occupant door is not fire rated with glass panels installed. Recommend replacing with solid wood door not less than 1 3/8 inches in thickness, solid or honeycomb core steel doors not less than 1 3/8 inches thick, or 20-minute fire-rated door for enhanced safety to occupants. Fire rated doors prevent the rapid spread of flames in the event of a garage fire.
--	-----------------	-------------------------------------	--

Garage occupant not fire rated (Glass Panel)

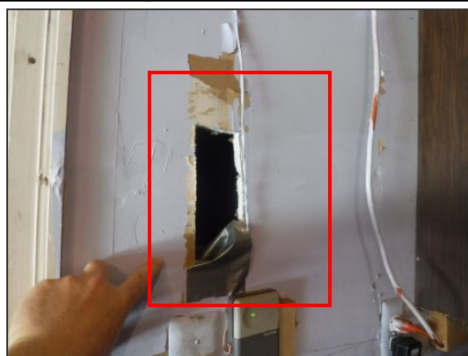
Page 15 Item: 5	Interior Walls / Ceilings (Includes Firewall)	5.2. There was an opening (breach) in the firewall that separates the livable area from the garage, this is a fire hazard. Recommend repair to maintain sealed walls to help reduces the potential of toxic automobile gases and path for fire to enter the house.
--	-----------------	---	--

Garage, breach in firewall

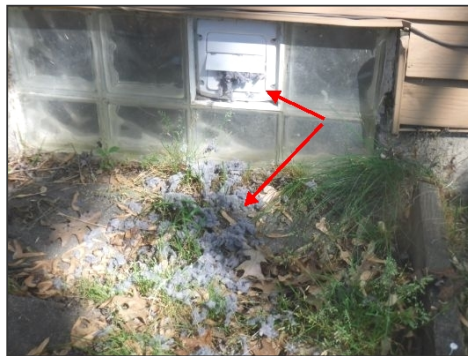
Page 18 Item: 2	Laundry Clothes Dryer Hook-Up	2.3. The dryer duct/vent has an accumulation of lint, this can become a fire hazard. Recommended duct cleaning and replace flexible foil type duct should with rigid metal duct to reduce lint build up and to bring the home up to standards.
---	-----------------	-------------------------------	--

Dryer vent obstructed with lint (safety Hazard)

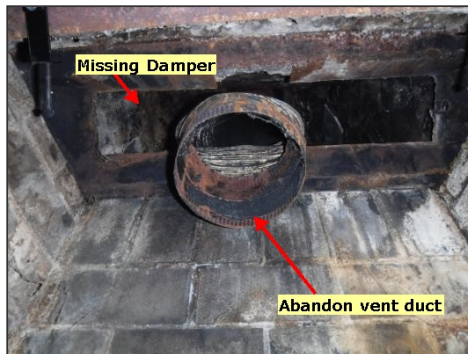
Page 20 Item: 4	Exhaust Venting (Chimney and Gas Burning Appliances)	4.1. There was an abandon vent duct in the chimney flue. The fireplace is not function until removed. Contact a qualified chimney contractor to remove the vent duct, clean, and inspect the interior of the flue.
---	-----------------	--	--

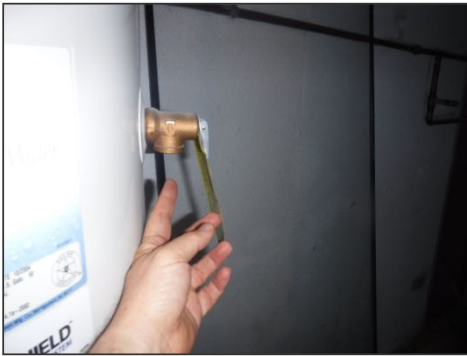
Page 28 Item: 4	Water Heater	4.3. The temperature-pressure relief valve (TPRV) discharge tube was missing. This is a potential safety hazard due to the risk of scalding if someone is standing next to the water heater when the valve opens. Recommend installing discharge tube to bring the home up to standards and to enhance the safety of the occupants. 4.4. Water heater, cold water side, there was an active pin-hole leak from the shut-off valve and leak damage at the dielectric connection (heavy rust/corrosion). Recommend service by a qualified and licensed plumber to prevent further leaking and damage. Service can uncover problems not discovered or that are beyond the scope of home inspection standards.
---	-----------------	--------------	---

Missing discharge tube

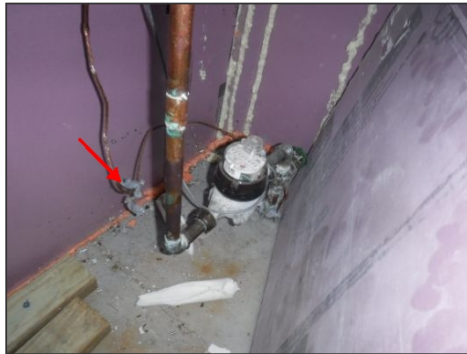
2.3. The bonding clamp was not clamped to the water pipe ahead of the water meter. This is a safety hazard. Recommend service to secure the bonding clamp. Service can uncover problems not discovered or that are beyond the scope of home inspection standards.

Bonding clamp not secured to water pipe

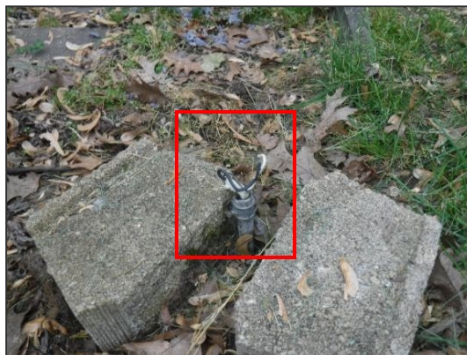
3.2. Back right side, there was an abandon circuit with its conduit protruding the grade that is a trip hazard. The conduit was protected by landscaping bricks. Recommend removing abandon circuit to prevent trip injury.

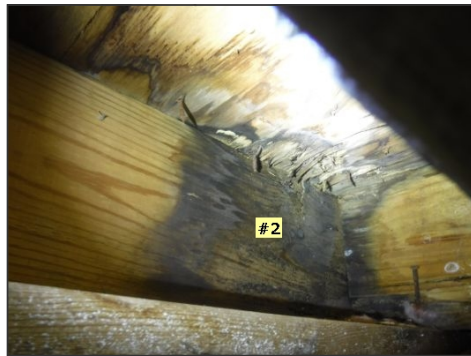
3.1. I observed stained and water damage/rot to the sub-floors and rim joists in the following location. Location #2 and 3 had significant structural damage to the sub-floor and rim joists. I was not able to determine the underlining damage. Recommend qualified and licensed contractor evaluate and provide estimate of repair. Servicing can also uncover problems not discovered or that are beyond the scope of home inspection standards.

- #1 dried stains - no elevated moisture,
- #2 elevated moisture and significant dry rot to sub-floor and rim joist (structural damage)
- #3 no elevated moisture measured but significant dry rot to sub-floor and rim joist (structural damage)
- #4 stains - no elevated moisture.

Location #2 (Structural Damage), Elevated moisture, damage sub-floor/Rim Joist (Left side of door wall)

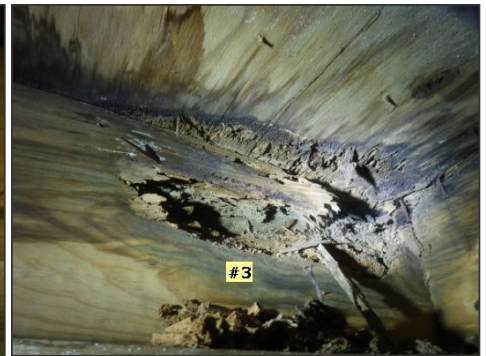
Location #3 (Structural Damage), damage sub-floor/Rim Joist (below glass door wall)

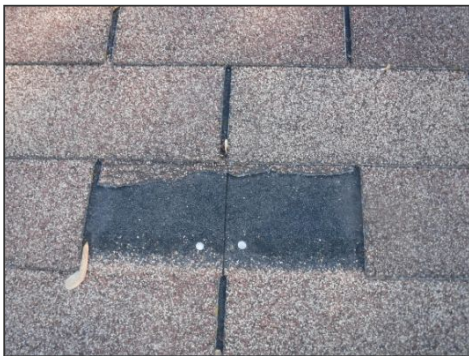
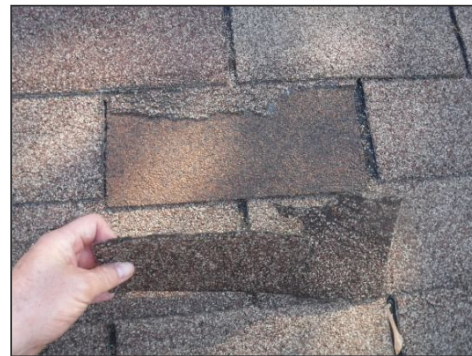
1.1. Roof covering was nearing end of its useful life. I saw (9) damaged/missing shingles. Recommend contacting a qualified and license roof contractor repair to prolong it useful life. Servicing can also uncover problems not discovered or that are beyond the scope of home inspection standards. Budget for replacement.

Roof Covering Missing Shingles (Front Side)

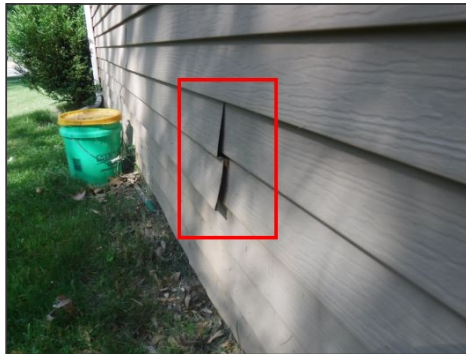
4.1. Delayed Maintenance (right side of garage), loose siding was observed that needs to be secured to help prevent underlining material from water damage. Recommend securing any loose siding to help prevent wind damage and to help maintain water tight building structure.

Loose siding

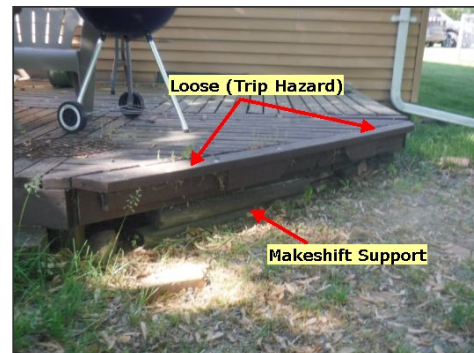
8.2. There was a section of the deck that was not properly supported and edge board was loose. This is a trip hazard. Recommend repair to prevent injury.

Deck not property supported / loose edge board (trip hazard)

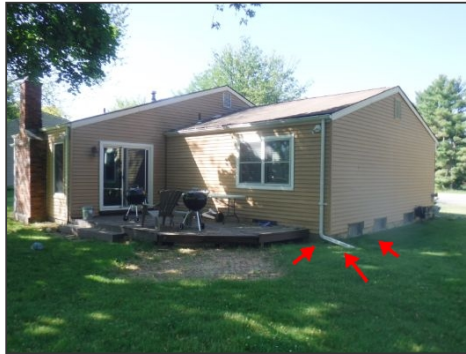
- 9.1. The grade was flat and/or slopes towards the structure, mainly along the back left corner of the home. This should be corrected to help prevent water from pooling against foundation and potential of seepage. Recommend back filling to encourage drainage away from the home.
- 9.2. The trees and/or bushes were too close to the house, need trimming. Vegetation should maintain a minimum of 12 inches clearance from the structure for bushes and 3 feet for tree limbs to help prevent damaged to the structure, unobstructed access for service, and adequate air circulation to dry out structure as well as limit potential organic growth.

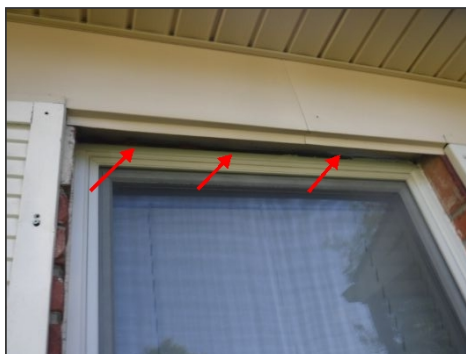
- 10.1. See Moisture - Exposed Sub- Floor Structures Section for additional information.
- 10.2. There was caulking missing / deteriorated (shrinking, dried, cracked) noted at one or more locations (doors / windows and wall / siding penetrations). The caulk may no longer provides water tight weather seal. Recommend removing deteriorated caulk before application and replacing using a high quality exterior silicone based caulk to create a water tight seal to help prevent water intrusion and insect entry into the interior structure. This includes opening and gaps between the porch platform and structure and the exterior wall around plumbing, A/C Lines, service conductors / receptacles, exterior light fixtures, vents, doors, windows and siding. All exterior caulking should be annually examined and re-caulked as needed. Caution as to NOT seal/caulk the "weep holes" located at the bottom sill of many newer type of windows that allow moisture to escape if condensation does accumulate.

Delayed Maintenance, front windows, missing caulking

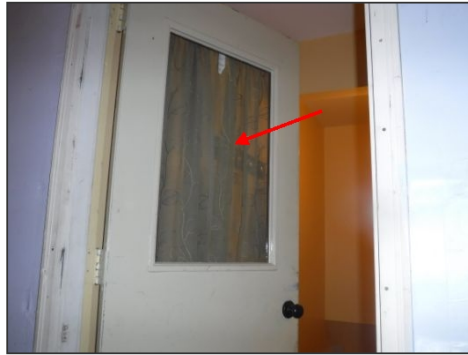
4.1. Garage occupant door is not fire rated with glass panels installed. Recommend replacing with solid wood door not less than 1 3/8 inches in thickness, solid or honeycomb core steel doors not less than 1 3/8 inches thick, or 20-minute fire-rated door for enhanced safety to occupants. Fire rated doors prevent the rapid spread of flames in the event of a garage fire.

Garage occupant not fire rated (Glass Panel)

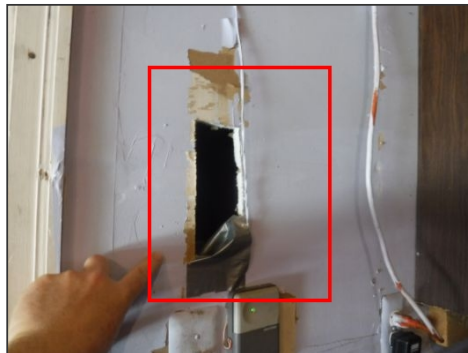
5.2. There was an opening (breach) in the firewall that separates the livable area from the garage, this is a fire hazard. Recommend repair to maintain sealed walls to help reduce the potential of toxic automobile gases and path for fire to enter the house.

Garage, breach in firewall

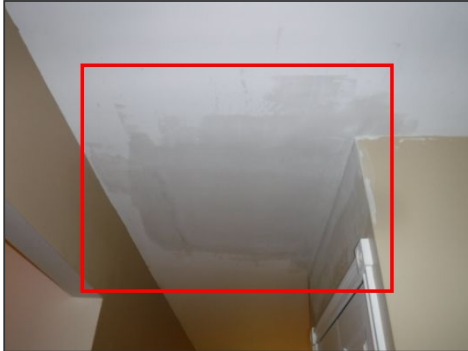
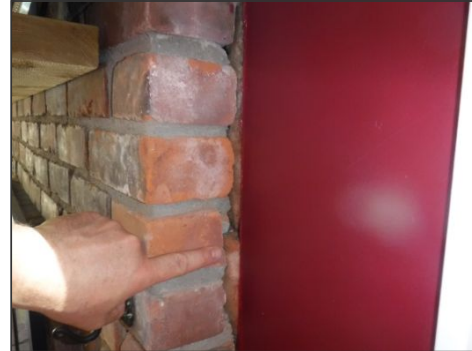
4.1. There was a repair to the ceiling between the kitchen and living room. I did not see any indication of moisture, but I was not able to enter the attic to determine if there was underlining structural or moisture issue. Recommend gaining access to the attic for inspection. Ask the seller about the repair history (why necessary, prior leaks, etc.).

4.2. Family room, recommend caulking/sealing the open gap between the drywall and fireplace brick to help prevent air leaks and improve over all indoor comfort.

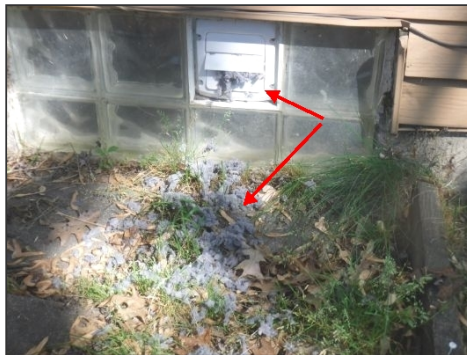
- 2.1. Gas shut-off valve was present in same room and within 6 feet of the appliance.
- 2.2. There was a 220-volt dryer electrical outlet available (not used). The outlet circuit was disconnected from its 30amp break in the panel.
- 2.3. The dryer duct/vent has an accumulation of lint, this can become a fire hazard. Recommended duct cleaning and replace flexible foil type duct should with rigid metal duct to reduce lint build up and to bring the home up to standards.

Dryer vent obstructed with lint (safety Hazard)

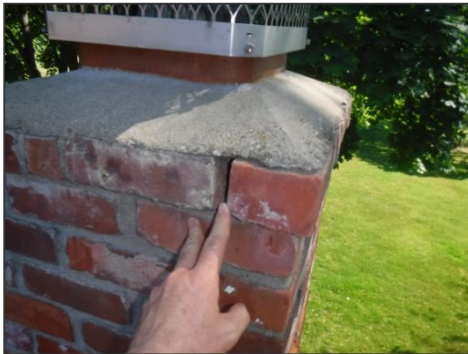
5.1. Delayed Maintenance, deteriorated mortar joints observed. Recommended retucking the mortar joints to prevent future deterioration and to maintain a water tight structure.

Delayed Maintenance, retuck mortar joint.

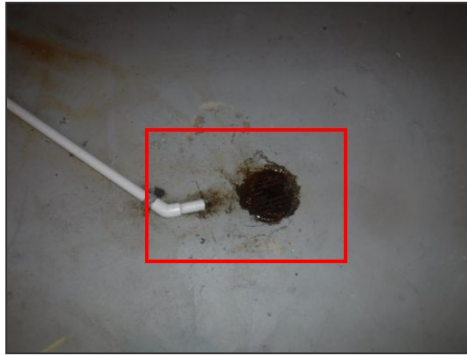
Discharge tube need extension to the floor drain

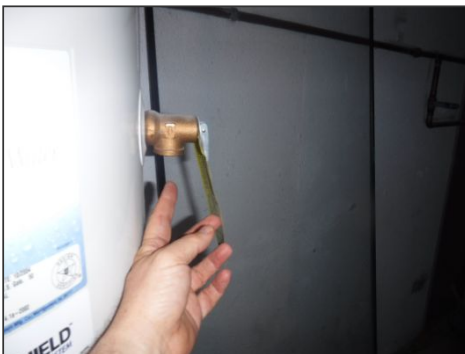
Missing discharge tube

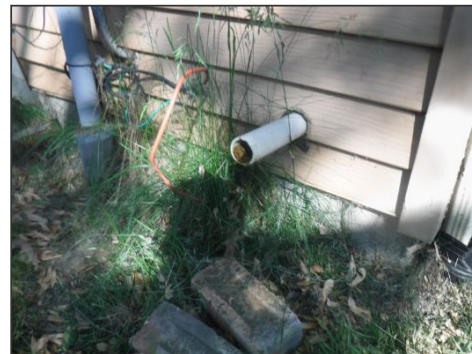
5.2. Pump discharges to the exterior grade and against the foundation. The grade was wet at the time of the inspection. There was a flexible gutter extension installed that was ineffective in draining discharge away from the structure. The discharge has caused the soil to settle in this area which is an indication of water pooling against the foundation. Recommend back filling with soil and properly installing a drain tube to encourage discharge away from the foundation to help seepage soil settlement and seepage into the basement.

Example Of Sump Pump Discharge Pipe To Close To Foundation

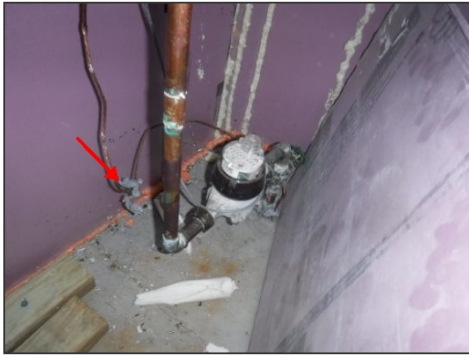
Bonding clamp not secured to water pipe

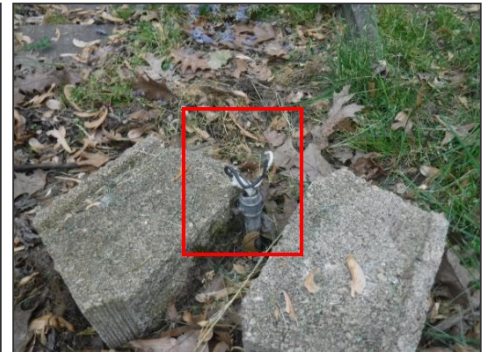
Junction box missing cover

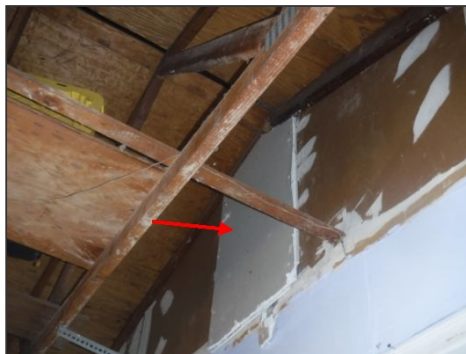
- 1.1. Attic was not inspected due to the limitations. Recommend access to the attic and have inspected before closing.

Garage, attic secured by drywall panel (I did not access the attic)

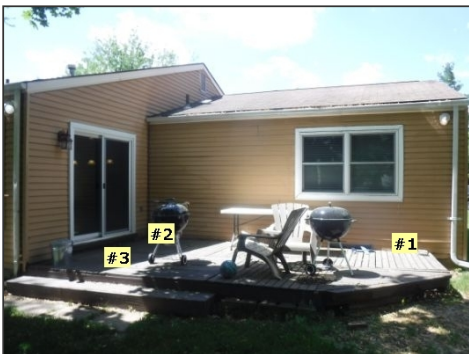
Approximate Exterior Location #1, #2, & #3 (of Stained Sub-floor/Rim Joist)

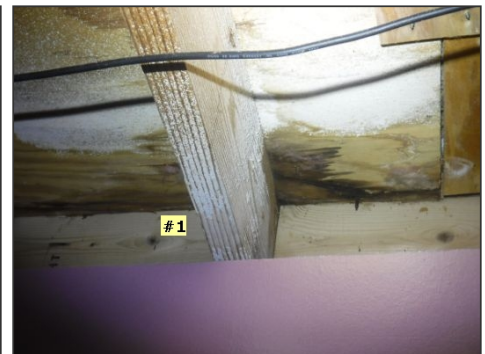
- #1 dried stains - no elevated moisture,
- #2 elevated moisture and significant dry rot to sub-floor and rim joist (structural damage)
- #3 no elevated moisture measured but significant dry rot to sub-floor and rim joist (structural damage)
- #4 stains - no elevated moisture.

Location #1, Stained sub-floor (Below bedroom)

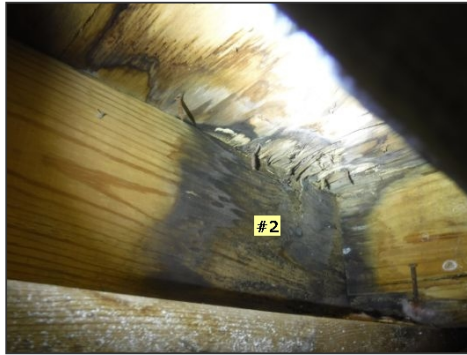
Location #2 (Structural Damage), Elevated moisture, damage sub-floor/Rim Joist (Left side of door wall)

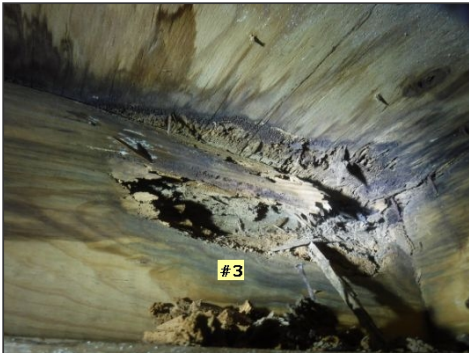
Location #3 (Structural Damage), damage sub-floor/Rim Joist (below glass door wall)

Location #3 (Structural Damage), Dry Rot, damage sub-floor/Rim Joist (below glass door wall)

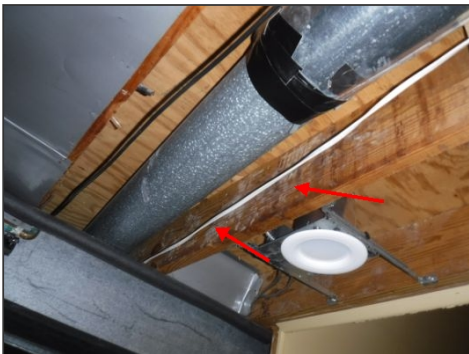
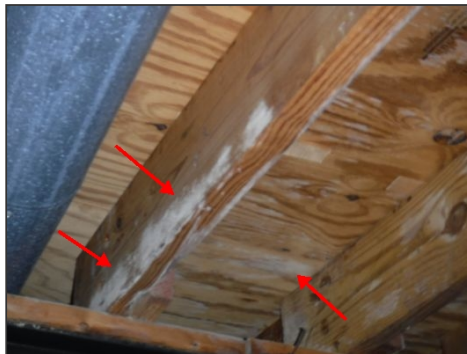
2.1. Sub-floor joists, I observed white powdery surface fungal grow on a few of the floor joist. Recommend properly cleaning and maintaining relative humidity levels below 60%. Reference Mich Mold Cleaning Guide attached to end of report.
