PROPERTY INSPECTION REPORT

Any Street, Any City, 44444

Report ID: Example Condo Inspection

Report Summary (Not A Complete List)

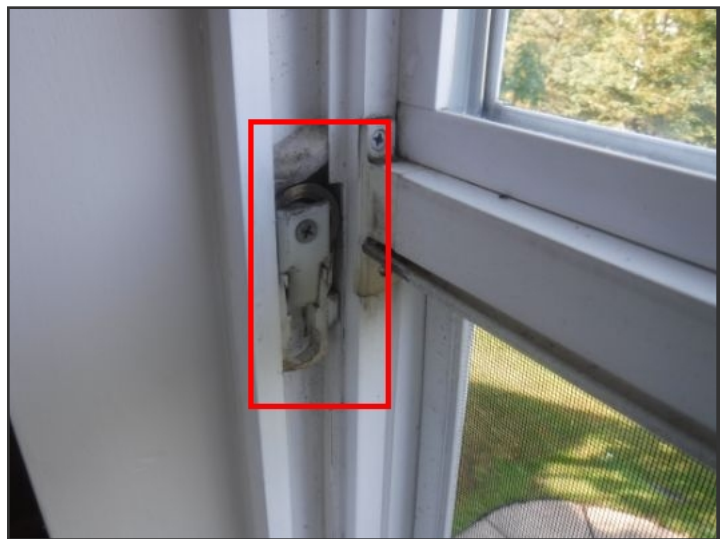
Page 11 Item: 2	Interior Window(s) [Representative Number]	2.1. Master bedroom, the left window would not stay open. Their sash coil assist were worn or damaged. Sash coils balancers are a necessary component to assist with operation as originally designed. Recommend repair to restore its function.
-----------------	---	--

Broken window left side sash (Master Bedroom, left window)

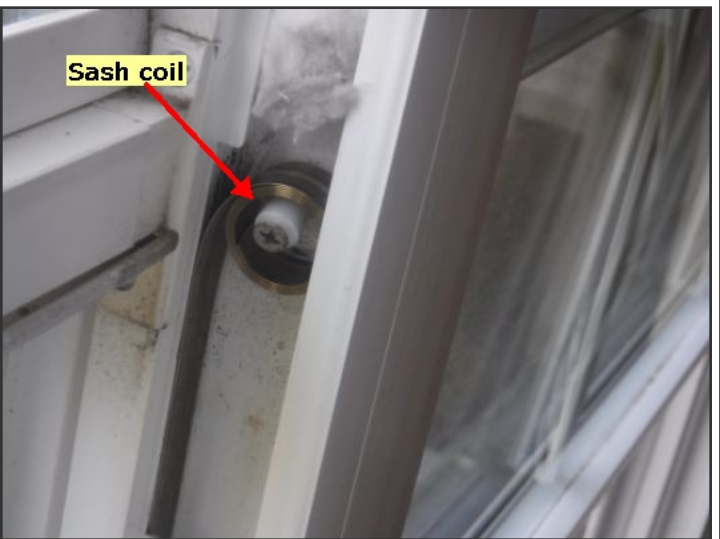
Broken window right side sash coil (Master Bedroom, left window)

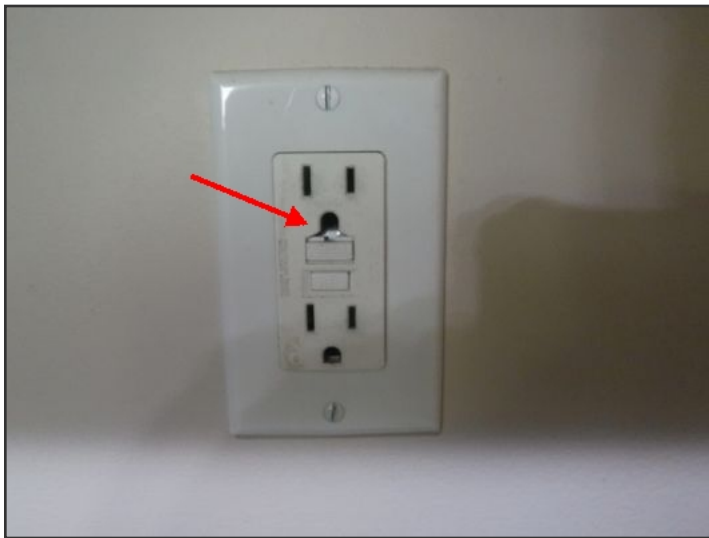
- 1. Laundry room outlets not GFCI protected, replace outlets with GFCI protected outlets.
- 2. Kitchen and garage GFCI protective outlets were damaged (ground slot), replace.

Kitchen, damage GFCI protected outlet (right side of refrigerator)

4.3. The following electrical safety defects were observed today. Recommend service and correction by a qualified electrical contractor to ensure safety of the occupants and to uncover problems not discovered or that are beyond the scope of home inspection standards.

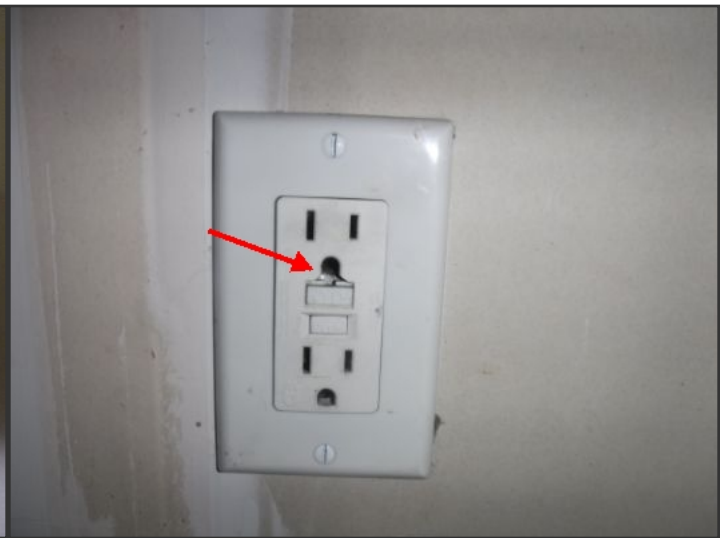
Garage, damage GFCI protected outlet

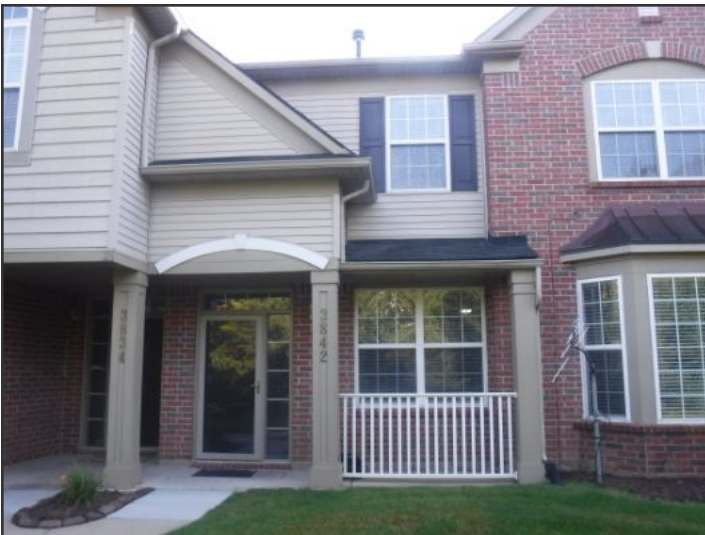
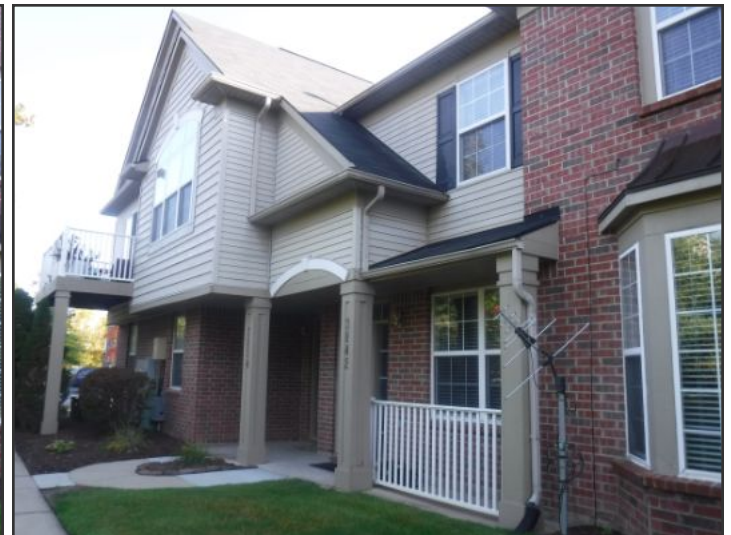
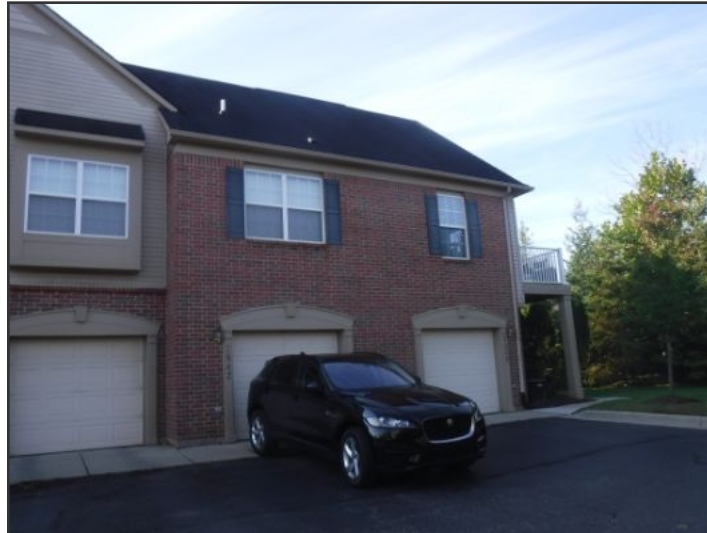
2. Example Of Exterior Photo(s)

- Exterior components and systems and Grounds are out of scope of a Condominium inspection and are not inspected except where noted below. These systems are under the jurisdiction of the condominium homeowners association. A description of property may be provided as a courtesy. It is the responsibility of the CLIENT to contact the condominium association to identify the systems they own and maintain.

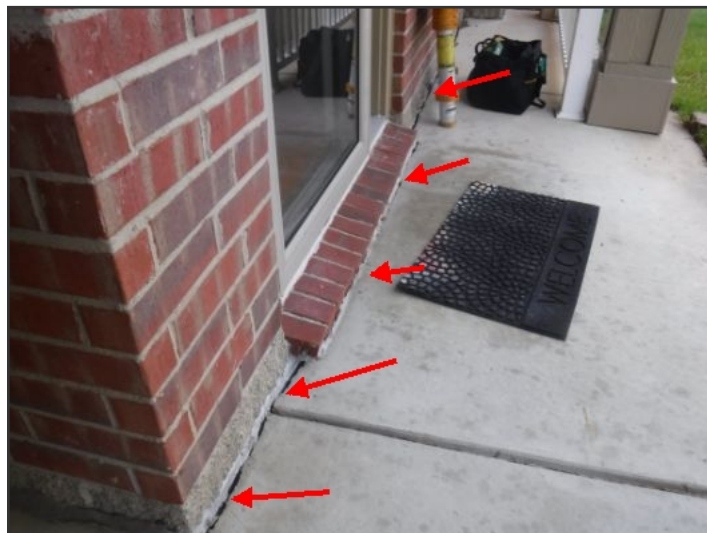
Caulking needed (Front Entry)

6.1. Fill gaps between the Walkway(s) concrete slab(s) and structure with a flexible fill material designed to prevent water drainage at foundation and from entering under the slab. Over time, the water will may seep into the basement and/or wash away soil from under the slab causing sunken areas that slope toward foundation and/or damage to the slab from the movement of saturated soil expansion and contraction through the freeze cycle.

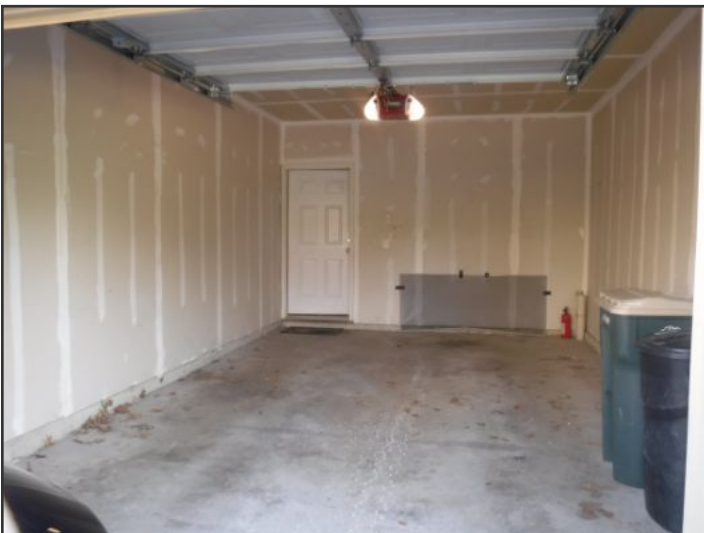
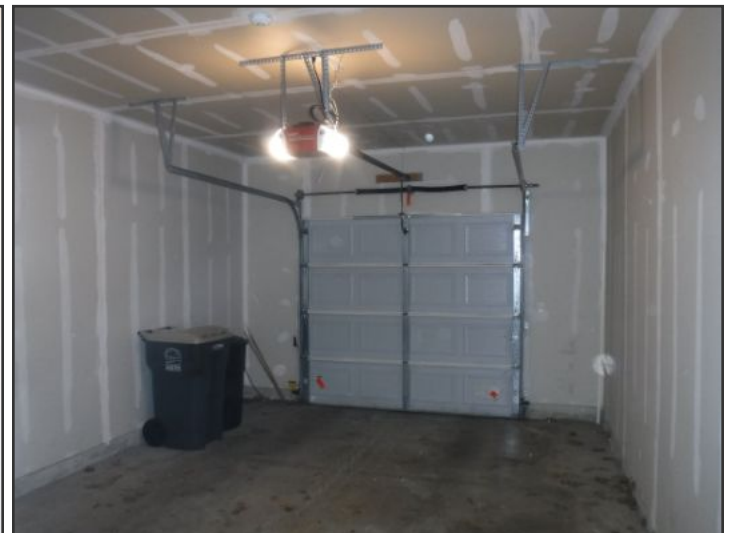
4.1. Finished ceiling and walls throughout the garage were in good condition with no significant defects noted. Some cosmetic and typical flaws were noted. This is normal wear for age of home.

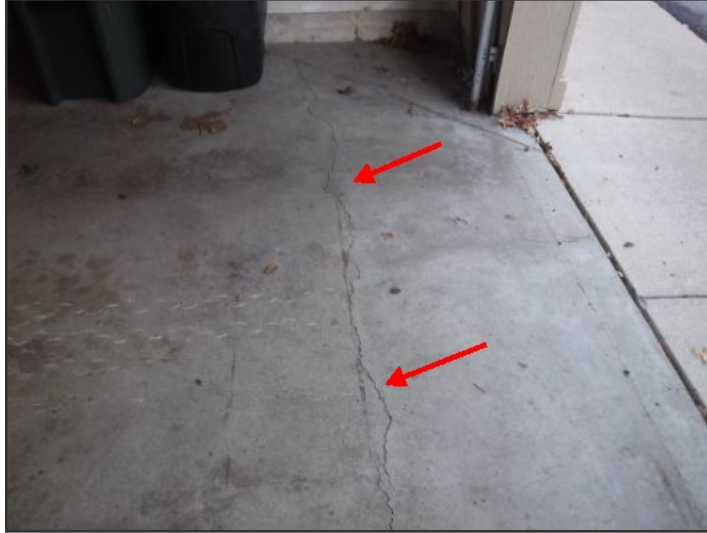
5.1. Delayed Maintenance: no major system, safety, or functional concerns noted to the exposed garage floor at time of inspection. The garage slab floor had typical cracks usually the result of shrinkage and/or settling of the slab. Recommend filling cracks with concrete repair to prevent further deterioration due to moisture intrusion and hydraulic separation from frost heaving and to prevent potential trip hazard.

Example Of Garage Floor stress cracks (No Trip Hazard)

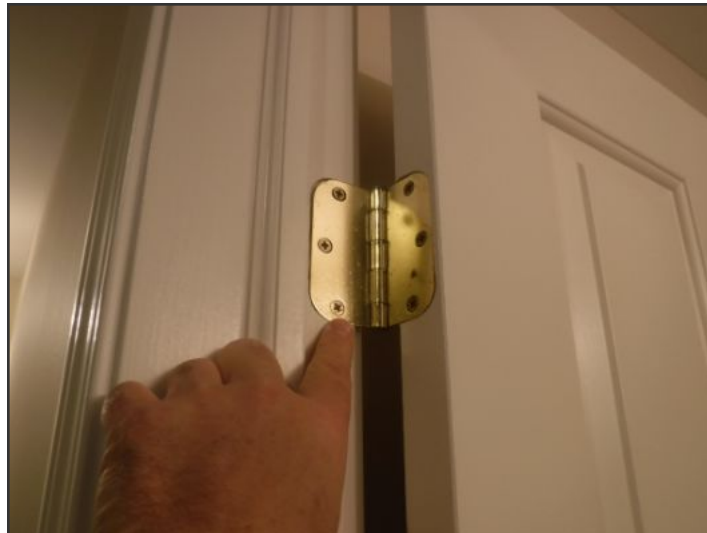
1.1. **Delayed Maintenance:** upstairs common bathroom door sticks when closing. Secure the door's loose upper hinge for smooth opening and closing.

Upstairs common bathroom loose upper hinge

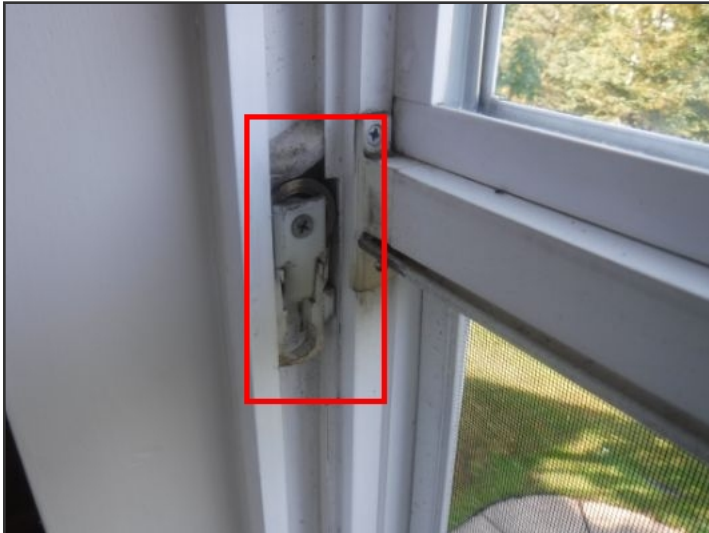
2.1. **Master bedroom, the left window would not stay open. Their sash coil assist were worn or damaged. Sash coils balancers are a necessary component to assist with operation as originally designed. Recommend repair to restore its function.**

Broken window left side sash (Master Bedroom, left window)

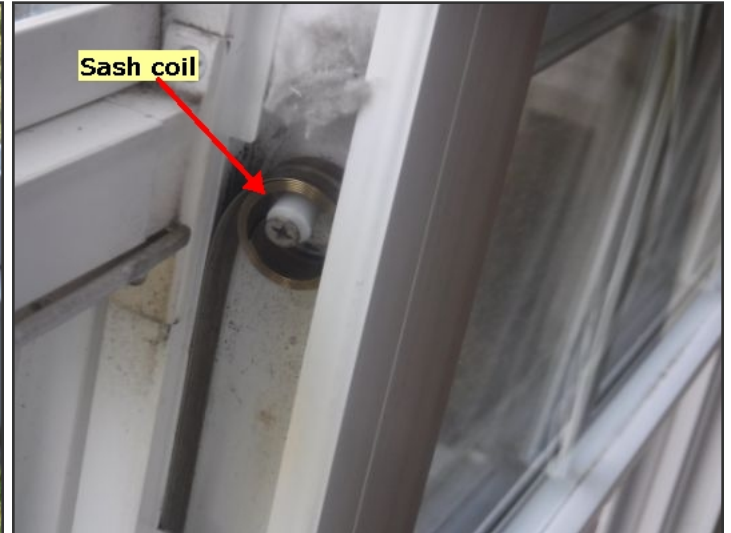
Broken window right side sash coil (Master Bedroom, left window)

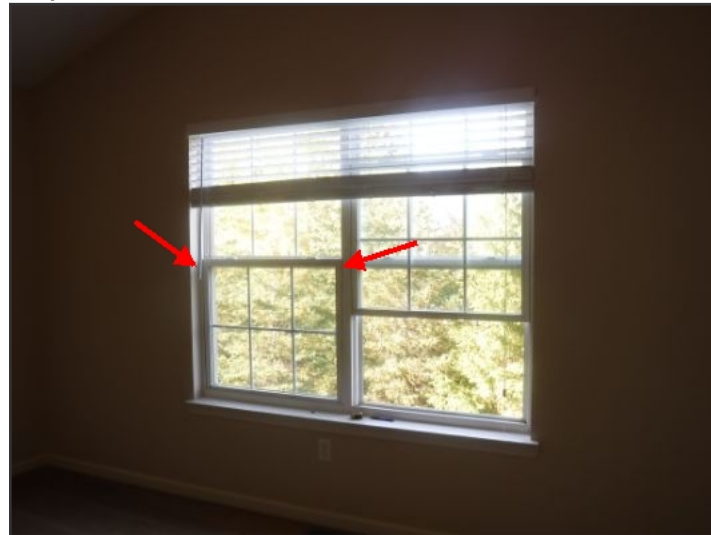
Broken sash (Master Bedroom, left window)

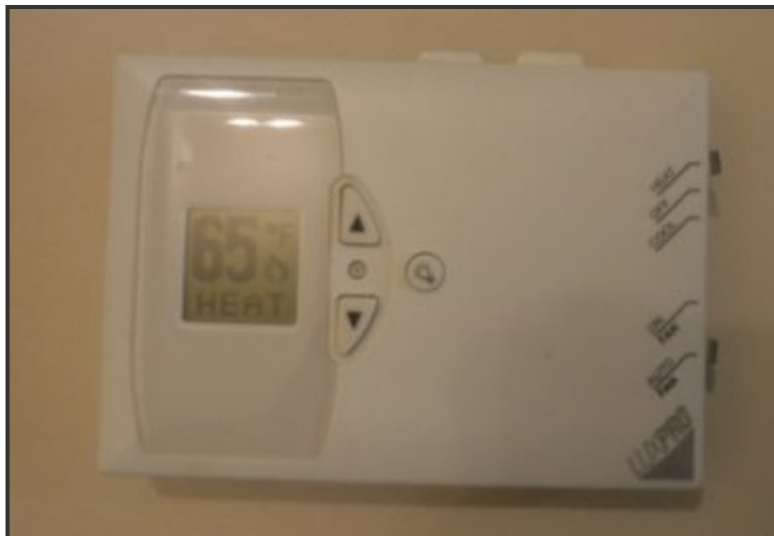
- 1.1. A digital programmable type thermostat was present on the day of the inspection and correctly attached to the wall.

Example Of Thermostat

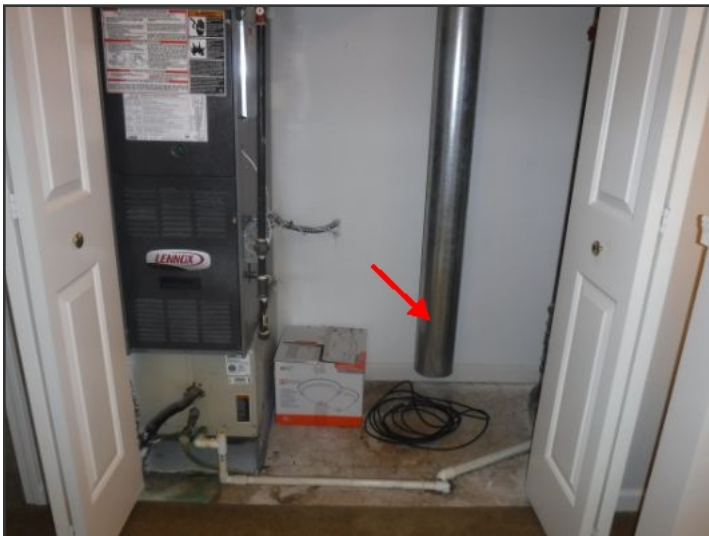
2.3. *** CAUTION *** There was a make-up air ducts installed for the furnace. Make-up air is required for proper and safe water furnace operation (burner combustion). You may notice a cooler room temperature or draft but do not block or plug the make-up air duct. There is a potential of back drafting from the furnace and/or water heater exhaust flues resulting in Carbon Monoxide entering the home.

Example of Heating System Make Up Air Duct (Do Not Block)

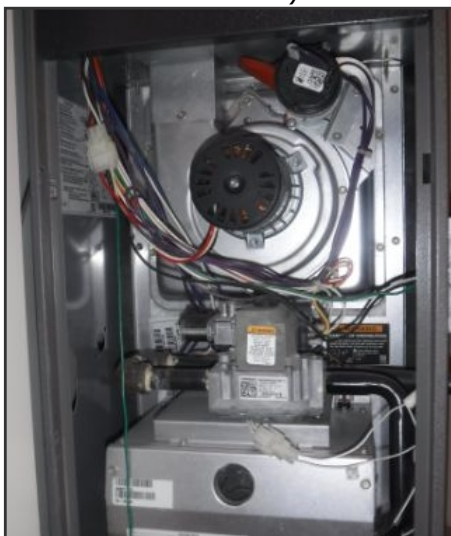
Example Of lower cabinet and burner window

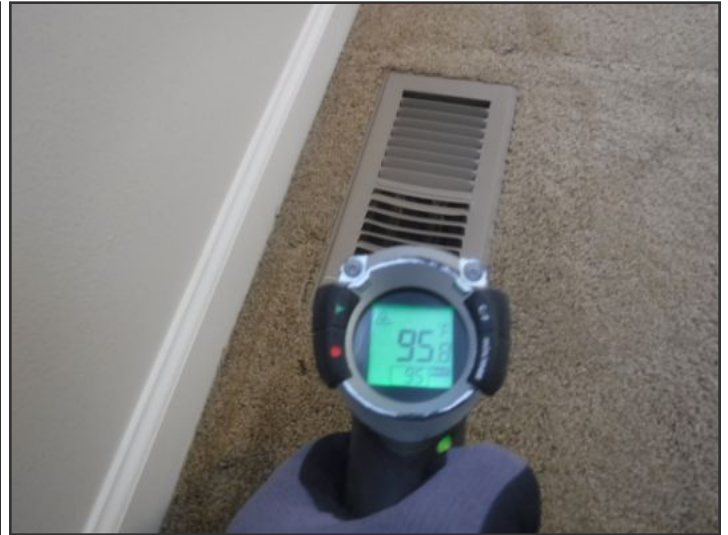
Heating air temperature during operation

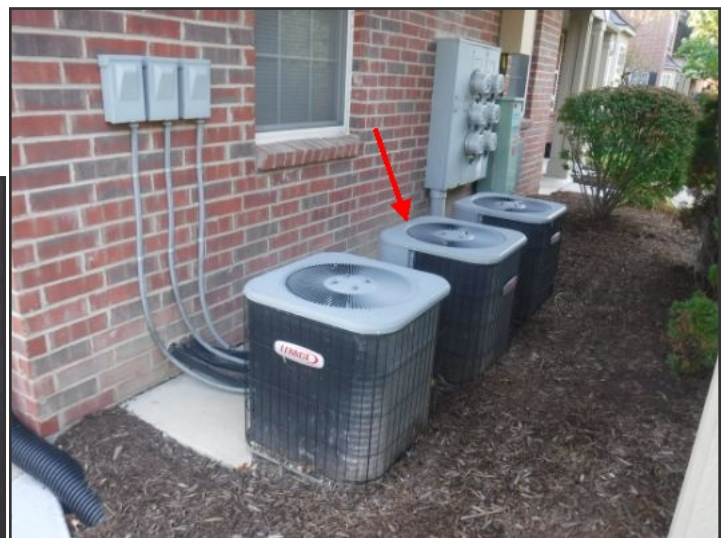
Example Of A/C Unit (your unit)

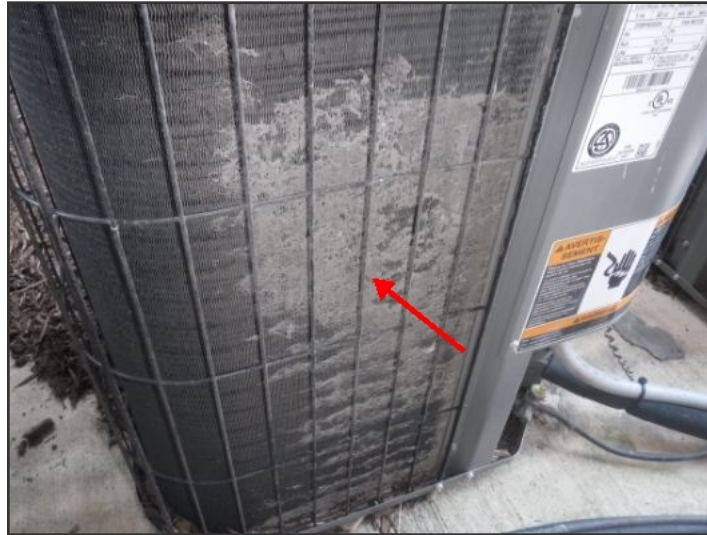
- 3.1. Outside condenser fan responded when turned on by the wall thermostat controller in manual mode.
- 3.2. Delayed Maintenance: outside condenser unit, air flow to the air conditioner condenser coil fins were restricted by dirt and/or debris on the exterior (delayed maintenance). The fins should be cleaned in order to maintain cooling system efficiency and avoid problems from overheating of the compressor.

Example Of A/C Unit dirty fins

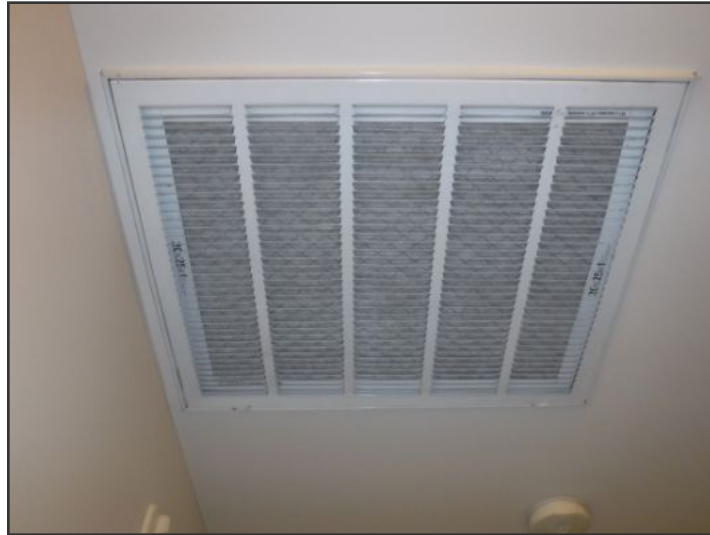
6.1. **Delayed Maintenance:** the air filter was a disposable type and observed to be dirty. Replace filter with manufactures recommend filter to enhance air quality as well as extending the lifespan of the furnace.

Ceiling access to air filter (upstairs hallway)

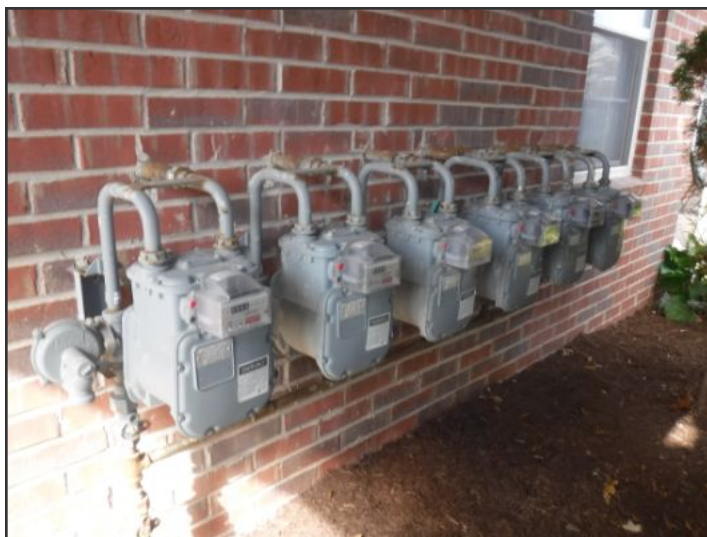
- 1.1. I did not smell any gas odors (Sulfur - similar to rotten egg odor) which is an indication of a leak. No evidence of damage was observed with the accessible gas piping today (concealed plumbing can not be inspected).

Example Of Gas Service Meters And Shut Off Valves

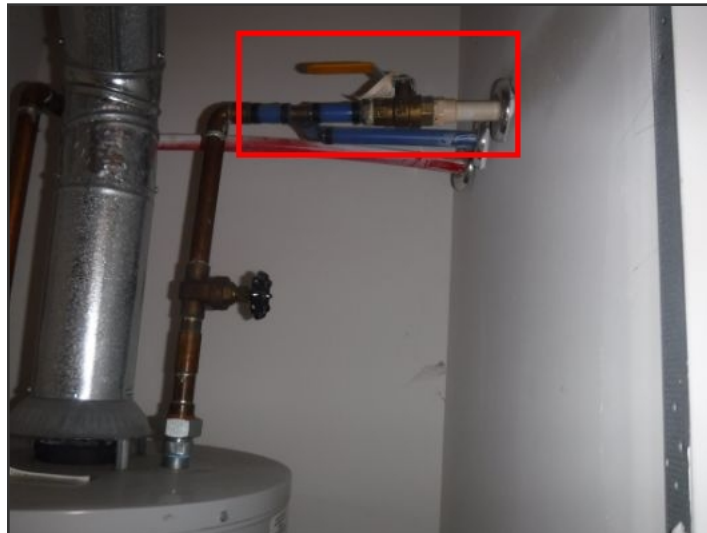
3.1. Good water flow, no visible drop in water flow when tested with two fixtures running water simultaneously. The property was vacant and the plumbing system has not been used on a regular basis. As part of my inspection, I ran the water from the plumbing fixtures for an extended period. No active leaks were observed during the inspection. Recommend annual maintenance inspection and repair any as needed and reviewing seller disclosure statement for history of leak/repair.

Example Of main shut off valve

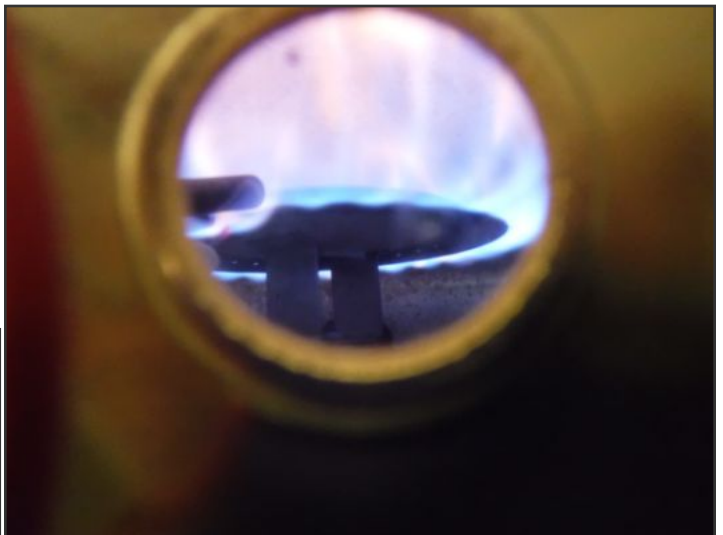
Example Of Water Heater Burner In Operation

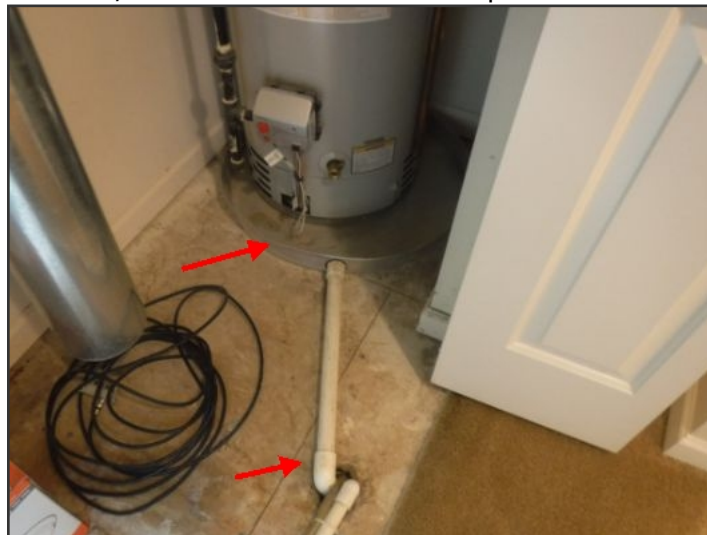
4.3. The water heater had a galvanized metal drip pan installed with a drain tube to the floor drain.

Drip pan and drain to floor drain

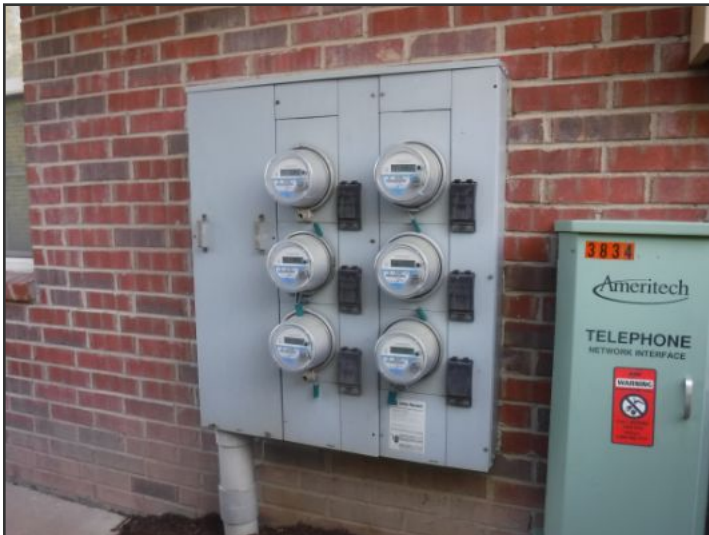
- 1.1. The exterior meter box was in good condition. No major rust or damage. Not loose.

Example Of Service Meters

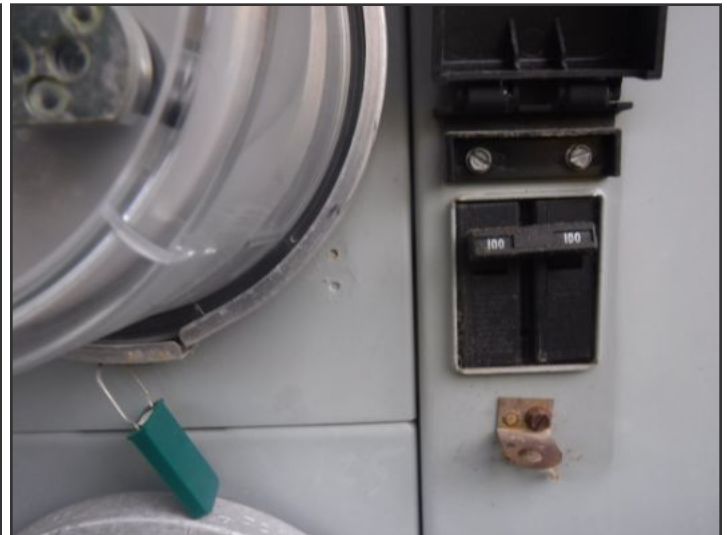
Main Breaker at meter (100 amp)

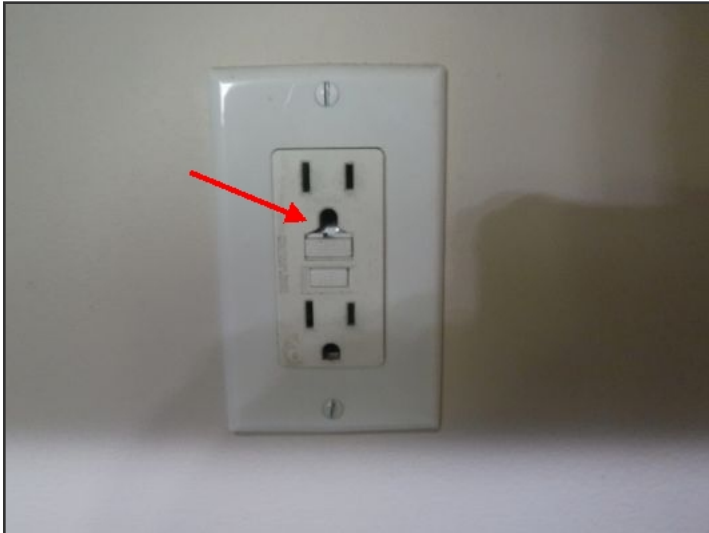
1. Laundry room outlets not GFCI protected, replace outlets with GFCI protected outlets.
2. Kitchen and garage GFCI protective outlets were damaged (ground slot), replace.

Kitchen, damage GFCI protected outlet (right side of refrigerator)

4.3. The following electrical safety defects were observed today. Recommend service and correction by a qualified electrical contractor to ensure safety of the occupants and to uncover problems not discovered or that are beyond the scope of home inspection standards.

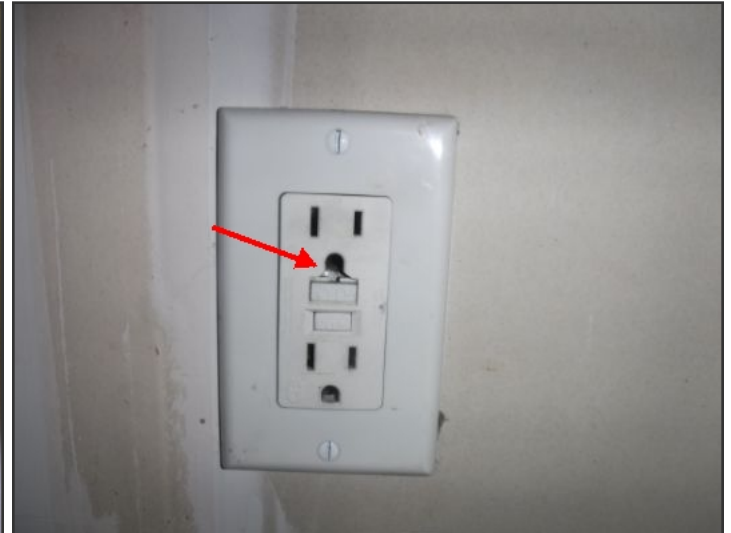
Garage, damage GFCI protected outlet

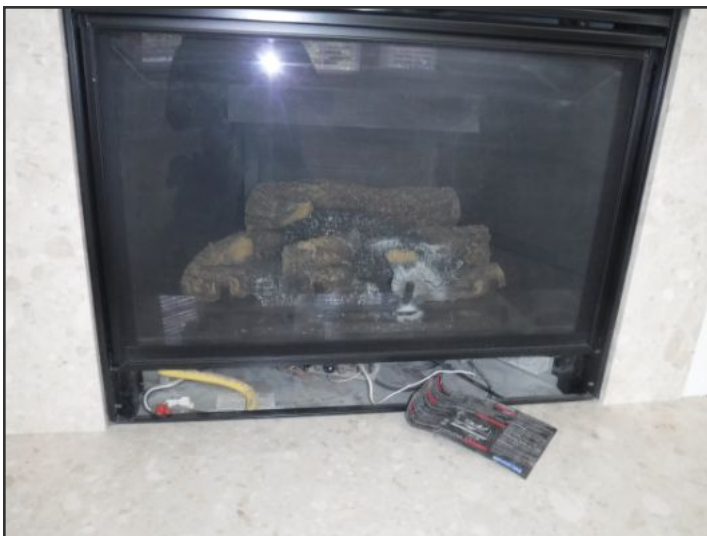
- 2.1. The fireplace fan did not activate when turned on by the wall switch. Recommend service.

Example gas fireplace with lower gas control/ shut-off valve

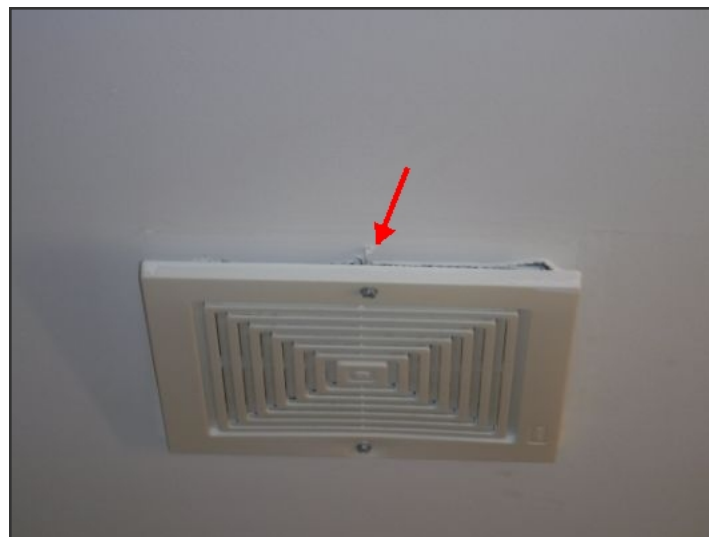
- 2.1. Interior exhaust fan(s) operated at time of inspection. Note fan CFM Volume/capacity is out of scope of inspection.
- 2.2. Delayed maintenance, upstairs common bathroom ceiling fan grill was loose. Recommend securing.

Upstairs common bathroom loose ceiling fan grill

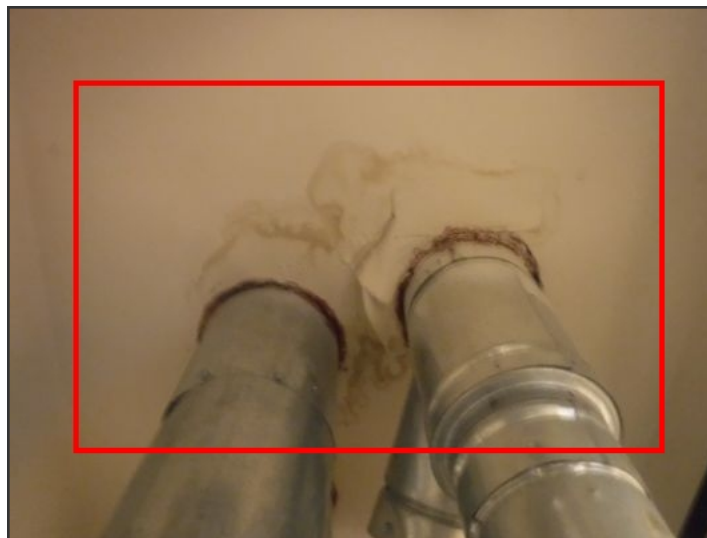
1.1. On the main floor, I did not observe any ceiling/wall moisture stains or ceiling patching below the second floor bath(s) areas. The second floor, in the utility closet I did observe dried ceiling stains around the vent ducts. There was active leak today but the stains are indication of prior leaks from attic region. Ask the seller and refer to the seller's disclosure in reference to any water/moisture history and damage/ repairs. Only the property owner would have accurate knowledge of this information.

Utility closet, dried ceiling stains
