Waterfront Reconstruction Project Shoreline View

There are two components to this project: A Land Based Portion and a Water Based Project

Waterfront Reconstruction Project Proposal to Establish a Perched Beach

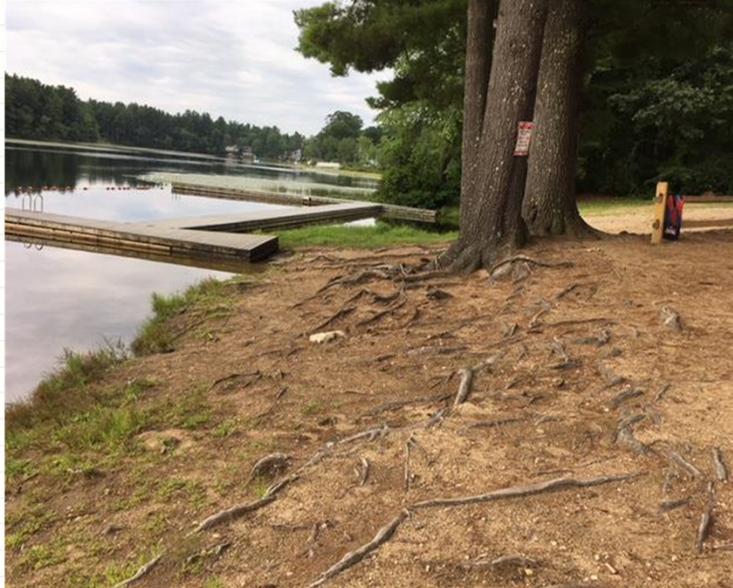
The waterfront area at Wasserman Park is the only official public swimming area within the Town of Merrimack for our residents and unfortunately it's not a very nice setting at this point due to significant erosion over the years.

In addition to the aesthetics of the beach, the exposed root system from these giant pine trees in the middle of the beach have created a significant safety hazard for beach users. The roots extend all the way to the water and so people utilizing the beach have to climb over the roots to get to the docks.

The first component of this project is the land based portion of the project to address the erosion and safety issues that exist on our beach. As you can see from the pictures which were taken last summer, there is hardly any sand on our beach anymore since it has all washed into the lake.

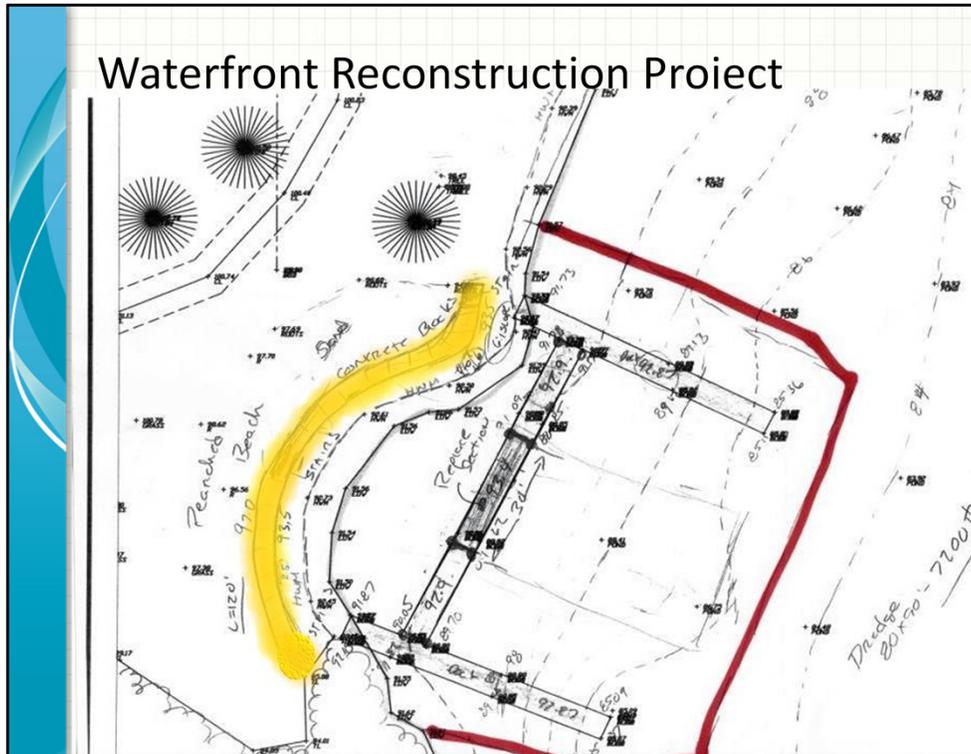
For the land Portion of the project – it consists of several steps:

- First we must reluctantly remove the two pine trees and their root system from the center of the beach. In addition to the tripping hazard caused by all of the exposed tree roots; all the pine needles contribute heavily the organics in the front section of the dock (which makes it all but unusable).

- We are prohibited by State Law from simply dumping new sand on the beach. State Law only allows for 10 cubic yards of sand (we would need 80 cubic yards to cover all the tree roots). In addition, before the State will grant permission for 10 yards of new sand you have to establish a way to prevent the new sand from going into the water. The only way that we can do that is remove the tree and its roots and regrade the beach. The trees are no longer holding the embankment which is why the beach needs to be rebuilt.

- We would then establish a 210 foot grass lined swale above the beach area to divert the water that is coming down the hill and move it away from the swimming area.

- We will then build a perched beach to address not only the slope of the area but will also address future erosion of the sand so that it doesn't wash into the lake as it does now. This is represented by the yellow line on this chart.

- Once the perched beach is established, 80 cubic yards of sand are added to the beach to complete the land portion of the project to restore the beach.

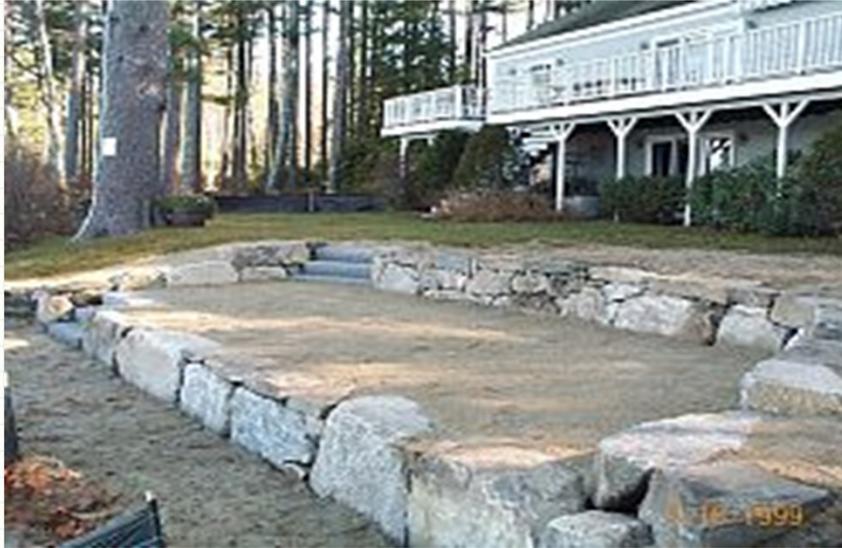
What is a perched beach? A perched beach is a beach area that is elevated at least 12 inches above the high watermark. Similar to a garden terrace, there is a retaining wall set along the water's edge with steps allowing easy access to the water; often there is a retaining wall on the uphill side as well to provide a level beach area.

A “perched beach” must have little or no slope and must be located entirely out of the water, above and landward of the existing undisturbed natural shoreline. Narrow access steps to the water (and the docks) may be incorporated into the design. All sand must be placed above the high water mark and out of the water. The construction of a beach in a perched position helps prevent the future erosion into the lake. A perched beach requires less maintenance, which is a benefit to the landowner

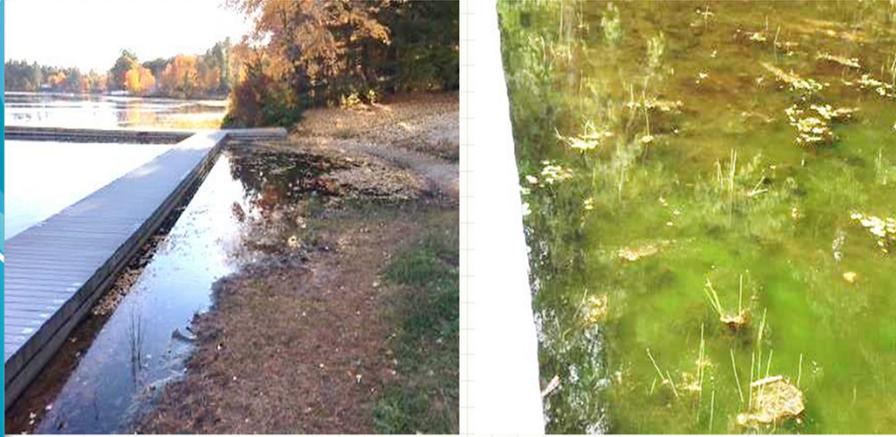
Waterfront Reconstruction Project Front section of the water

The front section of the swimming area in a “normal summer” starts at about 1 foot deep at the beginning of the summer. This sits on top of several inches of muck which is caused by erosion into the lake and poor water circulation. By the end of the summer this front section of the water is down to about 5”; which makes the front section unusable for the most of the summer.

What little water is here sits on top of several inches of mud so when you step in it you sink in. There are actually markings on the dock showing the lake depth in this front section used to be 2 feet deep. Over the last few years; the water depth has dropped every year and this summer it was down to just a few inches of water as it is filled with mud and organics.

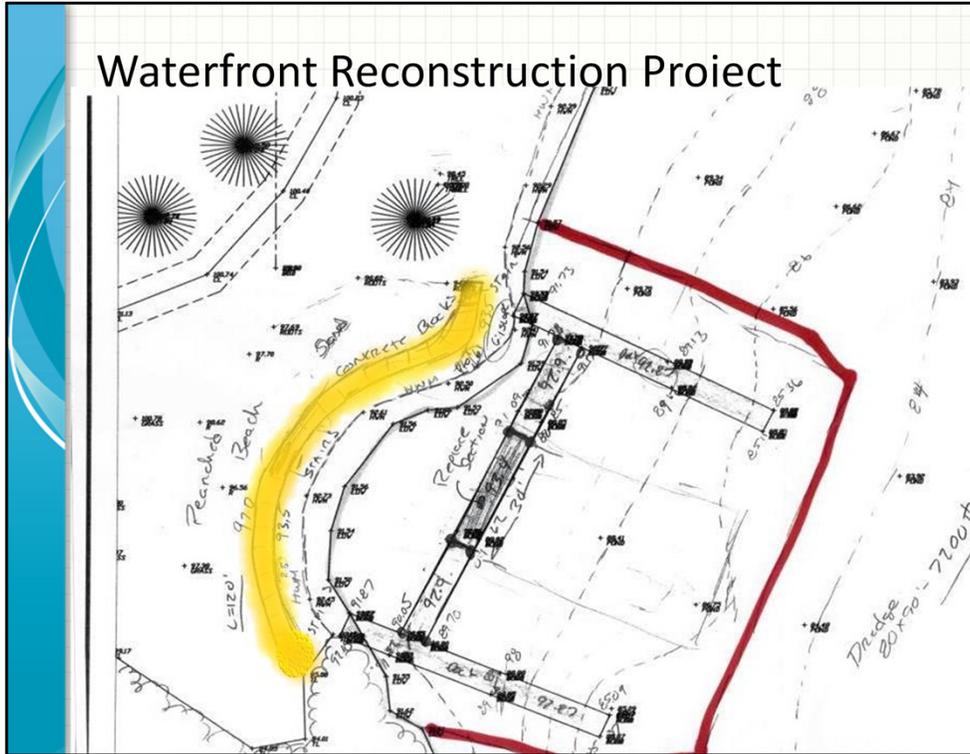
Water Based Portion of Project

The second portion of the project which is dealing with the existing conditions in the lake itself. What we are doing is reclaiming what we've lost over the years due to the erosion.

- The way that we do this is that we start by installing a temporary cofferdam around the swimming area (marked in red on the map). It will be 80 feet x 90 feet in length.
- Once the temporary cofferdam is build; the entire area dredged of all the mud and organics that have accumulated over the years and is restored to a much nicer resource for our residents to utilize.
- Once the excavation is complete the cofferdam is removed and the swimming area is restored.
