PRELIMINARY ASSESSMENT/
FOCUSED SITE INVESTIGATION REPORT

FORMER AEROMARINE PROPERTY
55 WALNUT STREET
TAX BLOCK 141, LOTS 14, 15, AND 15.01
KEYPORT, MONMOUTH COUNTY, NEW JERSEY
PROGRAM INTEREST NO. G000030506

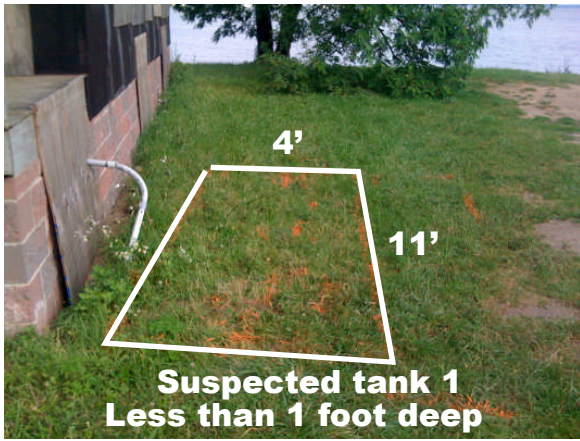
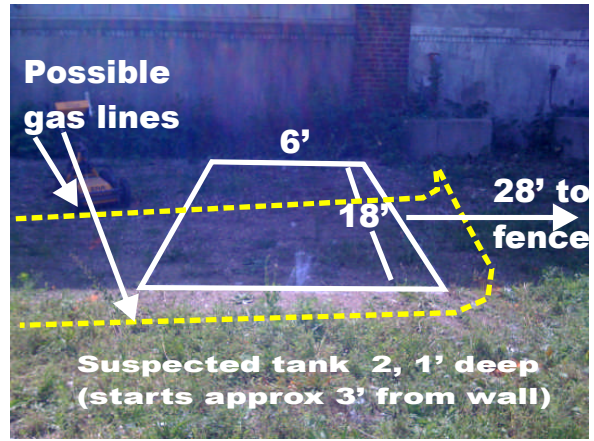
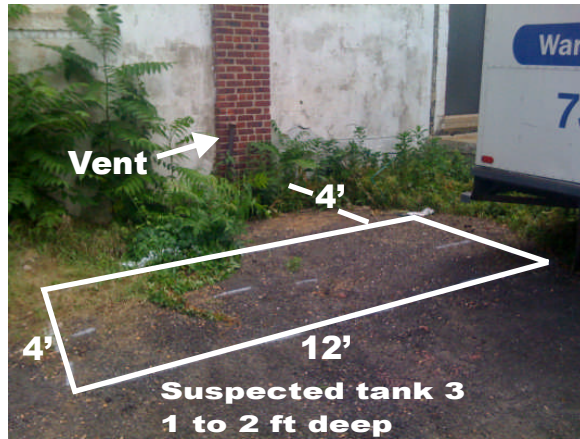
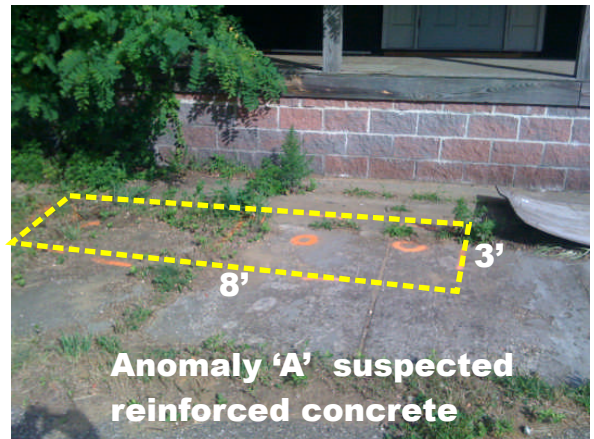
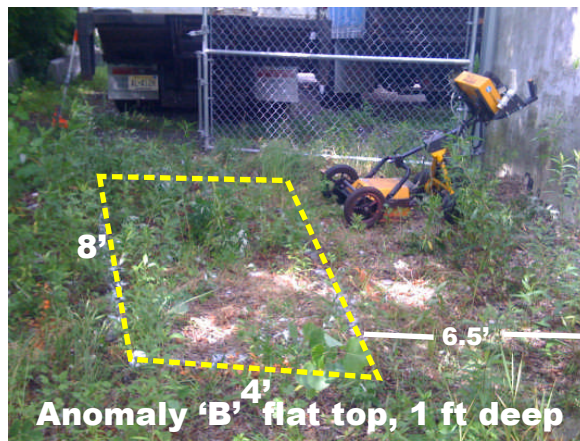
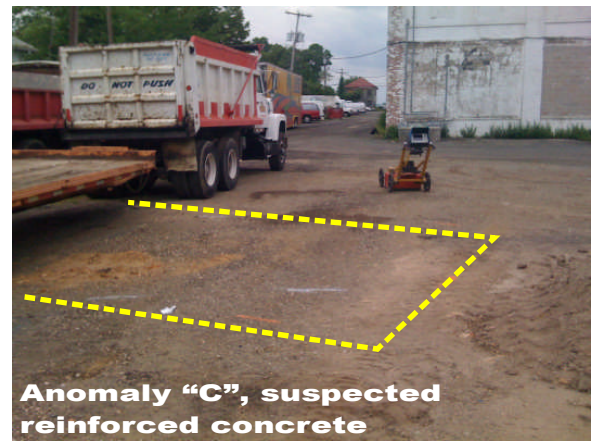
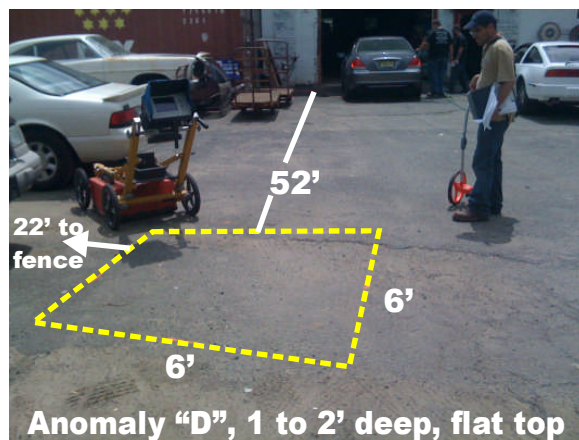
NOTICE: The methods used at this site have been used successfully at many sites to locate buried targets. There can be no guarantee, however, that every target will be detected at a particular site. Sub-surface conditions may prevent some or all geophysical methods from detecting a particular buried target. This is particularly true for non-metallic targets and areas paved with steel-reinforced concrete. Target locations should be considered accurate to one foot on each side for targets defined by radar, and two feet per end for targets defined by other means.
