SENSITIVE AREA CERTIFICATION FORM

Clean Water Services File Number 21-003135

On behalf of the Portland Golf Club (PGC), Terra Science, Inc. (TSI) prepared the following report to document site conditions and delineate wetlands for a proposed irrigation pond maintenance project. The study area includes an undeveloped parcel adjacent the golf course (herein, the Pinger Property), the immediate vicinity of the irrigation pond within the golf course, and a potential haul road corridor and staging locations between the pond and the Pinger Property. PGC is located within an unincorporated portion of Washington County, Oregon between Beaverton and Portland (Appendix A, Figure 1). More specifically, the ±17.43-acre study area consists of a portion of Tax lot 1700 on County Assessor Map Township 01 South, Range 01 West, Section 24, Willamette Meridian (Appendix A, Figure 2). Access to the study area is from Scholls Ferry Road (OR 210) approximately 0.9-miles south of Beaverton-Hillsdale Highway (OR 10). The centroid of the study area is approximately 45.471435° N and -122.760355° W.

Wetland Delineation Report for Portion of Tax Lot 1700, T. 1S R. 1W Sec. 24

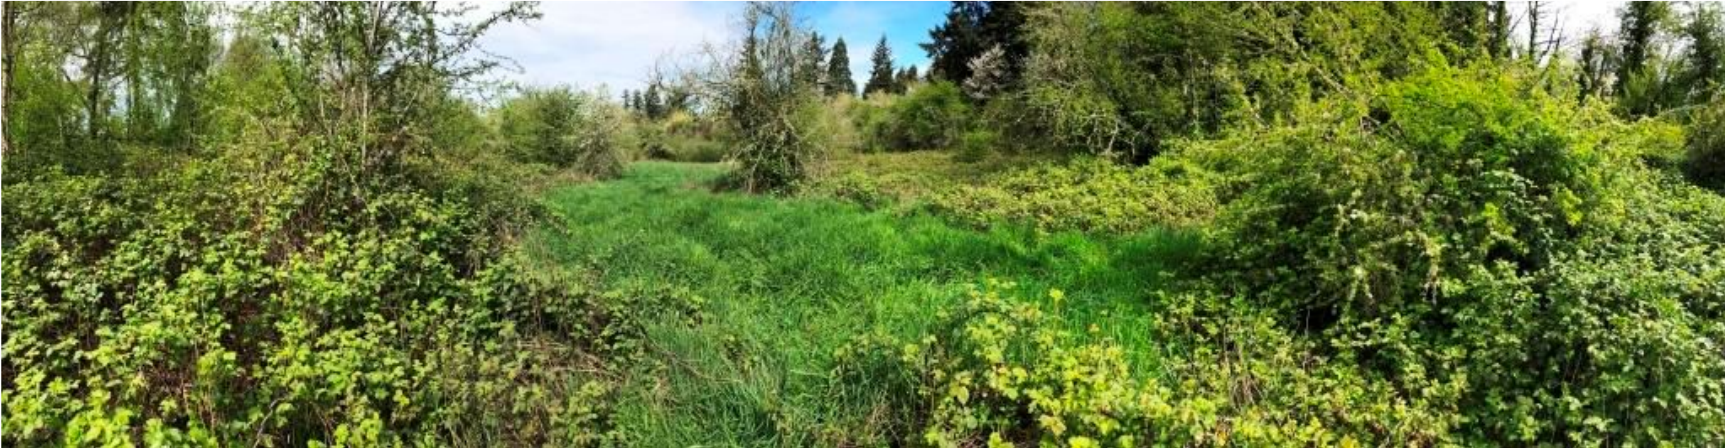
Photo Point A (above, taken 4/20/2018): Northwest to northeast facing view of south part of Wetland A which is dominated by meadow foxtail in the wetter portions and Himalayan blackberry around the fringe.

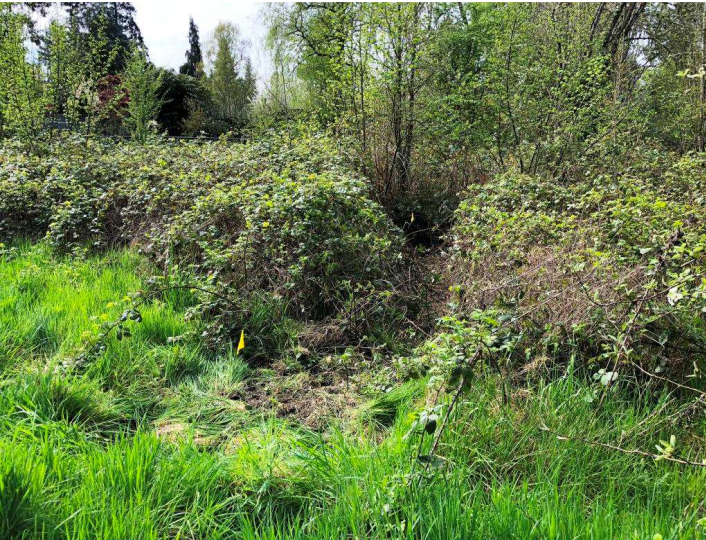
Photo Point B (left, taken 4/20/2018): Southwest facing view of sample transect T2 (yellow flags).

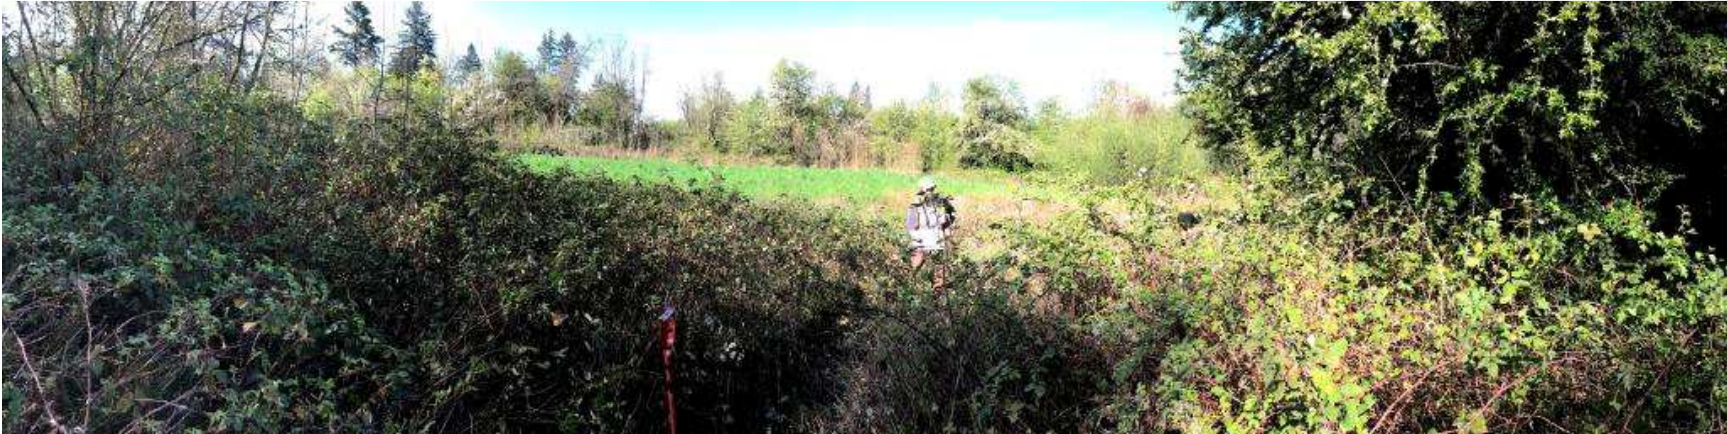
Photo Point C (above, taken 4/20/2018): Southwest to northwest facing view of Wetland A from vicinity of sample transect T1. Himalayan blackberry dominates the fringe of the wetland with meadow foxtail and spreading rush evident in the wetter areas (background).

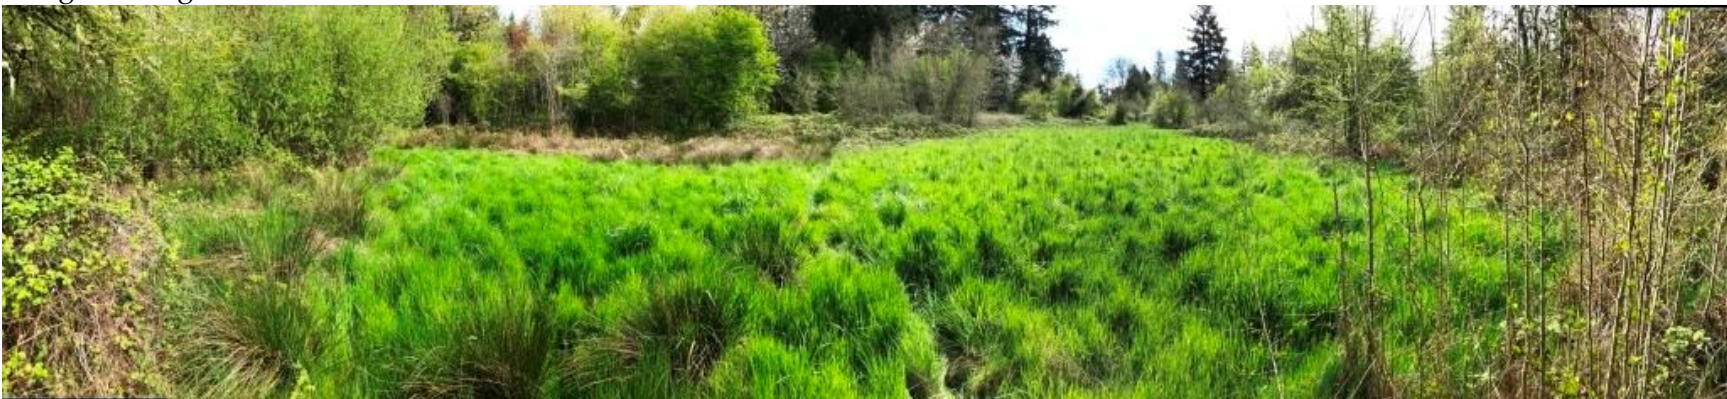
Photo Point D (below, taken 4/20/2018): East to south facing view of the northwest part of Wetland A. The lower elevation portion of the wetland is dominated by spreading rush and meadow foxtail with willow, English hawthorn, and Himalayan blackberry along the fringe.

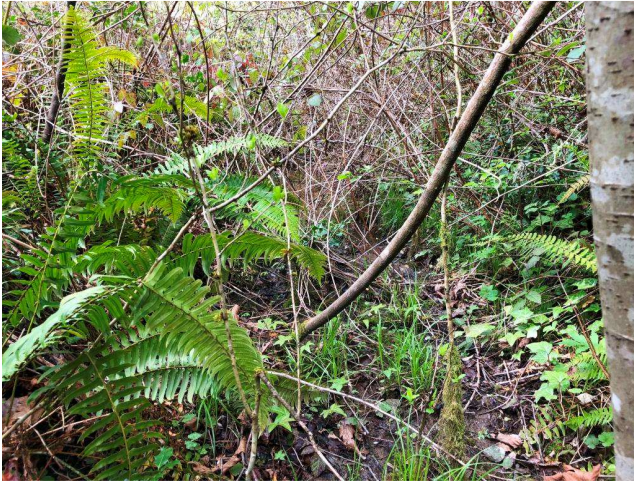
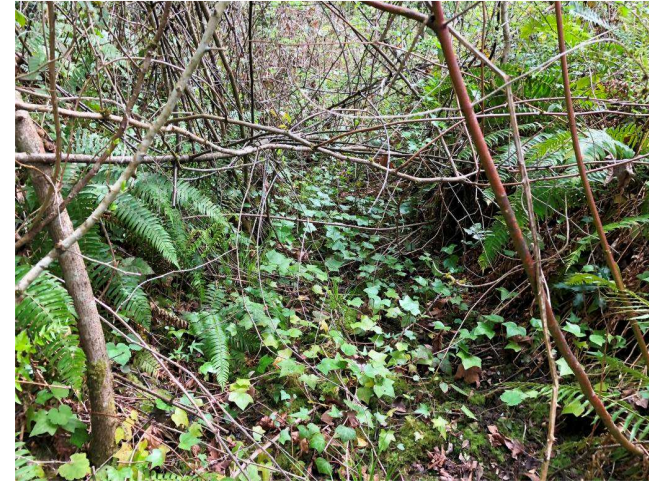
Photo Point E (left and right, taken 4/20/2018): West (left) and east (right) views of the remnant rail line ditch taken at the upper (east) extent of wetland within the ditch. Atlantic ivy is the dominant vegetation in much of the understory outside of the wetland both in and outside of the ditch.

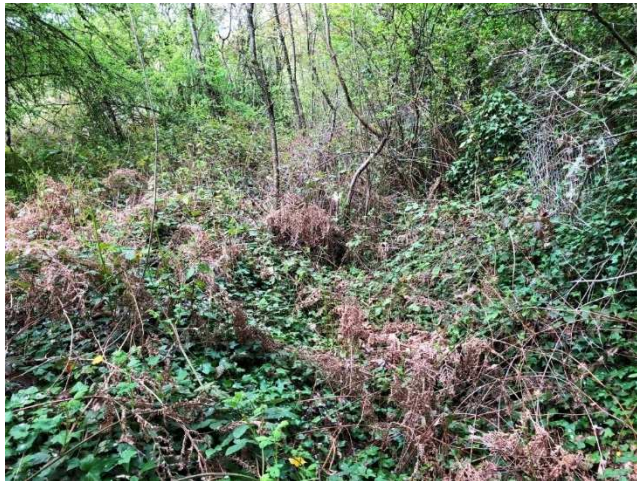
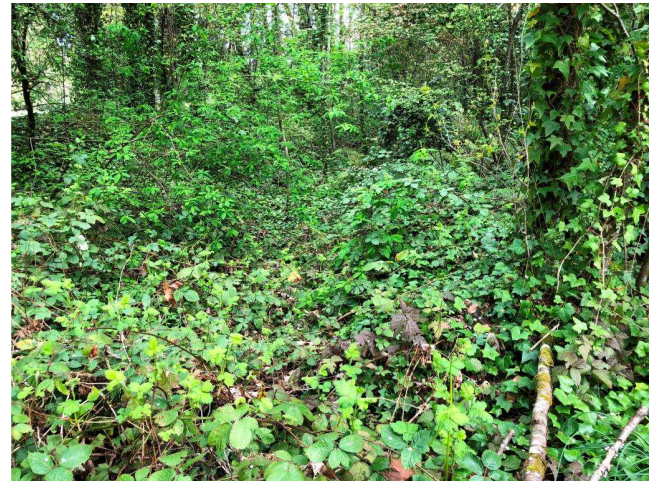
Photo Point F (left and right, taken 4/20/2018): West (left) and east (right) views of the remnant rail line ditch taken from vicinity of sample plot SP-C. Atlantic ivy and Himalayan blackberry are the dominant vegetation in much of the understory.

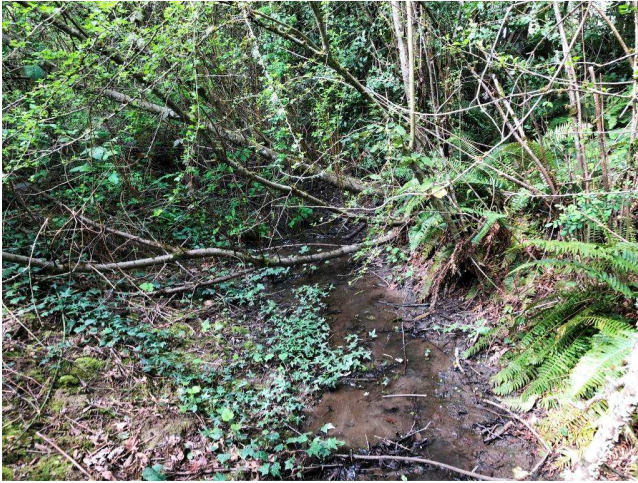
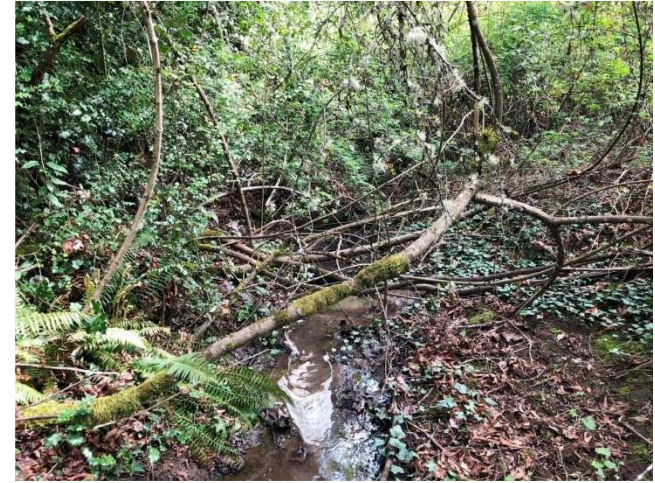
Photo Point G (left and right, taken 4/20/2018): West (left) and east (right) views of the remnant rail line ditch taken from northwest part of study area just downstream (west) of where the wetland swale discharges.

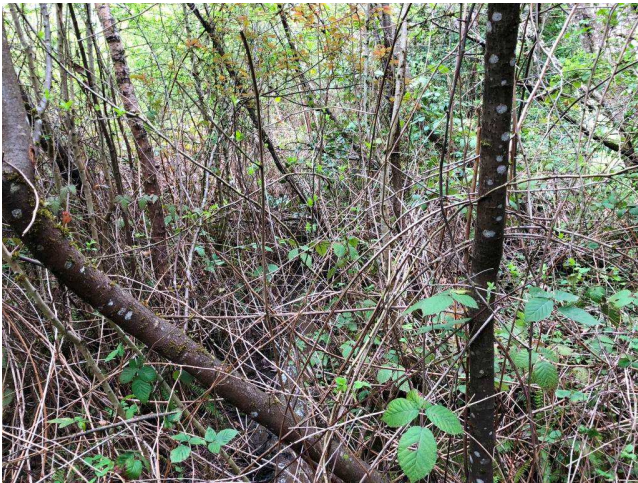
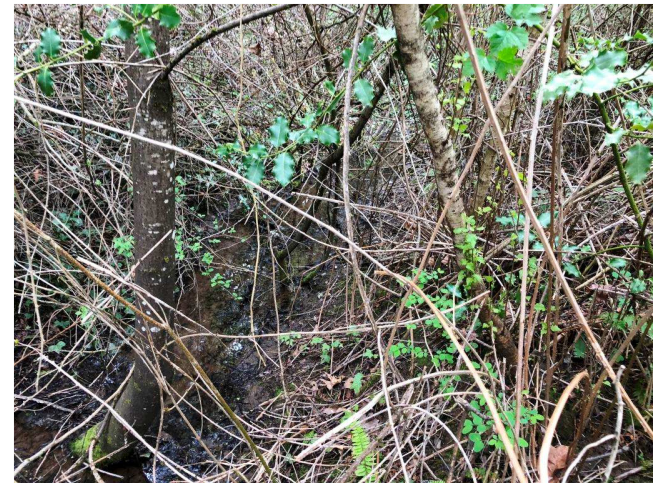
Photo Point H (left and right, taken 4/20/2018): West (left) and east (right) views of the remnant rail line ditch taken from vicinity of sample transect T2. The ditch is incised at this location.

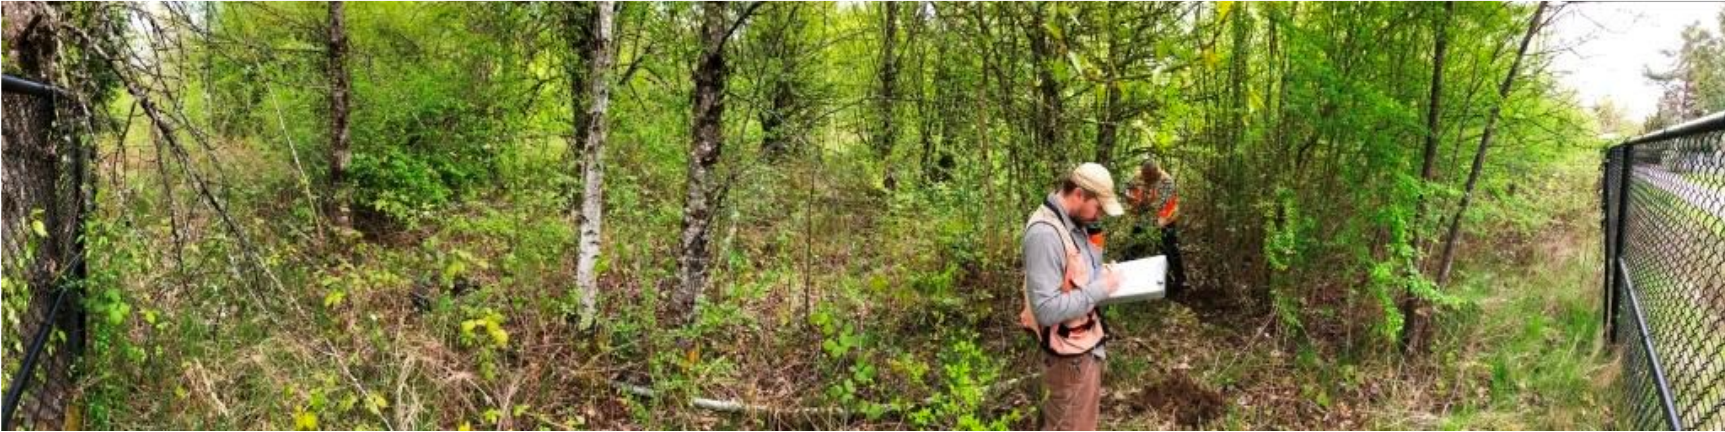
Photo Point I (above, taken 4/20/2018): North to south facing view of west part of Pinger Property taken from vicinity of sample plot SP-B. This part of the study area is dominated by English hawthorn, Himalayan blackberry, Atlantic ivy, and sweet vernal grass with several black cottonwoods in the overstory.

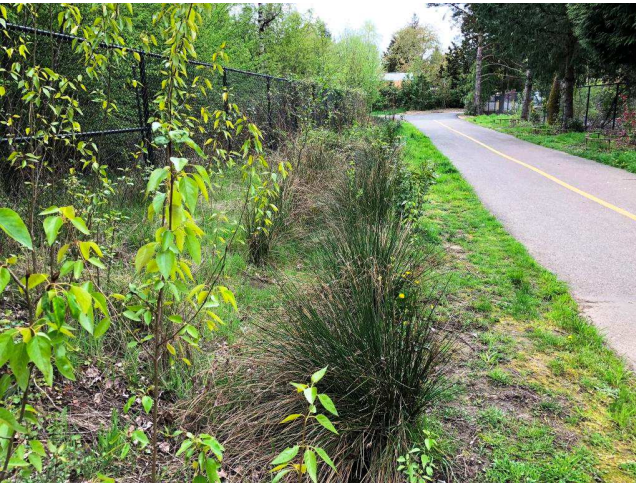
Photo Point J (left, taken 4/20/2018): South facing view of offsite ditch and Fanno Creek trail along west edge of Pinger Property.

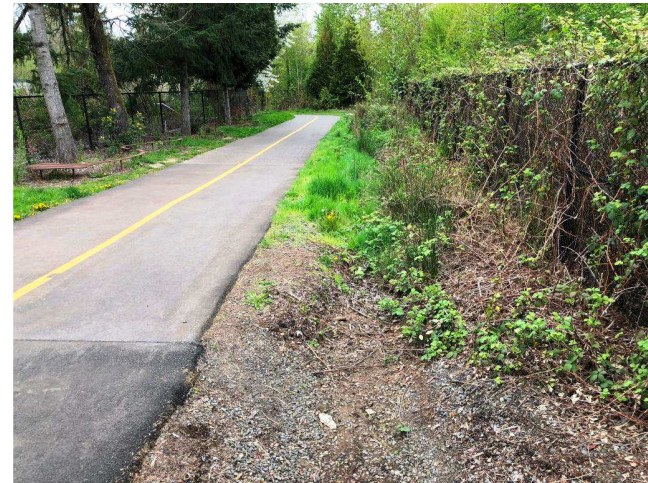
Photo Point K (right, taken 4/20/2018): North facing view of offsite ditch and Fanno Creek trail along west edge of Pinger Property.

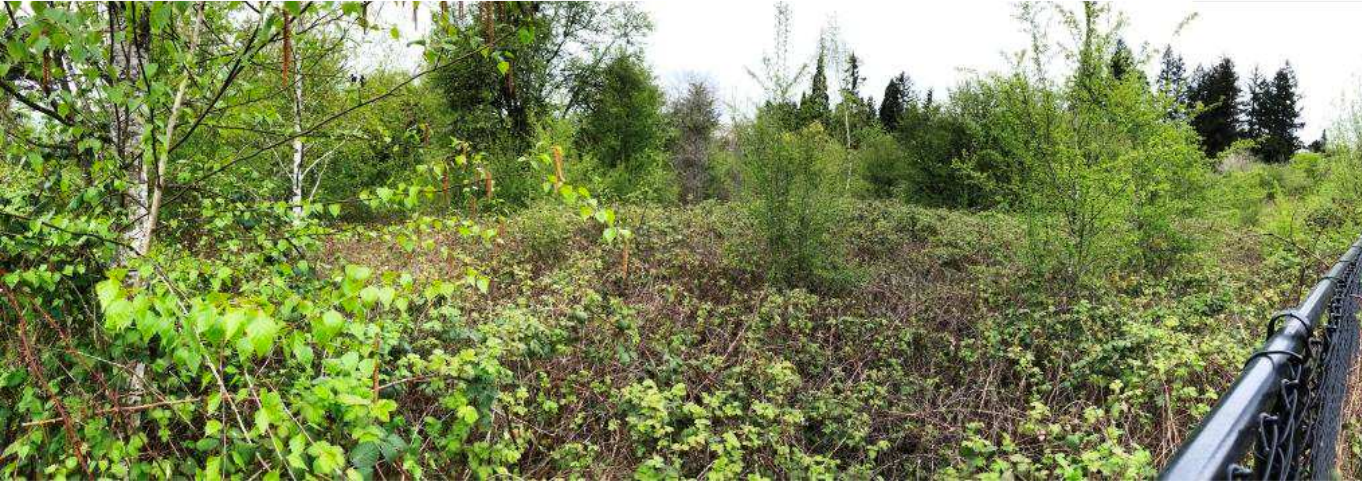
Photo Point L (above, taken 4/20/2018): North to east facing view of southwest corner of Pinger Property. Himalayan blackberry and English hawthorn are the dominant vegetation.

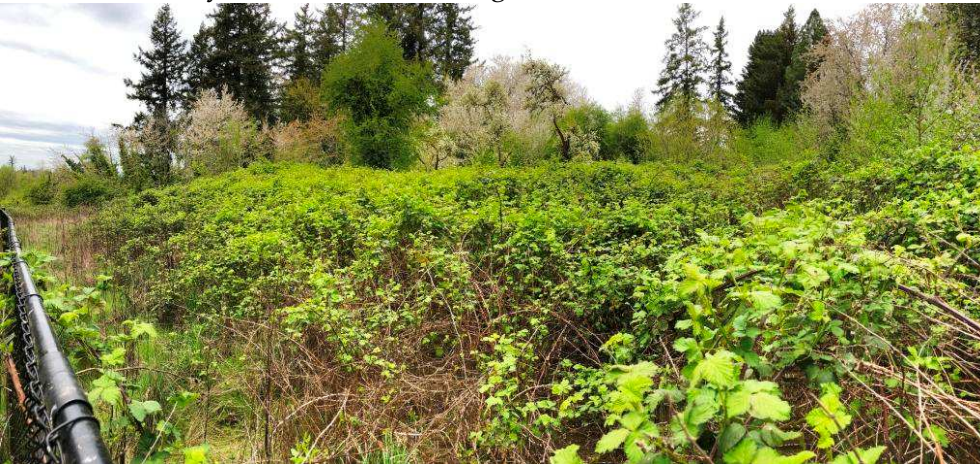
Photo Point M (below, taken 4/20/2018): West to north facing view of southeast corner of Pinger Property. Himalayan blackberry and sweet cherry are the dominant vegetation.

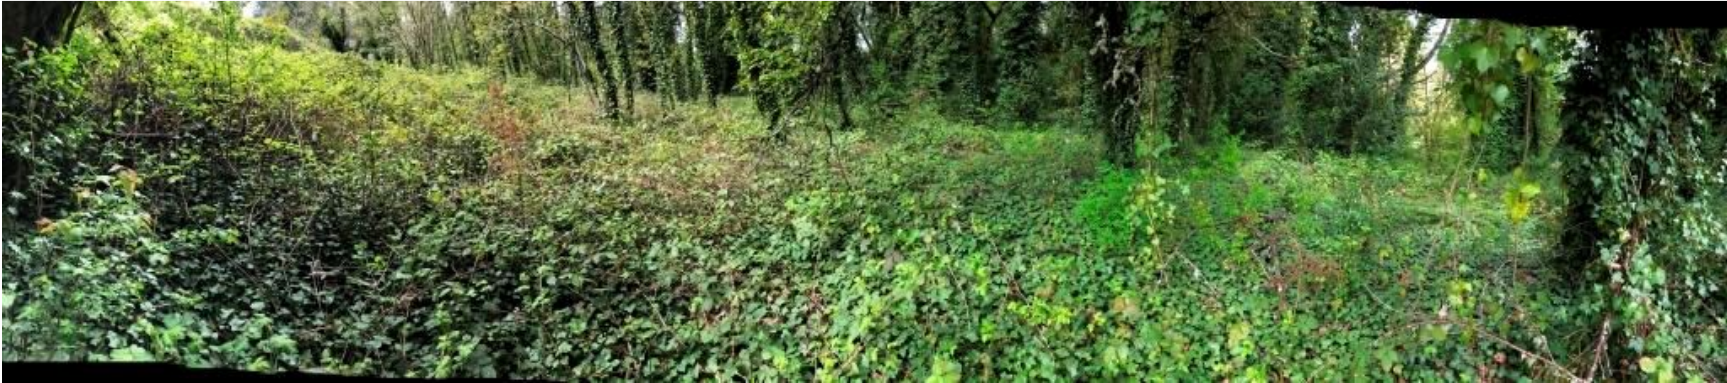
Photo Point N (above, taken 4/20/2018): Southwest to northwest facing view taken from central east part of Pinger Property showing typical vegetation on the gentle knoll in the east part of this part of the study area. Much of this area is dominated by Atlantic ivy, English hawthorn, and Douglas fir.

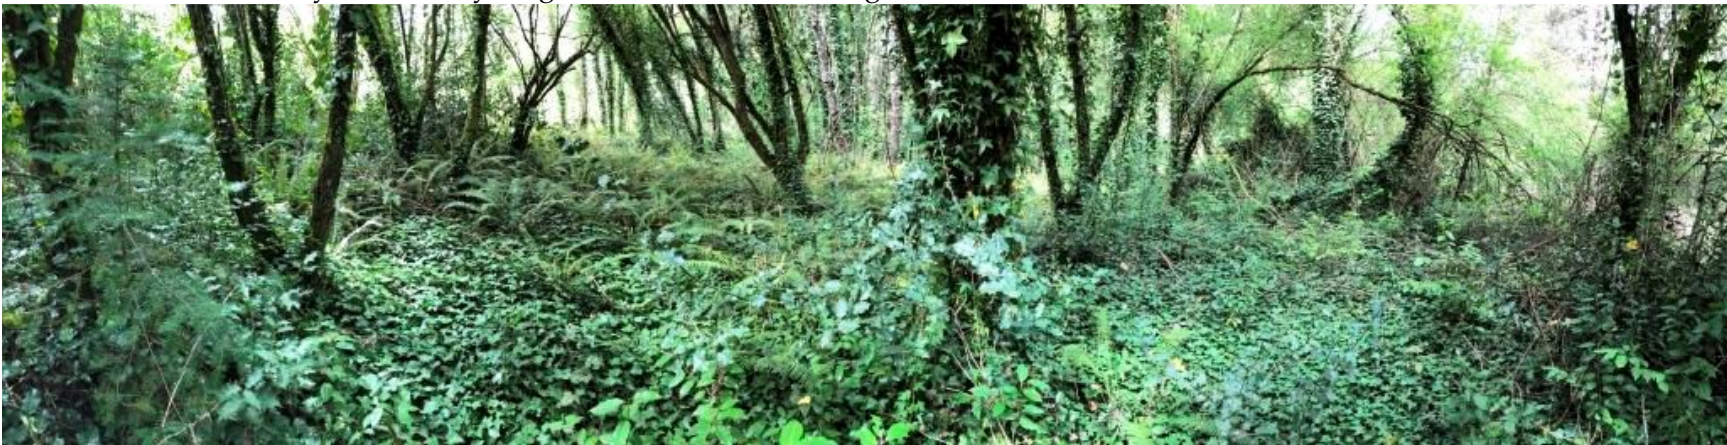
Photo Point O (below, taken 4/20/2018): Southwest to northeast facing view taken from along east edge of Pinger Property. Much of this area is dominated by Atlantic ivy, English hawthorn, and Douglas fir.

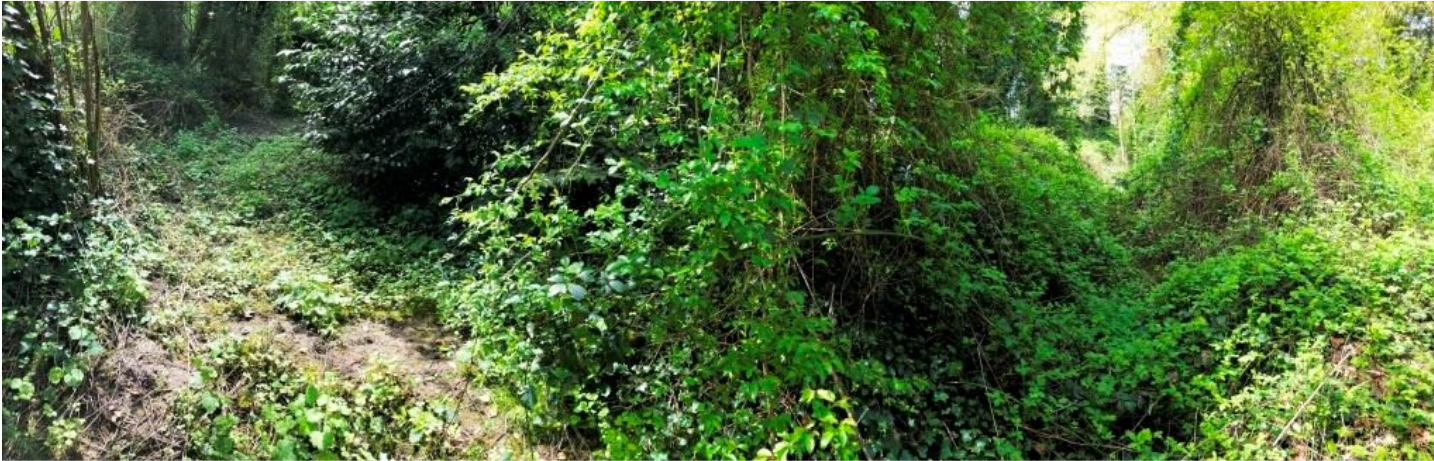
Photo Point P (above, taken 4/20/2018): South to west facing view taken from northeast corner of Pinger Property. The remnant rail line ditch can be seen in the right part of the photo. Much of this area is dominated by Atlantic ivy, English hawthorn, cherry laurel, and Douglas fir.

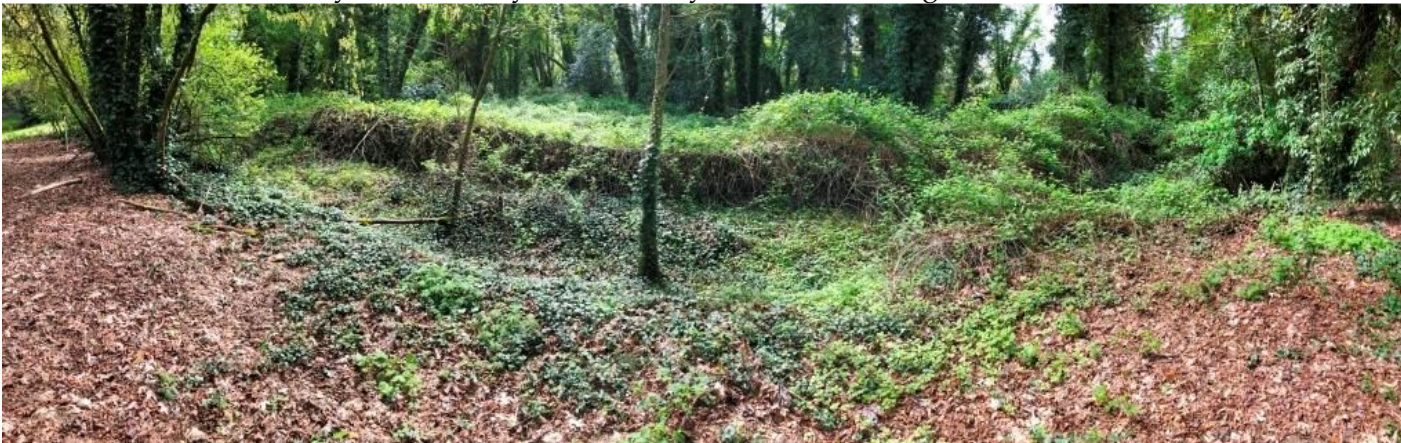
Photo Point Q (below, taken 4/20/2018): Southeast to southwest facing view of northeast part of Pinger Property taken from atop old rail line berm. Atlantic ivy and Himalayan blackberry dominate the vegetation.

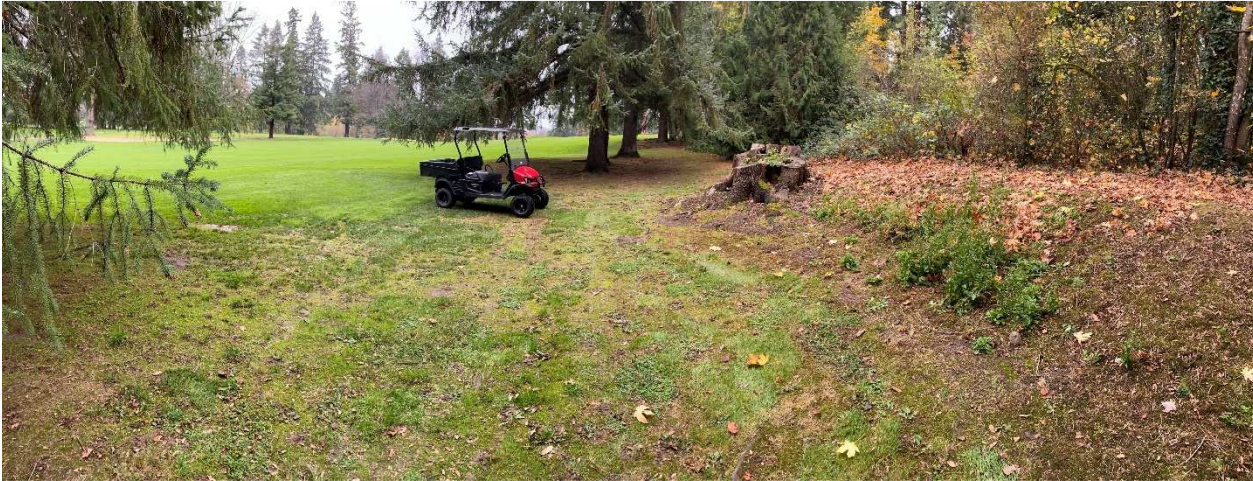
Photo Point R (above, taken 11/03/2021): Northeast to southeast facing view of south edge of the 15th Fairway along the old rail line berm (right part of the photo). Much of this area between the fairway and the old rail line berm is a mix of golf course grasses (annual bluegrass and perennial ryegrass) and non-native weeds (English daisy, oxeye daisy).

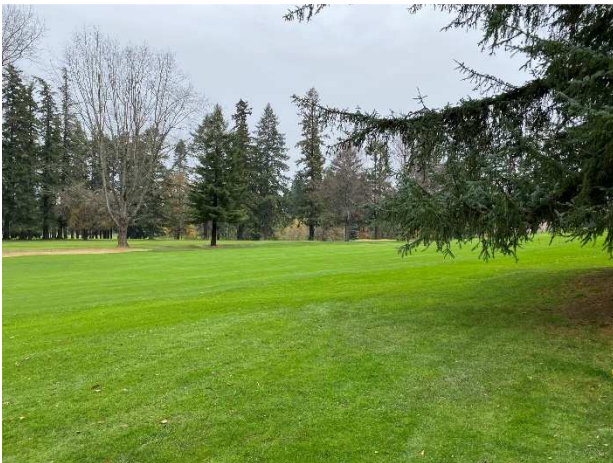
Photo Point S (left, taken 11/03/2021): North-northeast facing view across the 15th Fairway from golf cart in Photo Point R (above).

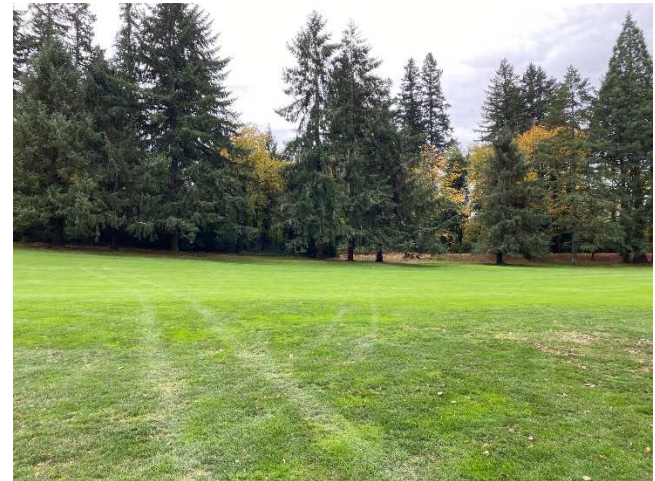
Photo Point T (right, taken 11/03/2021): South-southeast facing view across the 15th Fairway toward location of Photo Points R & S (left and above).

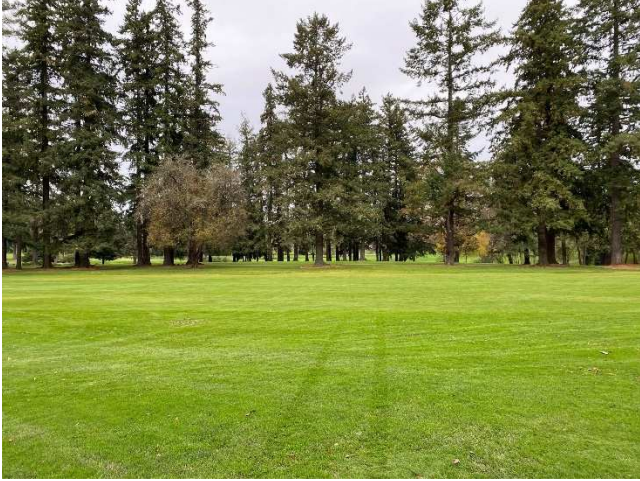
Photo Point U (left, taken 11/03/2021): North-northwest facing view across the 14th Fairway toward location of Photo Points V & W (below).

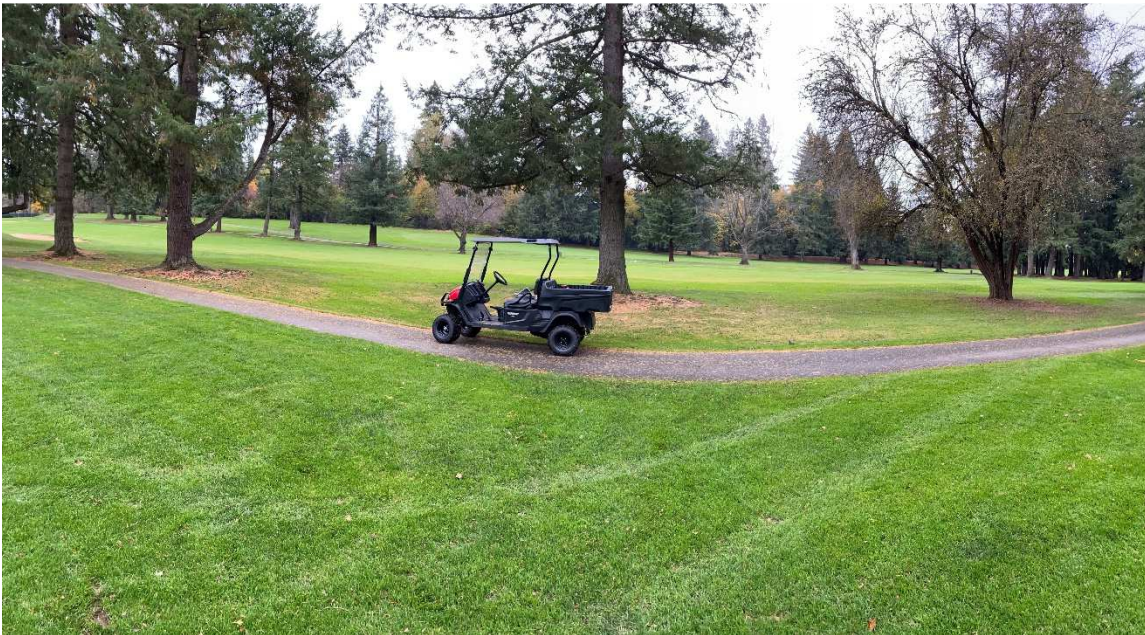
Photo Point V (left, taken 11/03/2021): Southeast to southwest facing view across 14th Fairway toward location of Photo Points U and T (above).

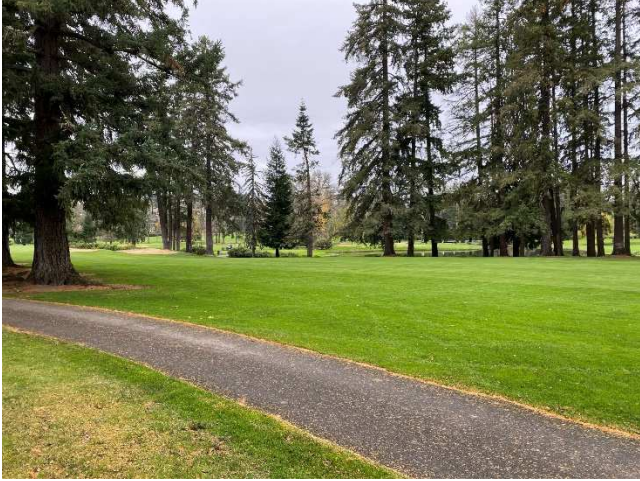
Photo Point W (left, taken 11/03/2021): Northwest facing view across 13th Fairway toward location of Photo Point X (below) and the Irrigation Pond (beyond line of trees).

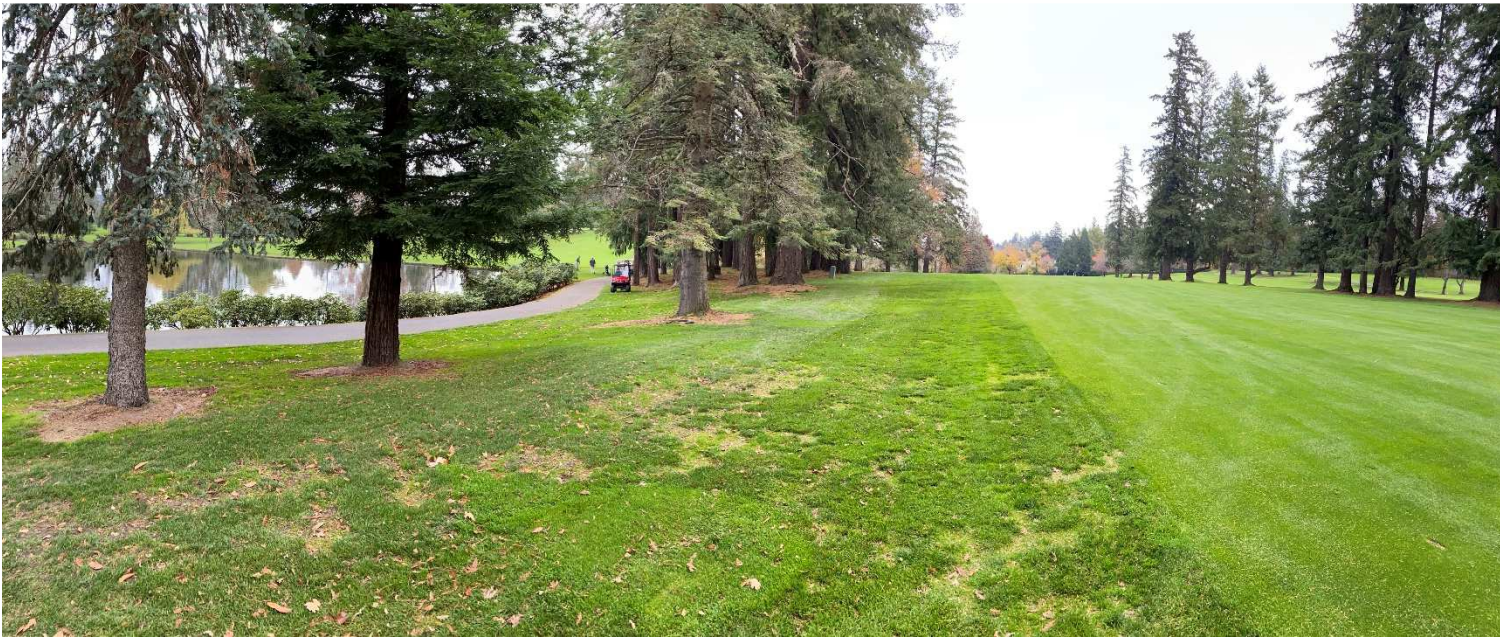
Photo Point X (below, taken 11/03/2021): Northeast to southeast facing view along north edge of 13th Fairway showing the Irrigation Pond (at left beyond cart path). This location is approximately 10 feet higher in elevation than the pond elevation.

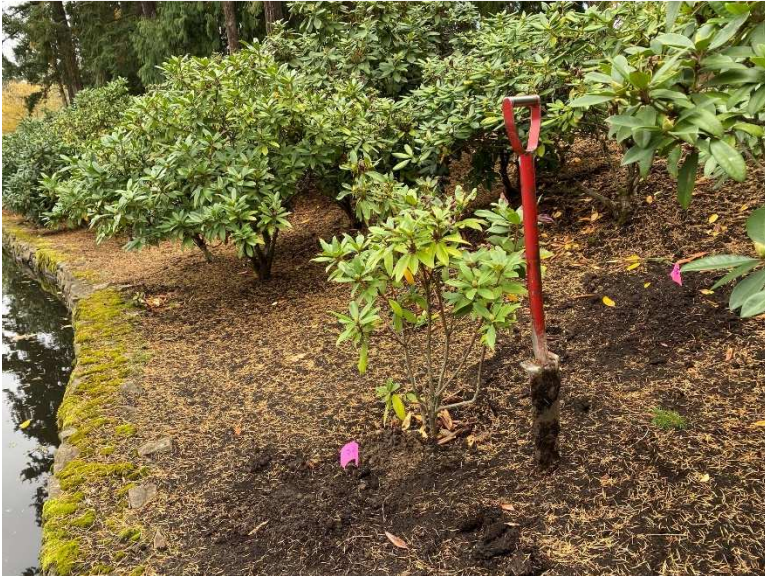
Photo Point Y (left, taken 11/03/2021): East facing view of sample plot transect T4 along the south edge of Irrigation Pond. The slope beyond the pond edge rises sharply and is landscaped with bark mulch and rhododendron. The wetland fringe (Wetland C) of the Irrigation Pond (between the shovel and the stone retaining wall) is very narrow along this edge of the pond.

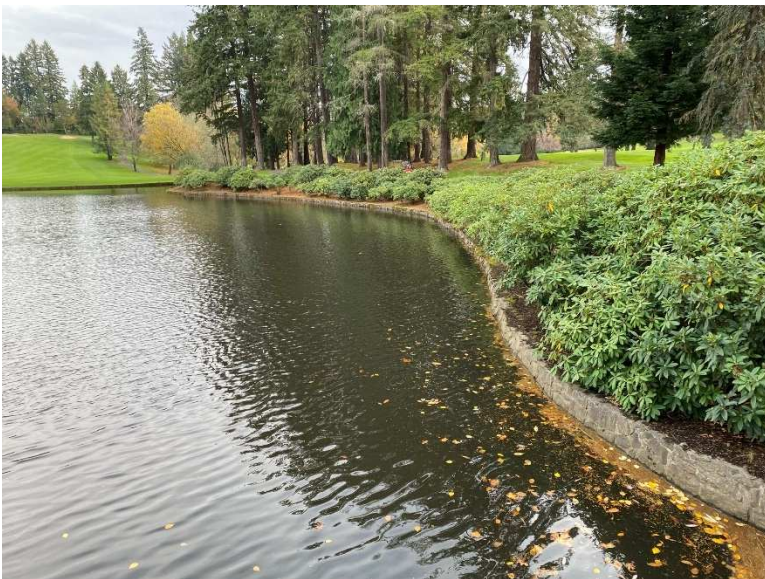
Photo Point Z (left, taken 11/03/2021): East facing view of south edge of Irrigation Pond taken from bridge over pond outlet in the southwest corner of the pond. The sloping 11th Fairway is in the background (at left) whereas the 13th Fairway is beyond the rhododendron and trees (at right).

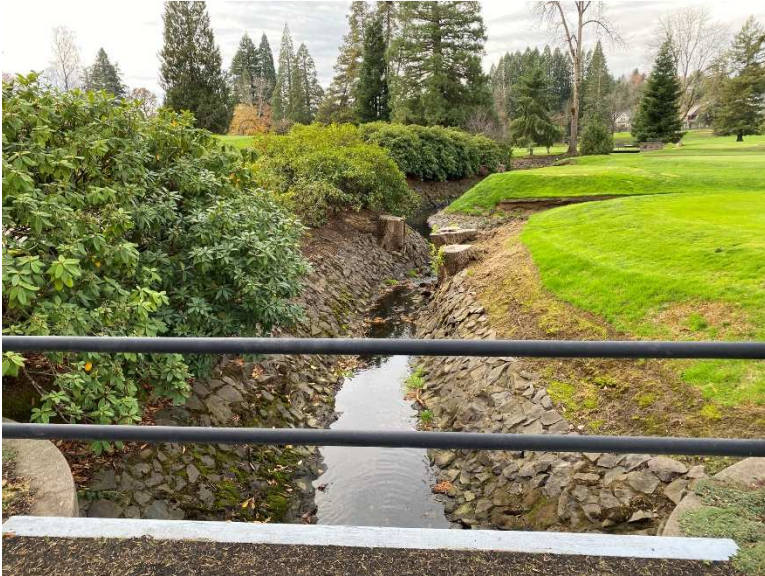
Photo Point Z (left, taken 11/03/2021): West facing view of Woods Creek below outfall from Irrigation Pond taken from bridge over pond outlet in the southwest corner of the pond. Fanno Creek joins Woods Creek from the north just downstream (west) of this photo location.

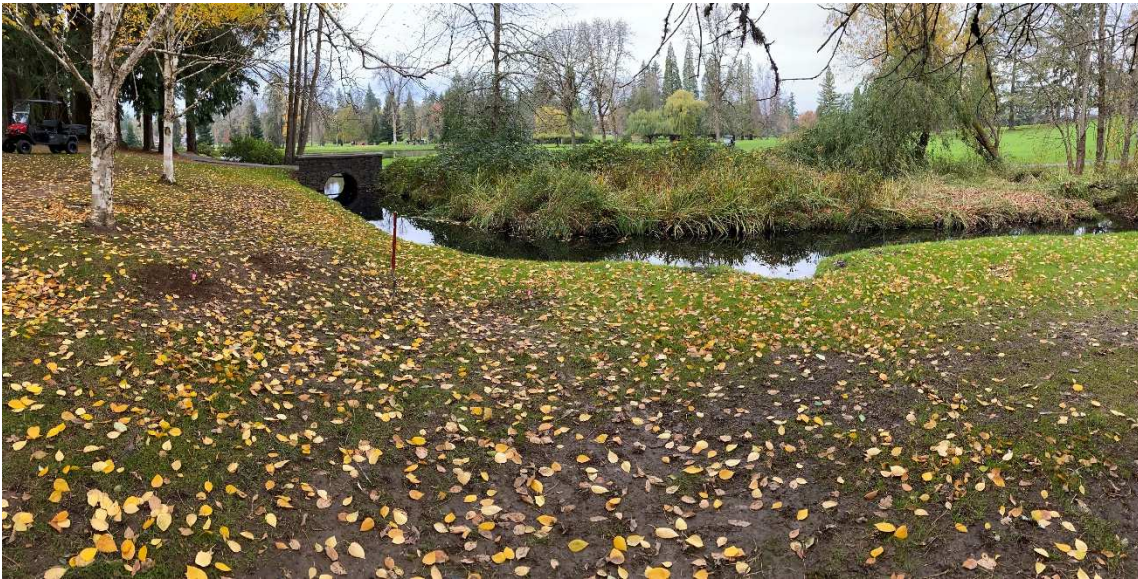
Photo Point AA (left, taken 11/03/2021): Northwest to north facing view of portion of Wetland B adjacent to Woods Creek at sample transect T5 (pink flags with shovel at approximate wetland boundary). Note the vegetation in this part of the wetland is managed for turf with annual bluegrass and creeping bentgrass as the dominant species in the herb stratum and Oregon ash as the dominant species in the tree stratum.

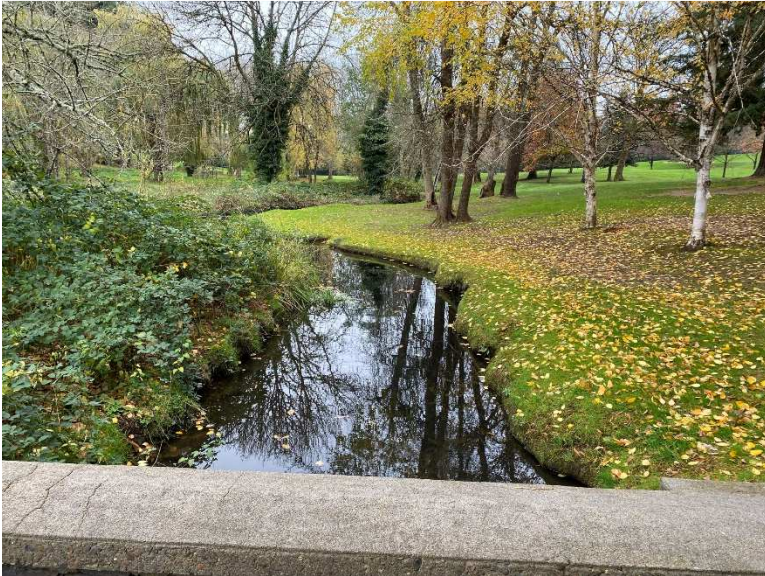
Photo Point BB (left, taken 11/03/2021): Southeast facing view of Woods Creek and adjacent portions of Wetland B taken from bridge over creek located just southwest of the Irrigation Pond. Sample transect T5 is located between the white barked birch tree (second tree from right) and the Oregon ash (center clump) with a noticeable difference in management practices on either side of the creek.

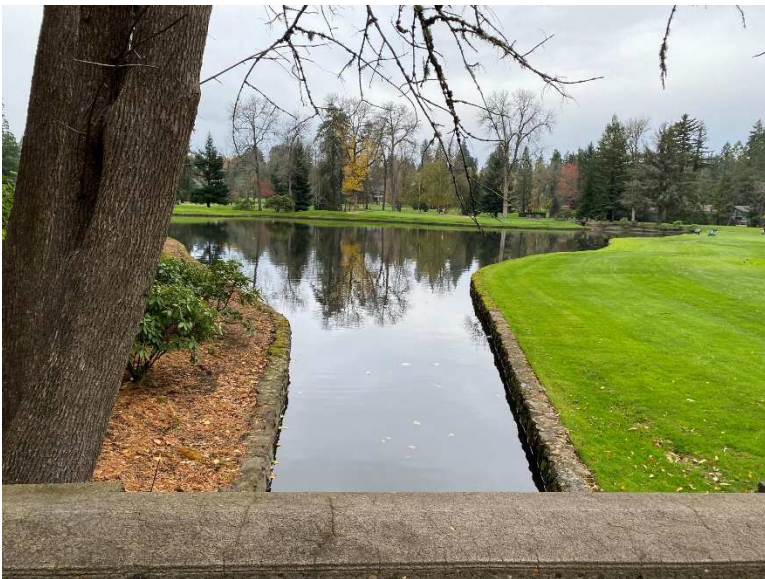
Photo Point BB (left, taken 11/03/2021): Northwest facing view of where Woods Creek enters the Irrigation Pond taken from bridge over creek located just southwest of the Irrigation Pond. The wetland fringe (Wetland C) of the Irrigation Pond is narrower on the steeper landscaped (left) edge of the pond than on the wider, flatter 11th Fairway (right) edge of the pond.

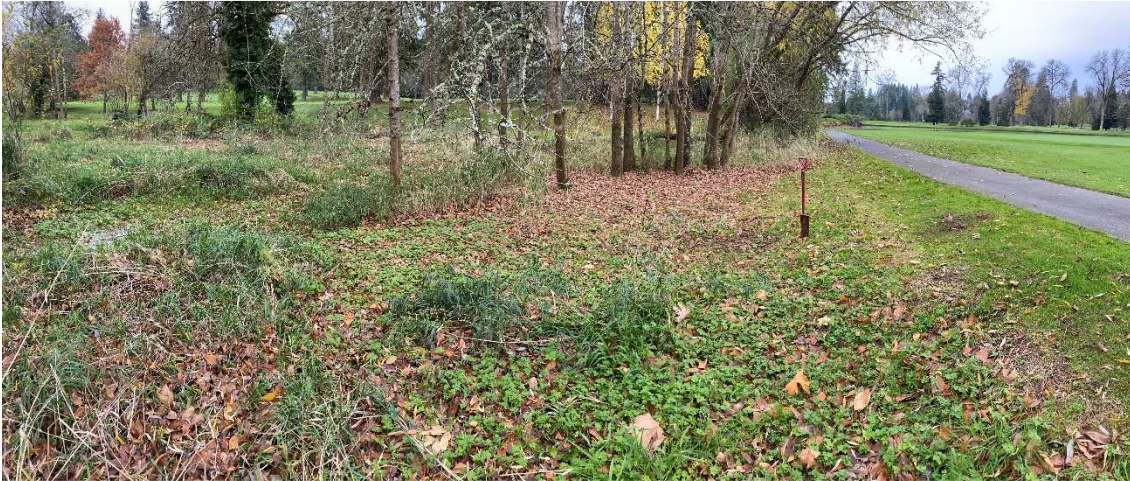
Photo Point CC (above, taken 11/03/2021): South to west facing view of Wetland B located south of 11th Fairway (at right) taken from just east of sample transect T6 (pink flags with shovel at approximate wetland boundary). Wetland B is several feet lower than the cart path and fairway and almost entirely unmanaged. Dominant vegetation includes creeping buttercup, creeping bentgrass, and common reed in the herb stratum and Oregon ash in the tree stratum.

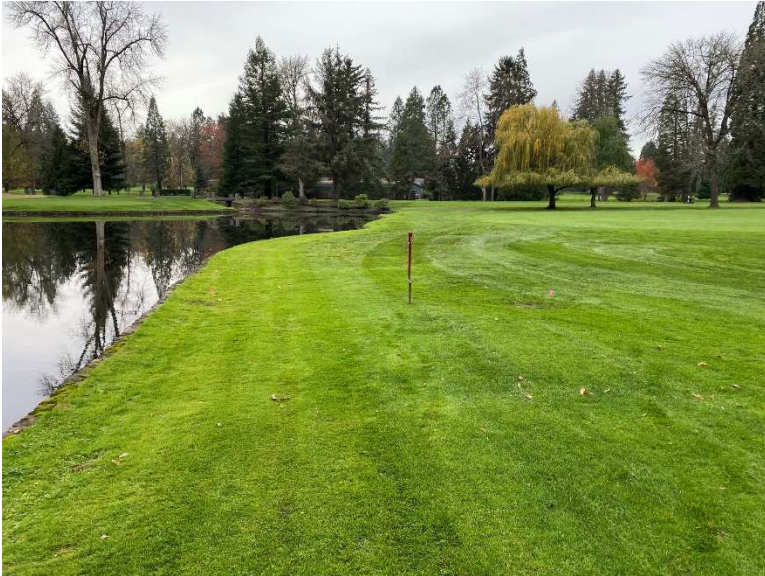
Photo Point DD (left, taken 11/03.2021): North northwest facing view of the wetland fringe (Wetland C) along the east edge of the Irrigation Pond and the 11th Fairway taken from just south of sample transect T7 (pink flags with shovel at approximate wetland boundary).

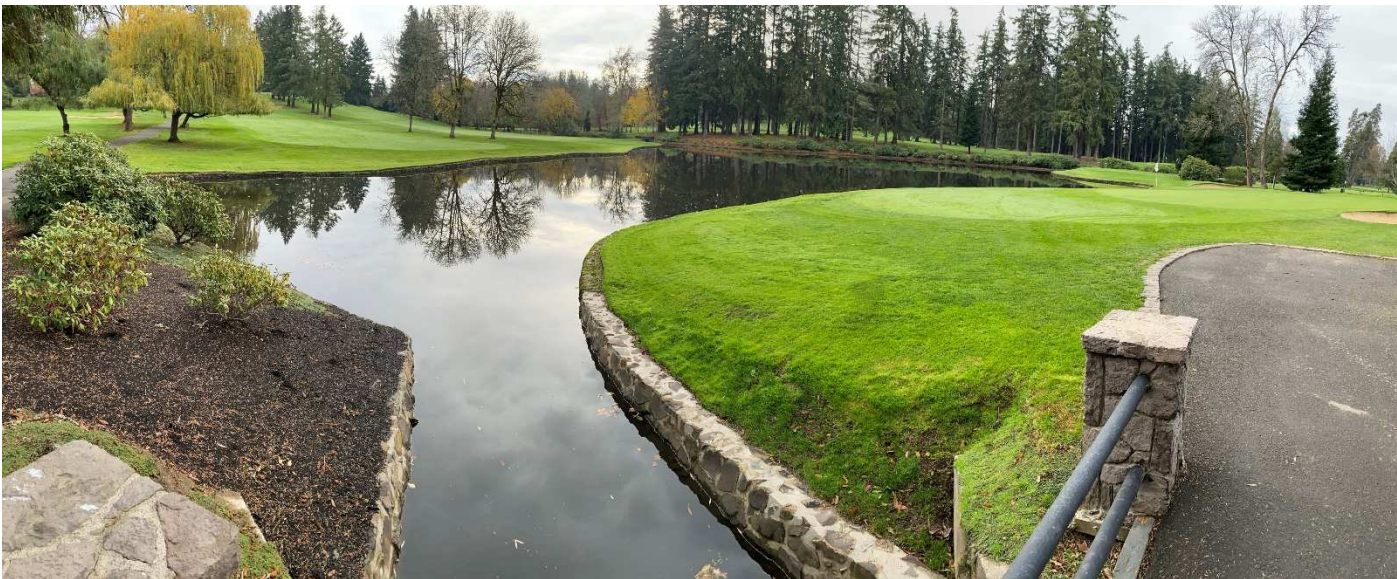
Photo Point EE (left, taken 11/03/2021): Southeast to southwest facing view of the Irrigation Pond taken from bridge over inlet from Fanno Creek (not pictured) in the north part of the pond. An irrigation gate allows water into the pond from Fanno Creek at this location.
