Portland Golf Club Brush Trimming (Nov. 2024) for Sediment Bag Placement Area and Staging Area

CLEAN WATER SERVICES EROSION CONTROL PERMIT
FOR PORTLAND GOLF CLUB BRUSH CLEARING & TRIMMING;
SOUTH PART of TAX LOT 1700, T. 1S, R. 1W, Sec. 24 (BC)
Washington County, Oregon

Portland Golf Club Trimming Areas and Avoided Vegetated Corridors Photographs

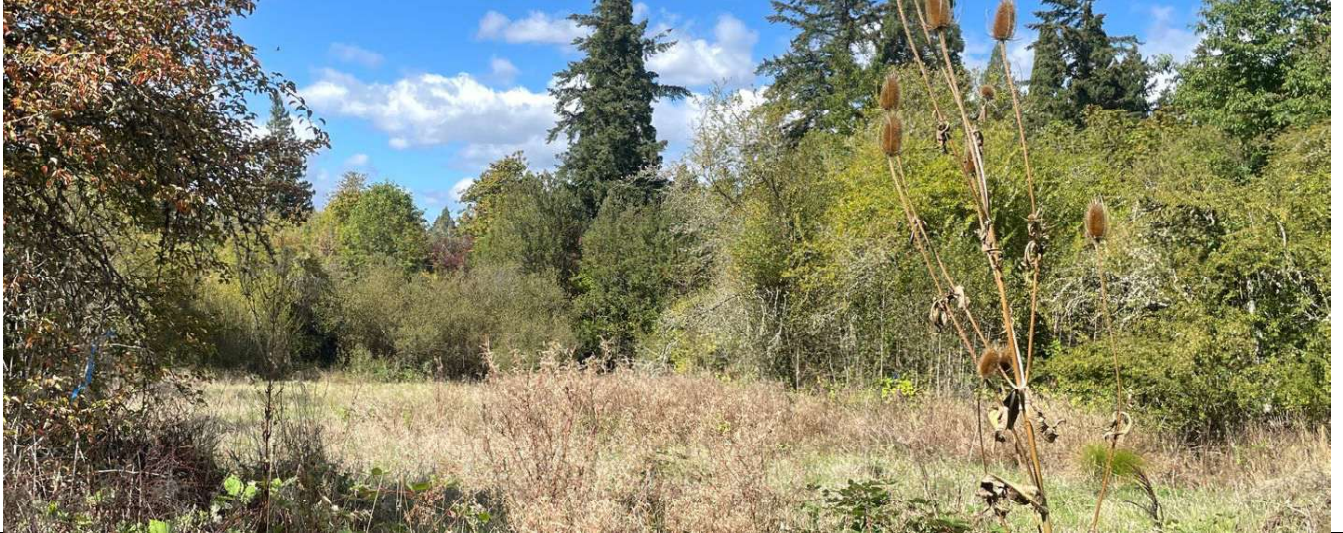
Photo 1. View north from upper part of Wetland A. Brush in background growing on former railroad berm (no disturbance proposed). Fir trees in background located outside of project area. Wetland A would not be subject to brush trimming.

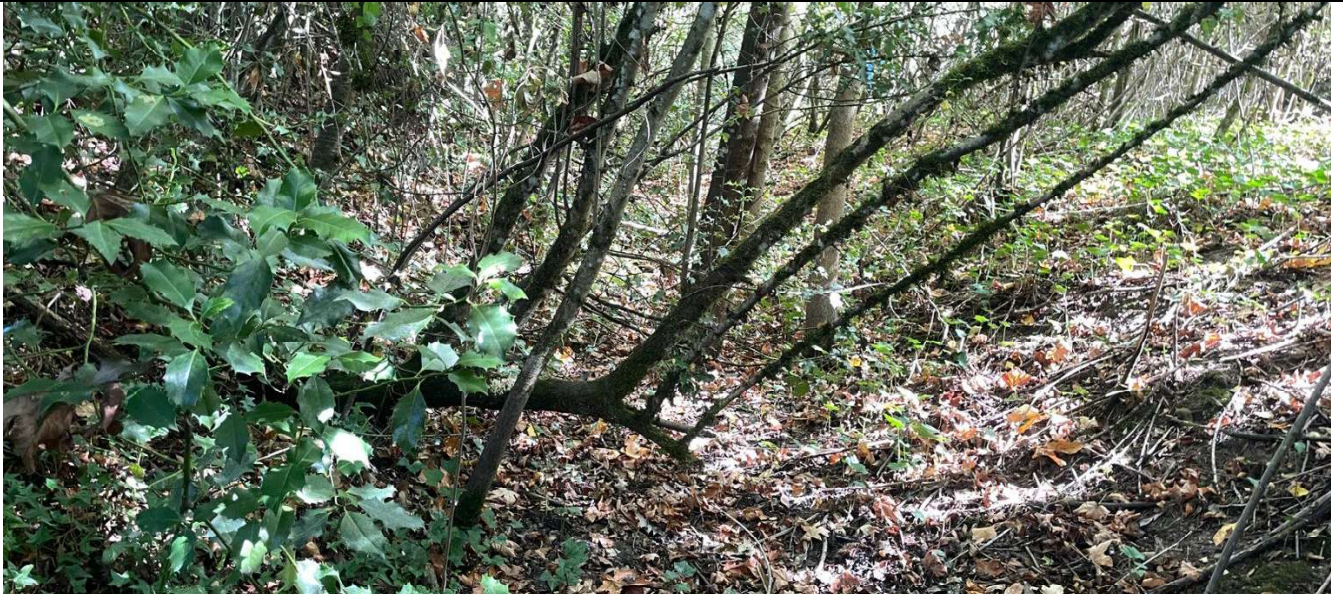
Photo 2. View west at ditch located on south of the former railroad berm. The ditch diverts runoff from Wetland A to the west (historically flowed to northwest where golf course is located). This area would not be disturbed by brush trimming.

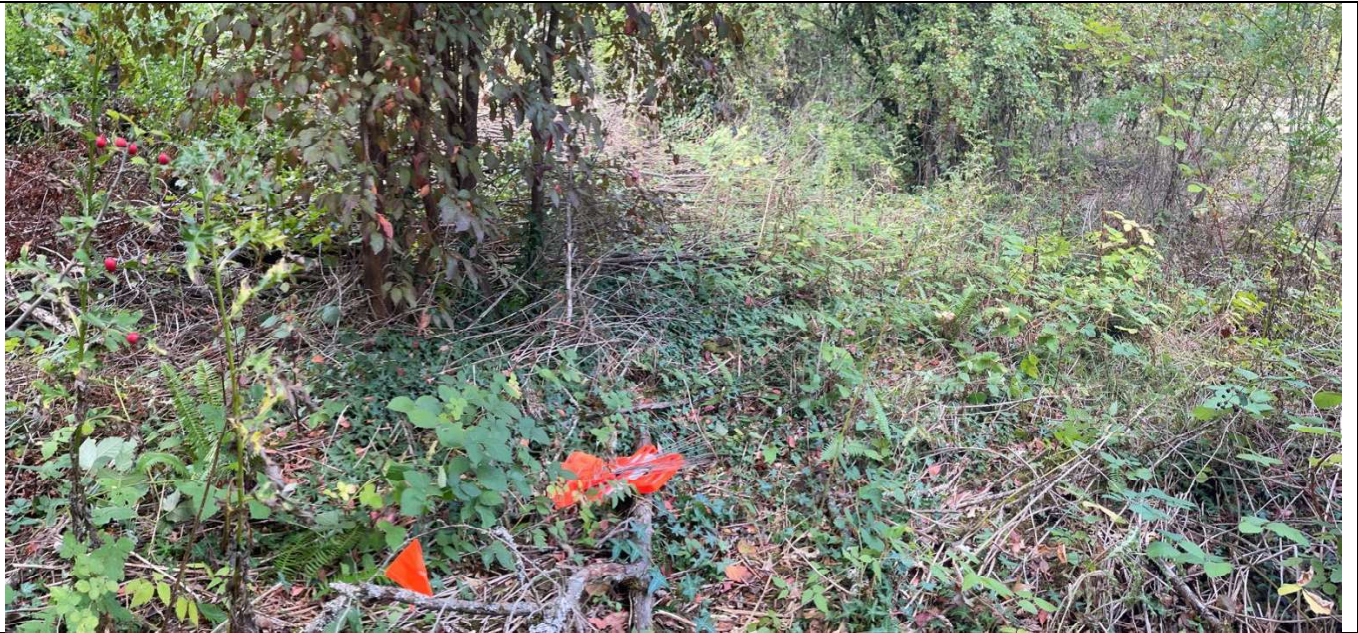
Photo 3. View northwest of 50-foot vegetated corridor on west side of Wetland A. Vegetated corridor between orange pin flag and right edge of photo. English ivy, Canada thistle, and Himalayan blackberry on ground, while wild cherry and red hawthorn are shrubs and trees.

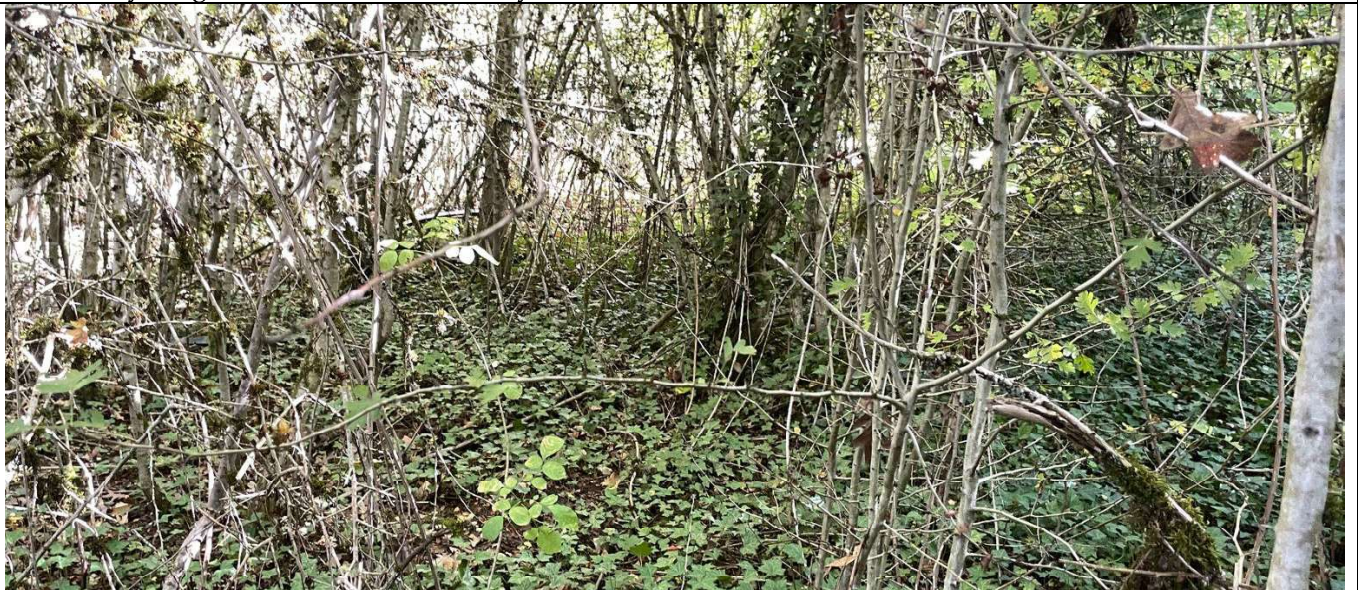
Photo 4. View southwest of 50-foot vegetated corridor on south side of former railroad ditch. Vegetated corridor dominated by red hawthorn, Himalayan blackberry and English ivy.

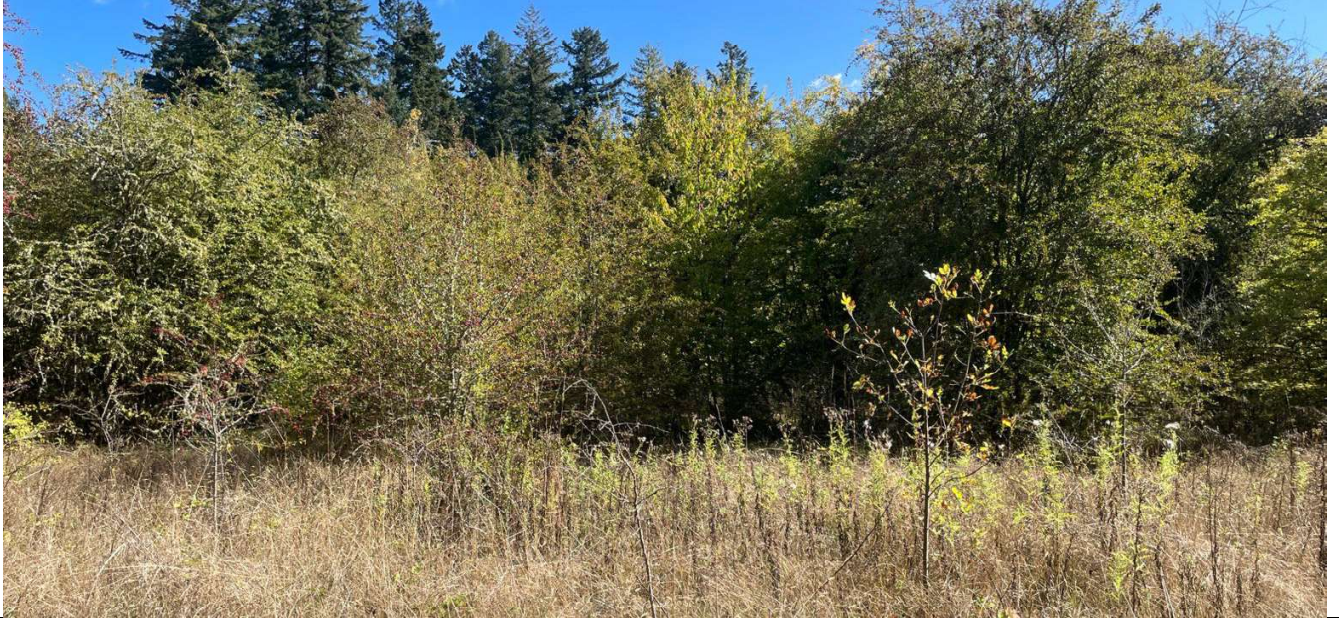
Photo 5. Typical view of upland brush growing in the sediment bag placement area. Dominant trees/shrubs are red hawthorn, cherry, plus a few hazelnut and paper birch. Herbaceous plants in Canada thistle, English ivy, fescue, sweet vernalgrass, and blackberry. Fir trees not in project area.

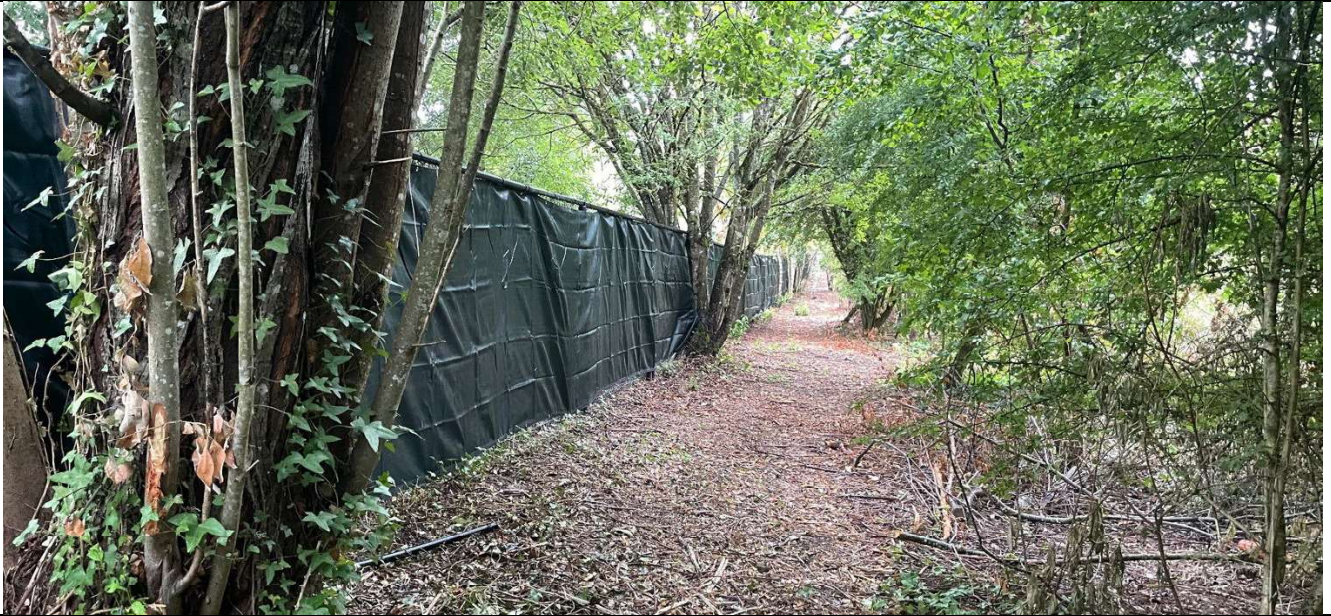
Photo 6. A narrow corridor was cleared when the black fence fabric was installed in July 2024. The clearing avoided larger trees/shrubs (many with multiple stems) and shredded the vegetation into a mulch (no ground disturbance).

While the subject area has access from S.W. 83rd Avenue, PGC will conduct the brush trimming areas via Fairway 15 to avoid interrupting bike and pedestrian use on Fanno Creek Trail. There is a narrow upland corridor that connects the east and west sides of Wetland A. For installation of fence fabric, this corridor was cleared of the understory vegetation (species previously mentioned), but large trees were not removed. Such clearing was surgical and did not scarify the ground – the vegetation was shredded (mulched) in place (see Photo 6). The brush trimming for the fence fabric installation was inspected by Lindsey Obermiller of CWS on August 23, 2024 with wetland consultant Phil Scoles. It was mentioned in that site meeting that vegetated corridor (VG) enhancements surrounding Wetland A would be needed as a component of the dredge project. PGC will be coordinating with Ms. Obermiller on such matters (a request separate from this erosion control matter).

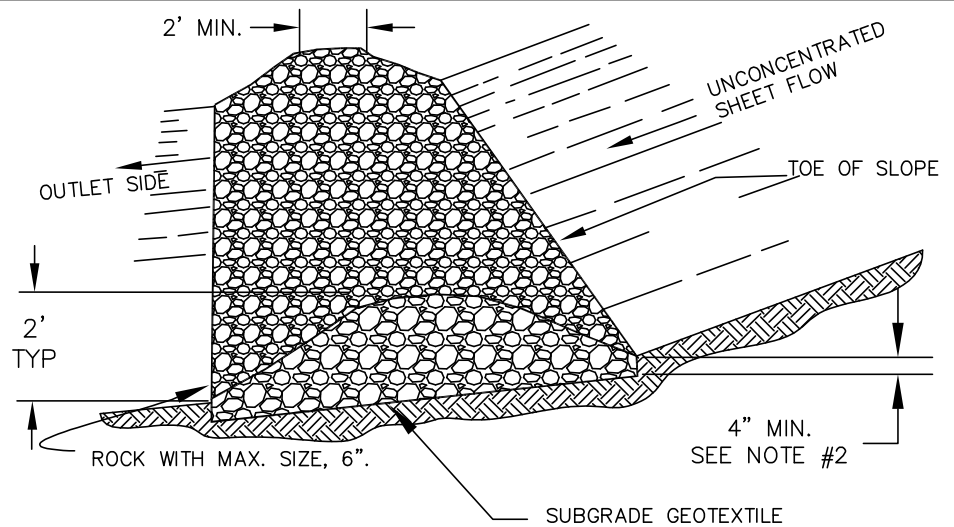
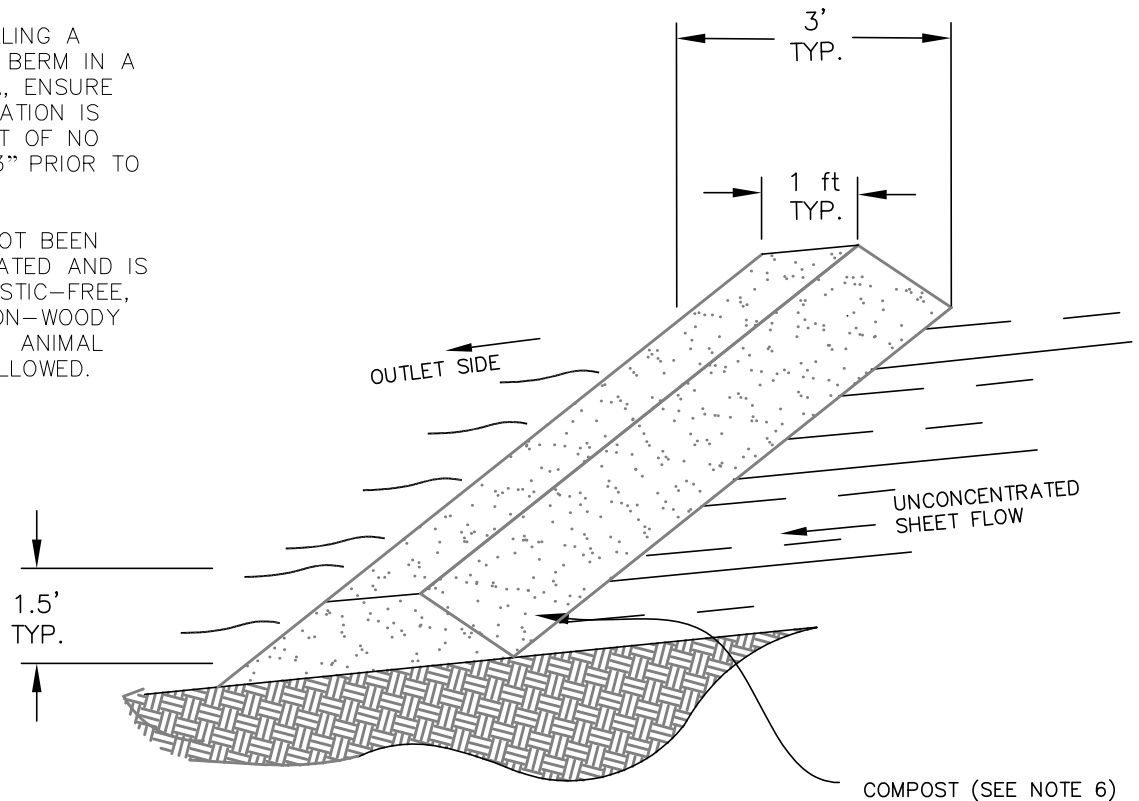
DRAWING NO. 890

ROCK FILTER BERM

COMPOST FILTER BERM

FILTER BERMS ROCK/COMPOST

If needed along the perimeter of the brush trimmed areas, a compost berm (see attached detail) will also be installed along the outer edge of the vegetated corridor (current marked with orange pin flagging). Such berms are typically 1 foot high and 2 to 3 feet wide. Straw or coconut-fiber waddles are a suitable substitute if compost berm installation is not feasible. The weight of the berms, when naturally moistened by rain, forms sufficient contact with the soil to slow runoff and filter fine sediment. If waddles are substituted, they will be countersunk into the soil as shown on the attached detail. The compost berm will be placed concurrently with seeding and straw cover. In the event of hydromulching, the compost berm will be installed first at the interface of the brush trimming area and avoided vegetated corridor.

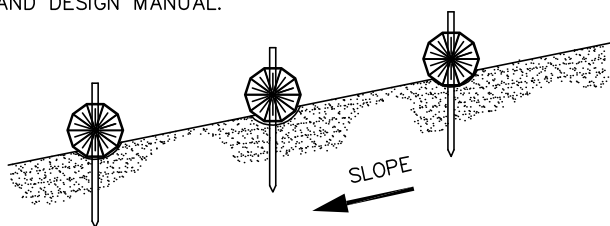
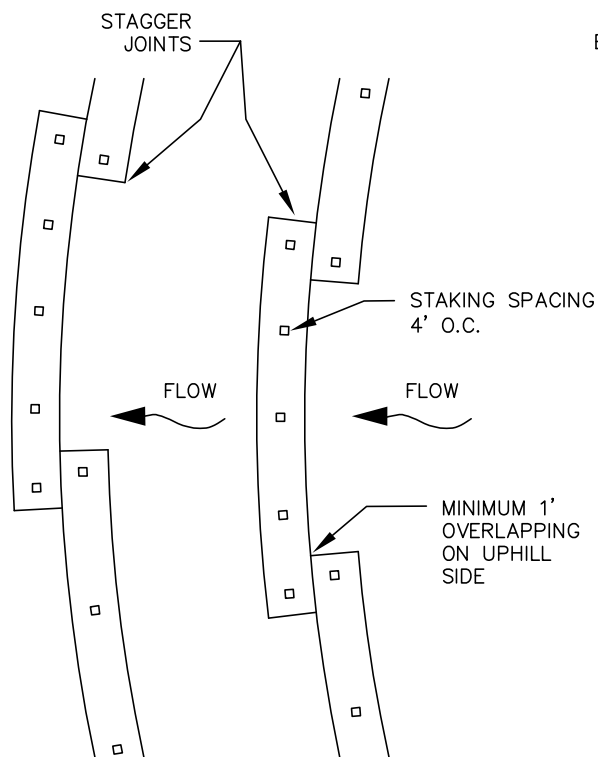
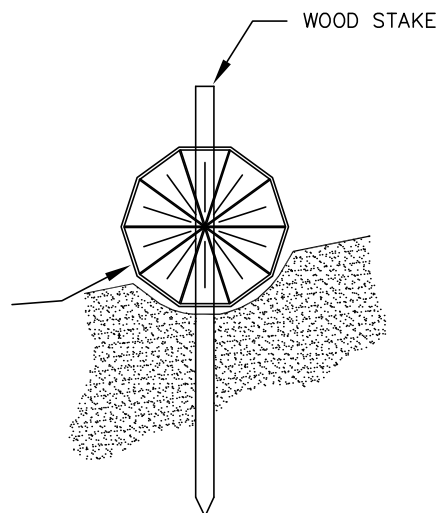
PLACE WATTLES ALONG SLOPE CONTOURS.

PROFILE

PLAN VIEW

WHEAT STRAW, RYE
GRASS STRAW,
COCONUT OR
EXCELSIOR WATTLES

SECTION

WATTLES
