**UPDATED C.W.S. VEGETATED CORRIDORS
ASSESSMENT REPORT FOR
PORTION OF TAX LOT 1700, T. 1S R. 1W Sec. 24
WASHINGTON COUNTY, OREGON**

PORTLAND GOLF CLUB
5900 S.W. Scholls Ferry Road
Portland, OR 97225

TSI Project No. 2017-0916

JUNE 2023

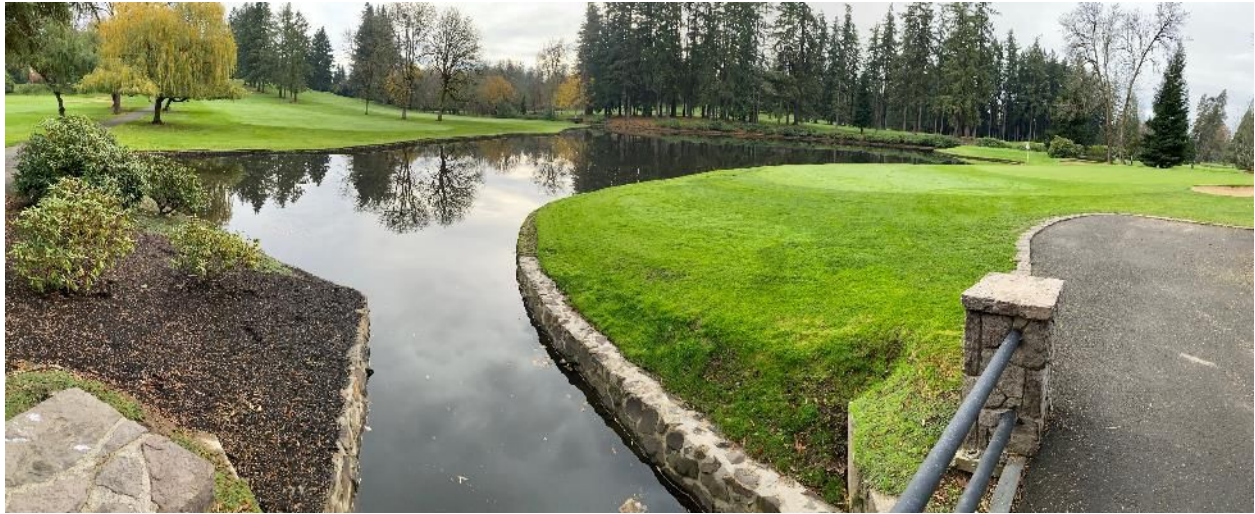
Point 1 (above): Southwest to south facing view of the irrigation pond (CWS Sensitive Area) taken from the northwest corner of pond. A wetland fringe (aka Sensitive Area) is present along the edge of pond. The 50-foot wide CWS vegetated corridor for the pond has degraded condition due to mowed turf and lack of tree canopy.

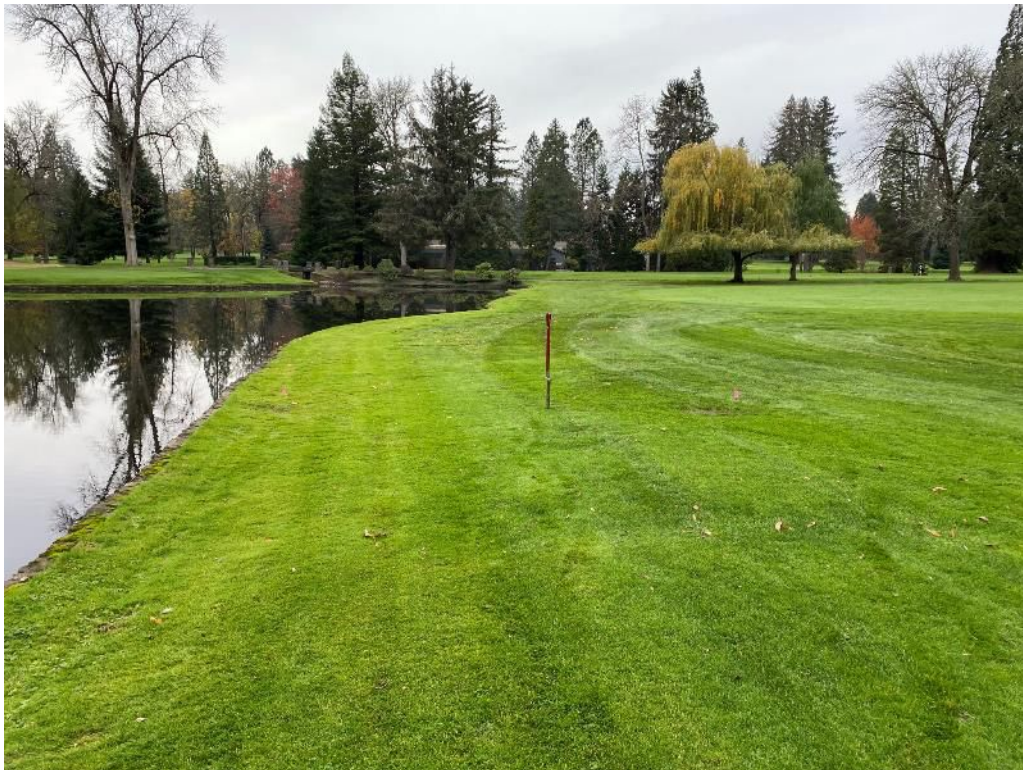
Photo Point 2 (above): North facing view of the irrigation pond Sensitive Area, adjacent wetland Sensitive Area (Wetland C, between shovel and pond), and its associated Vegetated Corridor (Northeast Vegetated Corridor, right of shovel) taken from east edge of Irrigation Pond. These are in degraded condition due to the presence of heavily managed golf course turf grasses and lack of tree canopy.

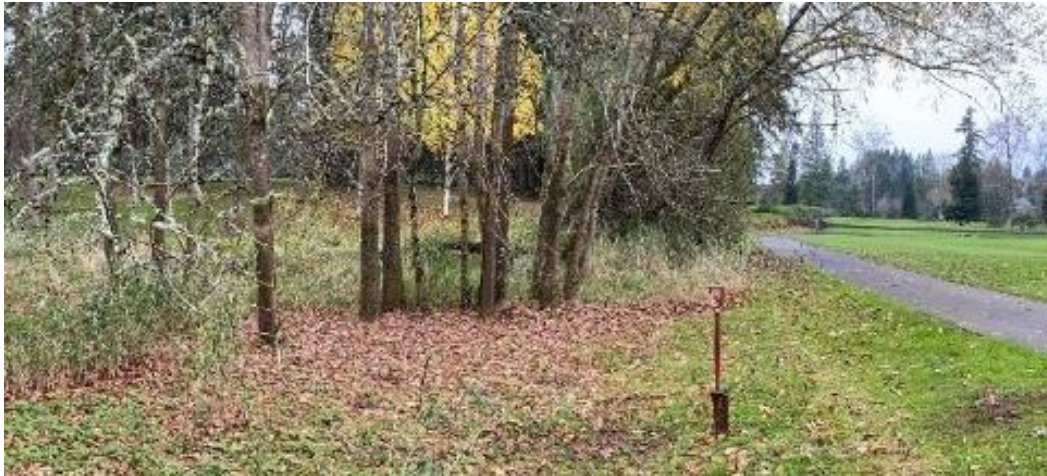
Photo 3 (above): Southwest facing view of Wetland B, left of shovel (CWS Sensitive Area). The associated Vegetated Corridor (aka North Vegetated Corridor) begins right of shovel and extends into Fairway no. 11. This 50-foot wide corridor qualifies as degraded condition due to mowed turf (non-native grasses) and lack of trees and shrubs (outside of wetland).

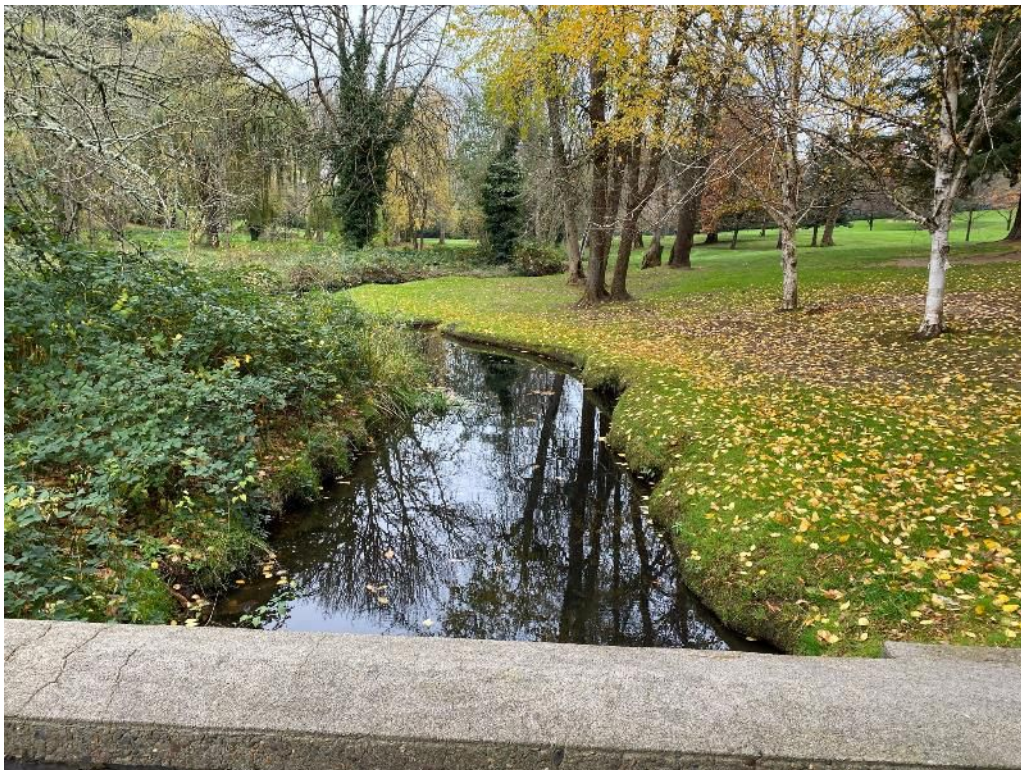
Photo 4 (above): East facing view of Woods Creek (CWS Sensitive Area), which includes wetland flanking both sides of creek (albeit overgrown by blackberries and mowed turf). The South Vegetated Corridor (to the right) extends from the planted birch trees into a mowed section of Fairway no. 13. Both Vegetated Corridors (opposite sides of creek area) qualify as degraded (50-wide) due to the invasive species (blackberries to left), mowed turf grasses and non-native trees/shrubs.

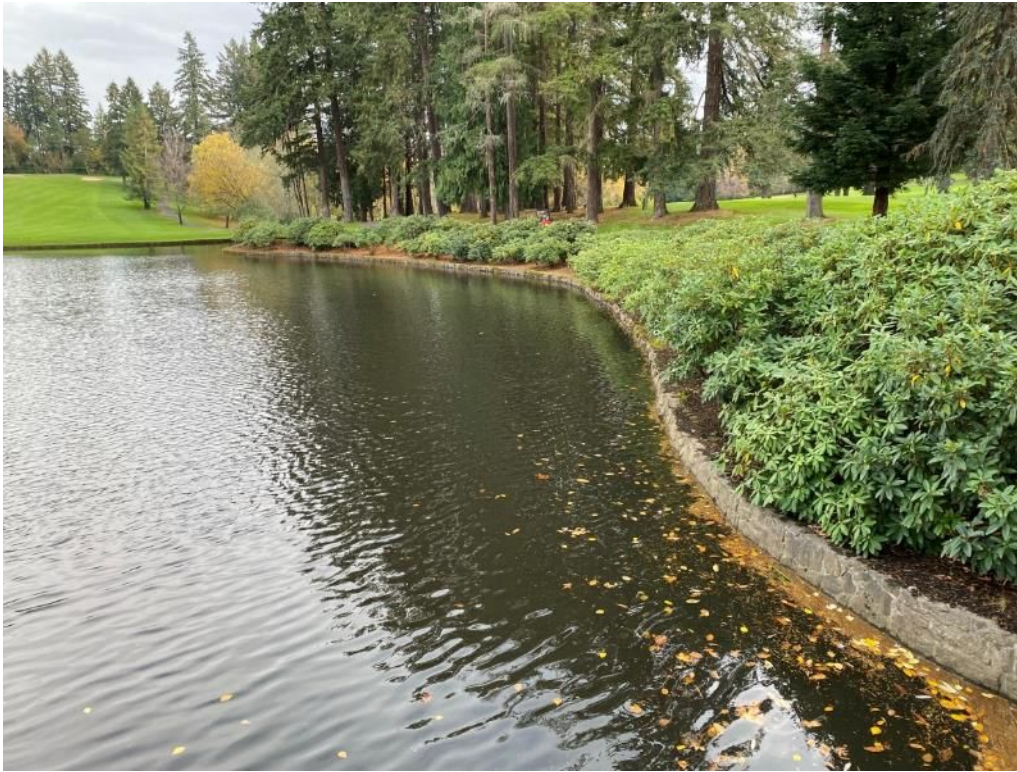
Photo 5 (above): East facing view of the irrigation pond (CWS Sensitive Area), with submerged wetland fringe (not visible, at base of retaining wall). The South Vegetated Corridor begins to the right of the pond. This Vegetated Corridor condition also qualifies as degraded due to managed landscaping and low tree canopy cover. About half of tree grove in photo occurs in the 50-foot wide Vegetated Corridor.

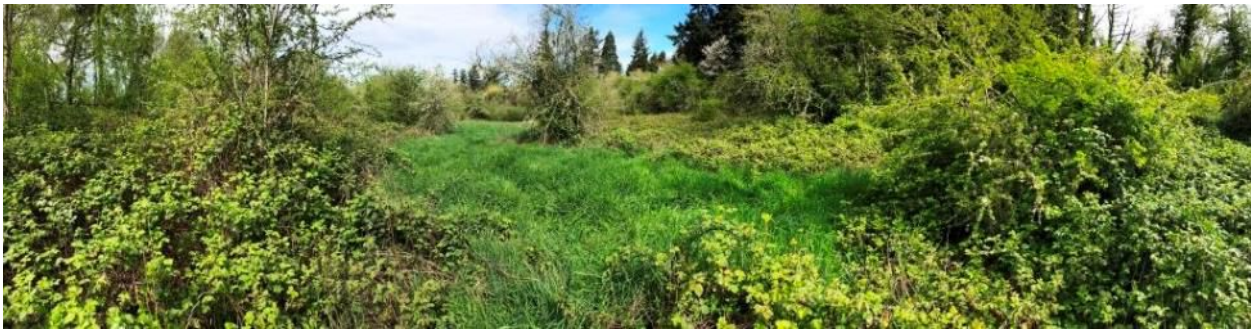
Photo 6 (above): North by northwest facing view of Wetland A (CWS Sensitive Area Sensitive Area. This feature is not shown on County natural resource inventory, but it is mapped on Beaverton Local Wetland Inventory. The associated Vegetated Corridor surrounding the wetland is dominated by invasive Himalayan blackberry, non-native grasses and has relative low tree canopy. This 50-foot wide Vegetated Corridor condition qualifies as degraded, as per CWS criteria.
