**VEGETATED CORRIDORS ASSESSMENT AND
HABITAT ENHANCMENT REPORT FOR SOUTH PORTION
OF TAX LOT 1700; T. 1S R. 1W, SEC. 24;
PORTLAND, WASHINGTON COUNTY, OREG.**

TSI Project No. 2017-0916

OCTOBER 2025 (Amended)

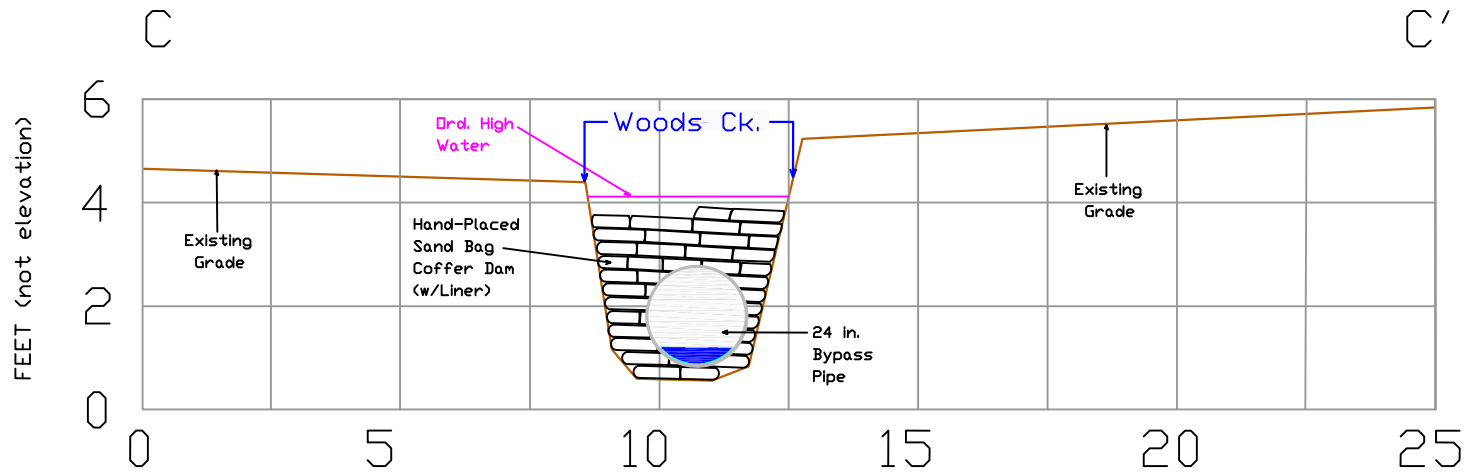
TEMPORARY BYPASS PIPE/COFFER DAM, NOT FOR CONSTRUCTION

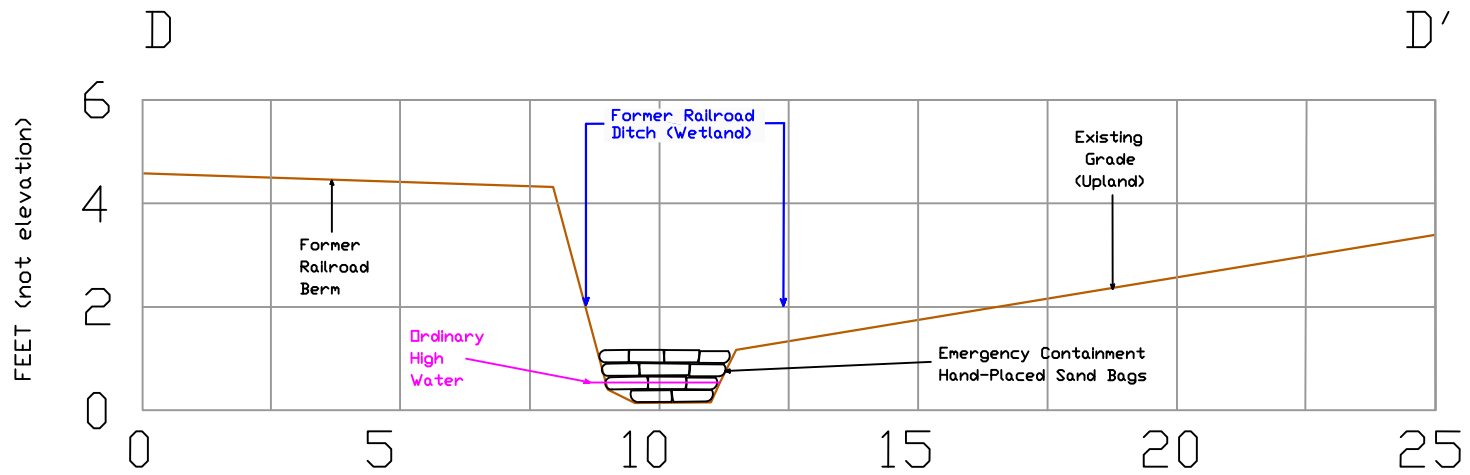
TEMP. EMERGENCY CONTAINMENT BERMS, NOT FOR CONSTRUCTION

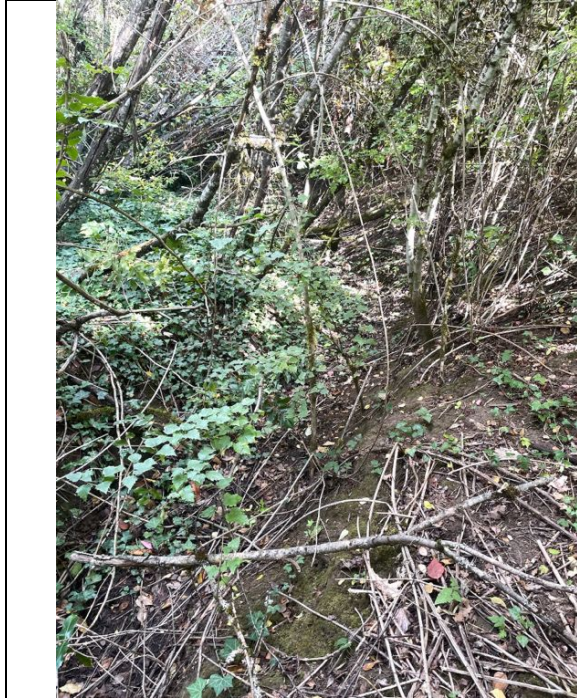
Photo 1 (above): View west at ditch along south side of former railroad berm. This feature amounts 950 sq. ft.

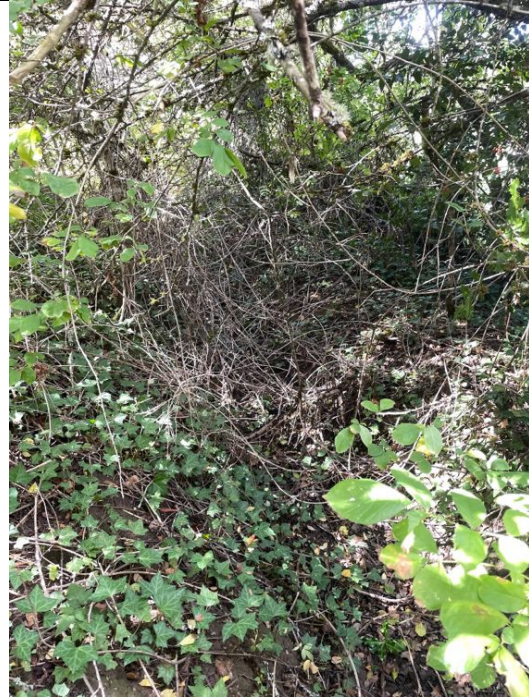
Photo 2 (above): View east at former railroad ditch. The ditch is heavily shaded, so herbaceous growth in channel is minimal.

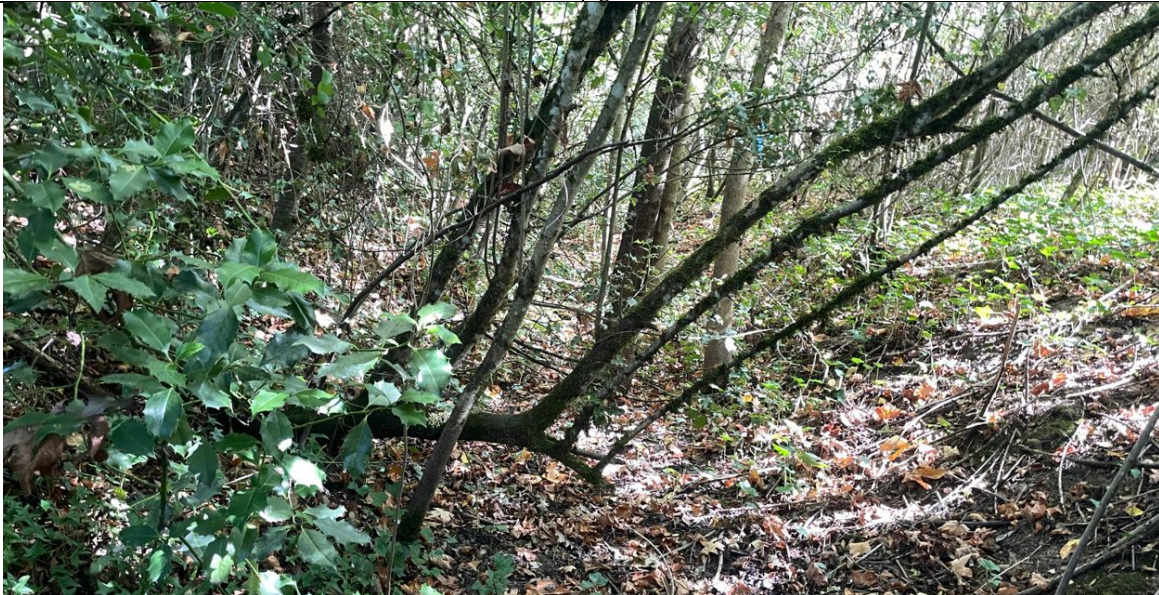
Photo 3 (above): View east of ditch situated on south side of former railroad berm. Bottom of ditch has seasonal flow of only 1 to 2 inches deep. No channel scouring. Side slopes define wetland edge.

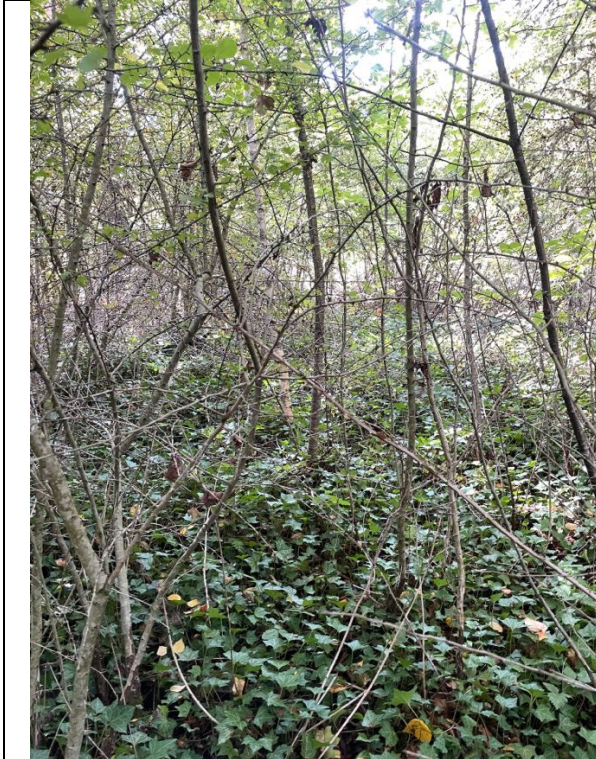
Photo 4 (above): View south from ditch toward center of 50-foot vegetated corridor.

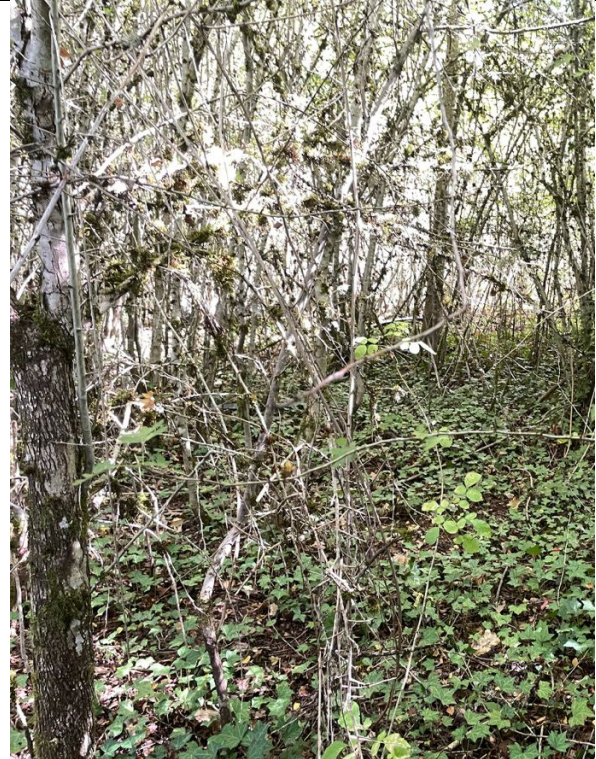
Photo 5 (above): View southwest from center of 50-foot vegetated corridor on south side of ditch.

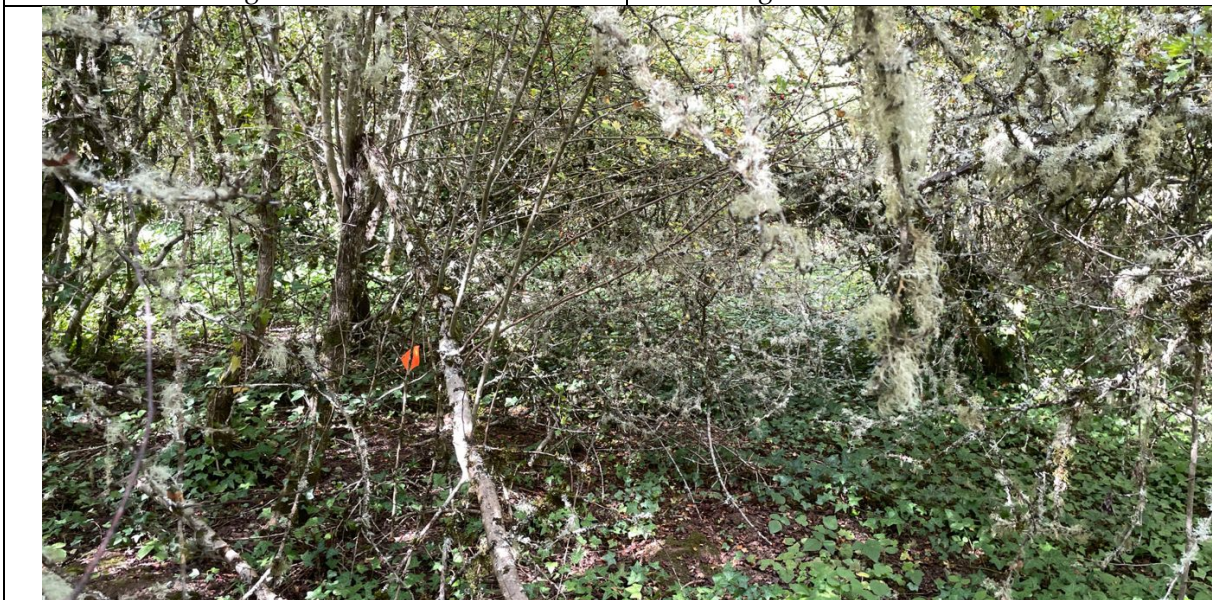
Photo 6 (above): View west at 50-foot vegetated corridor on south side of ditch. The dominant vegetation is red hawthorn and English ivy. The understory has several sword-fern and Oregon ash saplings, as well as Himalayan blackberry. This corridor qualifies as degraded.

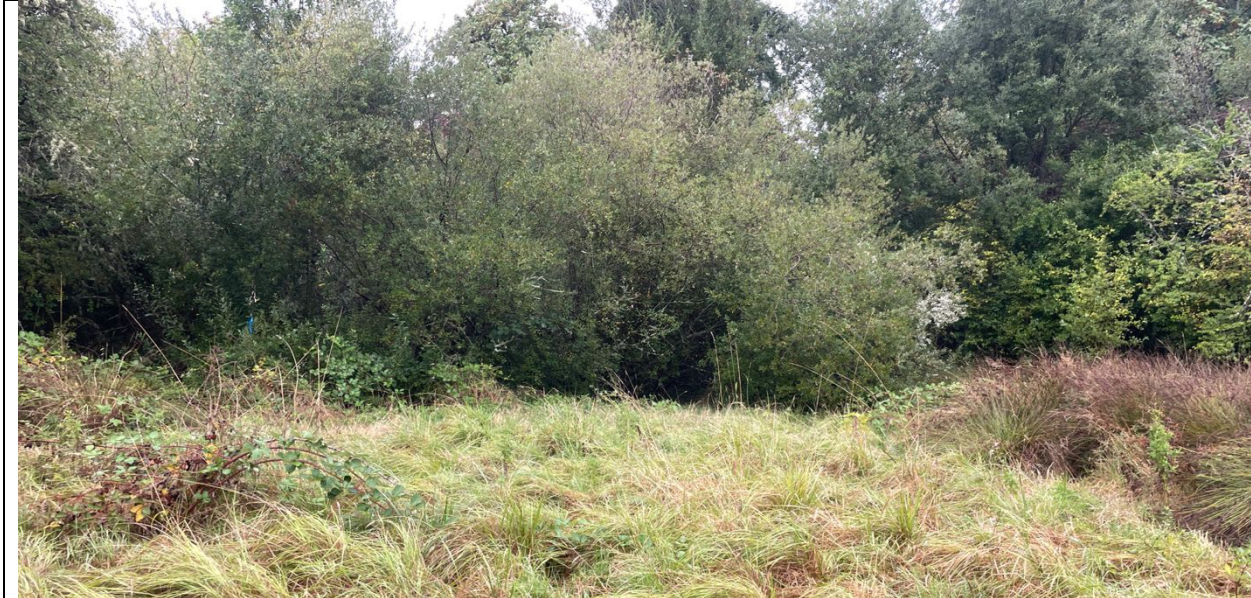
Photo 7 (above): View north at lower (north) edge of Wetland A. The wetland is largely dominated by tall fescue, common velvetgrass, meadow foxtail, with lesser amounts of soft rush, Himalayan blackberry, fringed willowherb, and Canada thistle. Willows are present along the north and northwest edges of Wetland A, while red hawthorn is the predominant shrub-tree along the east, south and west edges.

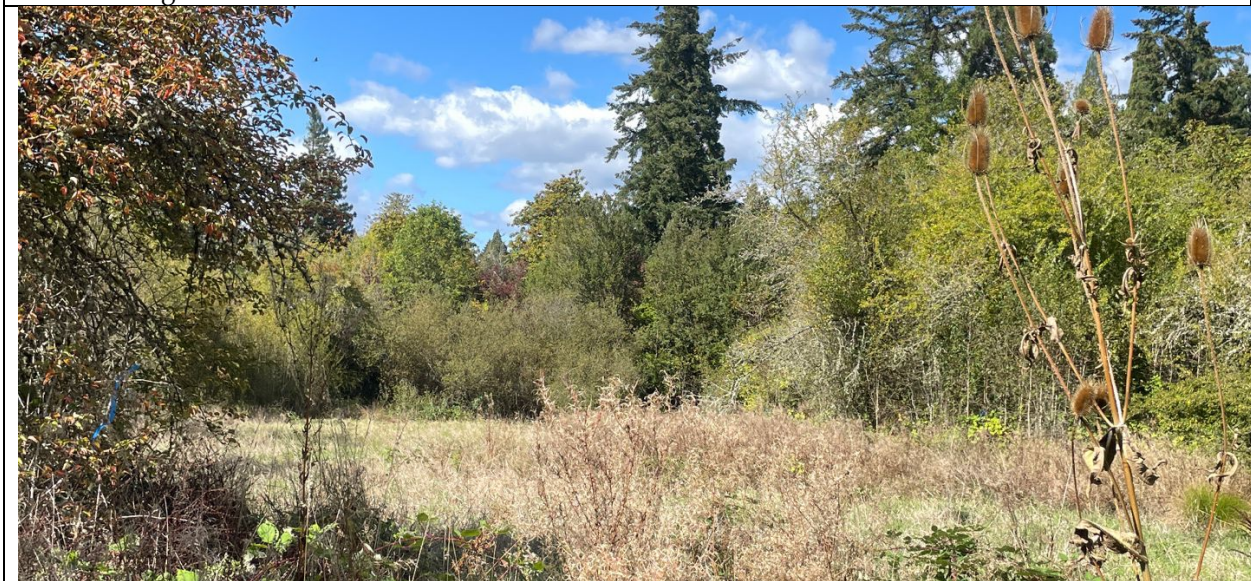
Photo 8 (above): View north at upper (south) edge of Wetland A. Stormwater runoff from the south and rainfall are the primary hydrology source for the wetland. Wetland A slopes north by northwest and it is intercepted by a former railroad berm, which diverts runoff to the west and eventually discharges to a low terrace parallel to Fanno Creek (offsite about 0.25-mile).

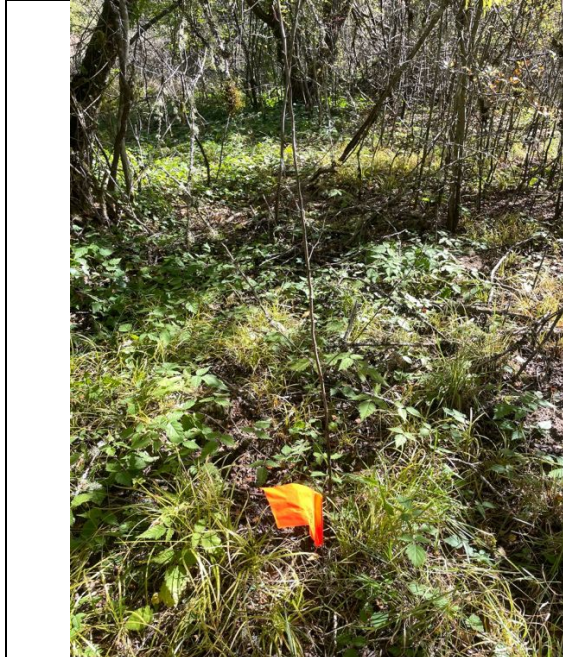
Photo 9 (above): View east toward Wetland A from outer edge of 50-foot vegetated corridor.

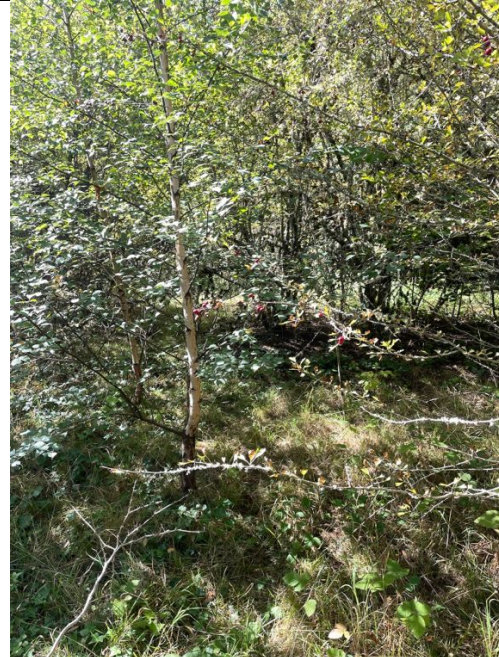
Photo 10 (above): View north, about halfway between Wetland A (west side) and 50-foot V.C.

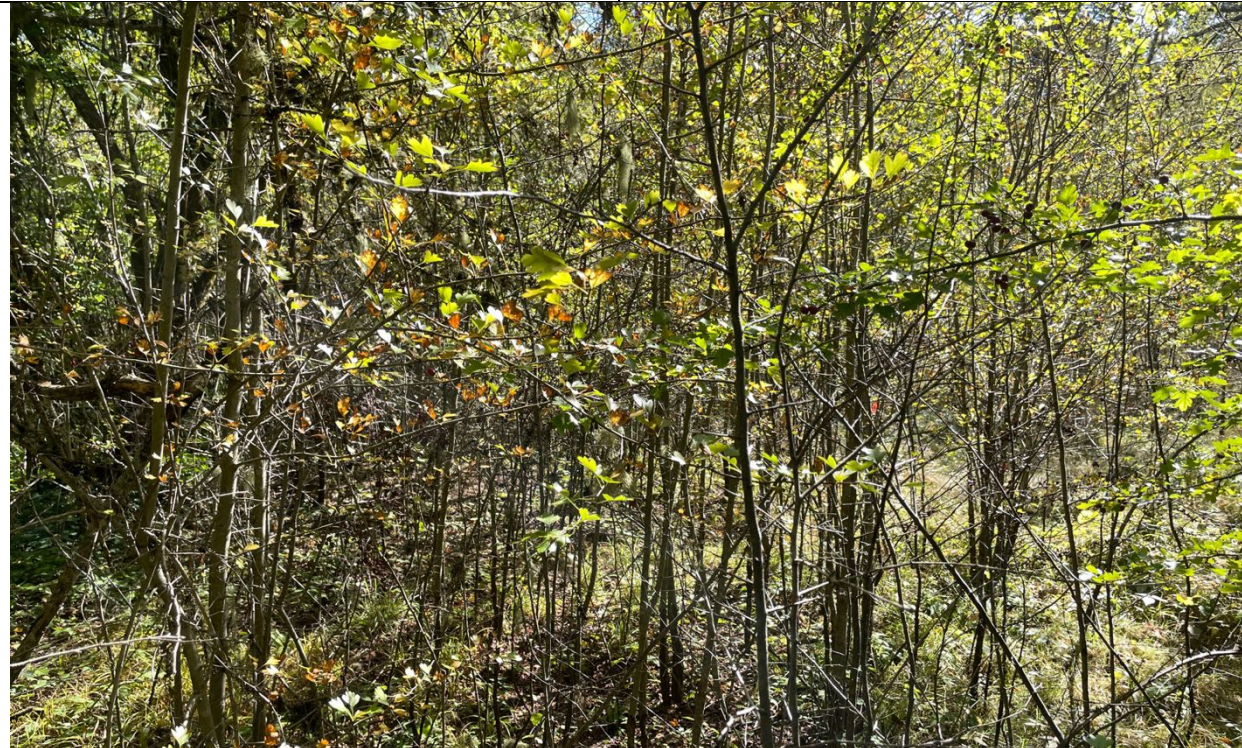
Photo 11 (above): View southeast at 50-foot vegetated corridor west of Wetland A. This setback is dominated by red hawthorn saplings, plus scattered cherry, paper birch, hazelnut, and fruit trees. This Vegetated Corridor condition also qualifies as degraded due to invasive species and few native species.

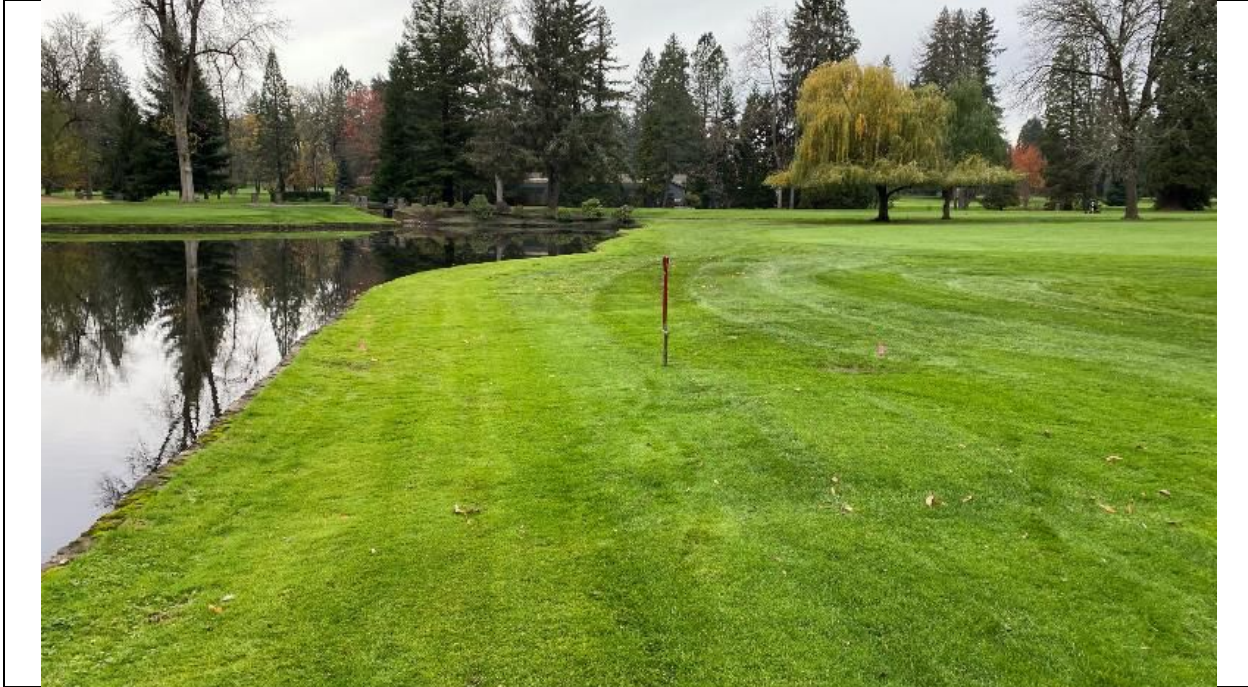
Photo 12 (above): View north along east edge of irrigation pond. Lacking native species and vertical habitat, this highly managed (mowed) vegetated corridor qualifies as degraded condition.

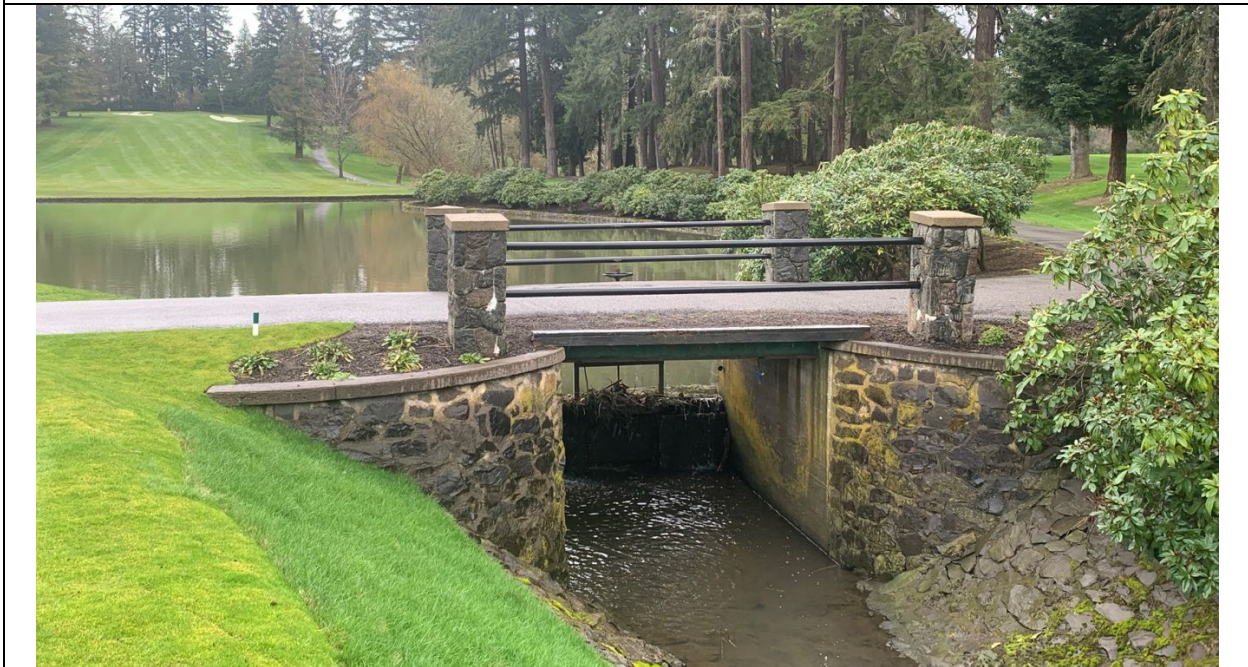
Photo 13 (above): View east at outlet of irrigation pond. The vegetated corridor in this vicinity is turf grass. The corridor on the south side of pond consists of planted rhododendrons (non-native) and planted Douglas-fir trees. This Vegetated Corridor condition also qualifies as degraded.
