Works undertaken 23 Oct 21

58022 Autumn and winter work schedule:

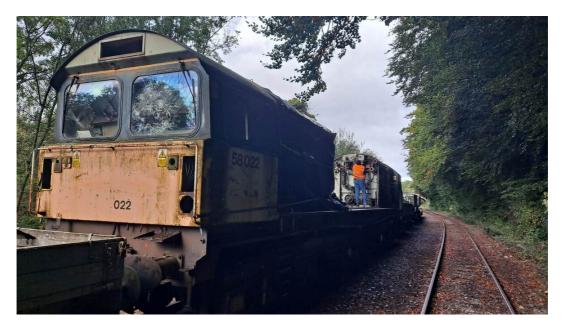
The cab is totally stripped out. The wooden floor panelling has been removed, as have all gauges, switches, the cab heater, seats and the power controller pedestal. The windows have unfortunately mostly been broken by the local vandals.

The power controller pedestal is in the photos but will be removed before the cab is sold. The cab is 2390mm high, 2615mm wide and 2050mm long. It weighs about 2 tonnes.

The cab doesn't include the buffer beam, which is part of the chassis. Basically, if you look at the picture, it starts at the yellow bit. The external doors are part of the main body shell and aren't part of the cab. When removed the rear of the cab will be the central rear access door. We unfortunately don't have any of the internal or external parts available to complete the cab. If you would like to have a look at the cab, let us know at info@lms10000.co.uk. The loco isn't currently publicly accessible, so please arrange a time and date before visiting.

If all goes to plan, the cabs from 58022 will be removed by the end of November. We will be keeping one as a future exhibit, and the other, the number 2 end, is available for sale. If anyone would like to make an offer on it, the deadline for receipt of offers is 15th November.

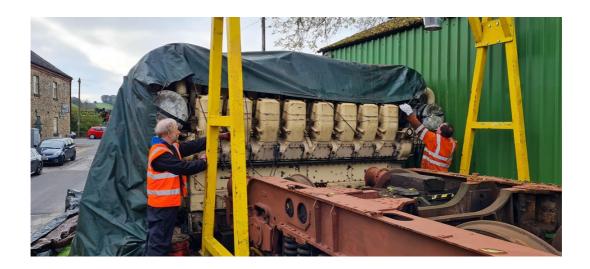
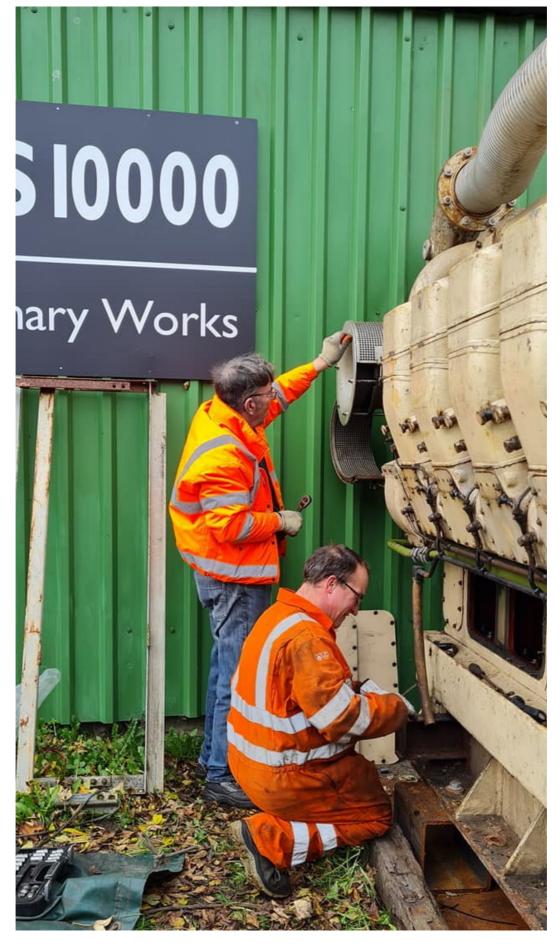
Two turbo filter housings stripped and impellers spun round. (Perfect) all crankcase covers removed one side, internal inspection for any damp damage (very minimal witnessed) all crankshaft thrust clearances checked. .016 to .019 along the webs of every crankshaft journal. (As it should be) all crank pins bottom end bearings plus bright steel and fasteners coated in rust inhibiting 75-90 hypoid gear oil. WD 40 sprayed on all internal surfaces.

Inside the power unit, the covering of oil was updated.

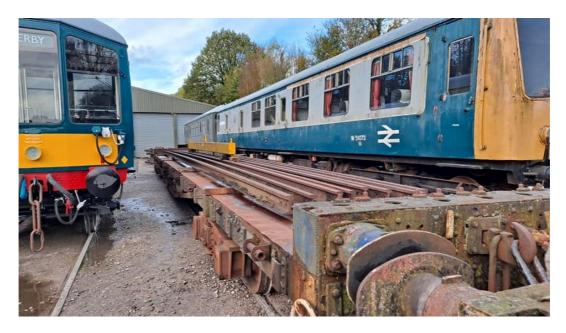
Seen during October, the bogies have been cared for over the summer and prepared for winter storage. The yellow frame above has also been prepared for testing and certification, which should happen during November.

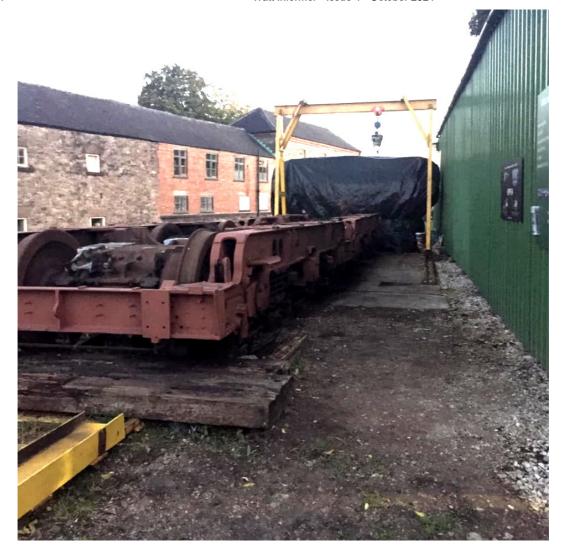
On the 16th Mark L spend a couple of hours scraping, chiselling and brushing off years worth of congealed brake muck from the bogies and bagging what could be reached underneath.

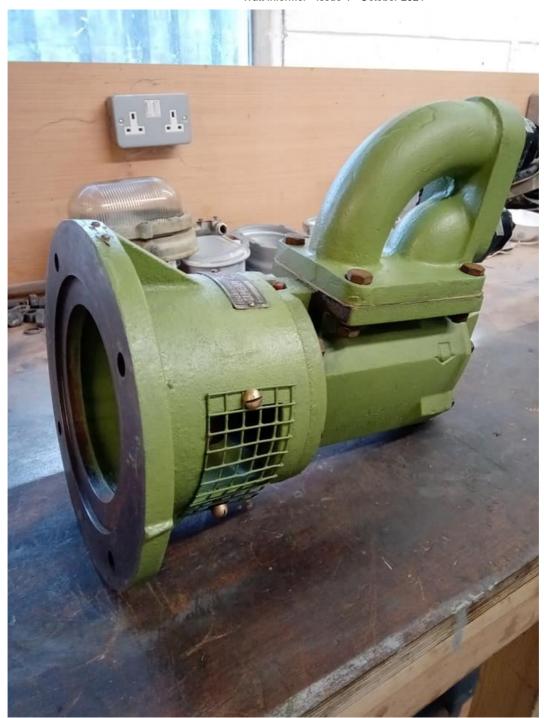
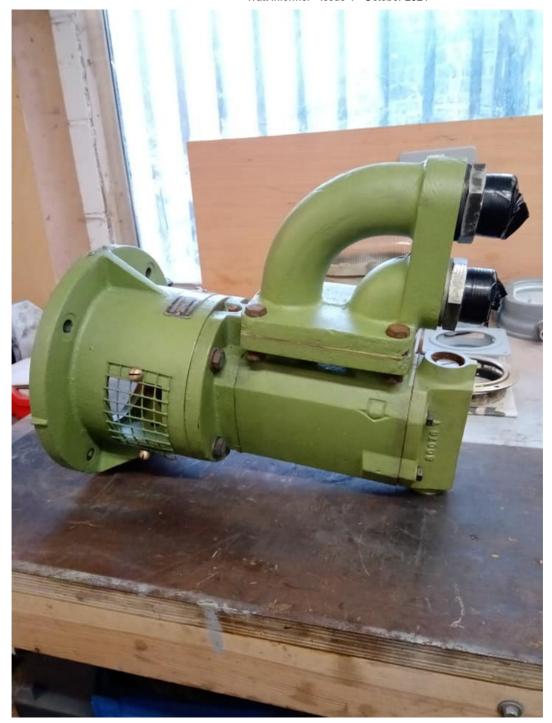
Mick has refurbished the engine priming oil pump off the 58. The 16SVT does have its own full duty oil pump but, as with all large diesel engines, due to the weight of the crankshaft and it's rotating parts, it has to be supported on a pressurised oil wedge to prevent the bearing surfaces from being damaged during start-up. Once the engine is running the main duty oil pump then takes over supplying the rotating components with oil. The locomotive electronics system won't allow the starter to engage until sufficient oil pressure is available.
