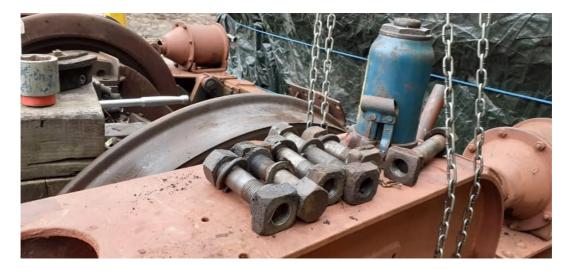
Now that the lifting beams are tested, things are moving along with the bogies. The first traction motor is unbolted and ready to come out for assessment.

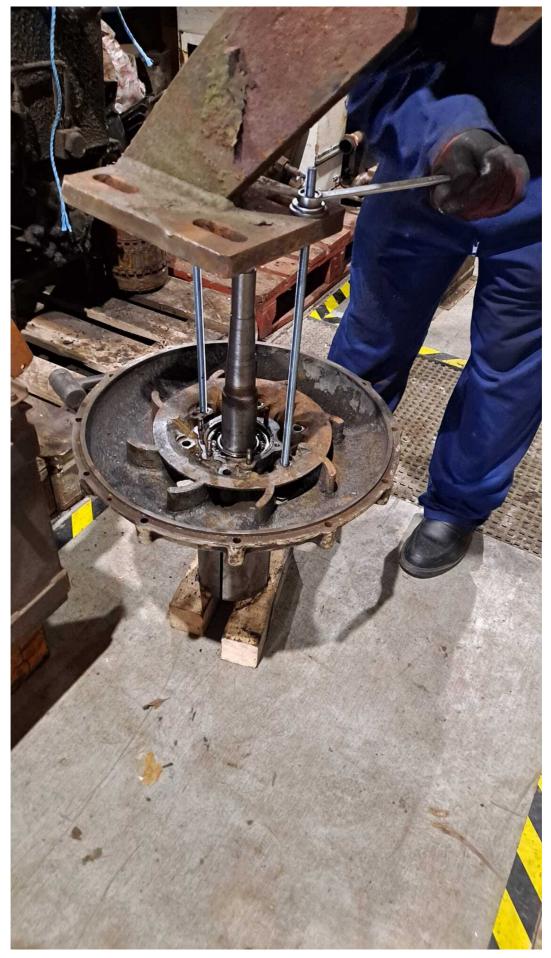
A bit of lateral thinking on the 23rd, using one of the bogie stone guards as a bearing puller

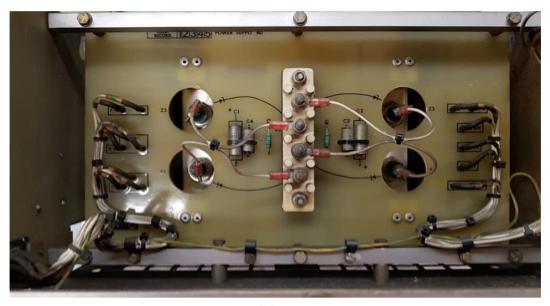
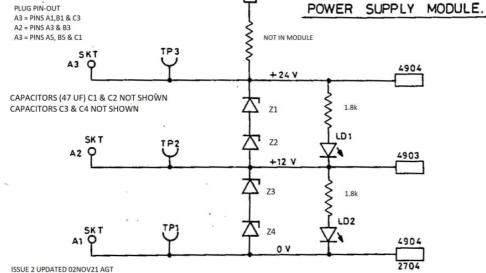
Our electrical expert Drew has started the unenviable task of checking out the 193 control cubicle modules. First on the list were the power supply modules. This is the wiring diagram for it, and an internal view of the module itself. The good news is that all of them seem to work ok, despite most of them being covered in fine black dust..... Only 189 to go Drew!

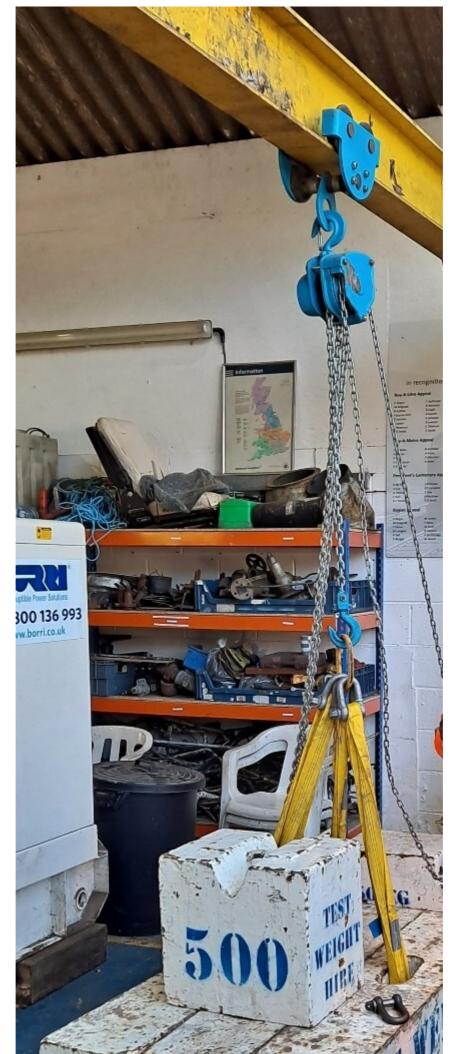
On the 3rd an inspection was made of our two lifting beams. They passed and we can now make use of them. One is in the shed while the other is set up over the bogies, ready to lift out the traction motors. However one has minor bending on one piece of steel so that will be replaced before we put the frame to use.

On the 20th fresh steelwork arrived to replace a warped beam on one of the two lifting frames. With one frame already passed for use, the second will soon follow.

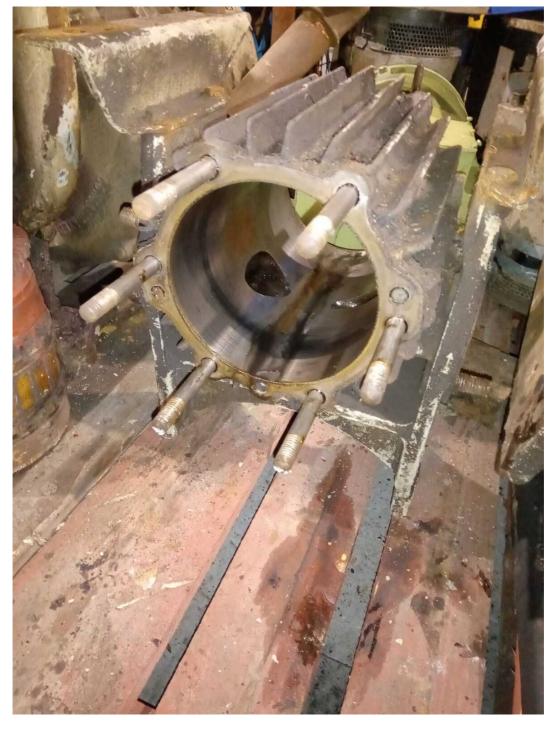
A bit of a slow day on the Exhauster today so I didn't get to where I planned to get to with it. My plan was to completely strip the rotor out of the casing, extract the support bearings/seals then clean up and inspect. I also intended to carryout a dimensional survey of the existing fibre rotor blades ready for procuring new modern material replacements. But a shortage of some equipment on my part slowed me up. However I did take an initial set of feeler readings to determine the rotor - casing clearances and it seems we are at our maximum tolerance with the current bearings. But once I've cleaned it all up and fitted new bearings I'll check again then we'll have a "as built" set of tolerances that we can use to select the 2 potentially best performing Exhausters of the 4 available, once overhauled. For next week I need to procure 2 x M12 X 500mm screwed rods with nuts to extract the bearing from the rotor shaft. The rotor assembly is very heavy and unbalanced when trying to manoeuvre it around so much H&S care is required to prevent damage and injury.

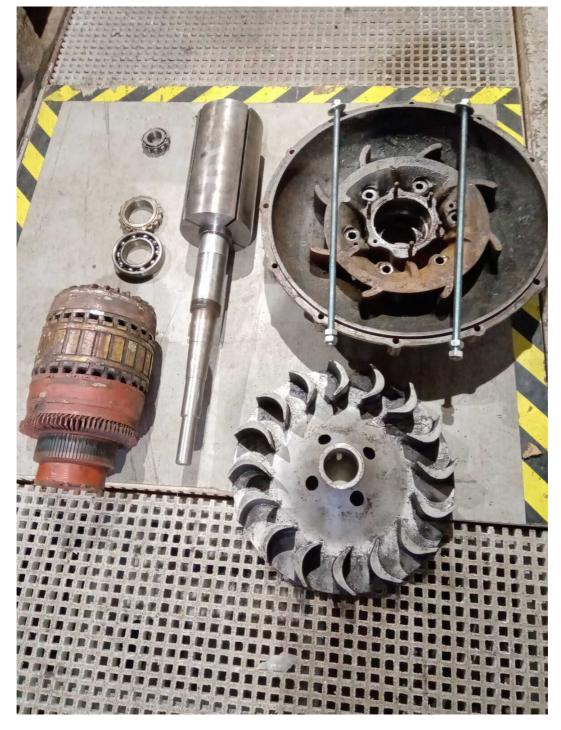
I few hours in the works today completing the strip down of the Exhauster, rigged up 2 lengths of screwed rod and a strong-back to draw the housing and bearings off the rotor shaft, Tony's post shows the set up. After trying several different unsuitable strong backs Tony came up with the mother of all strong backs, it's a bracket off the old bogies and although it was a bit over the top but it worked a treat, thanks Tony. There are a pair of bearings in this location the outer (motor side) one is a ball bearing maybe deep groove to maintain the shaft location and the inner is a roller bearing to support the weight of the 30kg rotor, the outer race of the roller bearing has yet to be withdrawn. Degreased the housing and commenced cleaning the casting ready for painting, but because of its age it has several coats of very chipped paint that needs to come off for it to look decent when it's refurbished. Scraping, chipping and wire brushing is a slow and tedious process but it's the only way and there's a lot of casings to do unless a local member knows of or has facilities to have all the casing shot blasted for the project, FOC of course.
