THE IVATT INFORMER

Recording progress with LMS 10000

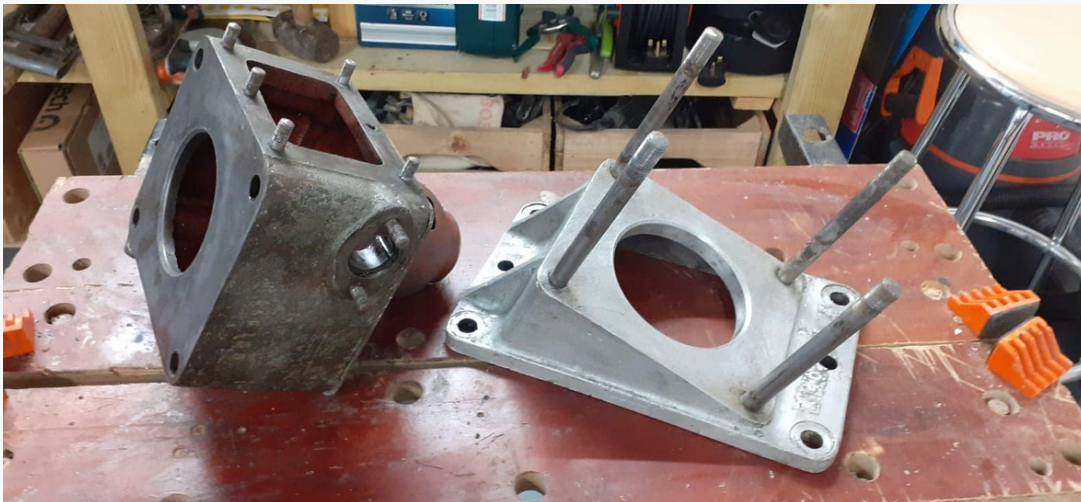
Phil has been busy today working on the governor tower, ready for the overhauled and adapted class 56 governor to sit on top (see pic below). The Governor regulates the speed of the power unit.

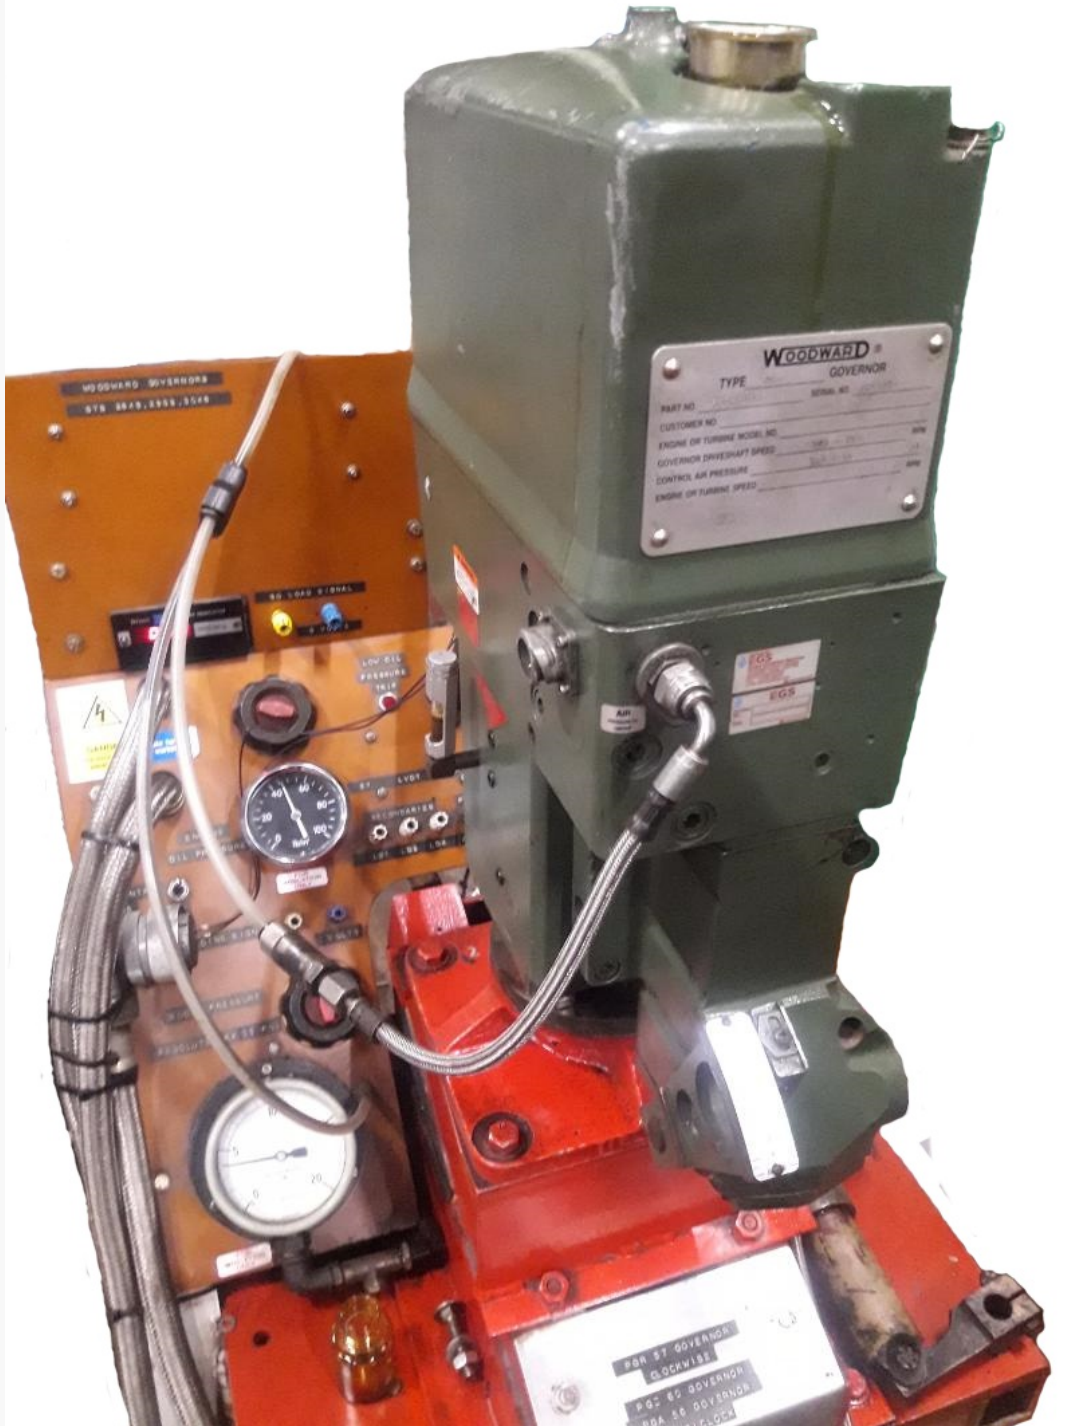
Here's a picture of one of the two Governors we have available. We only require one for the power unit, but have a policy of having 'two of everything' This picture was taken while it was on test.

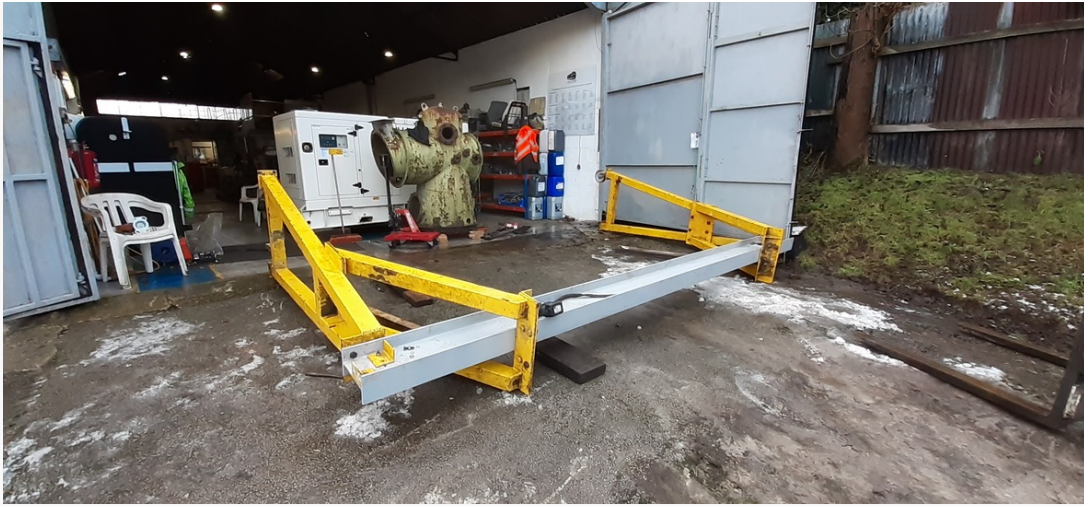
The top beam of one of our lifting frames was replaced on the 8th. The previous one had a slight bend to it. Seen with one of our ex Deltic steam heating boiler (green) immediately behind the frame.

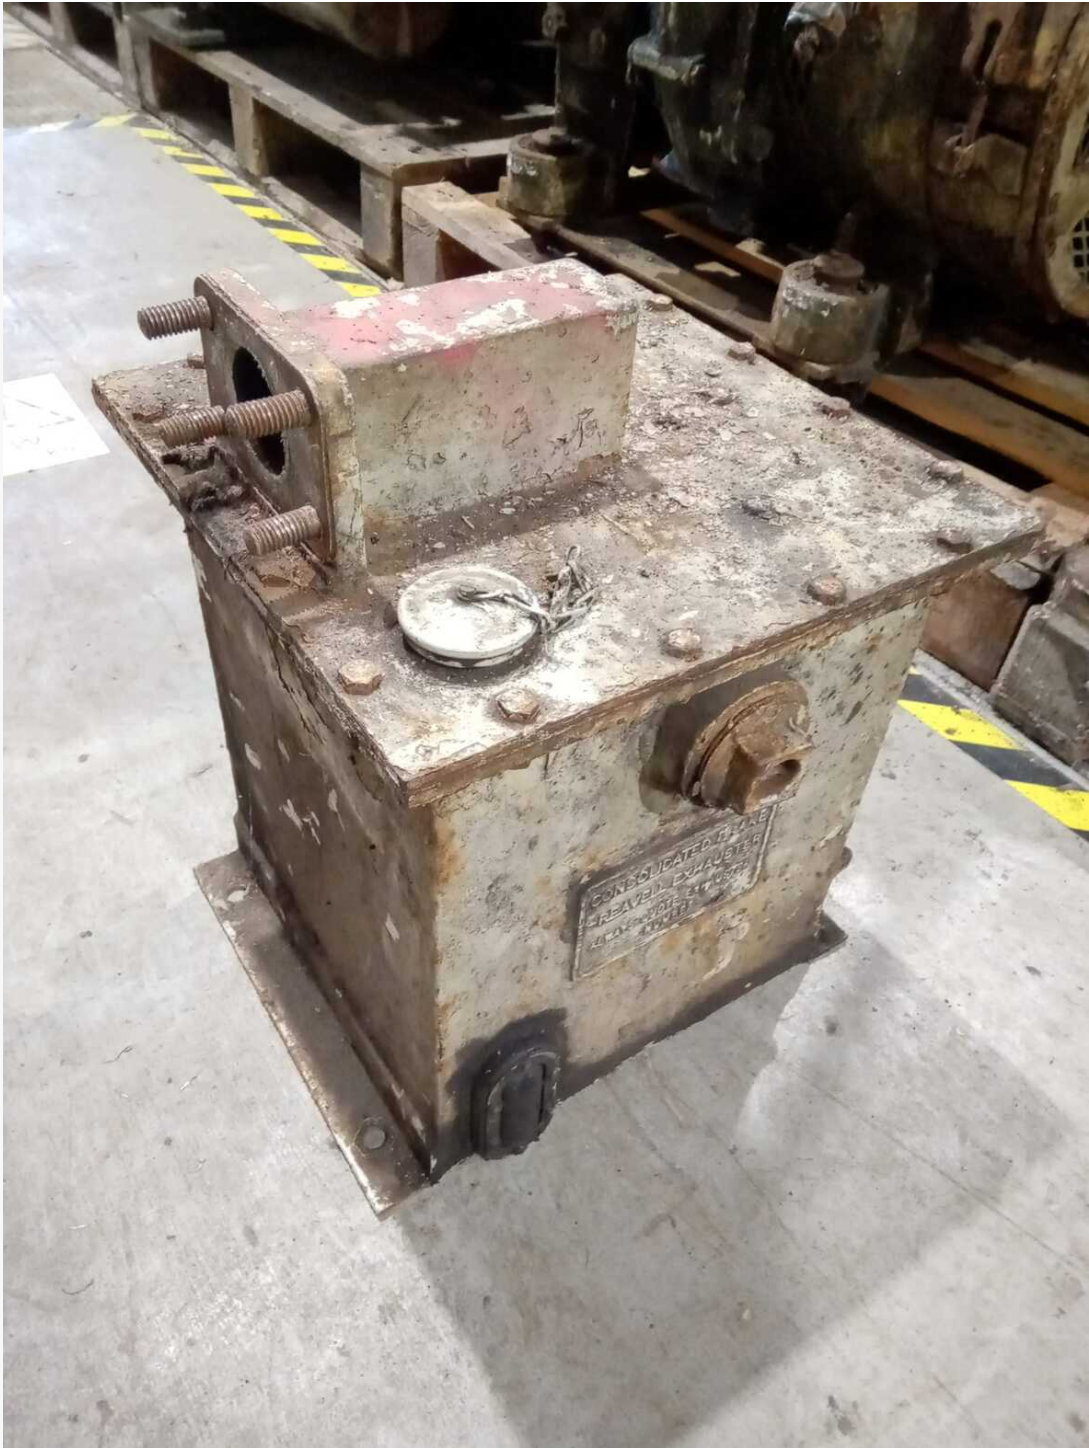
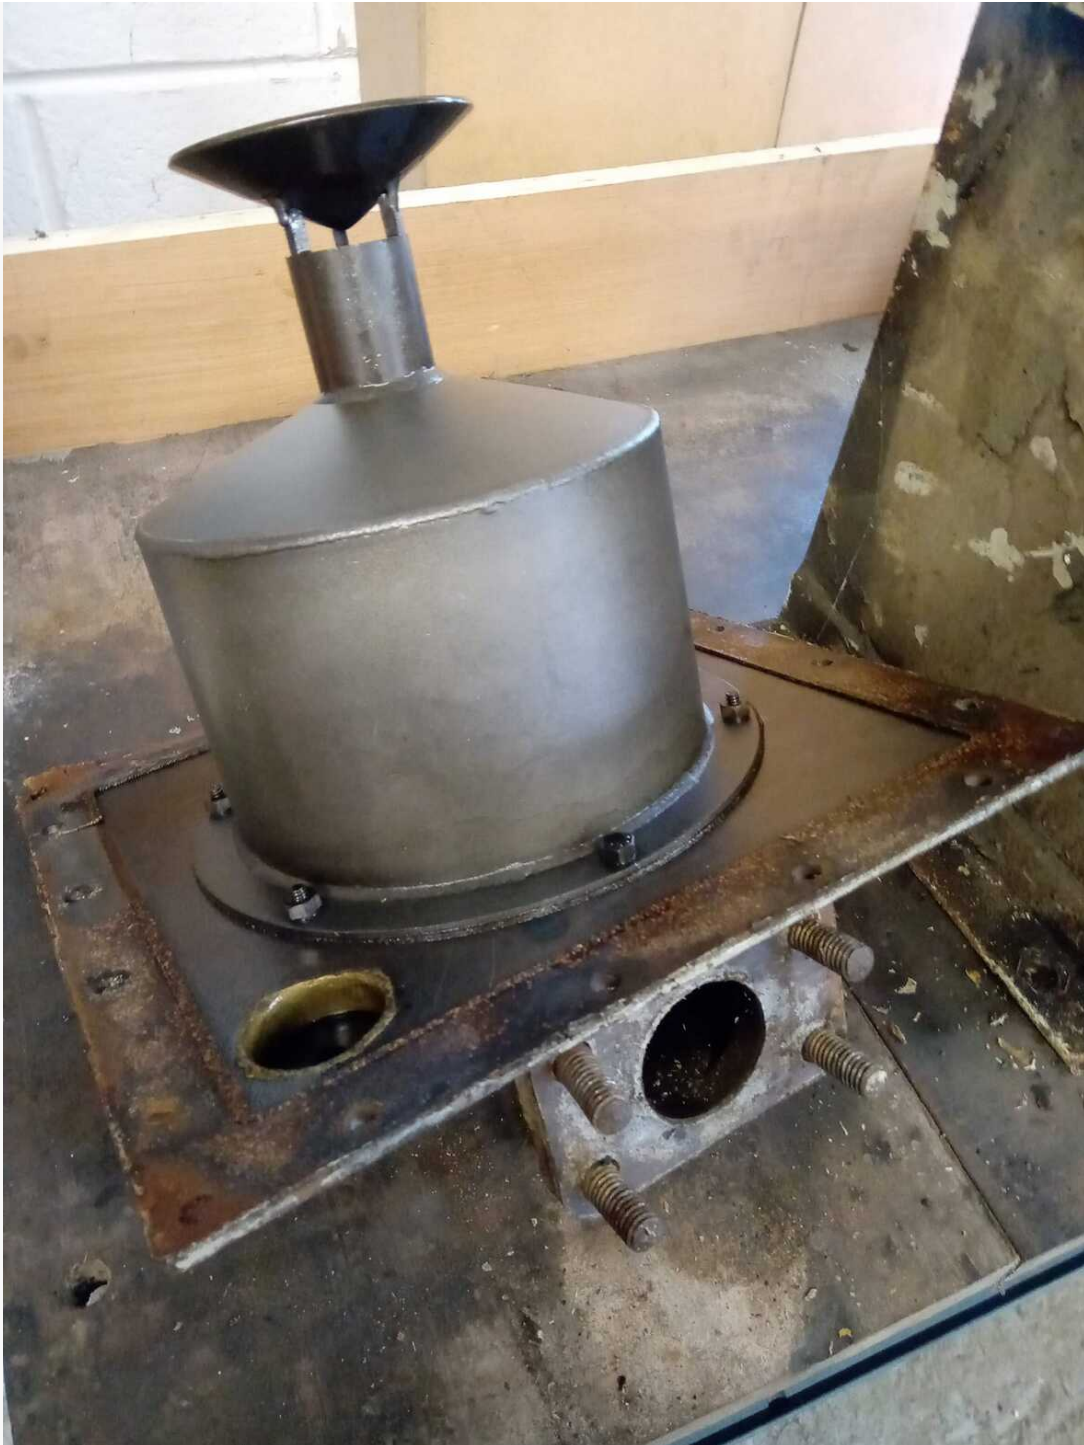
I spent a few very cold hours at the works yesterday, continued with the exhauster refurb by starting on the Seal Oil/Separator Tank. Removed the very painted nuts and bolts to remove the top cover. Cleaned off the old Nebar Gasket and removed the oil separator from the cover to access the oil strainer mess. The seal oil is contained in the bottom 3" of the tank under a baffle plate so it's not possible to directly clean the oil tank interior, the oil returns to the oil tank though ports in the corners of the baffle plate.

Removed the drain plug and initially oily water came out quickly followed by a gloopy mess that crawled out in blobs. To try and flush out the oil tank Tony poured in some old diesel and agitated the tank to loosen up the remaining gunge. Then a trip to the parts washer and finally a jet wash flush, thanks Tony. Cleaned out the oil strainer mesh and the rest of the parts, again finishing with a jet wash. Set all parts aside to dry ready for next week.

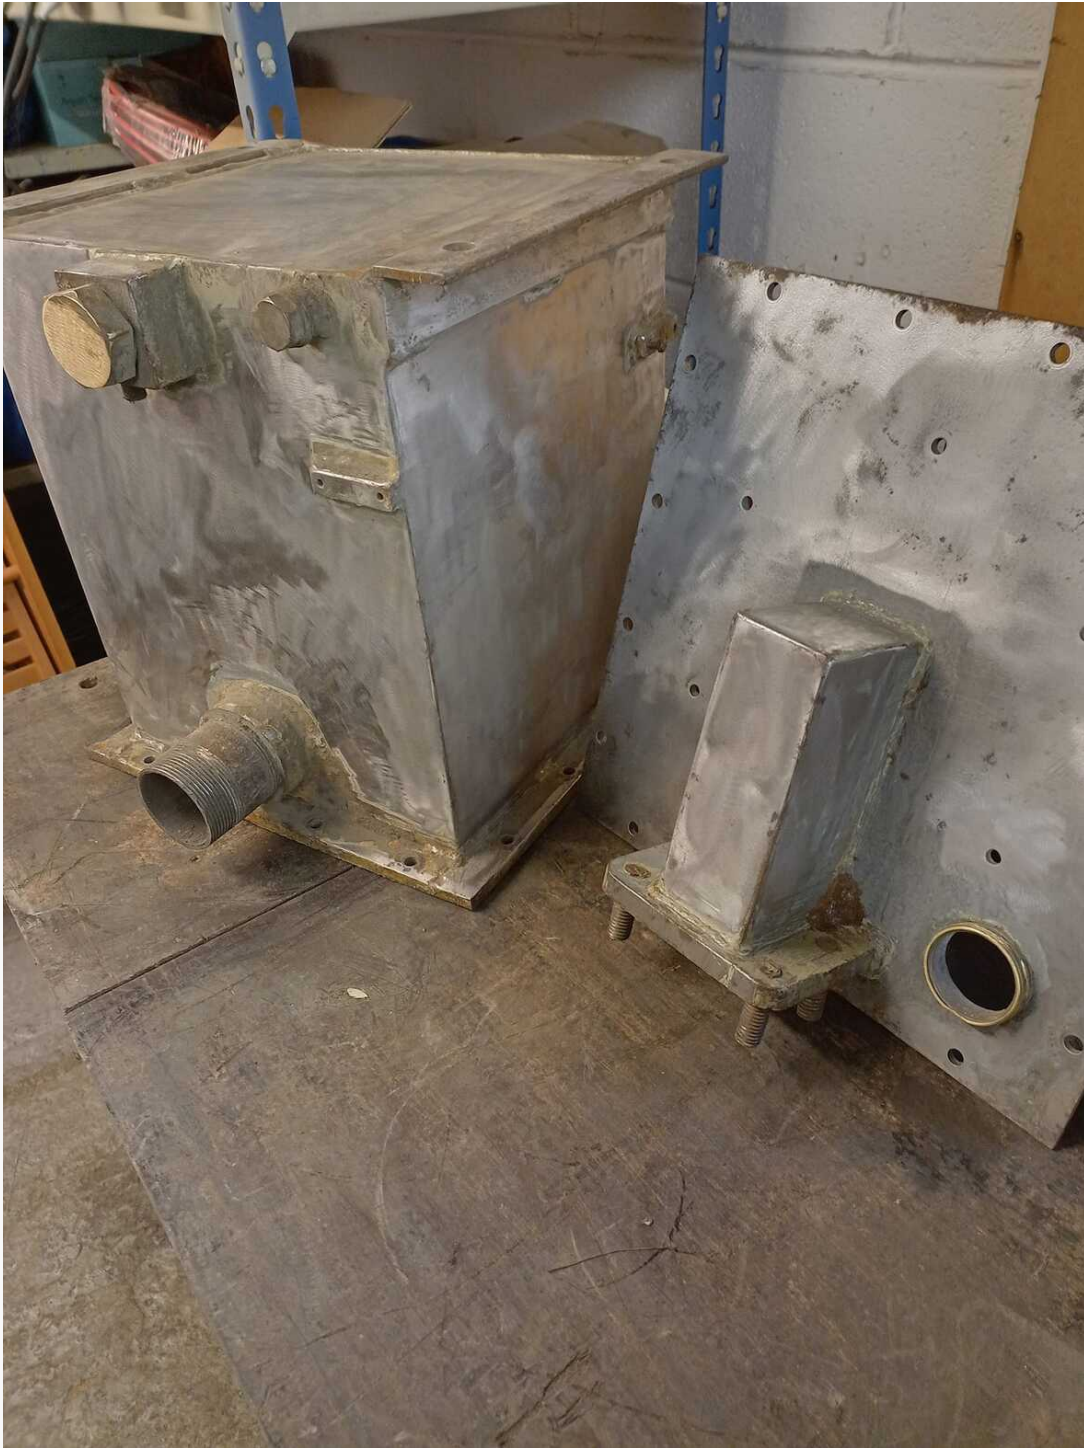
Today's work at the very cold works (zero degrees, I thought about putting my yogurt in the fridge to prevent it freezing) was stripping the old chipped and damaged paint off the exhaust oil separator tank. The heater was fired up to at least make it bearable and to keep toasting my cold hands.

Using a sharp scraper and a 5" angle grinder fitted with a paint removal disc made short but very dusty work of it, so full PPE was in operation. The areas that the disc wouldn't go were done with the sharp scraper, using a chipping and scraping motion, so I'm about 90% there now. Should have it ready for painting next week if its warm enough to apply the paint. Spring is on the distant horizon!

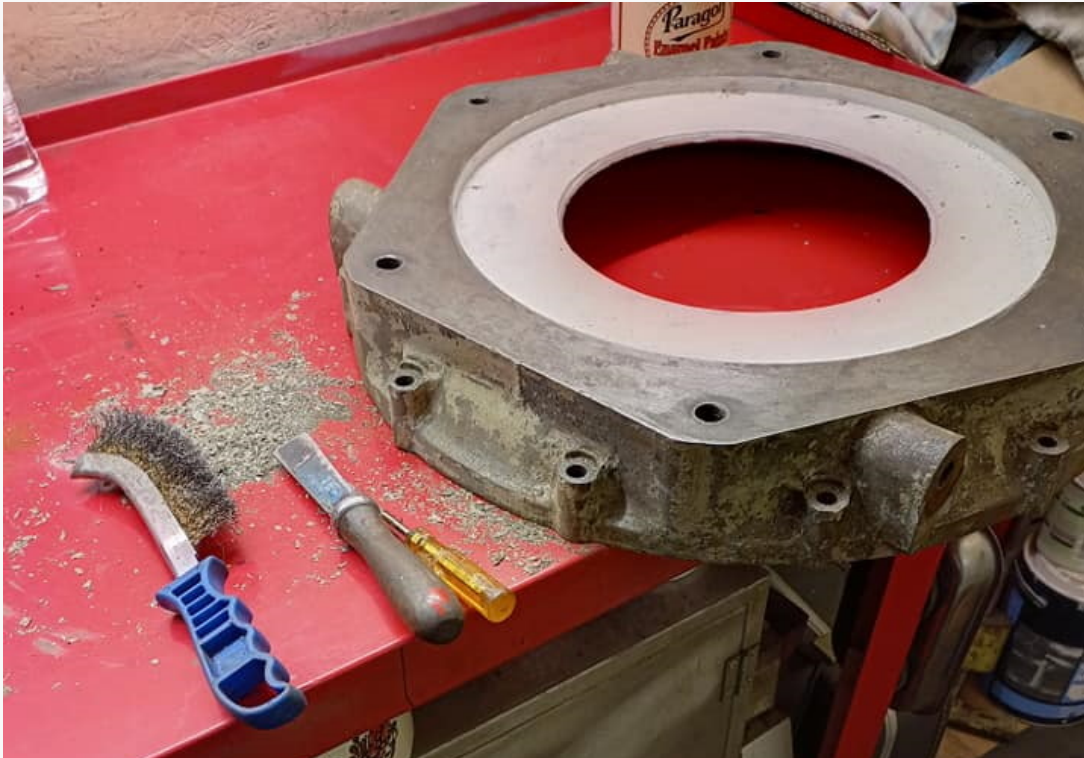
I managed to wrangle a pass out to escape to the garage this afternoon for a couple of hours to do some homework. Carried on chipping, scraping, wire brushing the old paint off the Exhauster fan casing/motor mounting. I want to get back to bare metal as I'm looking to see if any stitch repairs have been carried out on any of these casings. I remember from my Loco days that some casings were Meta-lock'd (a cold metal repair process for repairing cracked casings and housings) saves

pre/post weld heat treatment/distortion from weld repairs.

If I find any evidence of cracking or any previous crack repairs I can then do a visual check for any further obvious evidence of crack propagation at the repaired site, if any defects are found a Magnetic Particle Inspection (MPI) will have to be performed to discover the extent of the defect. As far as I am aware we don't have access to any NDT Qualified/Certified Personnel with the right equipment, unless any of you guys know different?

I discovered something interesting anyway this casing is stamped X58021, the other marking is probably the stamp of the Finished Work Inspector after the final stage of manufacturing.

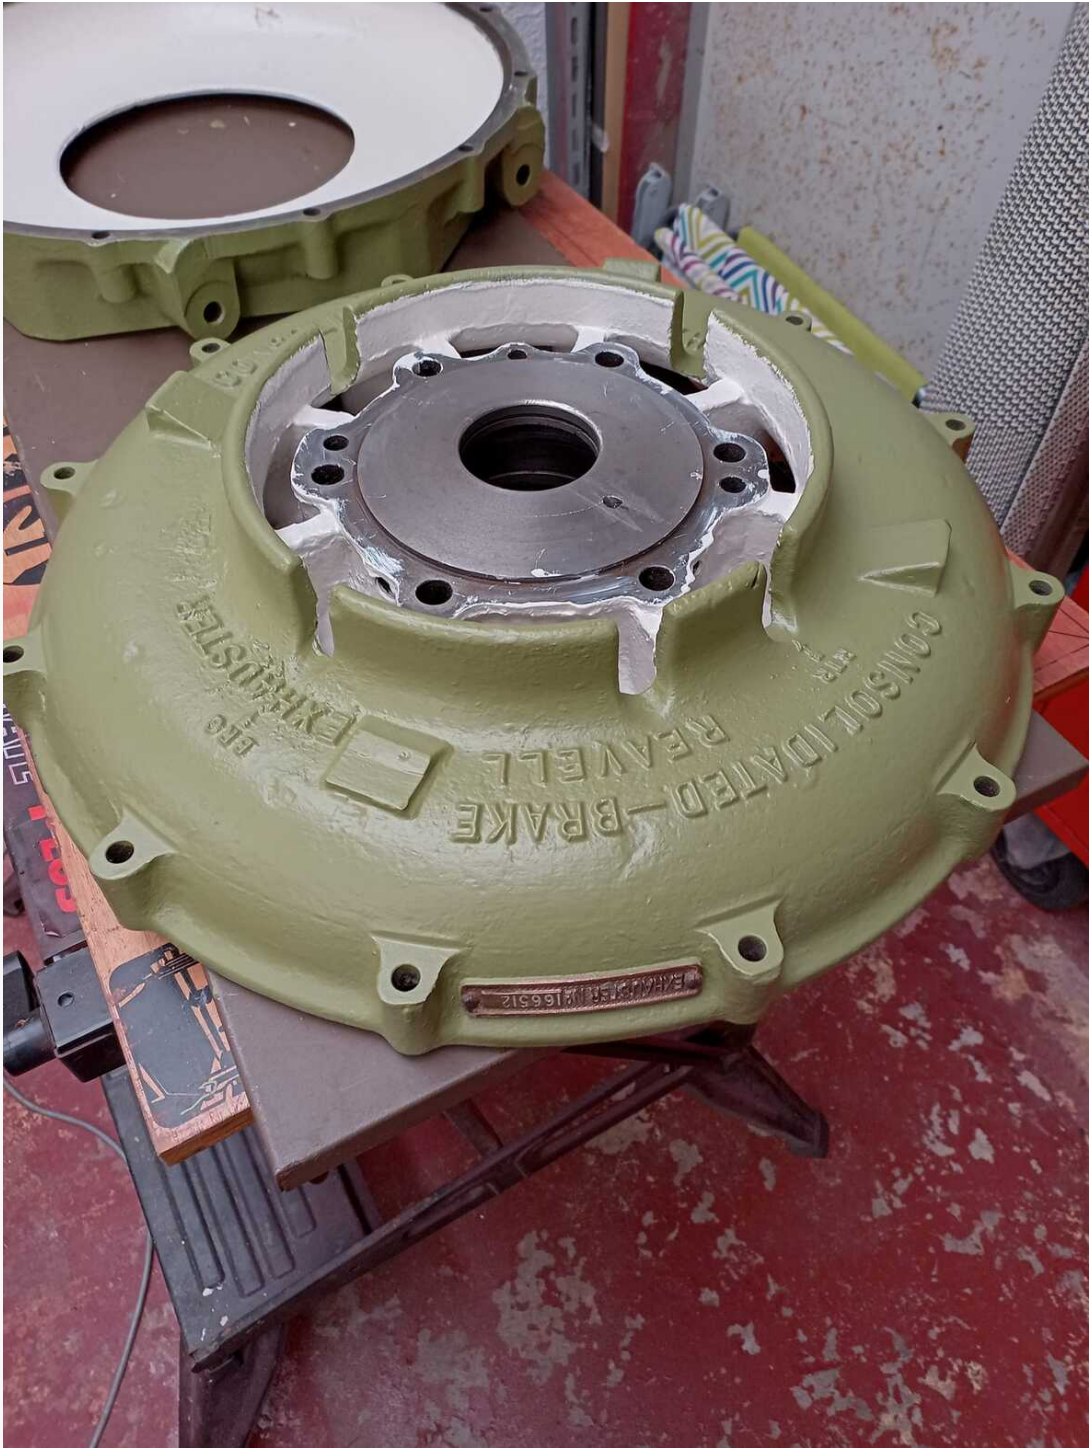
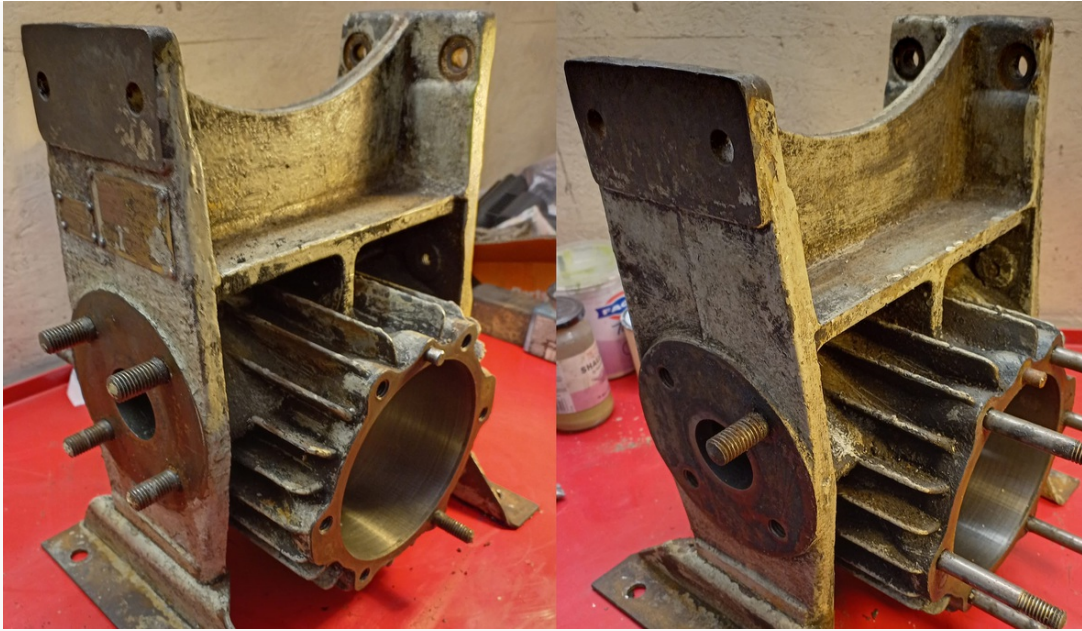
Cleaning and painting the Exhauster Casings has continued. The exhauster body is really caked in years of oily crud and will only come off with a scraper and white spirit, but it's coming along. The machined surfaces will be polished up prior to assembly.
