THE IVATT INFORMER

Recording progress with LMS 10000

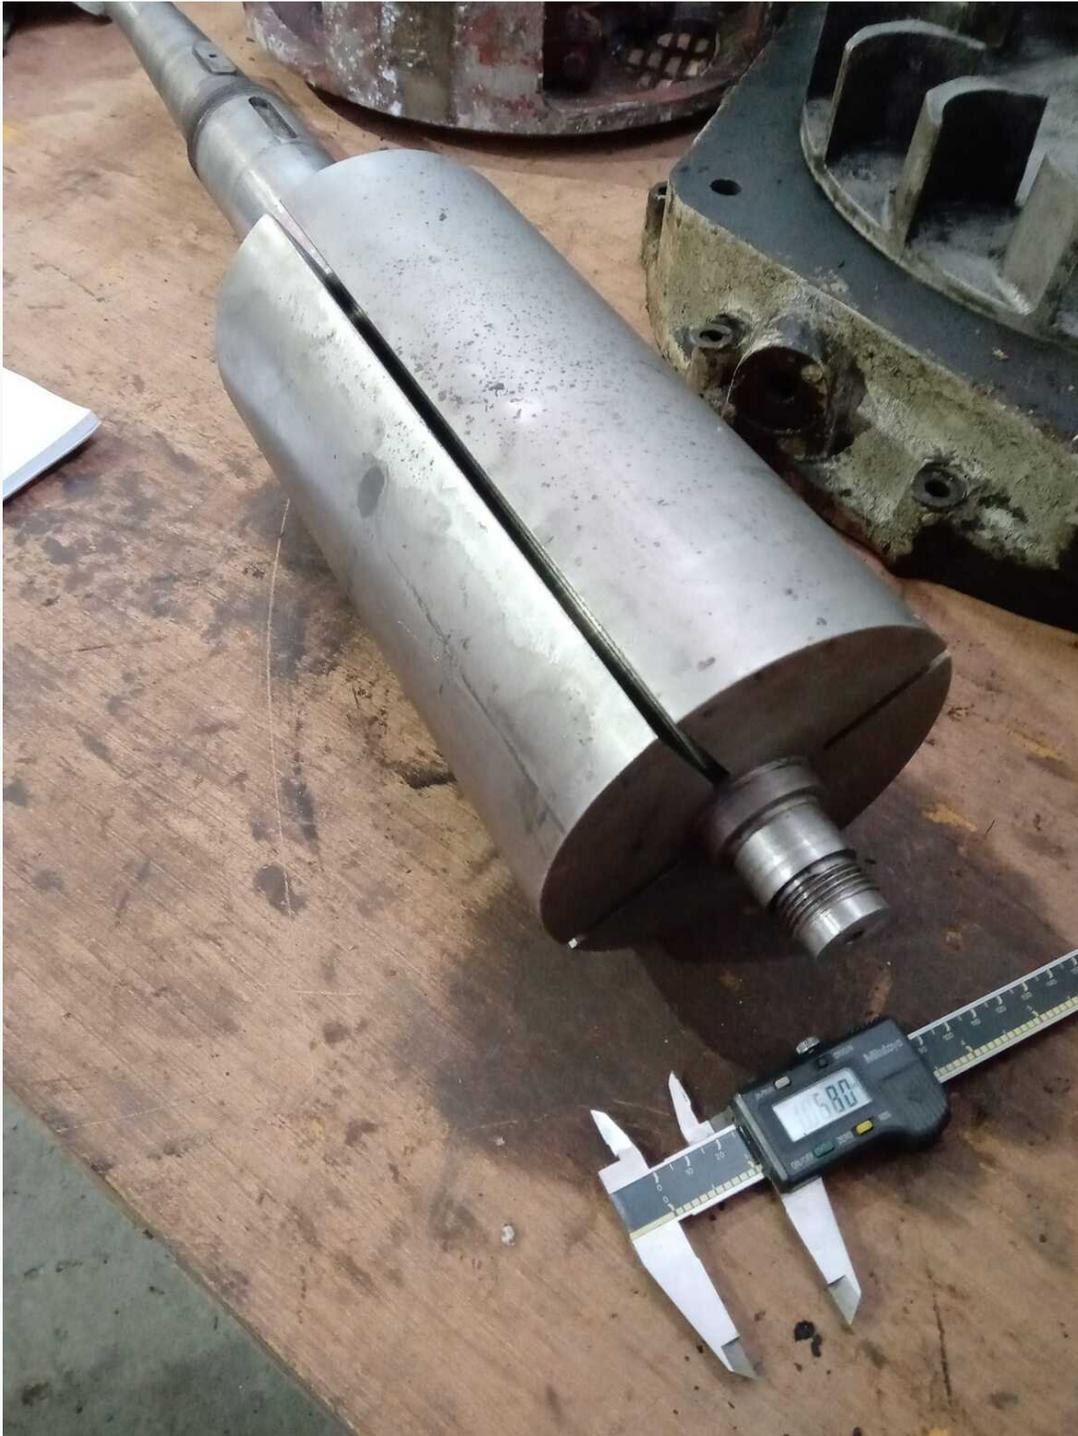
Spent a few very cold hours in the works yesterday but fortunately the snow had all gone. Got on with the Exhauster doing a detailed survey of the rotor measuring the bearing journals and all the vanes and assessing the wear already sustained by them, and although they are within the wear limitation tolerance their running time is an unknown so replacements will have to be sourced. I have found a company that manufactures new vanes in modern materials so I'll contact them in due course. My intention yesterday was to do a dry build of the vacuum unit to check the rotor to casing clearances but the components were so cold my hands went numb just doing the rotor measurements so I got on with doing a bit of cleaning and degreasing. Eventually got too cold despite having the space heater on, so had an early finish and went home early afternoon. We'll see what next week brings.

The exhausters have a single shaft running all the way through, with the motor armature on one end and the vanes that create the vacuum on the other. The grooves in the picture above hold the vanes. These will all be replaced before reassembly.

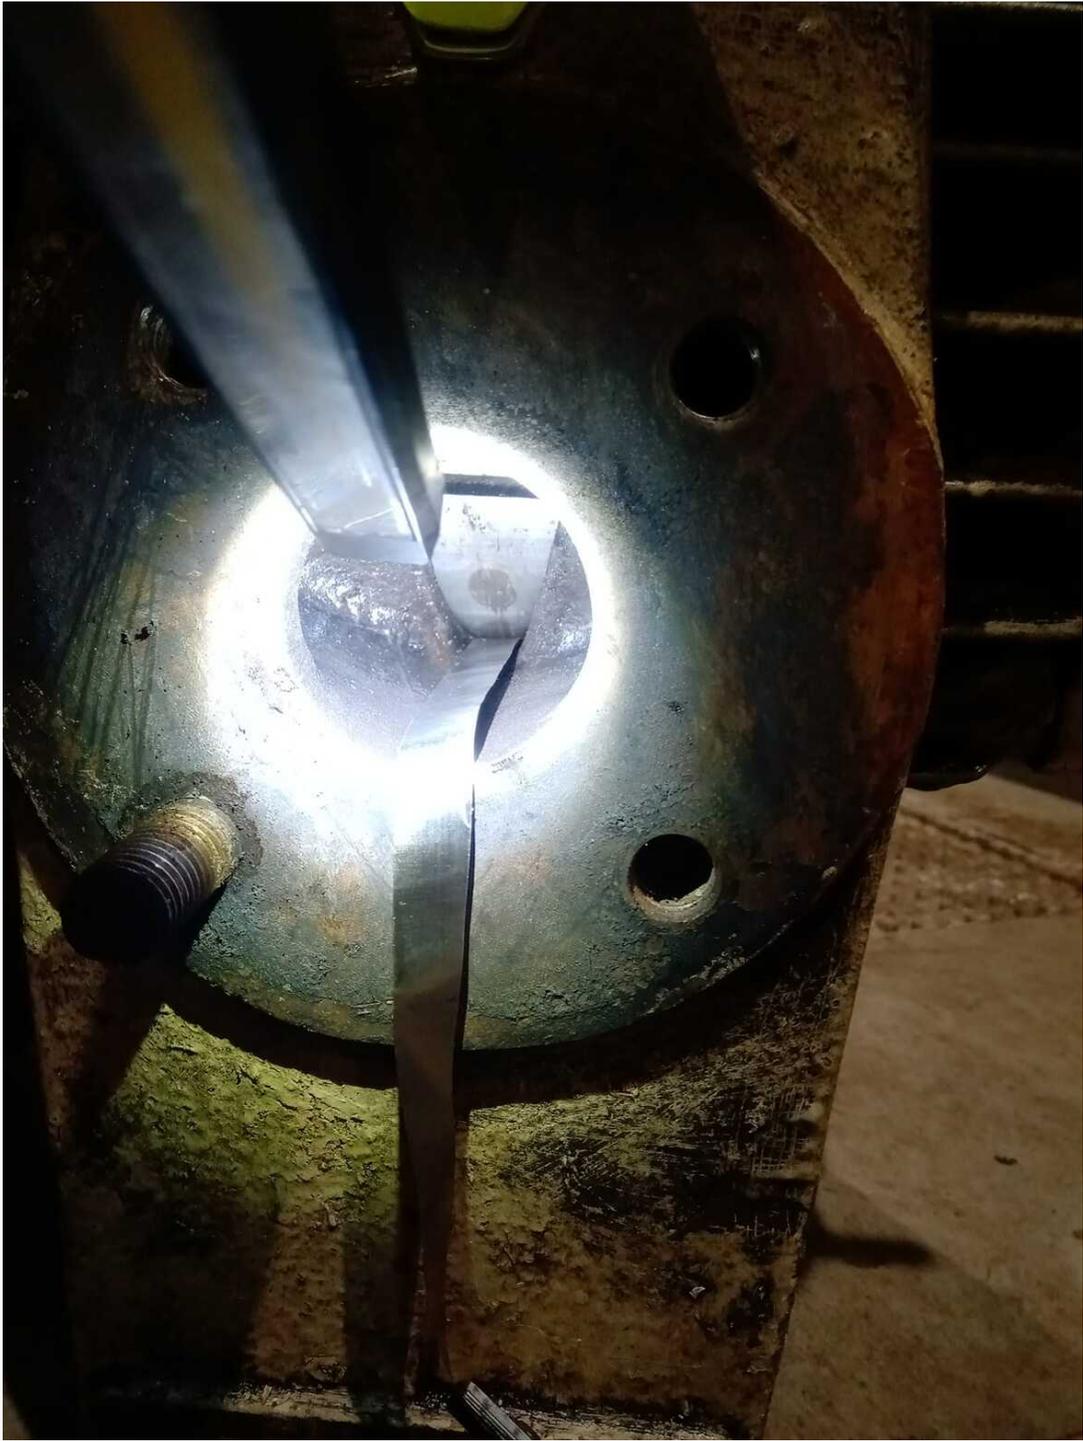
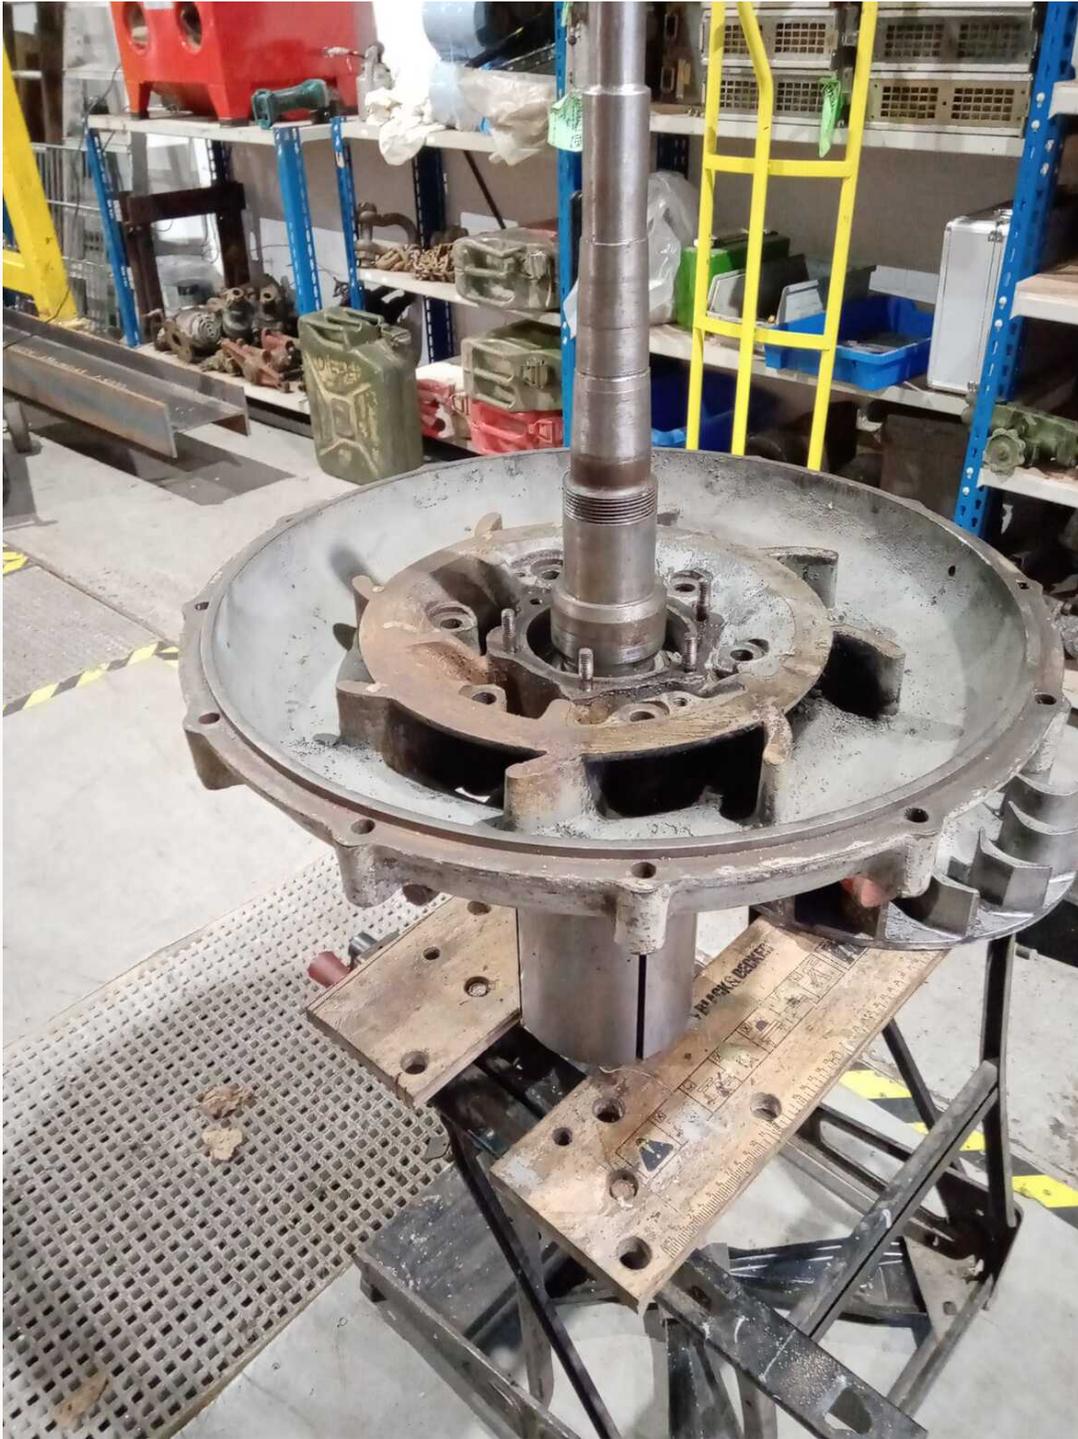
A few more very cold (6 degrees) hours in the works yesterday doing a dry build on the first exhauster. It was hard going fitting the bearings to the shaft with everything being so cold, I warmed the bearings up a little and it made them easier to fit but they'd still tightened up before being fully home, but the bearing rollers were located in the races sufficiently for me to assemble the vacuum unit and take some feeler and DTI readings of the rotor running clearances.

Using 12" feelers I was able to feed a 0.002" blade into the rotor - casing gap then slowly turn the shaft to draw the feeler blade in to measure the running clearance, as the 0.002" feeler was only drawn in about half an inch this would indicate that there is a clearance of 0.0015" at BDC between casing and rotor. The mag base and DTI measured the running clearance of the rotor within the sealed vacuum casing.

At this temperature the clearances were in spec at 0.0015" for the rotor to casing clearance and 0.012" of end float. In a running condition the rotor is fixed laterally by the ball bearing so it does not float at all, but we now know what the running clearances are. Provided that the coefficient of expansion of the steel rotor and cast steel casing are the same then the recorded clearances are fine and should produce a good vacuum unit once it's rebuilt with new vanes, bearings and seals. Thank you Tony for assisting me with the build.

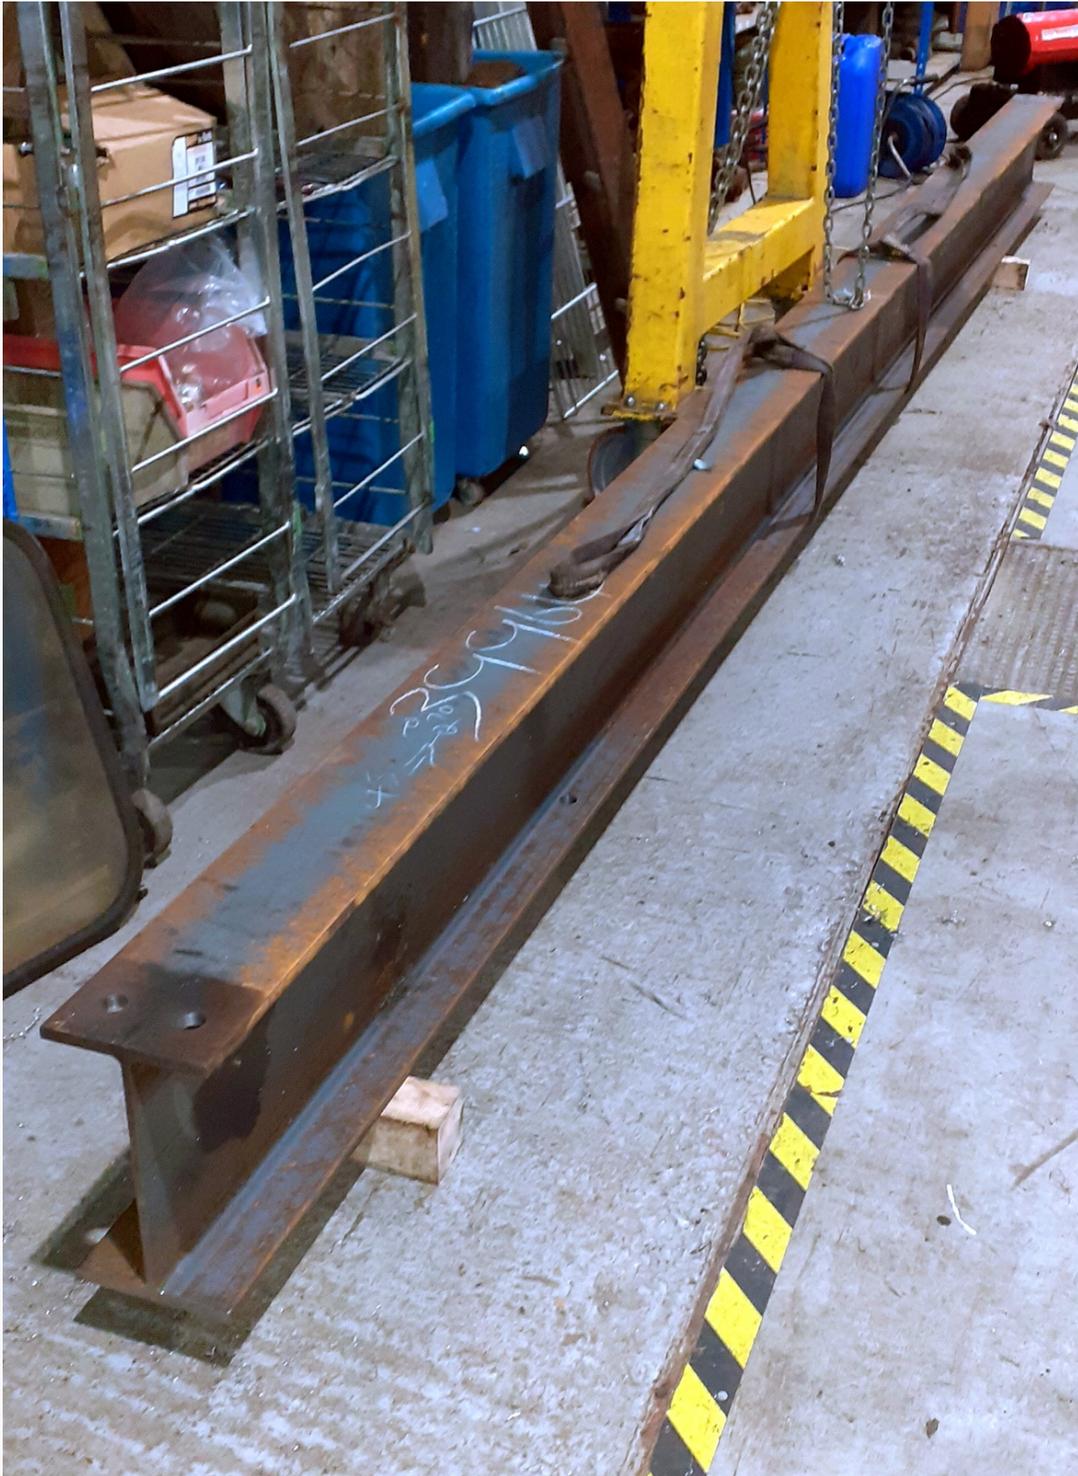
The new beam for the works lifting frame is all drilled ready for fitment...

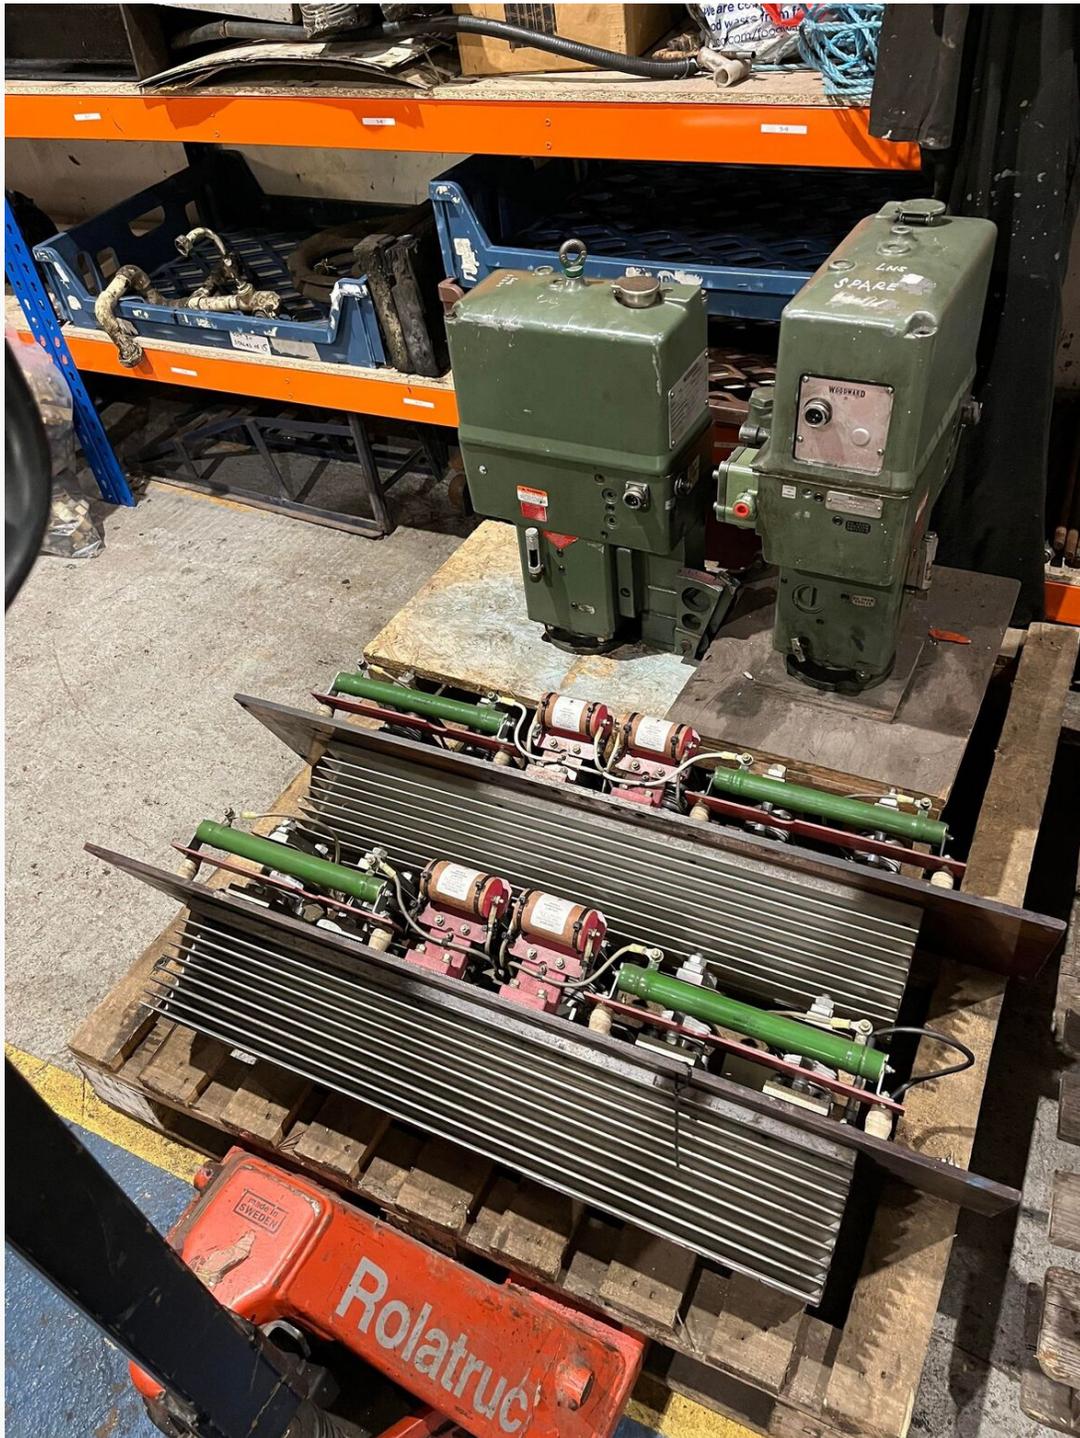
.... an overhauled rectifier and start contactors have been obtained and collected. The governor has been set up correctly for our engine and is back at the works, along with a spare.....

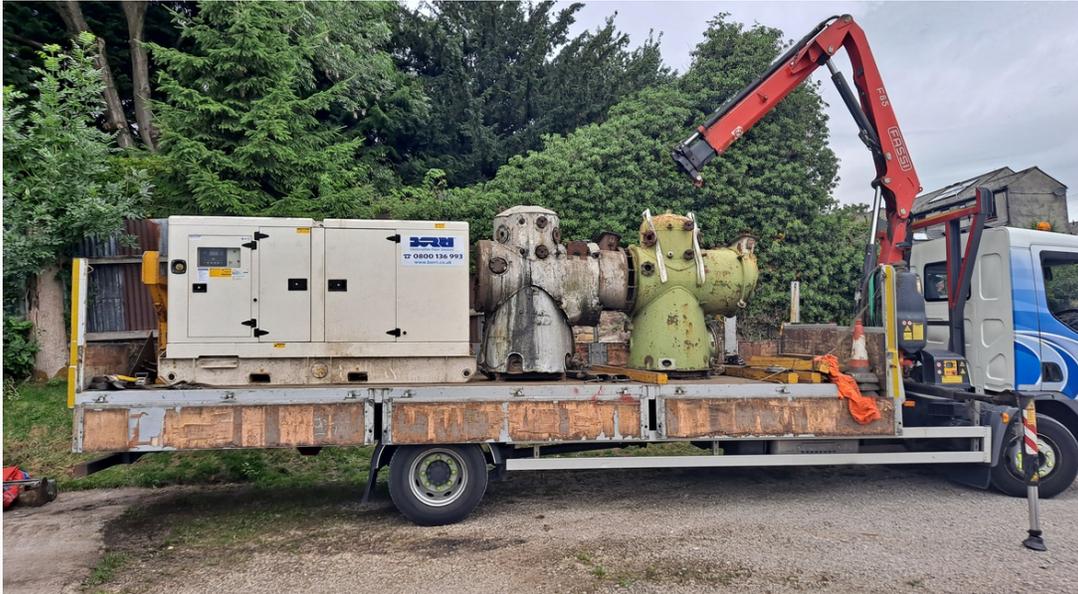
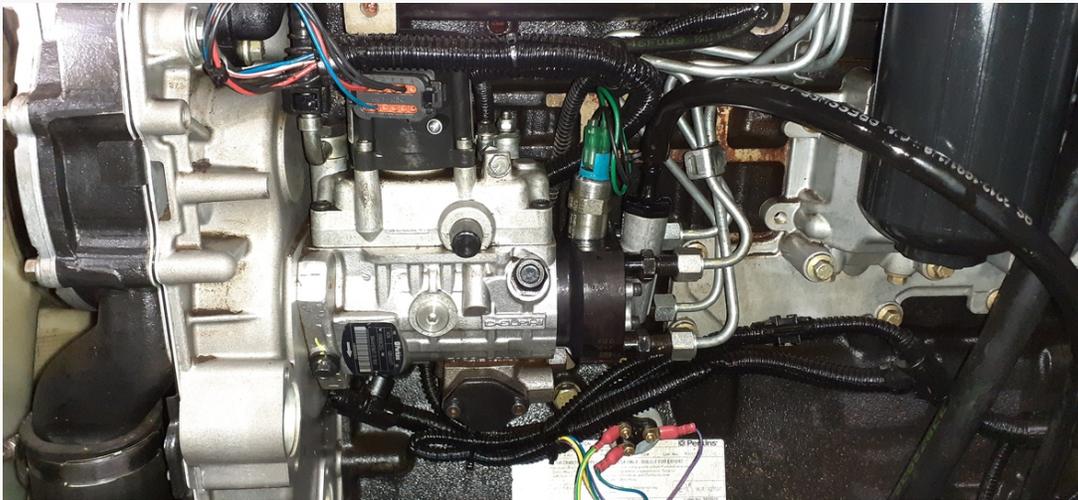
The generator is seen, below, when delivered in August along with the two ex Deltic steam heating boilers.

Aside from that Phil, Tony and I threw the full nine yards at the generator today, [it was donated specifically to be sold to raise funds]. We had to decide whether to sell it on as it was, or try to get it working and effectively double its value. Although it isn't quite working yet, it isn't far off. We have eradicated lots of possibilities, but the tank is still full of dirt after flood damage. Phil's mate works on these all the time as a job and he is going to come on Wednesday after Christmas to give us some support.. So the tank is empty, and it has been jacked it up on one side to allow the effluent to go to where I can get at it. Another washout is required.
