This report was provided to World Sailing by [Australian Sailing](#).

Patriot rudder loss 2018 Sydney to Hobart case study

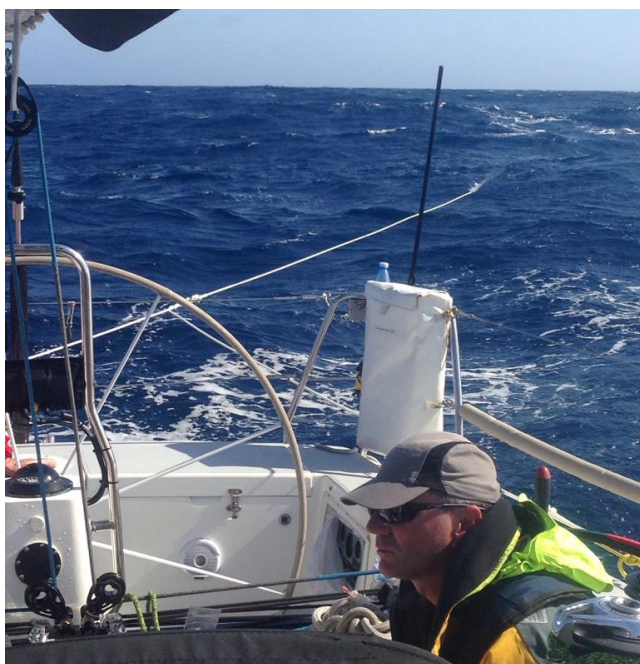
Eventually playing around with sails we managed to pull tight against the drogue and then started tracking straight under jib alone. The danger from the boom was seen to be too great and the boat wouldn't track so the main had been already dropped. We had plenty of diesel so it was decided to motor sail slowly. We were concerned at the time about the thickness of the warp so kept speed to around 3 knots (which later under tow proved we could have gone faster but at the time we were being cautious). In hindsight we should have tried trysail as well for additional balance and a little more speed. The shape of the hull and length of sheets meant the effect of going to beam max was negated as the sheets ran next to the aft cleats anyway.

It was difficult to track straight with the yacht hunting to port and starboard, although some adjustment of sheets and sails got it going straighter. Unfortunately, not having a swivel shackle at the bridle end meant we got bad twisting which effectively shortened the bridle and increased the poor tracking. We settled in to a slow and steady 3 knots heading towards land but relayed to the navigators that we could not go to windward, only reach. This information was provided to the navigator and skipper who determined an initial plan to head to the safe waters of Jervis Bay, later changed to Ulladulla due to facilities there. Lesson learnt, pre-plan safe havens to match the yacht's draught.

- Ideally have a dedicated emergency tiller and rudder box setup on the stern – wouldn't want to be on a lee shore with drogue steering
- Longer sheets and definitely a swivel at the bridle end of the warp. Weight of chain and swivel at drogue end saw the drogue sit well 2 wave lengths back from the boat. Warp and drogue size was right for the boat, a thicker warp would have been comforting though.
- 3 knots is about all you can do safely under drogue steering we noted. Current and moderate winds meant we couldn't go to windward.
- Without the drogue we wouldn't have been able to be towed.
- A dedicated towing bridle setup with full chafe protection is a must, ideally load shared to winches.
- Pre-plan safe havens before heading out, particularly those which cater to deeper draught vessels and understand available facilities.

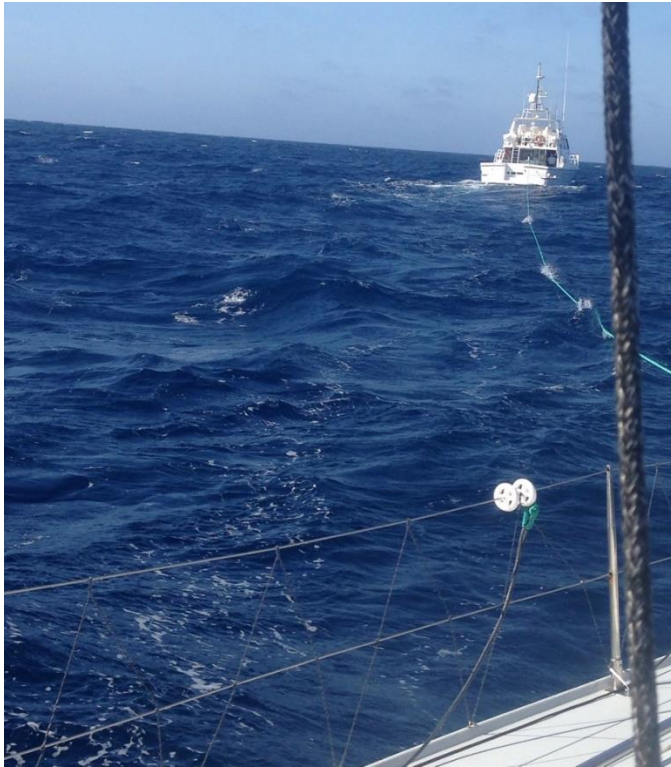
Early the following morning a Marine Police boat arrived to tow us in. The skipper accepted a tow, so we set up a towing bridle onto bow cleats through the fair leads. The Police boat initially went approximately 9 knots which was way too fast, with the yacht hunting dramatically. It was quite uncomfortable and led to the shearing of the fair lead on Port side and snapping of the bridal rope. Lesson learnt – don't use fair leads and keep the speed down, perhaps re-rig to mid aft instead of drogue bridle. We re-tied the towing bridle, doubling up the rope and added chafe protection around the forestay and adding load sharing ropes back to the primary winches and resumed at around 5 knots. Lesson learnt – we should have had a better dedicated towing bridle with chafe protection rather than rely on thick mooring lines. Also even Police boats often don't know the best setup, fortunately we had on board an experienced ex Police current Port Phillip sea pilot skipper who had himself towed many boats in the heads, so he determined the best approach. The revised setup worked well and was used the whole way in, we settled to 5k approx. speed, even then we moved around a lot. See <https://youtu.be/xEgMMtm3rd4> to watch how the yacht behaved under tow.
