# Comprehensive Pool and Spa Inspection Report

Address 2820 21st lane  
Vero beach, Florida, 32960

Date Saturday, February 7, 2026

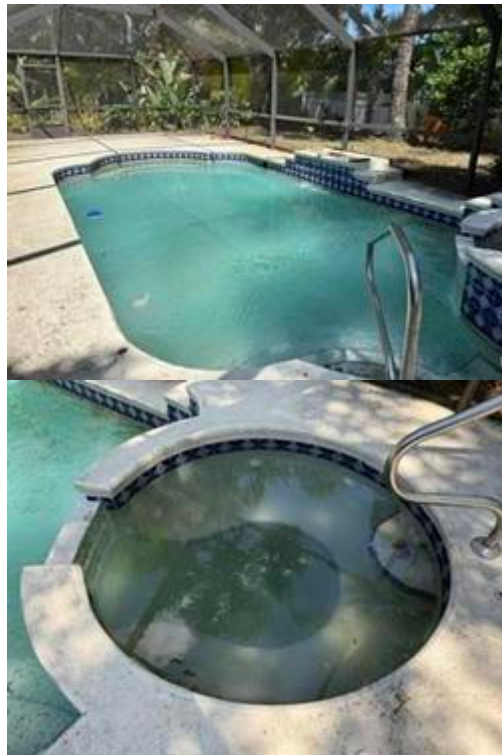
What type of pool is this? (e.g., in-ground, above-ground, saltwater, freshwater) | ground

Enter the total volume of the pool in gallons | 9000g

Provide the dimensions of the pool area | 20x10

Water Clarity | Cloudy

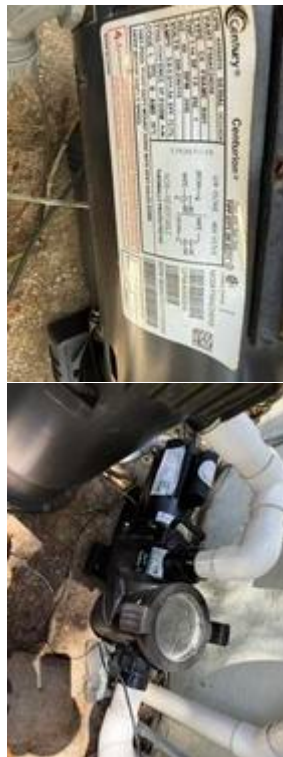
Enter the type, model, and serial number of the pump Jandy flopro. 1.14 hp

Check for any corrosion, rust, leaks, unusual sounds, or pressure issues New

Pump basket Clear

Enter the type, model, and serial number of the filter system Sta-rite. Pxc125

Check for any corrosion, rust, leaks, or improper sealing Good condition

Jandy FloPro circulation pump was installed and connected to the filtration system at the time of inspection.

Pump housing and motor exterior showed normal cosmetic wear and weathering consistent with outdoor exposure.

Plumbing connections appeared securely routed into the equipment system.

Pump basket housing and lid assembly appeared intact and accessible for maintenance.

No major active leaks or significant structural damage were visibly observed during inspection.

Technician reported the pump basket was clear at the time of inspection.

Technician noted the pump appeared in newer condition with no major corrosion, rust, unusual sounds, or pressure concerns observed during inspection.

Continue routine preventative maintenance and pump basket cleaning to maintain proper circulation efficiency.

Monitor pump unions, lid gasket, and shaft seal periodically for developing leaks or air intrusion over time.

Have the pump professionally evaluated if excessive noise, vibration, or operational inconsistencies occur in the future.

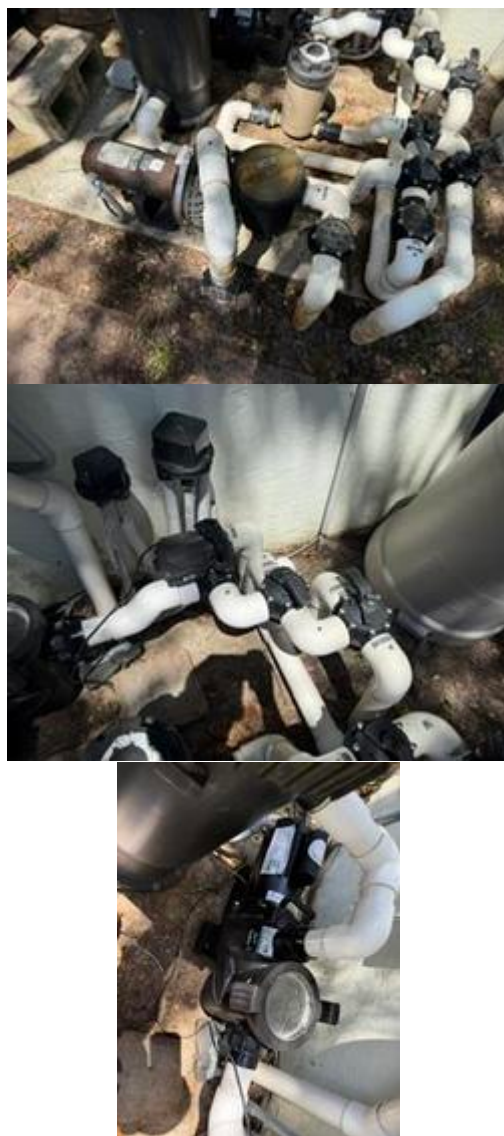
Auto valves not operational. Jandy branded

All other valves are Jandy

Multiple plumbing manifolds and valve assemblies were installed throughout the equipment area to control circulation, spa operation, and water feature routing.

Several automated valve actuators were present and connected to the plumbing system.

PVC plumbing appeared professionally routed with accessible unions and fittings for servicing.

Plumbing components showed normal weathering and discoloration consistent with outdoor exposure and age.

Minor surface staining and age-related wear were visible on portions of the plumbing and older metallic components.

No major active plumbing leaks or significant structural damage were visibly observed during inspection.

Technician noted the plumbing system utilized primarily Jandy-branded valves throughout the equipment configuration.

Technician reported the automated valve actuators were not operational at the time of inspection.

Have the automated valve actuator system professionally evaluated and repaired to restore proper automation functionality.

Continue routine inspections of valve seals, unions, and fittings for seepage or developing leaks over time.

Exercise manual valves periodically to help prevent stiffness and internal seal deterioration.

Monitor older plumbing components for signs of corrosion, cracking, or operational inefficiency as the system ages.

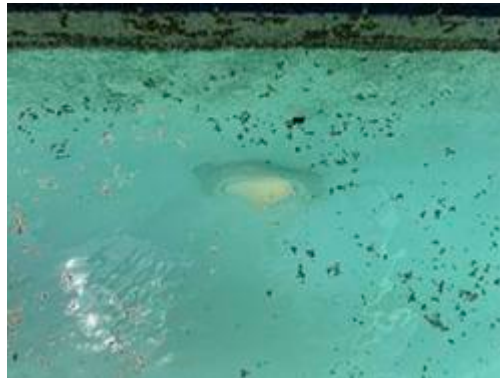
List the types and quantities of deck and underwater lights      Halogen in pool not operational in pool or spa

Check lights for operational status and any visible damage      Not working

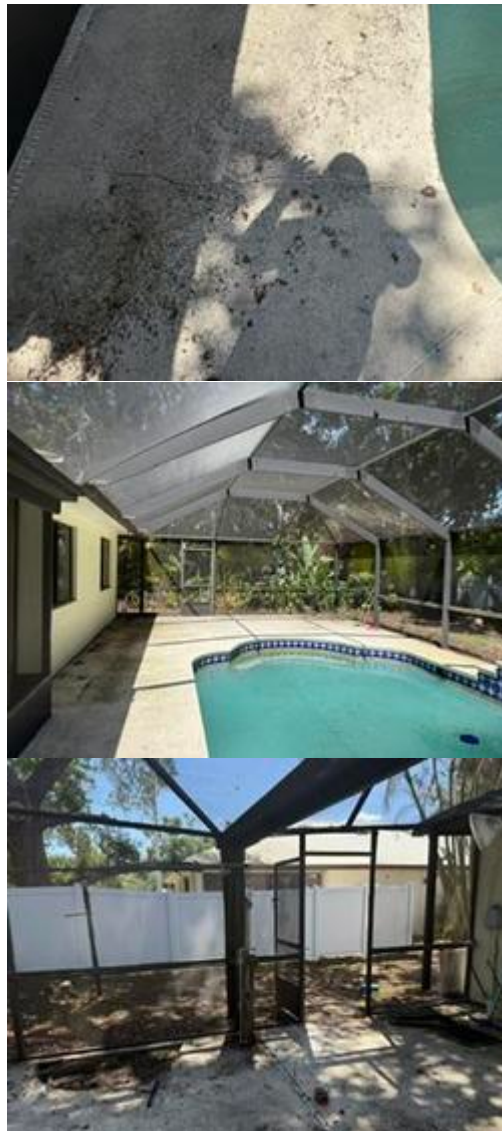
1 large crack

Deck surfaces showed visible discoloration, organic staining, and dirt buildup in multiple areas consistent with outdoor exposure and environmental accumulation.

Minor surface cracking and cosmetic wear were observed within portions of the deck surface.

Screen enclosure structure and framing were present surrounding the pool area at the time of inspection.

No major structural deck displacement or significant settlement was visibly observed during inspection.

Technician noted the presence of one larger crack within the deck area during inspection.

Consider professional deck cleaning or pressure washing to improve appearance and reduce organic buildup.

Monitor visible deck cracks for future movement, widening, or deterioration over time.

Seal or repair cracks as needed to help reduce water intrusion and further surface deterioration.

Continue routine inspection of the screened enclosure and surrounding deck surfaces for damage, corrosion, or wear associated with weather exposure.

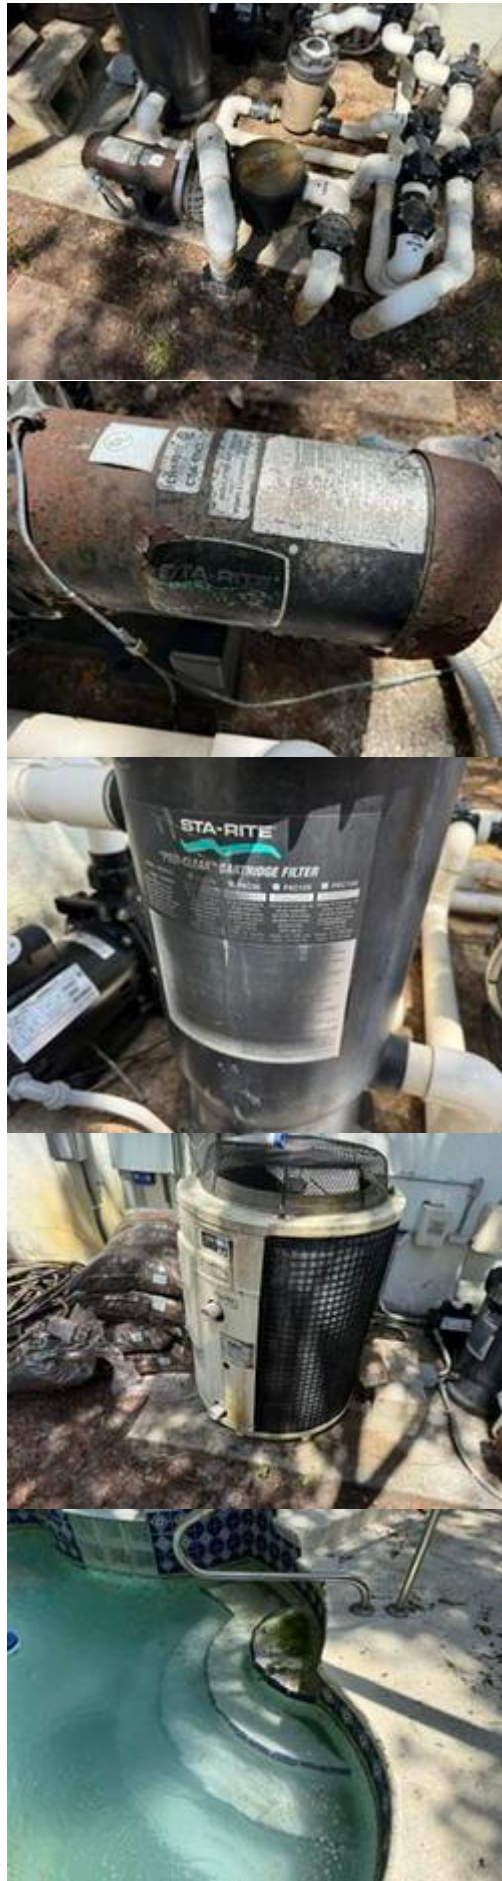
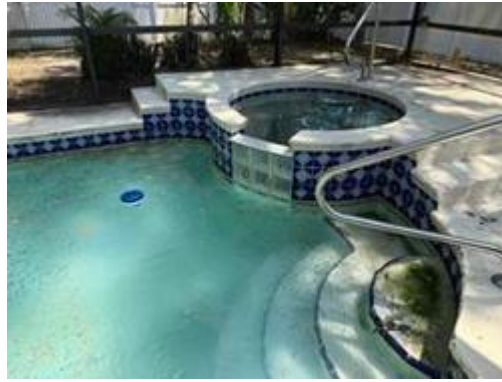
Visible algae growth and cloudy water conditions were present within the spa area at the time of inspection.

Organic staining and buildup were visible along portions of the spa and surrounding deck surfaces.

Surface staining and weathering were present on several older equipment components and metallic fittings.

The equipment area contained multiple aging plumbing and circulation components with visible exterior corrosion and wear consistent with prolonged outdoor exposure.

Technician reported the spa jet booster/jet pump was not operational at the time of inspection.

Exterior corrosion and significant weathering were visible on the spa jet pump motor housing and associated components.

Due to the non-operational condition, the spa jet functionality could not be fully evaluated during inspection.

Have the spa jet pump professionally evaluated to determine if repair or replacement is required.

Further diagnostic testing of the spa jet system, controls, electrical supply, and associated plumbing is recommended.

Continue corrective algae treatment and water balancing to improve overall pool and spa water quality.

Monitor aging equipment components for additional deterioration, leakage, or operational failure as part of ongoing preventative maintenance.
