# Dementia Active Carterton

## Current Room-by-Room Risk Assessment

Assessment type: Current-state visual assessment from supplied room photographs

Assessment date: 24/07/2026

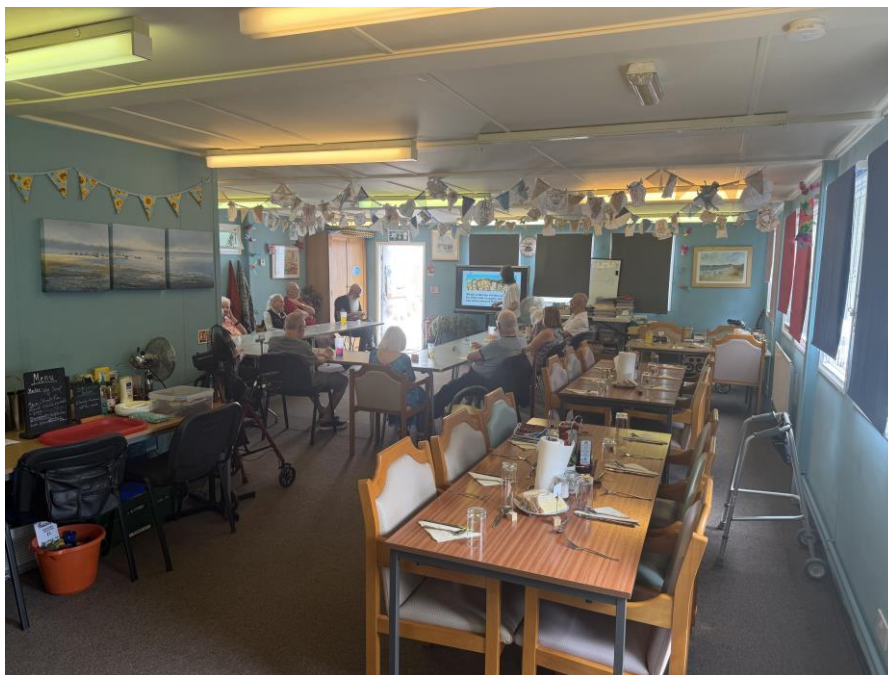
*Photo 1 - Current main activity / dining space with tables, chairs, members, mobility aids, refreshments and exit.*

| Feature / hazard observed | People potentially affected | Current condition / arrangement | Current risk rating | Responsible role | Normal review point |
|---|---|---|---|---|---|
| Tables and chairs arranged closely for dining and group activity, with mobility aids used in the same room | Members, carers, visitors and staff | The room is in active group use. Tables form several seating zones, chairs with arms are available, carpeted routes remain between groups, and wheelchairs/walking aids stay near the people using them. | Medium<br>(S2 x L2 = 4) | Session lead / duty staff | Reviewed as part of each session |
| Wheelchair and walking-aid movement around table legs and chairs | Members with reduced mobility and anyone assisting them | Members are seated around tables; mobility aids are parked beside or behind chairs. Staff and carers are present in the photographed session and movement takes place within the shared activity space. | Medium<br>(S2 x L2 = 4) | Session staff / carers | During normal session supervision |
| Open entrance and signed final exit directly from the activity room | Members who may become disoriented; staff and carers | The door provides direct access and is marked as an exit. During the photographed session the group is together in the room with staff and carers present. | High<br>(S3 x L2 = 6) | Session lead | Throughout each session |

| Feature / hazard observed | People potentially affected | Current condition / arrangement | Current risk rating | Responsible role | Normal review point |
|---|---|---|---|---|---|
| Hot drinks, glassware, cutlery and table settings in the occupied dining area | Members, staff, volunteers and visitors | Meals and refreshments are served to seated attendees. Tables are laid with individual place settings and drinks, and the refreshment/service area is positioned along the side of the room. | Medium<br>(S2 x L2 = 4) | Catering / duty staff | During meals and refreshments |
| Free-standing fans, presentation equipment and overhead decorations | Everyone using the room | Fans are positioned around the room perimeter, the presentation screen is at the front, decorations are suspended overhead, and an exit sign and ceiling detector are visible. | Medium<br>(S2 x L2 = 4) | Duty staff / facilities | Routine room review |

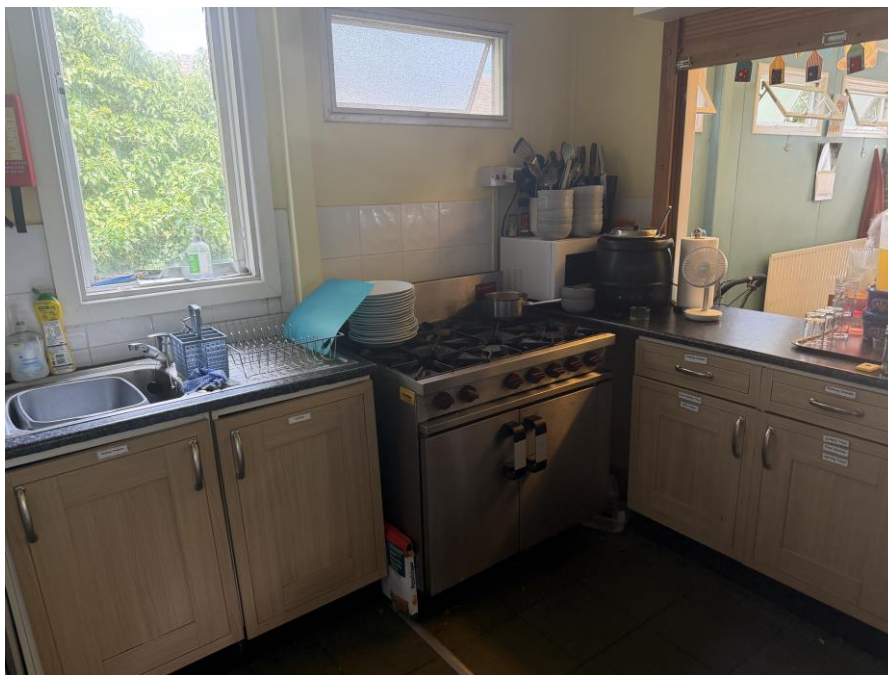
*Photo 2 - Current kitchen / servery with commercial cooker, utensils, sink, preparation surfaces and opening to the activity room.*

| Feature / hazard observed | People potentially affected | Current condition / arrangement | Current risk rating | Responsible role | Normal review point |
|---|---|---|---|---|---|
| Commercial gas range, oven, pans and hot surfaces in a working kitchen | Kitchen staff, volunteers and anyone entering the kitchen | The dedicated kitchen is connected to the activity room by a wide opening. The commercial range and oven are central, with preparation surfaces, sink and storage arranged around the room perimeter. | High<br>(S3 x L2 = 6) | Catering lead | Whenever the kitchen is in use |
| Knives and cooking utensils stored upright on the rear worktop | Kitchen staff and anyone entering the kitchen | Knives and utensils are grouped in containers at the back of the worktop. Cupboards and drawers are labelled to identify kitchen storage. | Medium<br>(S3 x L1 = 3) | Catering staff | Normal kitchen use |
| Washing-up and cleaning products around the sink area | Kitchen staff and volunteers | Cleaning and washing-up liquids are kept at the sink/worktop area, with labelled cupboards below. Food preparation, washing and cooking all take place within the same compact kitchen. | Medium<br>(S3 x L1 = 3) | Catering staff | Normal kitchen use |
| Hard kitchen floor and change to the carpeted activity-room surface | Kitchen staff, volunteers and anyone crossing the room boundary | The open floor in front of the cooker is a dark hard surface. The floor changes to carpet at the opening into the adjoining activity room. | Medium<br>(S2 x L2 = 4) | Catering / duty staff | During kitchen and service use |
| Ventilation and fire-safety features associated with gas cooking | Everyone in or near the kitchen | Openable windows and small fans are visible. A wall-mounted fire-blanket unit is visible at the left edge of the room, and commercial gas cooking equipment is installed. | Medium<br>(S3 x L1 = 3) | Centre / catering lead | Routine premises review |
| Food preparation, crockery and ingredients within a compact work area | Members receiving food and the people preparing it | Plates, bowls, utensils and appliances are organised on the worktops and in labelled storage. Food preparation and service operate from this established kitchen. | Medium<br>(S2 x L2 = 4) | Catering lead | During every food service |

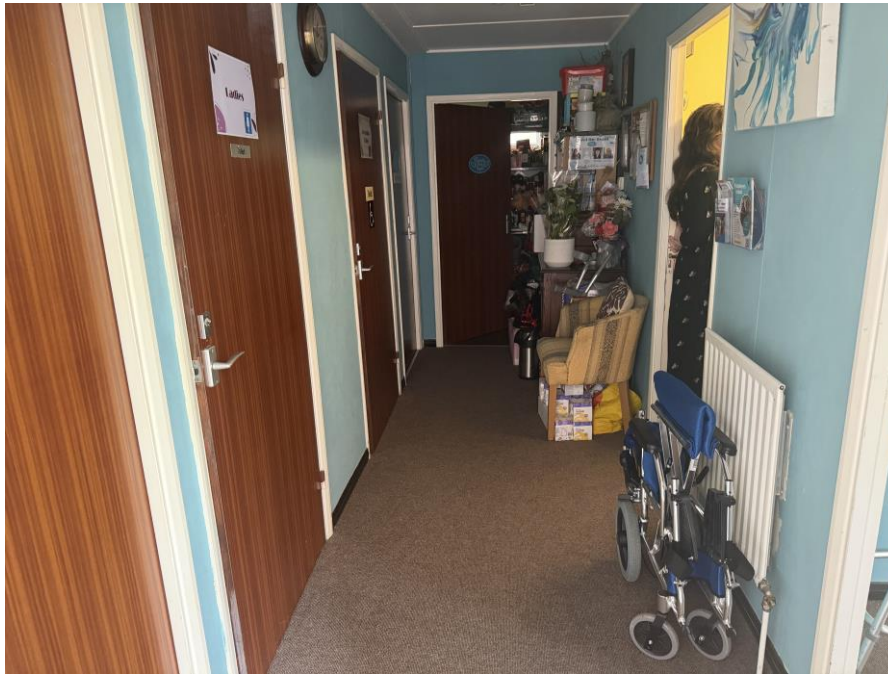
*Photo 3 - Current corridor / toilet route with signed doors, folded wheelchair, furniture, supplies and adjoining-room access.*

| Feature / hazard observed | People potentially affected | Current condition / arrangement | Current risk rating | Responsible role | Normal review point |
|---|---|---|---|---|---|
| Corridor used for access to toilets and adjoining rooms while also containing stored items | Members, carers, staff and visitors | The middle of the carpeted corridor remains the main walking route. Furniture, boxed supplies, bags and other items are positioned along the right side and at the far end. | Medium<br>(S2 x L2 = 4) | Centre / duty staff | During normal building use |
| Folded wheelchair parked beside a radiator and doorway | Wheelchair users, people walking through and staff handling equipment | The wheelchair is folded and parked against the right-hand wall beside the radiator, leaving the central part of the corridor open. | Medium<br>(S2 x L2 = 4) | Duty staff | Routine equipment use |
| Armchair, boxed stock and bags stored at the far end of the passage | People moving between rooms, including those using mobility aids | The armchair and supplies occupy the edge/end of the corridor rather than the central walking line, but they form part of the current corridor layout. | Medium<br>(S2 x L2 = 4) | Centre staff | Routine premises review |
| Multiple doors opening from the corridor, including signed toilets | Members, staff and visitors | Doors are positioned on both sides of the corridor. The ladies' toilet and other facilities have large, high-contrast signs, and the floor covering is continuous through the visible route. | Medium<br>(S2 x L2 = 4) | Duty staff | During normal use |
| Wayfinding, lighting and floor conditions in the toilet corridor | Members living with dementia and people with reduced vision or mobility | The corridor has consistent blue walls, a continuous carpet, overhead lighting and prominent door signs. Adjoining rooms are visible from the route. | Low<br>(S2 x L1 = 2) | Centre / duty staff | Routine premises review |
