April 18, 2022

Hazardous Materials Memorandum
East-West Corridor Project
Yakima, WA

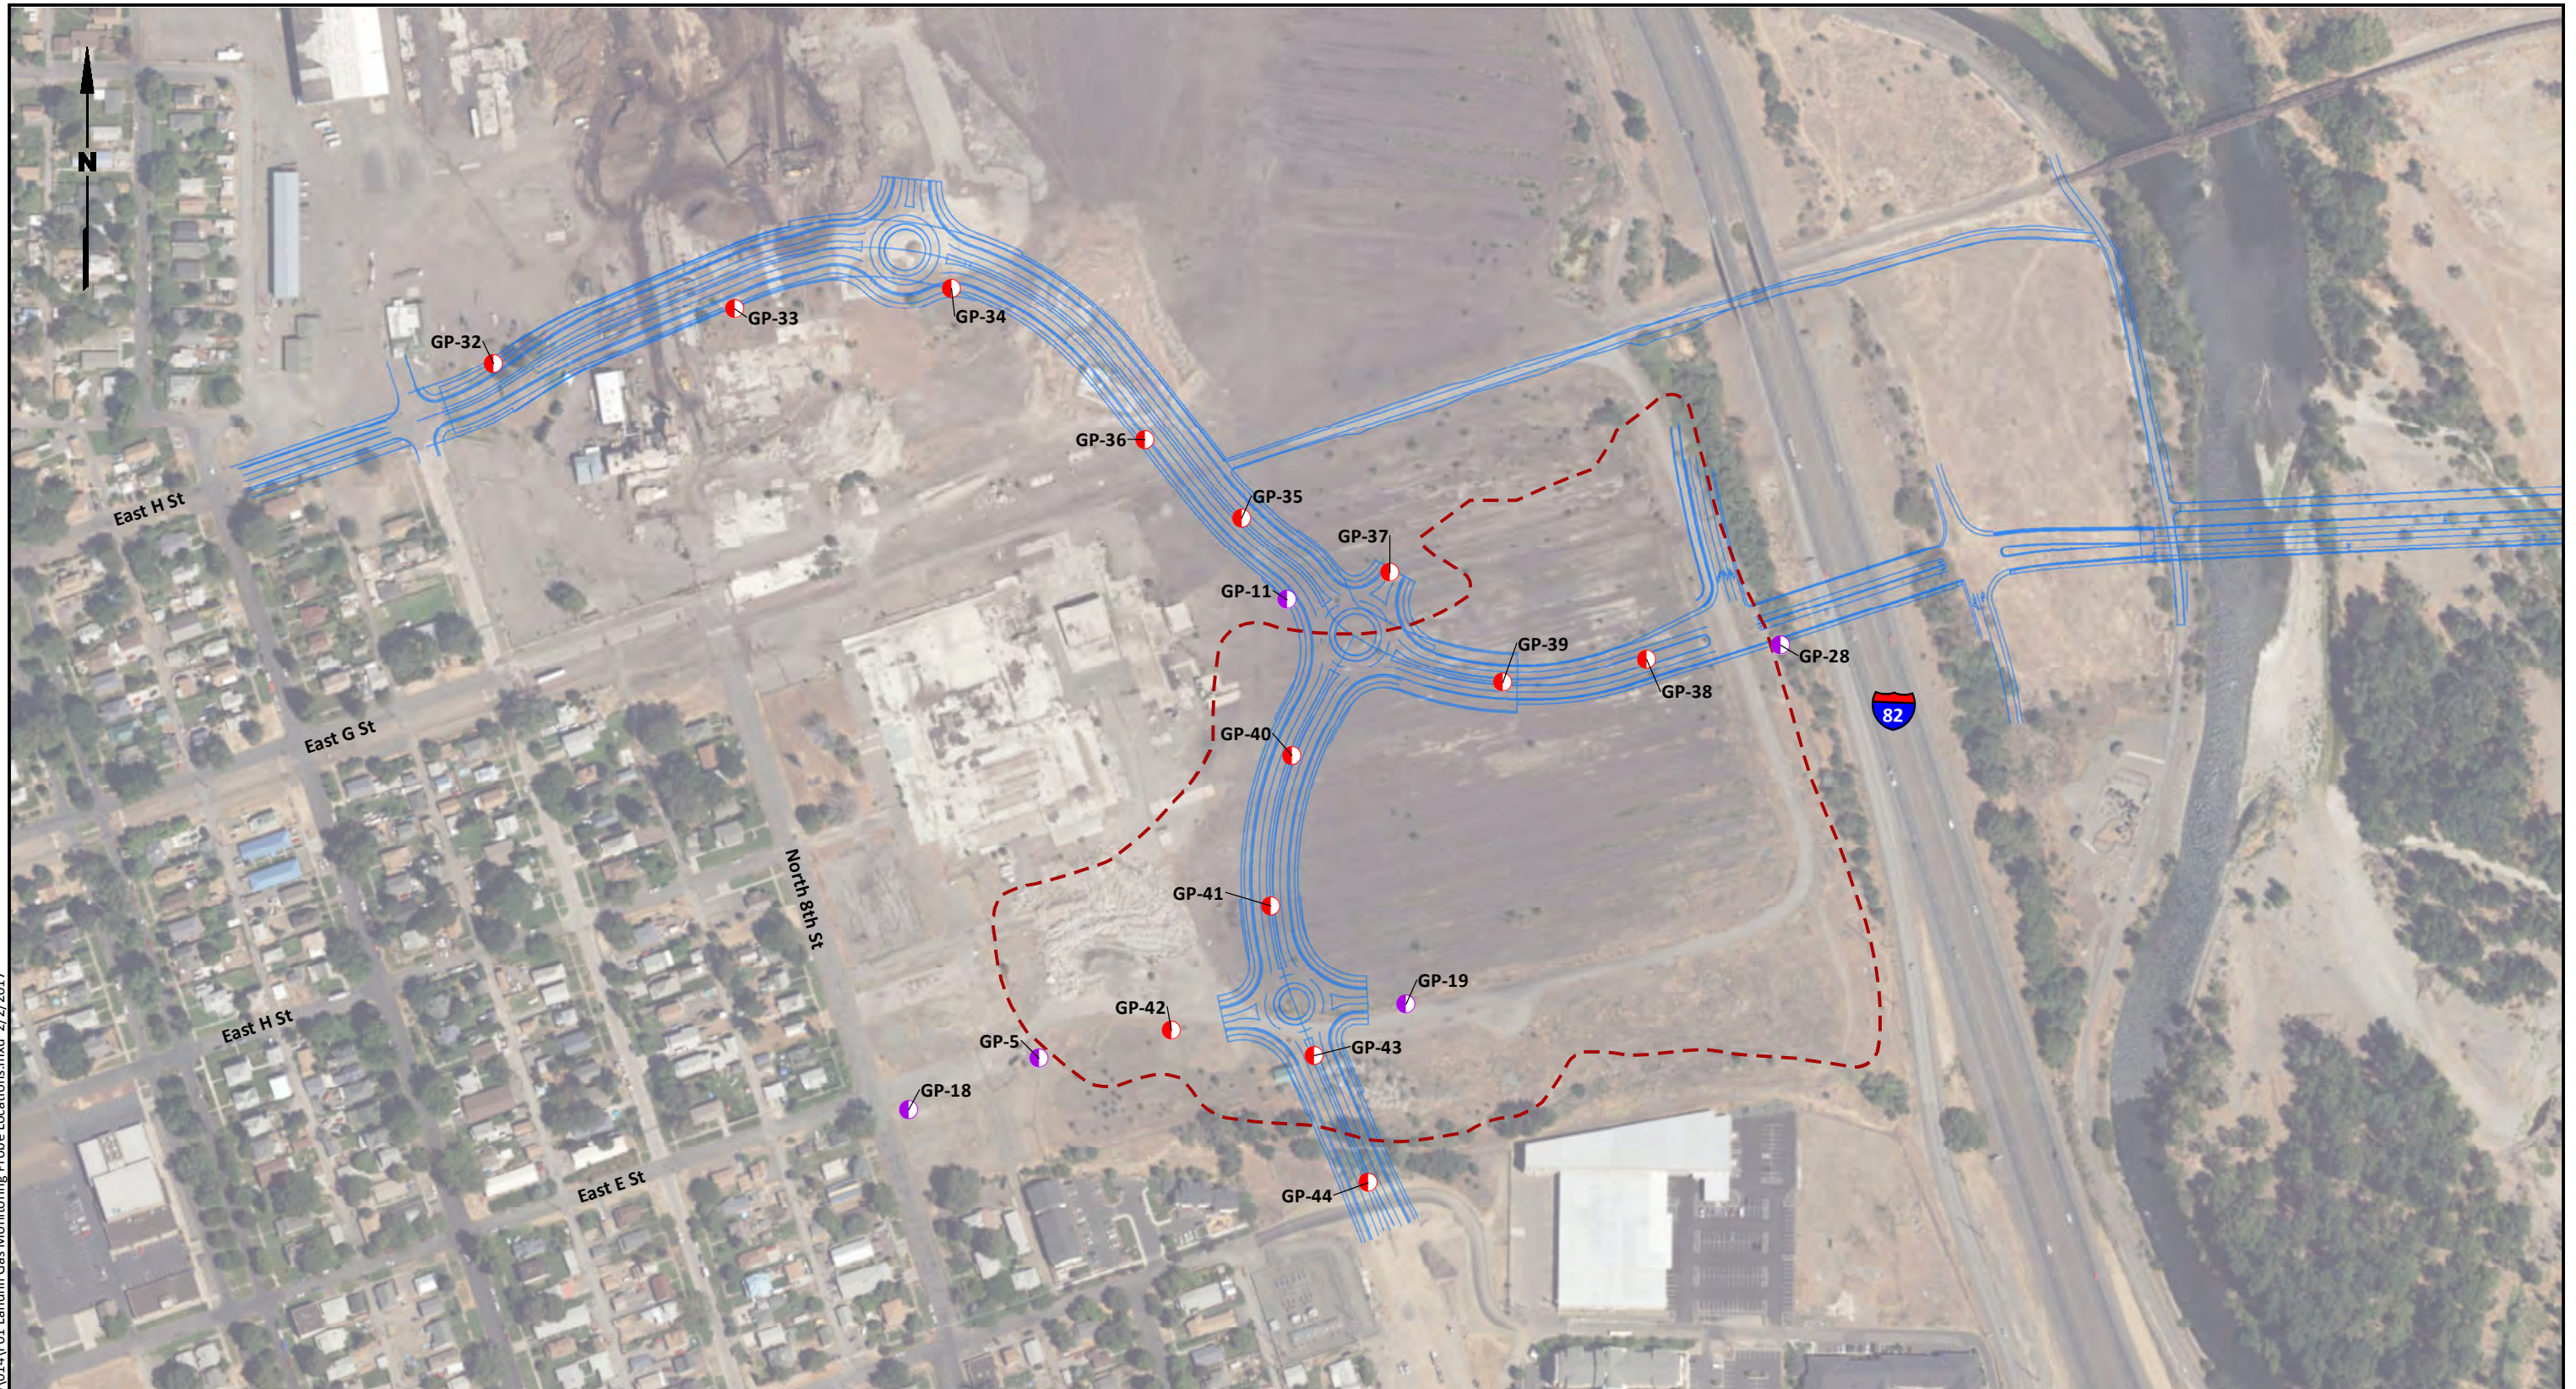
G:\Projects\1148\009\01\01\4\F01 Landfill Gas Monitoring Probe Locations.mxd 2/2/2017

- Gas Probe Location and Designation - LAI 2016
- Existing Gas Probe Location and Designation
- Extent of Municipal Solid Waste
