2012 BMW 550i Sedan (F10) V8-4.4L Turbo (N63)

N63 AND S63 ENGINE: VALVE SEAL REPLACEMENT

SI B11 08 15
EngineNovember 2017
Technical Service

N63 and S63 Engine: Valve Seal Replacement

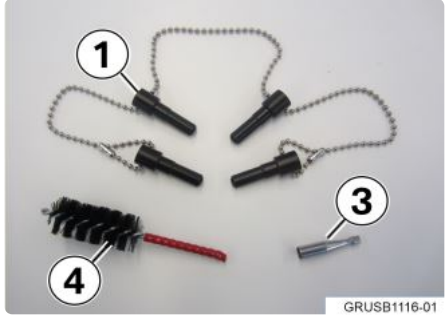
<p>GRUSB1116-01</p> <p>Open In New Tab Zoom/Print</p>	<p>N63/S63 Valve Seal Replacement Tool Update Kit P/N 83 30 2 443 944</p> <p>Oil return plugs (1) Brush (2) Valve seal install tool (3)</p> <p>Refer to SI B04 15 15 for additional ordering information.</p>
