REPORT

Shoreline Erosion Assessment

Cultus Lake Park Board, Cultus Lake, BC

1785357-001-R-Rev0

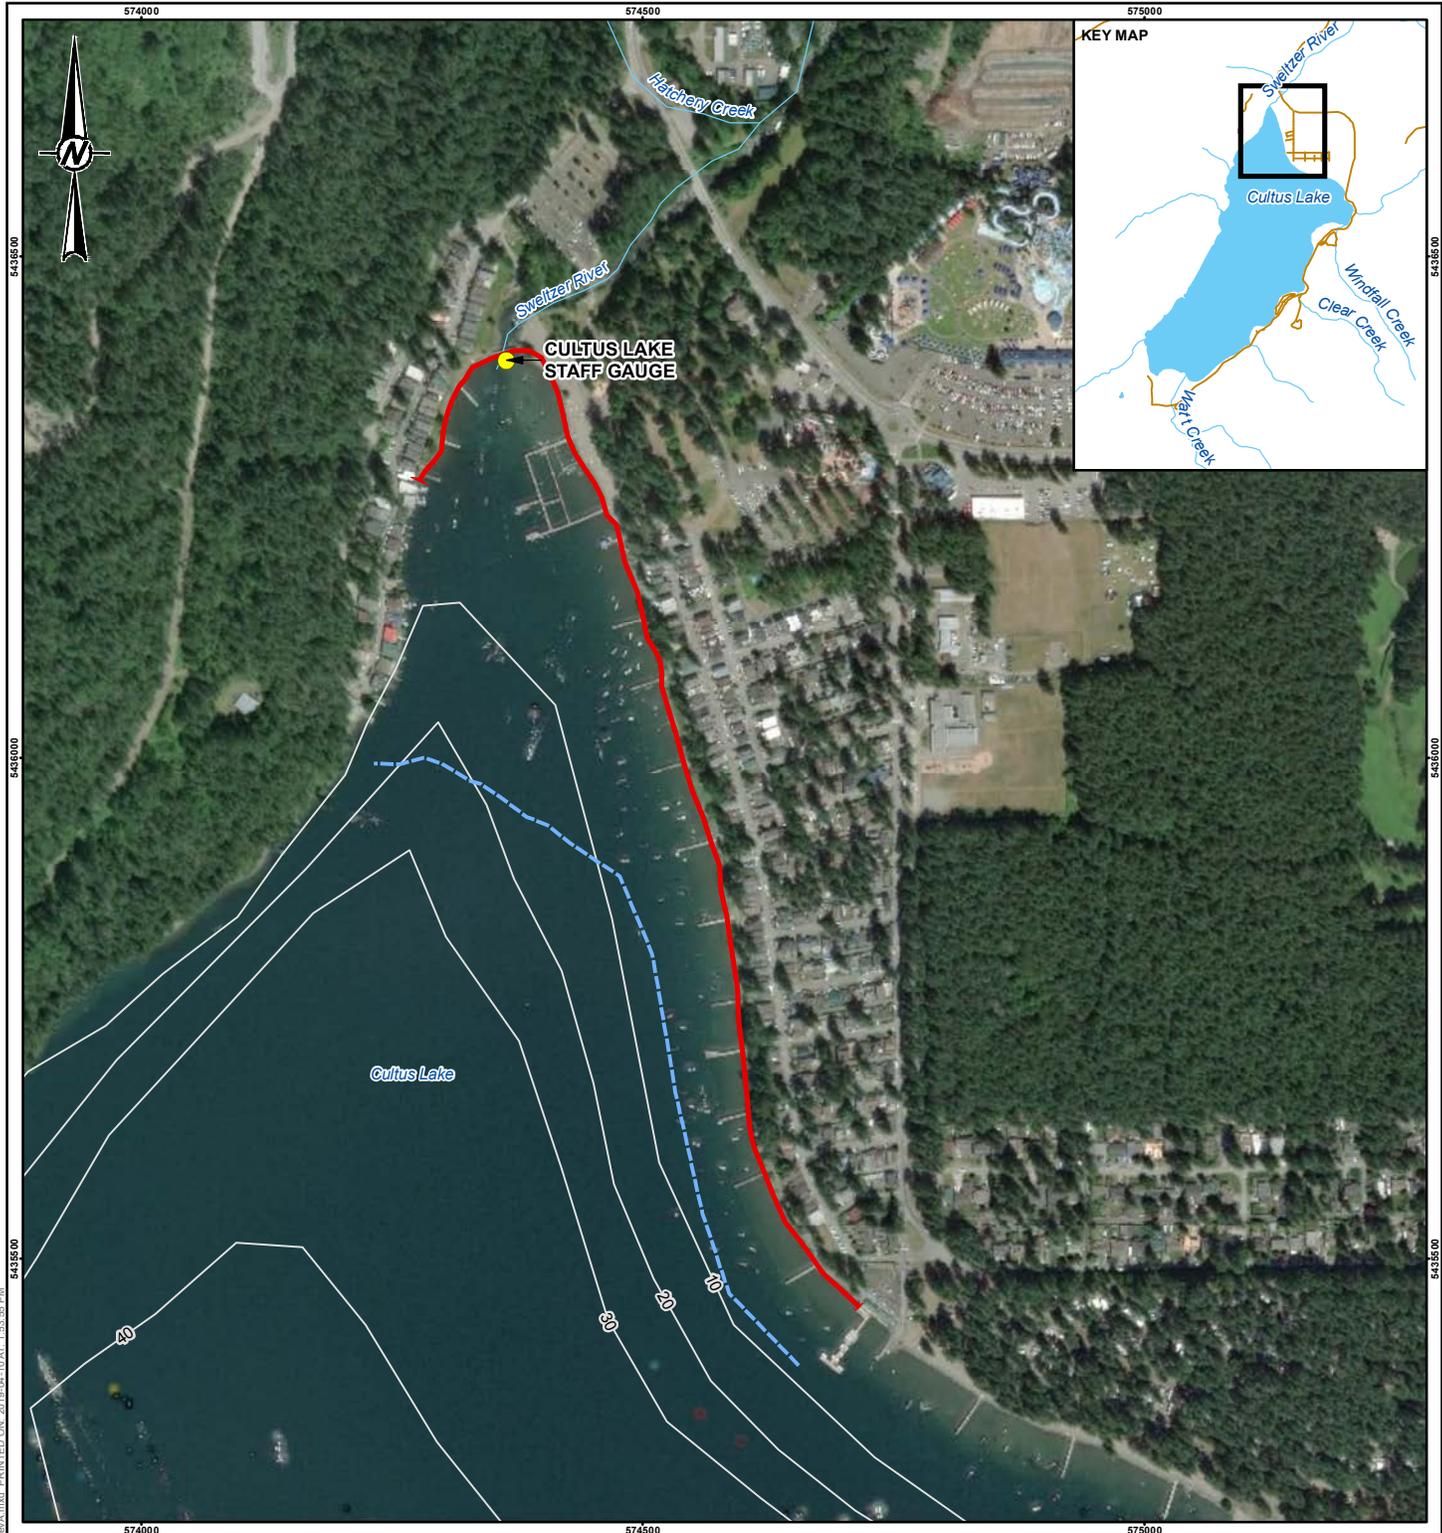
TITLE
SITE PLAN

Golder Associates Ltd. (Golder) has been retained by the Cultus Lake Park Board to carry out an assessment of shoreline erosion along sections of the shoreline of Cultus Lake. Cultus Lake is located in the Fraser Valley region of British Columbia, approximately 30 km east of Abbotsford and 10 km south of Chilliwack. The Cultus Lake Park includes 640 acres of park land and beach on the eastern shore of Cultus Lake and is the direct responsibility of the Cultus Lake Park Board. The study area for this project (the Project Site) is located along the north and east shoreline of Cultus Lake, either side of the Sweltzer River. The Project Site is shown on Figure 1.

Water level data was provided to Golder by the Cultus Lake Park Board. Water levels for Cultus Lake have been recorded using a manual staff gauge, maintained by the Cultus Lake Park Board, and located at the north end of the lake near the outlet for the Sweltzer River (shown on Figure 1).

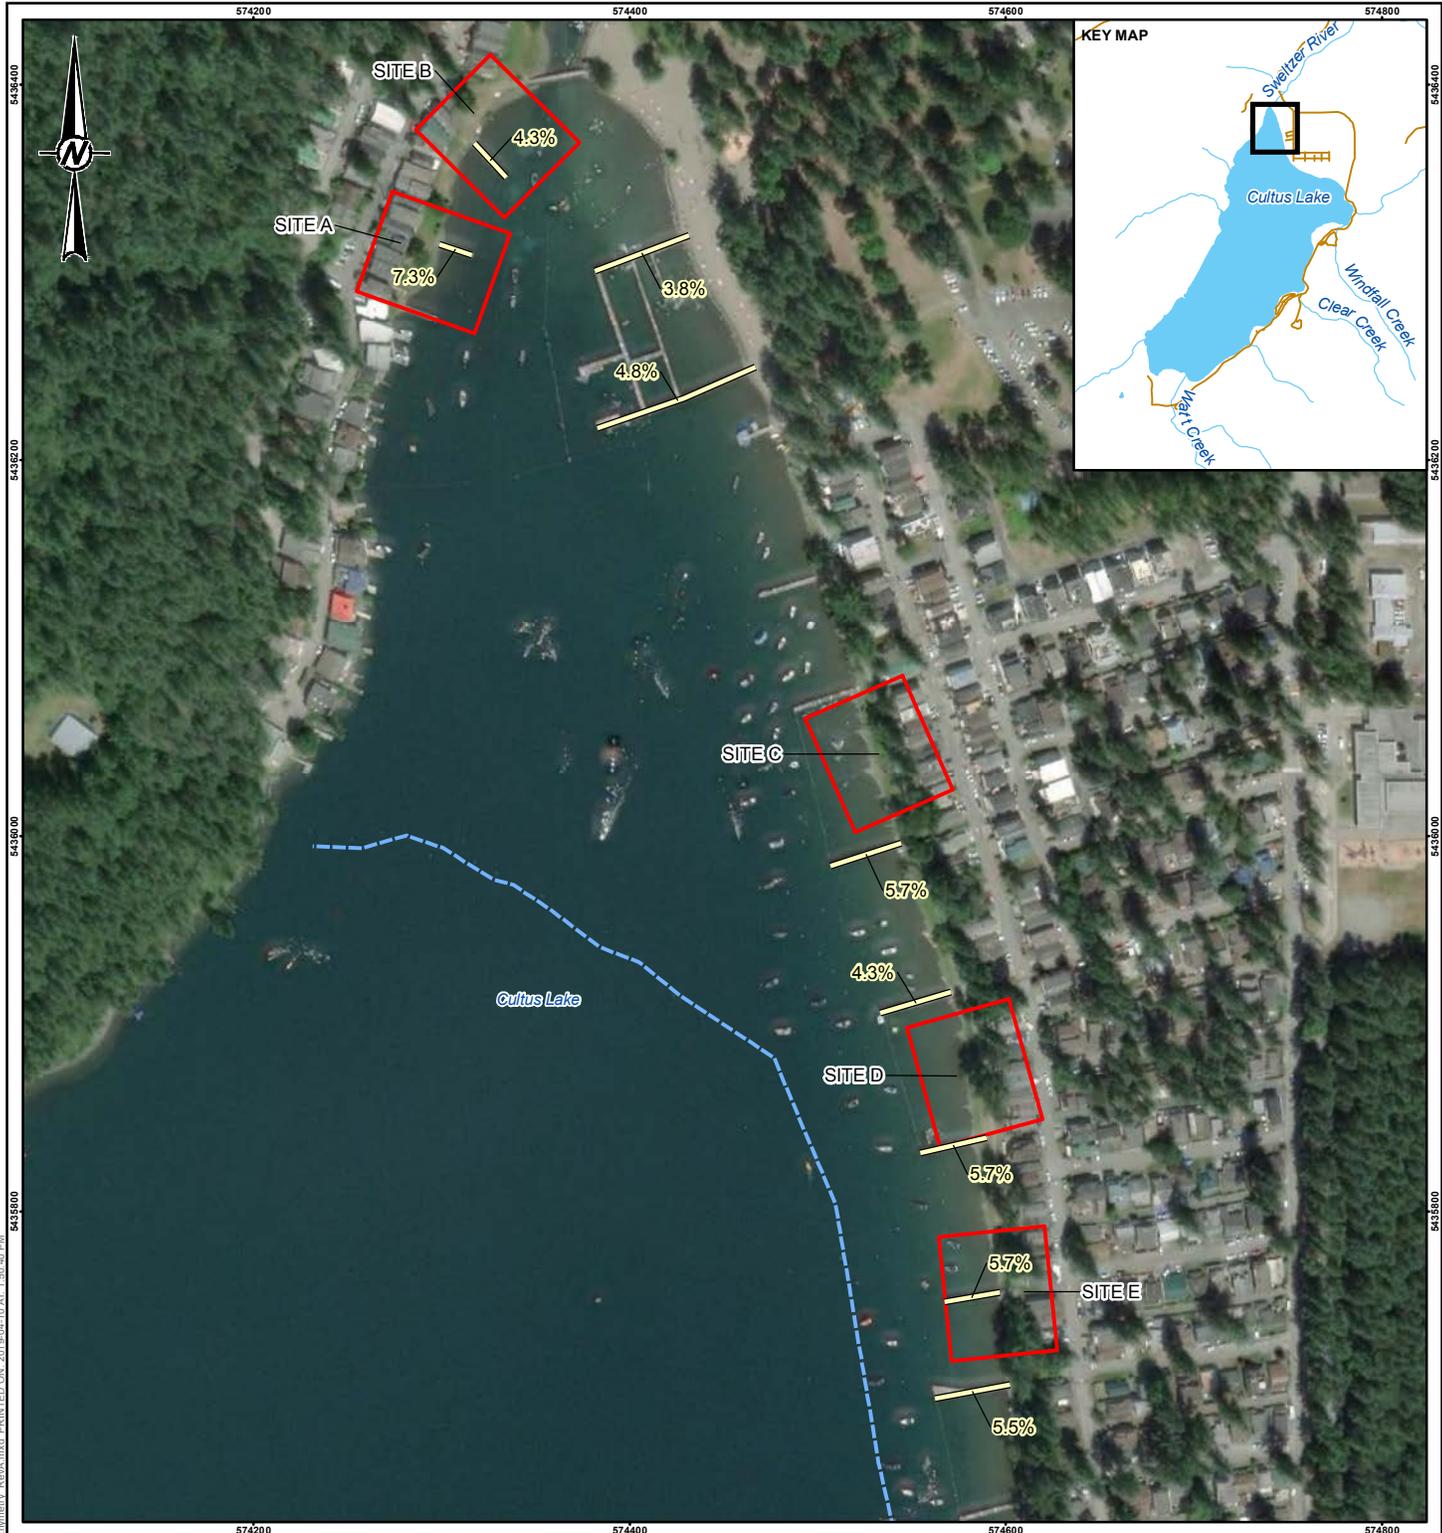
TITLE
SITE VISIT OBSERVATIONS

Figure 2 provides a summary of the shoreline area assessed during the site visit, including observations and estimated shoreline slopes. Figure 3 through Figure 7 provide details on specific observations made in selected areas, to provide representative examples of the indicators of erosion that were observed.

- Vertical bank escarpments were observed up to an elevation of approximately 45.0 masl. In some areas of the shoreline the bank escarpment is locally undermining constructed shoreline structures.

- Gravel of a size 3"-minus and larger was found on the lower beach. Gravel/sand of a size 1"-minus and smaller was found on the upper beach. Evidence of woody debris accumulation above the bank escarpment suggests potential for wave and water level overtopping of the escarpment.

- Asymmetric shoreline orientation (indicative of erosion and deposition processes) is leading to lateral erosion of beach material to the north of constructed groynes, up to approximately 2-3 m in some locations, and deposition of beach material to the south of constructed groynes. In some places, rock protection has been placed to control erosion in these areas.

- Locally-constructed shoreline structures (i.e. groynes, riprap material) are increasing the effects of erosion processes. This is discussed in more detail in Section 2.3.

- Observed erosion and deposition patterns indicate net direction of material transport is from south to north.
- Upland erosion was observed in some areas of the shoreline. This is likely from surface runoff due to heavy rainfall and surface flow, but was not considered further in this scope of work.

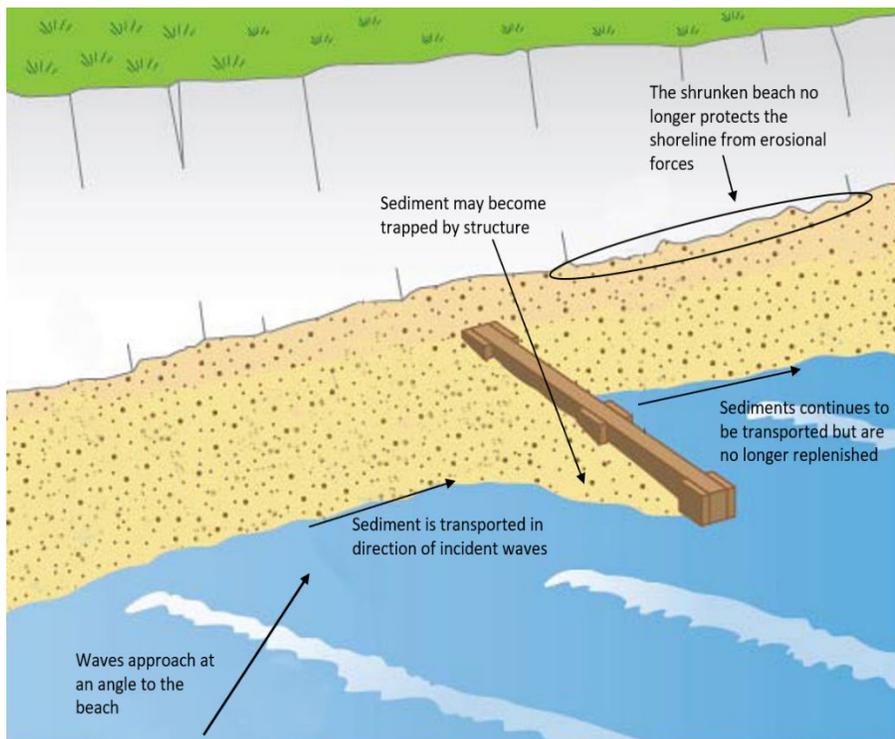
Longshore sediment transport (or longshore drift) is often caused by waves arriving at the beach at an oblique angle (i.e. wind waves from the south through southwest at the Project Site) and creating asymmetry in wave uprush and backwash or by creating a longshore current. The waves can be naturally occurring due to winds or be caused by wakewash from boats.

In either case, when a structure is placed in the path of the longshore sediment transport, the sediments moving towards the structure may become trapped on the updrift side (Figure 8). At the same time the transport of sediments in the immediate downdrift lee of the structure (i.e. area sheltered from the incoming waves) continues but are no longer replenished. Over time, this causes the beach to recede in the immediate lee of the structure and grow on the updrift side. The alongshore groyne placement (spacing) and shore perpendicular length of groynes along the Project site appear to be relatively ad hoc with each individual home taking independent measures to mitigate erosion in front of each property. This has led to variable results in terms of erosion protection performance and a progressive reduction in supply of sediment to beaches with distance along the beach cell. The latter ultimately leads to a sediment deficit and exacerbated erosion of downdrift beaches.

Figure 8: Illustration of groyne effect on longshore sediment transport

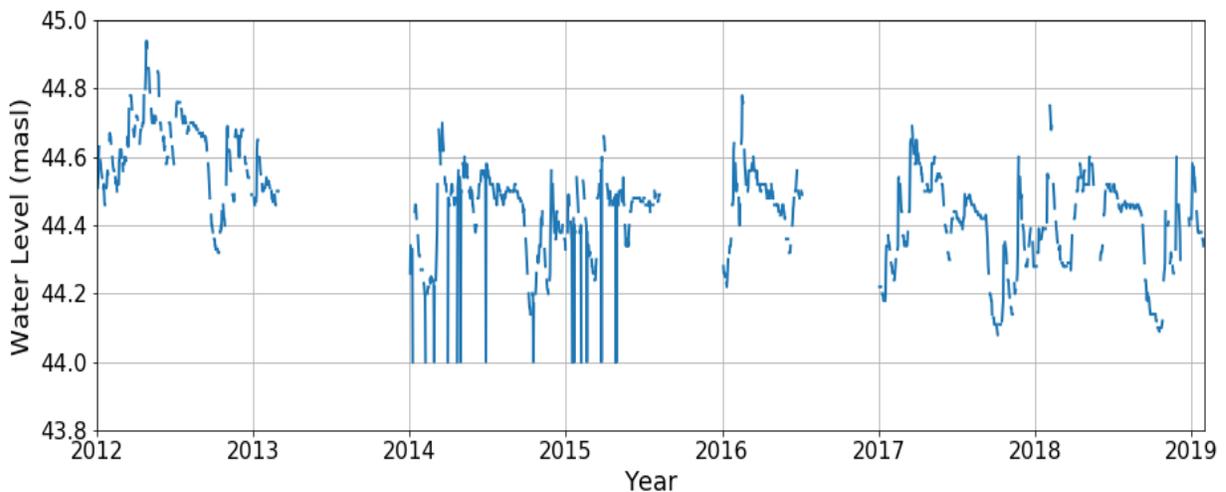
Daily water levels have been recorded manually between 2012 and 2019 (Figure 9). However, approximately 47% of the recorded daily data is missing and the reason for the gaps in the provided data is unknown. It is also noted that gaps in data occur more frequently during the winter months.

Figure 9: Cultus Lake water levels during the period 2012 to 2019

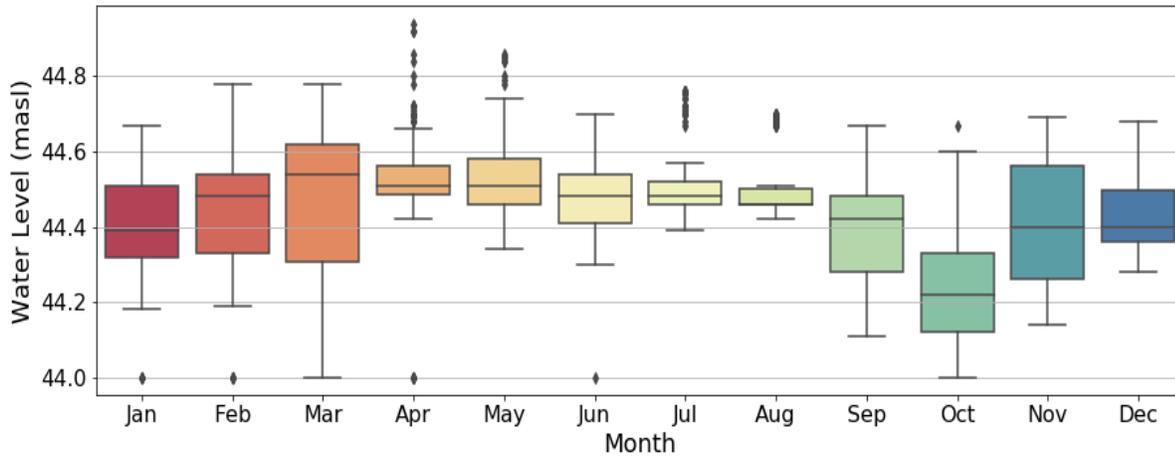
Between March 15th and September 15th each year, the water level is controlled by a weir at the lake outlet for the Sweltzer River, which maintains a water elevation of 44.5 masl for recreational purposes during the summer months. Outside of this period the water level fluctuates naturally in response to precipitation and flow within the Cultus Lake catchment. Figure 10 presents water level distributions for each month.

Figure 10: Monthly water level distribution in Cultus Lake during the period 2012 to 2019

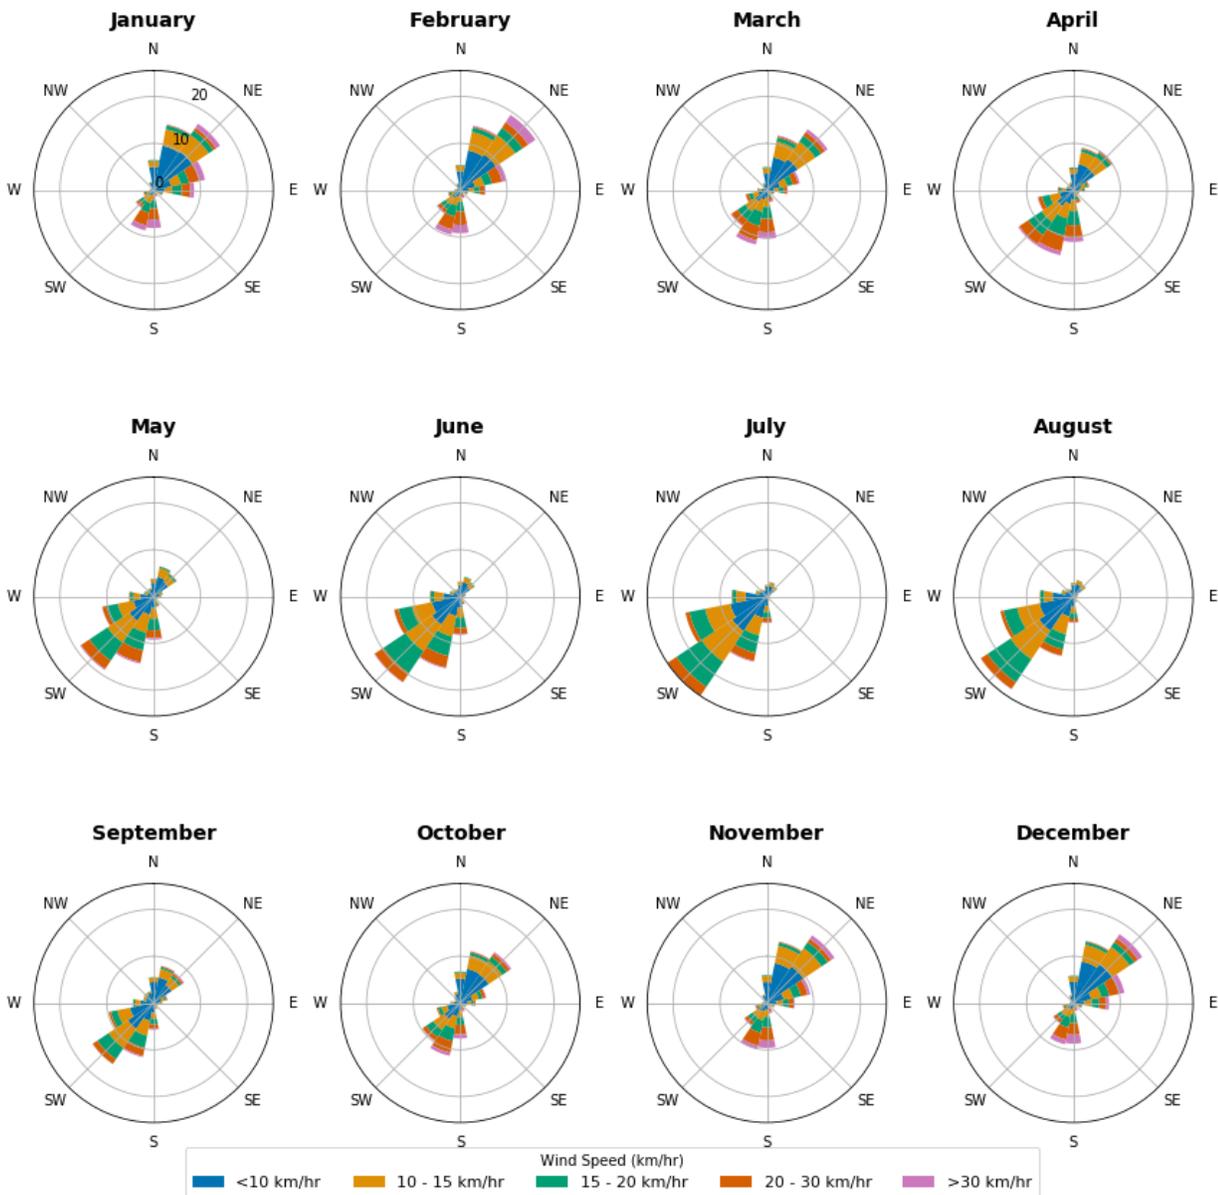
Wind speed and direction have been measured at Abbotsford Airport station 702 (Environment Canada) for a period of 66 years (1953 to 2019). During the winter season, typically November to March, the predominant wind direction is from the north-northeast with less frequent but strong winds from the south-southwest (i.e. storm events). In the summer season, typically May to August, the predominant wind direction is from the south-southwest. In general, the winds in the summer months are weaker than those observed in the winter from either the south-southwest or north-northeast directions. This is illustrated in Figure 11.

Figure 11: Monthly winds measured at Abbotsford Airport during the period 1953 to 2019

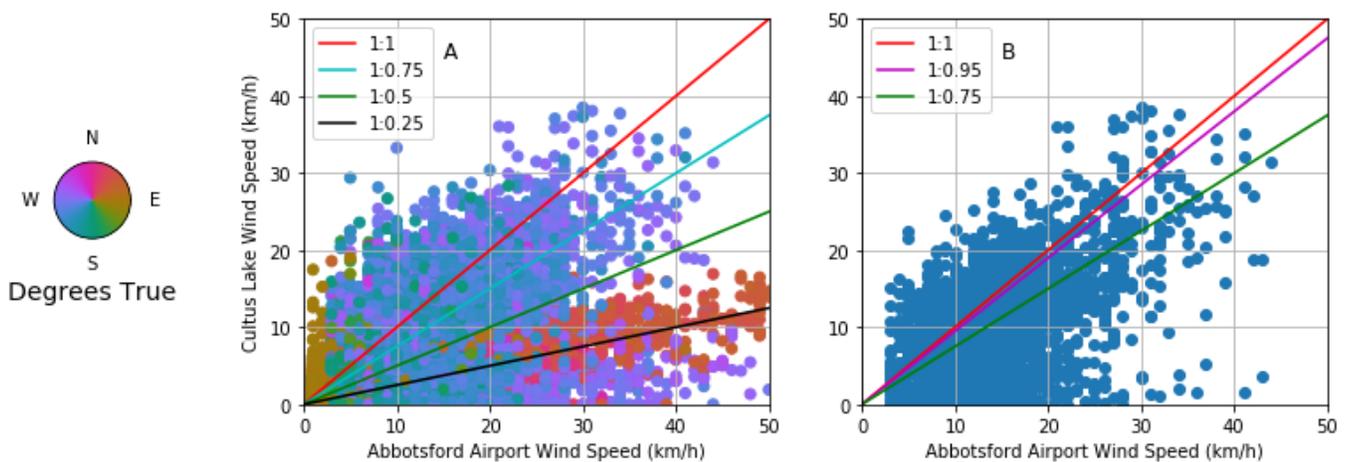
A sensitivity analysis of Abbotsford Airport and Cultus Lake Marina winds revealed that winds between the two stations are generally in good agreement when winds are from the south through southwest direction. This analysis is presented in Figure 12. However, northerly reported winds at Abbotsford Airport over-estimate the observed winds on Cultus Lake by a factor of 3 to 4 and easterly reported winds at Abbotsford Airport underestimate the observed winds on Cultus Lake by a factor of 4 to 5. For the purpose of this study only the south through southwest winds are considered (i.e. the long fetch direction) and the data from Abbotsford Airport is scaled to data from Cultus Lake Marina using a factor of 0.95 (Sumka 2017).

Figure 12: Wind speed sensitivity analysis for Cultus Lake Marina and Abbotsford Airport for the period 2016 to 2018 (A) and for the period 2016 to 2018 using winds between 170 and 230 degrees (B).

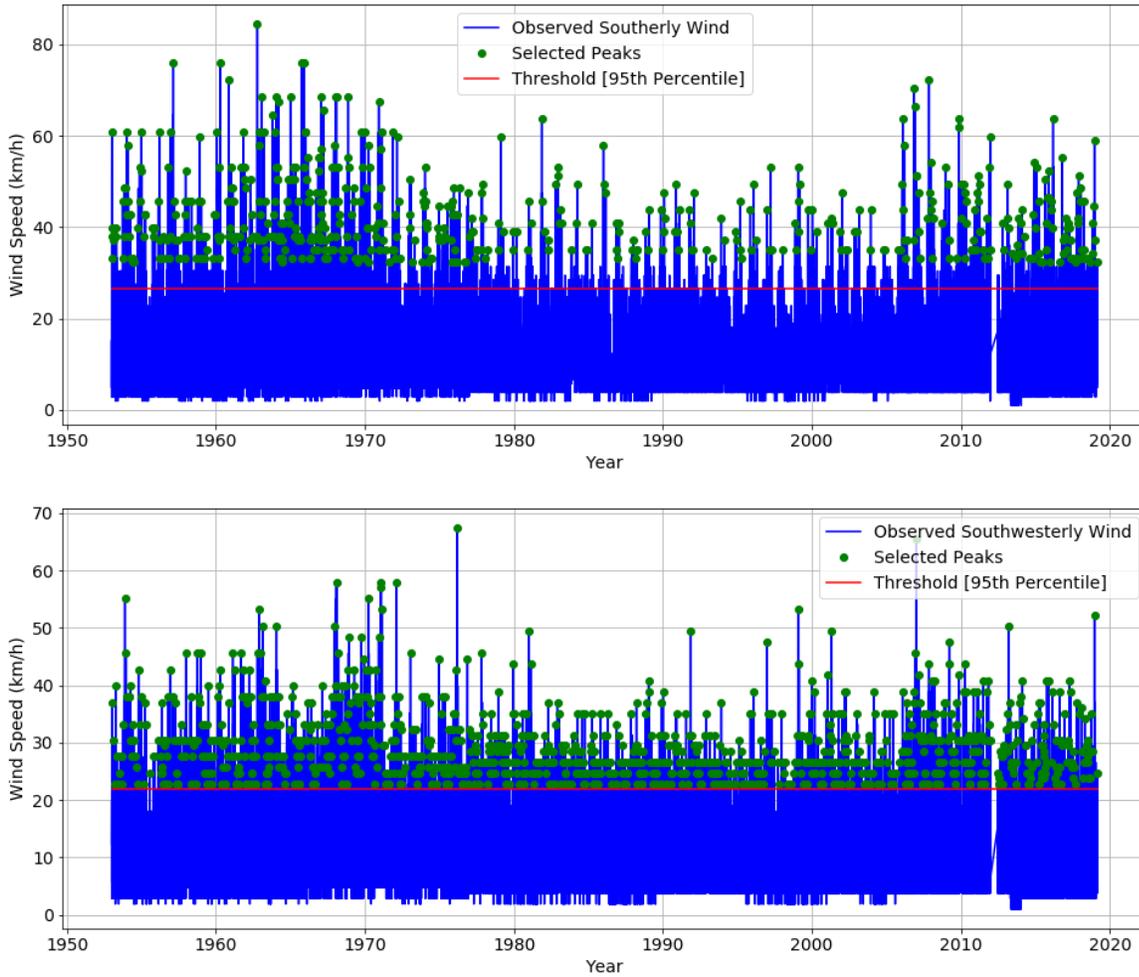
An extreme value analysis was used to estimate wind speeds for selected return periods for Cultus Lake using scaled south and southwest winds speeds from Abbotsford Airport. A Peak Over Threshold (POT) method was used to identify wind speeds above a defined threshold for the selected direction sectors on an annual basis and during the period April through August and September through March (Figure 13). The threshold was selected as the 98th percentile of the analyzed data (this varied based on the data subset) and identified peaks were filtered to have a minimum separation of 48 hours (Palutikof et al. 1999).

Figure 13: Illustration of Peak Over Threshold (POT) method for annual south and southwest winds using a threshold cut-off of the 95th percentile

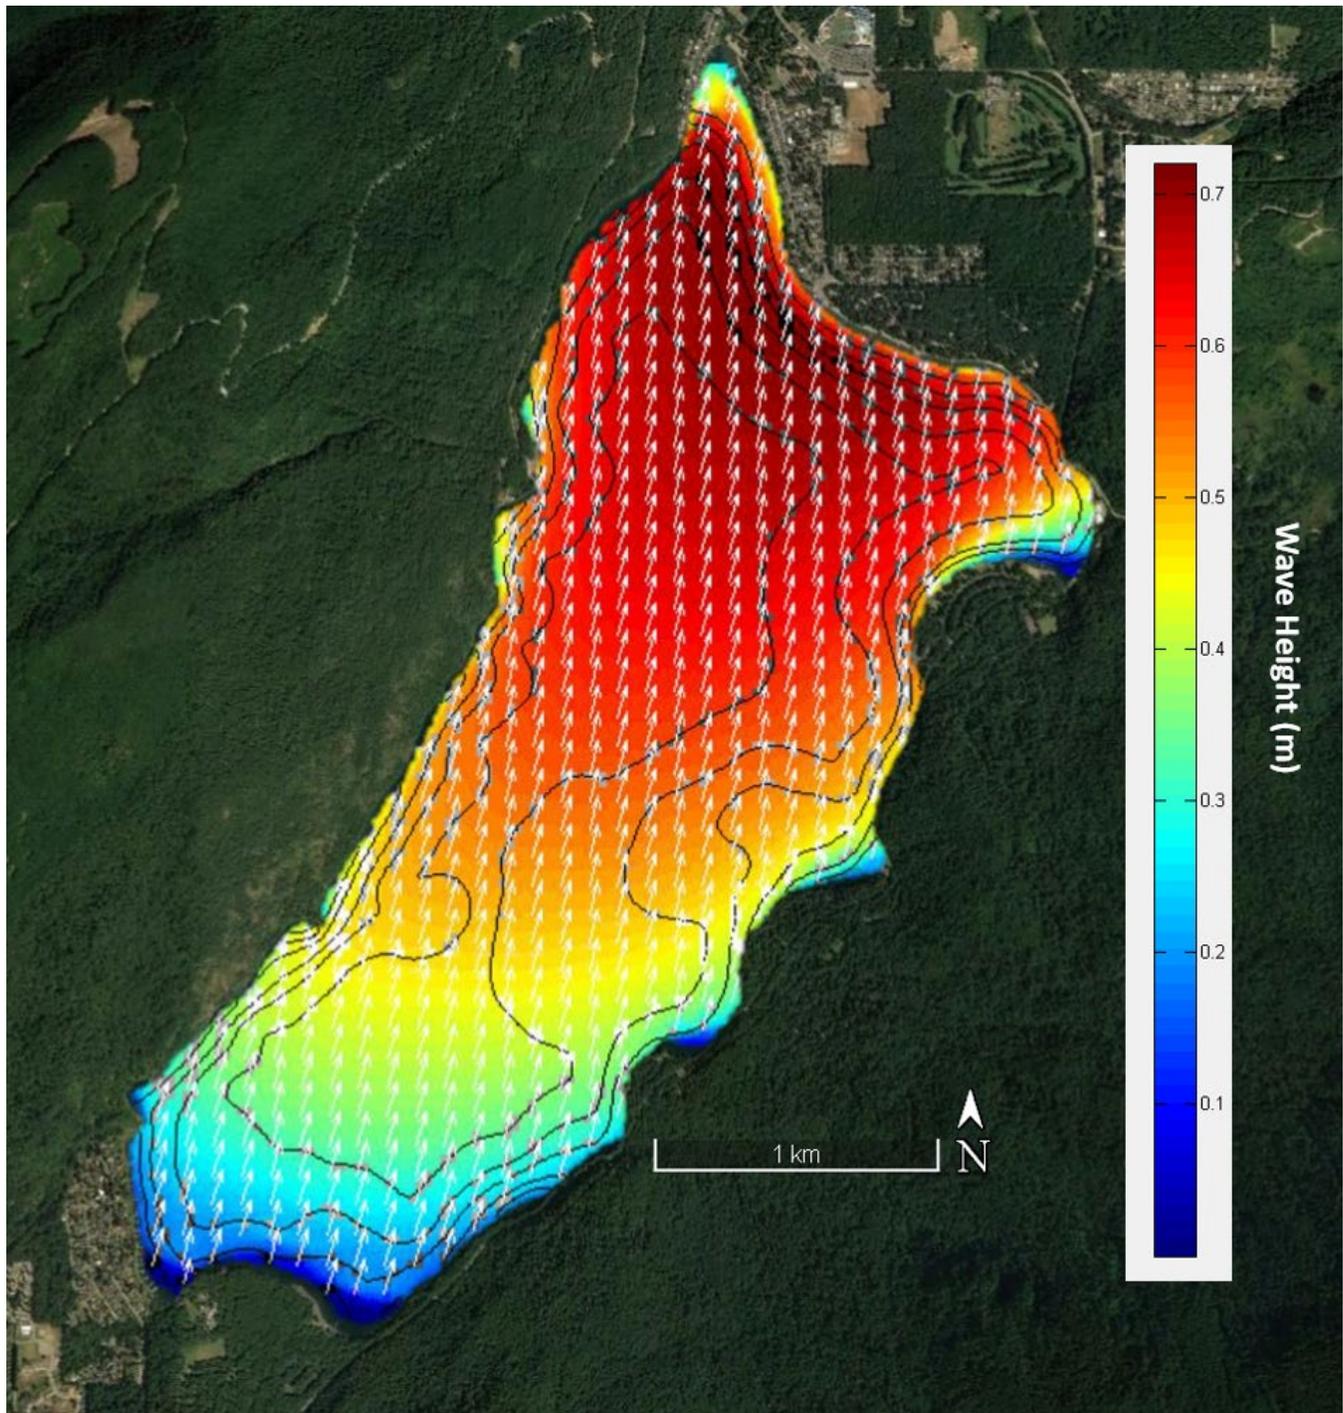
Modelled wave heights under the 90th percentile high water level and 10-year south-southwest wind during the non-controlled period are shown in Figure 14 and Figure 15. Wave heights are largest along the northern shore of Cultus Lake (i.e. the Project Site) and decrease near the outlet for Sweltzer River and vicinity of the shoreline as a result of the shallowing depths. Modelled deep water and shallow water wave heights, extracted from the model at the locations indicated in Figure 15, for various combinations of water levels and winds during the weir-controlled and non-controlled periods are presented in Table 7 and Table 8.

Figure 14: Modelled wave heights (colour) and direction (arrows) on Cultus Lake during the non-controlled period. Combination of a 90th percentile high water level and 1 in 10 year south-southwest wind. The 5, 10, 20, 30, and 40 m bathymetric contour are indicated.

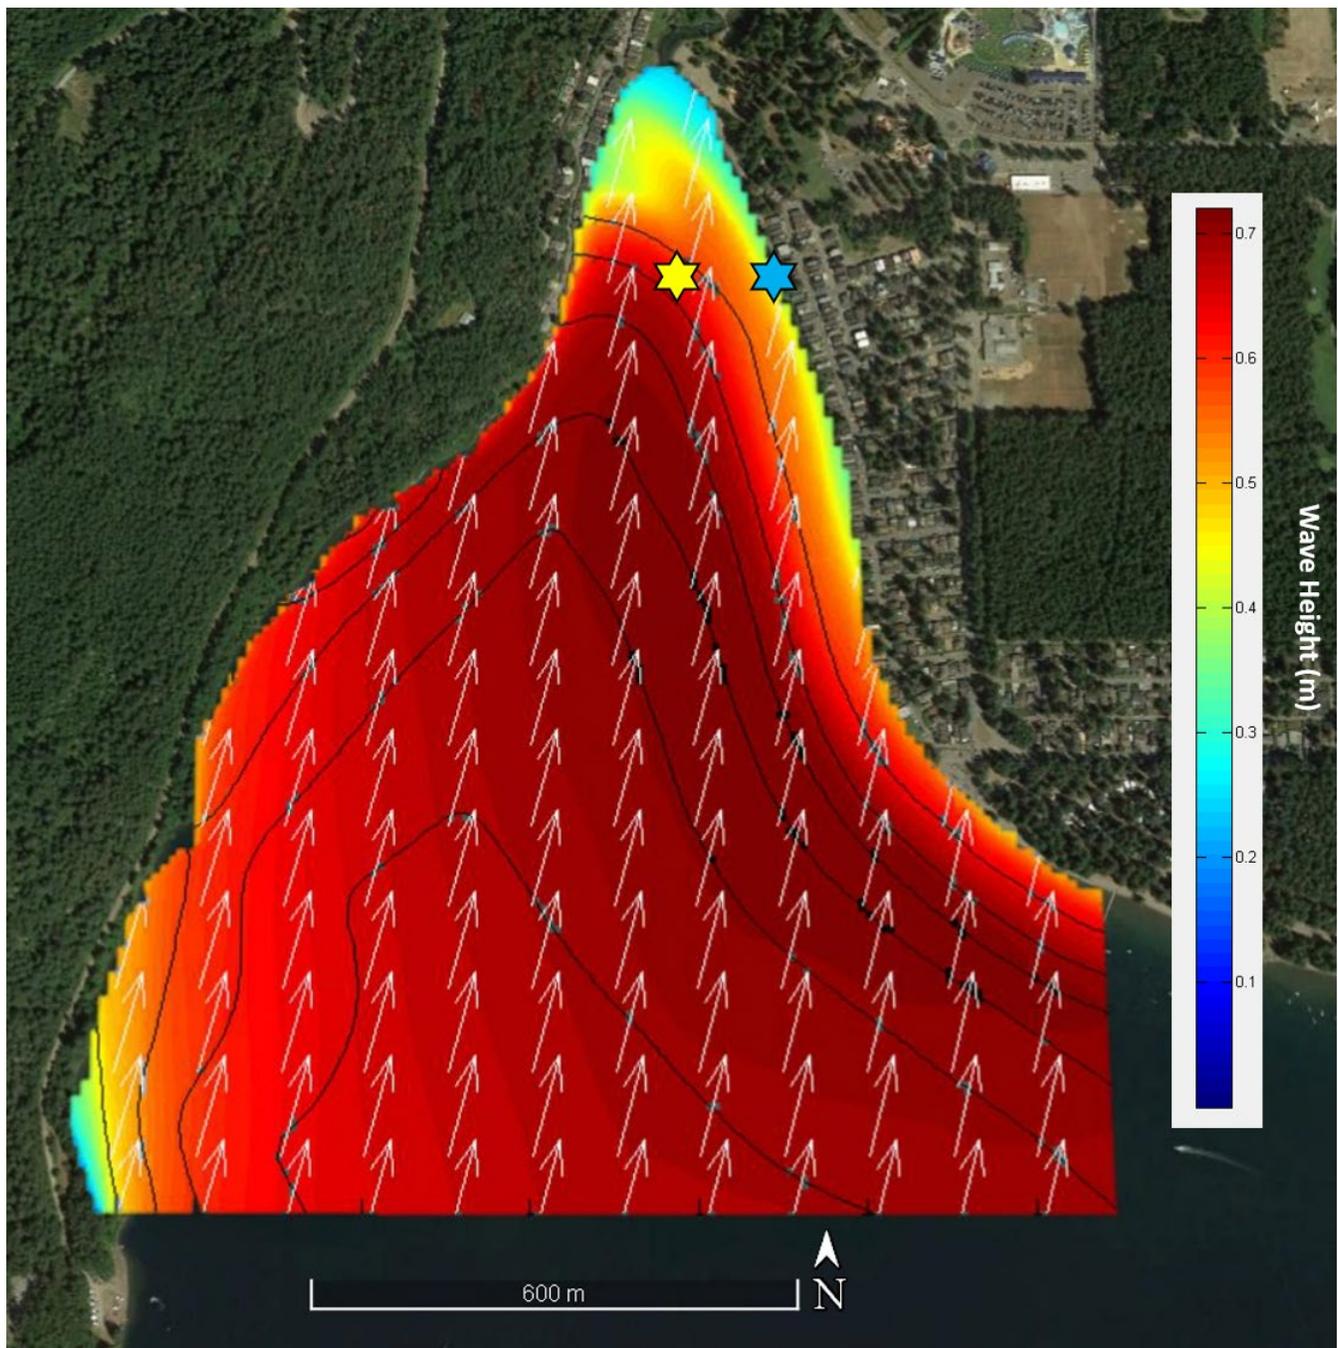
Figure 15: Modelled wave heights (colour) and direction (arrows) near the Project Site during the non-controlled period. Combination of a 90th percentile high water level and 1 in 10-year south-southwest wind. The 5, 10, 20, 30, and 40 m bathymetric contour are indicated. The yellow and blue star indicate the location of reported deep water and shallow water wave heights and periods in Table 7 and Table 8, respectively.

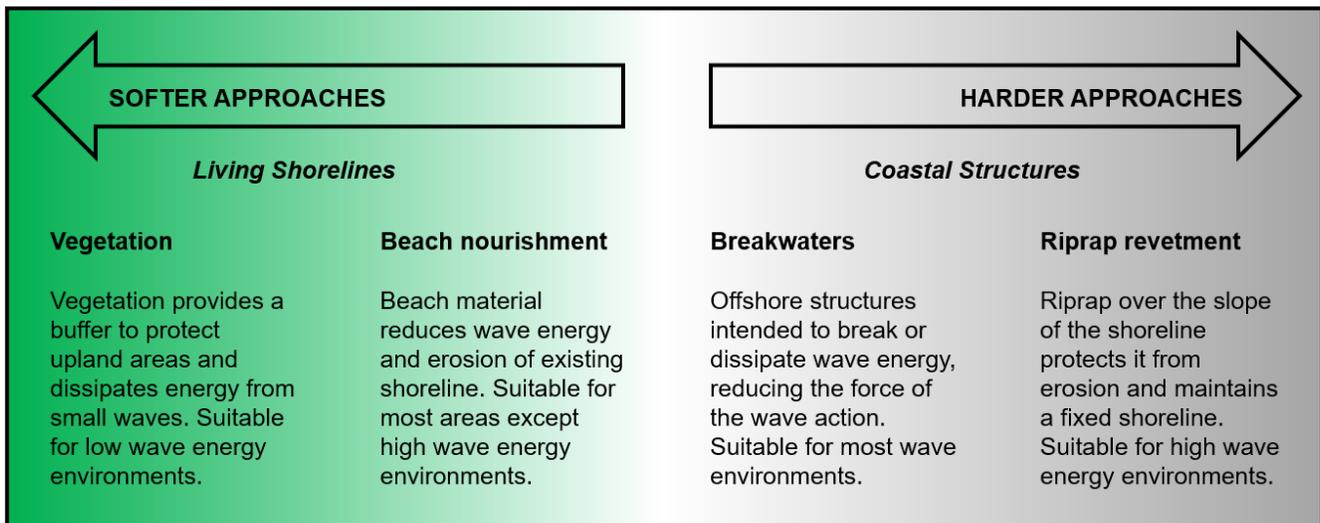
Typical approaches to shoreline protection can be categorized as ‘green’ options, indicating softer more natural engineering approaches, or ‘grey’ options, indicating harder engineering approaches like coastal structures. The range of typical approaches is illustrated in Figure 16.

Figure 16: Typical approaches to shoreline erosion protection

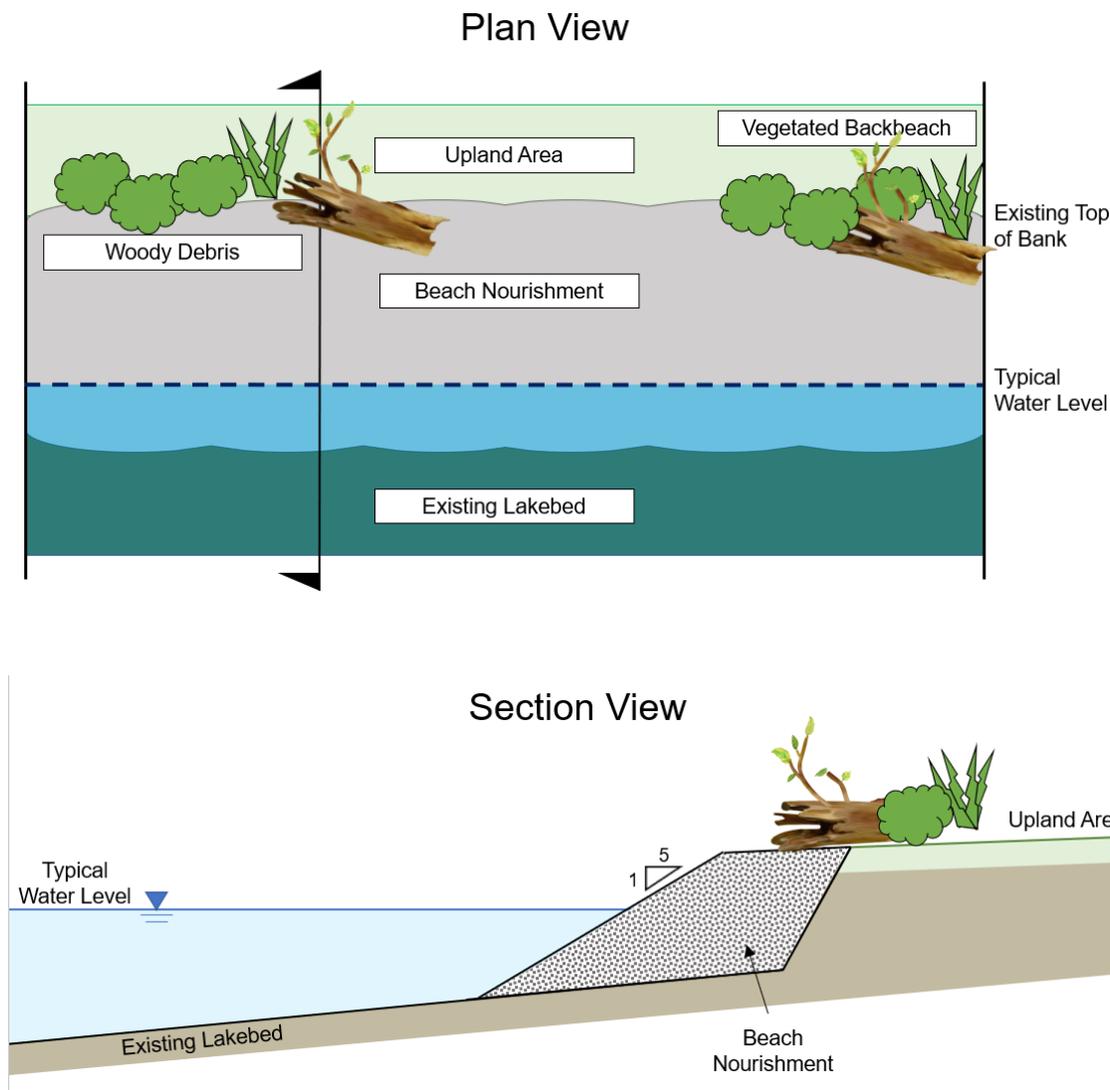
Figure 17: Option 1 Conceptual Sketch: Plan and Typical Section (not to scale)

This option includes recontouring the shoreline to eliminate existing groynes and erosion escarpments, and using a combination of beach nourishment and vegetation to control erosion and establish a living shoreline.

This is an example of a soft engineering approach. The existing shoreline planform, profile and condition varies so a combination of approaches (i.e. beach nourishment, vegetation and natural woody debris) provides flexibility in the design to suit specific site conditions for different areas of the shoreline. A conceptual sketch illustrating these concepts is shown in Figure 17 below.

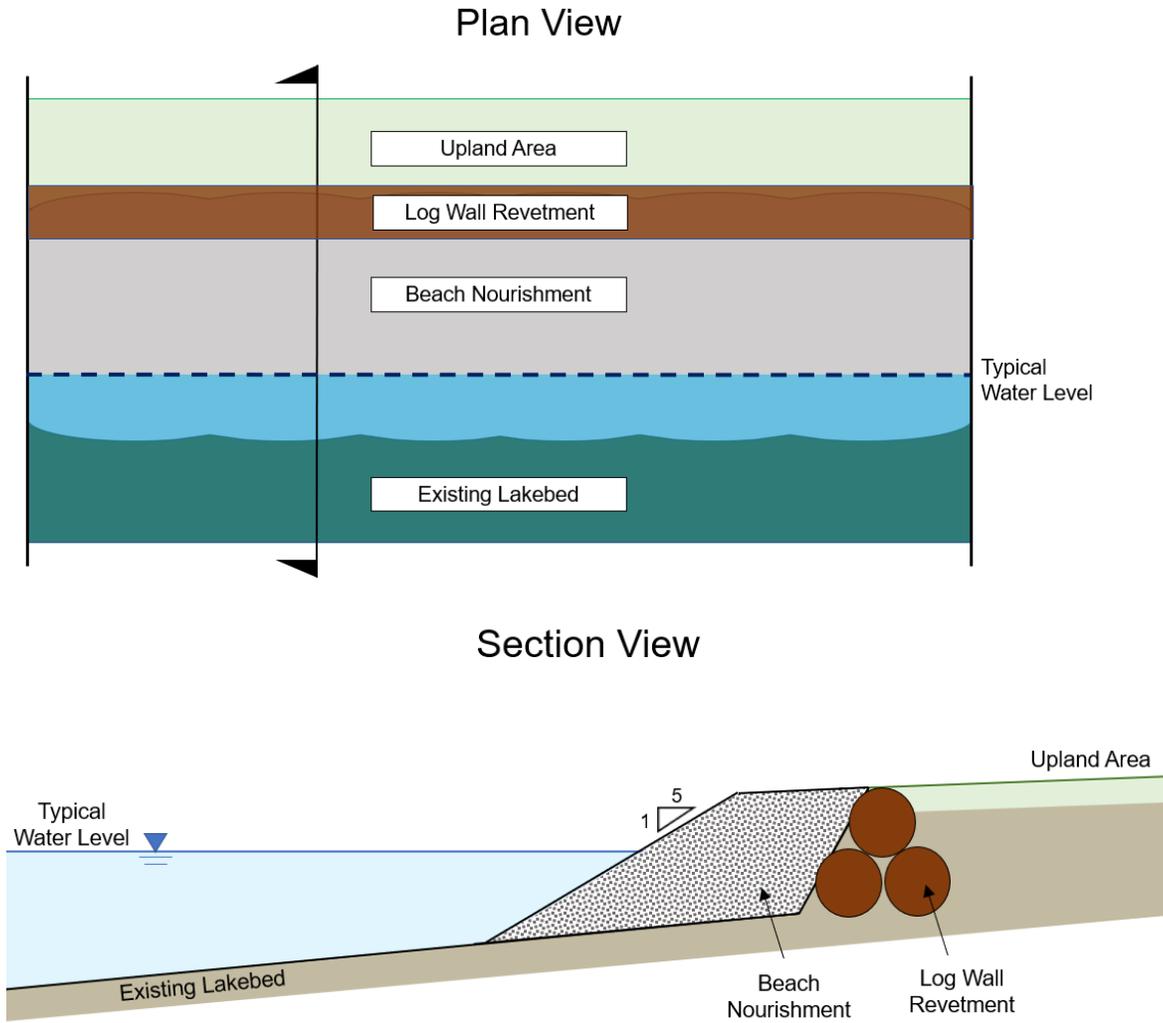
Figure 18: Option 2 Conceptual Sketch: Plan and Typical Section (not to scale)

This option includes recontouring the shoreline to eliminate groynes and erosion escarpments, and constructing a log wall revetment and gravel beach to act as shoreline protection.

This is an example of a hard engineering approach, although on the softer side than other coastal structures. This approach would fix the shoreline in place to prevent future erosion, although the gravel beach would require maintenance and future nourishment. A conceptual sketch is shown in Figure 18 below.

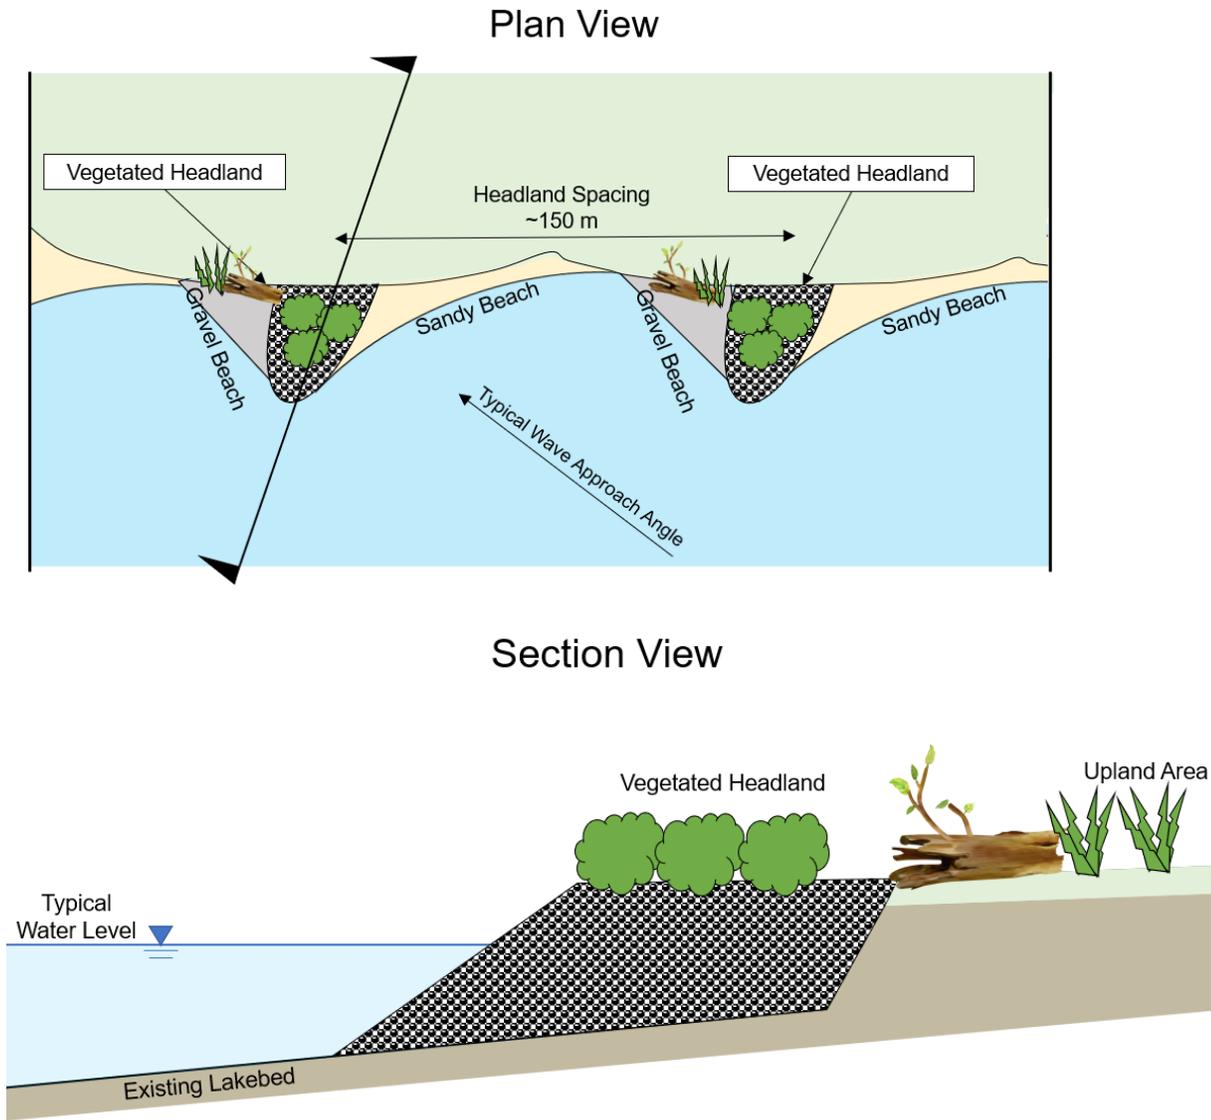
Figure 19: Option 3 Conceptual Sketch: Plan and Typical Section (not to scale)

This option is a hybrid approach combining features of Option 1 and Option 2. The proposed approach includes combining beach nourishment with vegetated headlands and gently bayed beaches, with some larger cobble gravel to protect the vegetation, a transition to gravel and then sand beaches between the vegetated headlands.

This approach would help develop an asymmetric shoreline configuration with beaches perpendicular to the dominant wave direction, which would help reduce the effects of erosion and sediment transport. A conceptual sketch is shown in Figure 19.
