SUPERFUND REPORT: THE DSC MCLOUTH STEEL GIBRALTAR PLANT

By Kellee Byard

December 8th, 2020

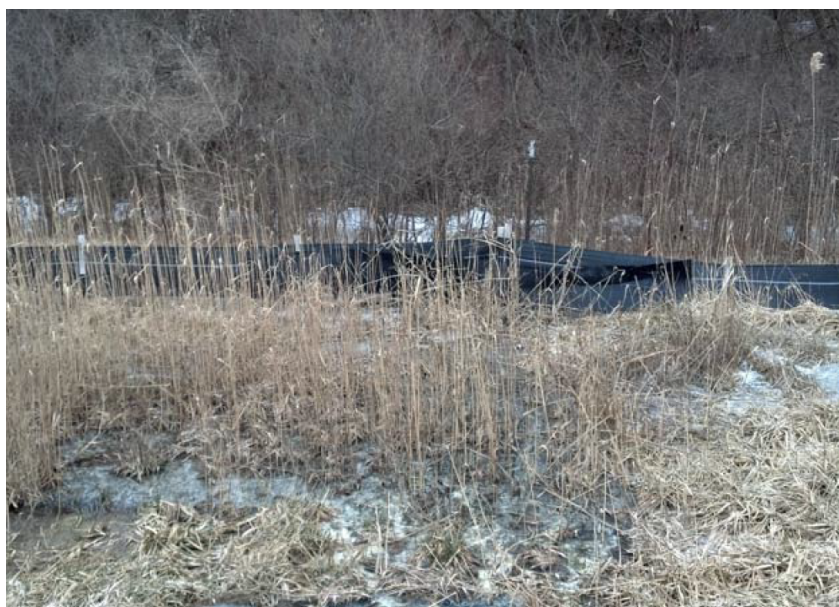
spring thaws result in leachate overflow into the Frank and Poet Drain (see left photo of a leachate outbreak in February 2012). The leachate from the steel processing contains phenolic compounds and is a highly corrosive, alkaline liquid.

When McLouth controlled the CWLF they did not properly maintain it and operated with improper licensing for the industrial waste they deposited there. The leachate that resulted from runoff that went through rubble in this landfill is supposed to go through the treatment lagoon system, but Landfills A and B generate around 100,000 gallons of leachate each week, and

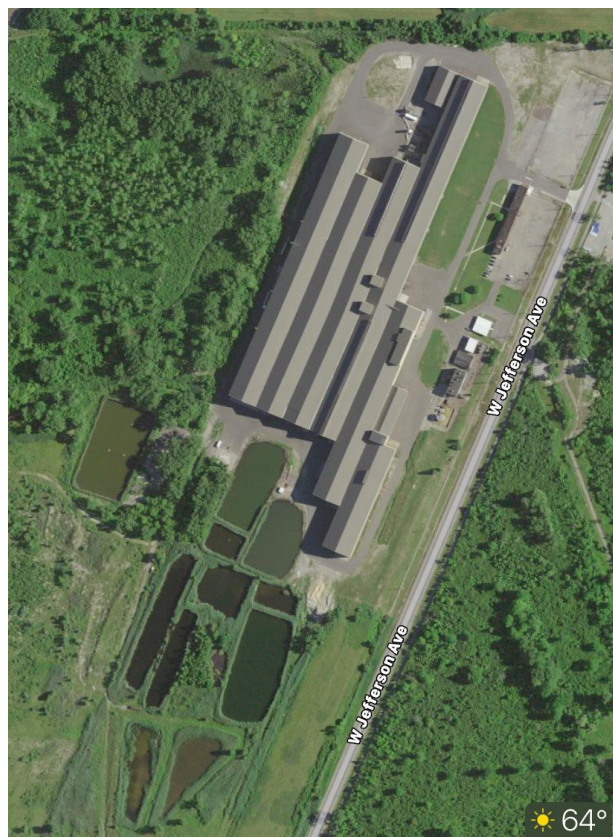
The leachate produced by industrial waste at this Superfund site is highly corrosive and contains phenolic compounds. The leachate comes from the landfills and is held in treatment ponds shown in the image to the right. Phenolic compounds can be naturally found in many fruits and vegetables used by humans, but the chemically synthesized phenols that can be found in high concentrations in wastewater can have significant short- and long-term effects on human and wildlife health. According to a study by Anku *et al.* focusing on the sources, treatment, and effects of phenols, the phenols in this case are likely coming from the municipal and industrial waste in the CWLF. Phenols in water can absorb into human skin, be metabolized, and bond with proteins in the body which results in toxic effects. Certain phenols are carcinogenic and damage red blood cells, heart, kidneys, and the liver. Other dangers include phenols acting as endocrine disruptors and altering mammary gland development in exposed animals; this can even delay puberty onset in girls. Drinking water with high phenol concentrations can cause GI tract problems, muscle tremors, and difficulty walking. Phenols are even known to cause DNA damage (2017).
