Inspector: Jason Trevino
luxinspectjt@gmail.com
(661) 666-7578
LUX Fireplace Inspections
CSIA Certification F.I.R.E. FCI-300 / CSIA-10168

This report and its recommendations are the results of a Level II inspection of the chimney system and/or decorative gas appliance. The report & recommendations are considered documentation of the inspection performed. This report and recommendations are not a statement of the worthiness or safety certification. There is no guarantee, warranty of safety/function as conditions of deterioration and use are beyond LUX Chimney Inspections control.

Living Room Mason Fireplace

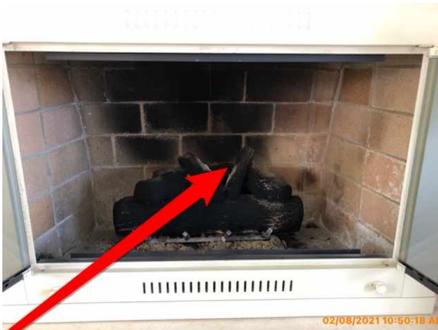
FIRE SFTY 6: **Fireplace Screens:** Missing Screen Set

While inspecting your fireplace, we noticed your fireplace does not have a screen set. Screen sets prevent embers from exiting the fireplace and contacting combustible material such as wood floor and/or carpet. In addition, screen sets prevent family animals and young children from accessing the firebox preventing injury.

RECOMMENDATION: We recommend you have a new screen set installed

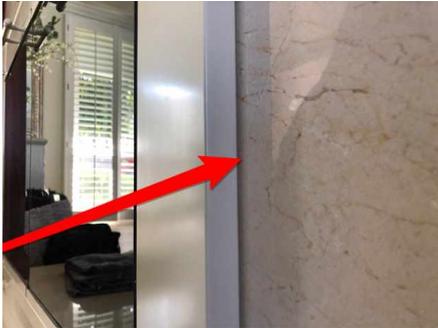
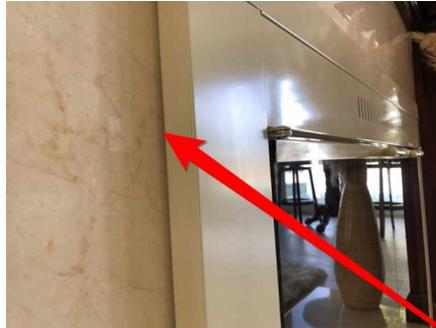
DRFT **SFTY** 7: Fireplace Doors: Gap Between Doors & Surrounding Facing Material

While inspecting your fireplace, we noticed a gap between your fireplace door set and the surrounding facing material allowing for transference of heat to combustible material. In addition, this condition may cause drafting as the glass door set will not draw air properly into the fireplace.

NOTE: Operation of the fireplace with the glass doors closed can have an adverse effect on drafting and potentially cause the tempered glass to shatter.

RECOMMENDATION: We recommend sealing these gaps with high temperature caulking

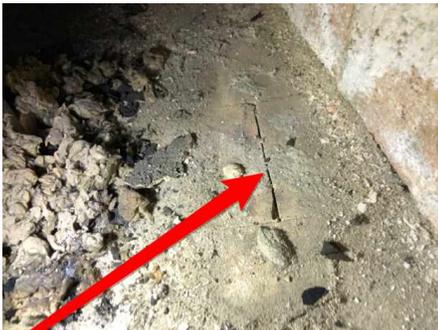
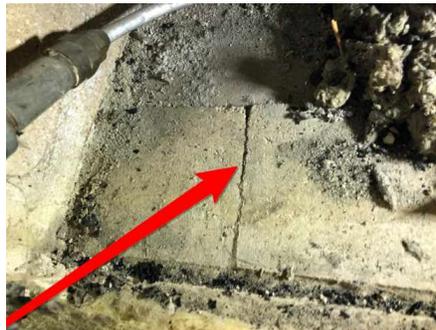
FIRE 8: Inner Hearth: Gaps In The Inner Hearth

During the inspection of the inner hearth gaps were identified. These gaps allow for the transference of heat to combustible material.

RECOMMENDATION: We recommend you have these gaps filled with high temperature cement.

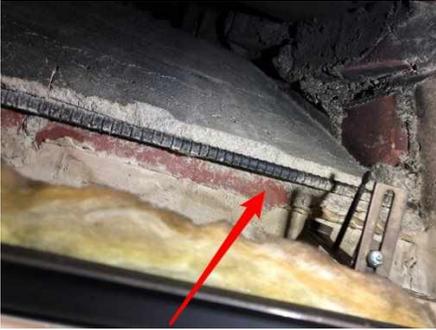
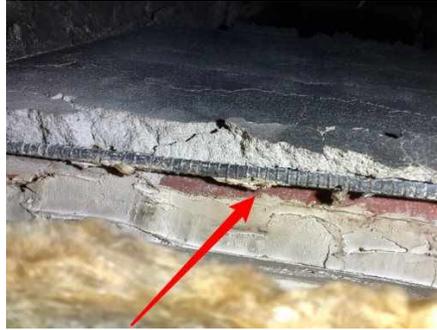
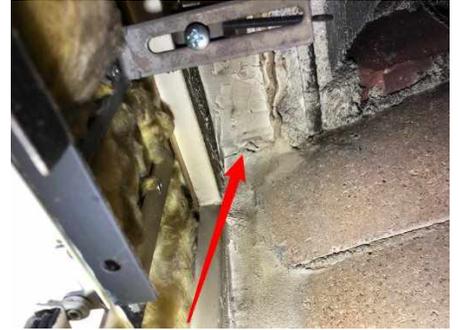
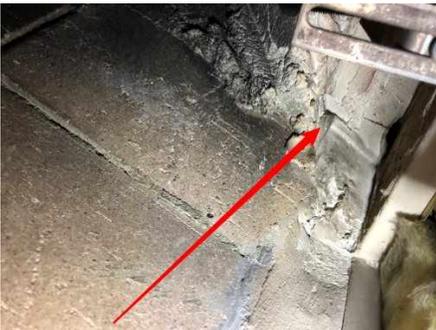
FIRE **DRFT** 9: Lintel Bar: Gaps at Lintel Bar

In the course our inspection, we noted that mortar joints at the lintel bar have eroded away producing gaps allowing for the transference of heat to combustible material.

RECOMMENDATION: We recommend not using the fireplace until corrective action has been completed by filling these gaps with high temperature caulking or high temperature cement.

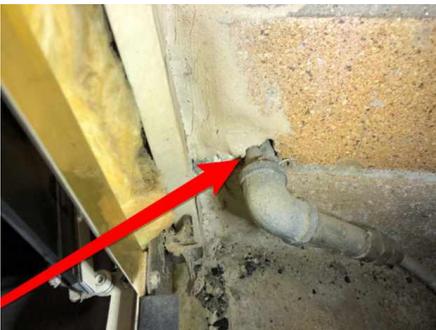
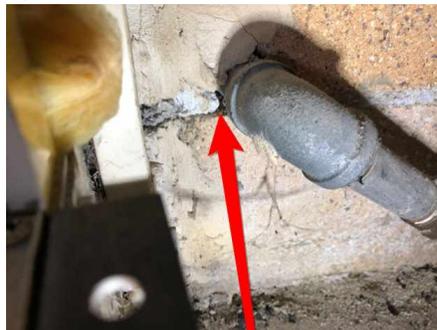
FIRE **DRFT** 10: Gas Line: Gap Around Gas Line

In the course of our inspection of the firebox area, we noticed that the gas line entry into the firebox has a gap around it. This should be remedied because if left unchecked, heat transference to combustible framing materials can occur.

RECOMMENDATION: We recommend that the gap around the gas line be sealed with high temperature cement before the fireplace is used again.

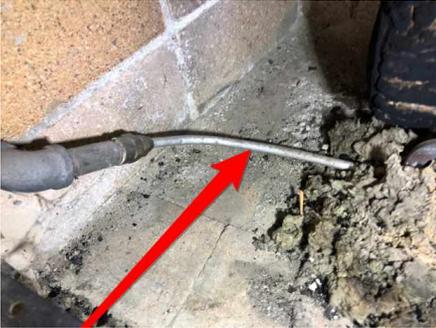
FIRE SFTY 11: Gas Line: Rigid Gas Line

During our inspection of the firebox area, we noticed that your gas line is an older rigid one and is in danger of crimping. In addition, gaps can occur in the gas line when crimping occurs.

RECOMMENDATION: It is recommended that you have the rigid gas line replaced with a flex gas line

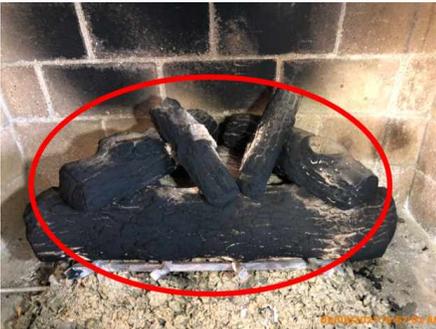
FIRE DRFT 12: Log Set: Improper Operation

In the course of our inspection of the firebox area, we noted that your gas log installation is not operating as the manufacturer intended. The logs have a significant buildup of soot on them. Over time, gas logs can break, or a buildup of soot and carbon can prevent them from operating properly. This potentially can cause thermal damage to the firebox, smoke chamber, and flue system.

RECOMMENDATION: It is recommended to operate the fireplace with the doors open to improve draft and flow through the system.

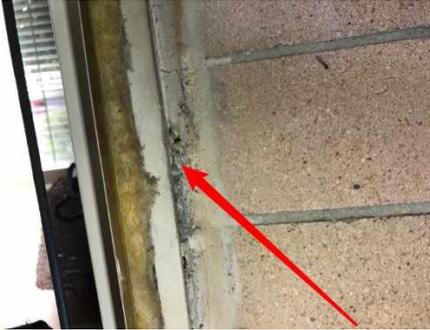
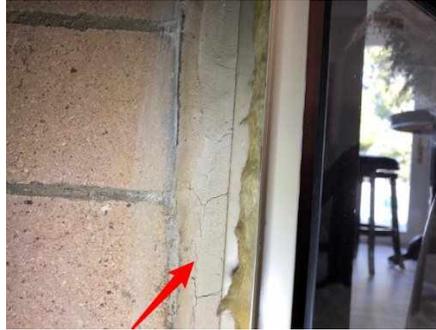
13: Combustion Chamber/Firebox: Gap(s) Between Firebox And The Surrounding Facing Material

During the inspection of the firebox, gaps were identified between the firebrick of the firebox and the surrounding brick facing material allowing for the transference of heat to combustible material. In addition, low temperature grout was used allowing for the transference of heat to combustible material.

RECOMMENDATION: We recommend you have these gaps sealed with high temperature cement or high temperature caulking

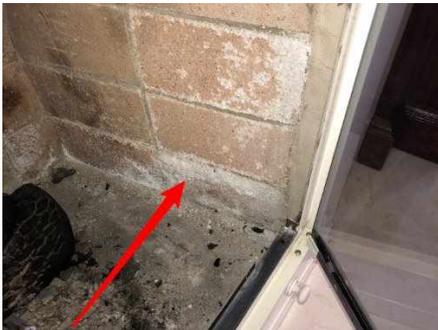
H2O SFTY 14: Combustion Chamber/Firebox: Efflorescence

The visible staining, efflorescence, on the walls of the firebox have been caused either by water entry from the top or sides of the chimney and/or through the smoke shelf.

RECOMMENDATION: This condition should be corrected by cleaning the efflorescence from the firebox and sealing any gaps with high temperature cement. It is also recommended to seal the exterior chimney structure with water soluble sealant such as ChimneySaver. Do not seal the chimney with a generic water sealer such as Thompson Water sealant.

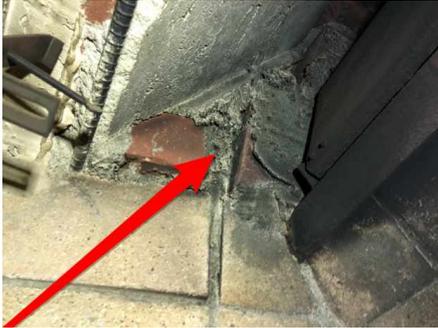
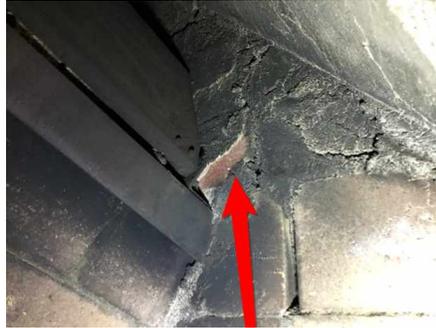
FIRE DRFT 15: Throat: Exposed Bricks

During our inspection we found exposed bricks in the throat of your fireplace. This should be remedied because if left unchecked, heat transference to combustible framing materials can occur.

RECOMMENDATION: We recommend that you have the throat of the fireplace sealed with high temperature cement.

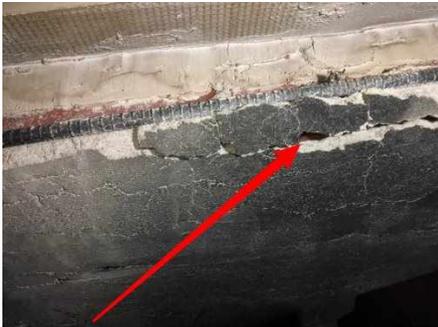
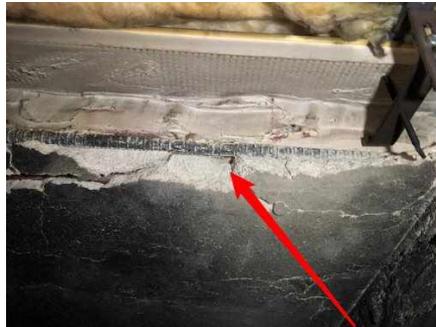
FIRE DRFT 16: Breast Plate: Gaps

During our inspection of the firebox area, we found gaps in the breast plate of your fireplace. This should be remedied as these gaps allow for the transference of heat to combustible framing materials. In addition, these gaps can cause turbulence not allowing for proper drafting of condensates to the smoke chamber.

RECOMMENDATION: We recommend that you have these gaps sealed/filled with high temperature cement prior to using the fireplace again.

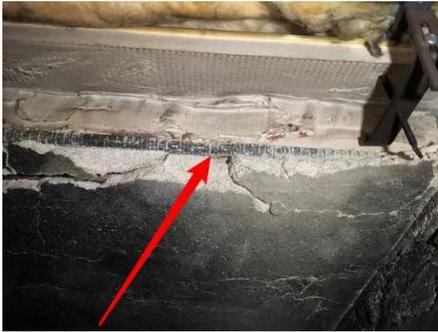
FIRE DRFT 17: Breast Plate: Exposed Rebar

During our inspection of the firebox area, we found exposed rebar at the breast plate of your fireplace. This should be remedied because if not corrected it allows for the transference of heat to combustible framing materials.

Recommendation: We recommend that you have the breast plate coated/sealed with high temperature cement. It may be necessary to rebuild your breast plate.

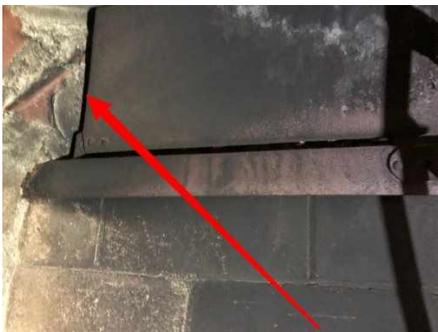
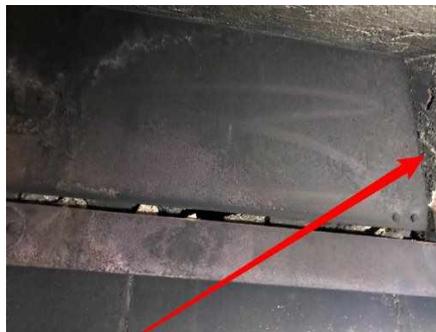
FIRE DRFT SFTY 18: Damper: No Damper Clamp

When inspecting the damper, we noticed it does not have a damper clamp installed on it. Damper clamps are required to hold the damper 100% open when using a gas log set to prevent the damper from closing. If the fireplace is operated when the damper is closed carbon monoxide could enter the living area potentially undetected.

RECOMMENDATION: We recommend you have a damper clamp installed.

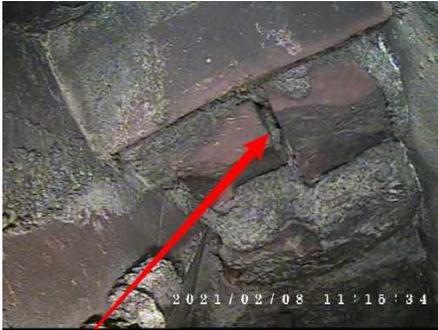
FIRE **DRFT** 19: Smoke Chamber: Gaps

In the course of our inspection within the smoke chamber, the area above the damper, we noticed openings or gaps in the chamber. These gaps allow for the transference of heat to combustible materials. In addition, these gaps may prevent the smoke chamber from properly and safely funneling flue gases and condensates from the firebox to the chimney.

RECOMMENDATION: We recommend repairing this area as soon as possible by coating the smoke chamber with high temperature cement or by rebuilding a new smoke chamber

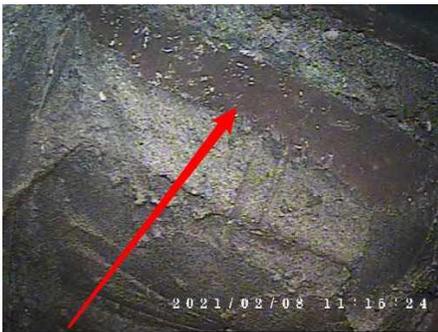
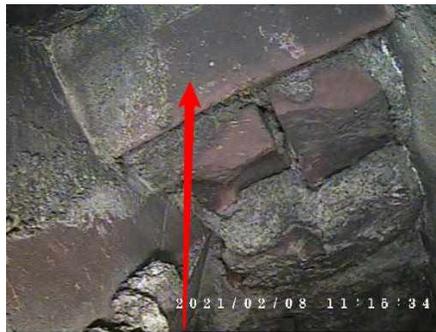
FIRE **DRFT** 20: Smoke Chamber: Exposed Bricks

The smoke chamber is the area just above the damper. During our inspection we found exposed bricks in the smoke chamber of your fireplace. This should be remedied because if left unchecked, heat transference to combustible framing materials can occur.

RECOMMENDATION: We recommend that you have the smoke chamber sealed with high temperature cement.

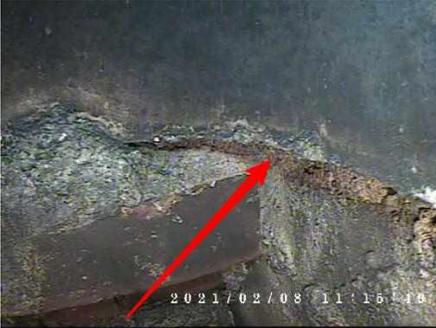
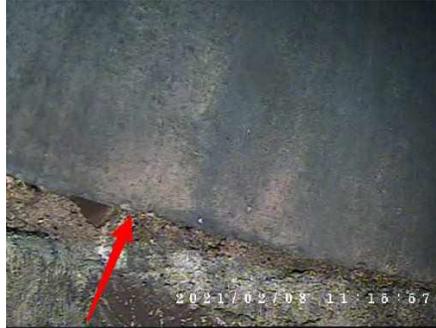
FIRE DRFT 21: Smoke Chamber: Gaps At The Transition To The Flue Liner

When inspecting the transition point of the smoke chamber to the flue liners we found openings or gaps. These gaps may prevent the system from properly and safely funneling flue gases and condensates out the chimney.

RECOMMENDATION: We recommend repairing this area as soon as possible by coating the transition point from the smoke chamber to the flue liners with high temperature cement or by rebuilding a new smoke chamber

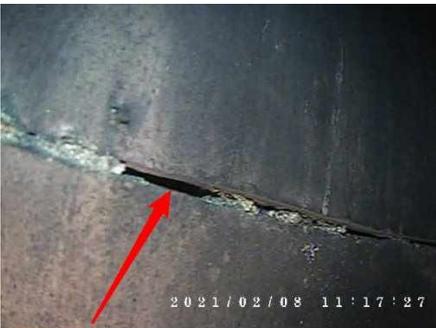
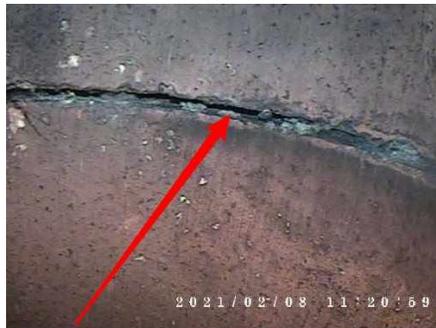
FIRE DRFT 22: Flue Liners: Gaps Between Clay Flue Liners

In the course of our inspection, we noticed your clay flue liners have openings or gaps at the joints. These gaps allow for the transference of heat to combustible materials. In addition, these gaps may prevent the proper and safe funneling of flue gases/condensates through the flue system and out of the chimney.

RECOMMENDATION: We recommend repairing this area as soon as possible by sealing the gaps in the flue liners with high temperature cement.

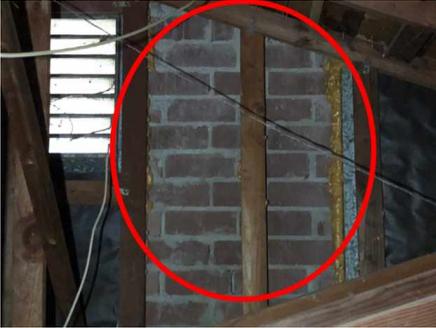
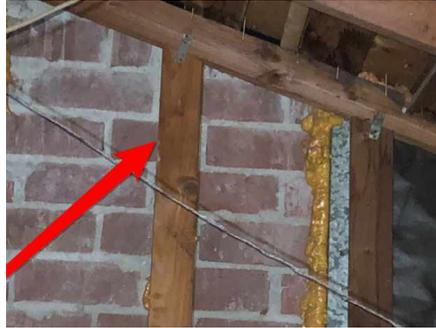
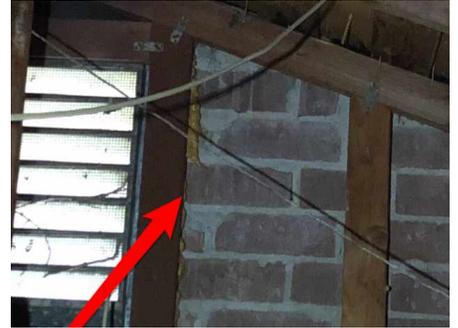
FIRE 23: Attic: Combustible Materials Too Close

The chimney system in the attic does not meet the required two-inch (2") clearance requirement to the combustible wood framing in the attic.

RECOMMENDATION: We recommend creating a two-inch (2) clearance between any combustible material and the chimney system.

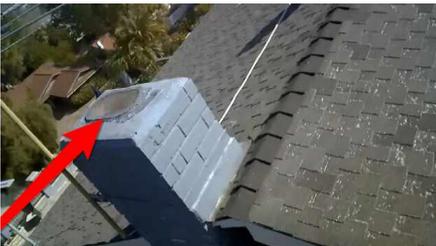
FIRE **H2O** 24: Chimney Cap/Spark Arrestor: Install

In the process of inspecting the chimney, we noticed that a chimney cap/spark arrestor is not installed at the top of the chimney. A chimney cap has a three-fold purpose, acting as a spark arrestor, preventing animal intrusion, and preventing rain from entering the chimney area.

RECOMMENDATION: We recommend that a chimney cap be installed as soon as possible.

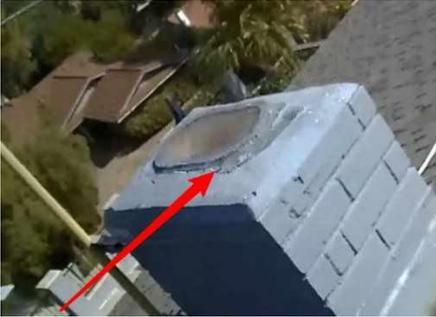
25: Chimney Crown: Gaps In Chimney Crown

Our inspection revealed that there is damage to the chimney crown. The purpose of the chimney crown (the area surrounding the opening of the chimney at the top) is to prevent moisture or rain from entering the chimney. Without a chimney crown staining and or deterioration to the dwelling and chimney will occur.

RECOMMENDATION: It is recommended you have the chimney crown resurfaced.

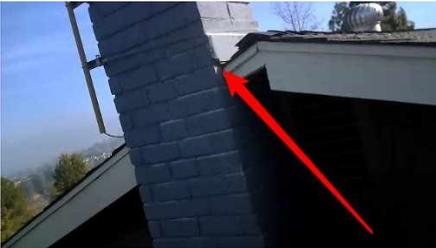
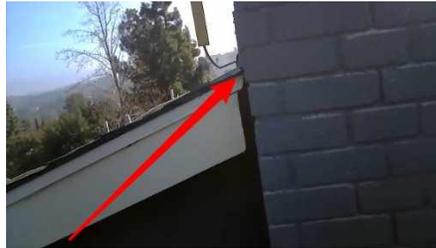
H2O 26: Flashing: No Kick Out Flashing Present

In the course of our inspection, we discovered a developing problem with the chimney flashing (located at the base of the chimney at the roof level). Flashing should extend past the roof eaves and away from the chimney to properly shed water. Your flashing does not do this.

RECOMMENDATION: It is recommended to replace your flashing.

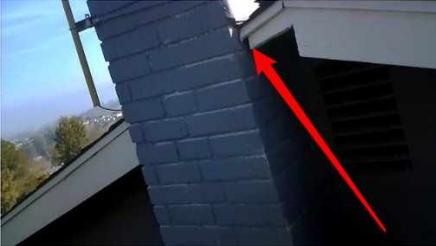
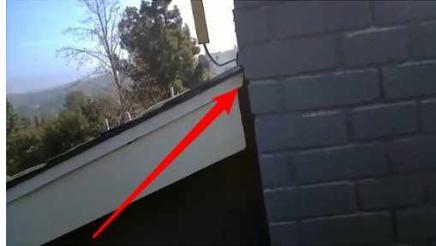
FIRE 27: Exterior Chimney Structure: Chimney Clearance To Combustible Roof Eaves

In the course of our inspection, we noticed that the combustible wood roof eaves next to your chimney do not meet the required two-inch (2") clearance.

RECOMMENDATION: It is recommended to have this corrected by having a roofer or a qualified professional create a two-inch (2") clearance between the chimney and the wood roof eaves.
