FIREPLACE INSPECTIONS

SUMMARY OF FIREPLACE/CHIMNEY INSPECTION

Marco Pl, Venice, CA 90291

Livingroom Fireplace

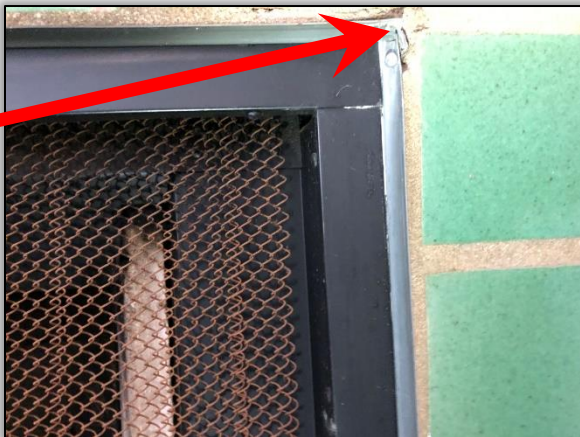
1.2 Fireplace Screens – Rusted

While inspecting your fireplace, we noticed that your fireplace screens are rusted. The rust is preventing the screens from tracking smoothly when opening and closing.

It is unfortunate but due to the rust at the collar of the firebox, which is not a repairable defect, the existing fireplace is a fire hazard. Rust at the collar will allow for the transference of heat to combustible material. If you intend on having an operating fireplace, replacement of the existing fireplace system is required. In addition, during installation of a new fireplace system a chase closet should be built enclosing the flue system which allows for proper venting and cooling of the fireplace system.

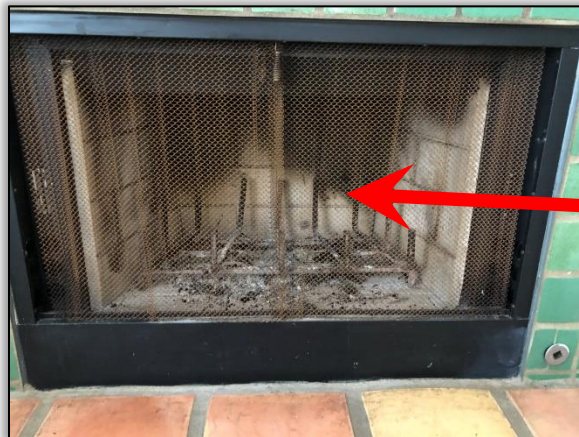
1.3 Prefab Fireplace – Clearance To Combustible Material Not Met

Access to the exterior flue pipe was possible from an outside door and no chase present. When inspecting the fireplace rust was found at the collar allowing for the transference of heat to combustible area. In addition, the collar of a pre-fabricated fireplace is not replaceable. The only alternative is to replace the entire fireplace system.

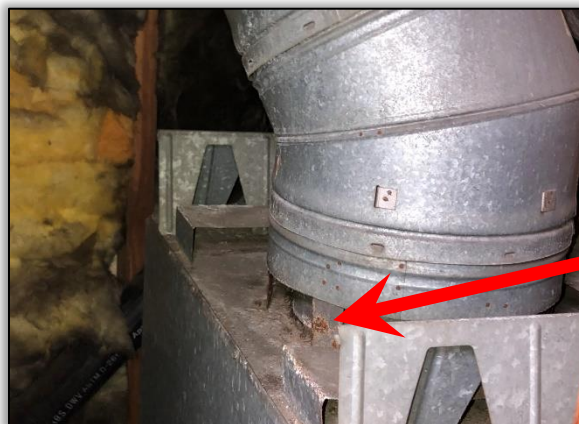
1.4 Gas Line – Gap Around Line

In the course of our inspection of the firebox area, we noticed that the gas line entry into the firebox area has a gap around it. This should be remedied because left unchecked, air from other areas can enter the fireplace and cause erratic operation or ashes and hot embers from the fire can escape into the area behind the firebox and come into proximity to combustible framing materials. We recommend that the gas line be sealed before the fireplace is used again.

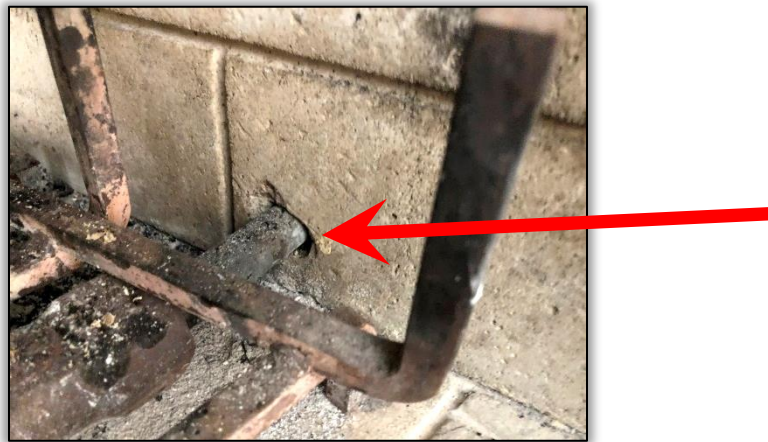
1.5 Flue Liner – Soot Present

Camera inspection of the chimney's flue liners revealed that there is a buildup of soot in the flue system.

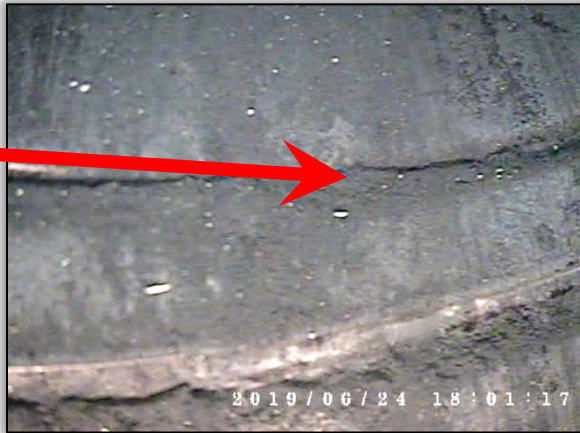
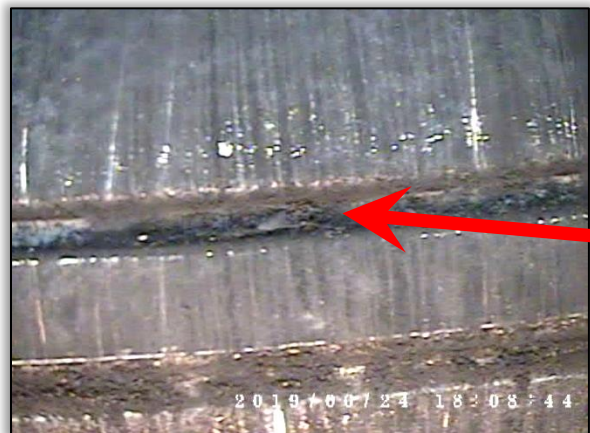
1.6 Flue Liner – Disengaged

During our inspection we observed that the chimney's liner sections are not connected together as intended by the manufacturer of the fireplace system. These systems are designed to contain the flow of gases and smoke within the interior liner of the chimney. In our opinion, continued operation in this condition may lead to smoke breaching into the chimney chase and overheating the chimney structure leading to the possibility of a fire.

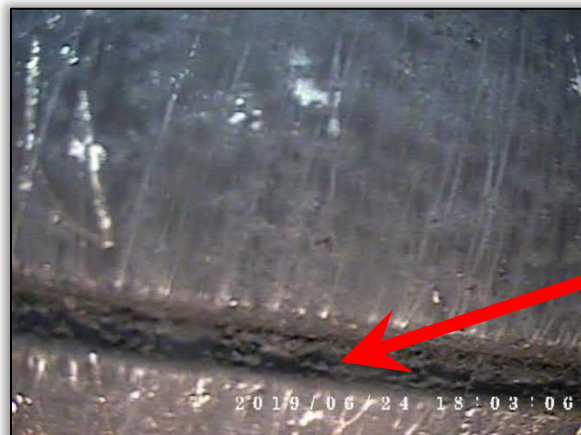
1.7 Flue Liner – Screw Holes And/ Or Screw Holes

In the process of inspecting the flue with our internal camera system we have observed screws and/or screw holes in the flue liners. In our opinion, continued operation in this condition may lead to smoke breaching into the chimney chase and overheating the chimney structure leading to the possibility of a fire.

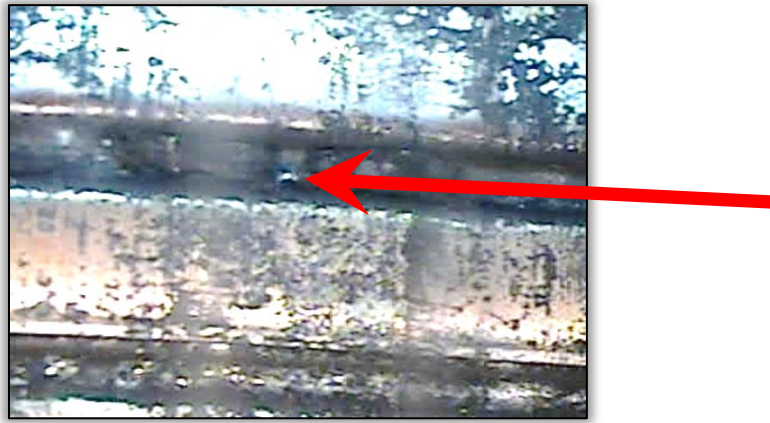
1.8 Flue Liner – Rusted Flue Pipe

Rust on the inner flue liners are indicative to sudden occurrences such as chimney fires and/or lack of proper maintenance, chimney sweeping, as soot and creosote produces acids that can rust the flue liners over time.

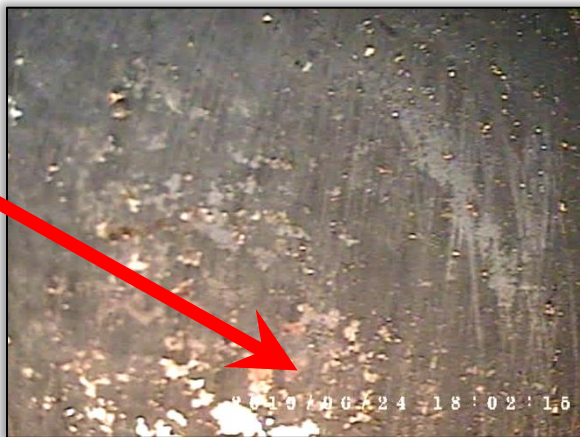
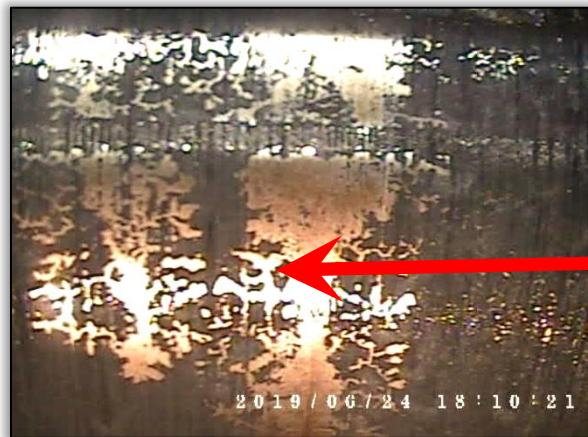
1.9 Chase – Combustible Materials Too Close

As revealed in our inspection photo, the combustible material (wood framing) is too close to the fireplace allowing for the transference of heat to combustible material. Building codes state that an air space of 2" is to be placed between the fireplace and the structural framing. It is recommended to have a 2" clearance between any the wood framing and any prefabricated fireplace.

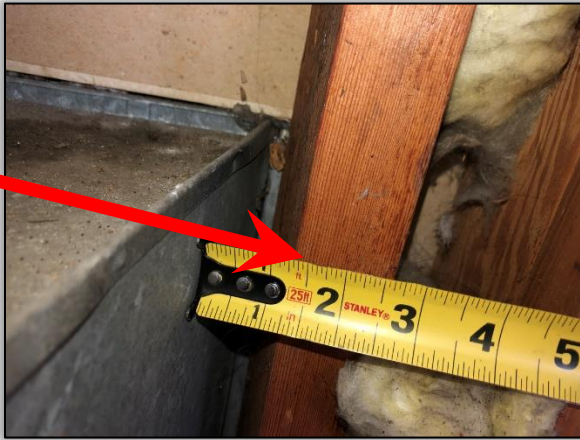
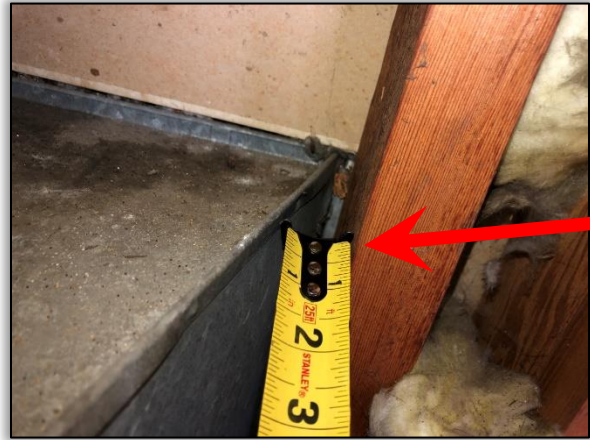
1.10 Chase – Installation

Our inspection indicated that the structure containing the chimney, known as the chase, is nonexistent. This can allow for heat to transfer to combustible material. In addition, there are boxes and other personal items in what would be the chase area. This situation is of high priority as a chase's intended function is to vent the products of combustion properly and seal the home from the elements. We recommend repairing the chimney structure before further operation or installation of a new fireplace.

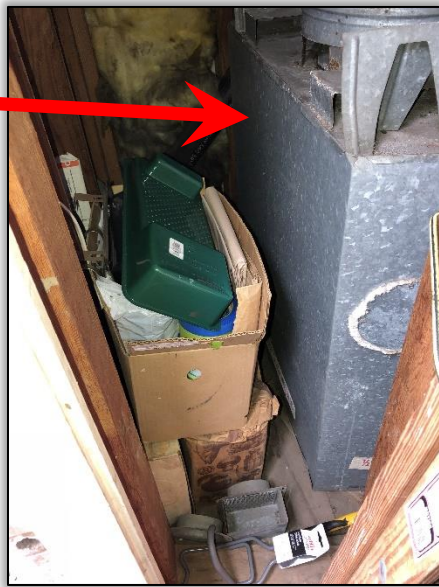
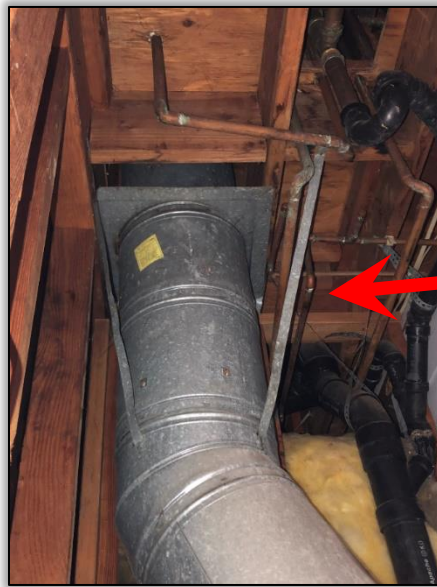
1.11 Chase – Firestop Repair

Access to the exterior flue pipe was possible from an outside door and no chase present. At the sealing line the firestop is not properly sealed allowing for the transference of heat to combustible material.

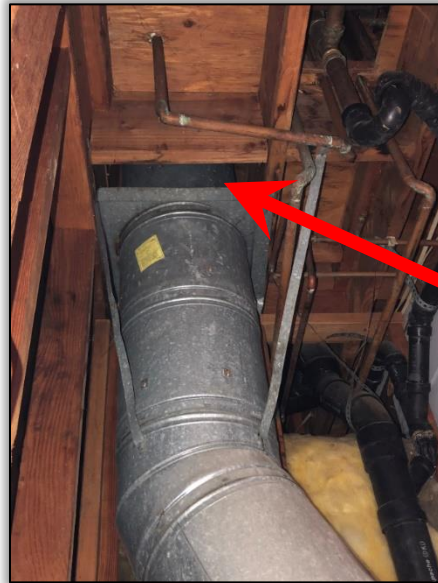
1.12 Exterior – Storm Collar Reseal

At the top of your chimney chase the structure which encompasses your prefabricated chimney is a large pan that seals the top of the chase from the elements. When the chimney rises through the pan there is what is known as a storm collar which surrounds the chimney to create a seal from the pan to the chimney. This collar is designed to deflect the elements from entering into the chase interior cavity. Your storm collar is not sealed to the flue pipe allowing for water to enter the system. It is recommended for the storm collar to be sealed with high temperature caulking. If left unattended there is the possibility for water damage to other areas of the chimney system and your house.
