Electrical Fires and Explosions

Vytenis Babrauskas, Ph.D.

14.11 Meters and meter sockets

14.11.1 Smart meters

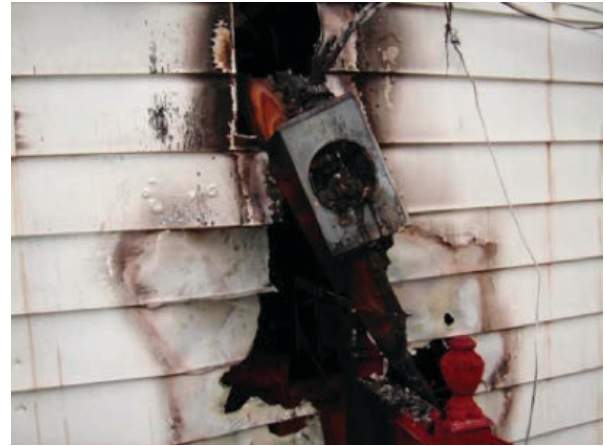
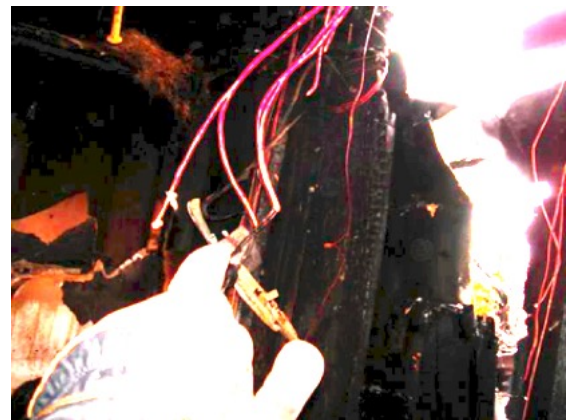
(a) Burn patterns near meter

(b) Actual fire origin at branch circuit wiring inside the wall (note beading)

Figure 71 Burn patterns suggesting meter fire; meter was actually victim of fire
(Photos: Eric Jackson)

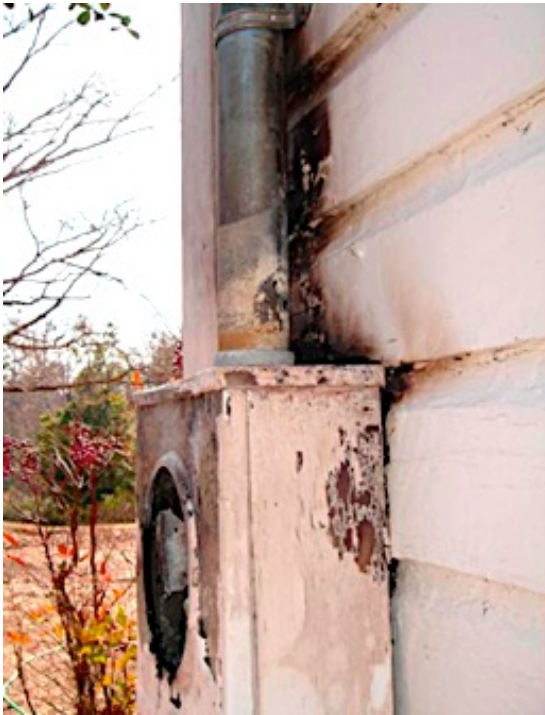
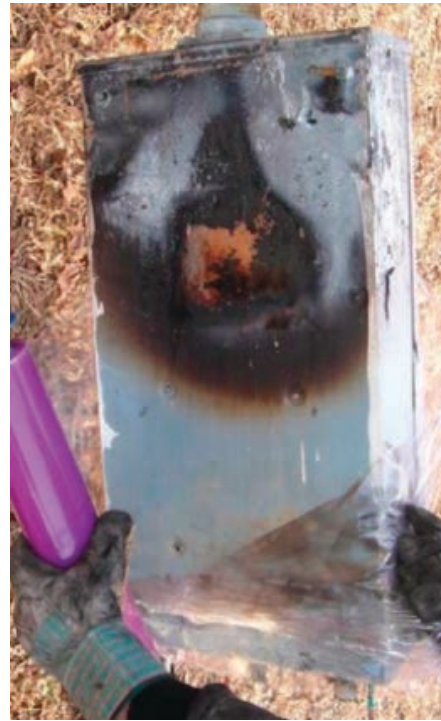
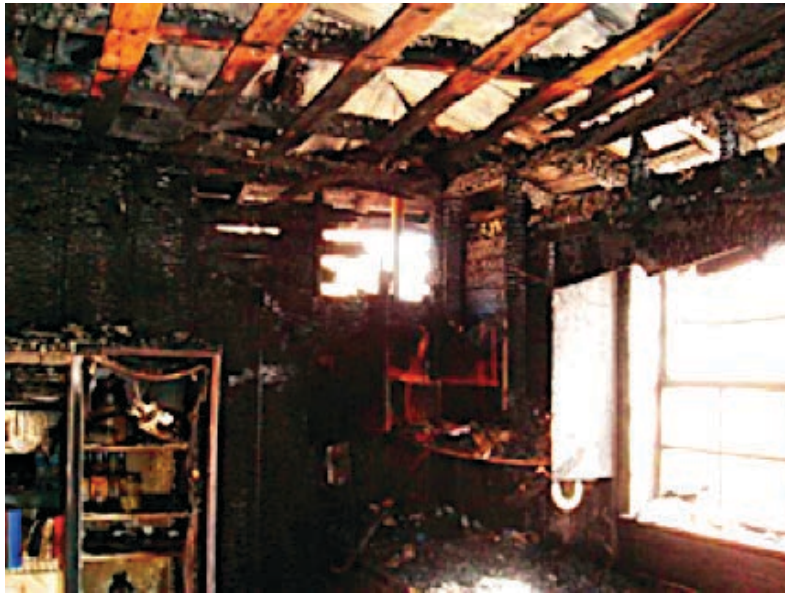
(a) Localized, but limited burn damage to wall

(b) Burn patterns on back of housing

(c) Major damage was inside the structure

Figure 73 Damages due to meter fire
(Photos: Eric Jackson)

Incidents involving a suspected meter fire have to be investigated carefully. Fires originating at a meter will generally leave distinct patterns (**Figure 73**). The meter location generally also has copious other wiring and the meter may be the victim, not the cause of the fire. In the incident illustrated in Figure 71, if the fire had originated at the meter or meter socket, a massive arc fault would likely occur at that location, de-energizing branch circuit wiring and eliminating the potential for downstream arcing.

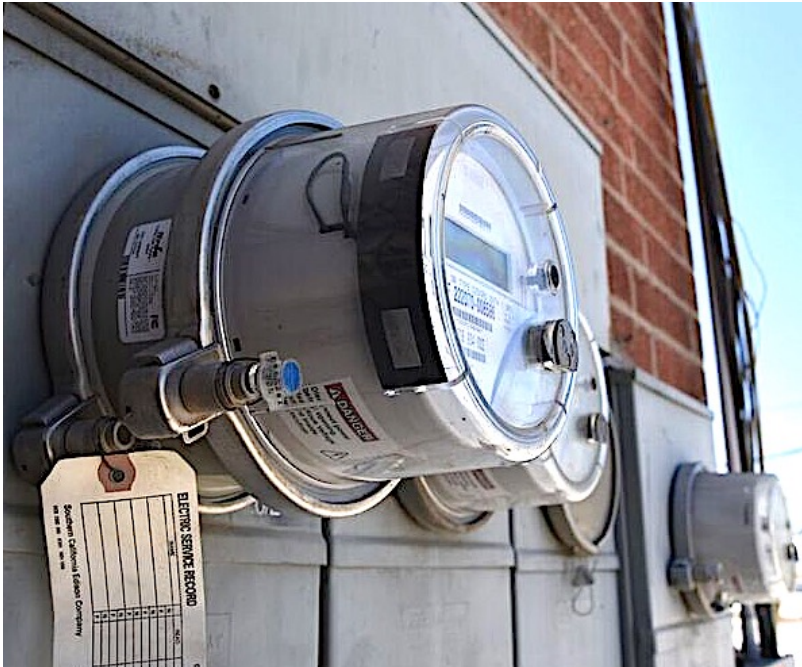
Figure 74 Smart meter installation, showing two ordinary smart meters (center, right), and a collector meter (left). Note that the collector meter differs in having an extra-deep base.

Smart meters are an innovative type of electric meter that uses RF/microwave signaling to communicate with the electrical utility (Figure 74). The basic function is enabling data on the consumption of electricity to be conveyed to the utility without need for manual meter reading. The meter reports readings frequently (at least hourly), enabling time-of-day pricing to be implemented. But various schemes can also be implemented whereby signals going in the other direction can be used for control purposes, e.g., for controlled load shedding. Smart meters are considered a component of Advanced Metering Infrastructure (AMI), but the latter is a broader concept and can include gas metering, water metering, etc. Nonetheless, industry often refers to smart meters as ‘AMI meters.’

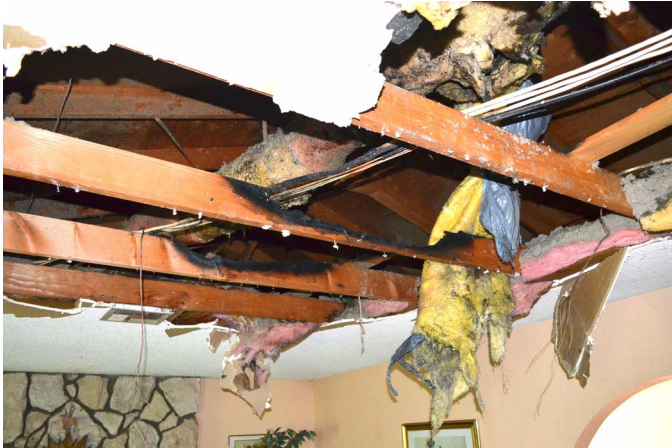
Figure 80 Fire originating mid-run on a branch circuit, about 3.9 m away from a smart meter which was located on the exterior face of the wall along the left side of photo. Note two joists with extremely heavy saddle burns, while no damage was seen to adjacent joists. No staples, nails, or other mechanical causes of damage were found.
(Photo: Jim Brown)

Perhaps the most revealing fire is illustrated in Figure 80 and Figure 81. Figure 80 shows the locale in the ceiling where fire broke out. A smart meter had been installed at the house around 4 months prior. The fire investigator decided to examine some unburned circuits in the area and found another location on an NM cable where severe insulation failure had occurred, but fire had not yet broken out (Figure 81). Due to extensive record-keeping, the homeowners were able to provide some very detailed, useful information on the case. About 2 months after the installation, the homeowners brought their dog to the veterinarian since he was repeatedly scratching his ears. The vet found no malady with the dog. One month later after the behavior failed to normalize, the owners again brought their dog in for medical attention and again received no diagnosis. But around the same time, the owners noticed that their cats started to concertedly avoid the room in which the fire later broke out. After the fire occurred and the fire damages were remediated, none of the animals continued to show aberrant behavior. The most likely explanation is that failure of the insulation on the NM cable caused arc tracking to be initiated, leading eventually to arcing across air (see *Arcing across a carbonized path* in Chapter 7). Dogs and cats are able to respond to ultrasonic frequencies which are beyond the audible range for humans. The emission of ultrasonic sound waves from arcing is discussed in Chapter 5 under *Acoustic noise*. It may be concluded in this case that the behavior of the animals indicates that arcing was already occurring about 2 months after smart meter installation, but that it took another two months for fire to break out.

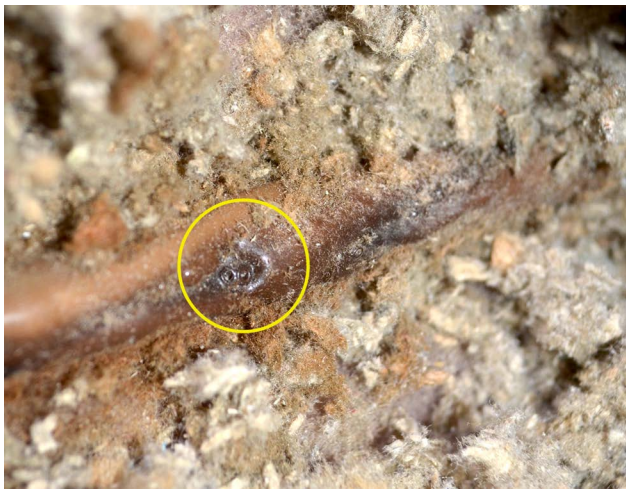
Figure 81 A damaged section from a cable in the same fire as shown in the previous figure. Note that there is no fire damage here, but a severe, localized insulation failure. The two dimples (in the middle of the yellow circle) are not mechanical damage. There was no mechanical damage, but evidently the cratering of the insulation occurred due to localized damage from RF waves. This location was about 2 m away from the smart meter.
(Photo: Jim Brown)

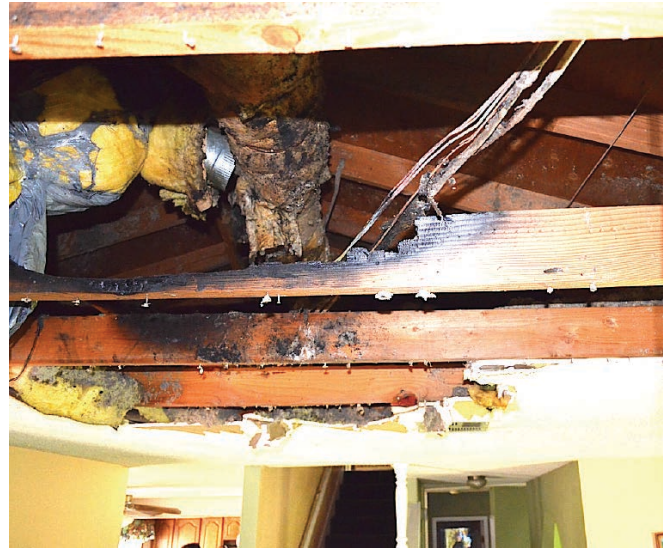
Figure 78 Fire originating mid-run on a branch circuit, about 3 – 4.5 m away from a smart meter which was installed some 4 – 6 months earlier. Examination of the fire origin area did not reveal any fasteners that could have damaged the cable, nor any other potential sources of mechanical damage.
(Photo: Jim Brown)

One unusual problem sometimes experienced with smart meters are fires which start in the general vicinity of a smart meter, but not directly nearby (commonly some 3 – 5 m distant). In situations where the location is inside a wall cavity and inspection does not reveal any likelihood of mechanical damage, the interpretation suggests that the cause is due to the smart meter, even though the exact mechanism has not yet been identified. Figure 78 shows a fire originating in mid-run of a branch circuit NM cable, away from any potential sources of mechanical damage, about 4 – 6 months after installation of a smart meter. Another similar case is illustrated in Figure 79.

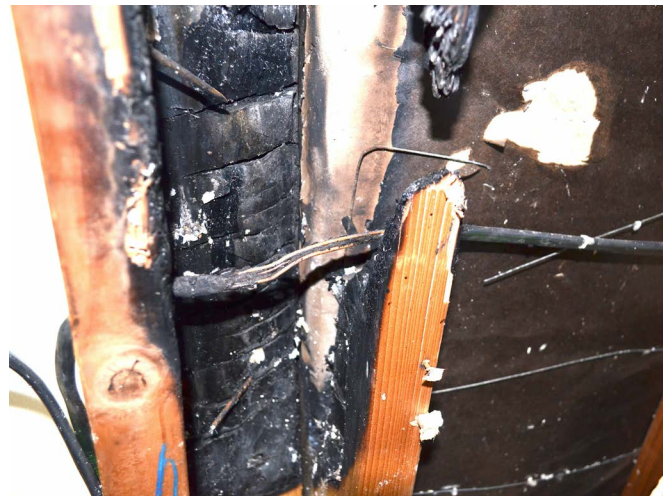
Figure 79 Fire originating in a wall cavity causing heavy damage to two studs. The smart meter was located about 4.6 m away. No arc marks were found on the NM cable. No staples, nails, or other mechanical causes of damage were found. The photo also shows some bare wires which were part of the wall stucco construction method.
(Photo: Jim Brown)
