STATE OF SOUTH CAROLINA  
RESIDENTIAL POOL INSPECTION REPORT

Pool Type: Residential Private Pool  
In Attendance: Buyer, Seller, Buying Agent

Pool Capacity: gallons estimated  
13230

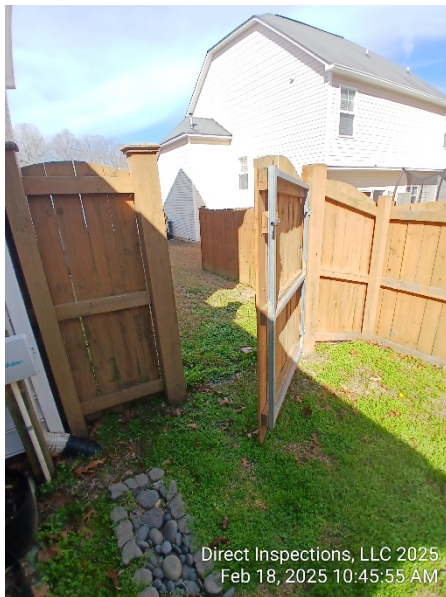
#### GATE CONDITION:

⚠ REPAIR

Both gates open inward which is incorrect and neither gate would self-close or self-latch.

**Note: The ISPSC is the industry standard that some insurance companies and HOA's may require compliance, some don't. I always recommend that pool owners make every attempt to comply with ISPSC standards to reduce liability. I would suggest contacting your insurance carrier with regards to fence and gate height, opening direction and self-closing and self-latching requirements they may have.**

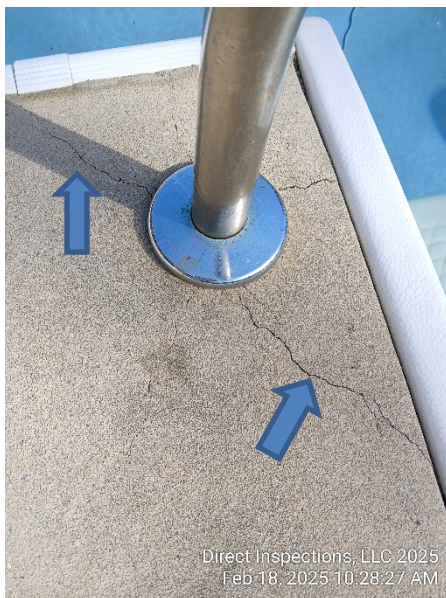
#### DECKING SURFACE CONDITION

INSPECTED - FAIR

There is some minor cracking around the handrail on the left side. These cracks should be sealed and monitored for further degradation.

Cracks

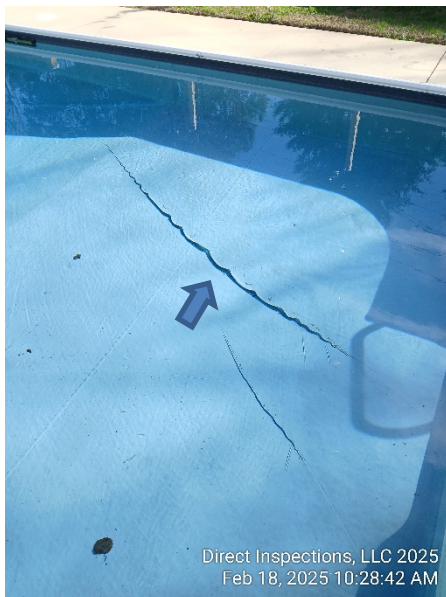
### LINER OR SURFACE CONDITION

REPAIR

The liner was installed incorrectly with a large wrinkle across the shallow end. The liner is faded and appears to be at least 5 years old. This liner may be reaching the end of its expected life.

Recommendation: Expect replacement of the liner within 2 years (approximately)

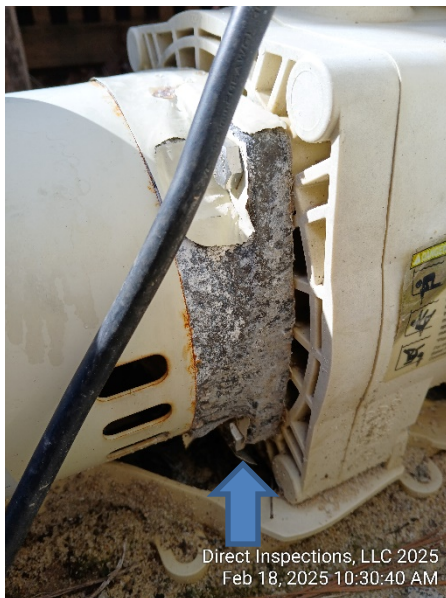
## PUMP

🚩 INSPECTED - FAIR

The pump has heavy corrosion and may be reaching the end of its expected life.  
Recommendation: Expect replacement in less than 2 years (approximately)

Corrosion

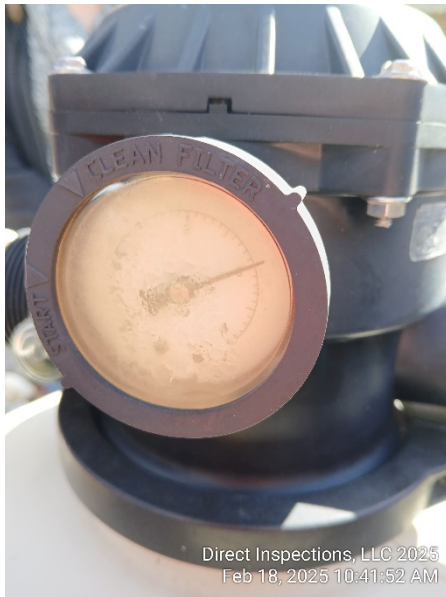
#### PRESSURE GAUGE

🚩 REPLACE

The gauge is stuck and non-functional, Replacement is recommended.

Stuck

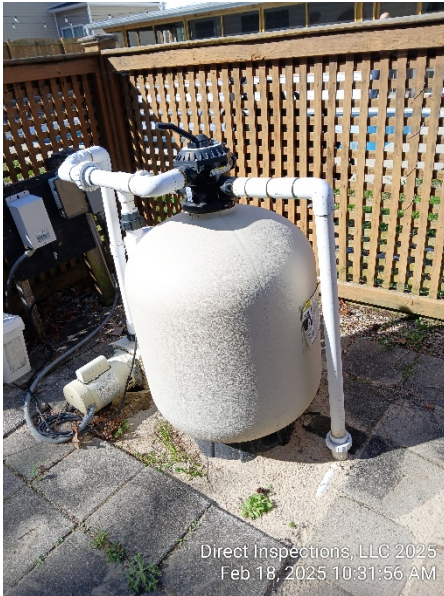
#### PLUMBING (ABOVE GROUND)

🚩 INSPECTED - FAIR

The PVC plumbing and valves are showing signs of UV wear and may have a limited life.

Exposed plumbing

Recommendation: The application of paint on the exposed plumbing will help prevent UV damage.

Optionally a full cover may help extend the life of all the pump/filter components.
