SOUTH CAROLINA  
RESIDENTIAL INSPECTION REPORT  
by Direct Inspections, LLC

[REDACTED]  
Rock Hill SC, 29732

📅 8/11/2025  
🕒 9:30 a.m.

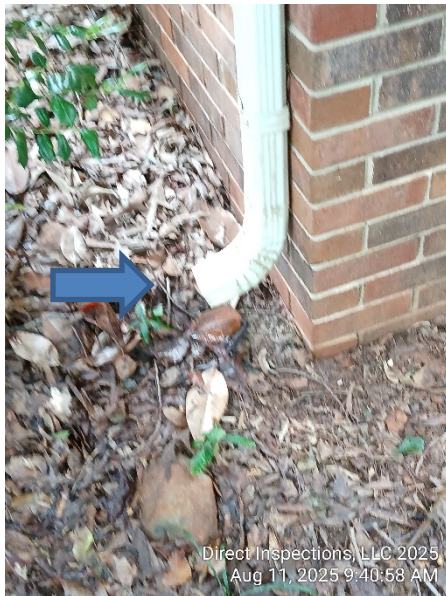
The downspout on the right front corner discharges too close to the foundation and may contribute to excessive moisture in the crawlspace. It should be extended away from the home.

Too close to foundation

**Recommendation:** The gutters and downspouts should be further evaluated, sealed, cleaned and repaired as needed by a licensed contractor specializing in roof drainage systems prior to purchase.

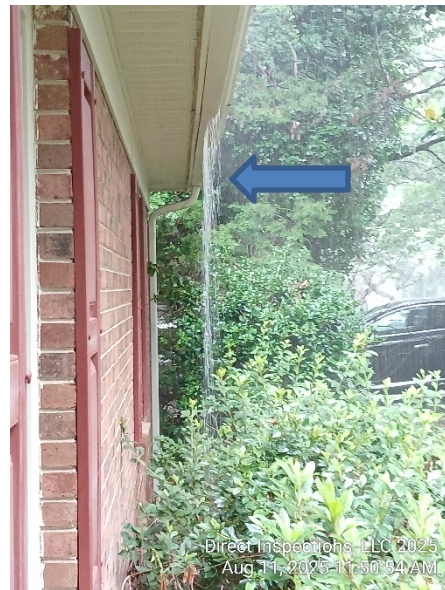
The gutters have several displaced leaf guards, the gutters do not function properly, during a moderate rain, the gutter at the front right did not drain properly, filled and overflowed. This may be from debris or clogs that were not visible in the downspout or under the leaf guards.

Overflow

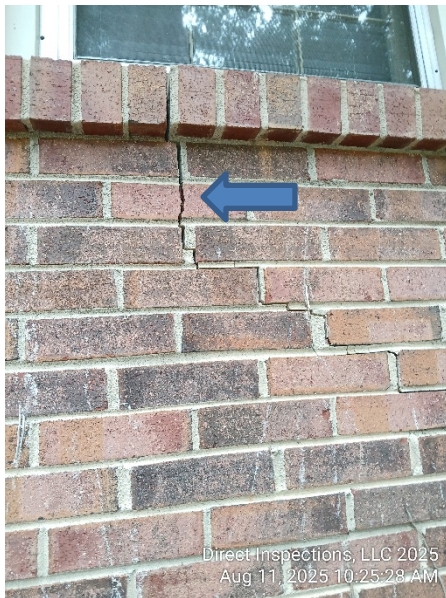
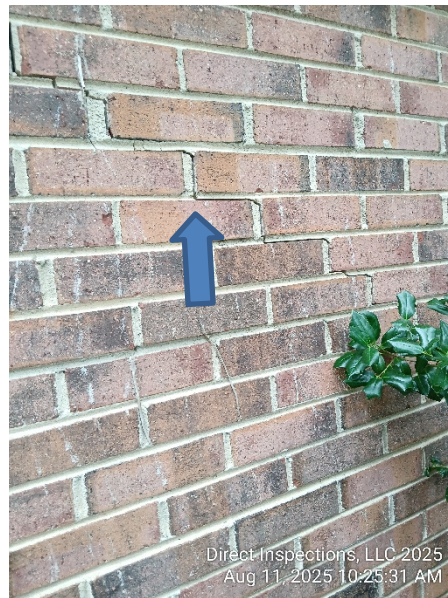
At the right-side rear, there is settlement step cracking, this is an indication of foundation issues and possible a failure of the footer, the large tree and roots near this defect may be a contributing factor. **Recommendation:** Further evaluation by a licensed contractor specializing in foundation repairs prior to purchase.

Cracks

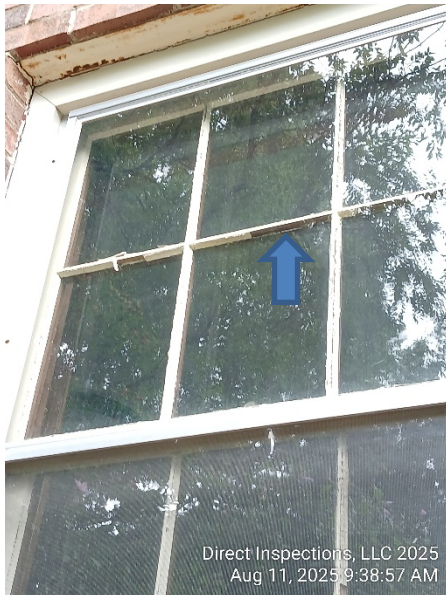
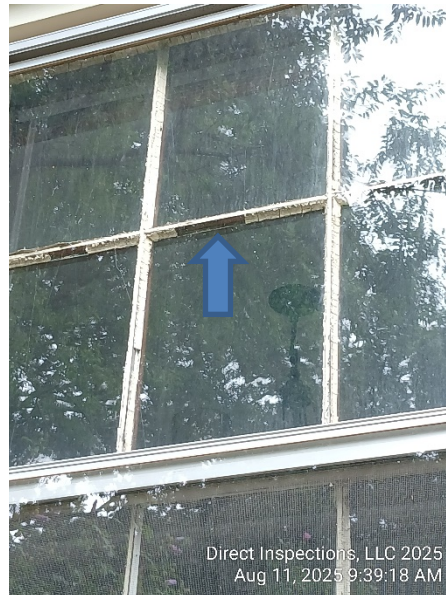
Many of the windows especially those on the left side have deteriorated or missing glazing. This glazing provides the retention for each glass pane.

Glazing deterioration

**Recommendation:** Further evaluation and repairs by a licensed contractor prior to purchase.

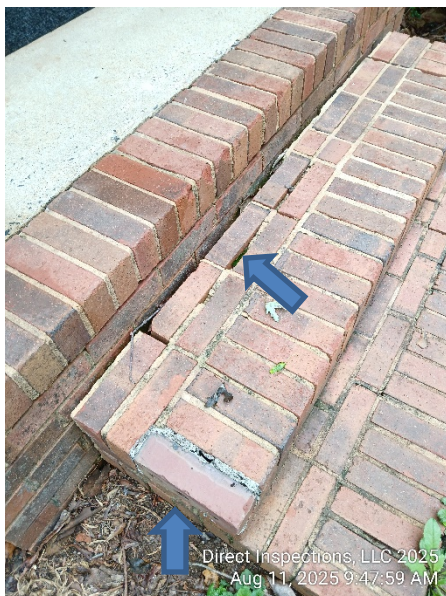
The front steps are slightly displaced from settlement, there are areas of missing mortar and mismatched brick that appears to be glued in place.

Amateur repair, missing mortar

**Recommendation:** Further evaluation and repairs by a licensed brick mason prior to purchase.

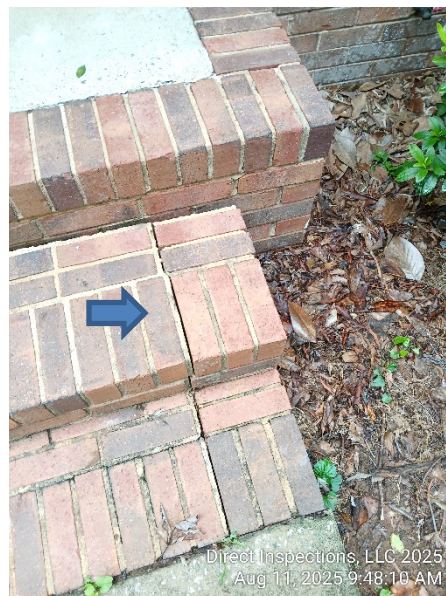
Settlement

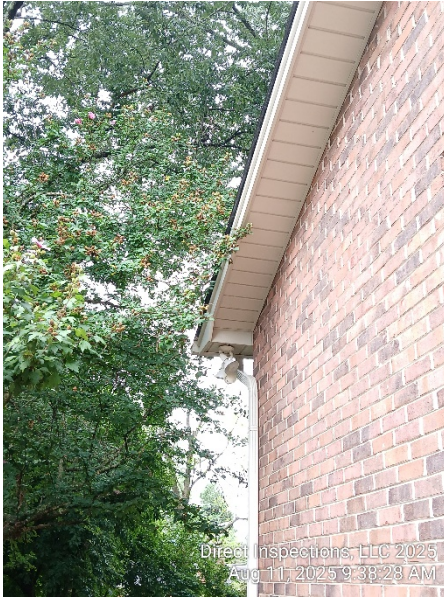
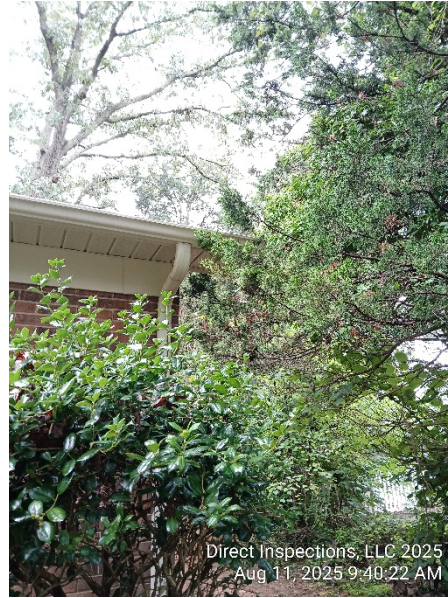
There are tree limbs touching the roof at the left side rear corner and right-side front corner. This condition may cause damage to the shingle surface and crumbling of the edges.

**Recommendation:** Prune any limbs or shrubbery that touches the home.

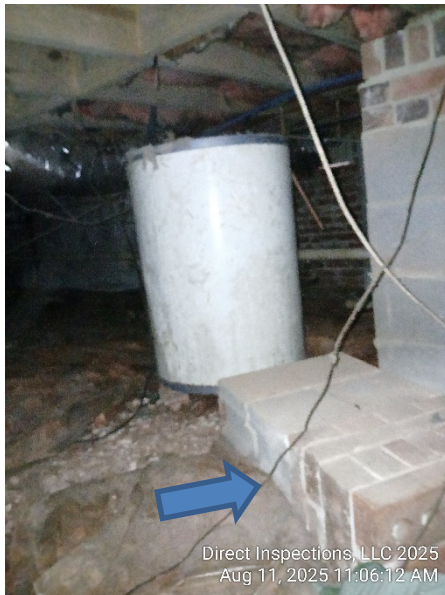
There is a column that has fallen or was removed and is lying in the crawlspace. The original location is unknown but it appears to be part of the original foundation construction.

Displaced or failed

**Recommendation:** Further evaluation by a licensed contractor prior to purchase.

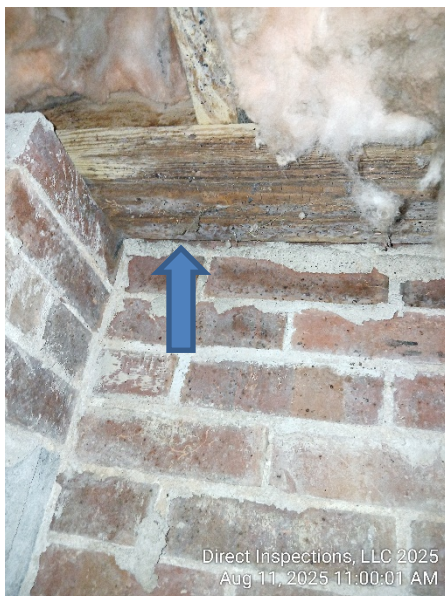
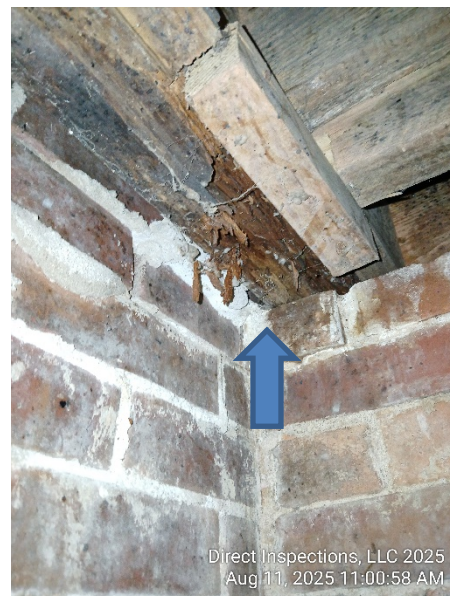
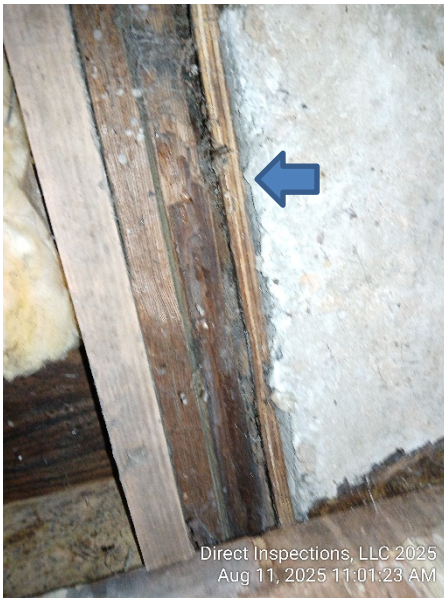
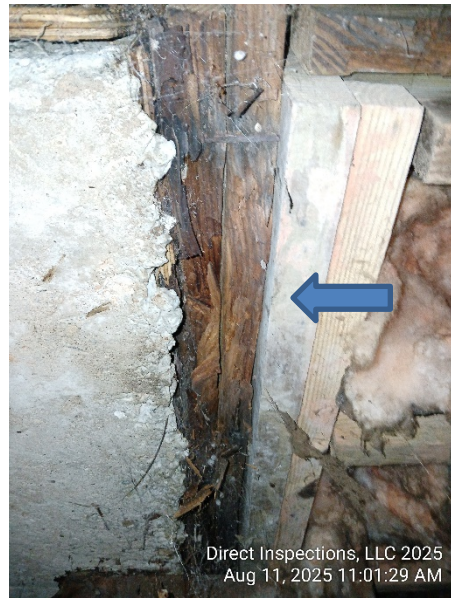
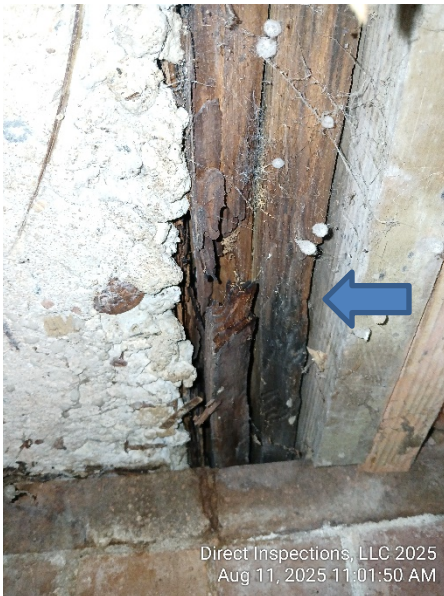
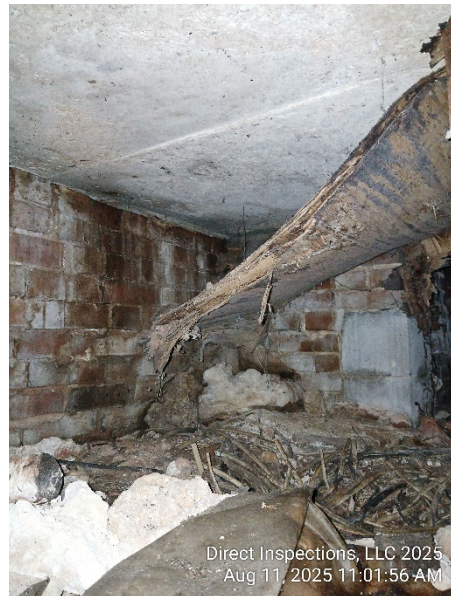
At the front, in the area of the front porch and extending on either side of the front porch by approximately 10 feet, there is wood deterioration along the sill.

**Recommendation:** Further evaluation by a licensed contractor prior to purchase.

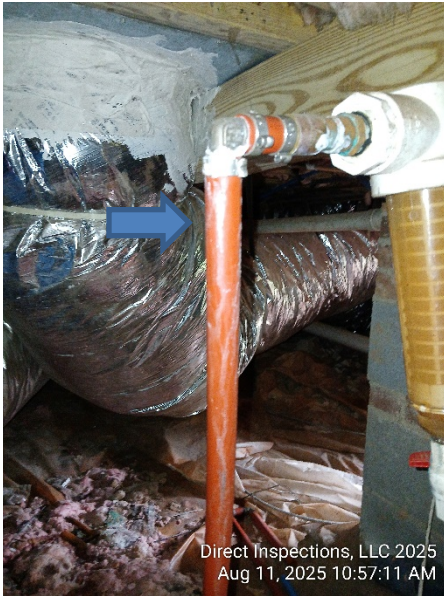
There is a minor water leak near the sediment filter.

Minor leak

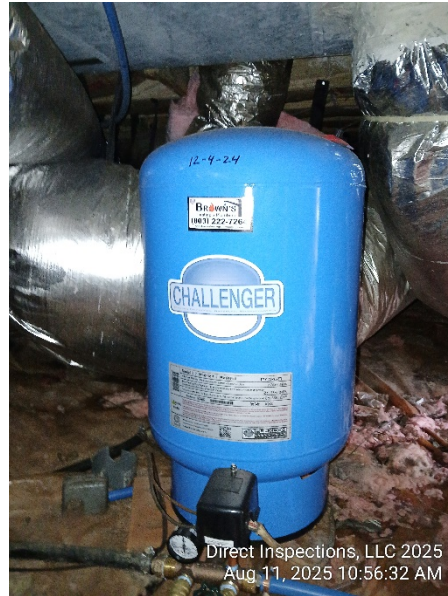
Note: There are components of an old well system still in place and pressurized. Although this is not necessarily incorrect, it does create possible issues with leaks and failure in the future. I would recommend further evaluation by a licensed plumber for by-pass and removal as a precaution.

Old well system components

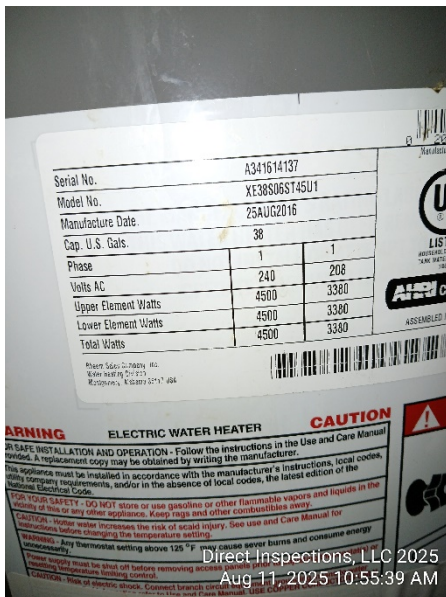
The water heater has reached the end of its expected life and is leaking. There is visible rust at the base and water pooling from a leak.

Manufacture date Aug. 25, 2016

**Recommendation:** Further evaluation and replacement by a licensed plumber prior to purchase.

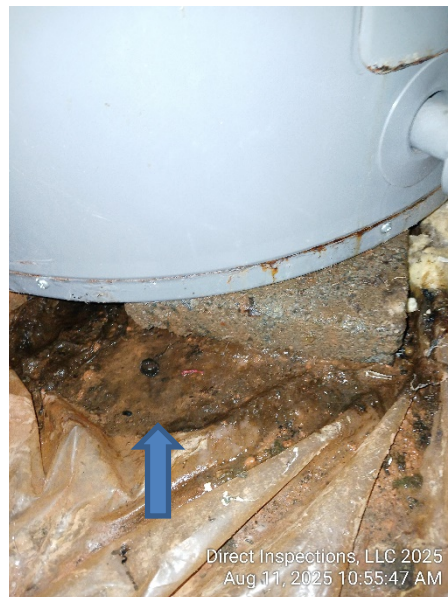
Water pooling from leak

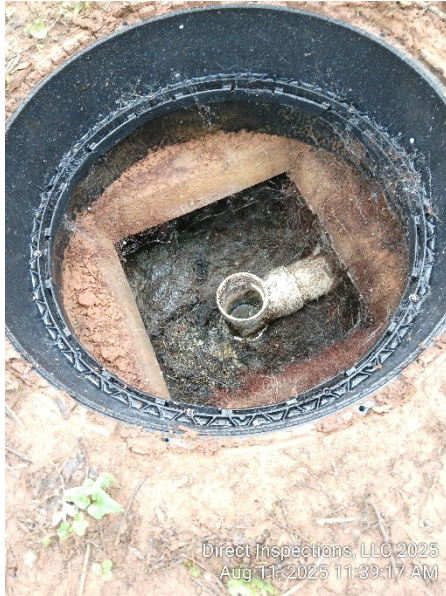
Septic tank layers were visually and manually inspected, a pump out is recommended due to excessive scum and sludge layers that exceeded 1/3 of the capacity of the tank. The physical condition of the observable areas of the tank were good. I would recommend further inspection of the tank walls, floor and output baffle after pump out by a licensed septic tank contractor prior to purchase.

Tank access and input baffle

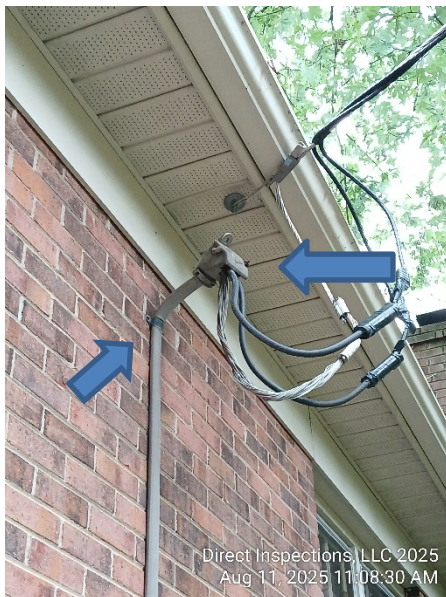
The service entrance has been pulled off the mount and the metal strap is cutting into the cable. This is a fire hazard and should be further evaluated and repaired a licensed electrician as soon as possible.

Mount failure and strap damage

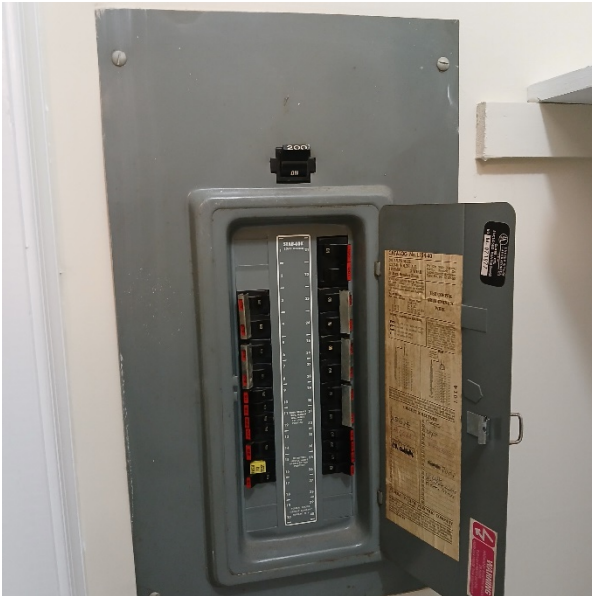
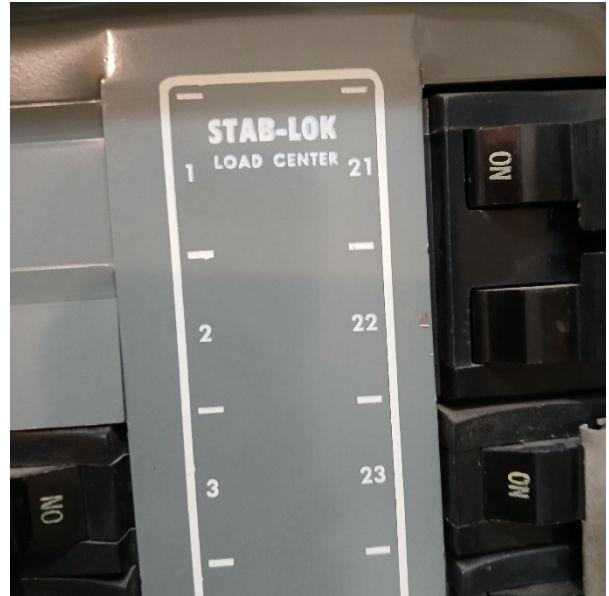
The distribution panel is a Federal Pacific “Stab-Lok” these panels have a long history of failure to trip and are a fire hazard. Some insurance companies may refuse to insure home with FPE panels due to the recognized fire hazard associated with FPE panels.

Federal Pacific Panel

Stab-Lok

**Recommendation:** Further evaluation and replacement by licensed electrician prior to purchase.

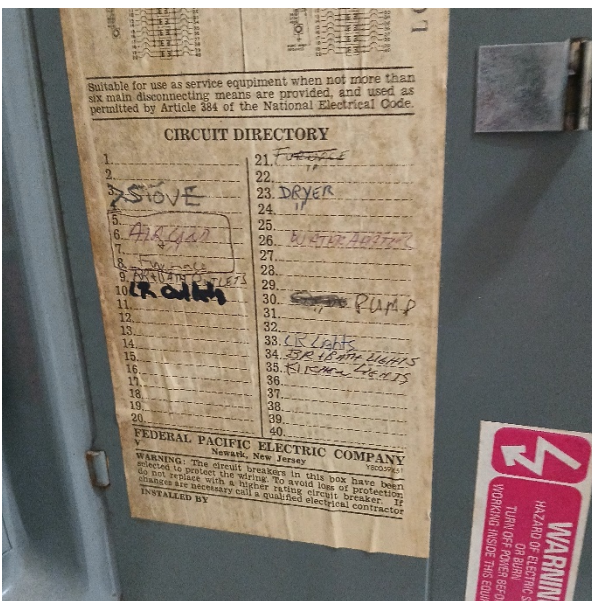
Lack of proper labels

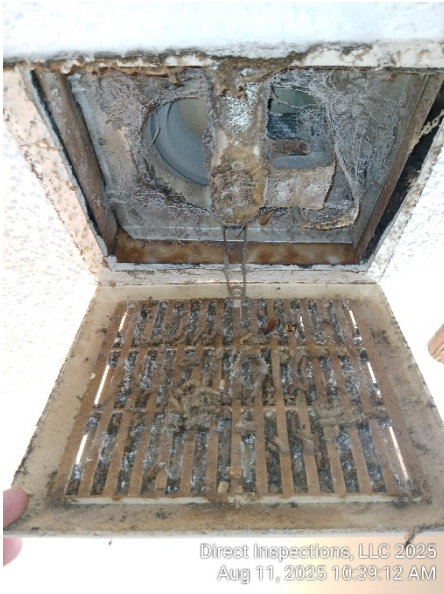
The vent in the hallway bathroom is completely clogged and the vent cover retainer spring is broken.

Completely clogged and broken

**Recommendation:** Replacement by a licensed electrician prior to purchase.

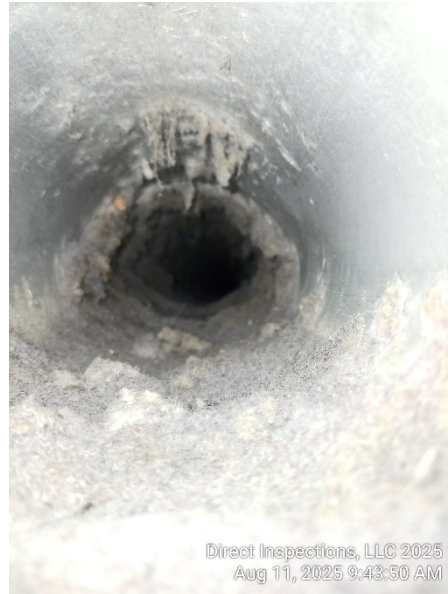
The laundry dryer vent duct is partially clogged and amateur repairs have been made with improper materials. In the crawlspace there is an elbow joint that has been repaired with ordinary duct tape, this is a fire hazard. High heat metal duct should be joint sealed with metalized tape designed for dryer ducts.

Partial clog (dryer vent)

**Recommendation:** clean and repair dryer ducts with proper materials prior to purchase.

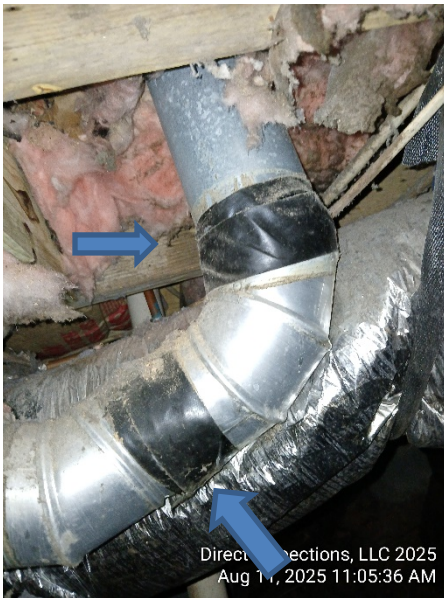
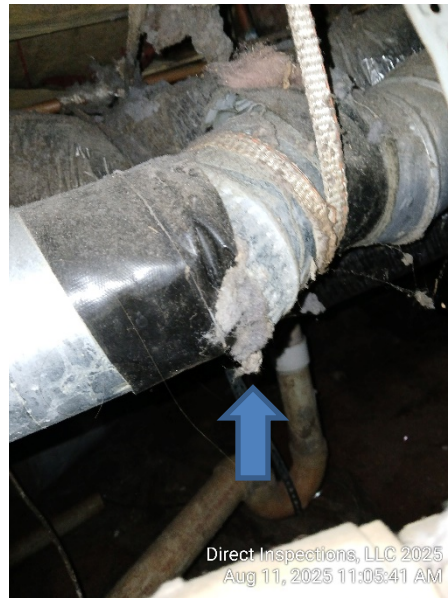
Amateur repair

Amateur failed repairs

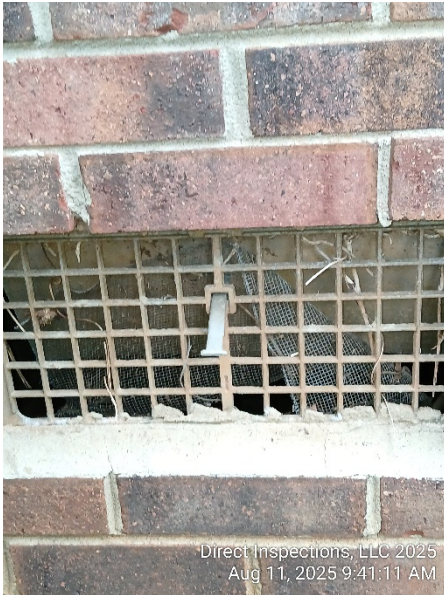
Several vents have damaged screens or have been damaged by modification. This condition may allow pests to enter the crawlspace.

Damaged screen

Recommendation: Repair or replace by a licensed contractor prior to purchase.

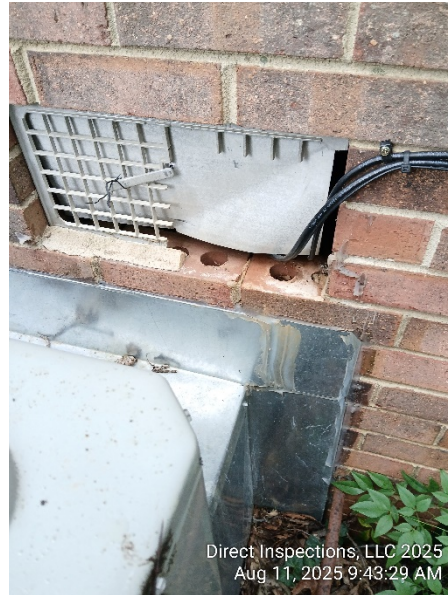
Damage by modification
