## *Silver Springs Lake* *Property Owners Association*

### **Launch Ramp and Driveway Access Updates Complete – Oct 2025**

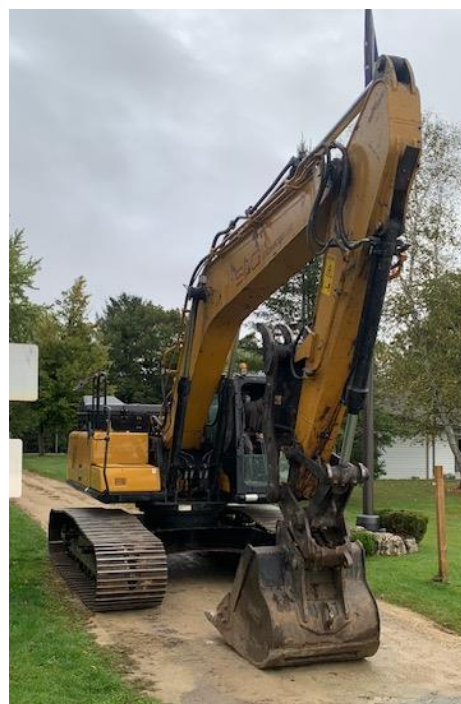
They leveled the rock pile at the deep end of the launch, which they had created and left when the interlocking 6 Ft x 12 Ft by 8-inch-thick concrete launch ramp pads were first installed. This was an oversight by S&G and it was contrary to our boat launch ramp design specifications. There are no billable costs for S&G's warranty work.

The second issue addressed by S&G was a separation and unevenness between the (5<sup>th</sup> & 6<sup>th</sup>) concrete pads, which resulted from a combination of 'settling' and ice-heaving this past winter. To remedy this the excavator was run back-and-forth over the uneven section, to level the space between the pads.

Lifting and re-setting the concrete pads is job that is beyond 'warranty-work'. Mother Nature caused the pad-separation, and she is likely to do the same thing every winter. Functionally, this unevenness is not noticeable during the launching or retrieving of pontoon and fishing boats.

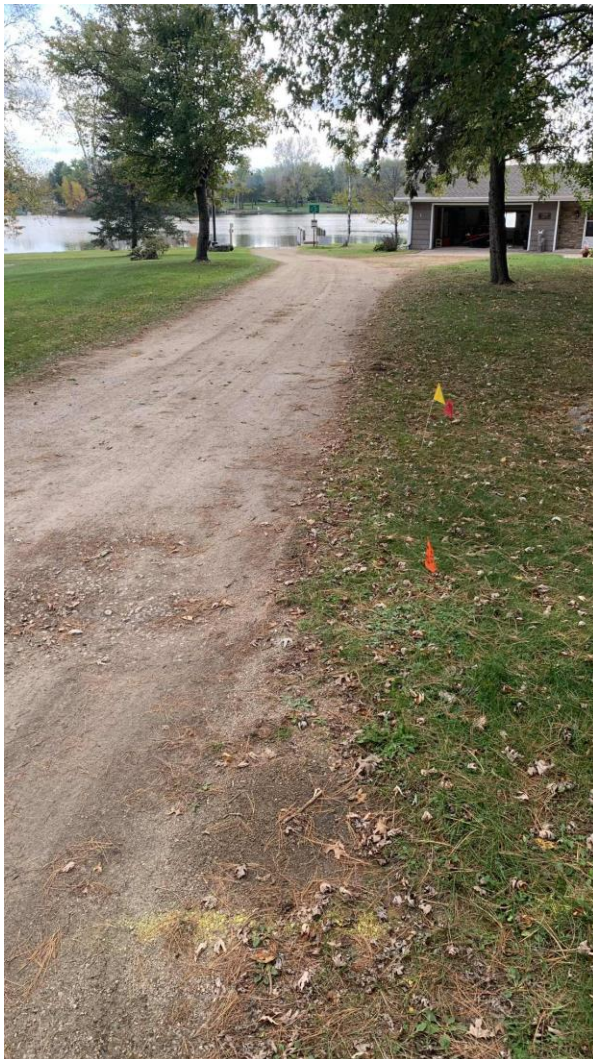
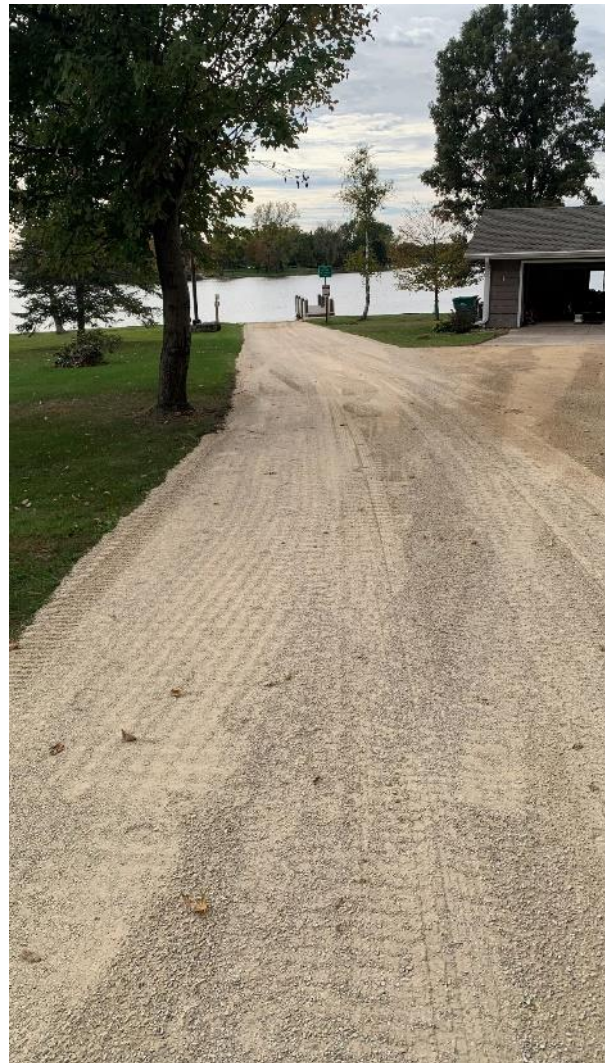
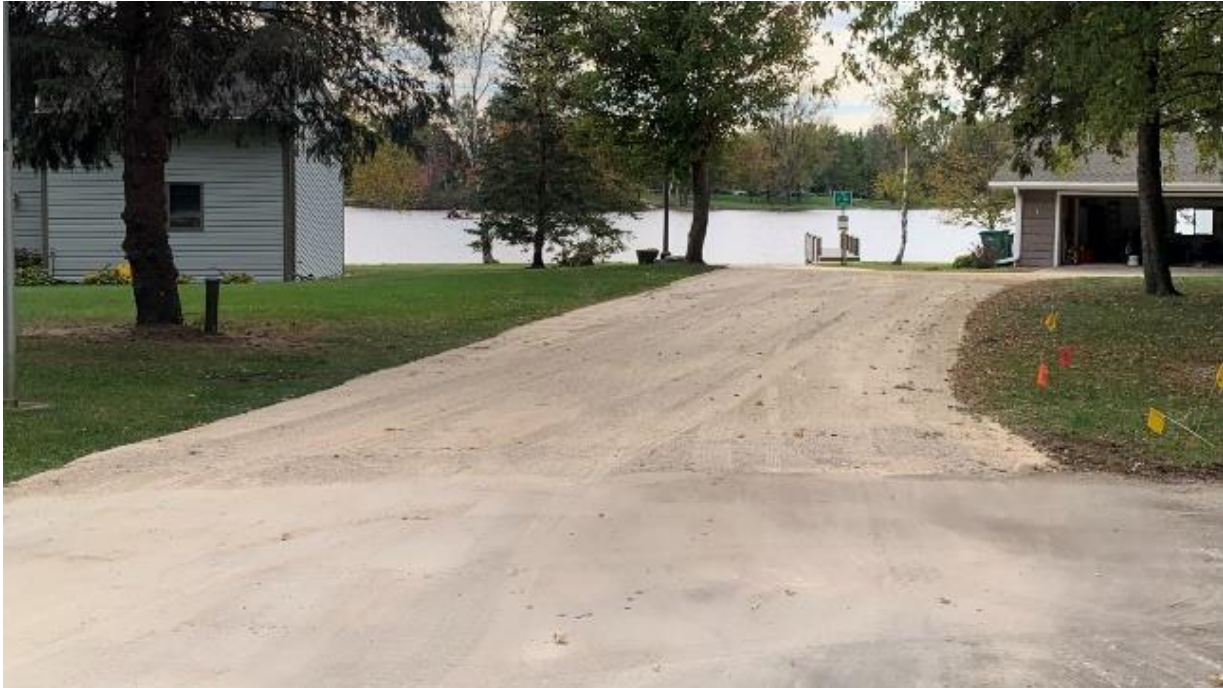
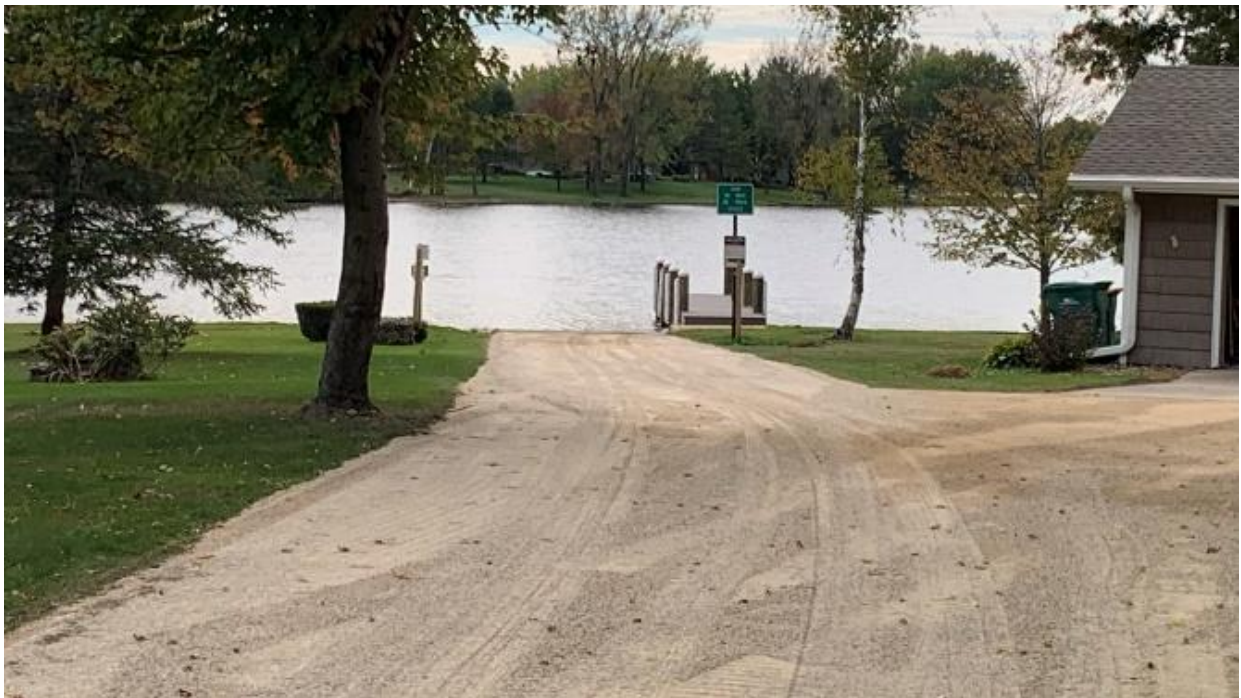
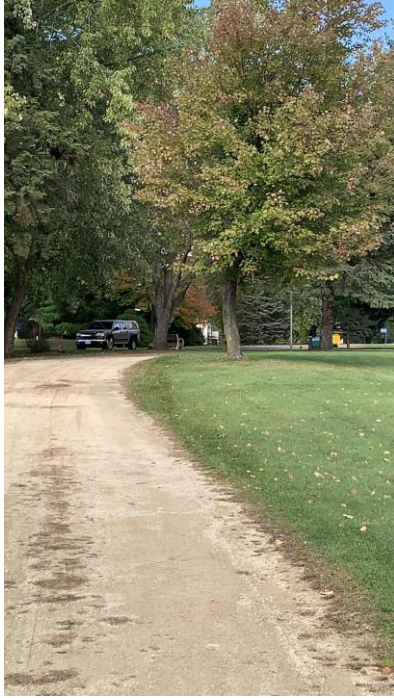
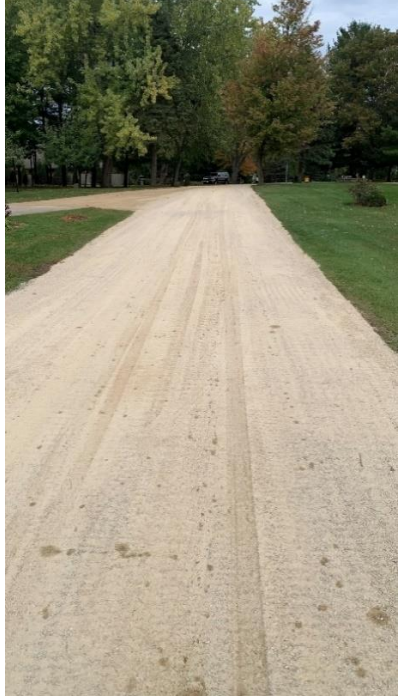
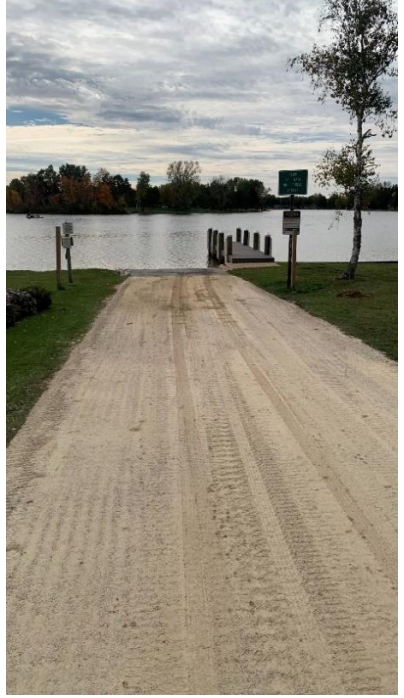
Before and After photos:

On Tuesday October 14<sup>th</sup> S&G widened, straightened, and added new gravel to the boat launch driveway access. The cost for driveway widening and straightening was negotiated in 2024 and budgeted for 2025, as Capital Improvements. The work was planned for 2025, to allow time for normal erosion and settling to occur around the new boat ramp and pier, which were installed in May 2024.

S&G also completed the boat launch warranty work (initiated on October 6<sup>th</sup>), by filling the void between the separated (5<sup>th</sup> & 6<sup>th</sup>) concrete pads on the launch ramp with gravel.

The Association anticipates that minor ice-heaving, settling, and erosion will occur around the boat launch ramp and drive every year. Future upkeep costs will be incorporated into the Maintenance Expense Budget Forecasts.
