# Shaft Grounding Rings

Protecting VFD Driven Motors  
from Bearing Currents

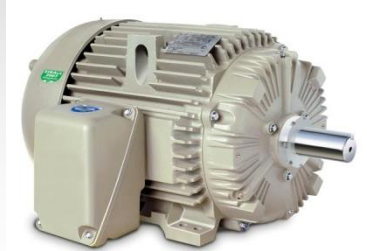
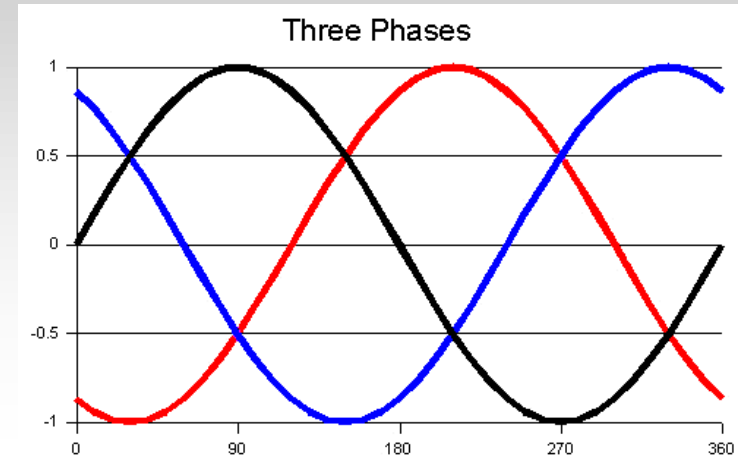
Most electric induction motors were designed for operation on 3 phase sine wave power – either 50 or 60 Hz.

The input power was balanced in frequency, phase (120 degrees apart) and in amplitude.

Common mode voltage – the sum of the 3 phases would always equal zero volts.

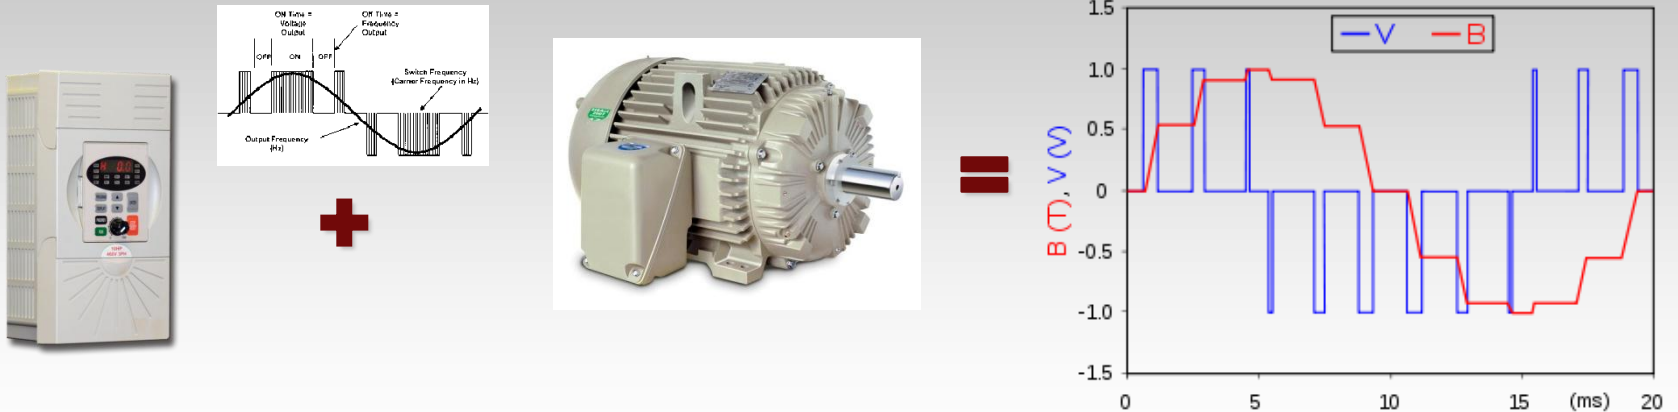
When operated by VFD, the power to the motor is a series of pulses instead of a smooth sign wave.

The input power is never balanced because the voltage is either 0 volts, positive, or negative with rapid switching between pulses.

The Three phases of voltage pulses ensures that the common mode voltage is never equal to zero and instead is a “square wave” or “6 step” voltage.

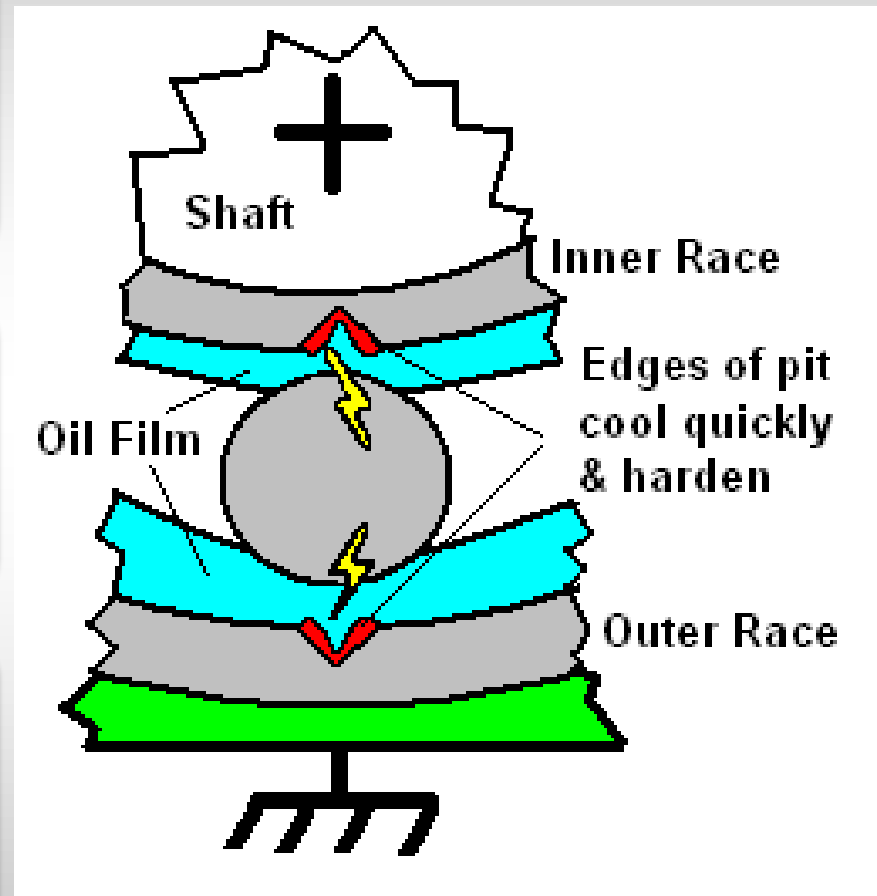
Voltage builds up until it exceeds the insulation level of the bearing's oil film layer – the “break-down” voltage of the bearing.

The voltage then arcs through the bearing creating an electrical discharge machining (EDM) pit from the rapid melting and cooling of the steel surface.

Thousands of pits per second may be created and over time the ball rolling over the disturbed surface can cause what is known as “fluting damage”

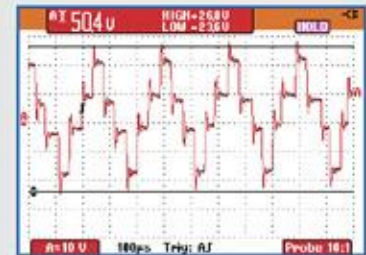
Low amplitude voltage discharge pattern

The lower peak to peak voltage indicated continuous conductivity in the bearing.

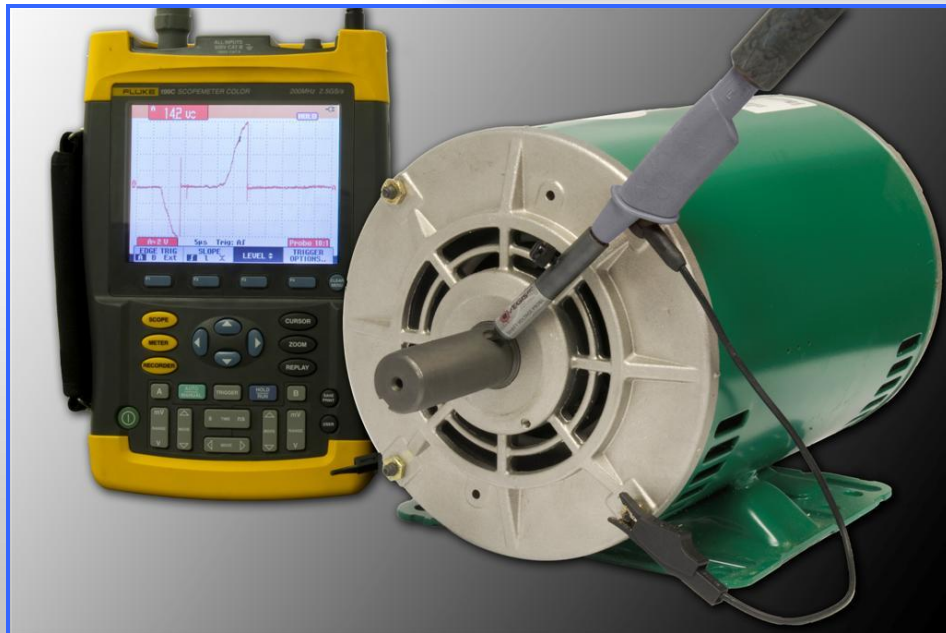
High Peak to Peak common mode voltage

A number of different wave forms may be present...

This wave form is typical before discharge takes place. Note the classic “6-step” wave forms.

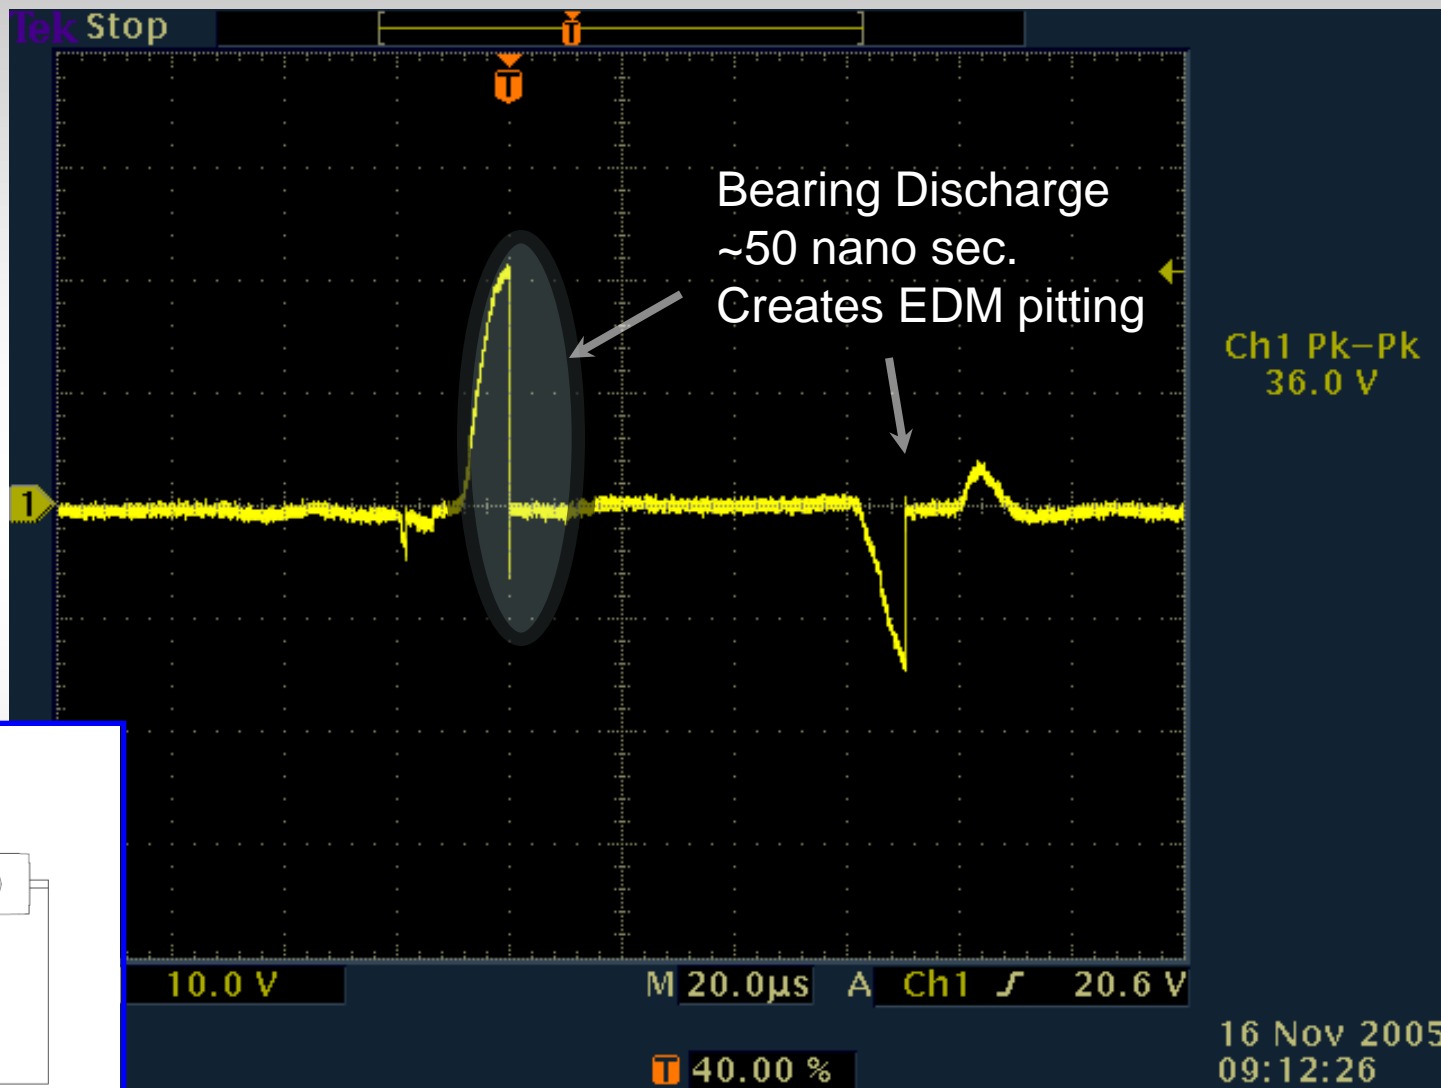
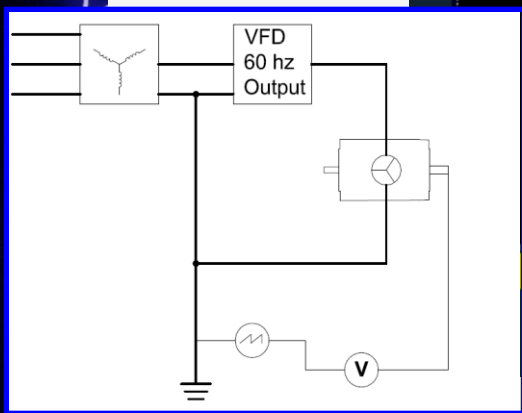
Voltage Increase & drop  
Signifying Current flow  
through Bearings

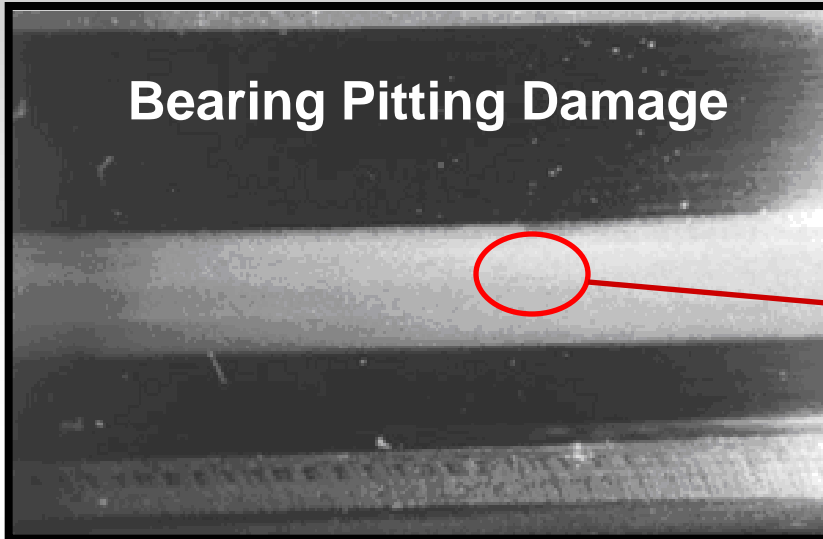
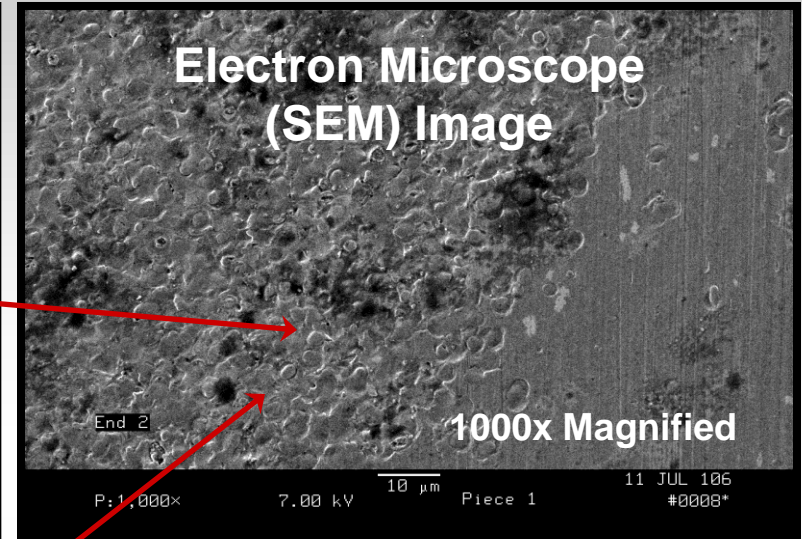
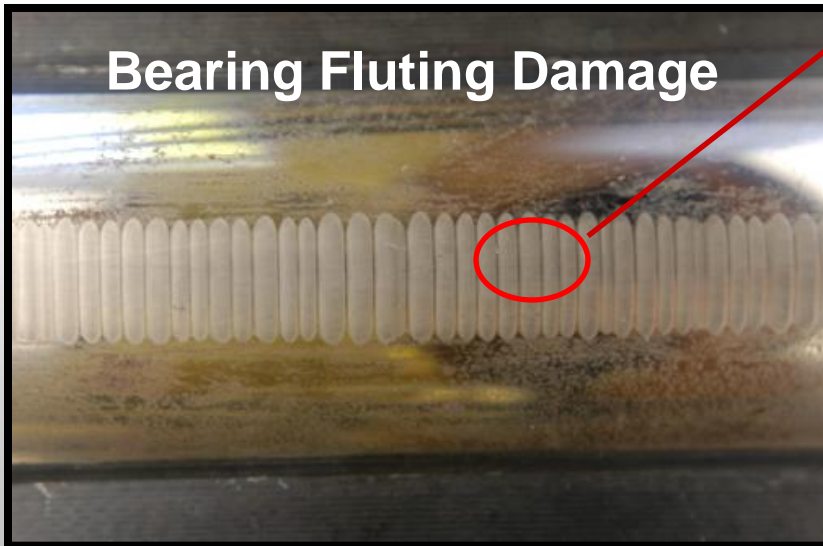
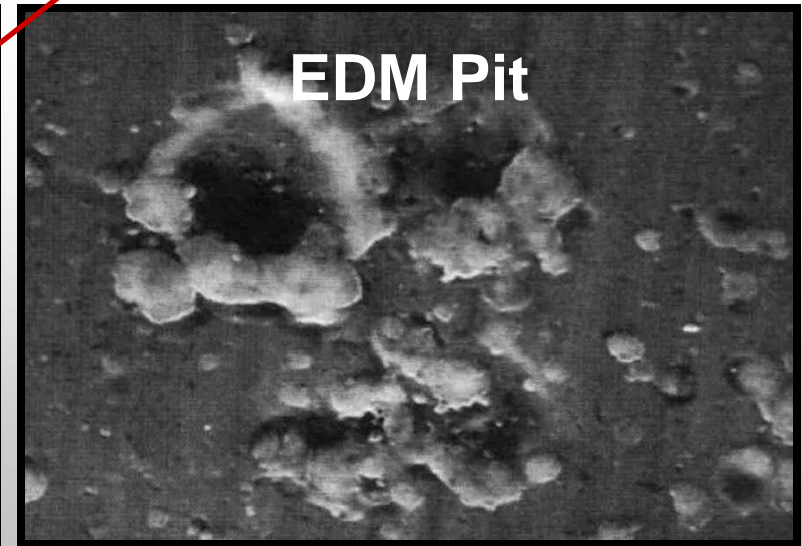
# Motor Bearing Damage from Electrical Currents Electrical Discharge Machining (EDM)

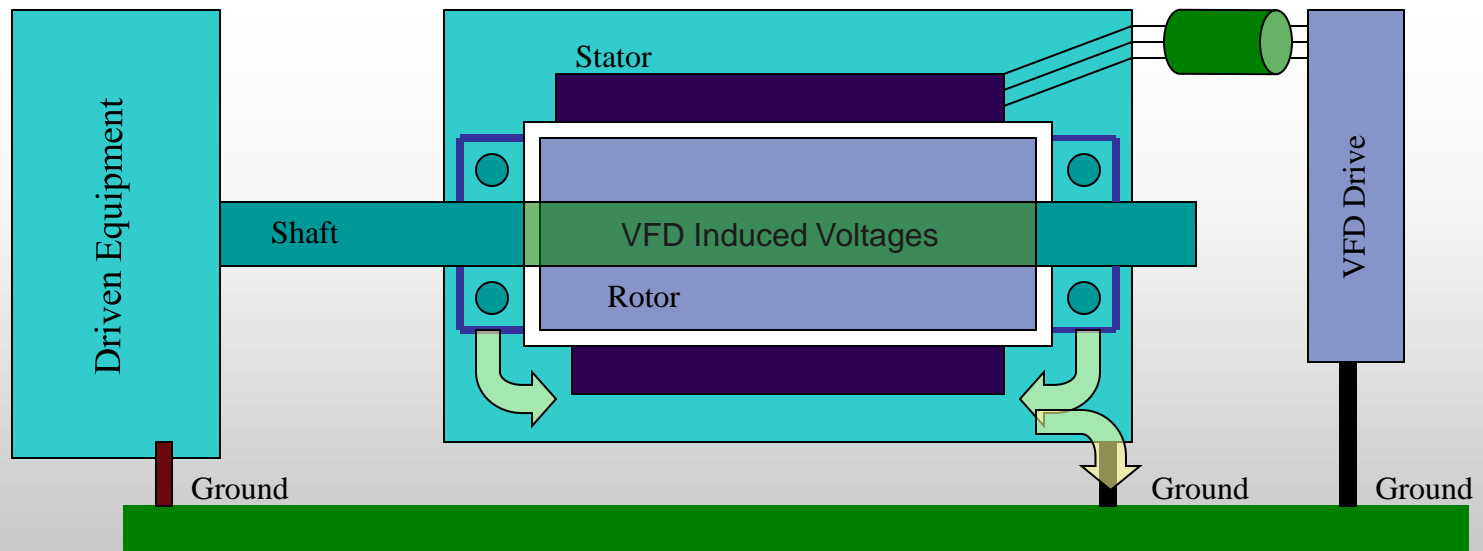
- ✓ **VFD induced capacitive voltages** from the high switching speed of the pulse width modulation (PWM) drives discharge through motor bearings and cause electrical discharge machining (EDM) effect in the bearing race.
- ✓ **Rotor ground currents** generated by PWM Drive will partly flow as rotor ground current through the bearings of the motor. These currents are caused by the rotor being connected to common ground with a significantly lower impedance path than the ground of the stator housing.

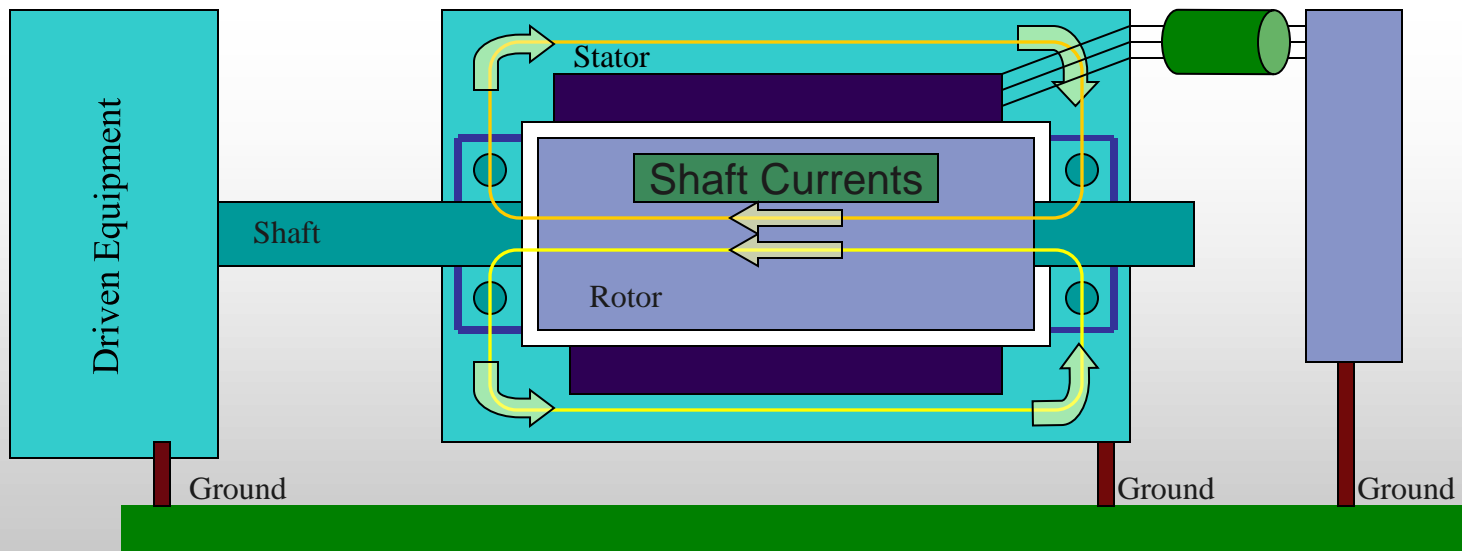
- ✓ Induced by the magnetic flux imbalance around the motor shaft from the stator windings, these currents circulate through the motor bearings. Circulating currents are a problem in large AC and DC motors of over 100 hp.
- ✓ Because these currents circulate through the motor via the shaft and bearings, the current flow must be either broken or an alternate path established to prevent bearing failures.

High Frequency Flux encircling the rotor causing shaft bearing currents

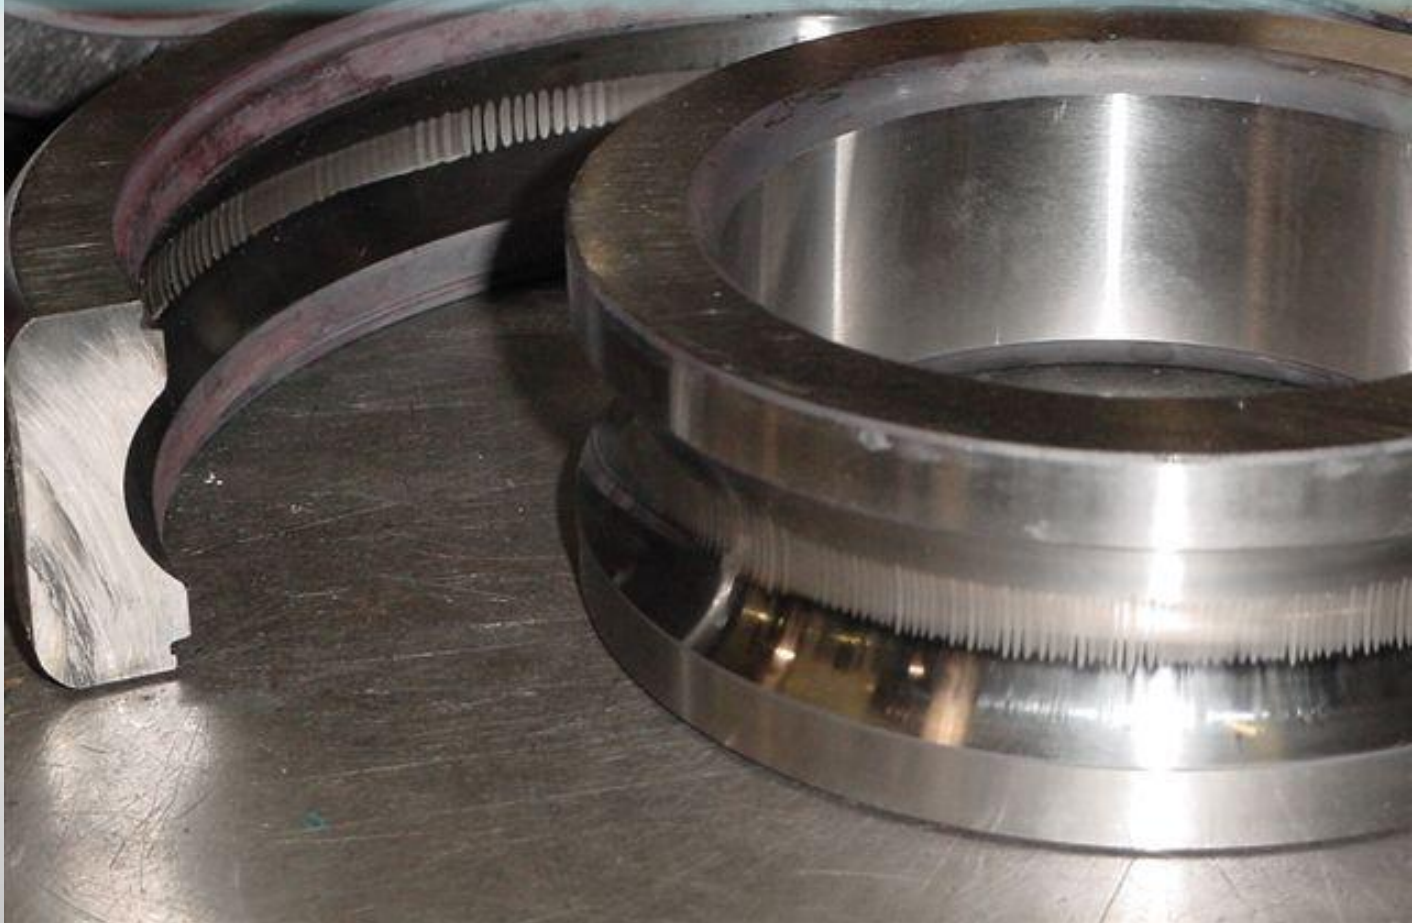
# True Inverter Duty Motors Have Inverter Rated Windings and Bearing Protection to Improve Reliability and Prevent Downtime

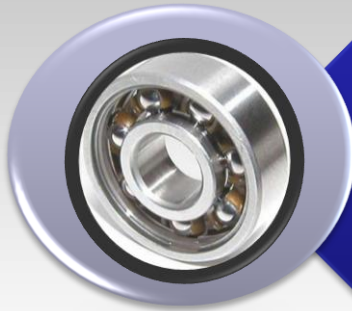
**Insolate the shaft from the frame of the motor:** Use insulated sleeve on the bearing journal ceramic coated or ceramic ball bearings. Protect the motor but not attached equipment. Best used to prevent circulating currents in motors above 100 HP

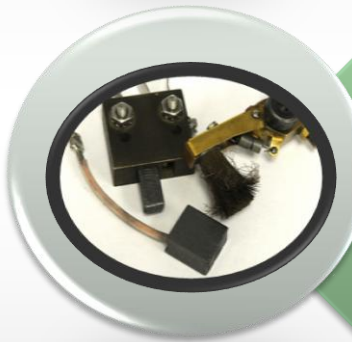
**Old Technology:** Legacy shaft grounding with spring pressure brushes. **Not effective because of wear, maintenance and contamination.** Usually a copper phosphor or bronze metal brush or carbon block brush.

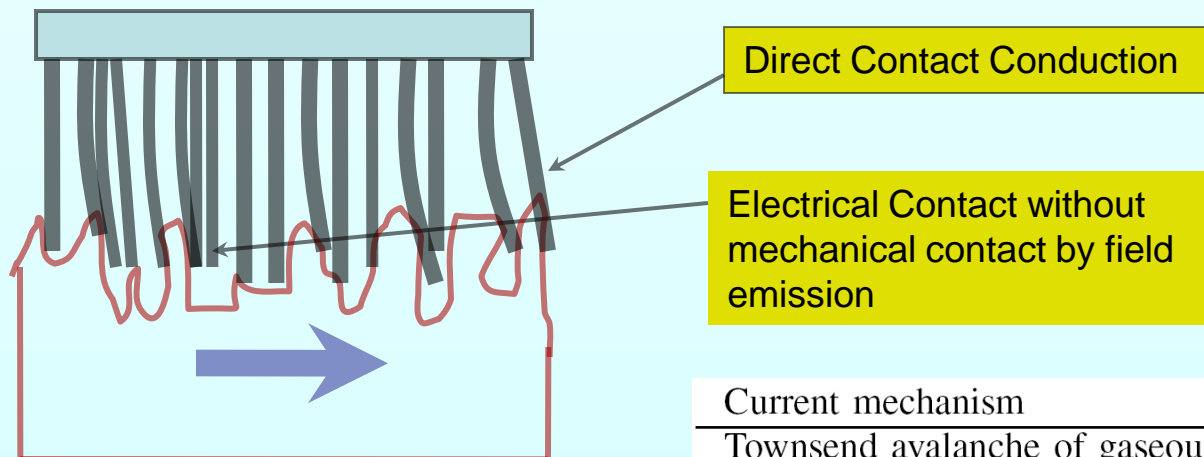
Uses several methods to transfer electrical currents\*

Current mechanism	Gap distance
Townsend avalanche of gaseous ions	$> 5\mu\text{m}$
Field emission of electrons	2nm to $5\mu\text{m}$
Tunneling of electrons	$< 2\text{nm}$

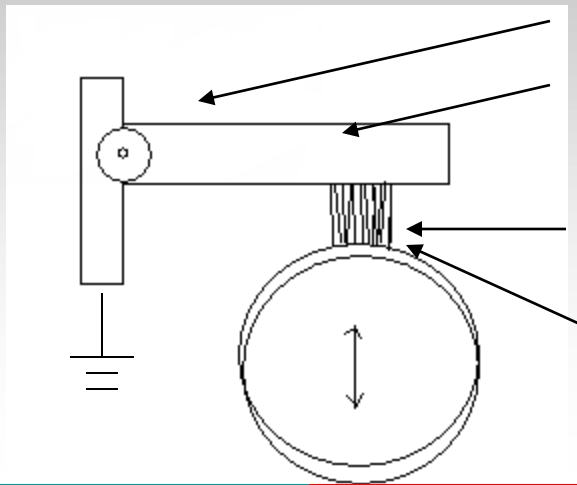
- Installation Difficulty
- Vibration due to “stick-slip”
- Material Wear (not suitable at high surface rate)
- “Shaft run-out” is compensated by spring load
- Not effective above 2MHz signal

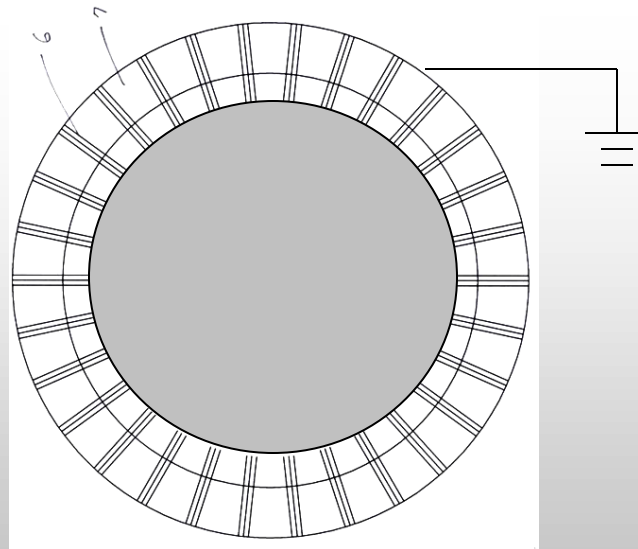
- No Spring load
- Negligible wear of micro-fibers even high surface rate
- Continuous contact despite “shaft run-out”
- Easy Installation
- Low cost
- Maintenance Free

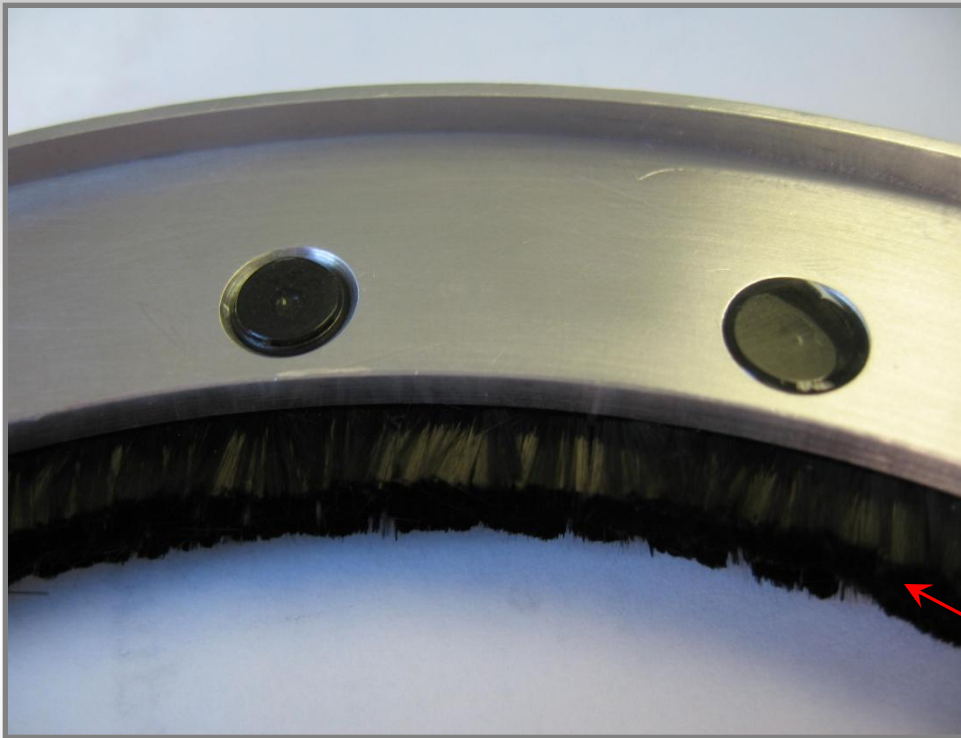
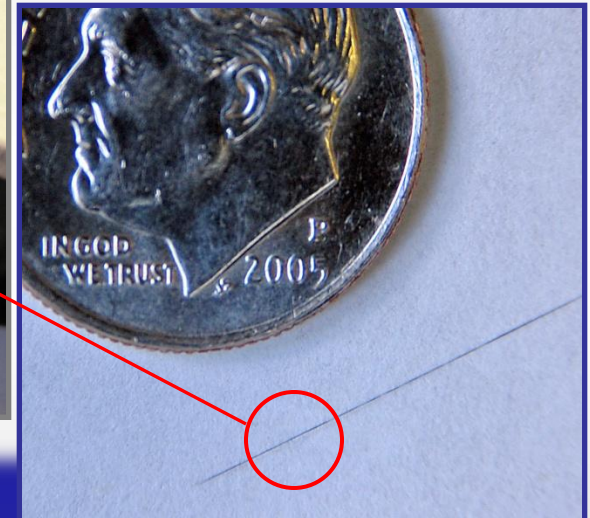
- ✓ Encircles complete 360 degree shaft area
- ✓ Unaffected by dirt and grease providing continuous grounding
- ✓ No maintenance required after installation

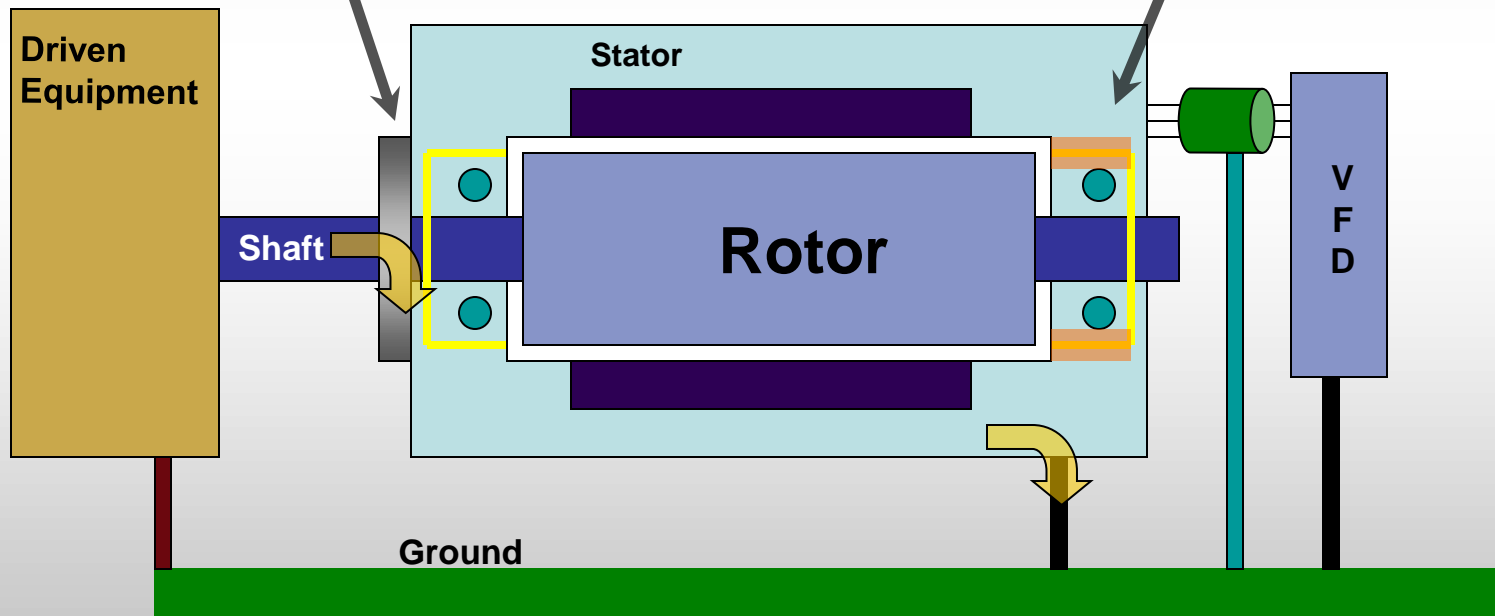
Shaft  
Grounding  
Ring on DE

Insolated bearing  
or Insulation on  
NDE

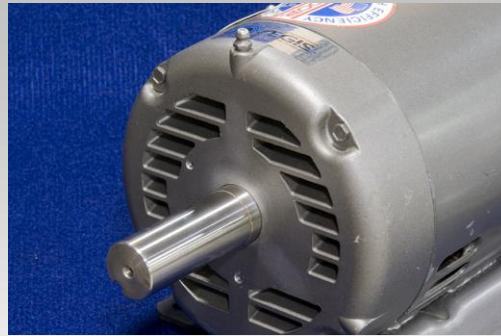
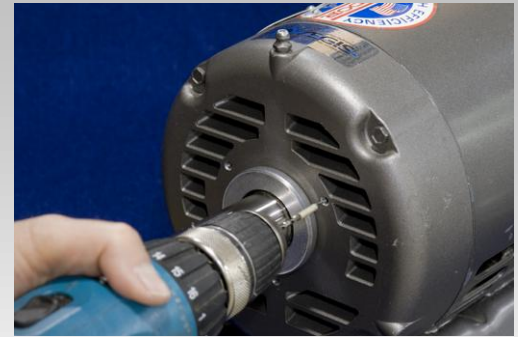
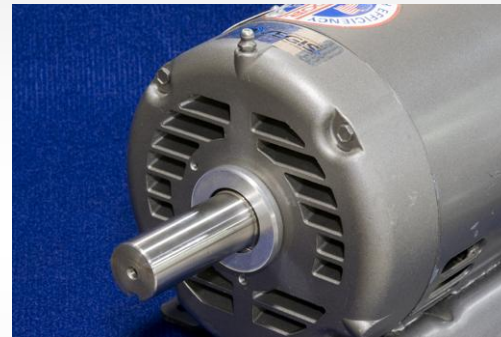
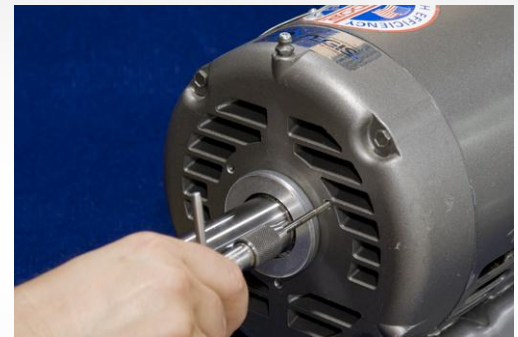
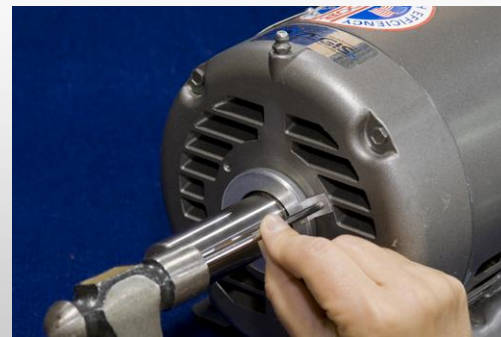
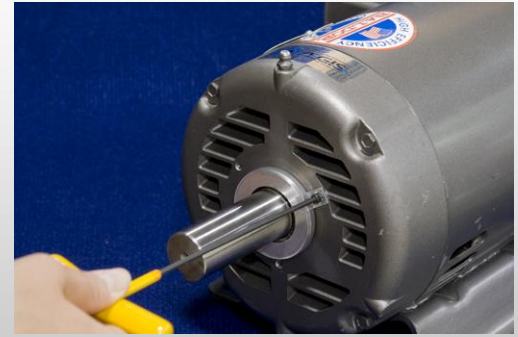
# *Easy To Install*

Shaft diameters: see chart for standard kits  
Custom kits available for other shaft diameters  
Clears any slinger, shaft shoulder or protrusion
