Excitation of Structural Resonance Due to a Bearing Failure

IMECE 2007

ASME, International Mechanical
Engineers Congress and
Exposition

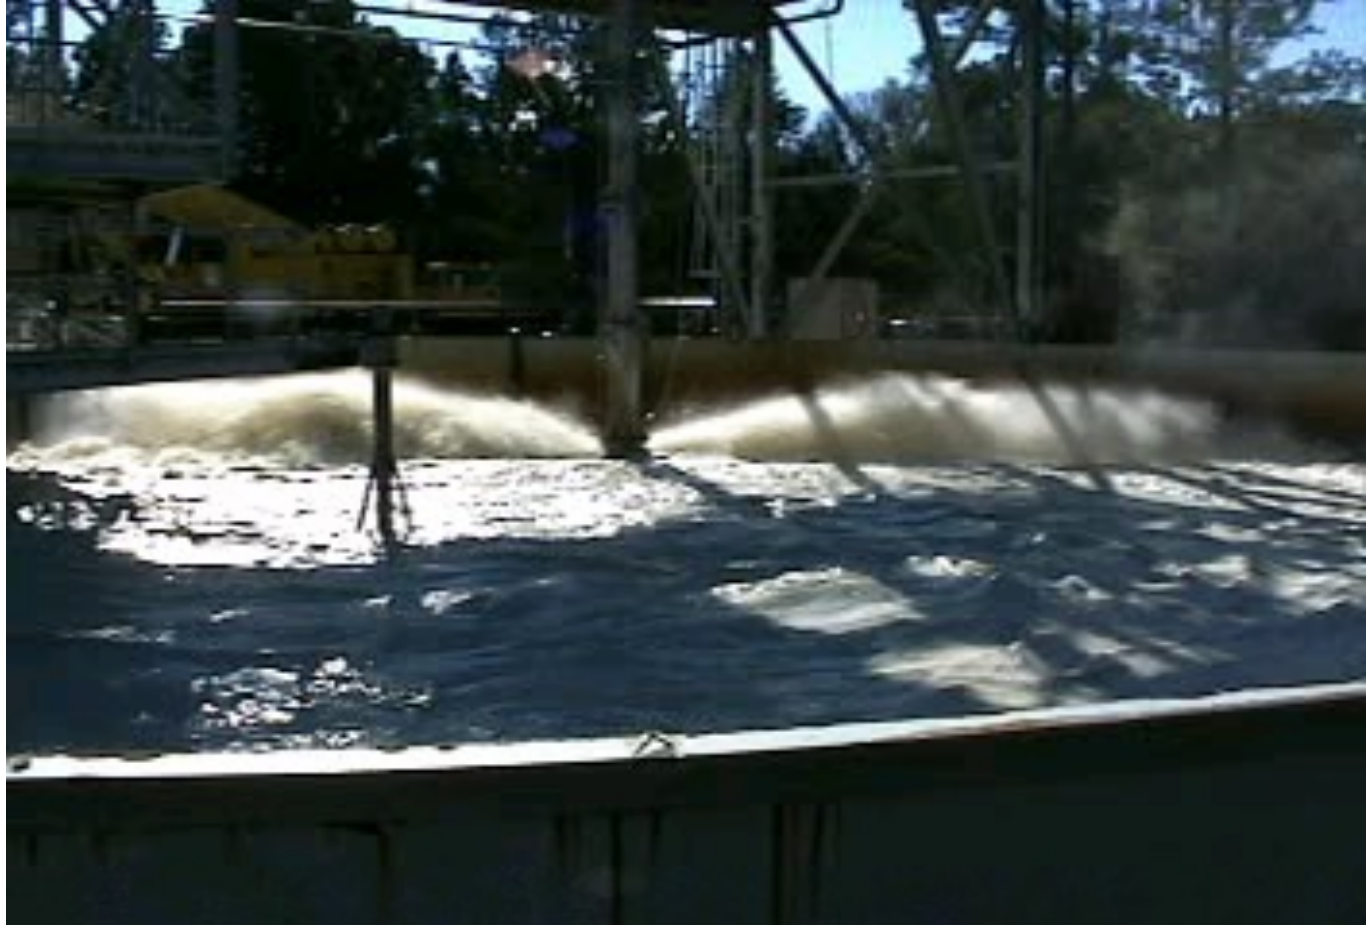
Pump^U Operation

- High velocity discharge jets are used to mix waste in 85 foot diameter by 30 foot high tanks.
- The tank at test facility is shown.

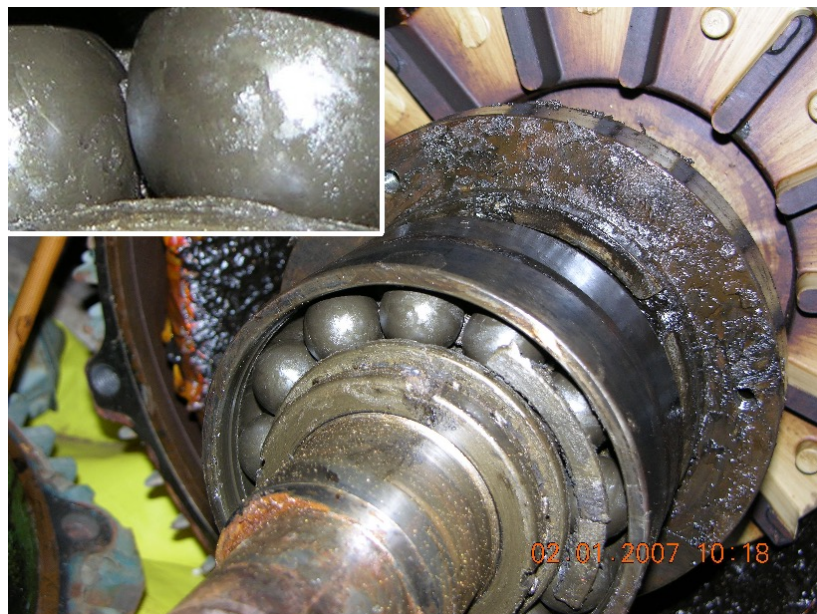
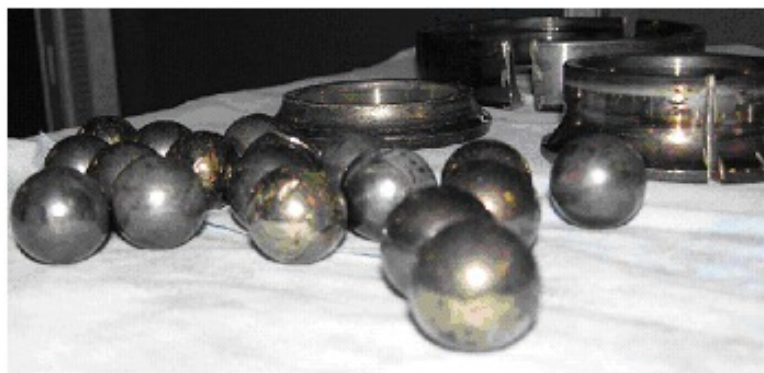
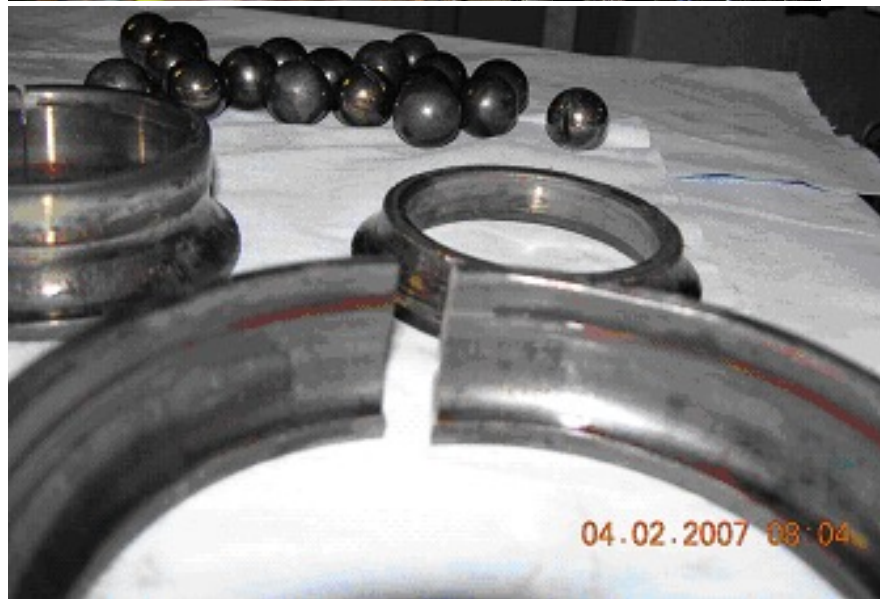
Bearing Damage Found After Motor Replacement

- The race was cut to disassemble the bearing for inspection.
- The bearing cage was broken, the balls were dented and spalled, and the race was scored.

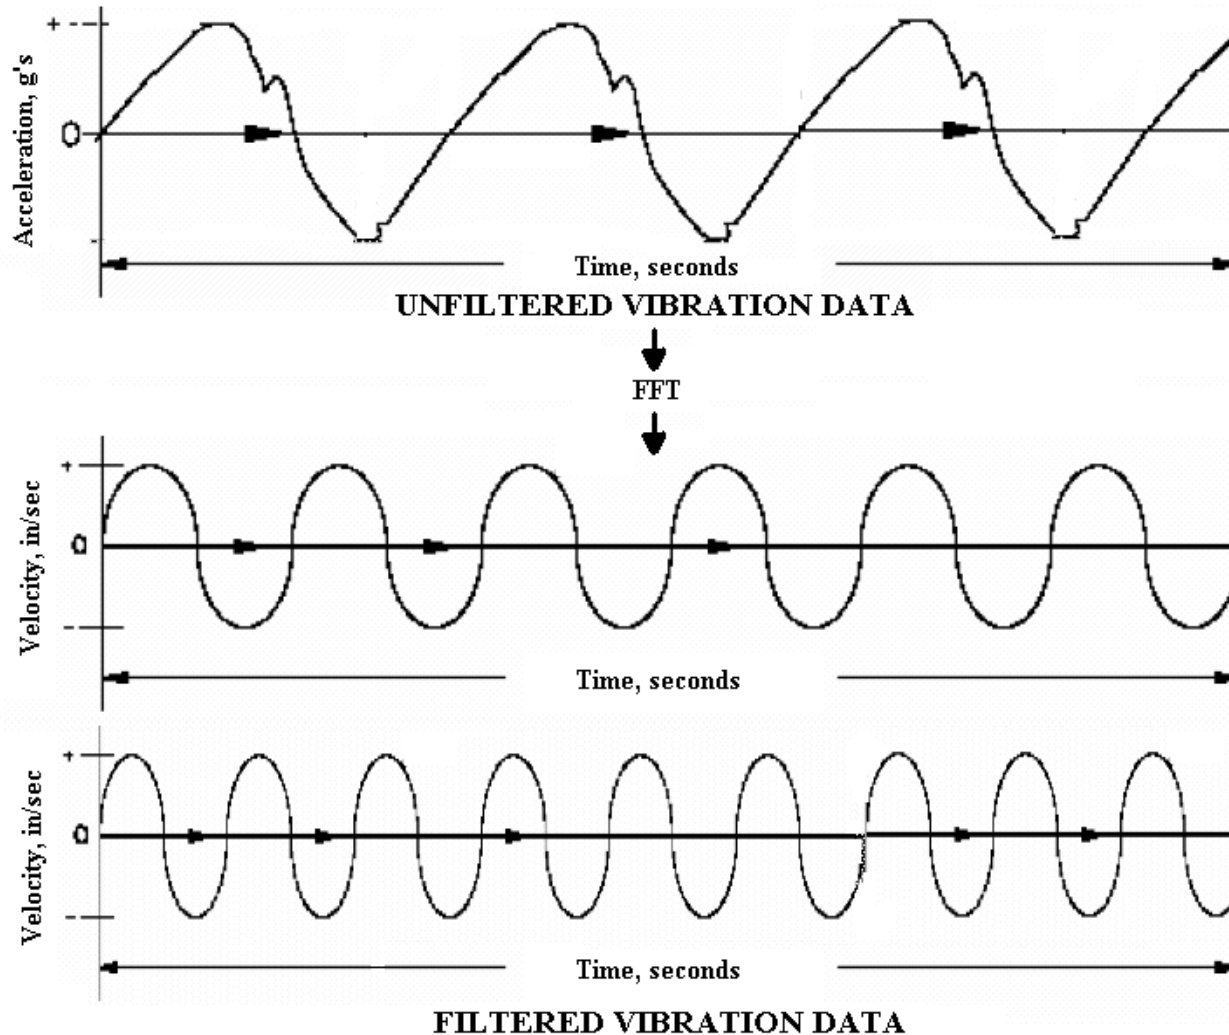
Vibration Monitoring Techniques

- Commercially available equipment used to measure accelerations, which were converted to velocities

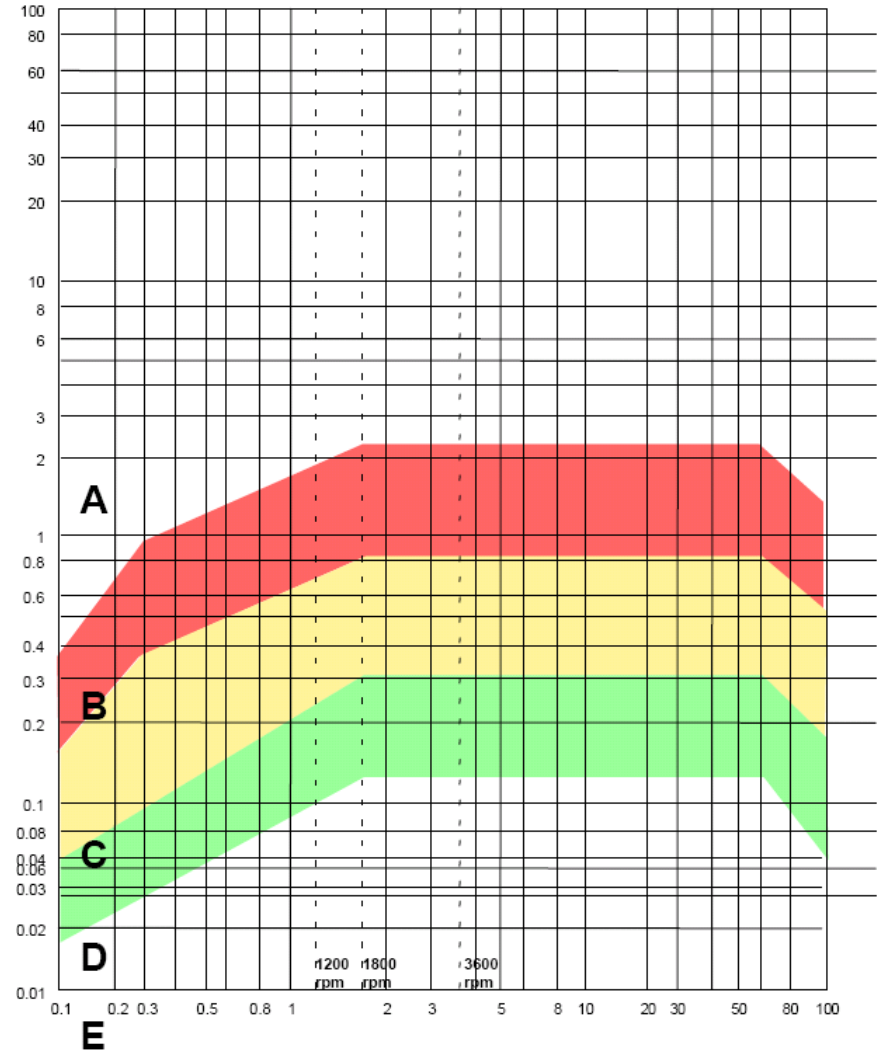
Vibration Acceptance Standards

- Commercially recommended standards are available.
- Vibration velocity is generally considered to be equivalent for different size equipment.
- Trending importance is recognized by vibration analysts, since the graphic approach is not always reliable.

Zone A: Danger imminent failure – Shut down immediately D: Fair
 B: Very Rough – Operate only if necessary E: Good
 C: Rough – Repair at next outage

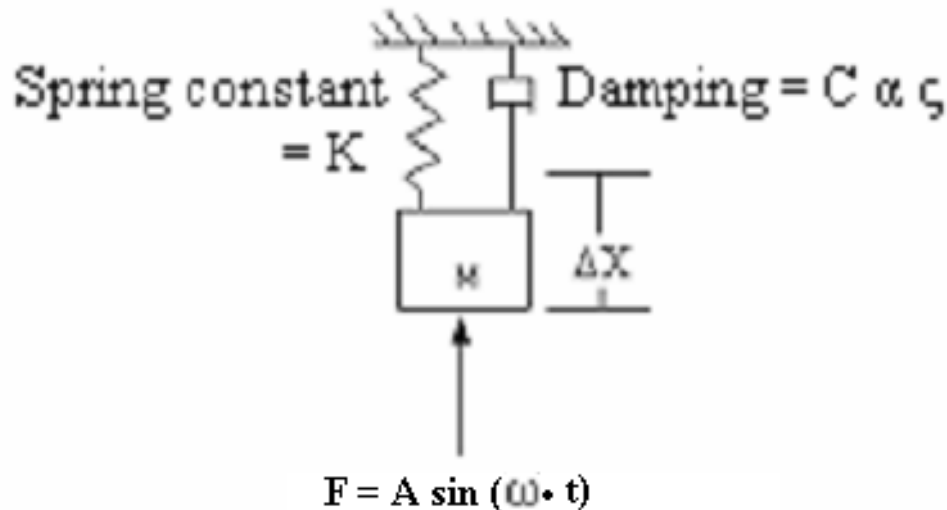
Resonance of Rotating Equipment

- In rotating equipment, resonance is achieved as the equipment vibration frequency, ω , approaches the natural frequencies of the equipment, ω_n .
 - Equipment frequency, ω , is proportional to the rotational speed of the motor, $\omega = 2 \cdot \pi \cdot f = 2 \cdot \pi \cdot \text{rpm} / 60$.
 - Natural frequencies ω_n , are the vibration modes inherent in any structure or its components.
- A SDOF system provides an approximation for the system response of rotating equipment.
- The SDOF model is developed from the equations of motion for a simple spring mass damper system

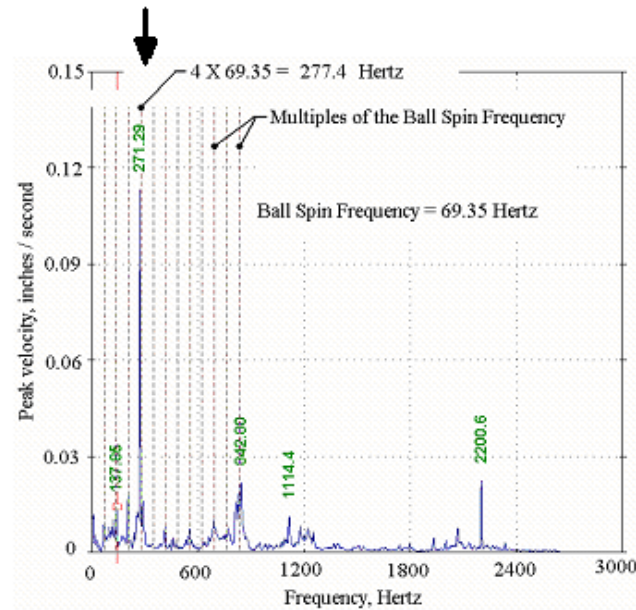
Ball bearing frequency

- The bearings, the platform, and the pump had nearly coincident, resonant vibrations at 271 Hz.
- Grating vibrations were random as the grating impacted the I-beams resulting from the I-beam vibration.
- Note that the maximum vibrations are ≈ 0.1 inches / second at the bearing.
- This vibration magnitude is < 0.2 inches / second per typical acceptance criteria.
