SPM LTD

Transients from Shocks

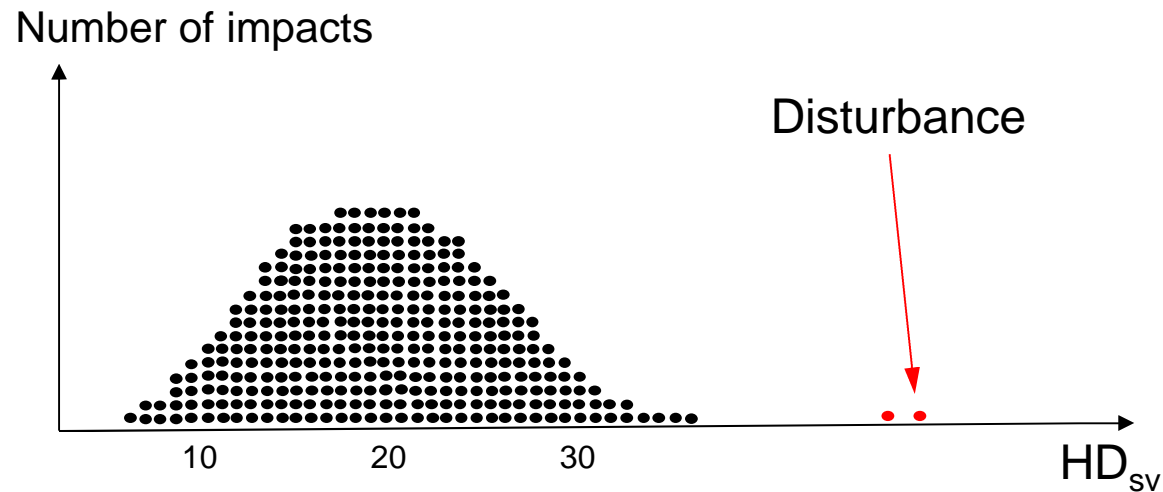
Gives accurate readings from a complex signal

Random Impacts are filtered out

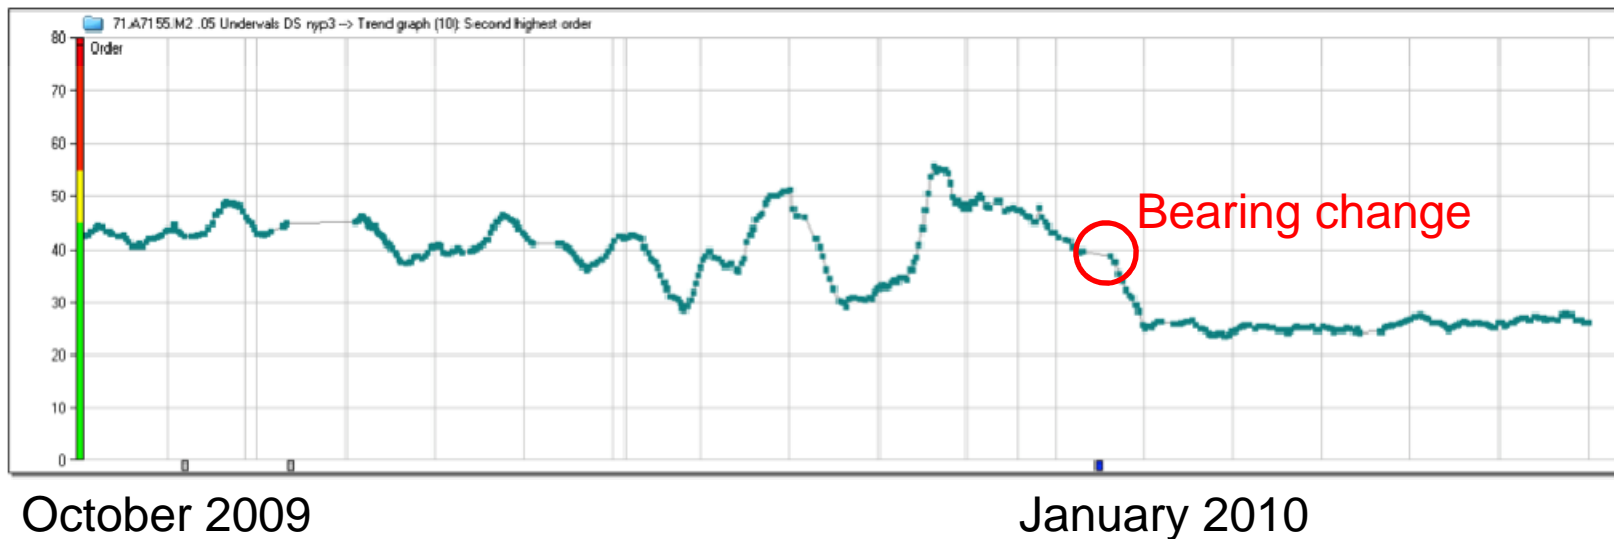
Twin Wire Press 13

nip 3, DS on lower section

Spherical roller bearing, 9 rpm

HdM values from mid-October 2009. Decreased values after bearing replacement in January 2010.

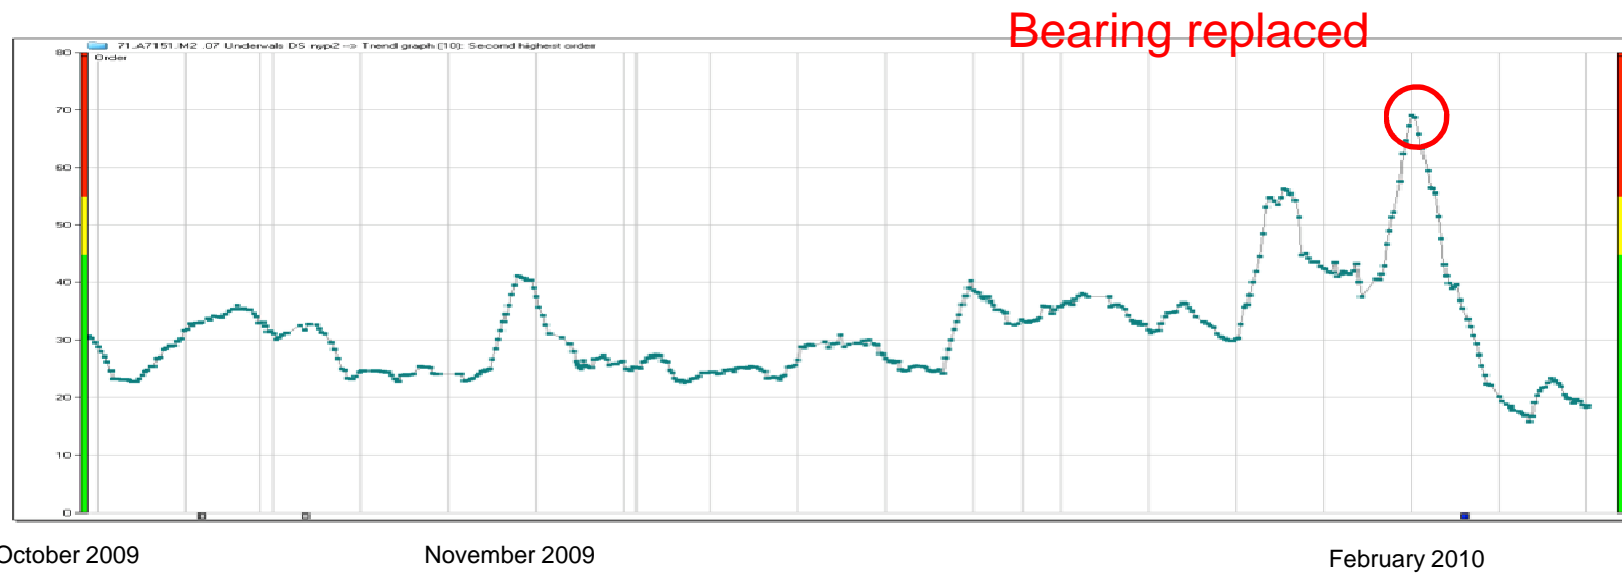
Twin Wire Press 11 Nip 2, DS, Lower section

Spherical roller
bearing, 14 rpm

HDm values from mid-October 2009. Decreased values after bearing replacement in February 2010.
