STIFFNESS & MACHINE VIBRATION

Barry T. Cease

Vibration Institute, Annual Conference, July 2018

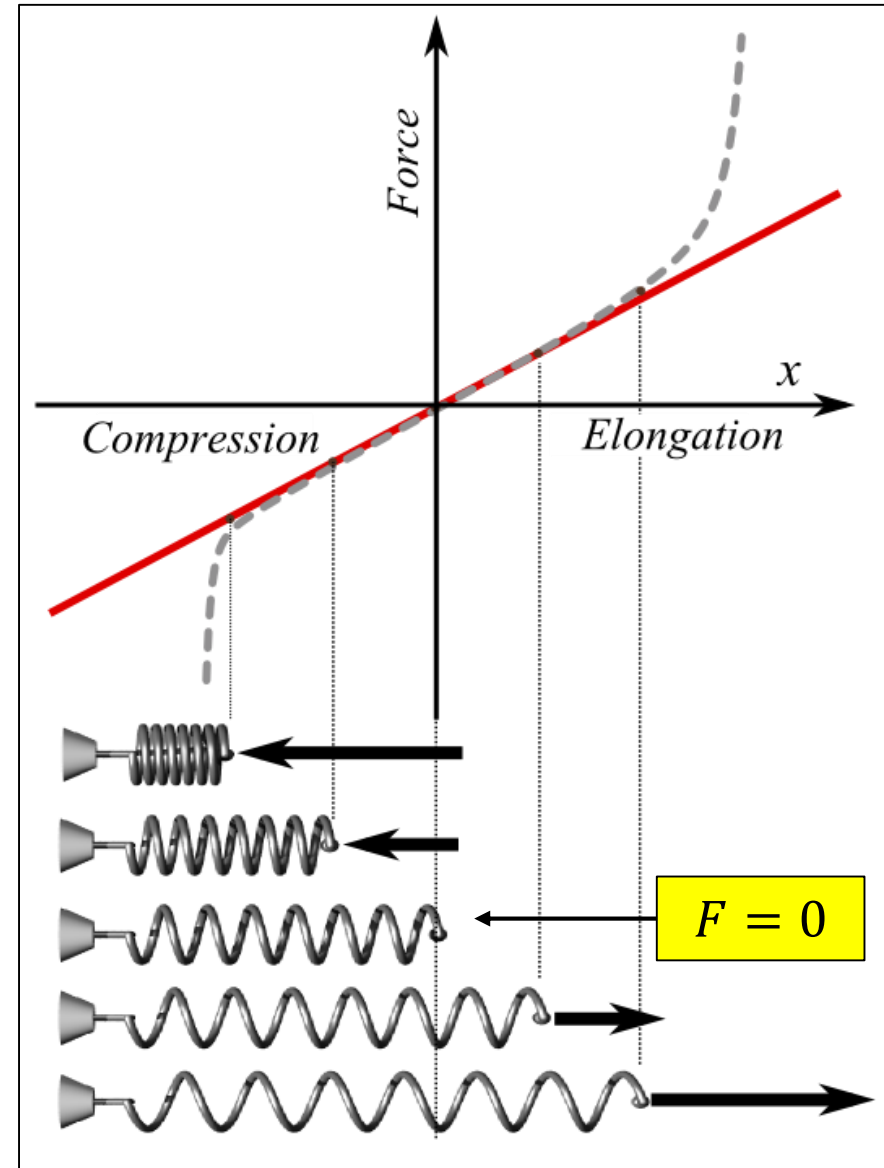
EXPERIMENTAL DATA - HOOKE'S LAW

- Plot of applied force F vs. elongation X for a helical spring according to Hooke's law (**red line**) and what the actual experimental data might look like (**dashed grey line**).
- At bottom, pictures of spring states corresponding to points on the plot are shown; the middle one is in the relaxed state (no force applied).
- Note how beyond a certain lower and upper force limit, Hooke's law doesn't hold (plot is non-linear).
- ***Thus, the idea that stiffness is a constant is only true within a certain force range for a given spring.***

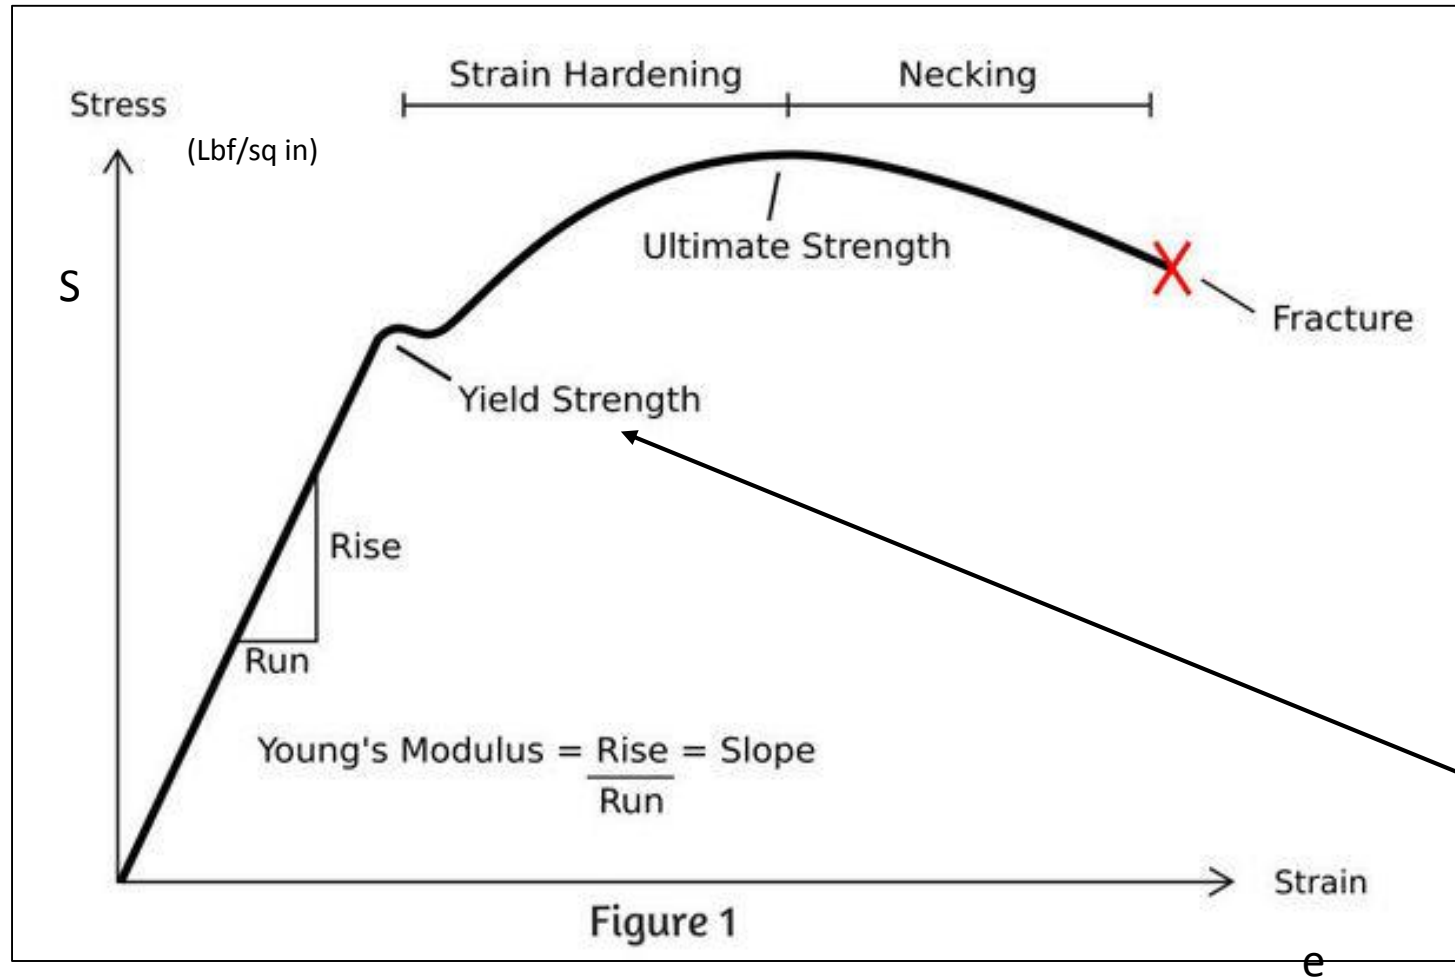
STRESS-STRAIN CURVE

- The plot at left is a typical stress-strain curve for a ductile material like some steels and aluminum.
- The Y or vertical axis is the stress applied to the material while the X or horizontal axis is the amount of strain or the % change in its length that occurs as a result of the applied stress.
- Strain = change in length / original length or $\Delta L / L$.
- The formula we showed earlier for Young's modulus $S = E \cdot e$ is only applicable for applied stresses up to the material's yield strength.

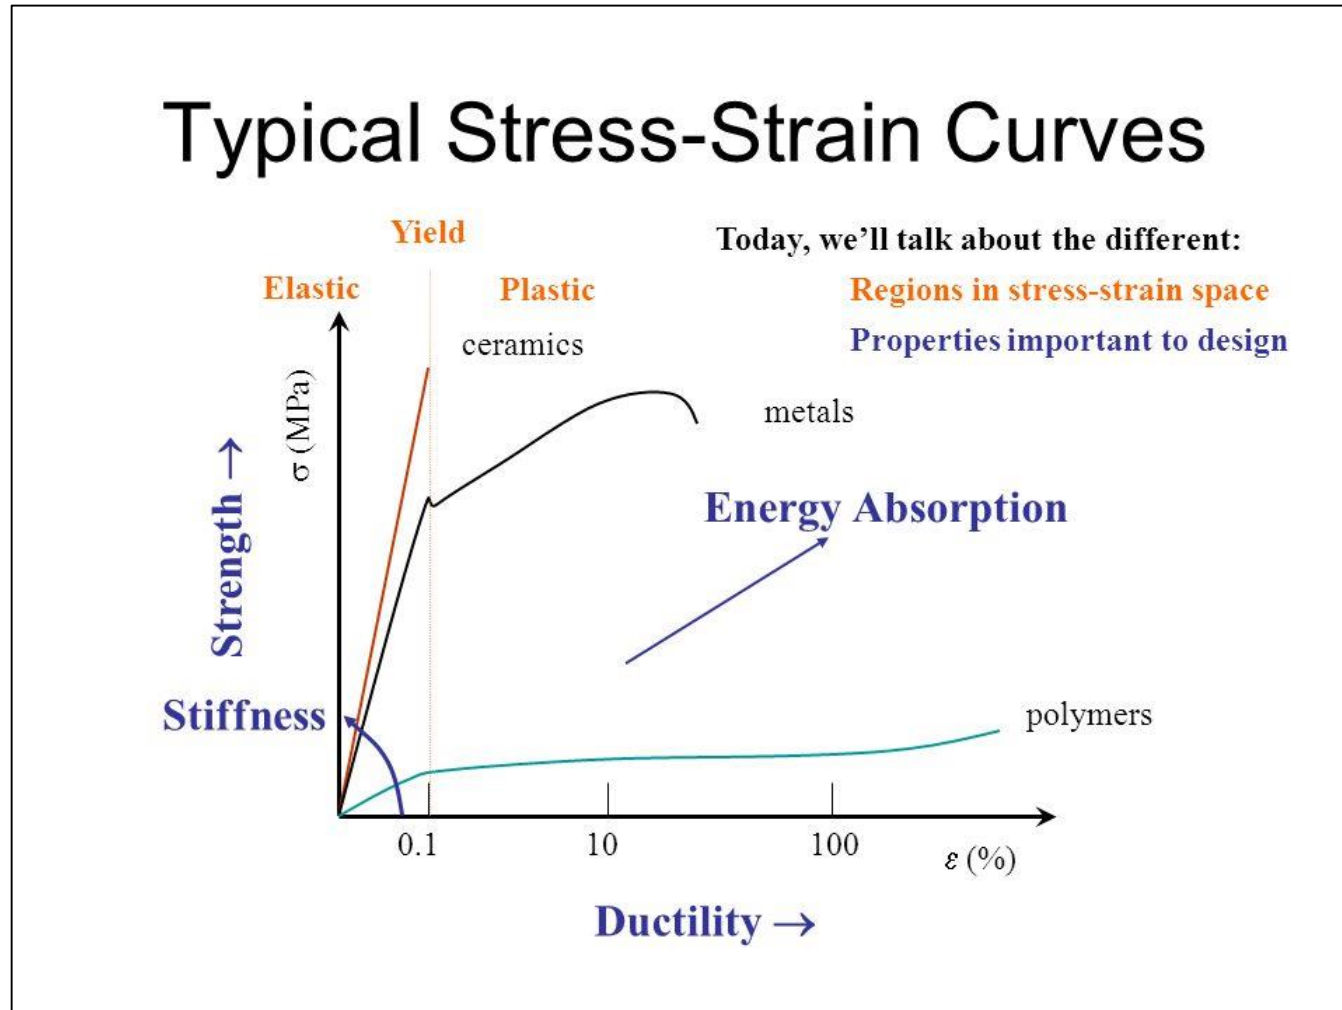
STRESS-STRAIN CURVES FOR DIFFERENT MATERIALS 1

- The plot at left shows stress-strain curves for three different general materials (from left to right): ceramics, metals & polymers.
- Note how the slope of the curve (material stiffness) for ceramics is steep in comparison to either that for metals or polymers.
- Note how the curve for metals and polymers becomes non-linear (plastic) once the yield strength is reached.
- Note how little if any plastic region exists for ceramics. This is another way of saying that ceramics are brittle (they don't yield, they break when you exceed their yield stress).

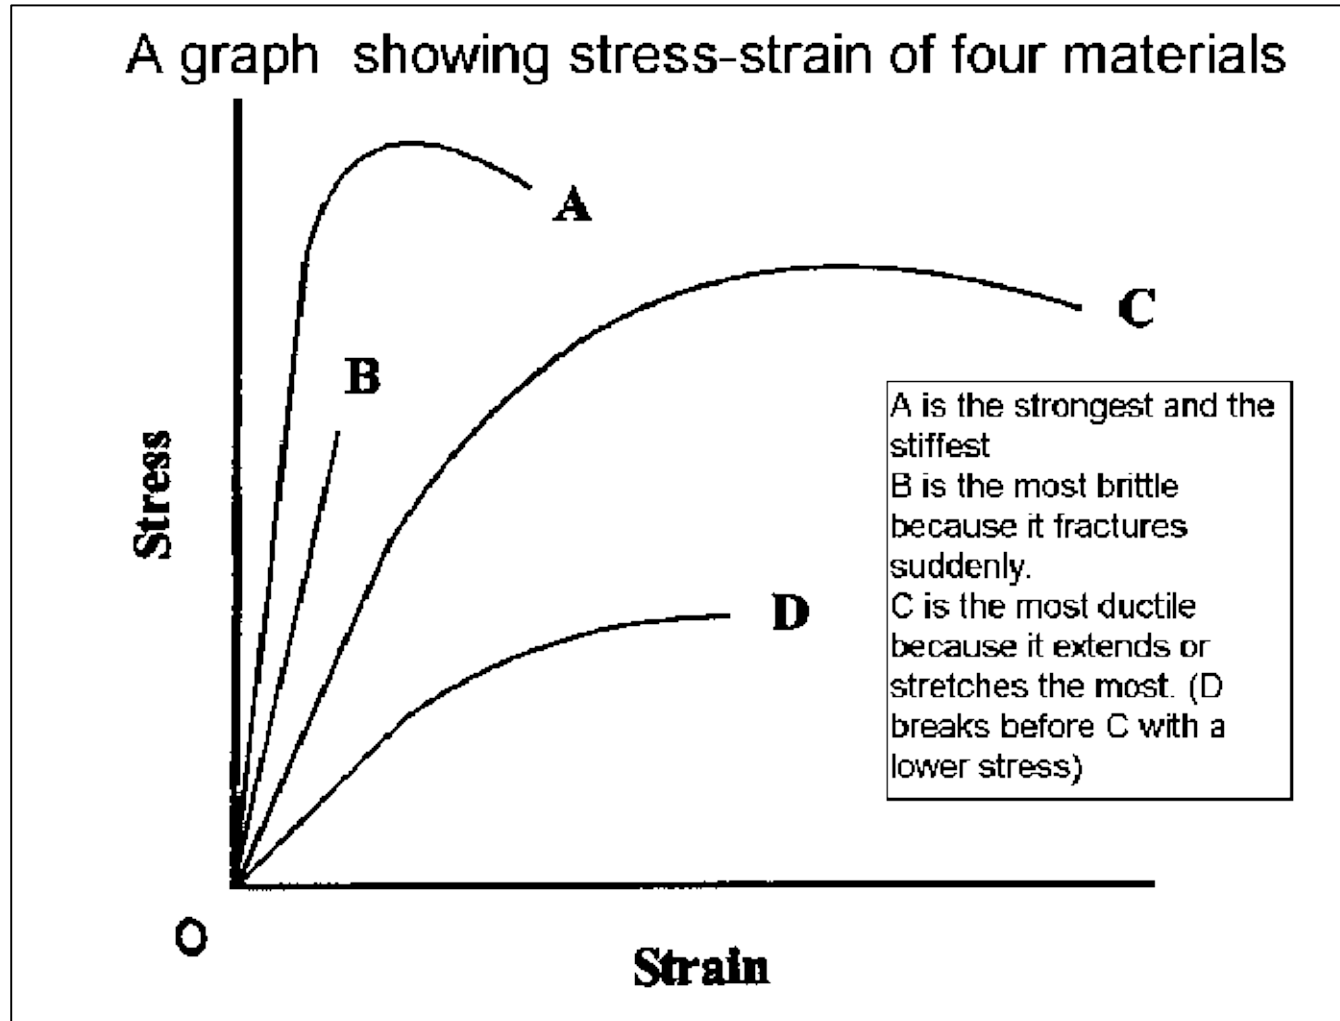
STRESS-STRAIN CURVES FOR DIFFERENT MATERIALS 2

- The plot at left shows four hypothetical stress-strain curves for different general materials (A, B, C & D).
- Material **A** would be considered the strongest & stiffest of the 4-ea materials shown as its stress-strain curve was the steepest and it endured the highest stress before yielding.
- Material **B** would be considered a stiff & brittle material with a steep stress-strain curve, but it fractured suddenly with little if any yielding.
- Material **C** would be considered the most ductile due to its long yielding prior to fracture.
- Material **D** would be similar to C but less strong as it yields and fractures at lower stress levels.

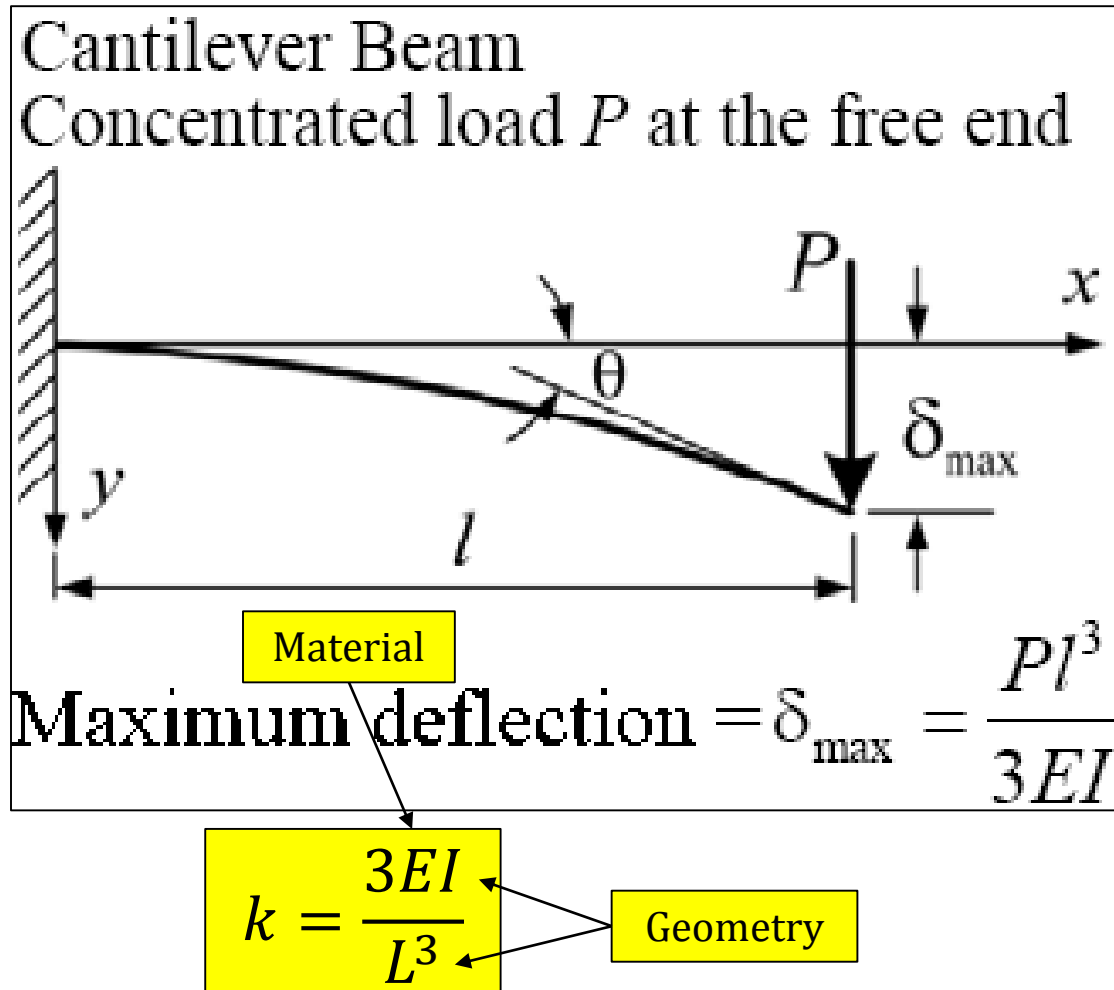
GEOMETRIC STIFFNESS – CANTILEVER BEAM

- The deflection is $\delta = \frac{Pl^3}{3EI}$
- From Hooke's Law we know that $F = kx$ where $x = \delta$ = deflection, and $F = P$ = Applied force.
- Rearranging this equation and inserting our formula for deflection above, we find the following for the stiffness $k = F / x = 3EI/l^3$
- Note that the **material** plays a role here in the term "E" which is Young's modulus for the beam material in question (steel, aluminum, etc).
- The majority of the terms in this equation relate to the **geometry** or geometric stiffness of the beam (length, cross sectional area, etc).
- The moment of inertia (I) would vary according to the cross sectional geometry of the beam (square, rectangular, circular, tube, etc).

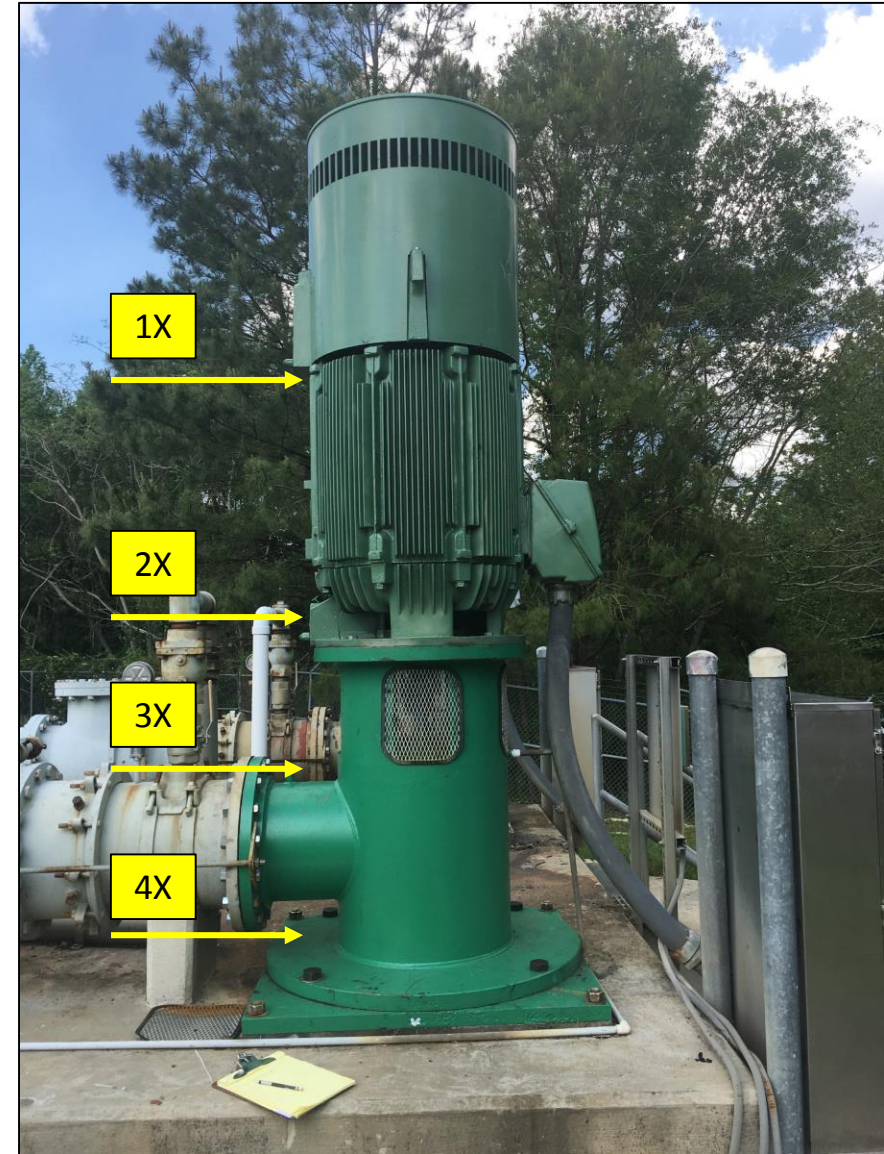
- Modal vibration data was collected on the vertical pump at right.
- Data was collected in both the discharge direction (X) and the transverse discharge direction (Y).
- Data was also collected at various points and elevations along the machine as follows:
 - 1) 1X = Top Motor Bearing, Discharge Direction
 - 2) 2X = Bottom Motor Bearing, Discharge Direct.
 - 3) 3X = Top Pump Bearing, Discharge Direct.
 - 4) 4X = Pump Base, Discharge Direct.
- What follows is a presentation of some of the modal data collected from this pump with the goal of illustrating that stiffness is dependent on location, direction, and the frequency of the dynamic force.

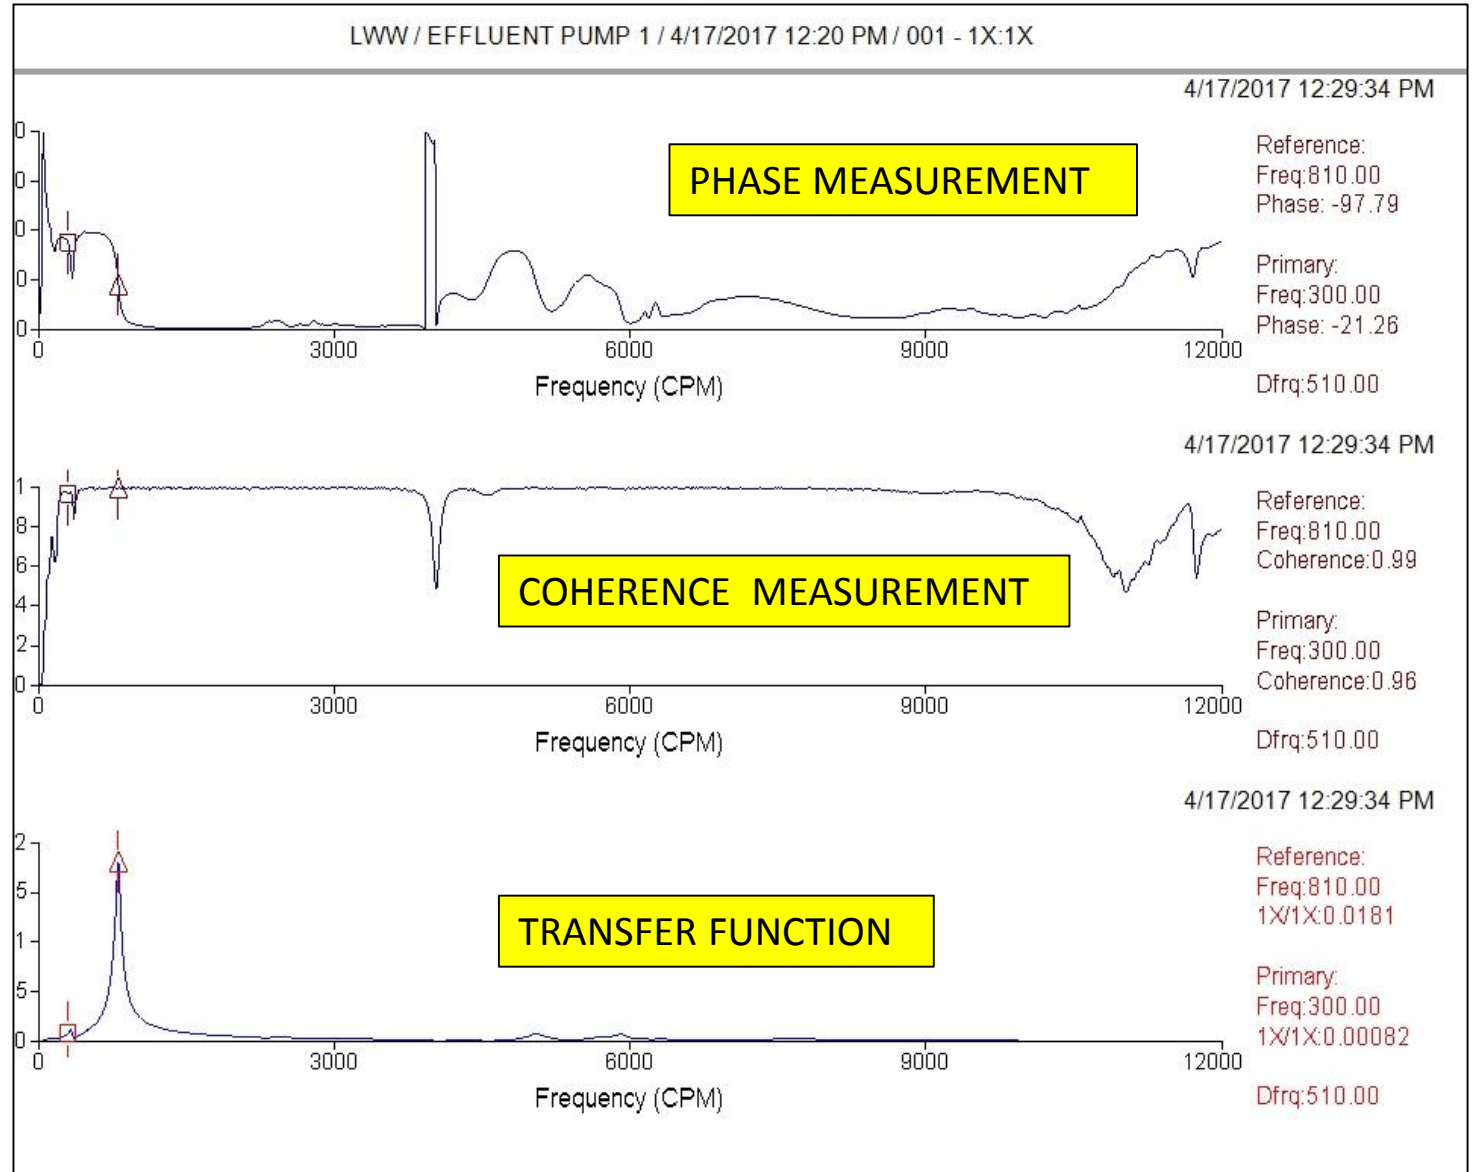
DYNAMIC STIFFNESS – VERTICAL PUMP

- The plots at right are modal vibration measurements from the top bearing of a vertical pump in the discharge direction.
- The bottom plot is known as the **transfer function** for the measurement which is a ratio of how much response (vibration) occurs as a result of the force applied.
- The middle plot is known as the **coherence function** which can be thought of as a measure of the quality of the modal measurement. Values of coherence > 90% are required while values > 95% or so are desired. When coherence values are lower than this, suspect problems such as looseness, bad wiring connections, transmitted vibration, etc.
- The top plot is the **phase function** which is a timing measurement between the force input and vibration response.

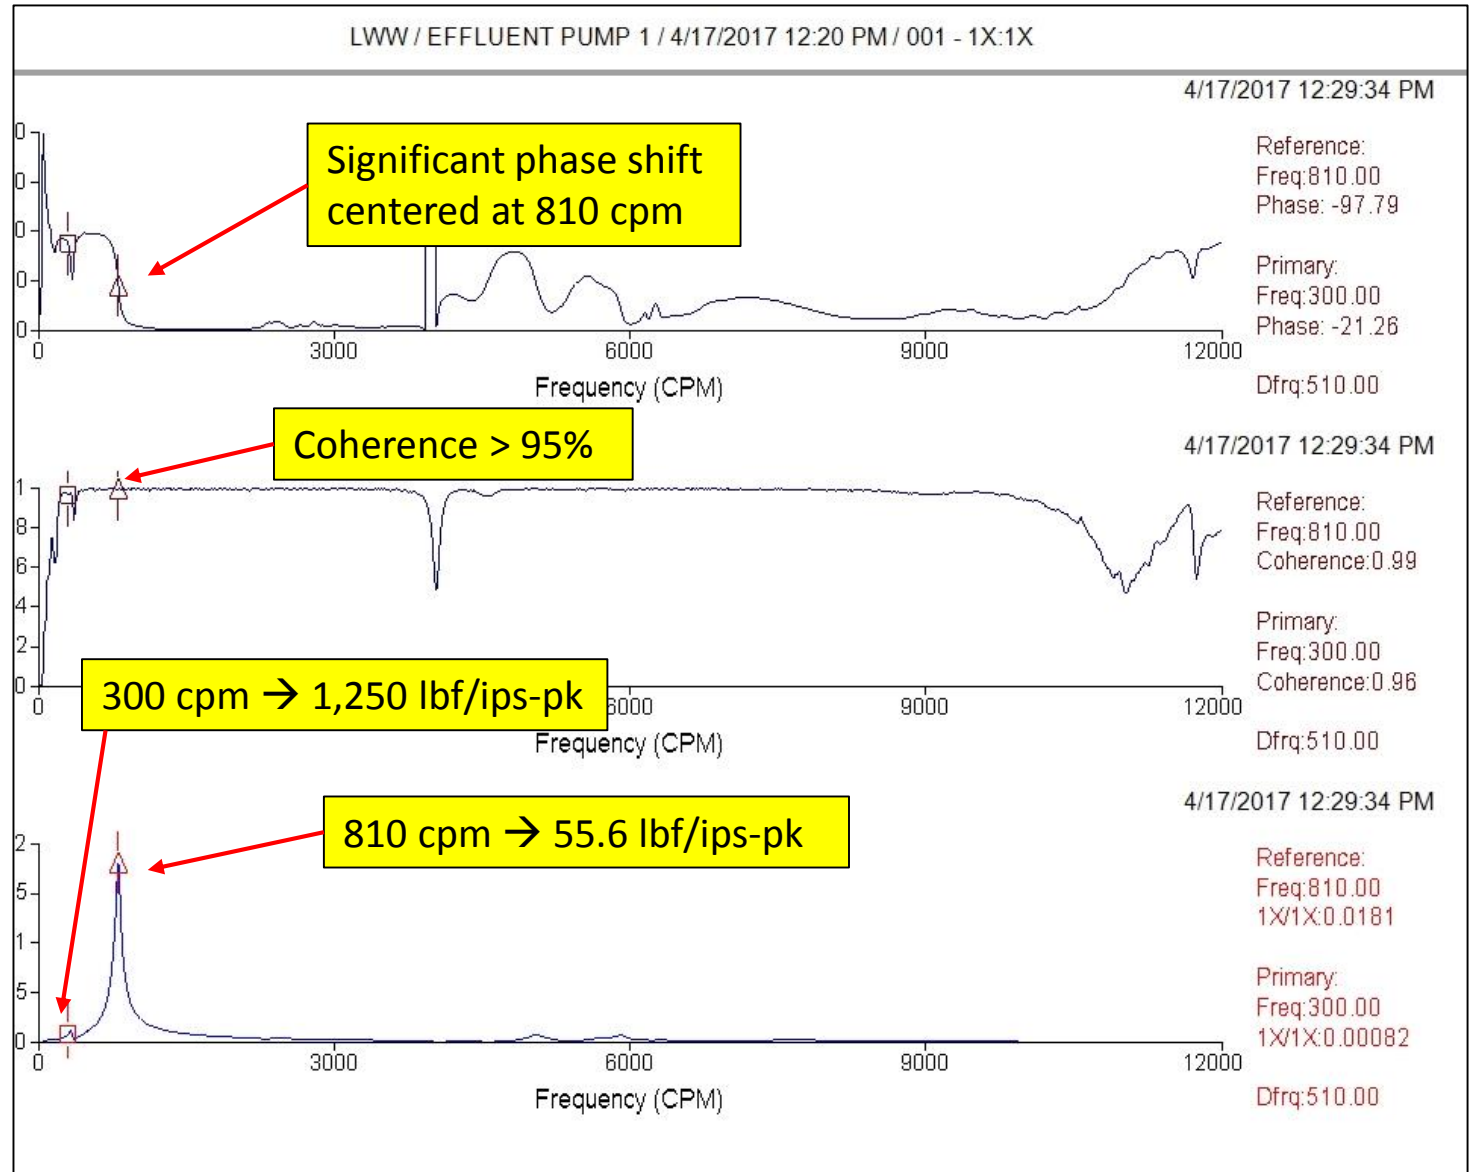
DYNAMIC STIFFNESS – FREQUENCY

- The transfer function measurement shown is in units of mobility, ips-pk/lbf which is the inverse of the “dynamic stiffness”, lbf/ips-pk.
- High mobility measurements equate to high flexibility and low stiffness.
- Note how the mobility of the top bearing at or near ~ 810 cpm is very high (0.018 ips/lbf) in relation to all other nearby frequencies (0.0008 ips/lbf) – **810 cpm is a natural frequency of the vertical pump.**
- Inverting these mobility measurements, we get a dynamic stiffness of 55.6 lbf/ips-pk at 810 cpm versus 1,250 lbf/ips-pk at 300 cpm – **this great difference in stiffness is the primary reason why we get so much more vibration (motion) when operating at or near a natural frequency.**
- ***Do you see now how stiffness is not a constant but highly dependent on the frequency of the dynamic force?***

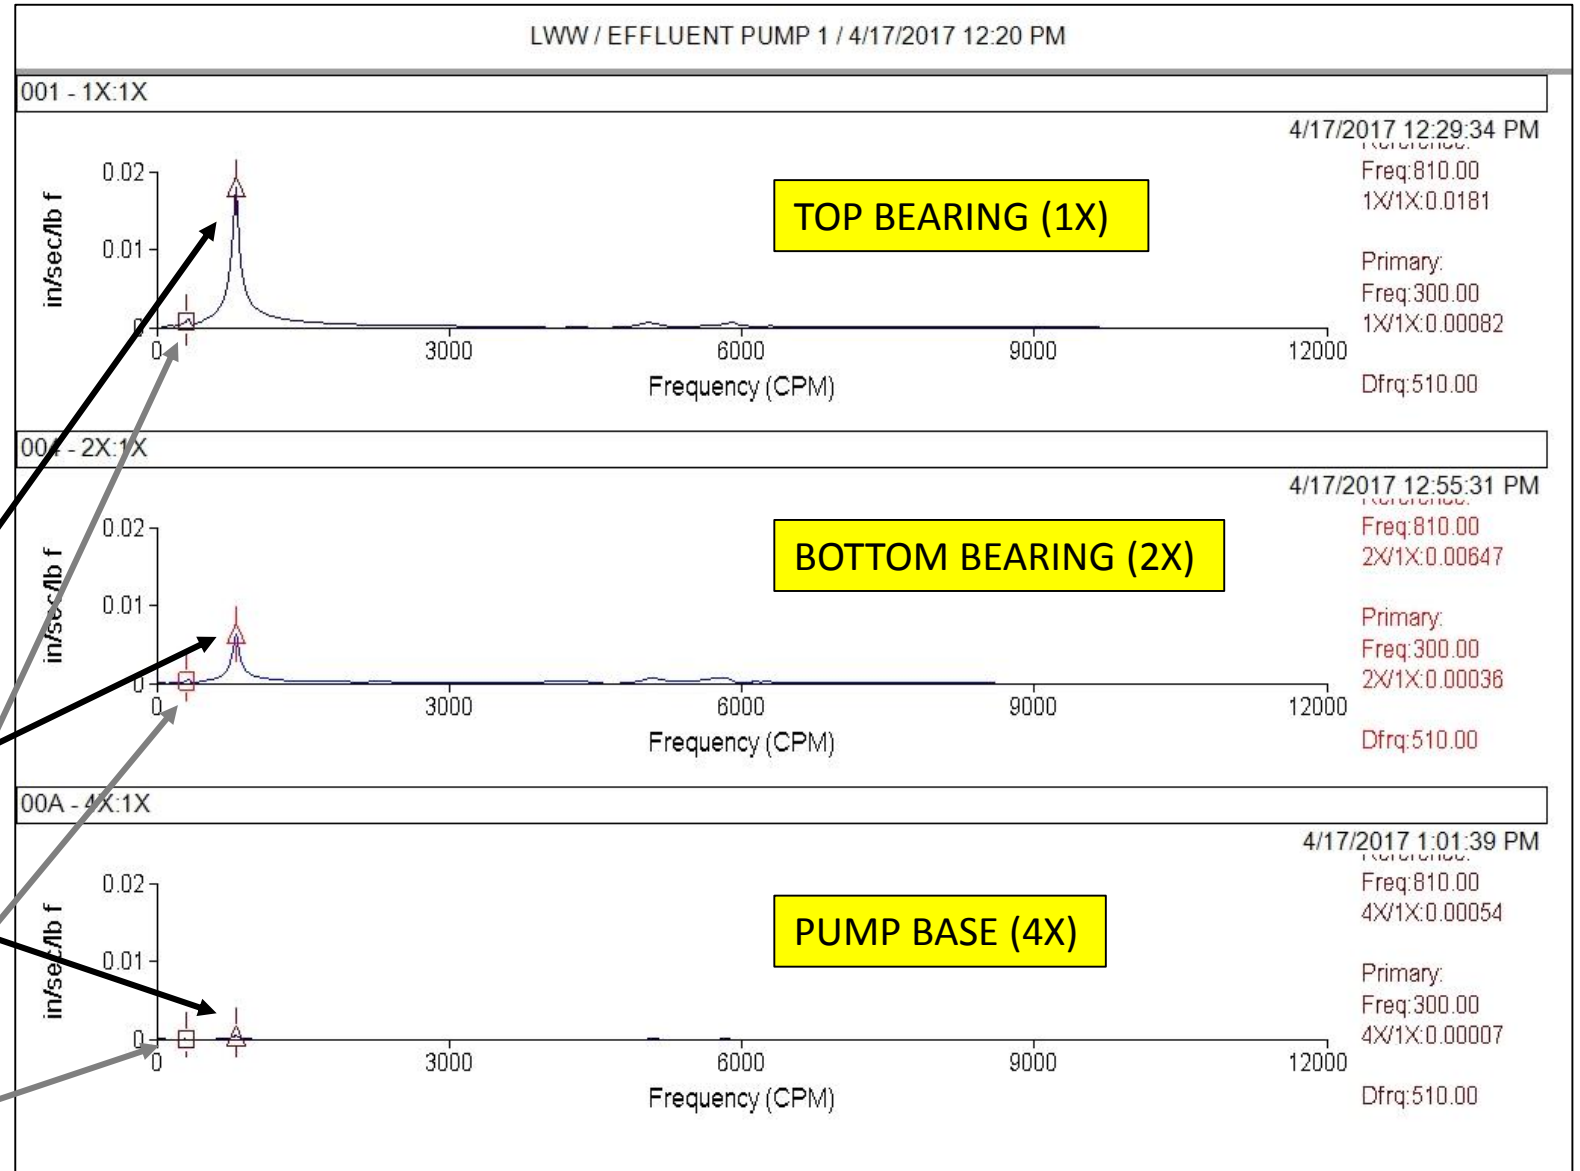
DYNAMIC STIFFNESS – LOCATION

- Stiffness 1X (810 cpm) = 55.6
- Stiffness 2X (810 cpm) = 154
- Stiffness 4X (810 cpm) = 1,852
- Stiffness 1X (300 cpm) = 1,250
- Stiffness 2X (300 cpm) = 2,778
- Stiffness 4X (300 cpm) = 14,286

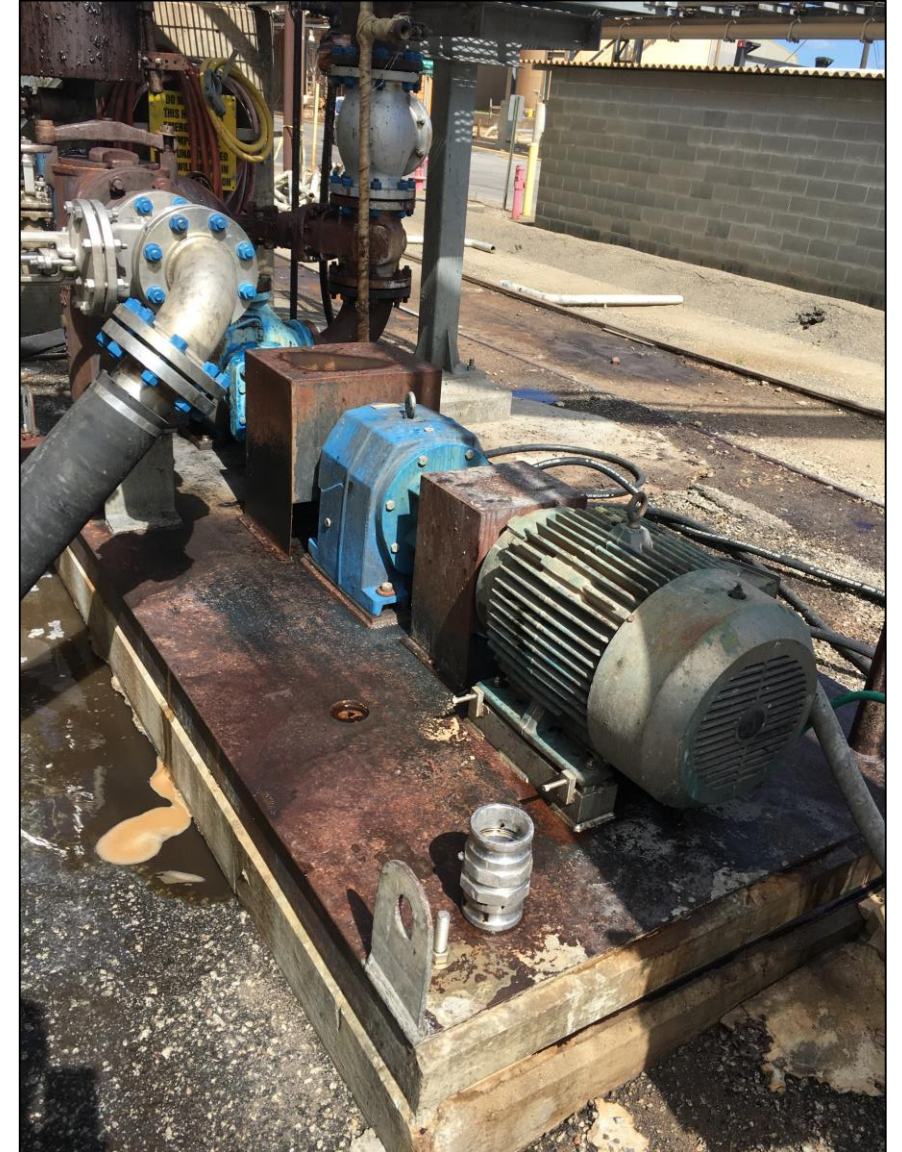
CASE HISTORY 1 – POSITIVE DISPLACEMENT PUMP

- The first case history involves a horizontal positive displacement pump driven by a 4-pole induction motor thru a small gearbox.
- The motor operates at $\sim 1,790$ rpm while thru gearbox reduction the pump operates at ~ 120 rpm and generates vane-pass vibration at $\sim 1,350$ cpm (11x rpm).
- The entire machine is supported by a fabricated steel base bolted to the concrete floor.
- A history of looseness problems were experienced by this machine that will be described in the following slides.

- This case history does a good job at illustrating two characteristics of looseness:
 - 1) Looseness is often **directional** in nature
 - 2) Looseness is often **localized** in nature.
- It also underscores the importance a solid foundation and machine base has on your machine's vibration levels.

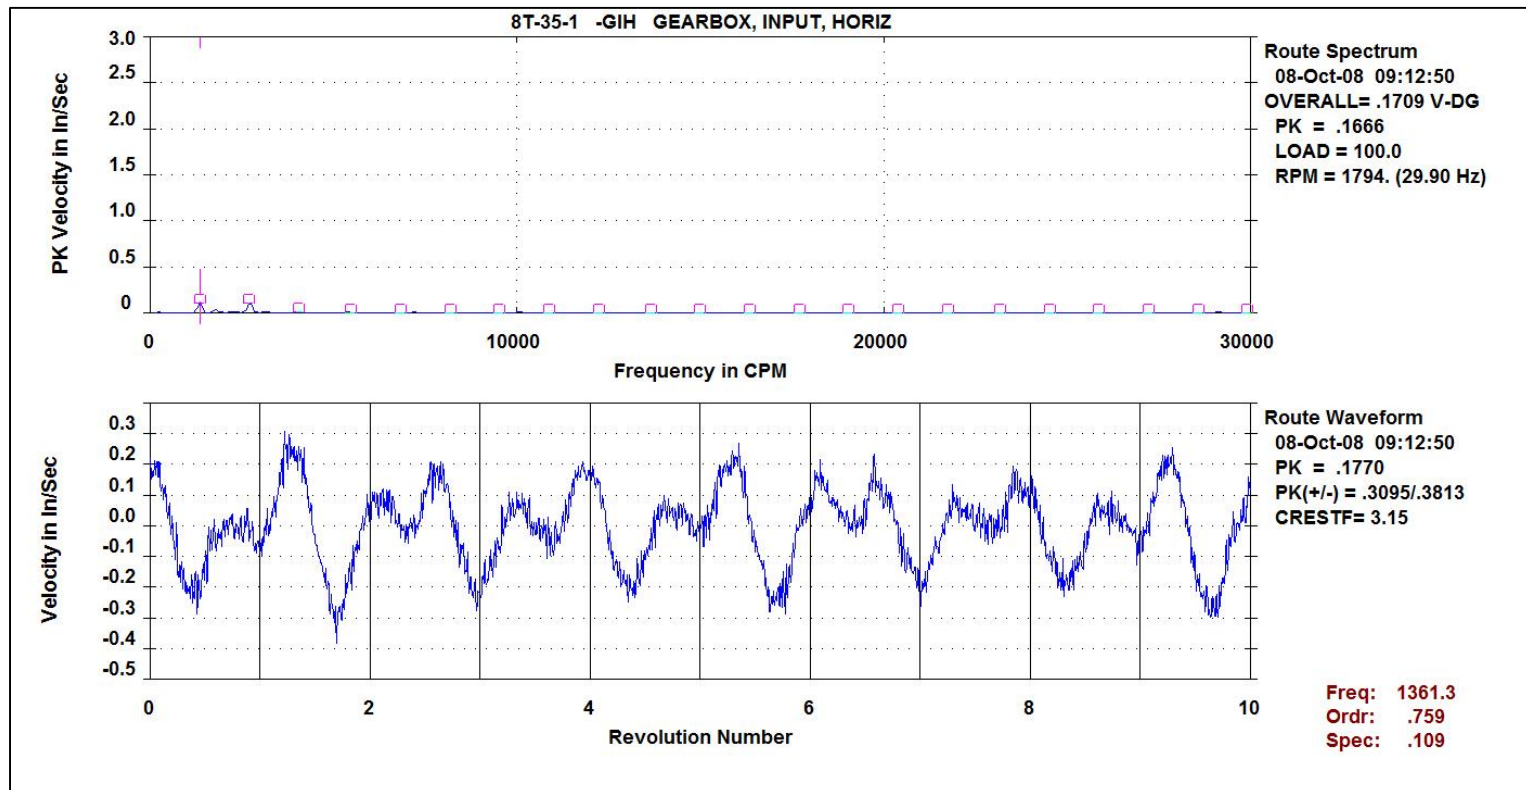
- 10/8/08 – Reference vibration data on pump.
- Spectral & waveform data shown at gearbox, horizontal point (representative point throughout machine history).

- Overall levels are low (~ 0.17 ips-pk) with no significant impacting seen in waveform data.
- Dominant frequency of vibration is at pump vane-pass frequency & 2x vane-pass (1,350 cpm & 2x).

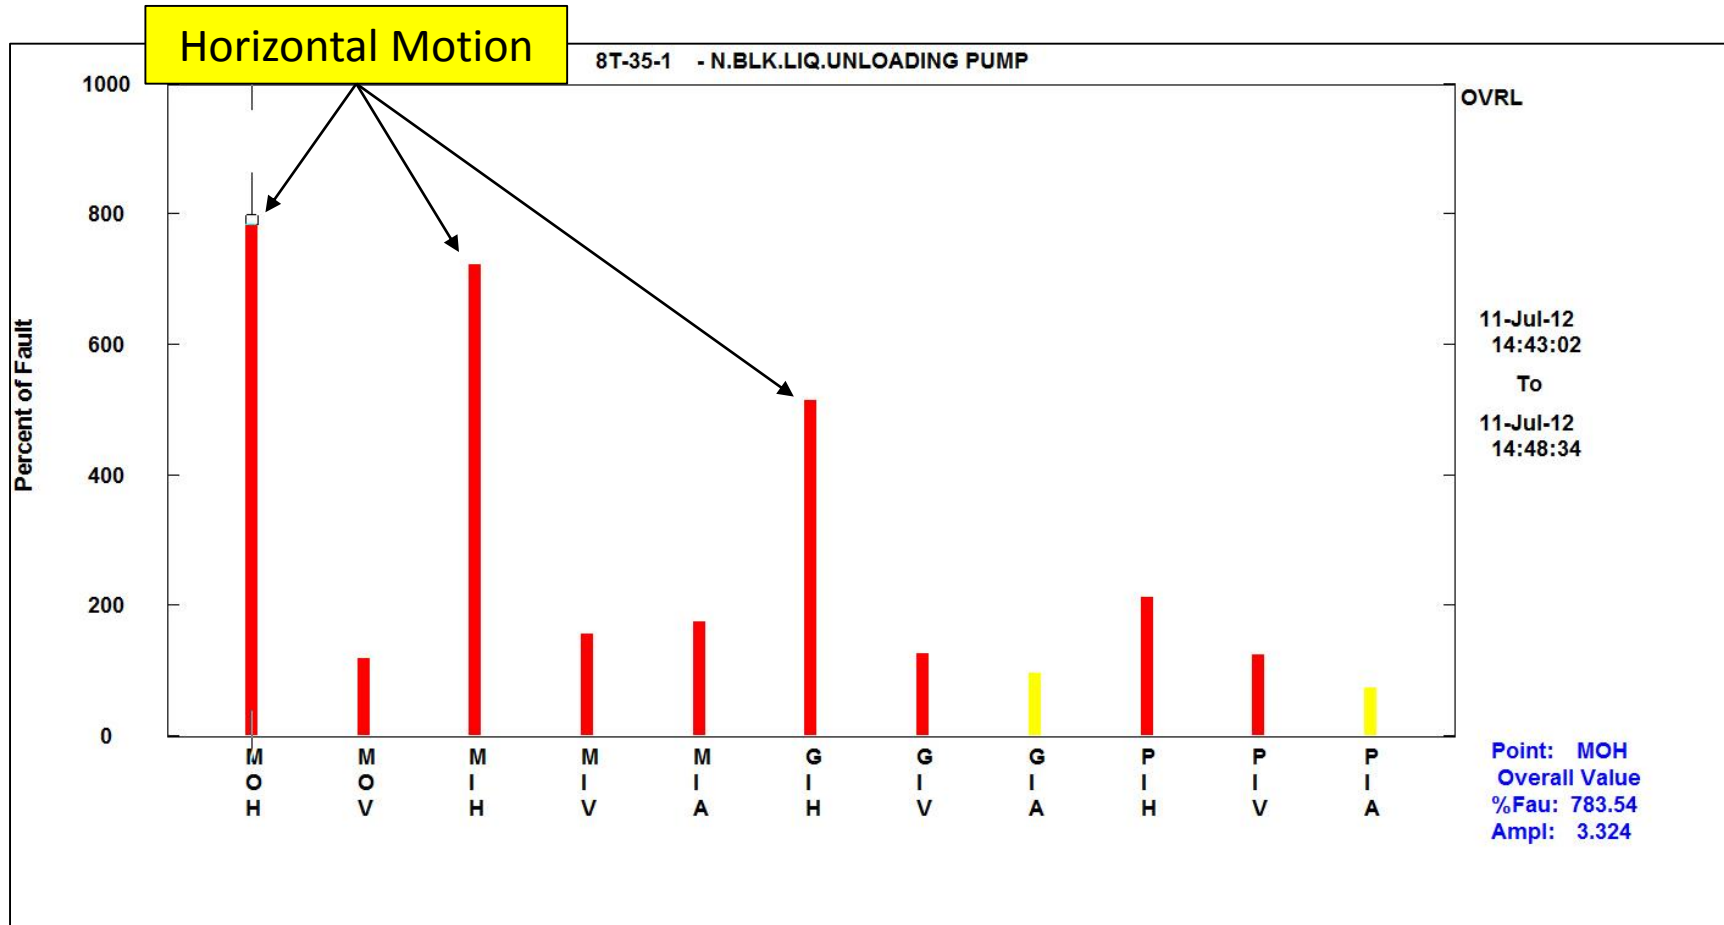
- 7/11/12 – Loose machine base & potential pump problems showing up at vane-pass.

- Overall levels are severe (~ 3.3 ips-pk).
- From the profile plot of overall vibration levels at left note how **directional** our vibration levels are.
- Dominant vibration occurring in the **horizontal direction** with highest levels at the motor.
- The source of the vane-pass frequency is at the pump where the vibration levels are lowest (PIH, PIV, etc).

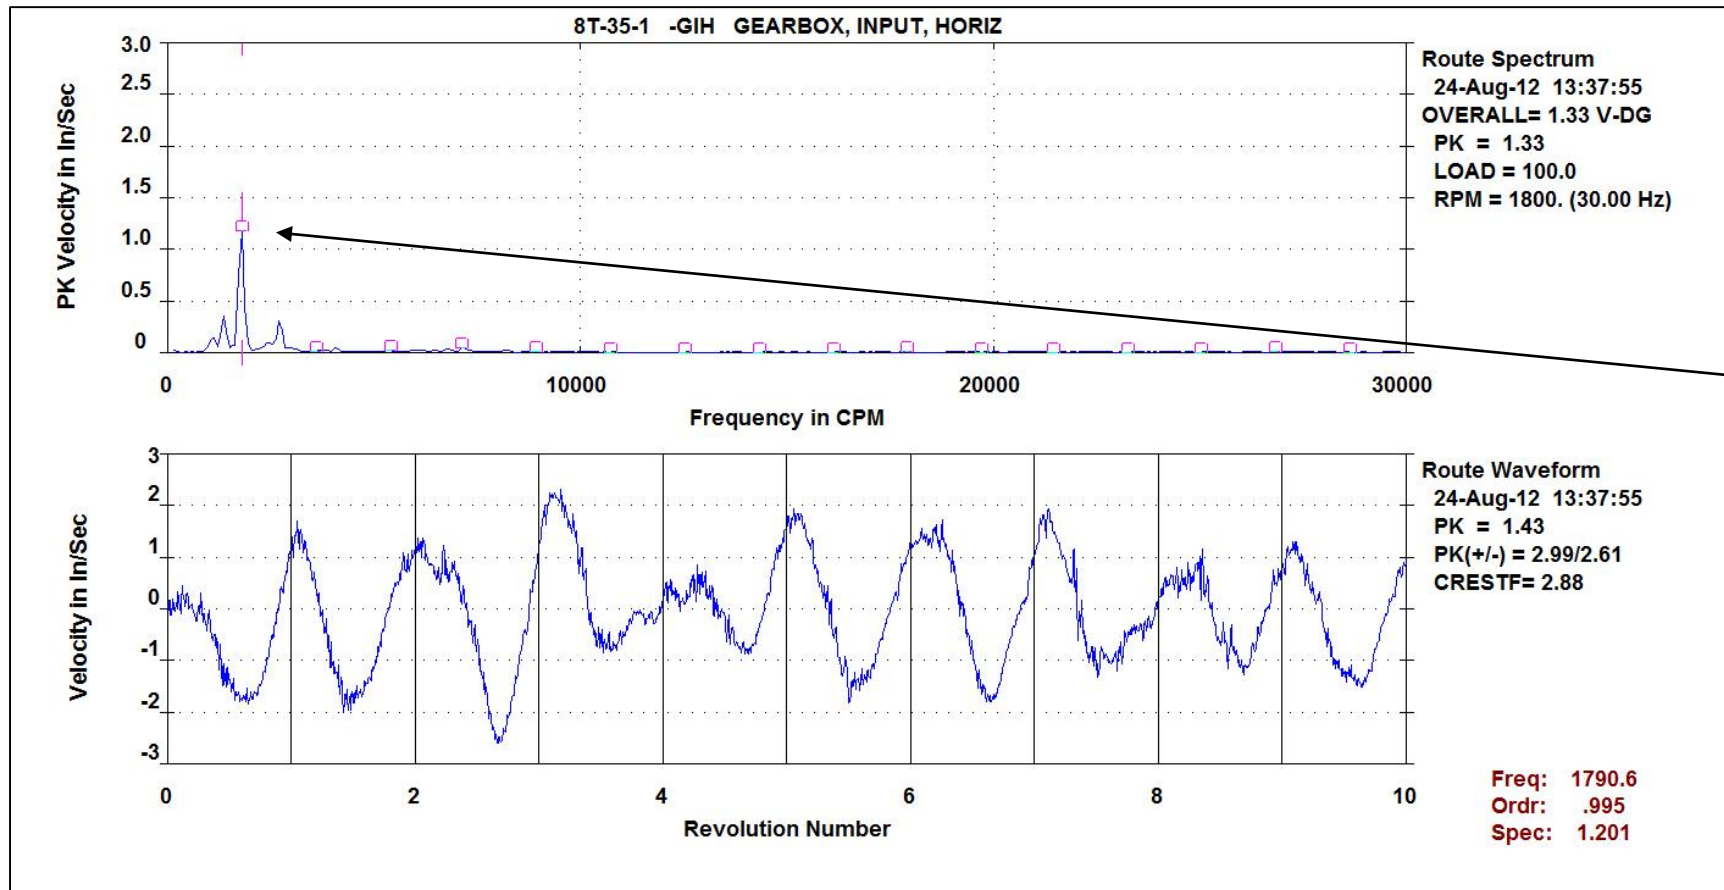
- 8/24/12 – Pump changed, but machine base problem remains.

- Overall levels are **lower** following the pump change (dynamic force reduced, but remain severe (~ 1.3 ips-pk)).
- Dominant frequency of vibration is now at **motor speed (1,790 rpm)**.
- Some level of alignment or coupling problems were also suspected.

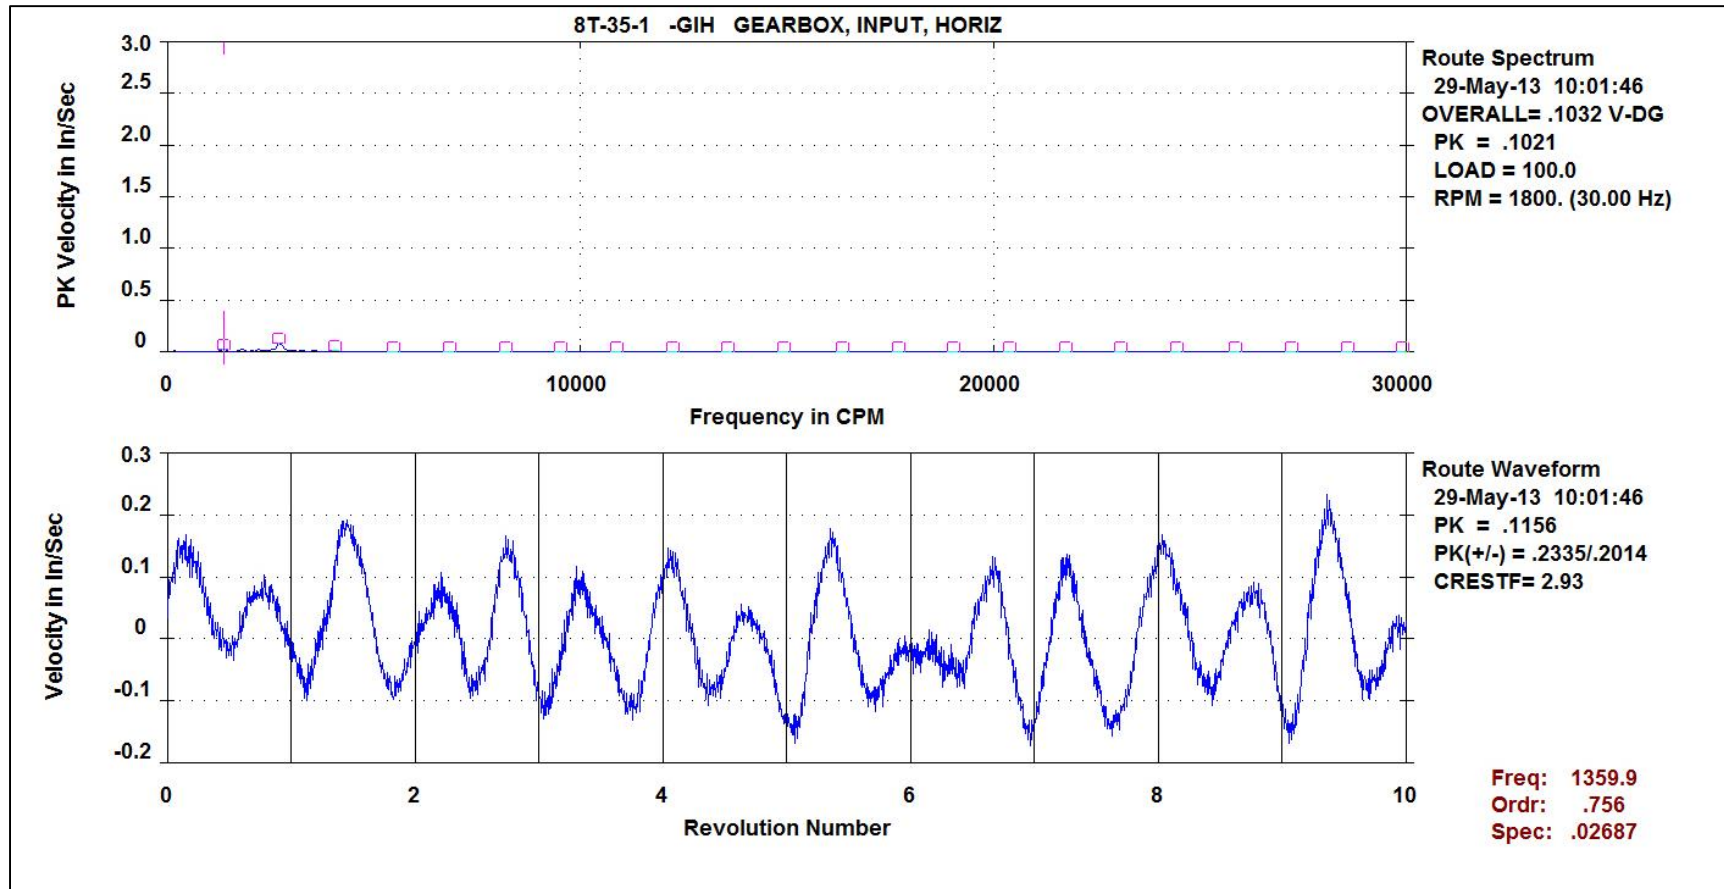
- 5/29/13 – Machine base repaired. All anchor bolts tightened up & base grouted into concrete floor.

- Overall levels are significantly lower following the machine base repairs (~ 0.10 ips).
