STIFFNESS & MACHINE VIBRATION

Barry T. Cease

Vibration Institute, Annual Conference, July 2018

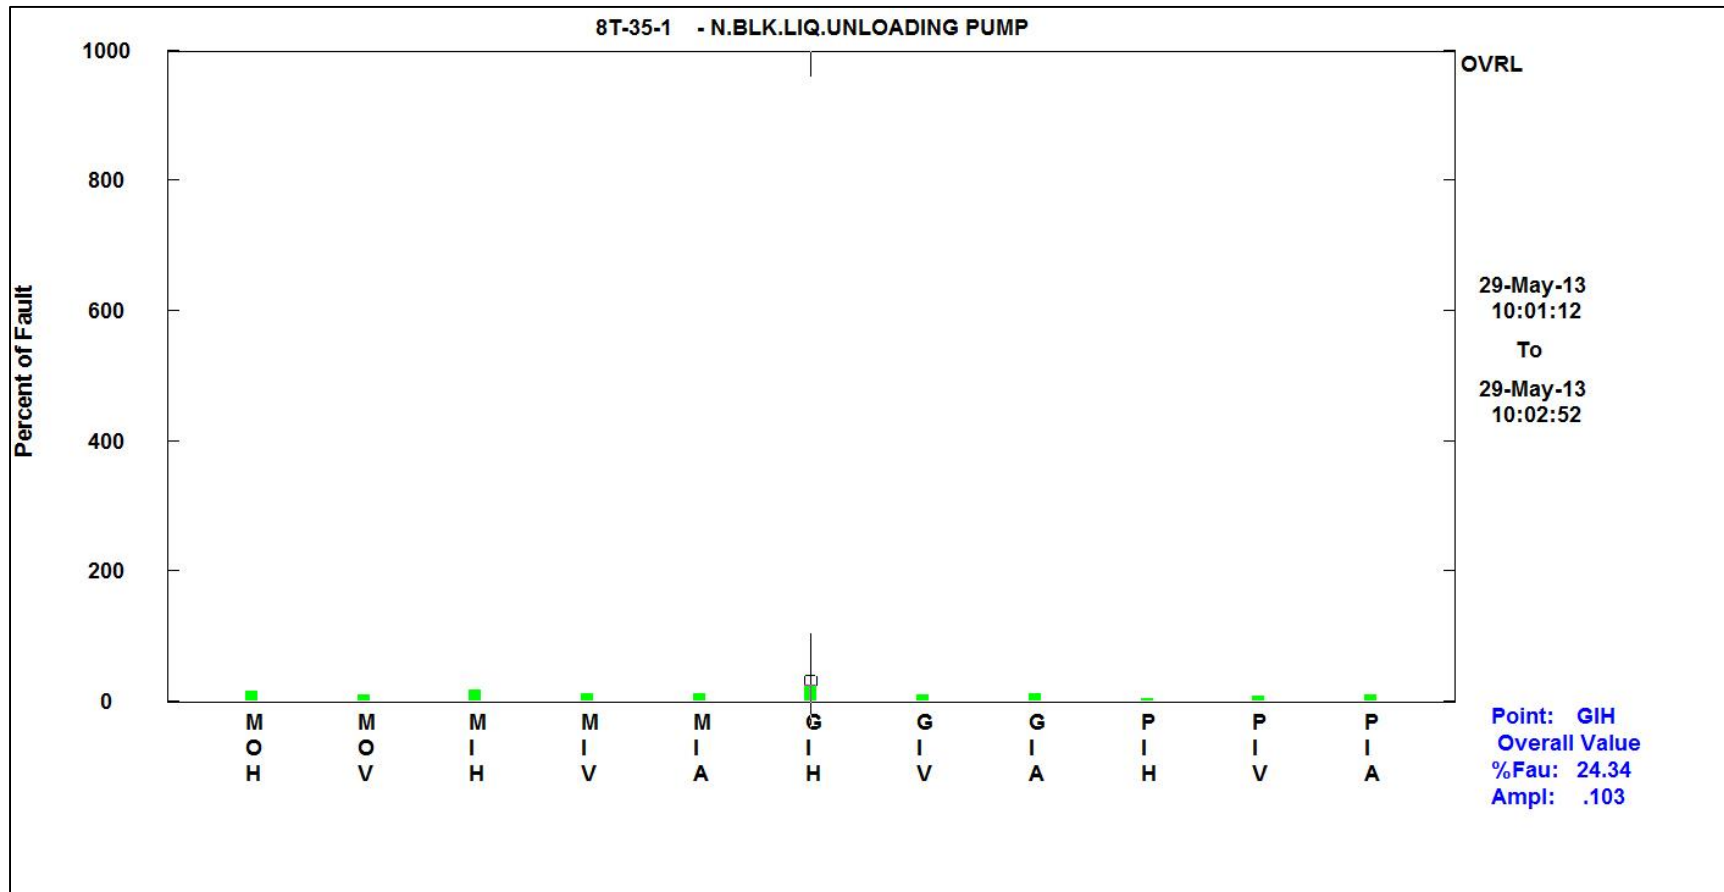
- 5/29/13 – Machine base repaired. All anchor bolts tightened up & base grouted into concrete floor.

- Overall levels are significantly lower following the machine base repairs (~ 0.10 ips).
- Note how following repairs to the machine base, vibration levels across the entire machine are significantly lower.
- Note also how now our horizontal levels don't stand out at all versus the others.

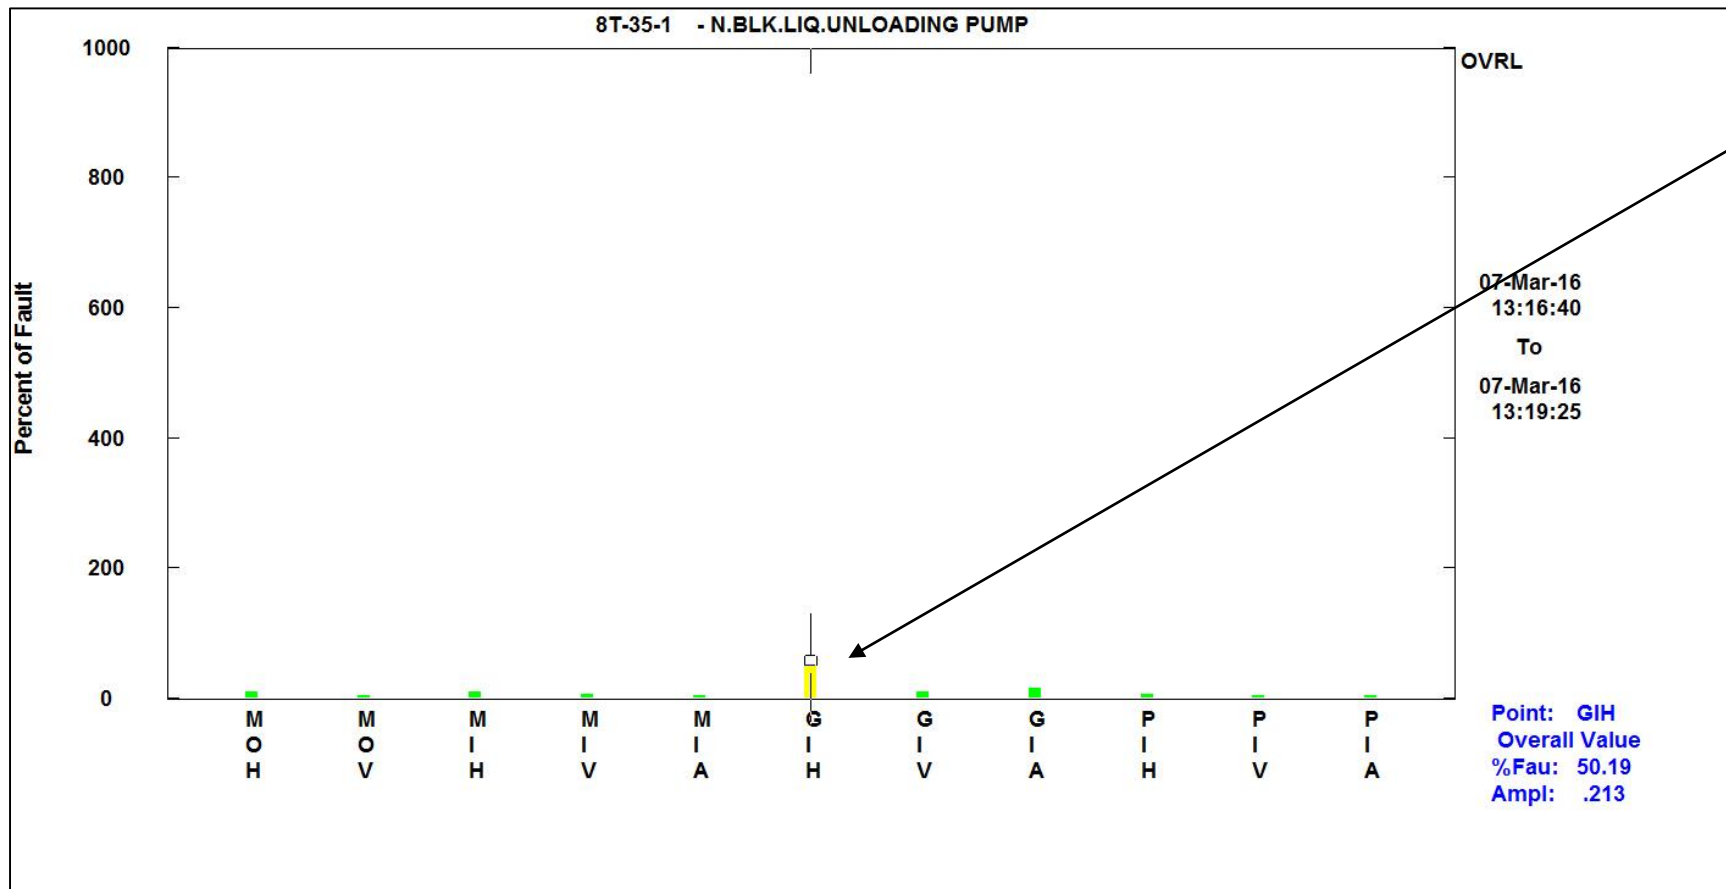
- 3/7/16 – Three years later, a new base problem begins (grout cracking and deteriorating at spots under machine base).

- Note how increase in vibration levels is occurring primarily at one measurement (**localized**).
- Levels at the gearbox, input, horizontal measurement (GIH) are elevated while all others remain ok.
- Remember that a characteristic of both looseness and resonance is **directional** vibration.

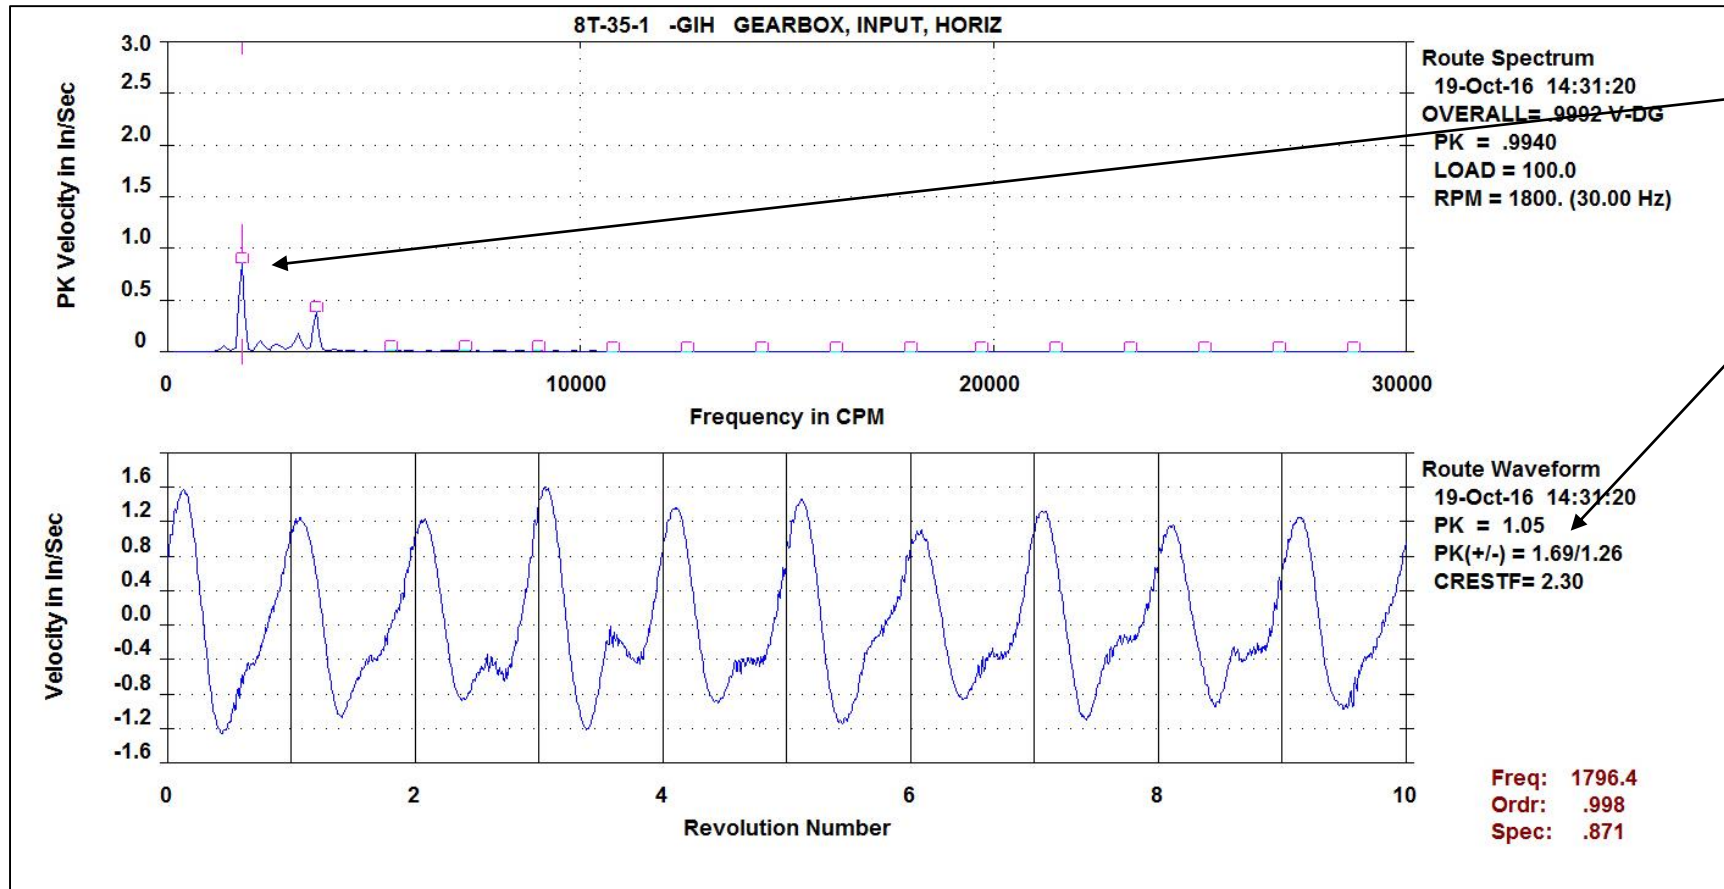
- 10/19/16 – New base problem continues to deteriorate.

- Overall levels continuing to climb (~ 1 ips).
- Dominant vibration occurring at motor 1x & 2x rpm.
- Asymmetric waveform (+1.69 versus -1.26).
- **On-site inspections noted significant movement and flexure of the machine base at or near the gearbox with much less movement at the machine base near either the motor or pump – being there matters.**

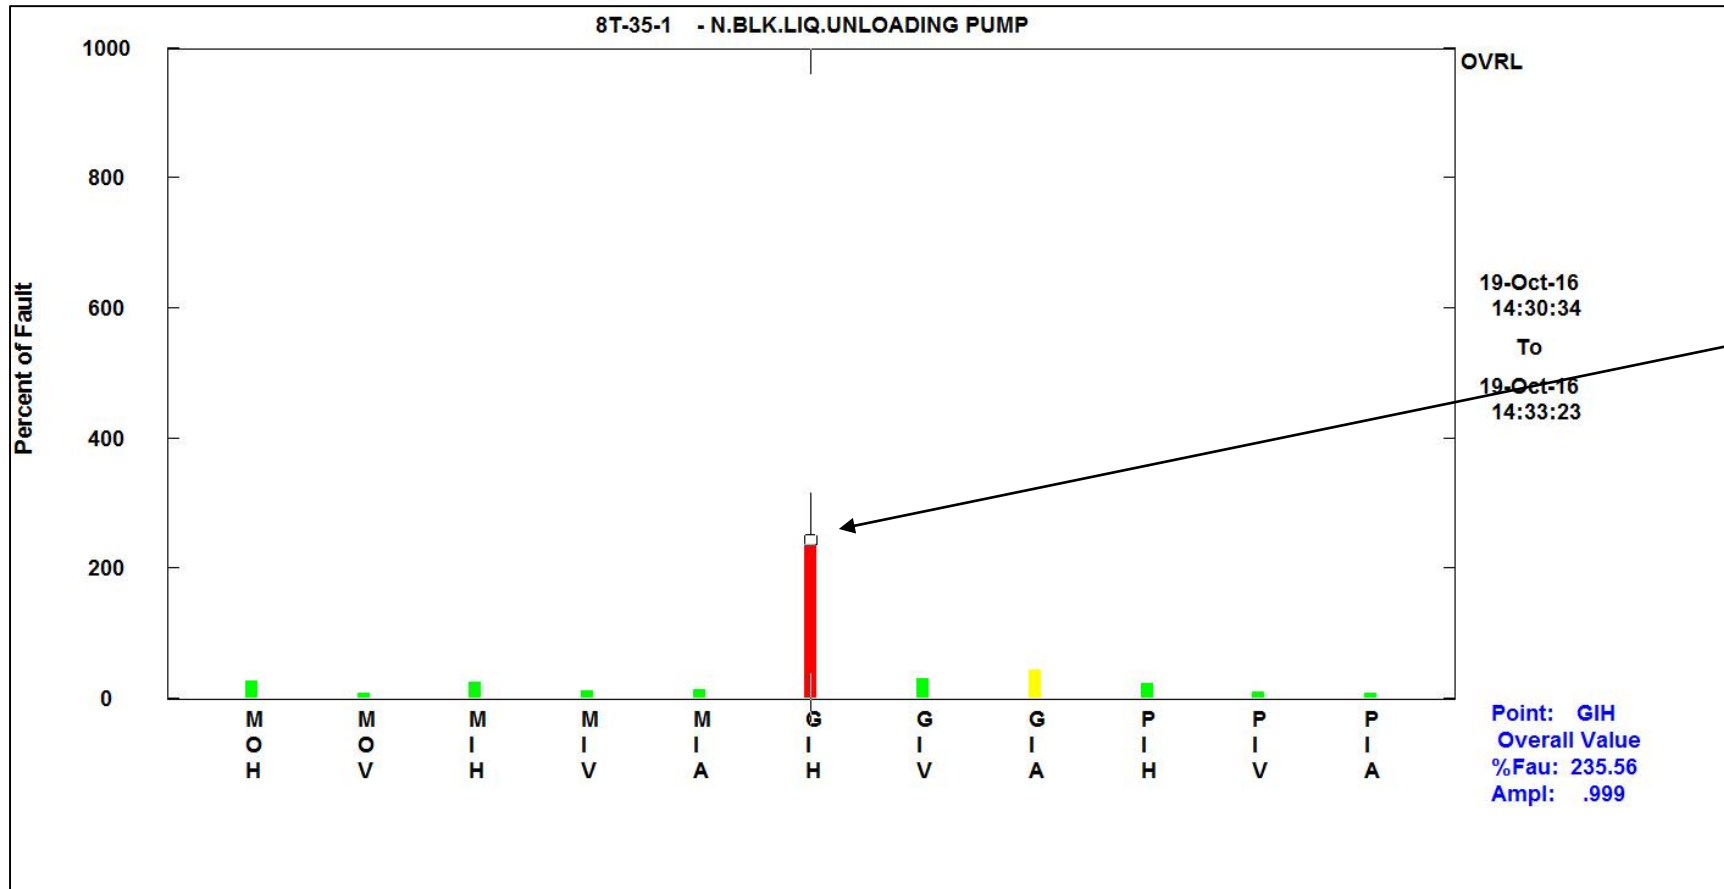
- 10/19/16 – New base problem continues to deteriorate.

- From this profile plot of the overall levels versus machine measurement point, note how the vibration is very **localized**.
- Majority of vibration is isolated at the gearbox in the horizontal direction (GIH).
- Further inspection found the grout had cracked and deteriorated under the machine base at the gearbox location reducing the stiffness at this spot (not generally) along the machine.

- This case history does a good job at illustrating two characteristics of looseness:
 - 1) Looseness is often **directional** in nature
 - 2) Looseness is often **localized** in nature.
- It also underscores the importance a solid foundation and machine base has on your machine's vibration levels.

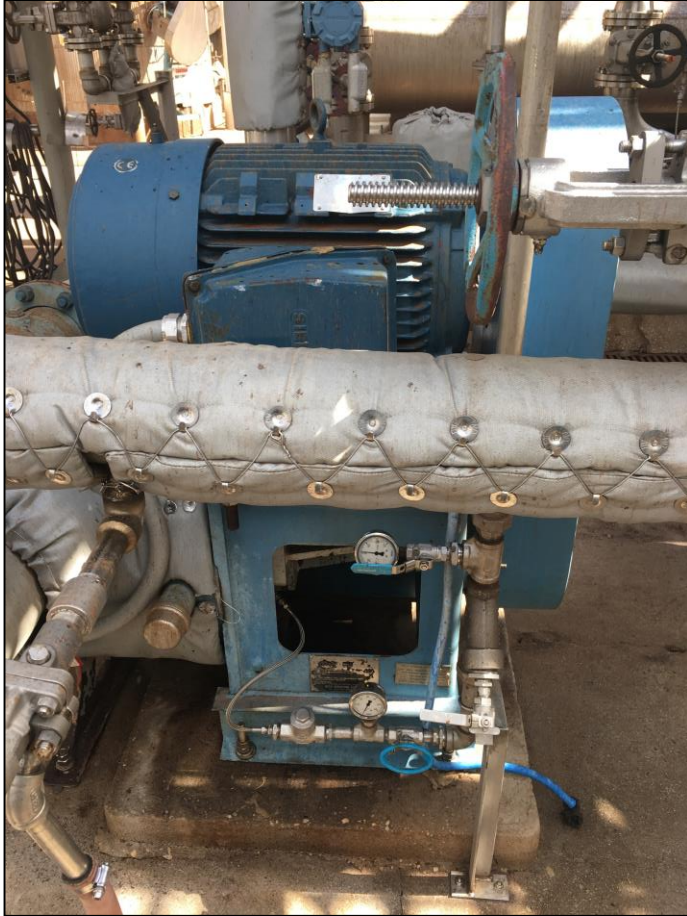
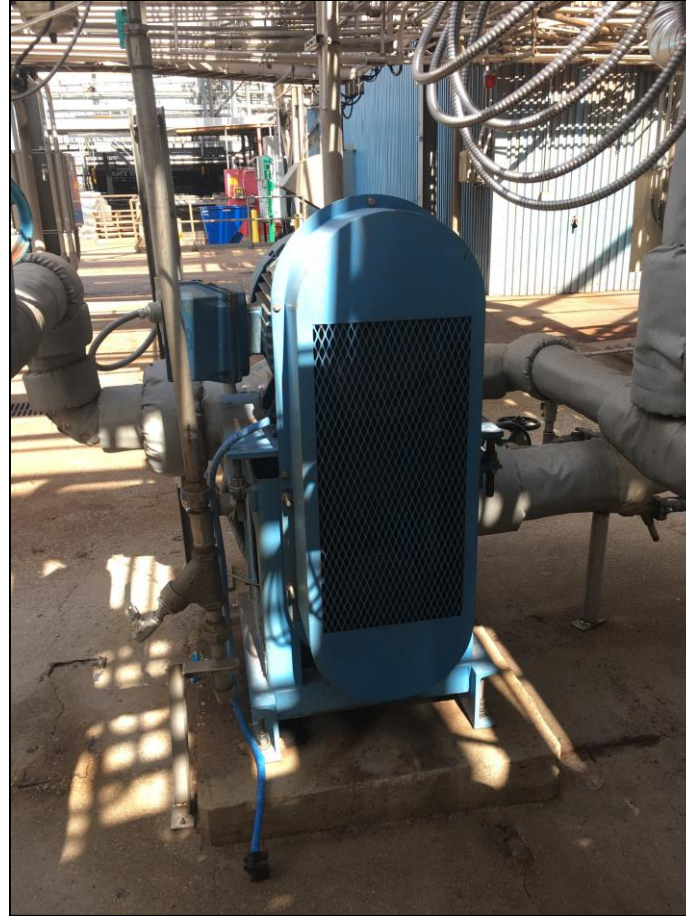
CASE HISTORY 2 – BELT-DRIVEN SCREEN

- The second case history involves a horizontal screen driven by a 4-pole induction motor thru a belt-drive.
- The motor operates at $\sim 1,780$ rpm while the screen operates at $\sim 2,000$ rpm.
- The entire machine is supported by a fabricated steel base bolted to the concrete floor via 4-ea anchor bolts (no grout).
- Just looking at the side and end-on views of this machine ask yourself in which direction is the stiffness high and low.
- Taking into account that fact that this machine is essentially a centrifuge generating high radial forces, where and in what direction might the vibration levels be high?

- My suspicion was the elevated vibration at 1,520 cpm was due to excitation of a natural frequency in the horizontal direction set up by the reduction in stiffness from the loose anchor bolts as simply tightening the anchor bolts eliminated the problem.

- **The moral of this story is that one loose anchor bolt on your machinery can result in major increases in its vibration levels due to the significant changes in stiffness that occur. The worst of both worlds can set up – looseness causing resonance.**

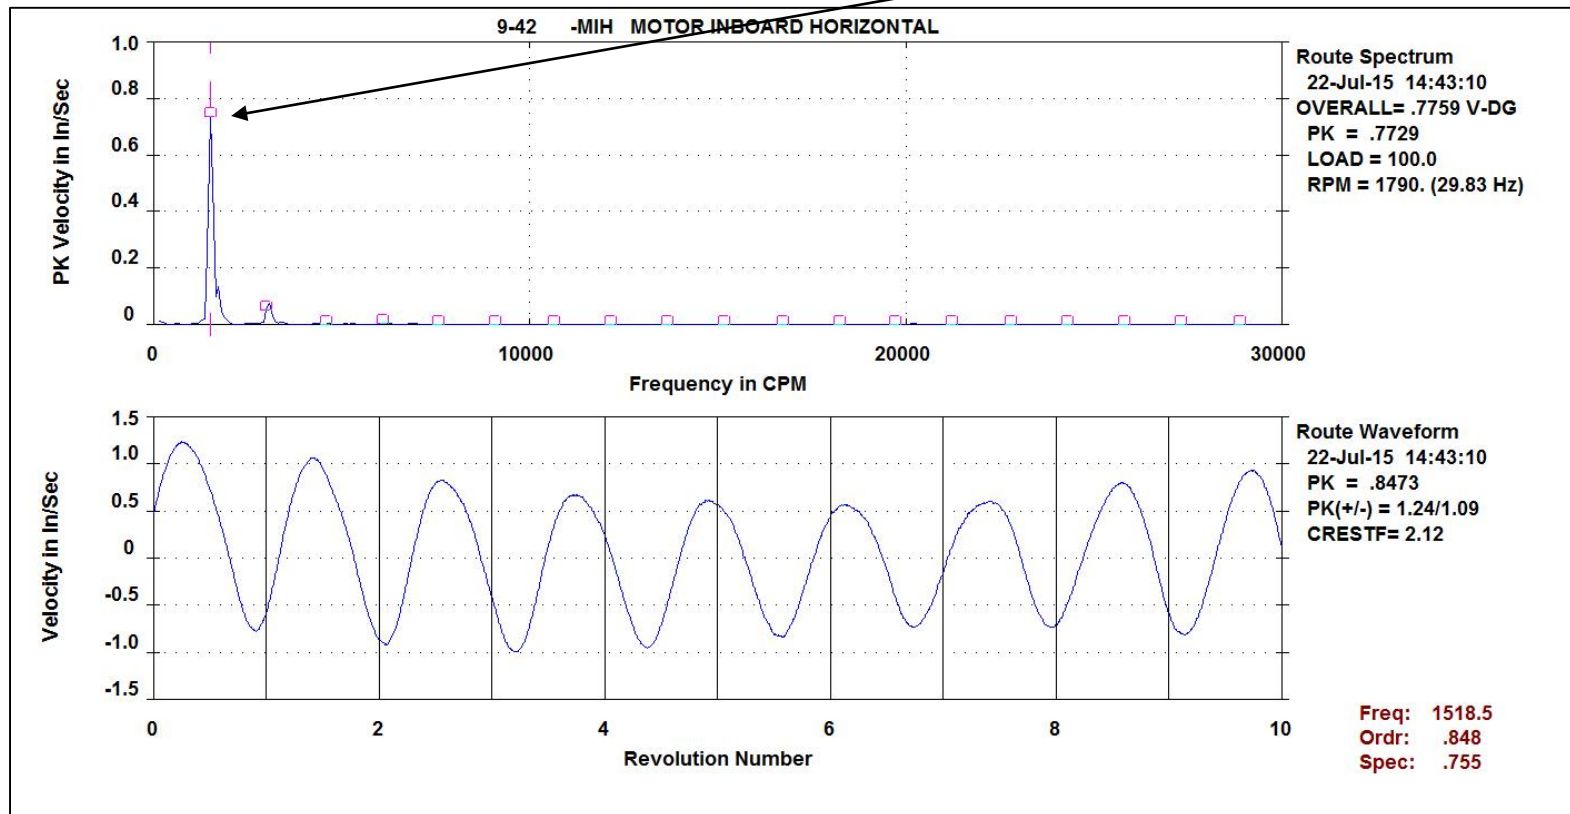
- 7/22/15 – Loose anchor bolt(s) at machine base.
- Significantly higher vibration levels than baseline (0.77 ips-pk).

- Dominant vibration is at $\sim 1,520$ cpm.
- The motor speed is $\sim 1,790$ rpm while the screen speed is $\sim 2,000$ rpm.
- The source of vibration at $\sim 1,520$ cpm was unknown – resonance was suspected with excitation from the motor speed and/or a multiple of belt frequency.
- On-site inspection following collection of the vibration data identified the loose anchor bolts – **being there matters.**
- At least one of the anchor bolts was loose in the concrete.

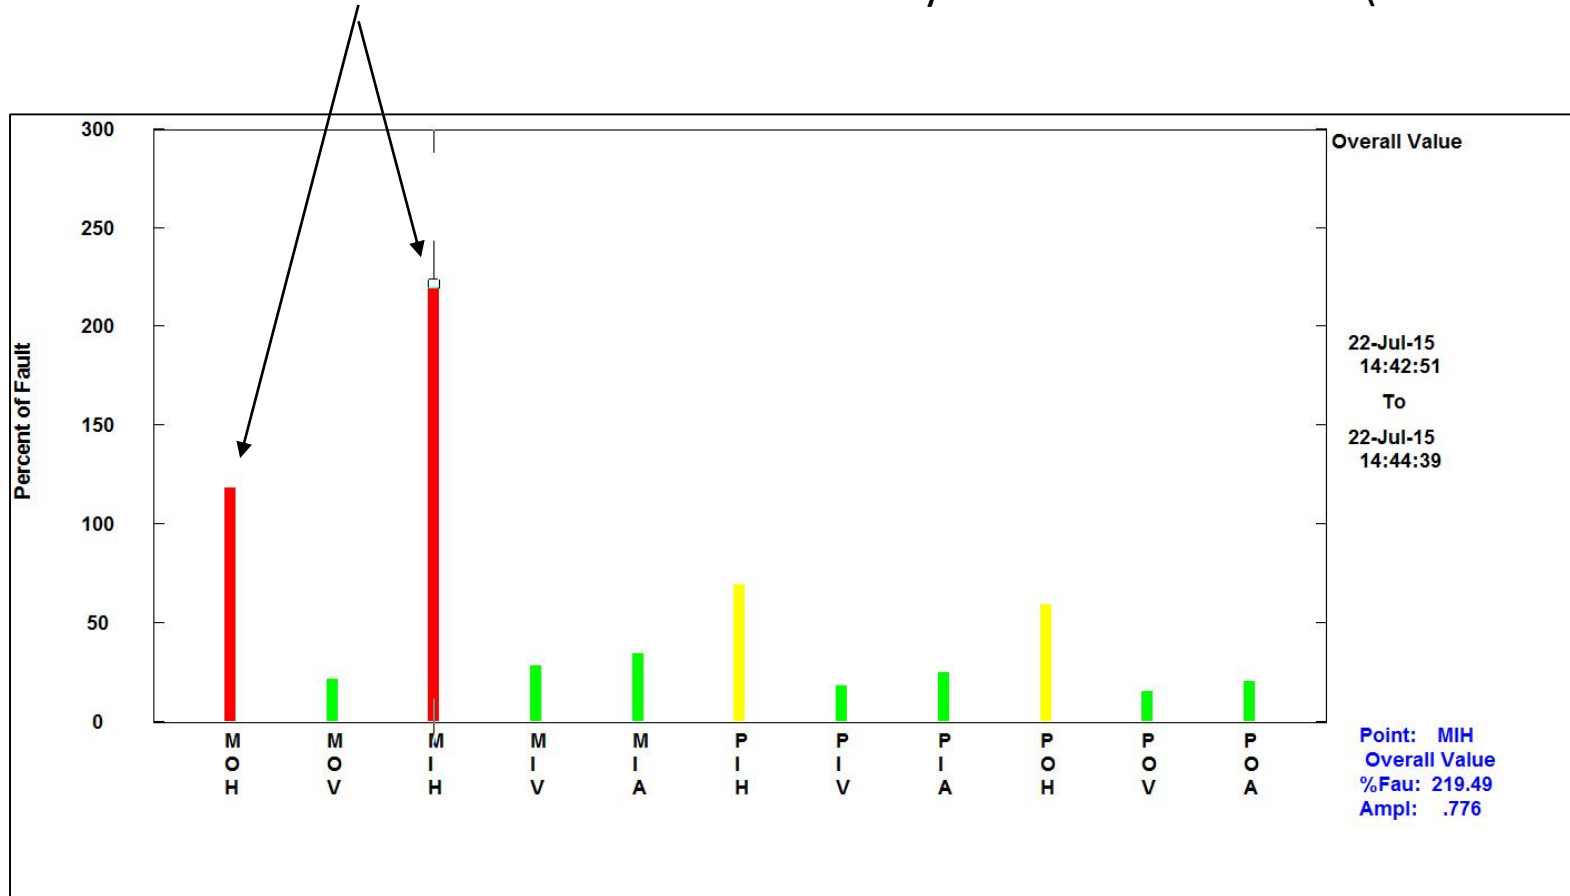
- 7/22/015 – Loose anchor bolt(s) at machine base.
- Profile of overall vibration levels shows very **directional** vibration (horizontal motion).

- Highest levels at the motor, inboard, horizontal (MIH).
- Much lower levels in both the vertical & axial directions.
- On-site inspection following collection of the vibration data identified the loose anchor bolts.
- At least one of the anchor bolts was loose in the concrete.

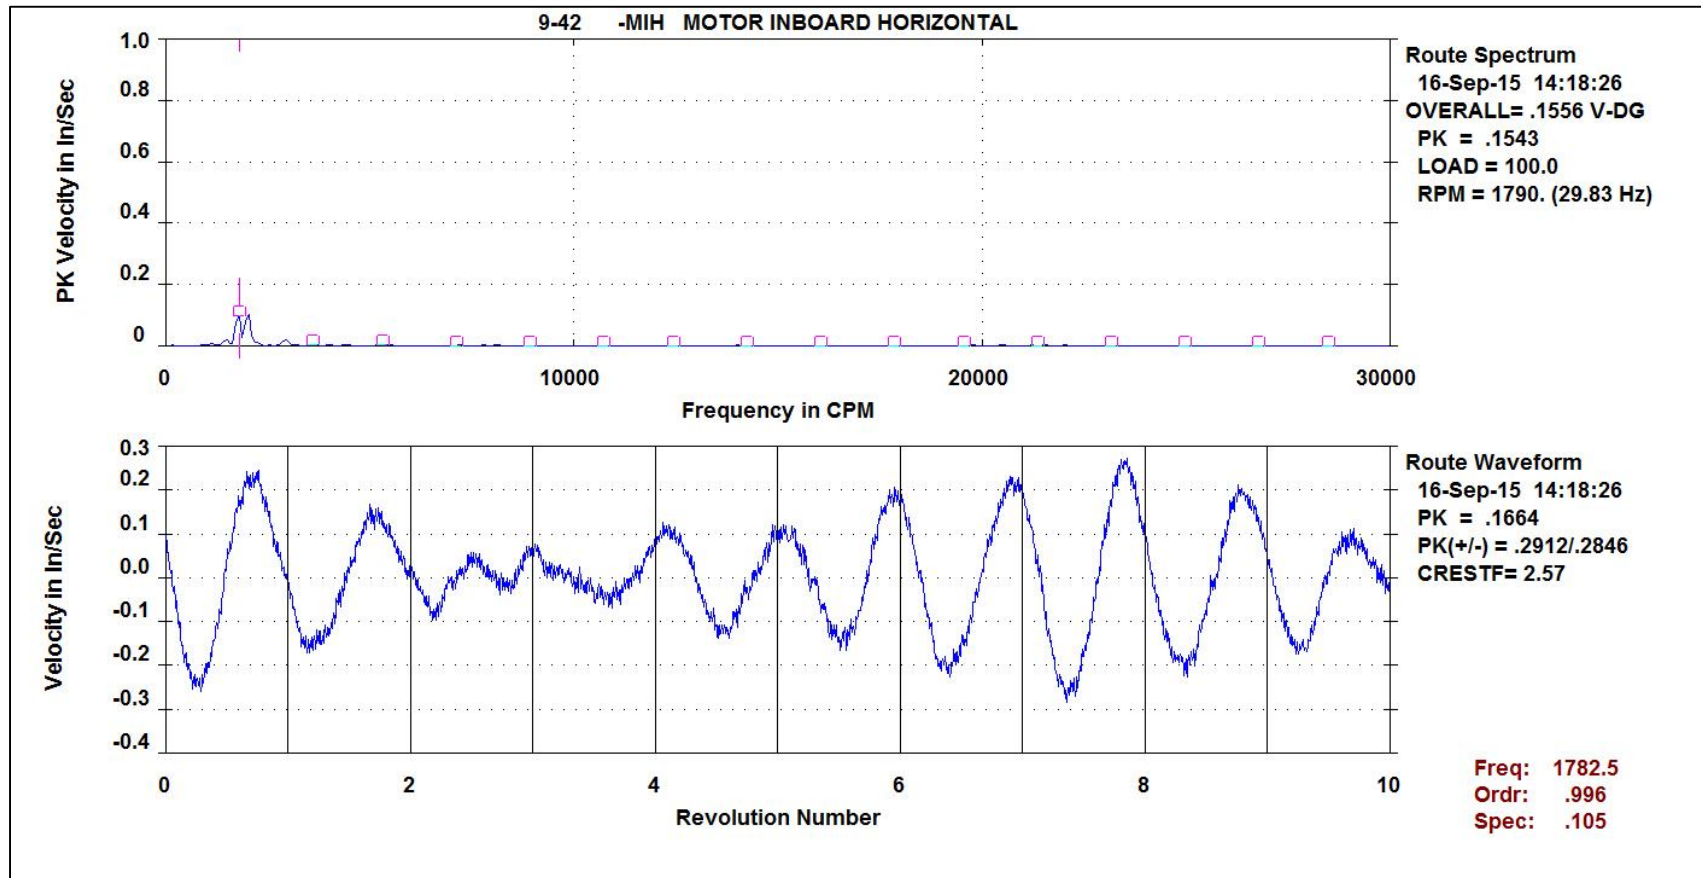
- 9/16/15 – All anchor bolts tightened up.
- Significant drop in overall vibration levels (0.77 ips → 0.16 ips) and elimination of prior vibration at ~ 1,520 cpm..

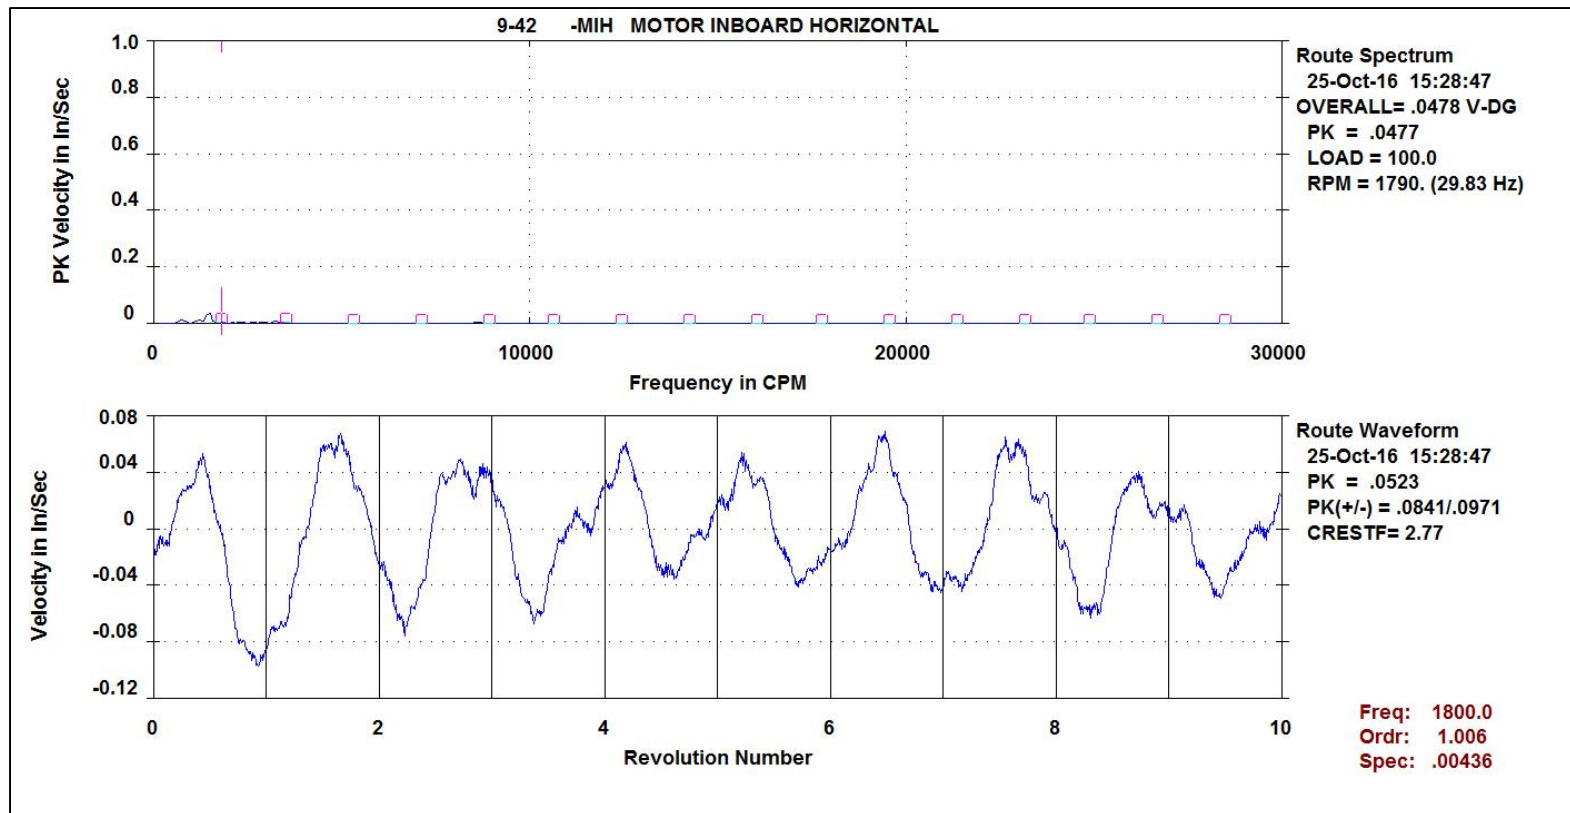
- 10/25/16 – All anchor bolts tightened up again and double-nutted to resist loosening.
- Drop in OA levels again: 0.16 ips \rightarrow 0.05 ips.

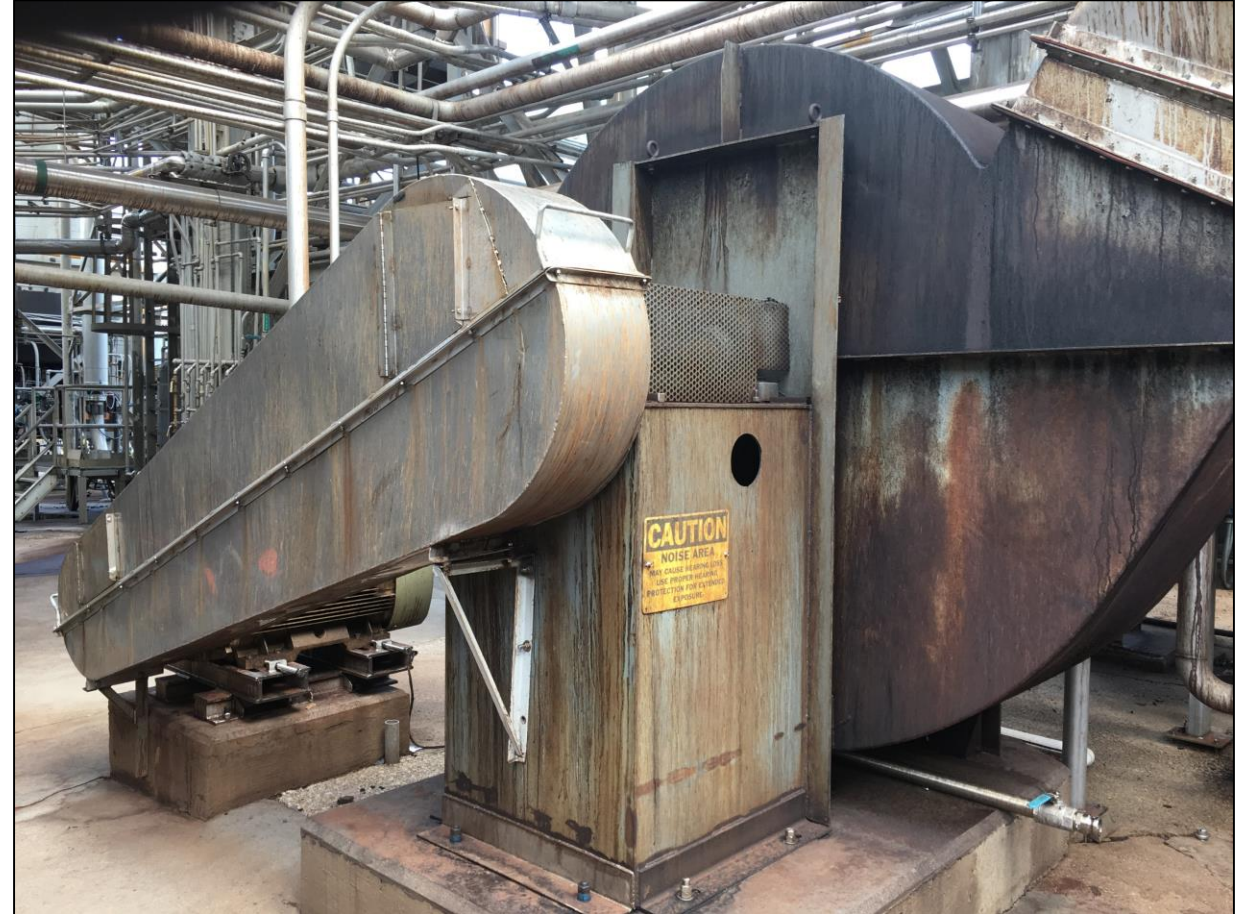
CASE HISTORY 3 – BELT-DRIVEN FAN

- The third case history involves a centrifugal fan driven by a 4-pole induction motor thru a belt-drive.
- The motor operates at $\sim 1,780$ rpm while the fan operates at $\sim 1,000$ rpm.
- The fan is supported by a fabricated steel base bolted to the concrete floor via 6-ea anchor bolts.
- High vibration at the fan speed was occasionally encountered at this machine, but a good cleaning of the fan usually reduced levels to a satisfactory level.
- In the following case history, more than just normal buildup on the fan wheel was at work.

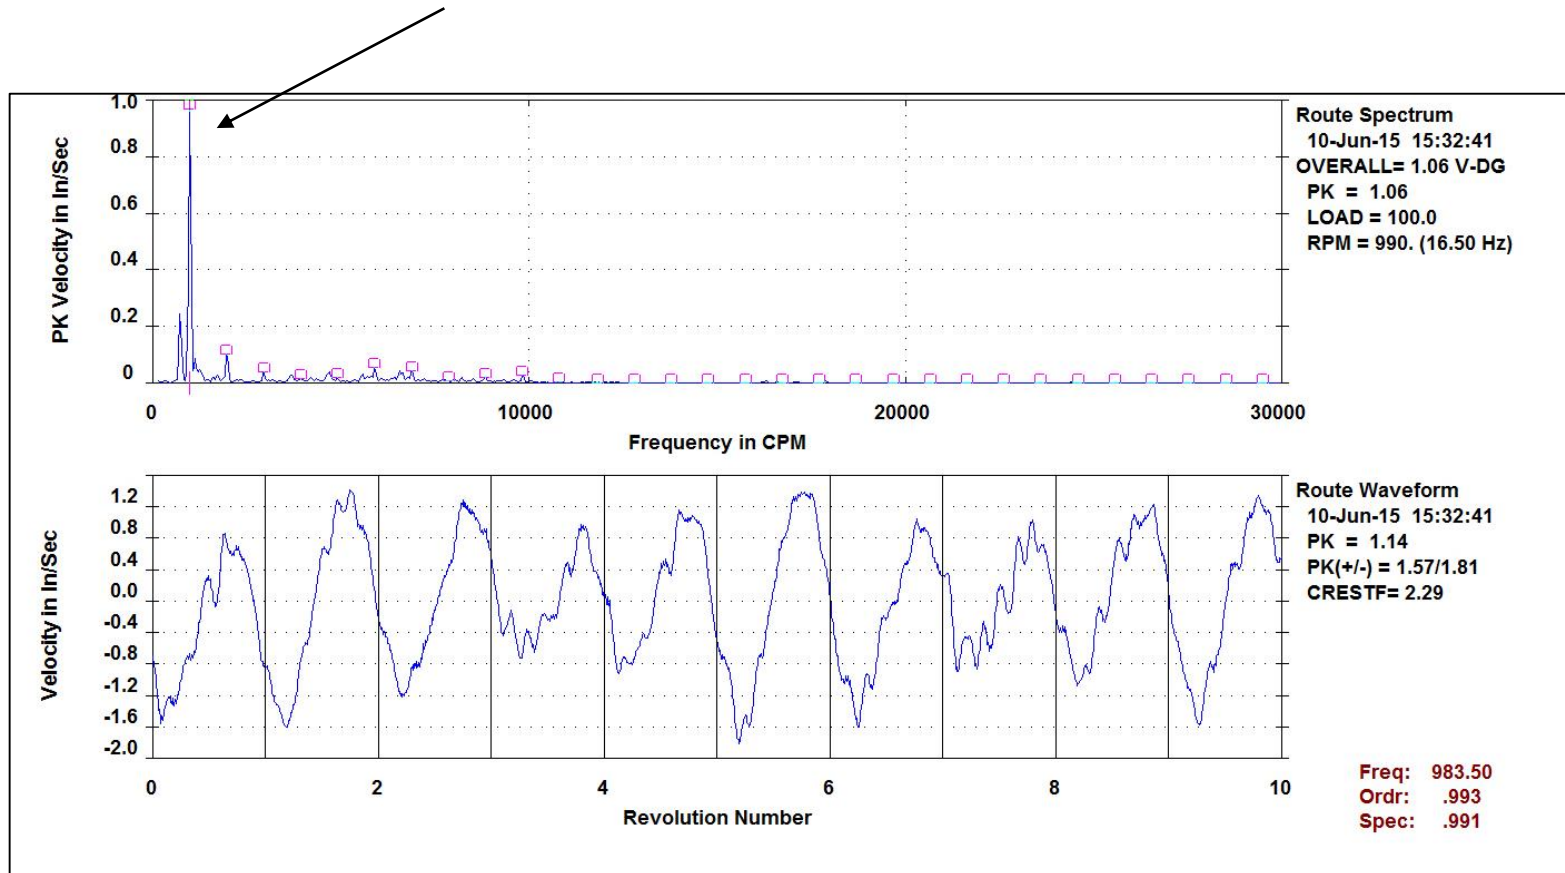
- 6/10/15 – High vibration noted at fan.
- Dominant vibration occurring at 1x fan rpm (984 cpm).

- As this was an over-hung fan, elevated axial vibration at 1x fan speed would be expected if unbalance in the fan wheel were present.
- To the **off-site analyst**, this vibration data would have been saying – unbalance.
- To the **on-site analyst**, the vibration levels in excess of normal prompted an on-site inspection that quickly revealed loose anchor bolts – **being there matters.**

- The moral of this story again is that being there matters.
- In this case history what looked just like overhung fan unbalance in the vibration data in fact turned out to be a case of looseness.
- The loose anchor bolts were at just the **wrong** place for the fan where a small amount of looseness resulted in a significant reduction in stiffness in the axial direction at the fan.
- The reduction in stiffness caused by the loose anchor bolts allowed a lot more vibration to occur from the existing residual fan unbalance.
- **Later impact testing at this fan while it was down during an outage found a natural frequency in the axial direction just above the running speed of 990 rpm, so looseness had caused resonance of the fan assembly in the axial direction.**

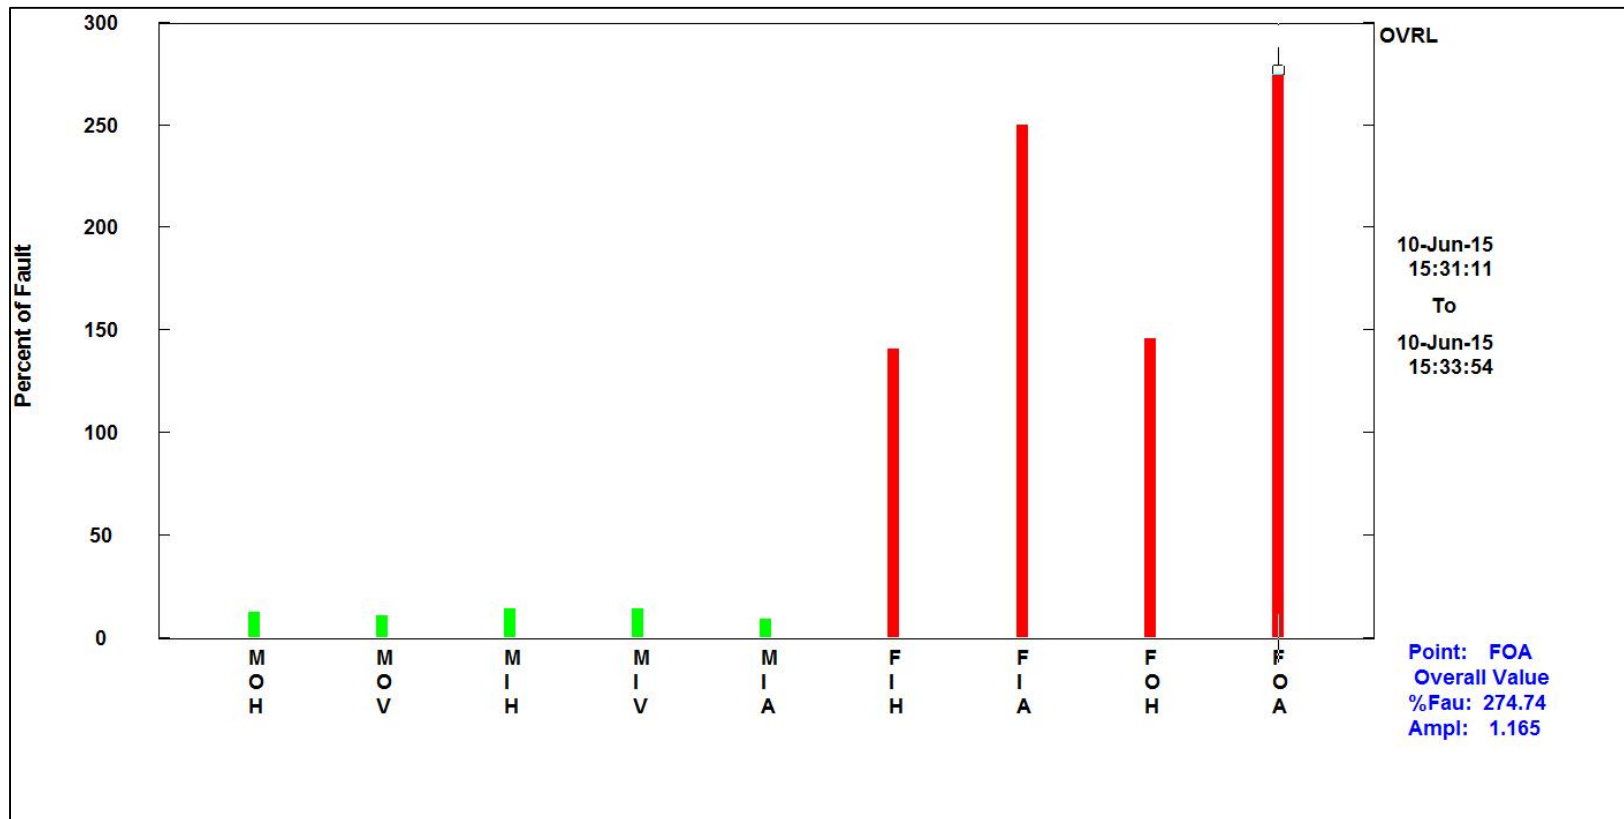
- 6/10/15 – Loose anchor bolts identified.
- Parameter profile plot of overall vibration levels shows dominant vibration at fan with highest levels in axial direction (FOA @ 1.2 ips-pk). This is a common pattern seen when unbalance is present on an over-hung fan wheel.

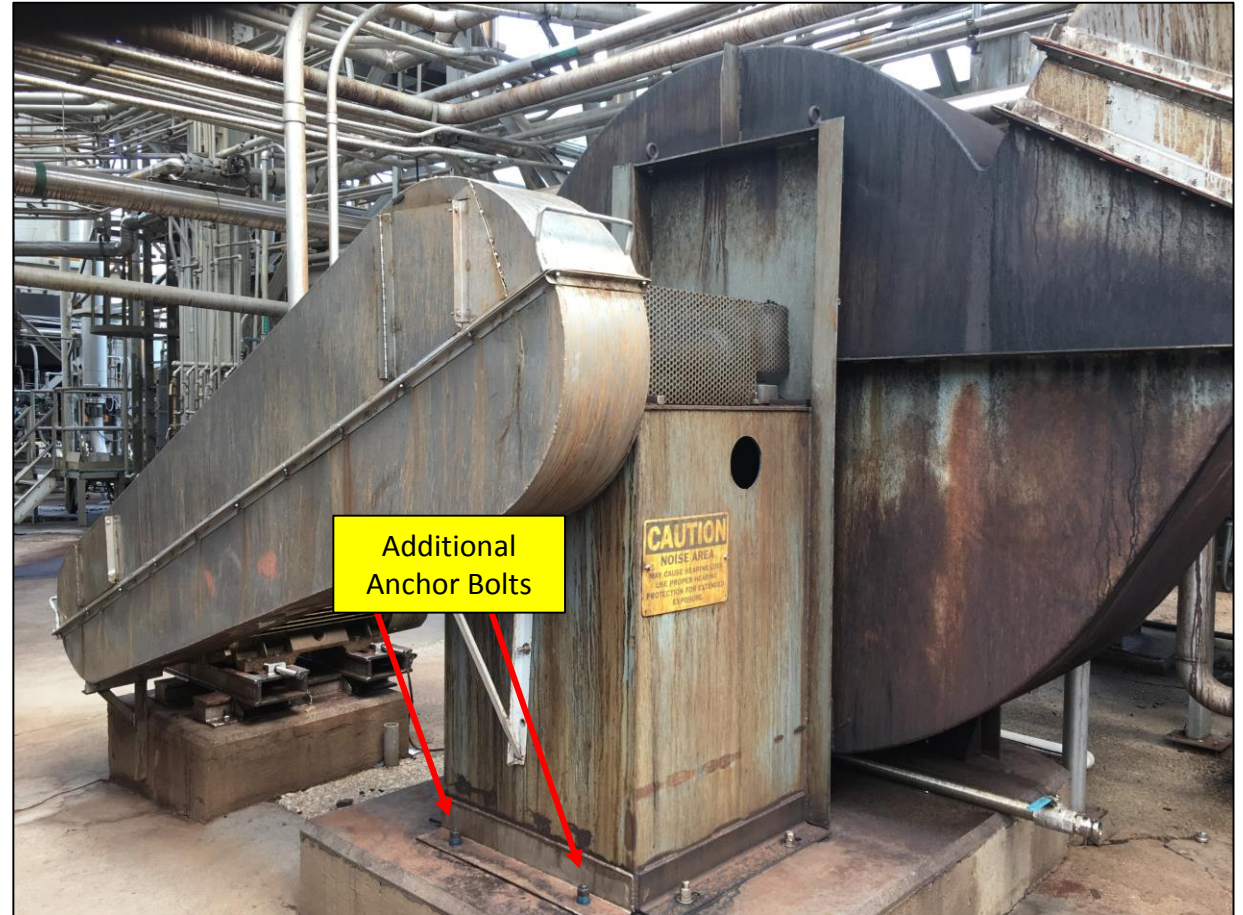
CASE HISTORY 3 – BELT-DRIVEN FAN

- The two red arrows point to the exact locations where additional anchor bolts were added to the fan base.
- Anchor bolts at this location were already present at a nearby sister fan that had experienced no trouble.
- Why these anchor bolts hadn't been installed at this fan in the past was unknown.

- 1/20/16 – Additional anchor bolts added at fan, sheave-end.
- Vibration levels now low & acceptable at 0.13 ips-pk maximum with dominant vibration at fan 1x rpm (984 cpm).
- Significant improvement in vibration levels (from 1.2 ips → 0.13 ips).

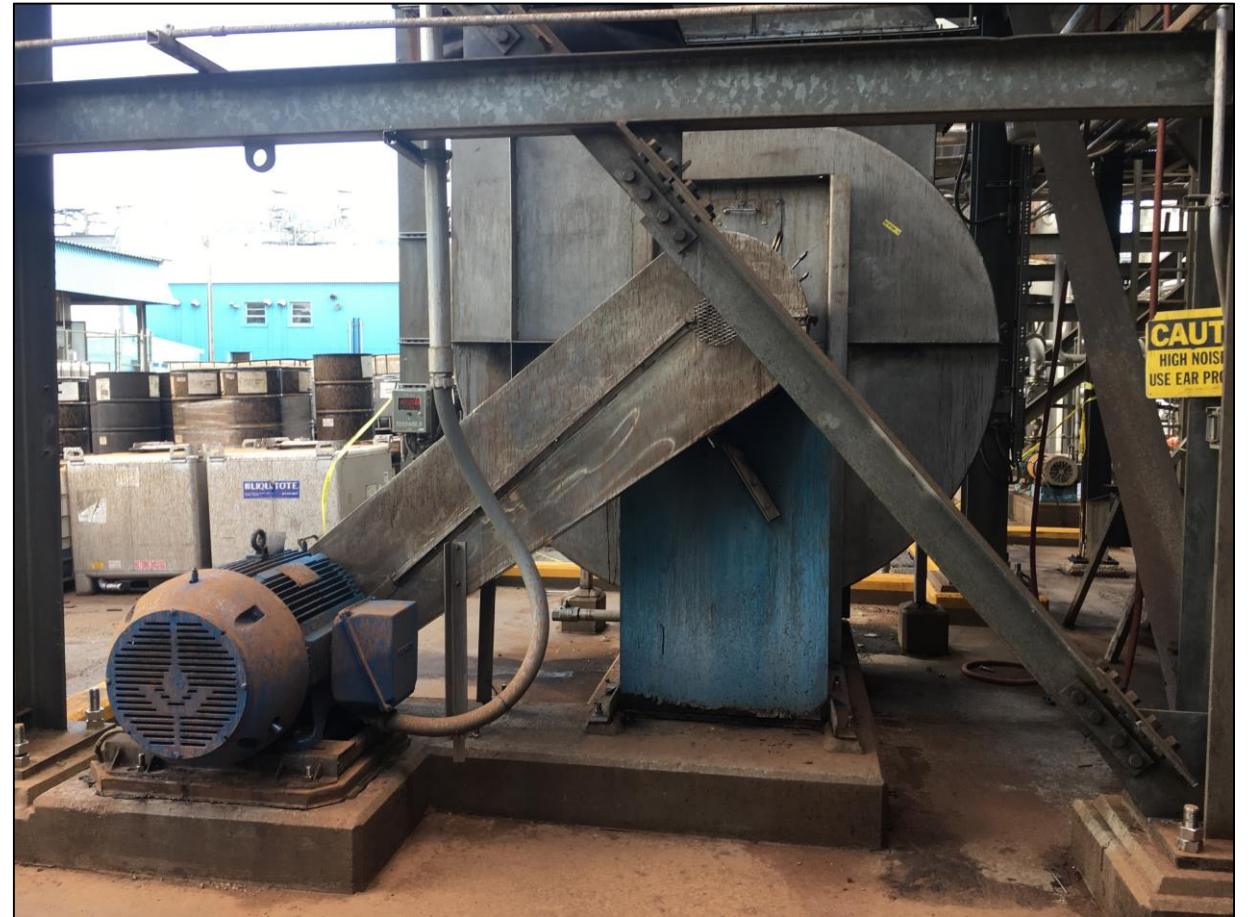
CASE HISTORY 4 – BELT-DRIVEN FAN

- The fourth case history also involves a centrifugal fan driven by a 4-pole induction motor thru a belt-drive.
- The motor operates at $\sim 1,790$ rpm while the fan operates at ~ 990 rpm.
- The fan is supported by a fabricated steel base bolted to the concrete floor via 6-ea anchor bolts.
- High vibration at the fan speed was occasionally encountered at this machine, but a good cleaning of the fan usually reduced levels to a satisfactory level.
- In the following case history, more than just normal buildup on the fan wheel was at work.

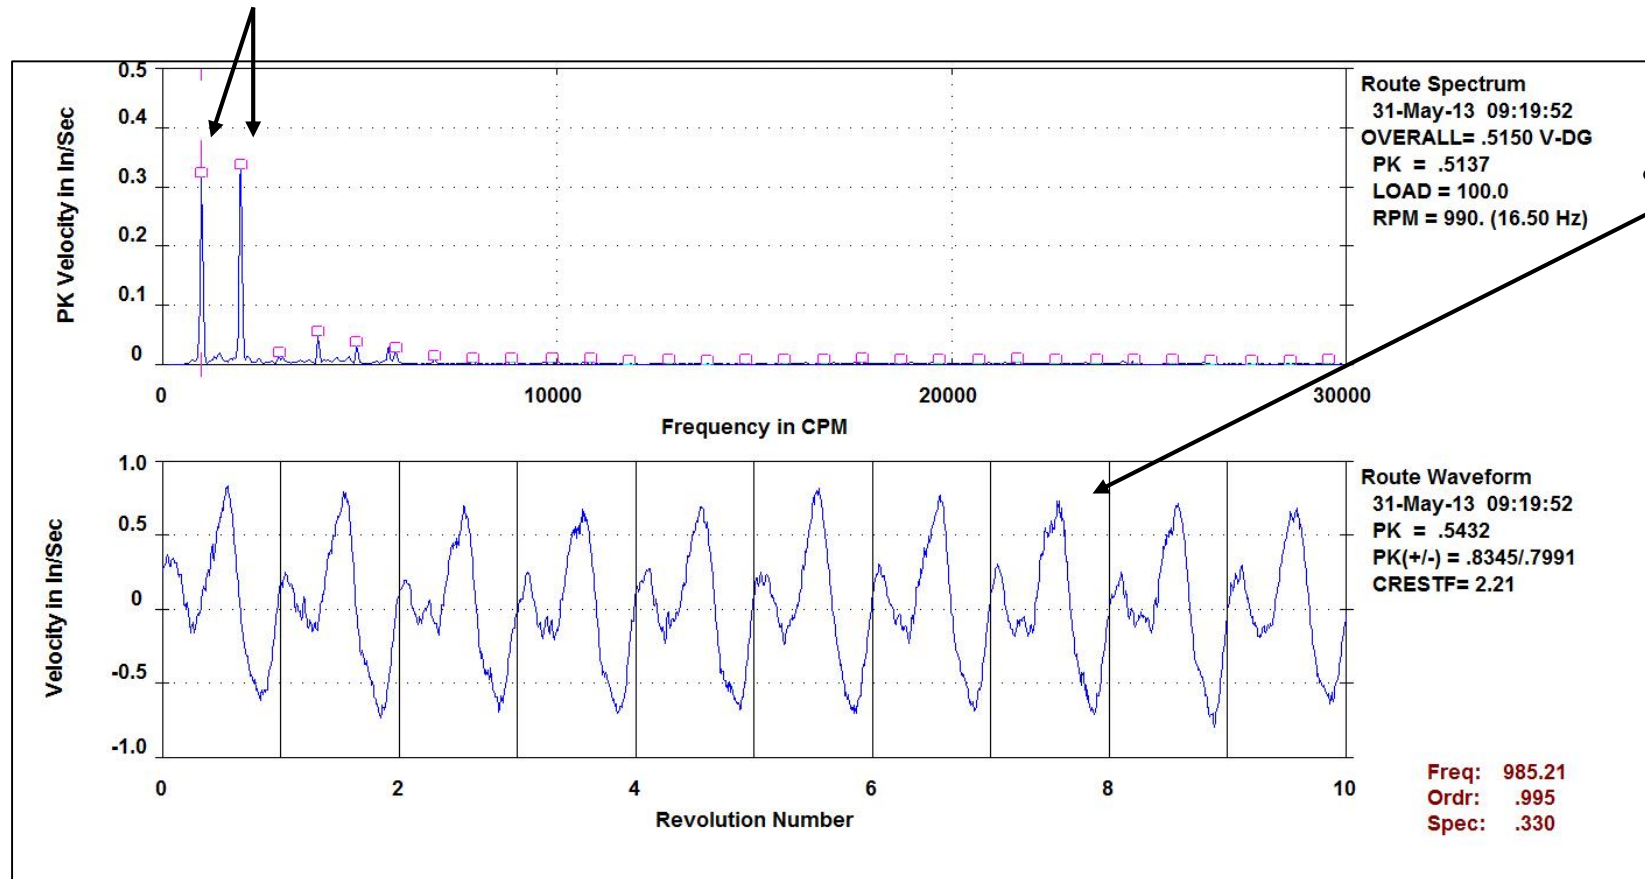
- 5/31/13 – Cracked welds identified at left side of fan frame near outboard bearing.
- Much higher vibration levels (0.51 ips) with dominant vibration at 1x rpm & 2x rpm of fan (type “B” looseness).

• Note the distortion of the waveform.
