STIFFNESS & MACHINE VIBRATION

Barry T. Cease

Vibration Institute, Annual Conference, July 2018

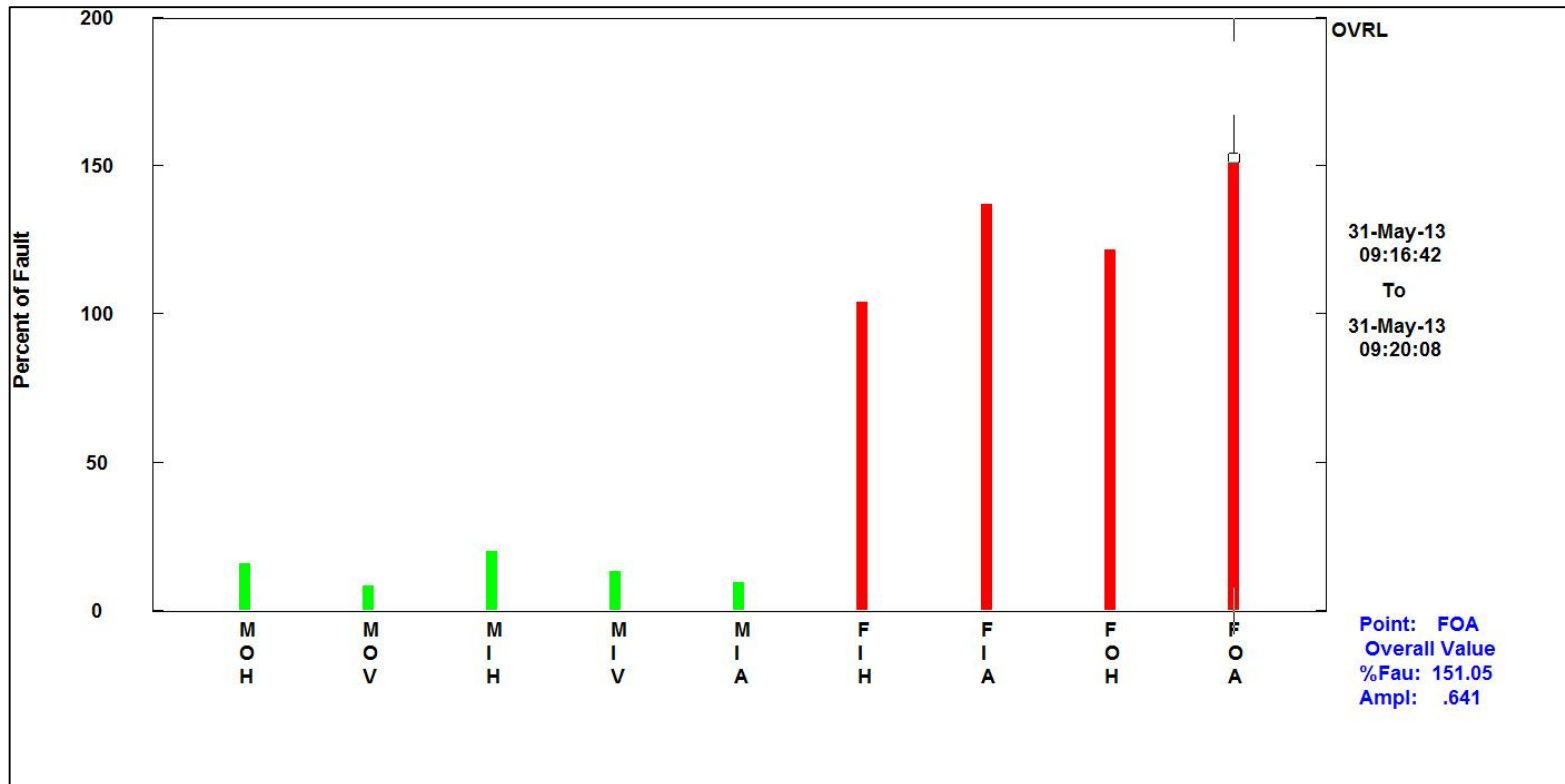
- 5/31/13 – Cracked welds identified at fan frame near outboard bearing; unbalance at fan wheel also possible.
- Much higher vibration levels with dominant vibration at 1x rpm & 2x rpm of fan (type “B” looseness).
- Note how problem is only at fan measurements, no issues seen at motor (low levels there).

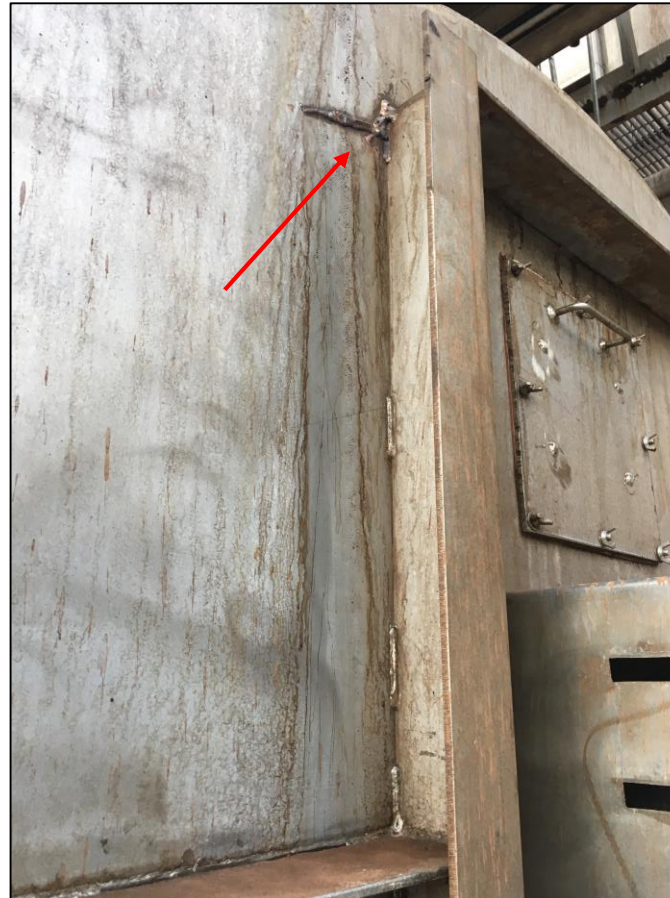
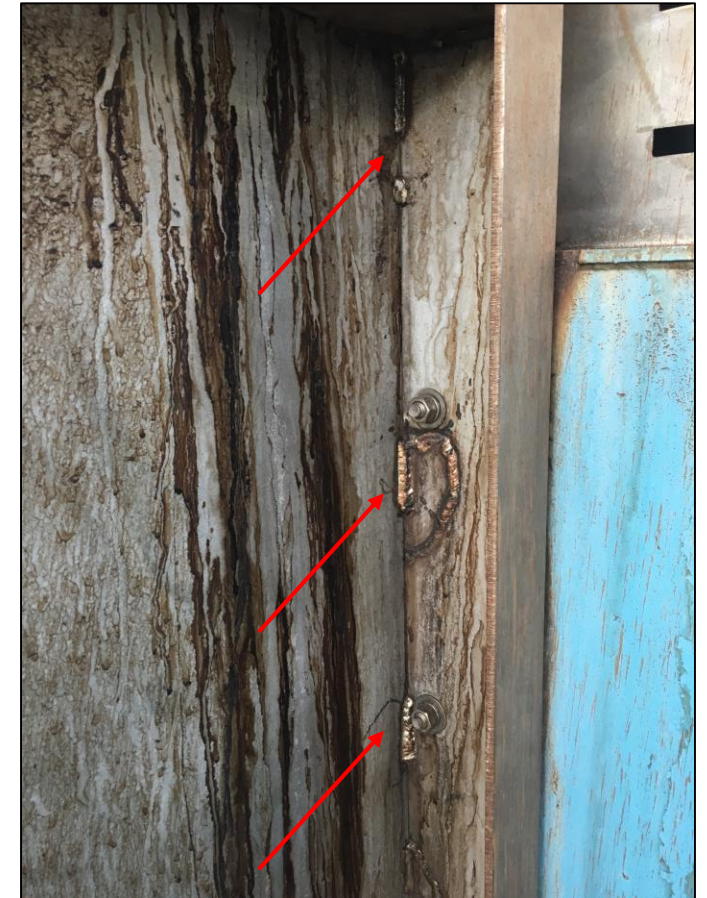
- 5/31/13 – Cracked welds identified at fan frame near outboard bearing; unbalance at fan wheel also possible.
- Much higher vibration levels with dominant vibration at 1x rpm & 2x rpm of fan (type “B” looseness).
- From photos at right you can see where these cracks were welded up. The fan shroud attaches to its supporting structure (angle and channel) via welds. A few of these welds were completely cracked and broken on the left side of the shroud only.
- **The cracked welds reduced the stiffness of the fan ONLY on the left side creating ASYMMETRIC stiffness from left to right (potential source for elevated 2x rpm).**

- Moral of this story:
 - 1) Reductions in stiffness are not always due to loose bolts. Inspect for cracked welds or broken components, etc.
 - 2) Asymmetric stiffness can be a source of vibration at 2x rpm.

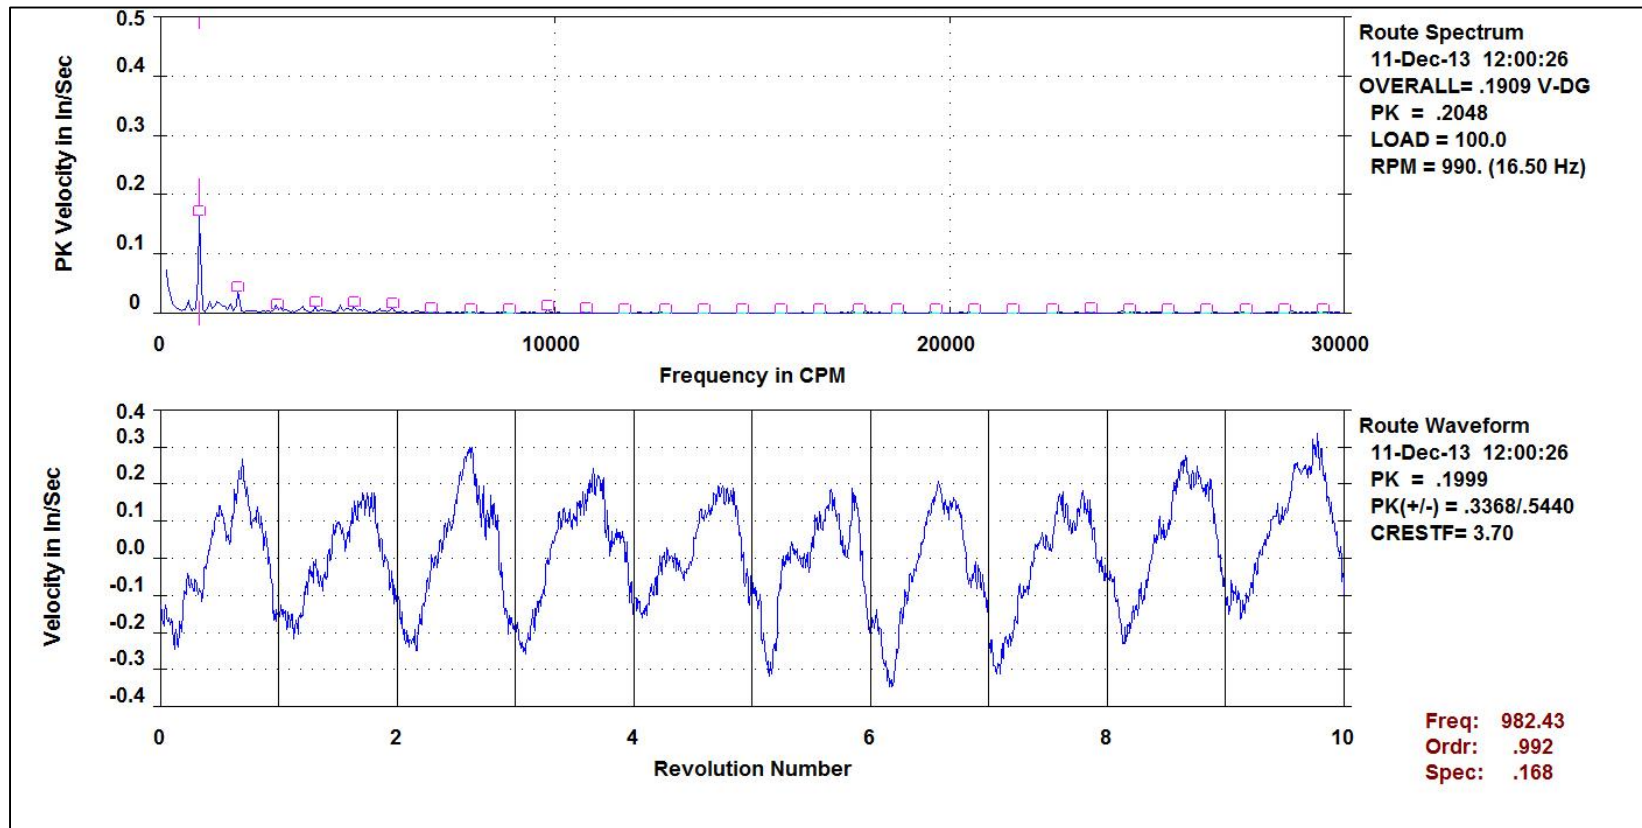
- 12/11/13 – Cracked welds repaired and fan wheel cleaned.
- Much lower vibration levels and significant reduction at 2x rpm.

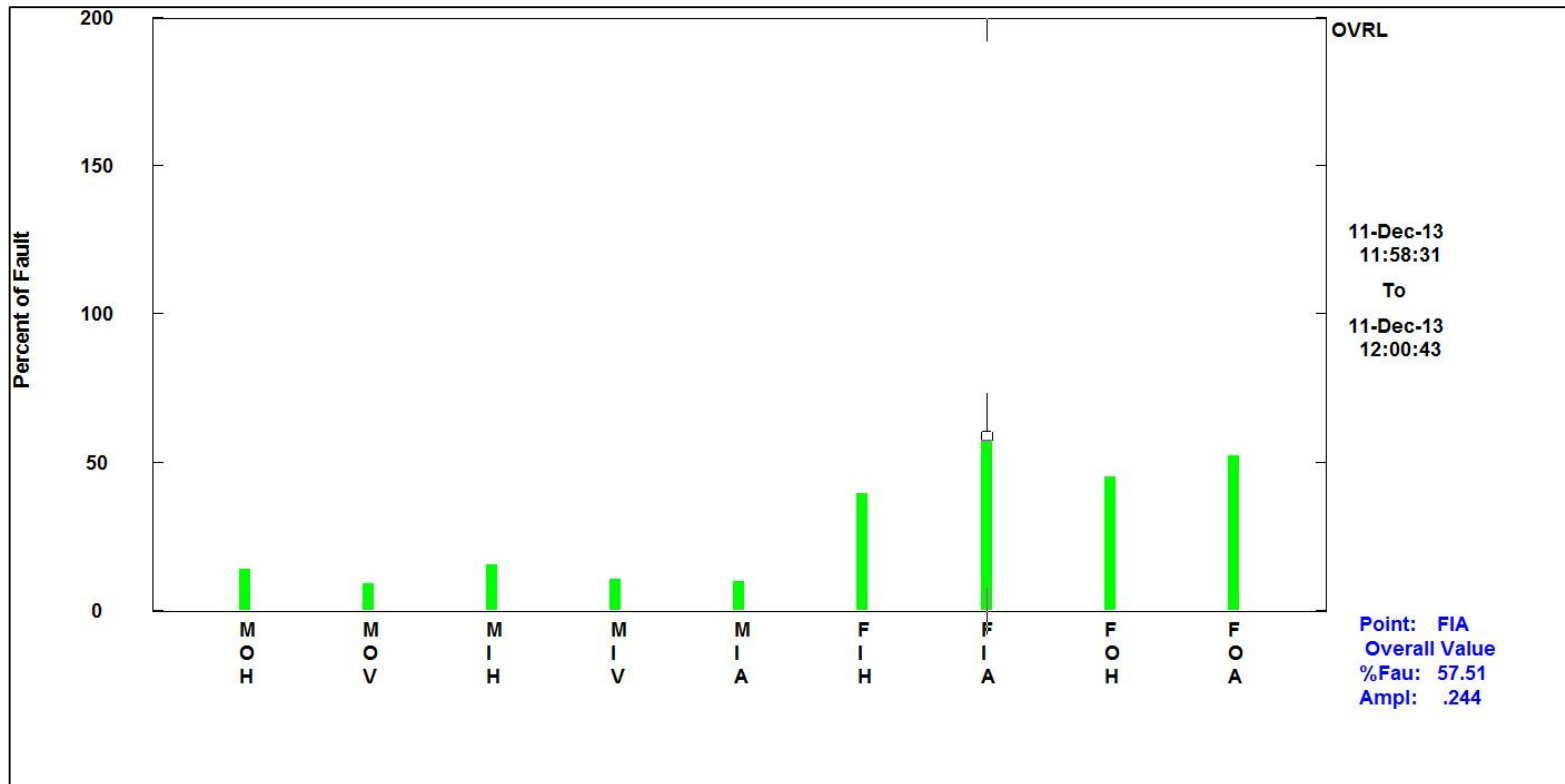
- 12/11/13 – Cracked welds repaired and fan wheel cleaned.
- Profile plot of overall vibration levels shows highest level at 0.24 ips-pk at fan, inboard, axial.

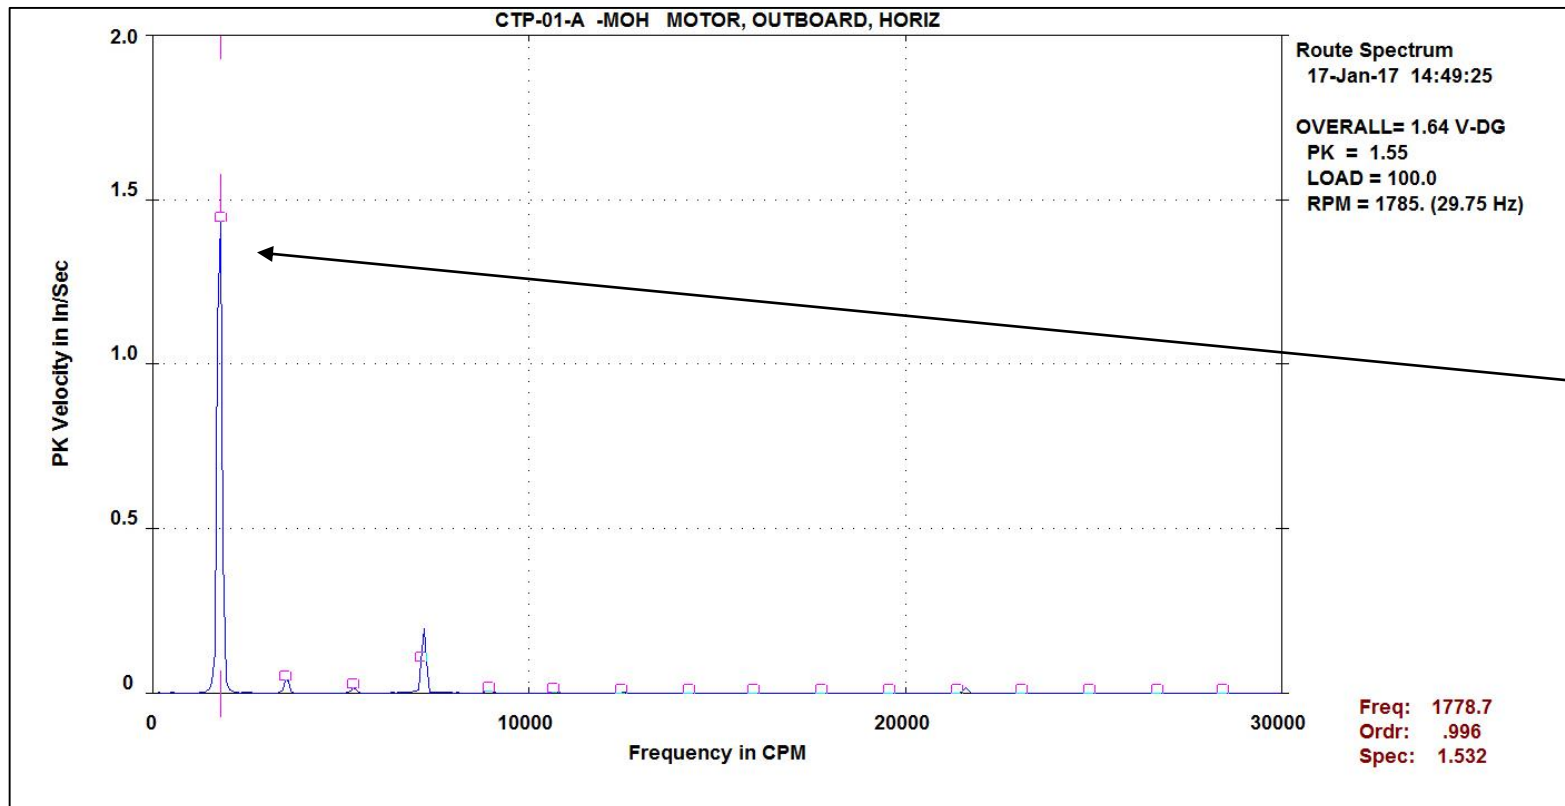
- 1/17/17 – Routine vibration survey noted severe horizontal vibration levels at motor. Levels much higher than previous levels.
- Loose anchor bolts at the motor-end of the machine base had been identified from the prior survey and repaired by the plant.

- Spectral data showed dominant vibration at the machine speed of ~ 1,780 rpm.

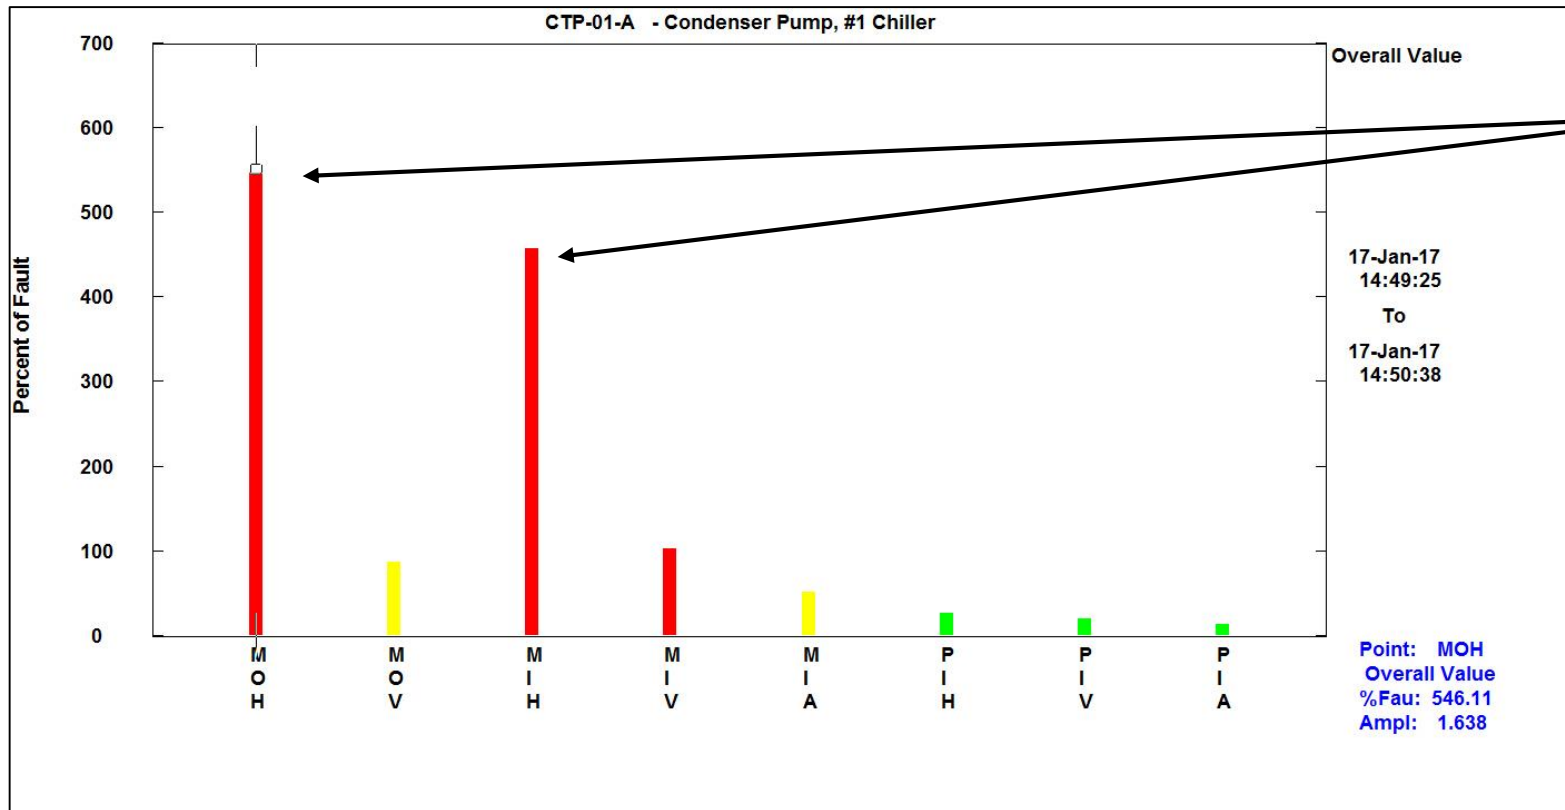
- 1/17/17 – Routine vibration survey noted severe horizontal vibration levels at motor. Levels much higher than previous levels. Loose anchor bolts at the motor-end of the machine base had been identified from the prior survey and repaired by the plant.

- Profile plot of overall vibration levels showed **very directional vibration (horizontal) and very localized vibration (motor only)**.
- No problems seen at any pump measurement.

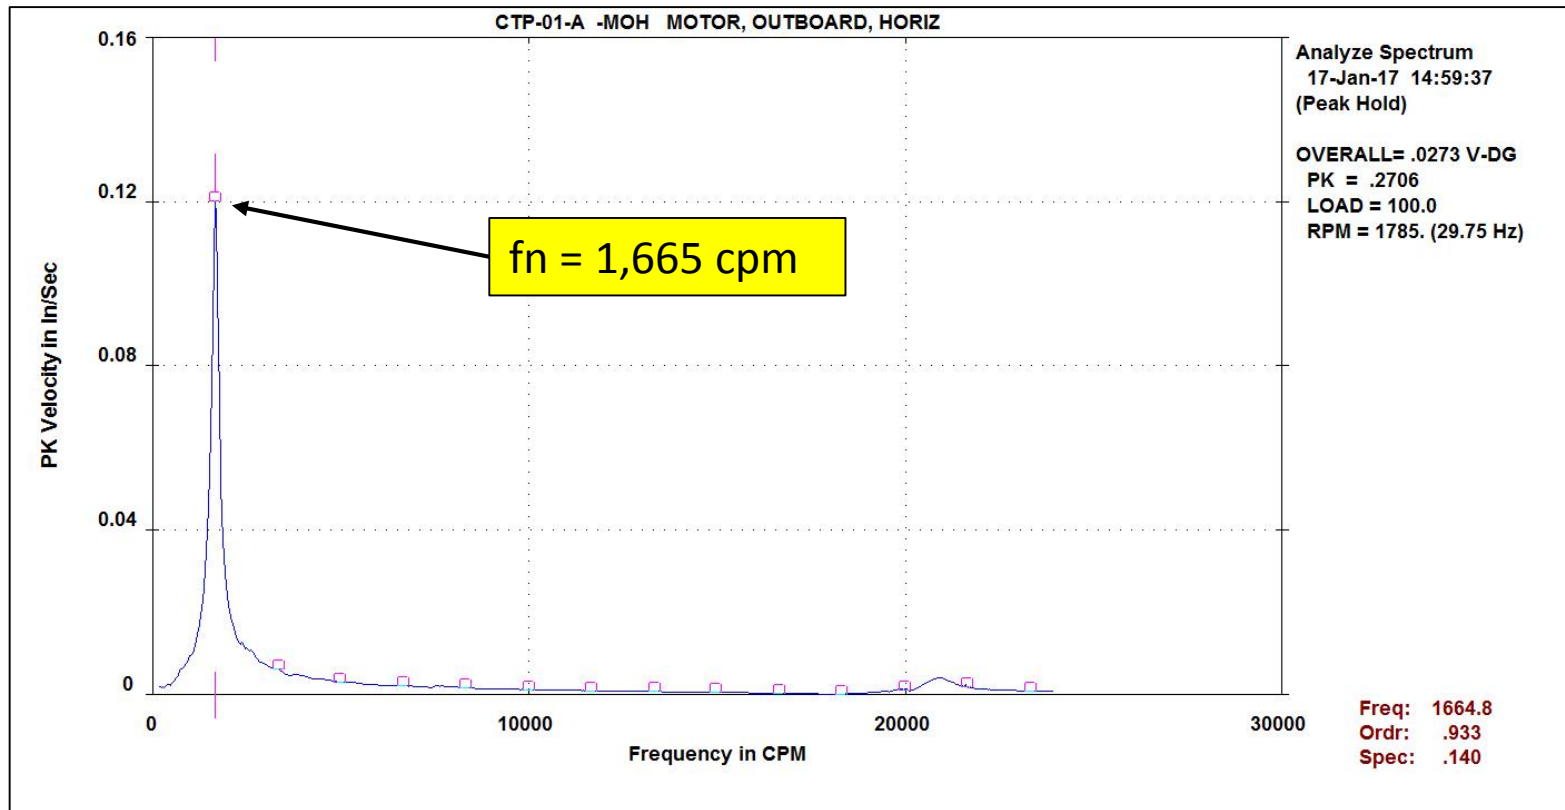
- 1/17/17 – As the prior levels were not nearly this high **and** it was known that the only repairs performed was to tighten all anchor bolts, the decision was made to slightly loosen one of the two anchor bolts at the motor outboard end (where the vibration was).

- A follow-up bump test confirmed a reduction in the natural frequency from 1,782 cpm (tight anchor bolt) to 1,665 cpm (loose anchor bolt).

- The tightening of the anchor bolts raised our horizontal natural frequency right into resonance with the machine speed of ~ 1,780 rpm.
- By loosening one anchor bolt at the motor end, we reduced the stiffness in the horizontal direction at the right location and moved our natural frequency sufficiently away from the machine speed to avoid resonance.

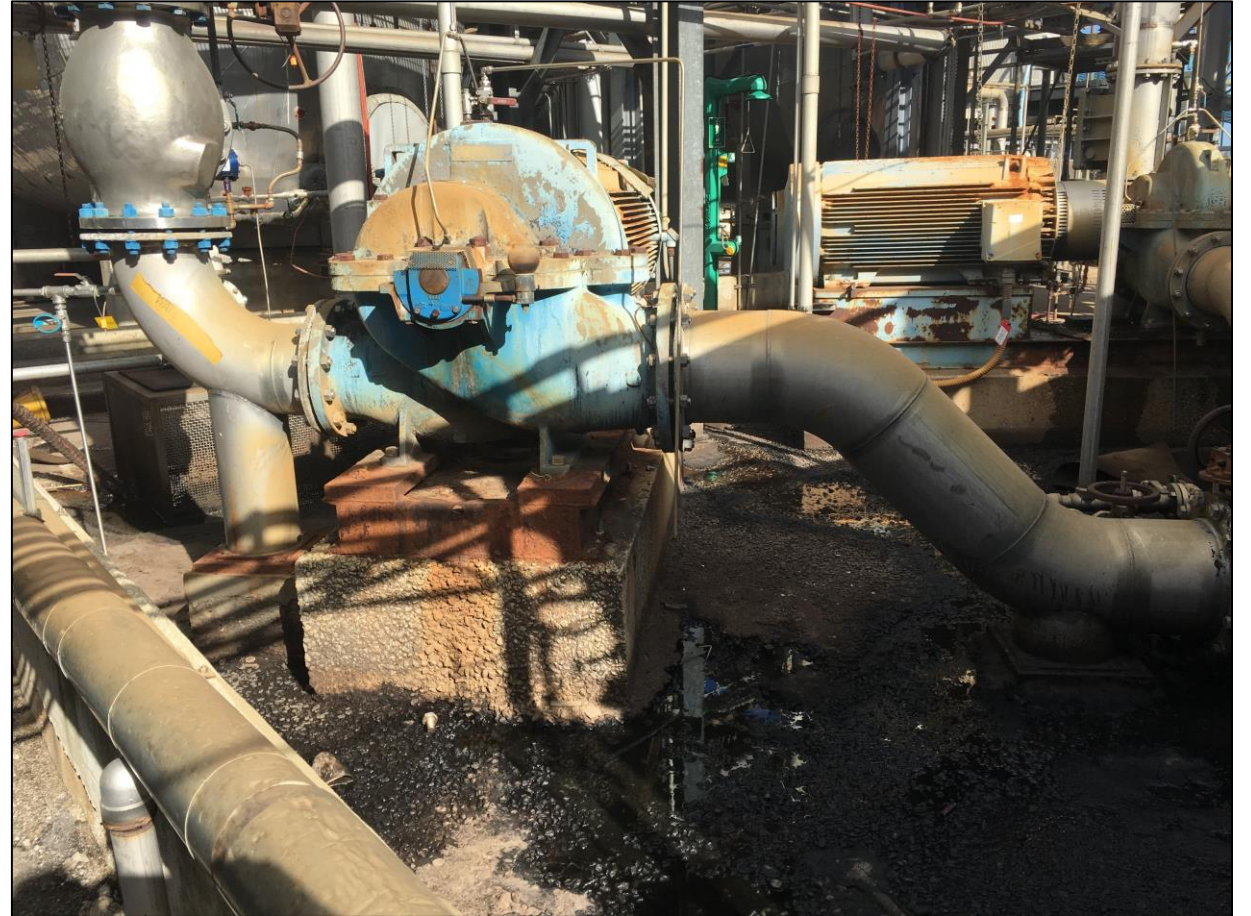
CASE HISTORY 6 – CENTRIFUGAL PUMP

- The sixth case history involves a horizontal, centrifugal pump driven by a 4-pole motor operating at $\sim 1,790$ rpm.
- Photo at right shows the view from the pump outboard end of this machine.

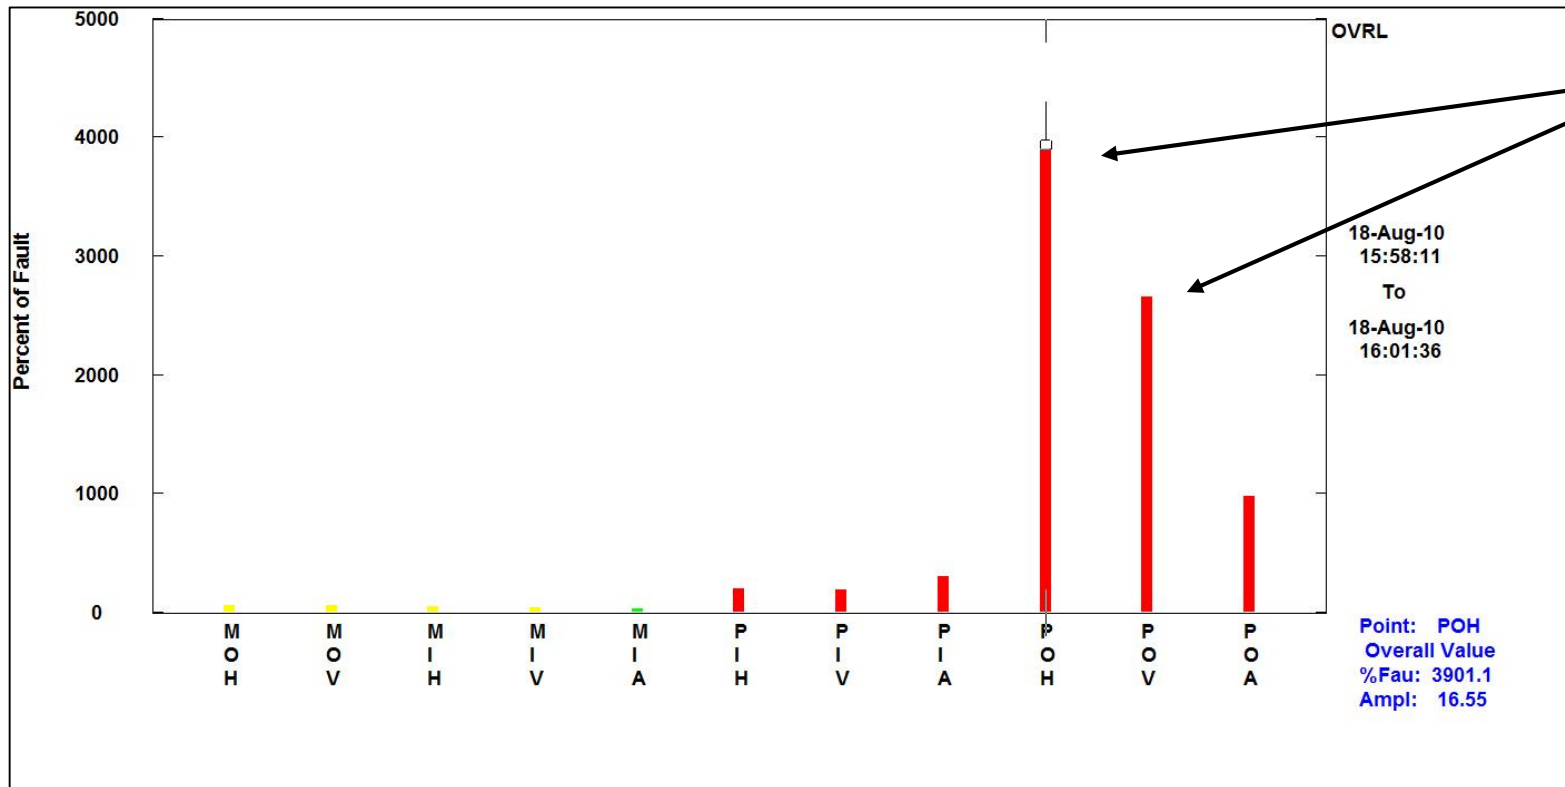
- Profile plot of overall vibration levels showed **localized vibration concentrated at pump outboard bearing.**

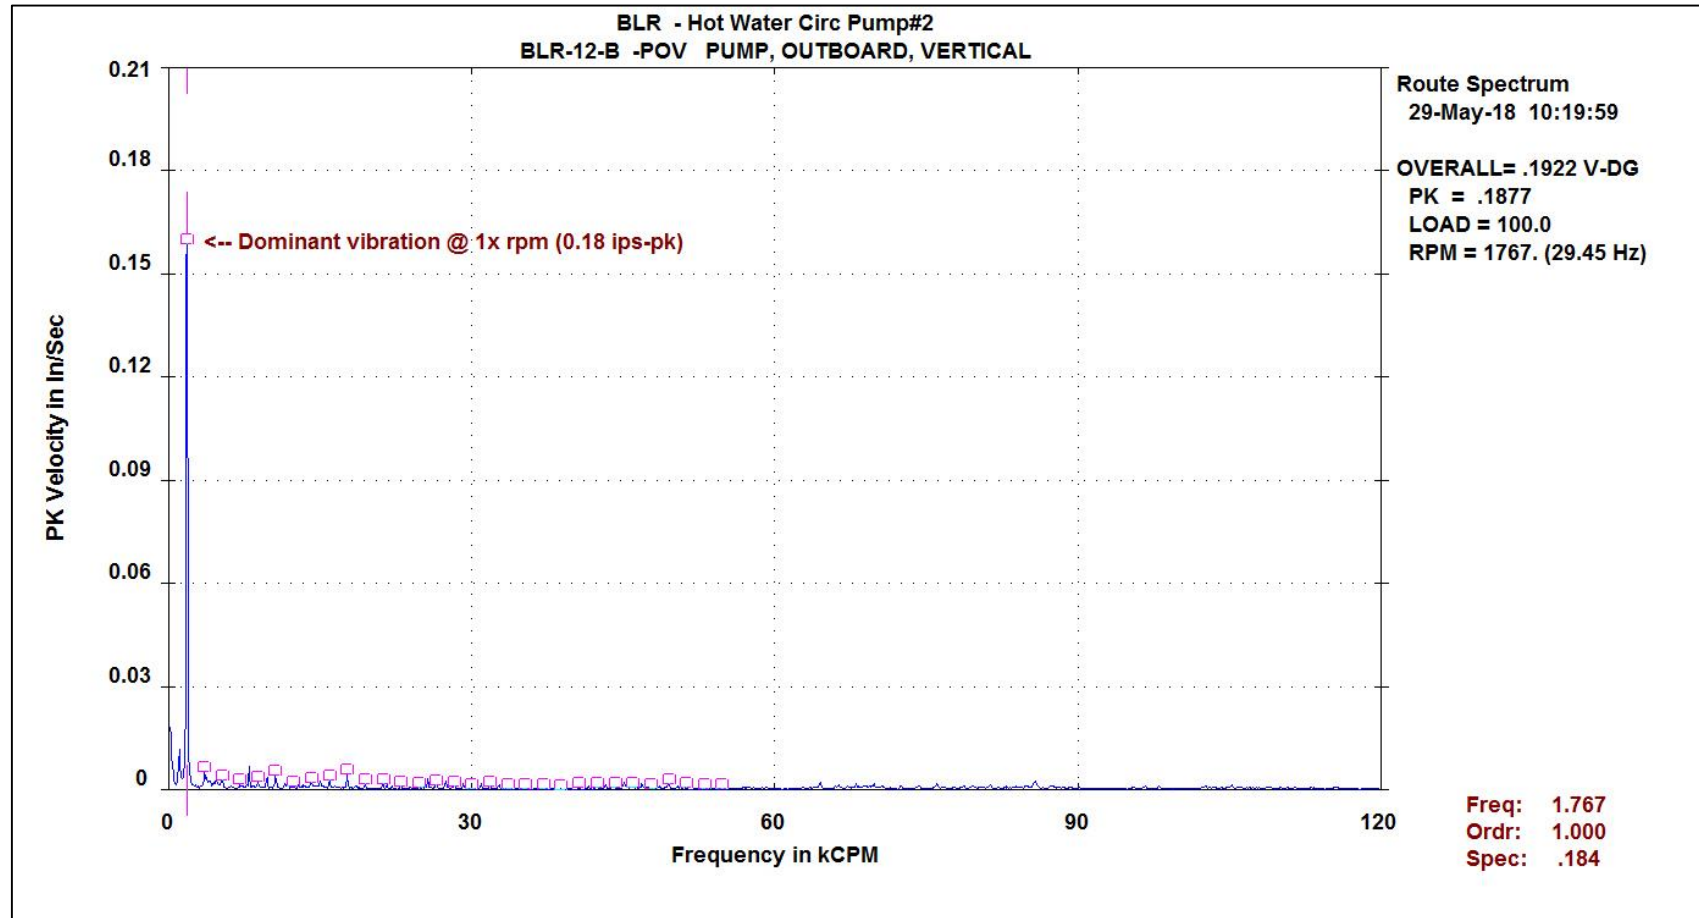
CASE HISTORY 7 – PUMP WITH VERTICAL VIBRATION

- Dominant frequency of vibration at the points of highest vibration was at 1x rpm (1,767 rpm).

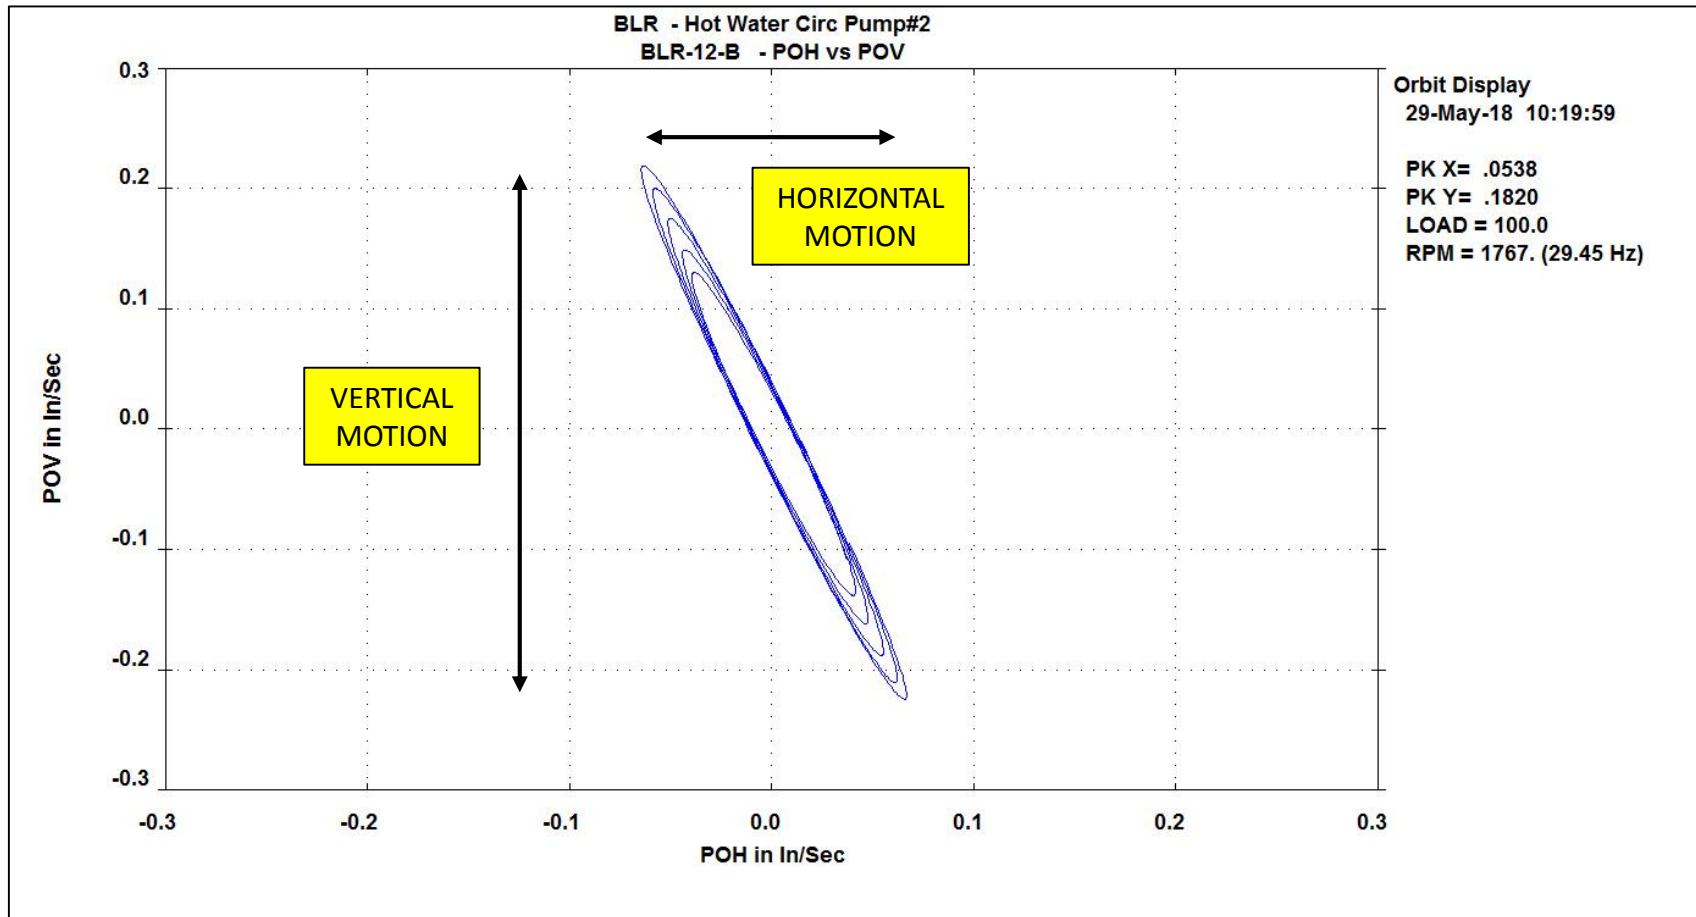
- Orbit plot of the pump outboard bearing filtered at the running speed 1x rpm (~ 1,767 rpm).
- Note how the overwhelming amount of motion is in the vertical direction.
- Compare ~ 0.4 ips-pk-pk vertical (POV) .vs. 0.12 ips-pk-pk horizontal (POH).
- Note how the orbit plot provides a good visual sense for what is going on at this pump.
- Remember how a symptom or fingerprint of looseness is directional vibration.
