What Makes an Award Winning PdM Program ?

Ted Royal

Duke Energy-Catawba Nuclear Site

September 11, 2009

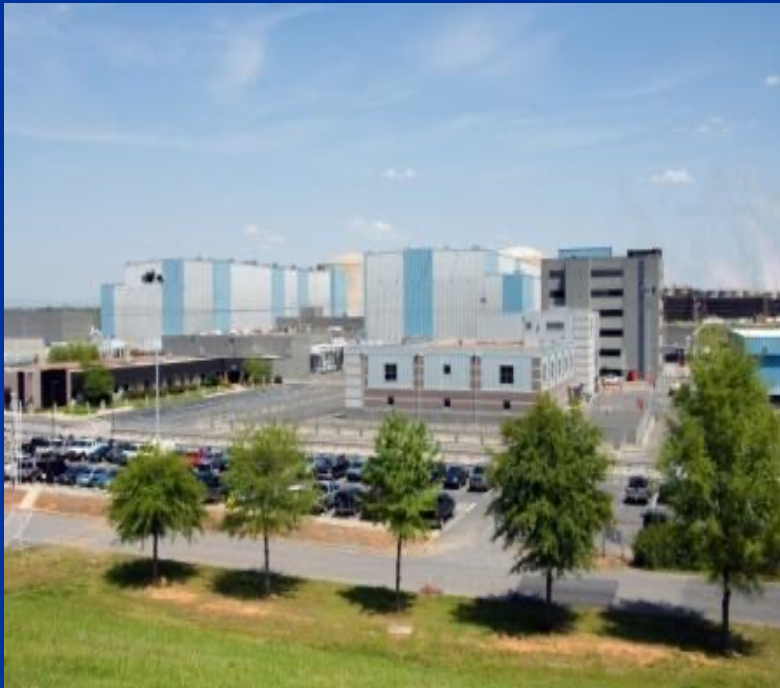
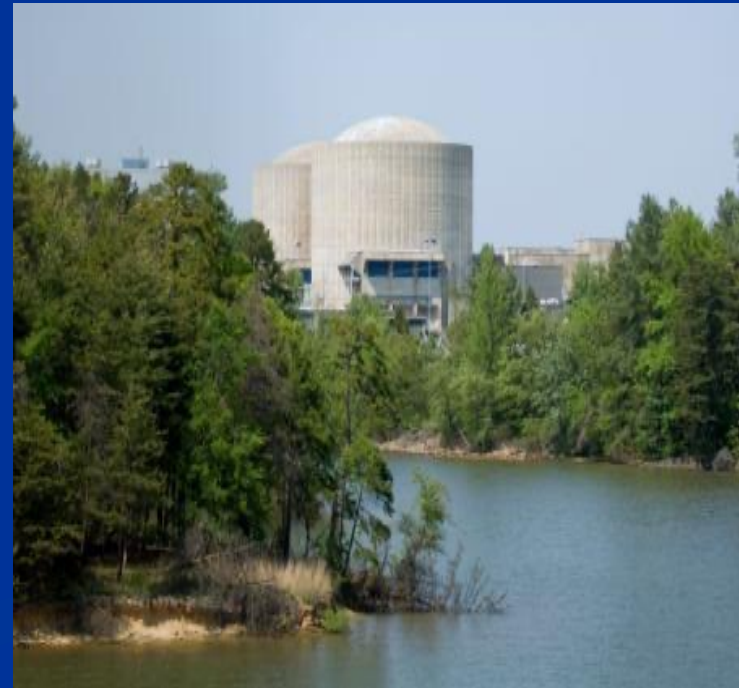
Infrared Scan of Catawba at 3 am

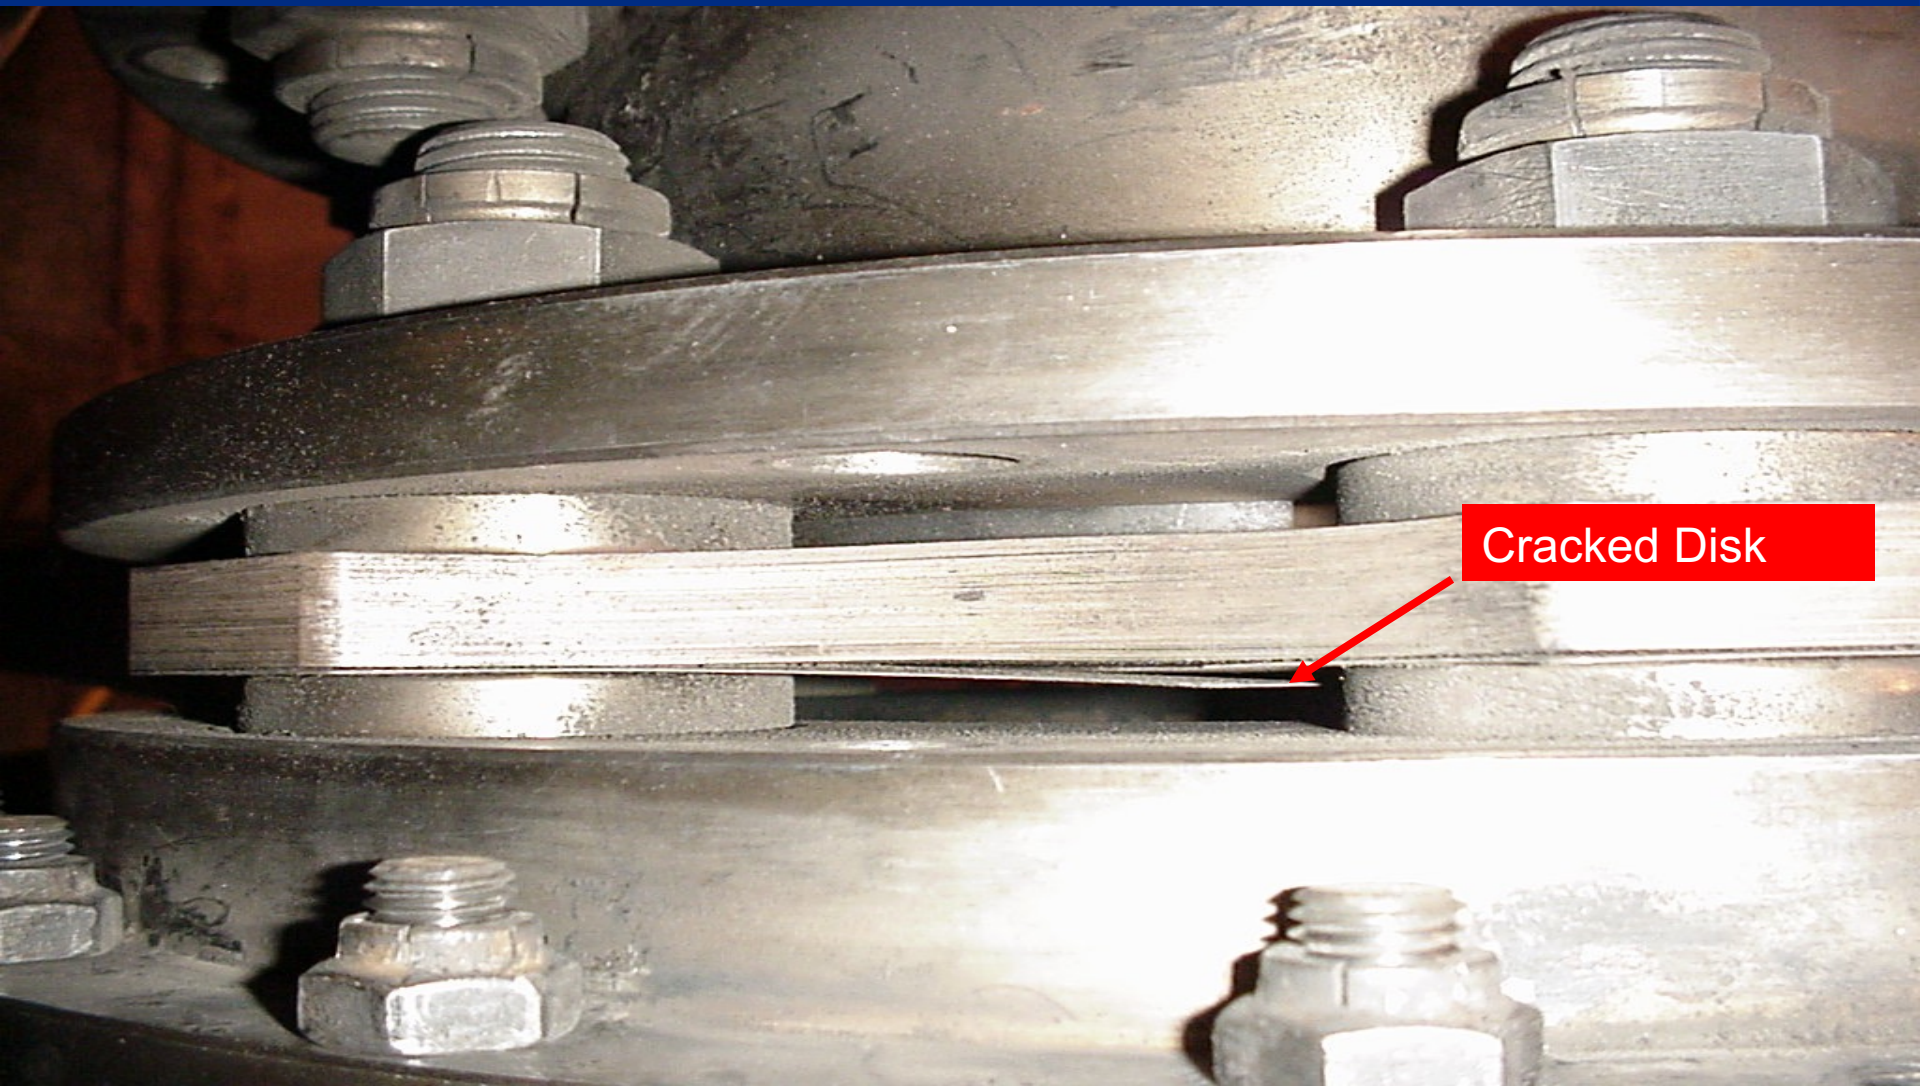
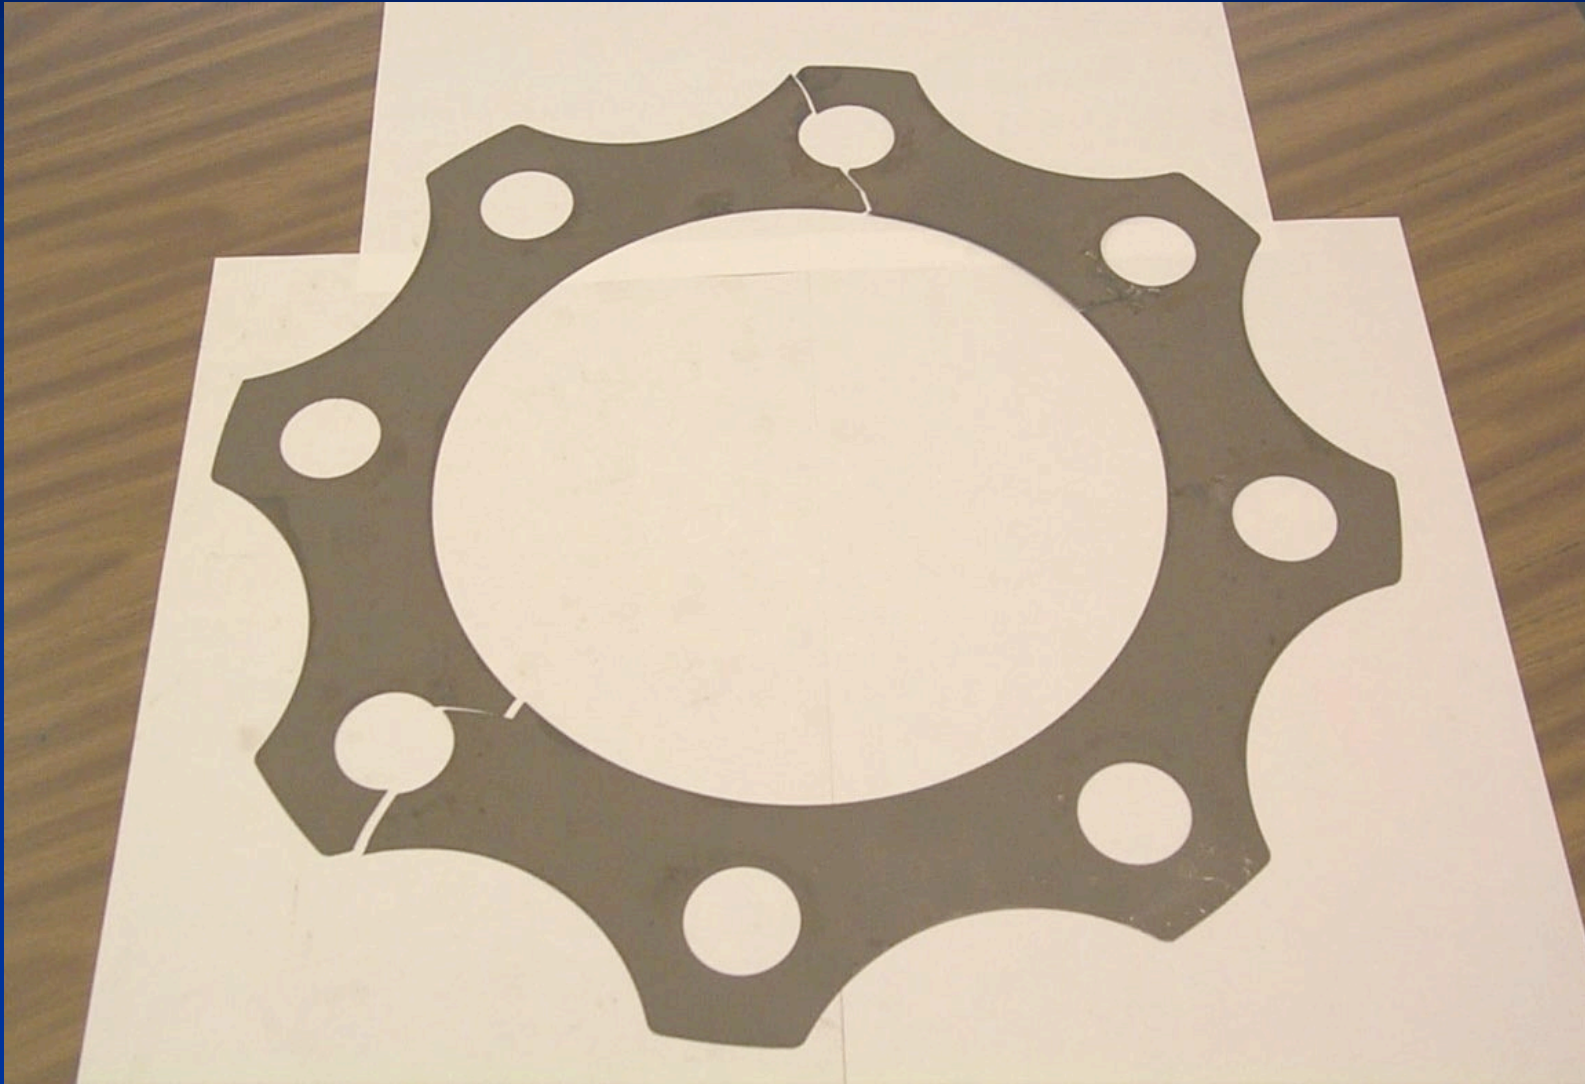
Coupling Failure Symptoms

- Vibration amplitude on Brg # 11 rapidly rose from about 2 mils to ~ 8 mils shortly after startup from a RFO
- Vibration frequency was predominantly 1X
- Visual examination of the running coupling using a strobe showed disk flexing and broken disks. 64% of Generator side Discs and 46% of Exciter Side were Cracked
- Unit # 3 was shut down (Two day duration) for coupling replacement

- Cause of Failure was Long Term Cyclic Tensile Fatigue. Cracked Discs caused coupling instability and higher vibration levels
- Inadequate PdM alarm limits: The new coupling lowered overall vibration levels when first installed. *However, we failed to understand that vibration limits should also have been lower.* If we had initially lowered our vibration alarm limits, we would have caught the problem earlier.
- Inadequate PM: The new disc coupling was “Maintenance Free”...discs were Teflon coated and required no lubrication

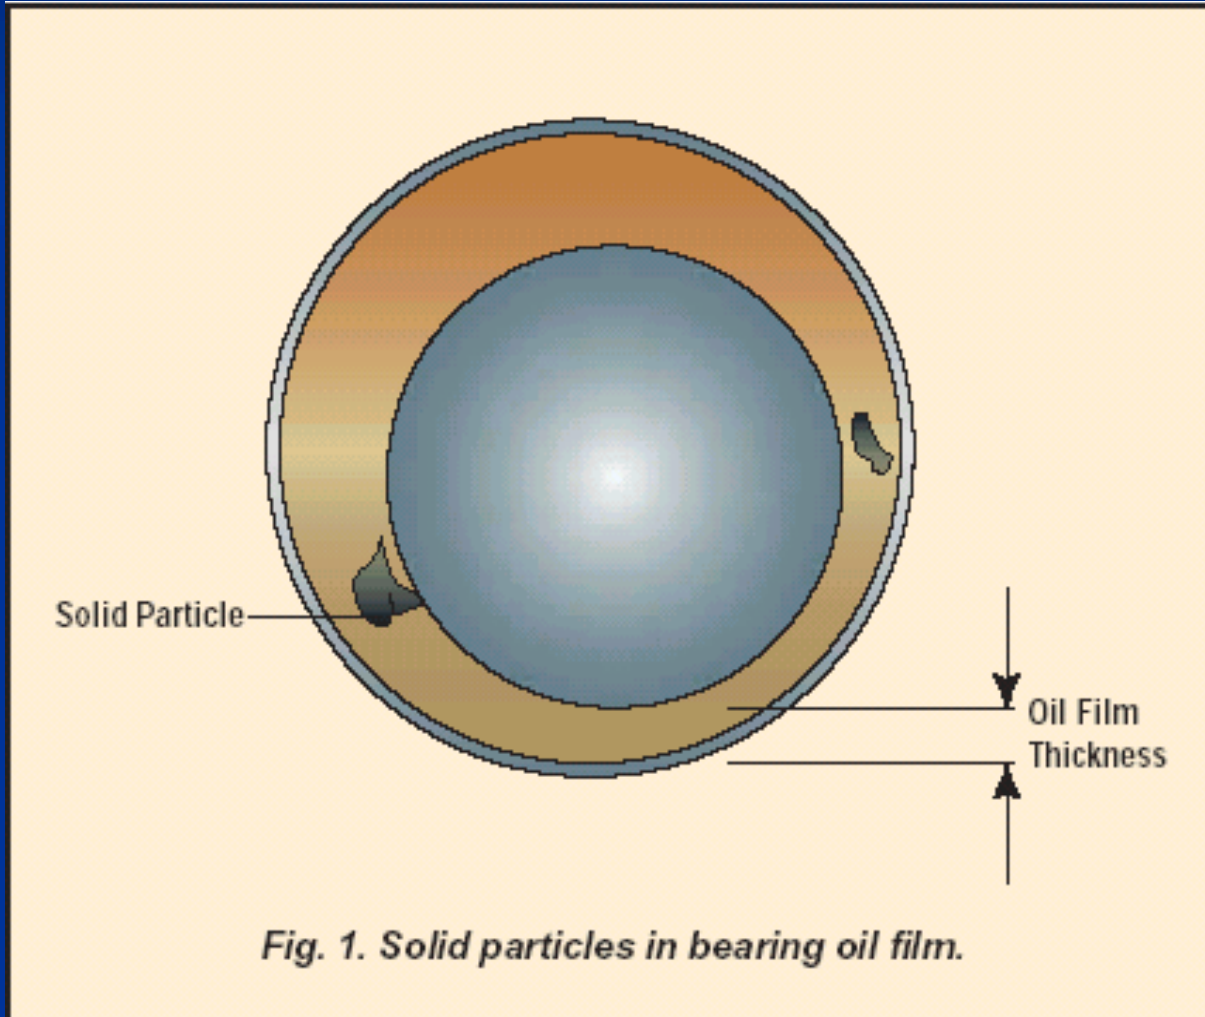
*Particles and Contamination Effect on Fluid Film
(picture obtained from Noria Website)*

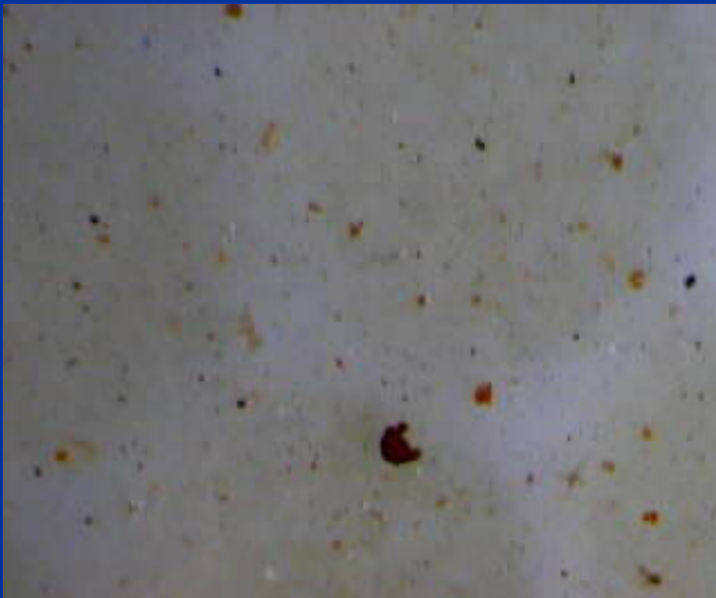
2A RC Pump

Filter Patches of Oil Samples Showing Trash and Contaminants

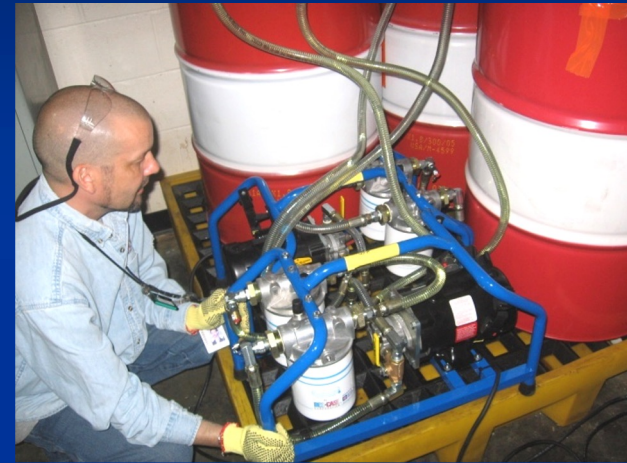
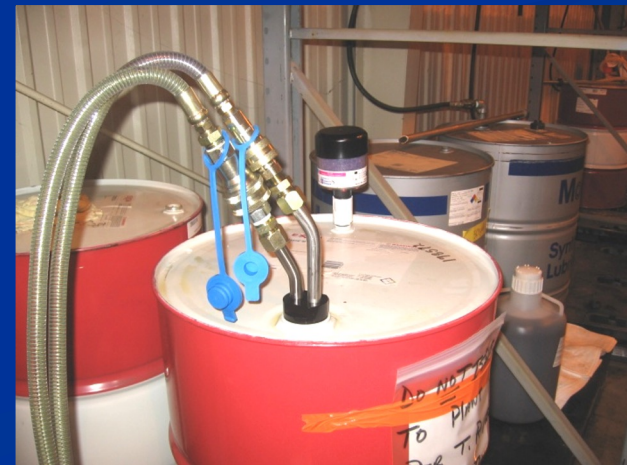
Satellite Storage and Oil Filtration Equipment

- 3 micron, Beta 200 particulate filter
- Water filter
- Drum adapter kit with dessicant breather

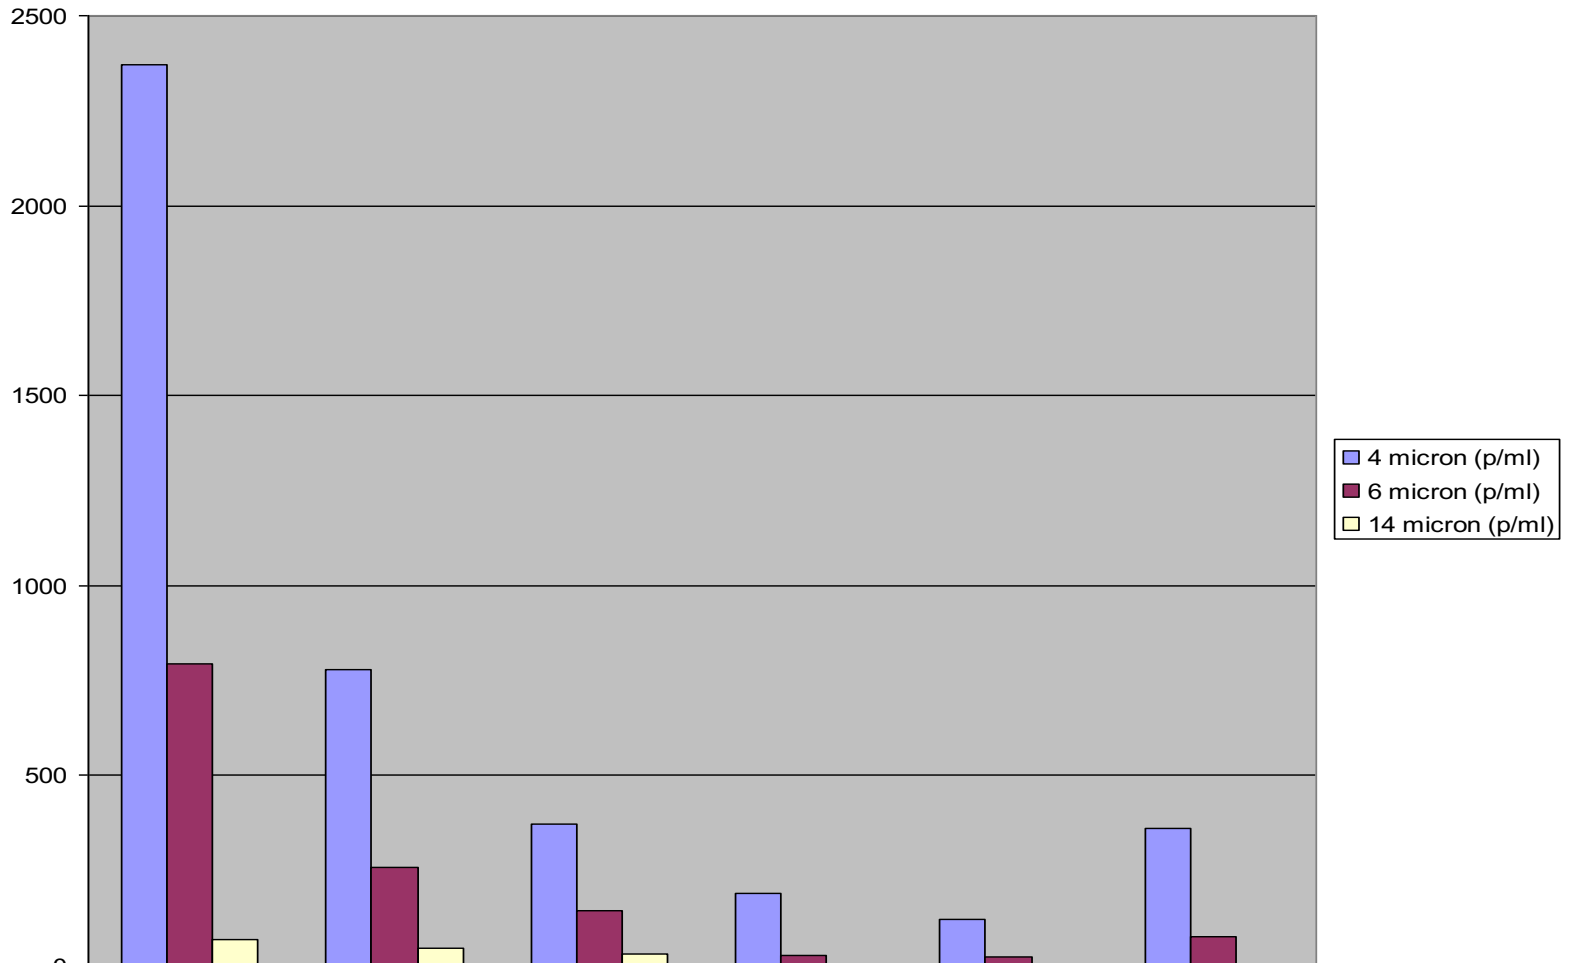
ISO 68 Filtration Results

0	0.5	1	2	2.5	3
4 micron (p/ml)	2371	778	373	191	122	361
6 micron (p/ml)	793	259	146	28	22	76
14 micron (p/ml)	70	45	30	5	2	4

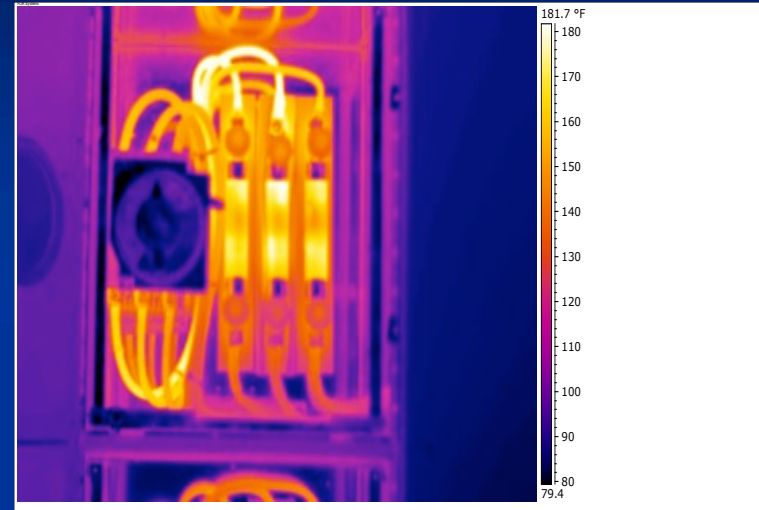
- 1PHP1D F02C,
Loose connections
X,Y Phase on breaker

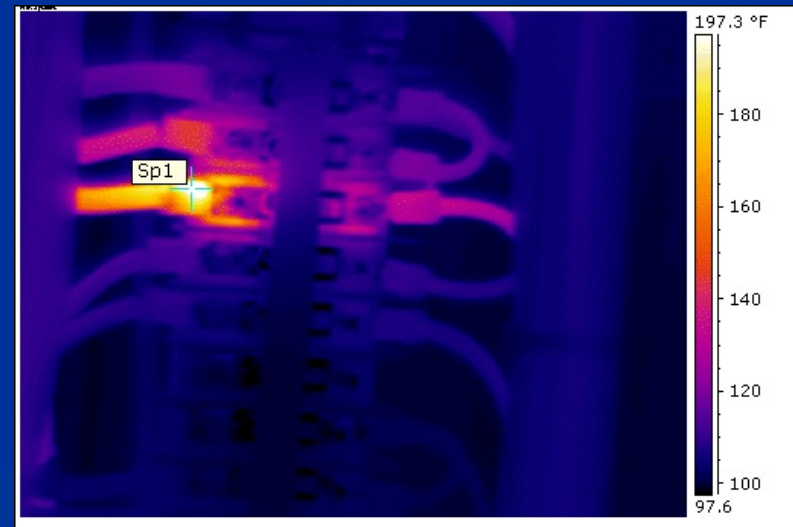
- 1CTCCSA CA Heat
Trace, Bad
Connection, Spot
temp of 206 deg F

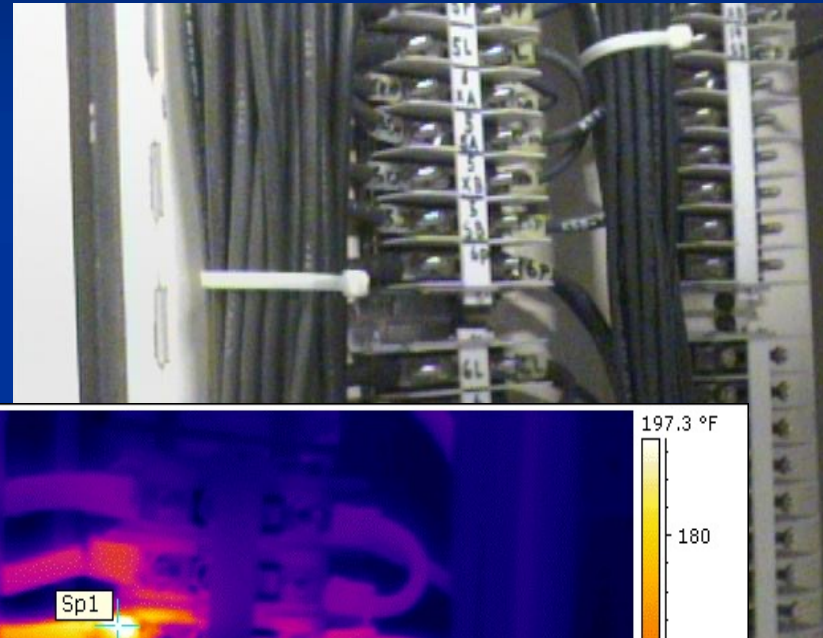
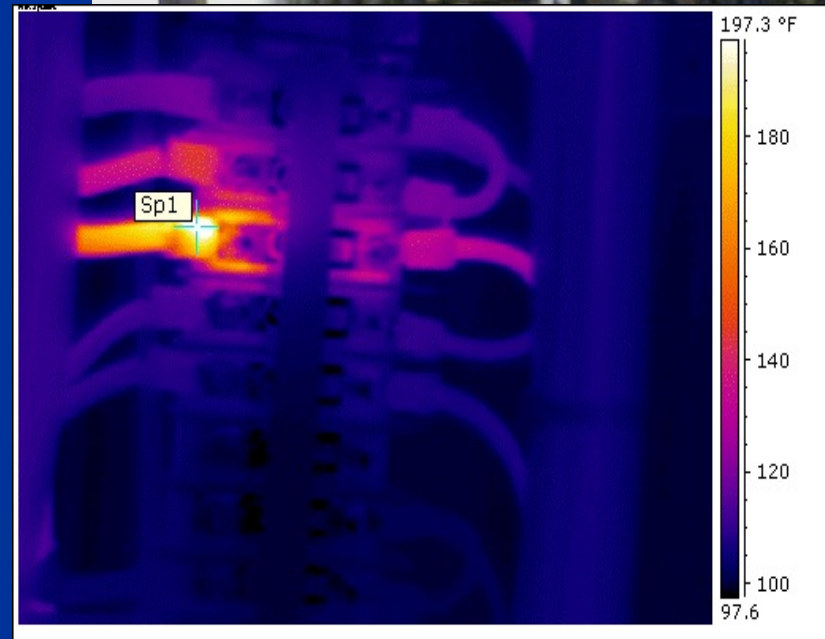
- 1CTCCSA CA Heat Trace
- Bad Connection, Spot temp of 206 deg F
- WR # 929411, Nov., 2007

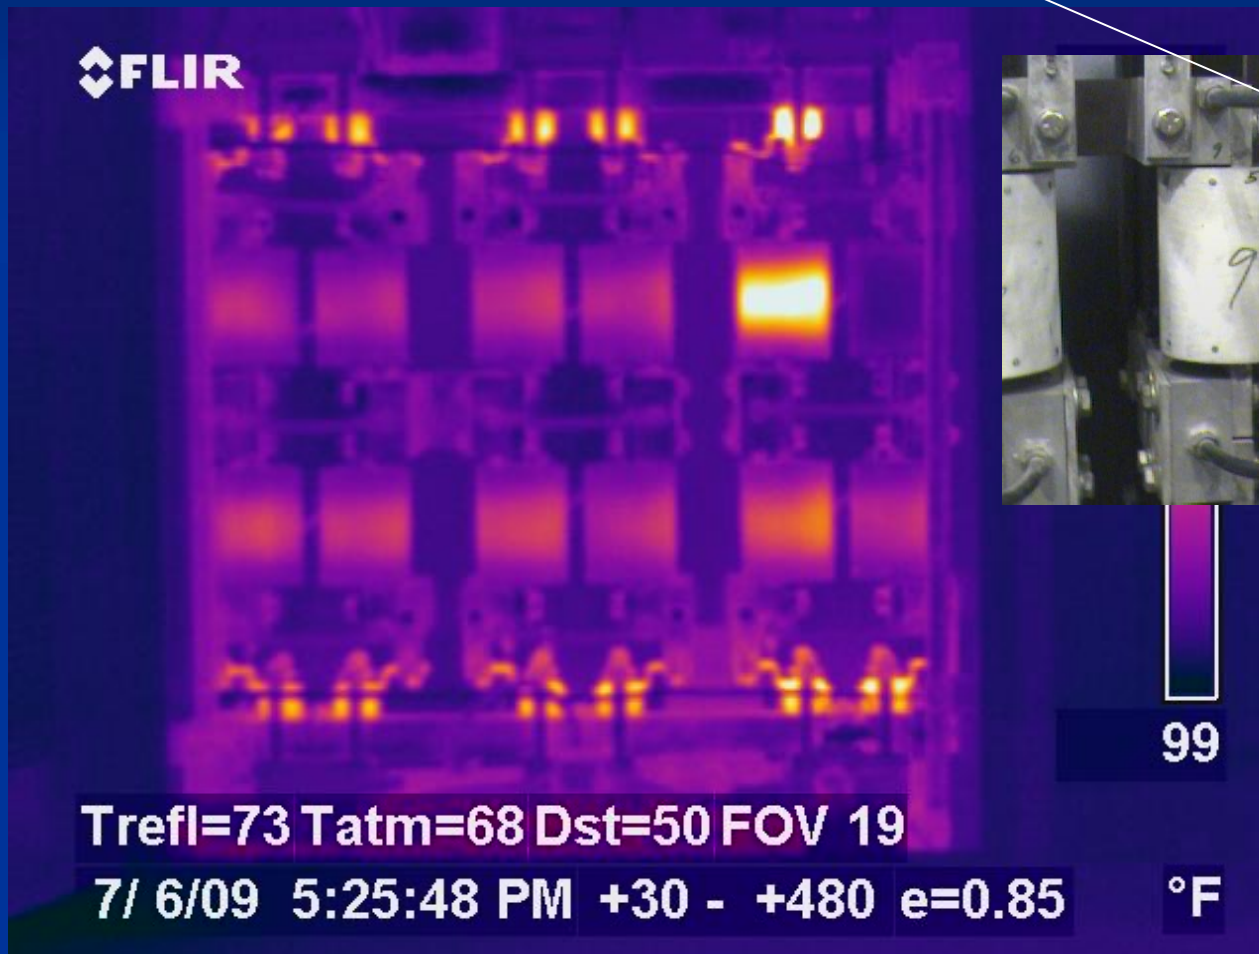
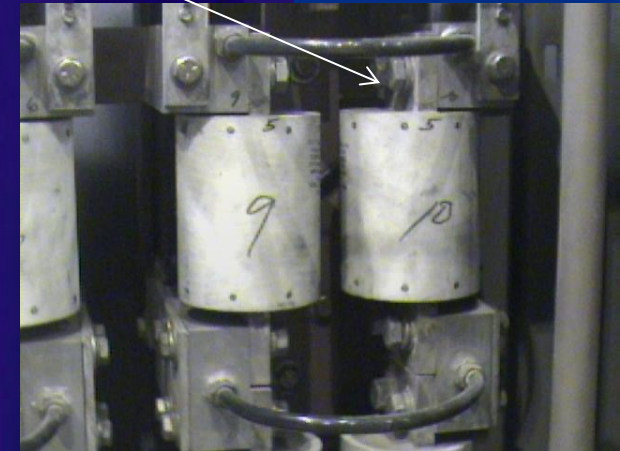
Unit 1 Exciter Rectifier Fuses Showing Unequal Loading (loose connection on #10)

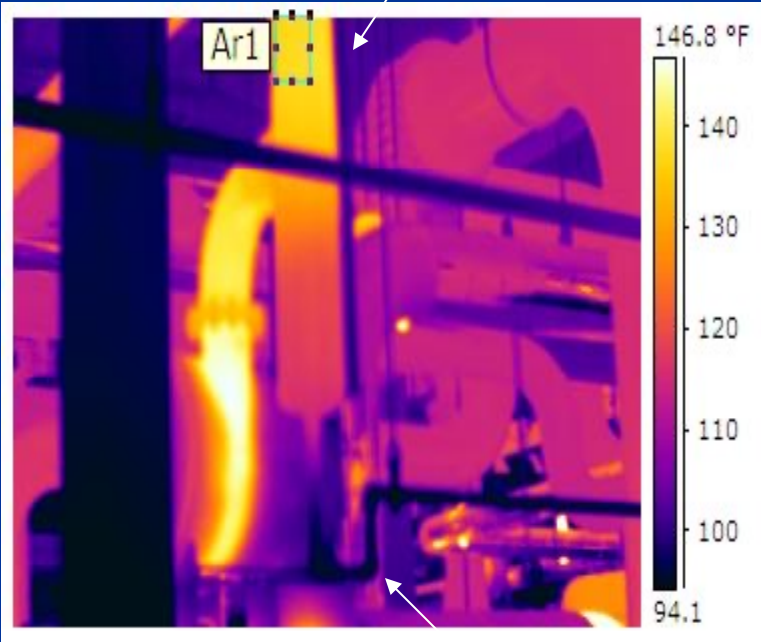
U1 SPE: Note Hotter Discharge Temp

Loop seal normal temp

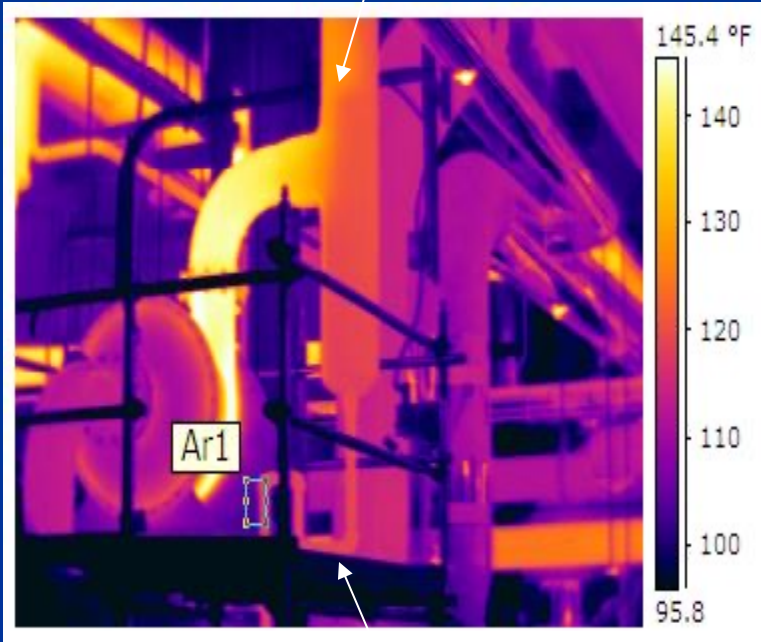
U2 SPE: Note Cooler Discharge Temp

Loop seal temp high, indicating Blow-by

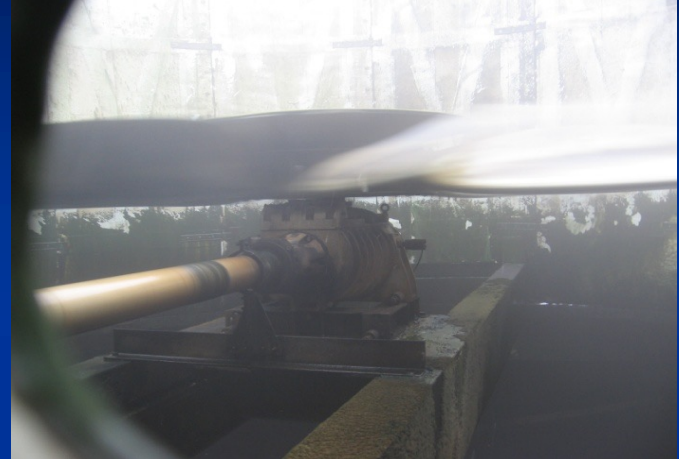
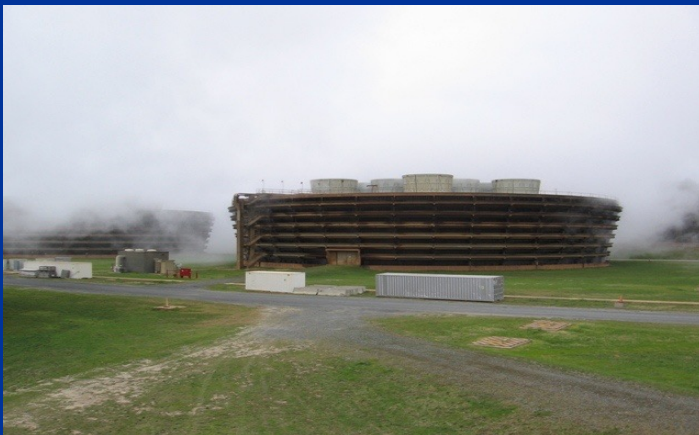
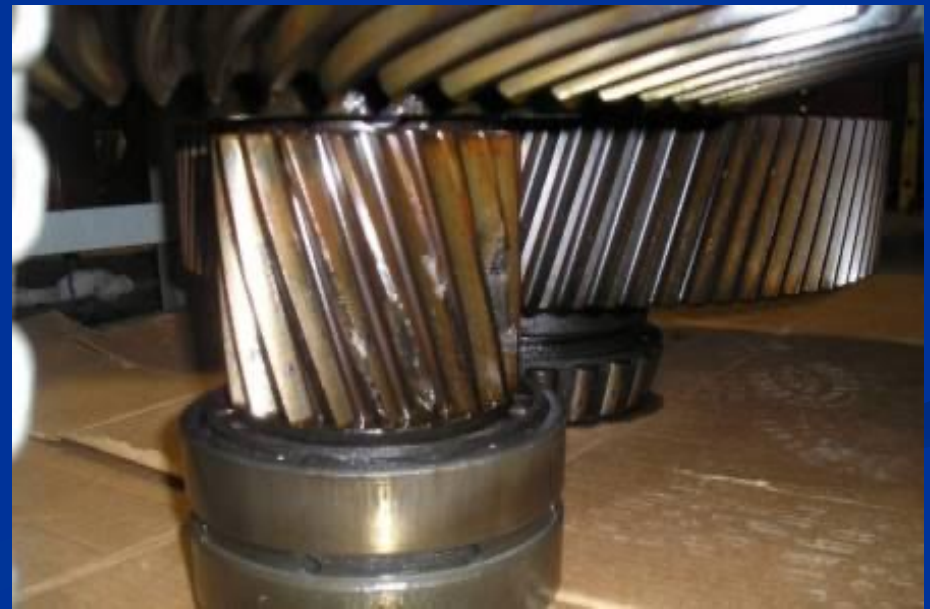
- Increased particle count and increased Fe (iron) along with changes in vibration spectra.
- 2C5 RC fan gearbox broken teeth

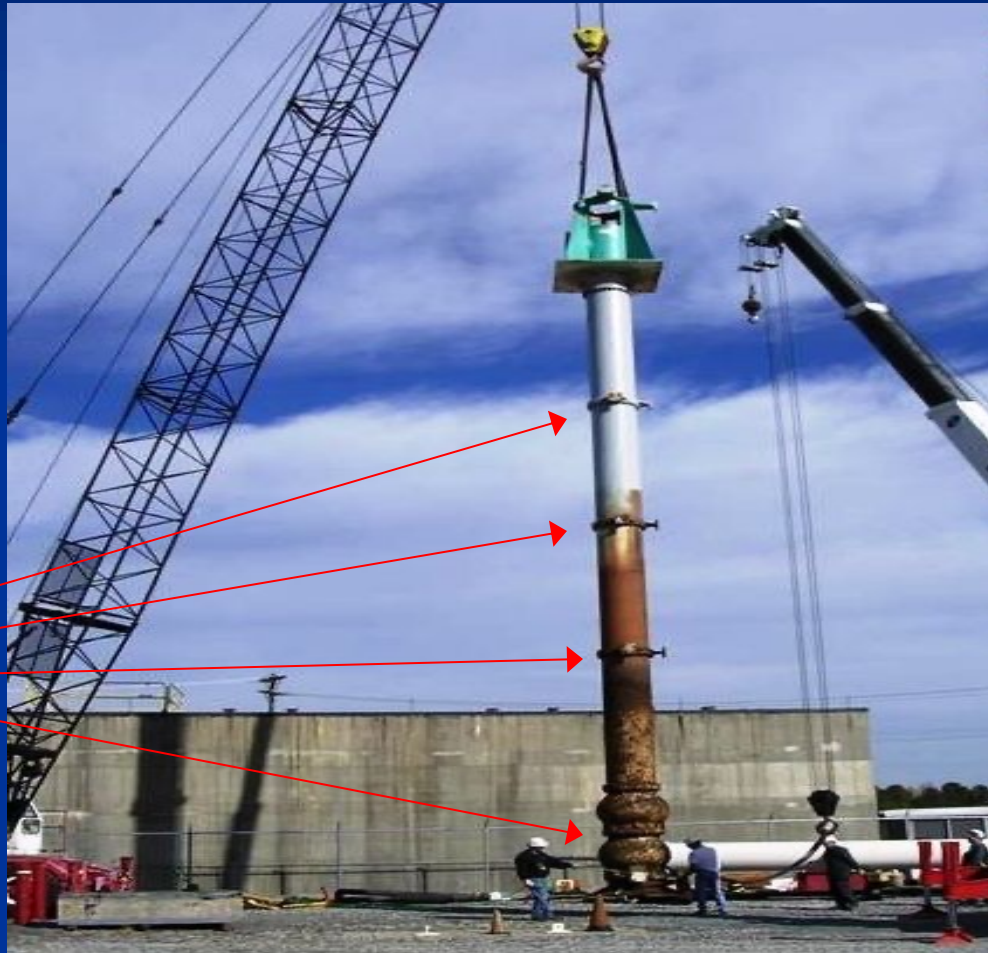
Hanger
Supports

Document Findings: 1A Nuclear Service Water Pump Hanger Misalignment

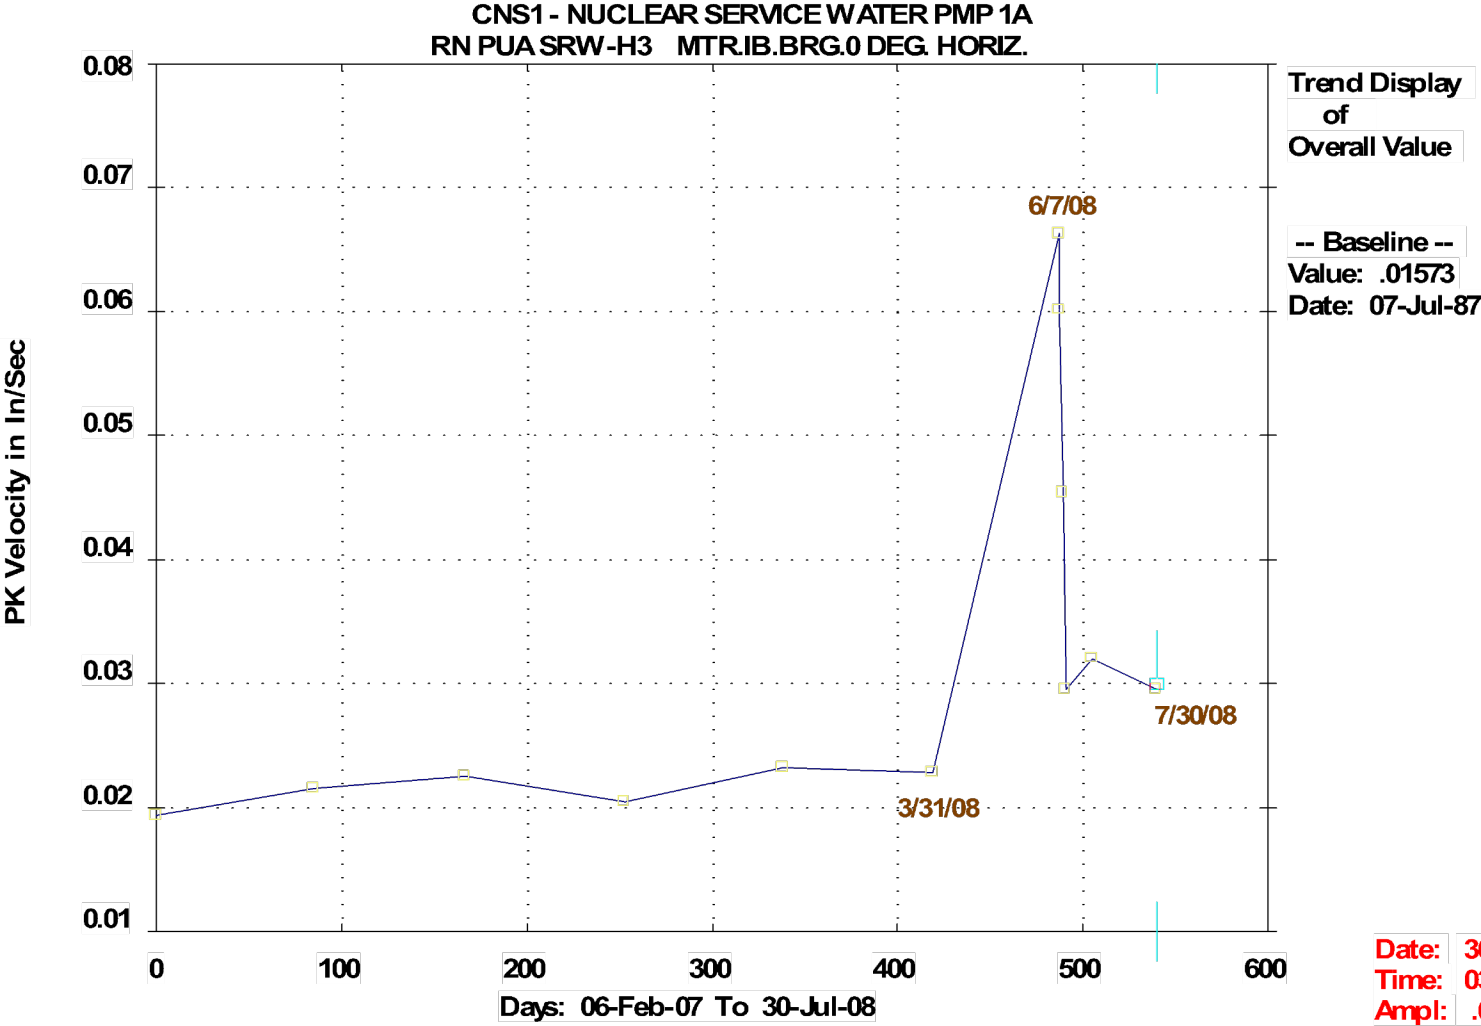
Plot of overall amplitude. Upper hanger readjustment led to a decrease in overall amplitude. Harmonics of running speed went away. We suspect the misalignment was causing a rub in one of the pump bushings.

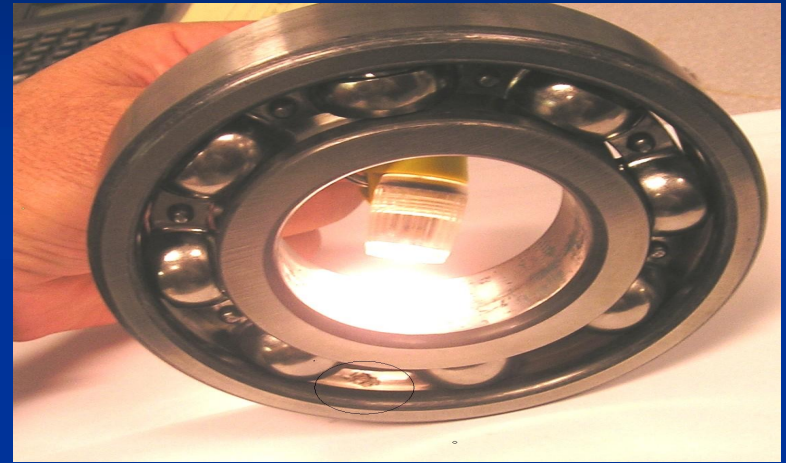
- 2A Lower Containment Ventilation Fan Motor Inboard Bearing Defect

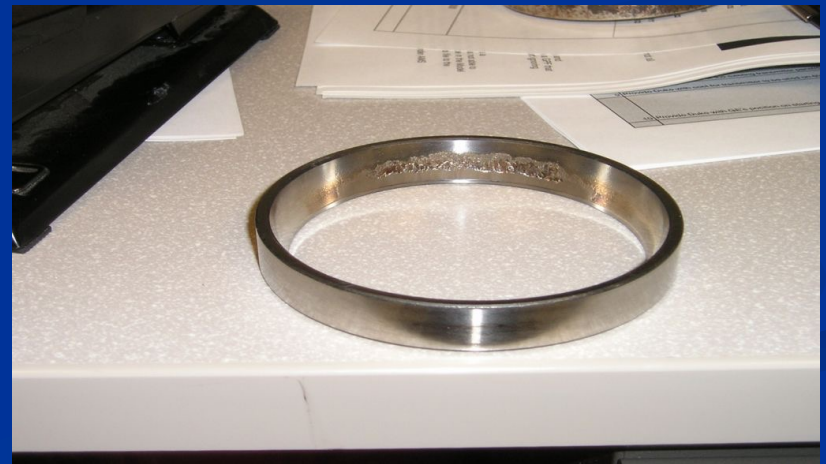
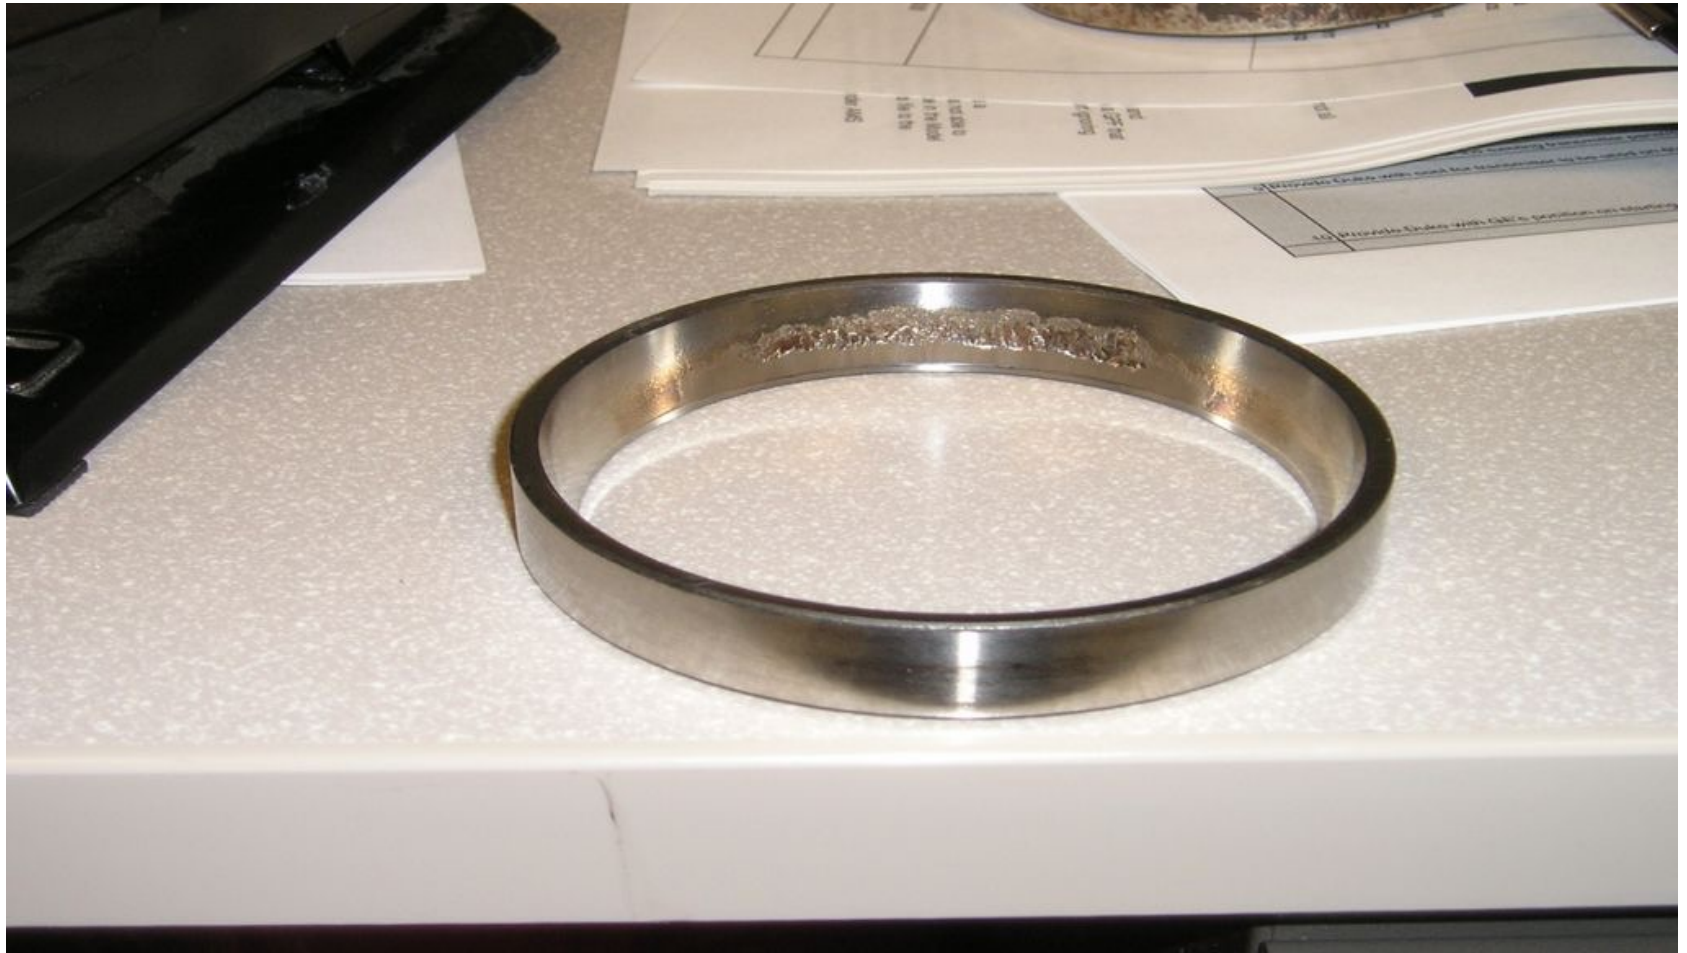
- 2Z1 IPB Outer Race Spall

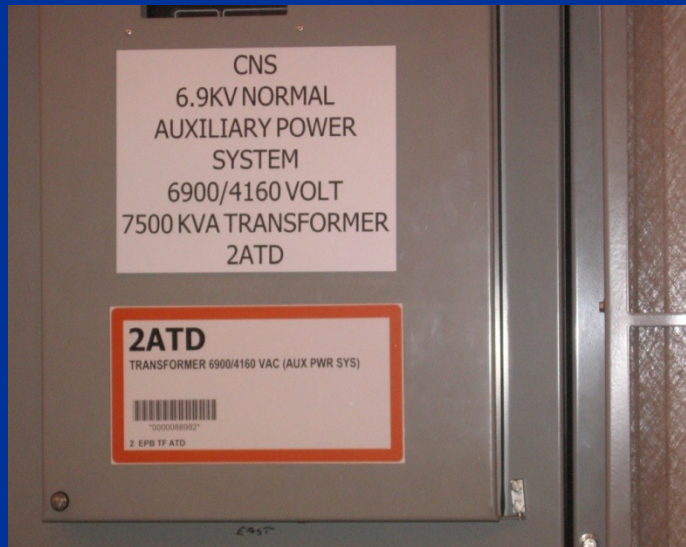
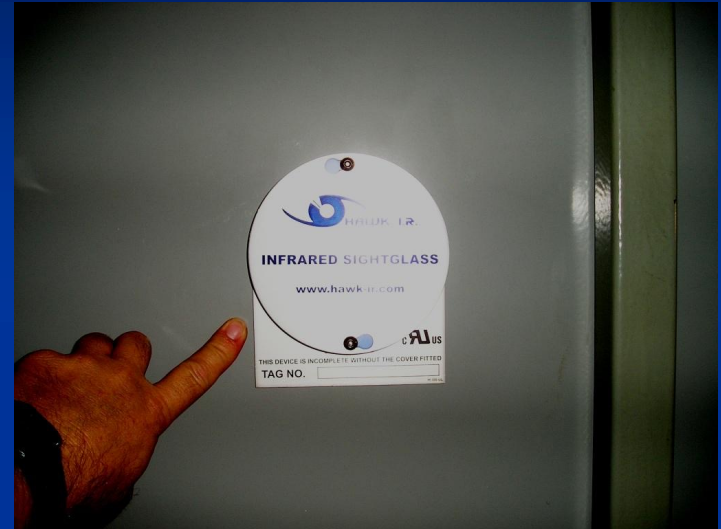
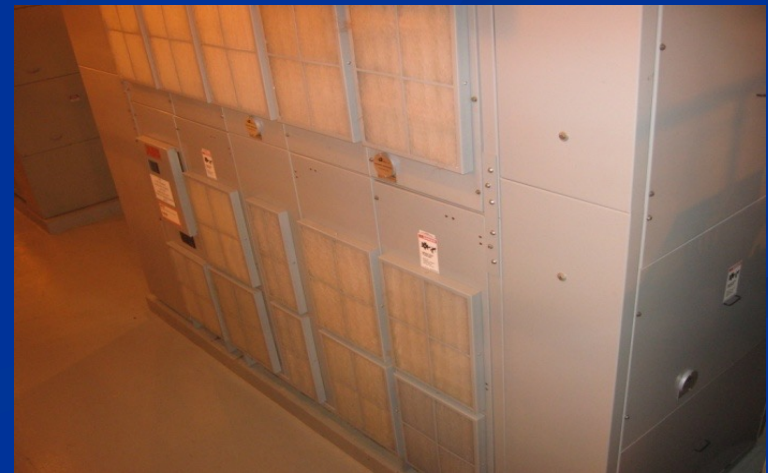
- Installation of Infrared sightglasses

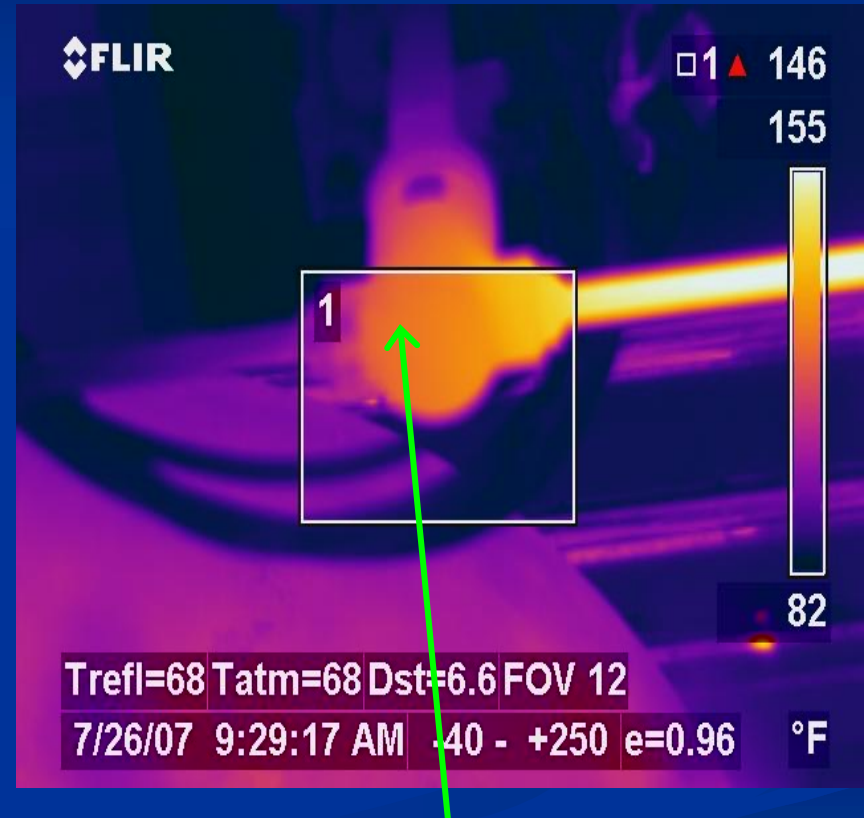
High Pressure Steam Extraction Valve 2HA-06 (Closed)

- Infrared thermography used to optimize FAC inspections
- If valves are closed, downstream piping UT inspections for pipe erosion are not needed
- Reduces labor intensive UT inspections by an average of 25 inspections/18 month cycle
- Savings
\$3,000 X 25 inspections=
\$75,000/cycle or \$50,000/year

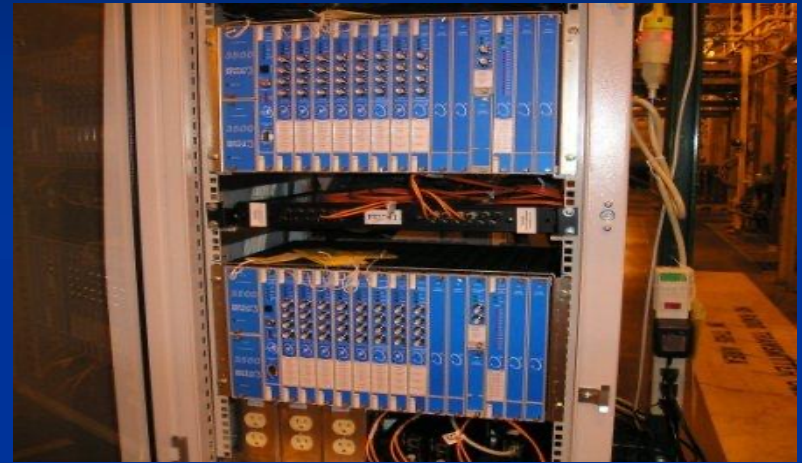
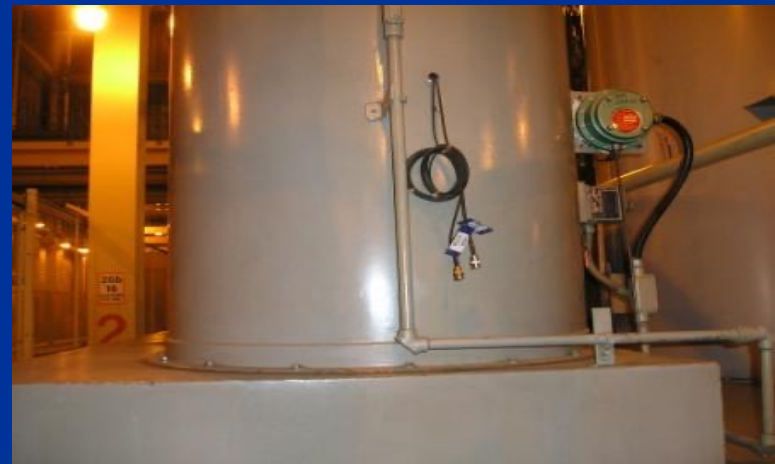
- Continue to improve on-line monitoring systems by replacing obsolete BN and SKF systems
- Install permanent accelerometers on more components that are enclosed
