# Reliability Improvement Project Multi-Stage Centrifugal Blowers

For  
Piedmont Chapter  
Vibration Institute  
Charleston, SC Sept 9, 2011

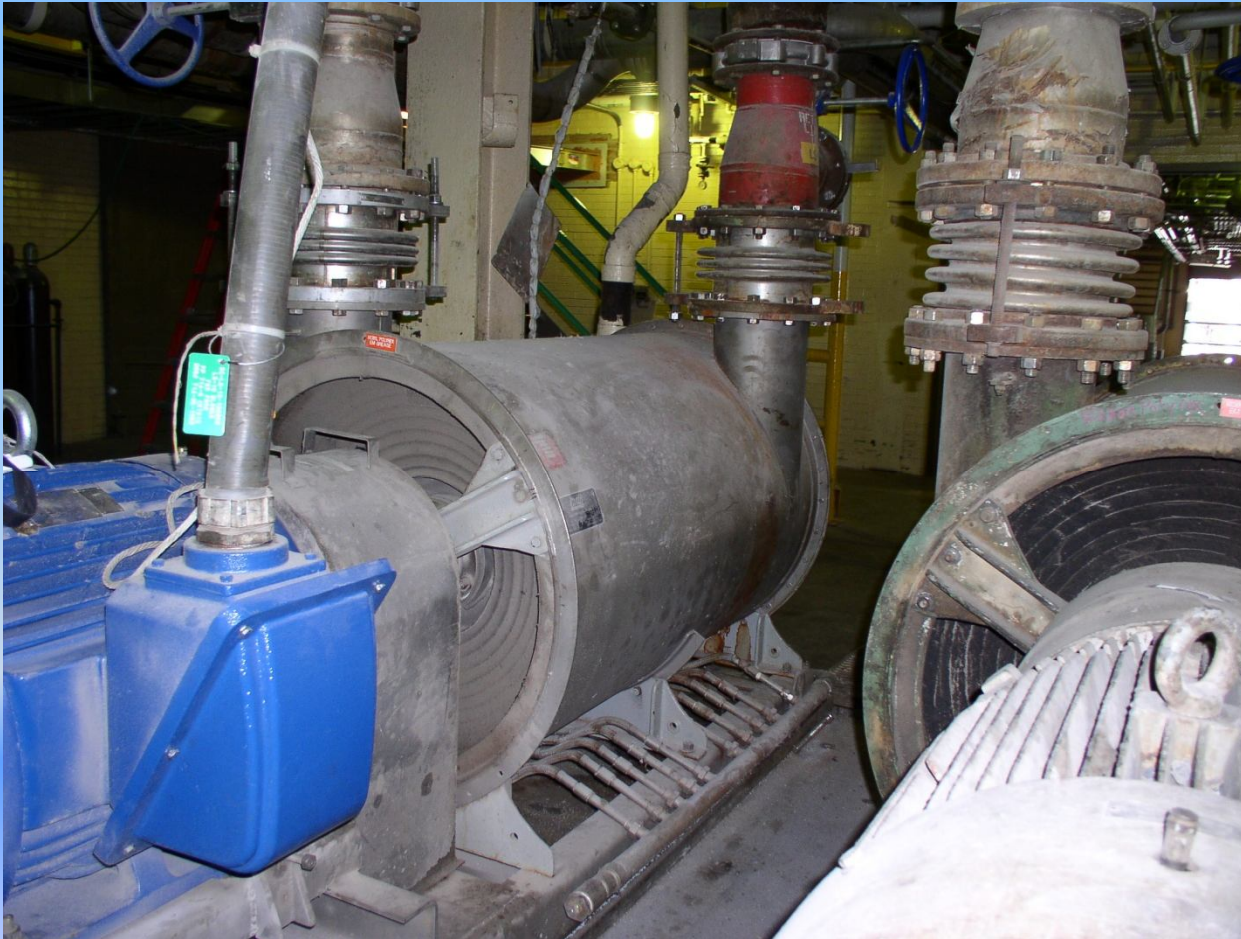
**Figure 1. Photo of Multi-Stage Centrifugal Blowers.**

Process gas was corrosive, required stainless steel construction of shaft, impellers, hubs, housings, piping.

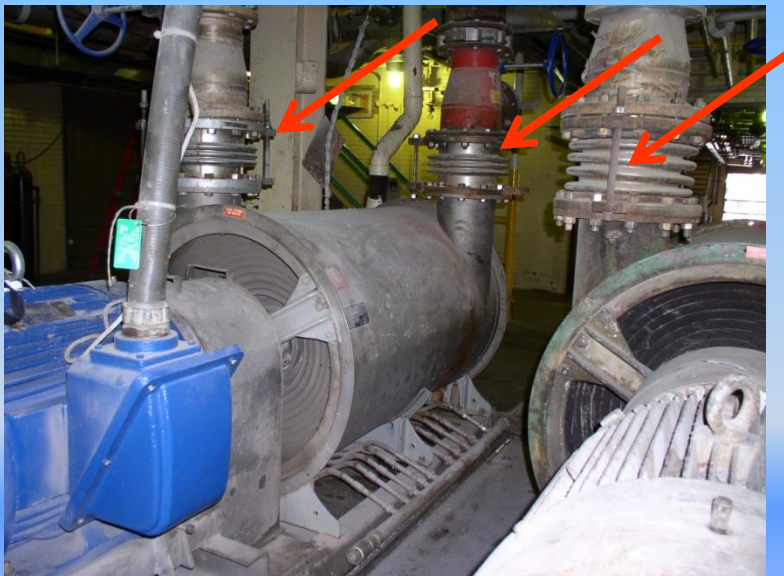
**Stainless Steel Bellows  
Connected to Piping at Inlet and  
Discharge.**

Inlet and discharge piping were connected to the blower nozzles with flexible stainless steel bellows.

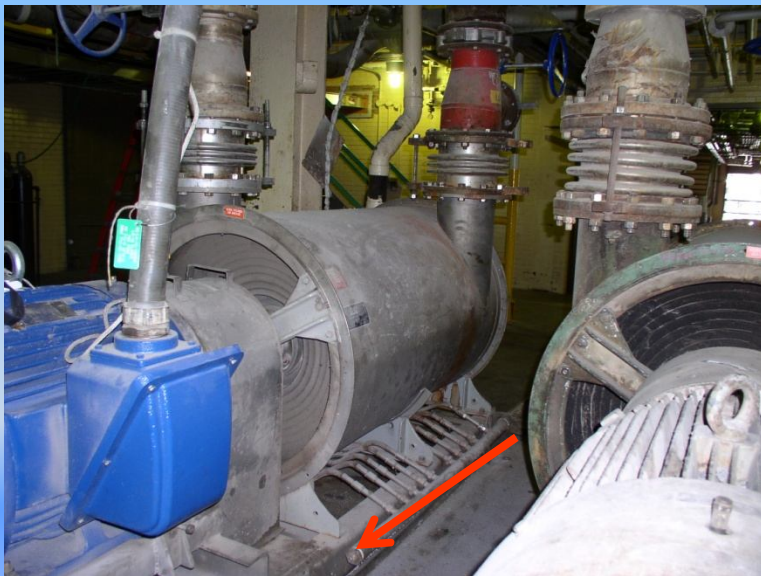
**Stainless Steel Skid (Channel)  
Supported on 1" Cork Isolation.**

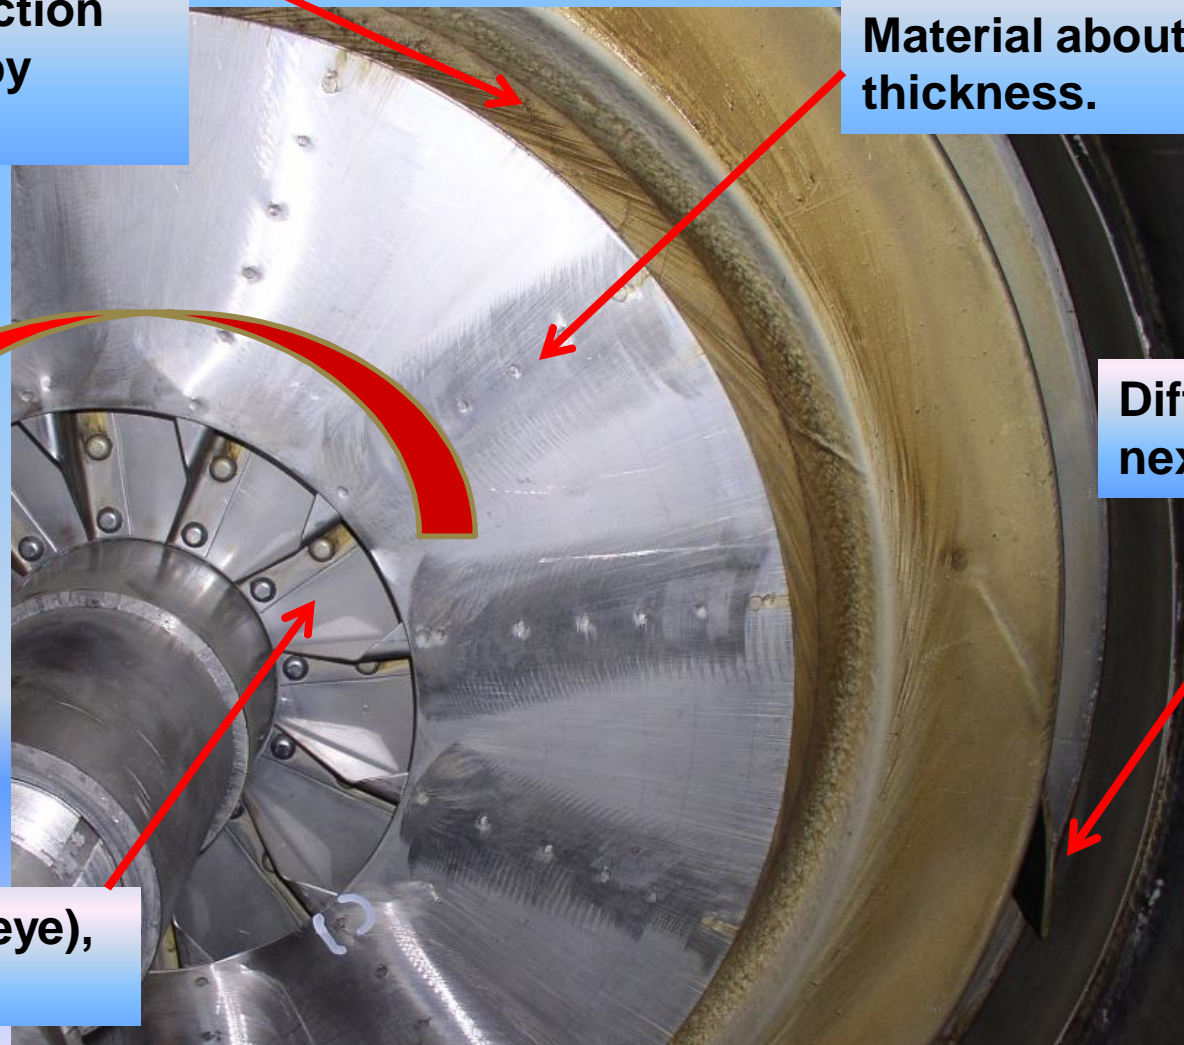
1<sup>st</sup> Stage Impeller, Deflector removed.

Flow exits impeller tangential direction as evidenced by residue.

Impeller with Riveted Construction. Shroud Material about 1/16" thickness.

Diffuser Blade, next stage.

Impeller inlet (eye), 12 Blades.

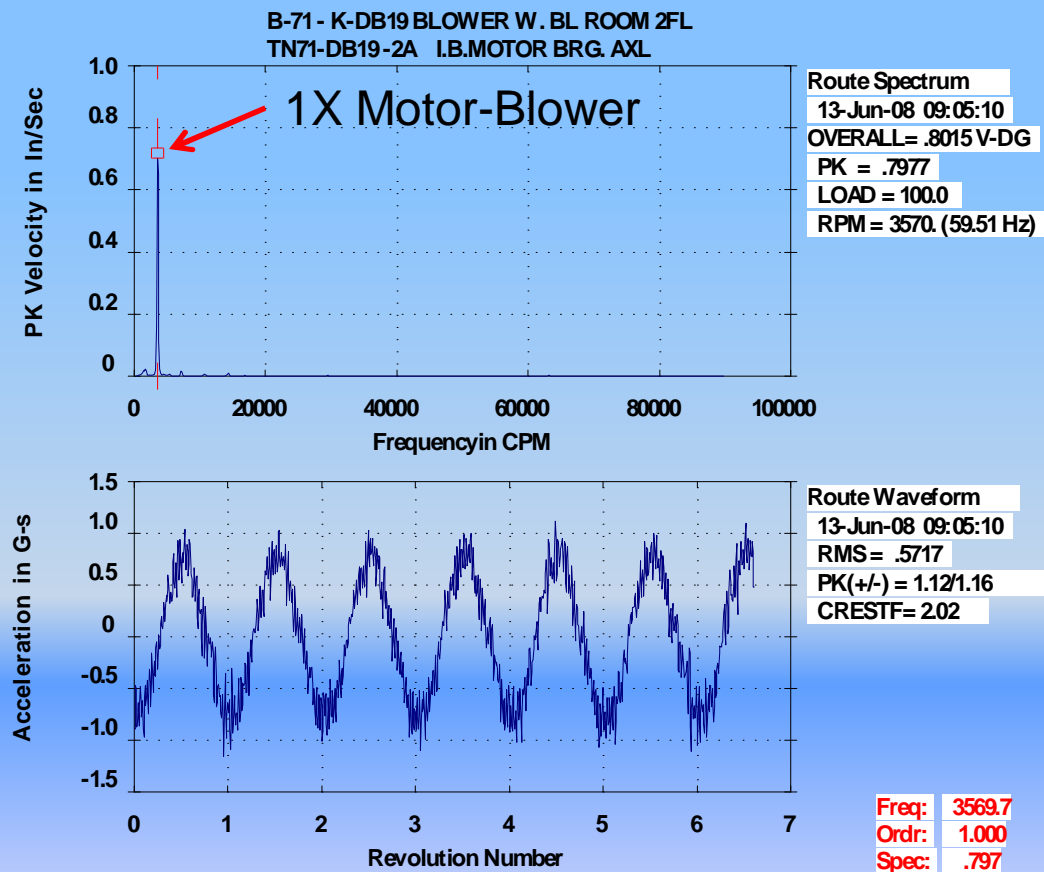
Figure 6. Frequency Spectrum and Time Waveform, DB 19, Motor IB Brg Axial.

Frequency Spectrum and Time Waveform for DB 19 Blower Motor IB Axial shown. Data at other point similar. Most vibration at 1X.

Could indicate unbalance, misalignment, resonance, bowed rotor, worn bearings, etc.

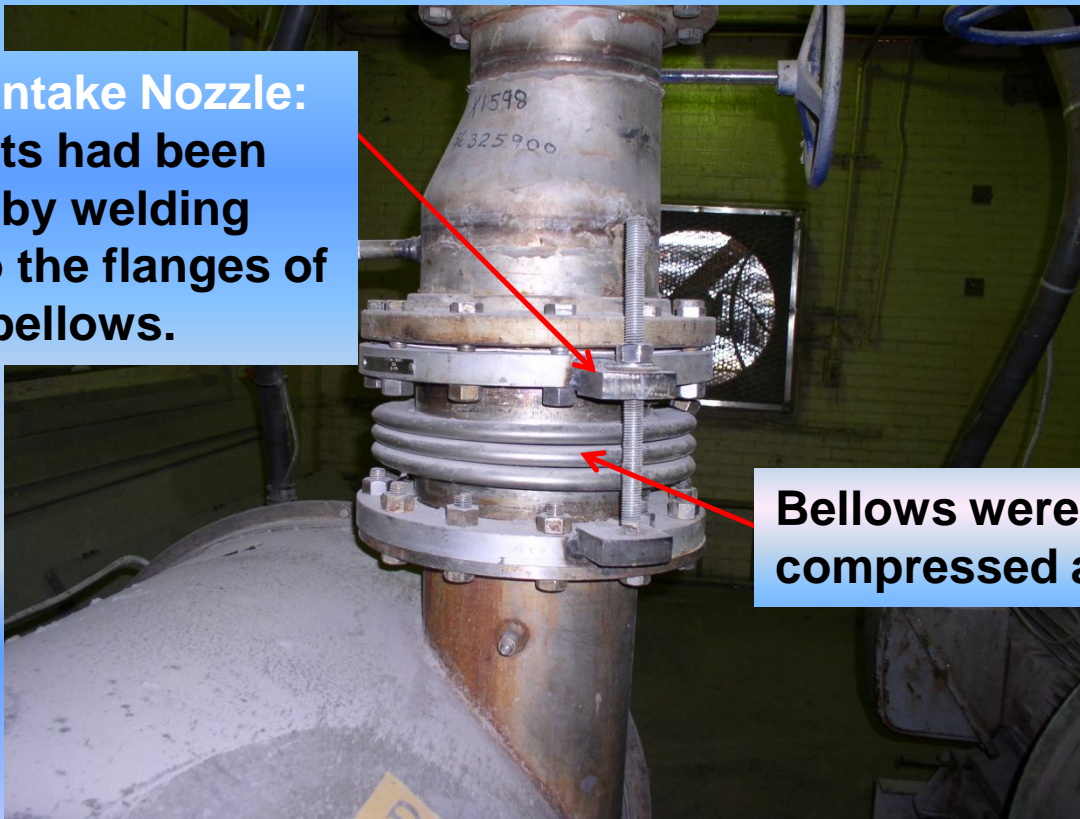
**Figure 11. LS 12 Blower, Compressed Bellows at Intake Nozzle.**

**LS 12 Intake Nozzle:**  
Tie bolts had been added by welding lugs to the flanges of some bellows.

**Bellows were completely compressed axially.**

- ❑ Blower Nozzle Loading (Pipe Strain)**
  - Conduct Piping Study**
  - Study to provide recommendations for piping supports and flexible piping connections to the blower nozzles.**
  - Obtain allowable blower nozzle loading from OEM.**

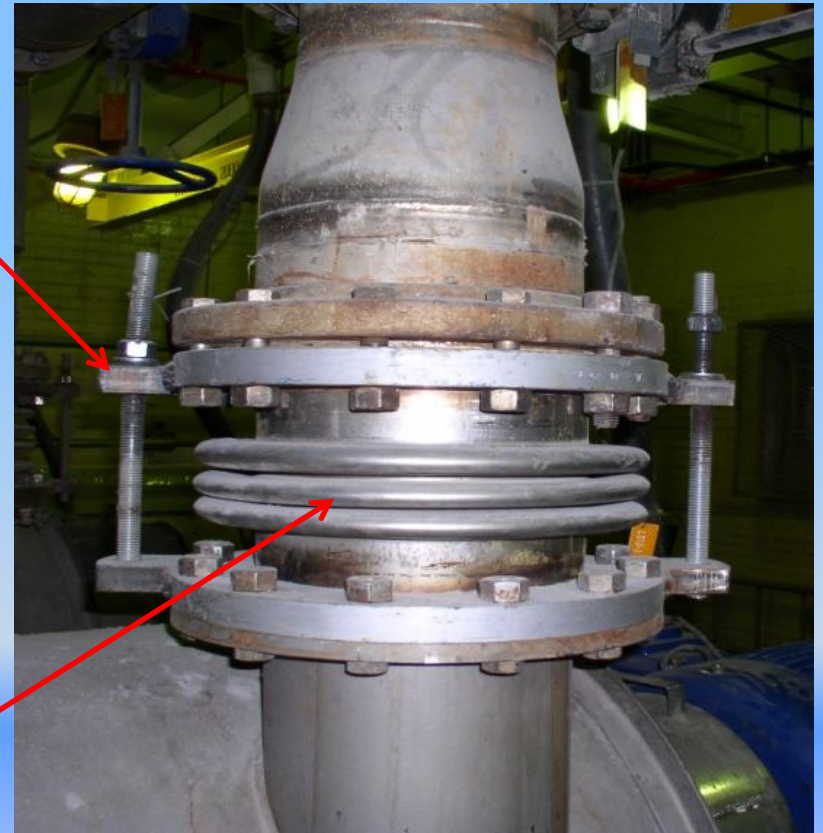
**Figure 12. Blower LS 10 Blower Discharge Connection, Bellows Collapsed.**

**LS 10 Discharge Nozzle:**  
Tie bolts added using  
lugs welded to the  
flanges of bellows.

**LS 10 Blower Intake Nozzle:**  
Bellows compressed axially.

Figure 12. Blower LS 10 Blower Discharge Connection, Bellows Collapsed.

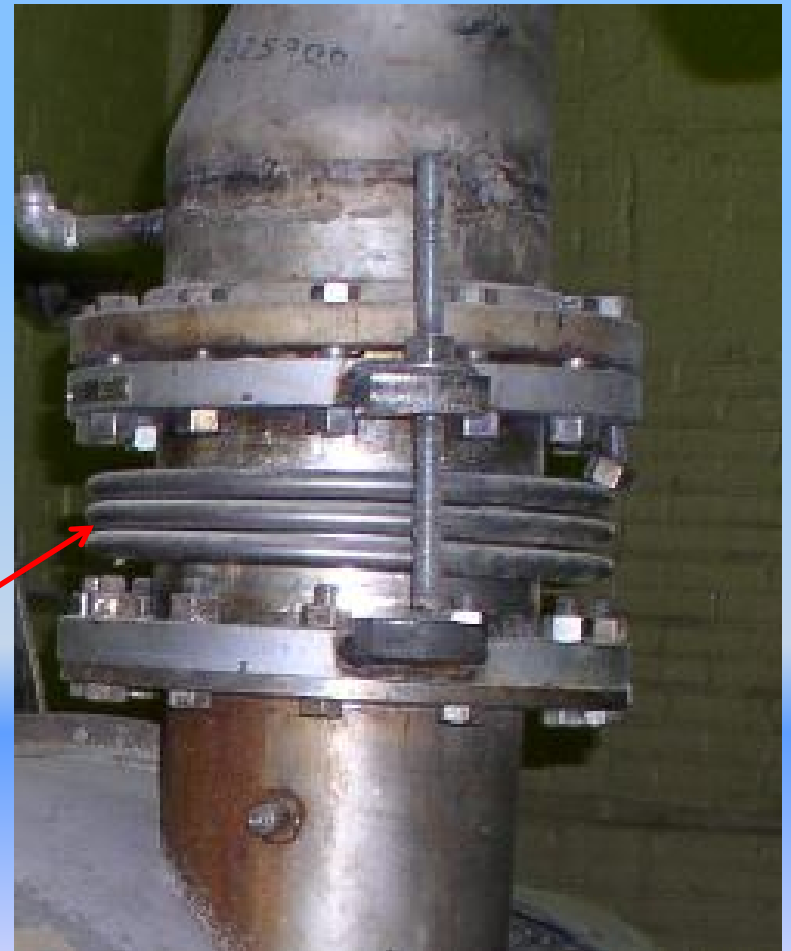
They are not designed to compensate for piping misalignment errors.

Bellows compressed on one side.

Pipe guides should be installed within four diameters of the joint and then again after fourteen pipe diameters. Ref 6

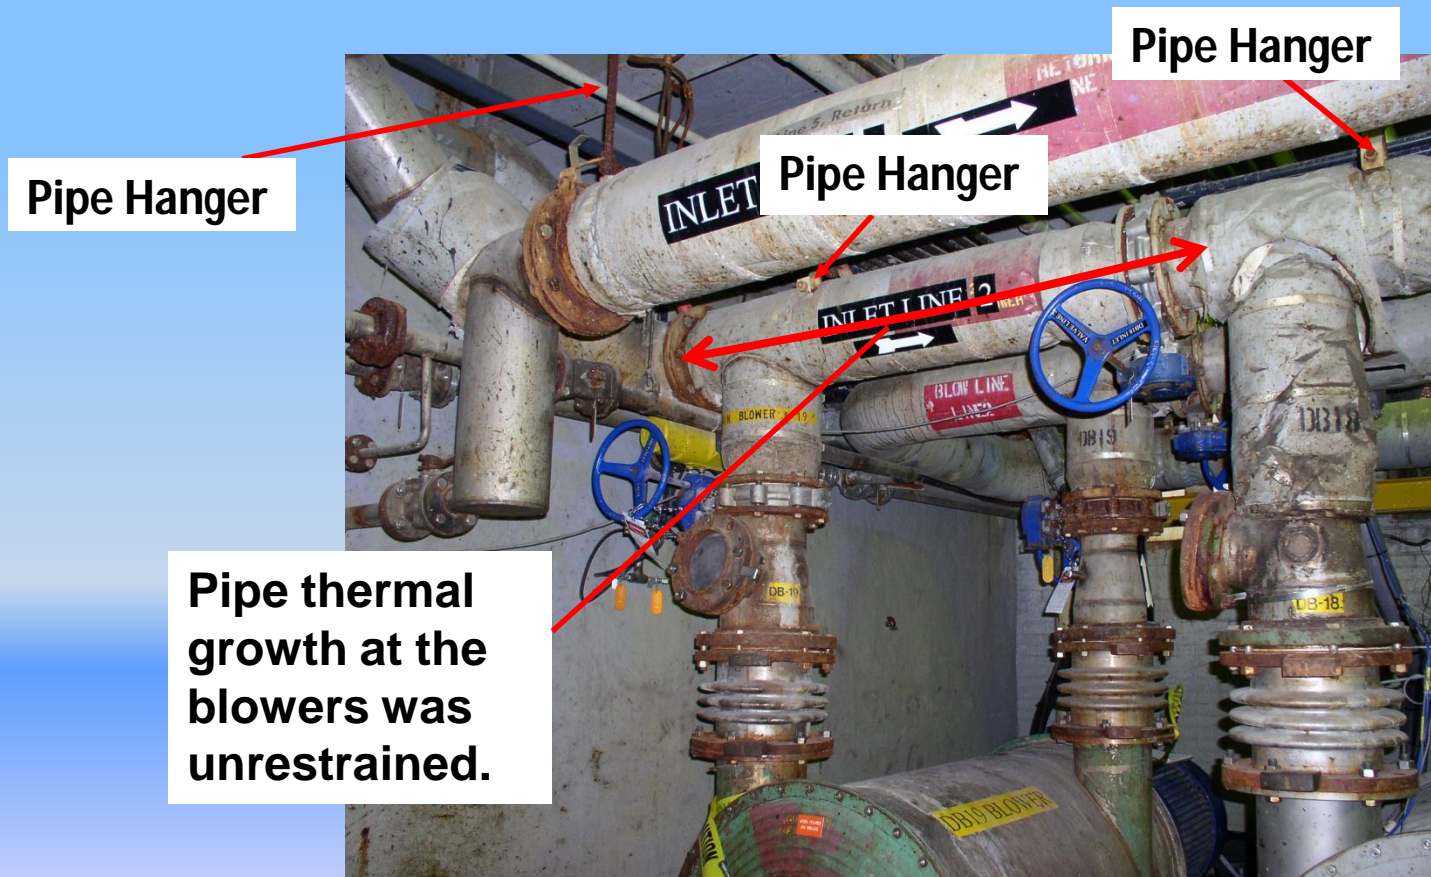
Figure 13. Piping Connected to Blowers, Blower DB 19 Shown.

The inlet and discharge piping to the blowers was not restrained so the bellows were transferring pipe movement forces to the blower nozzle flanges.

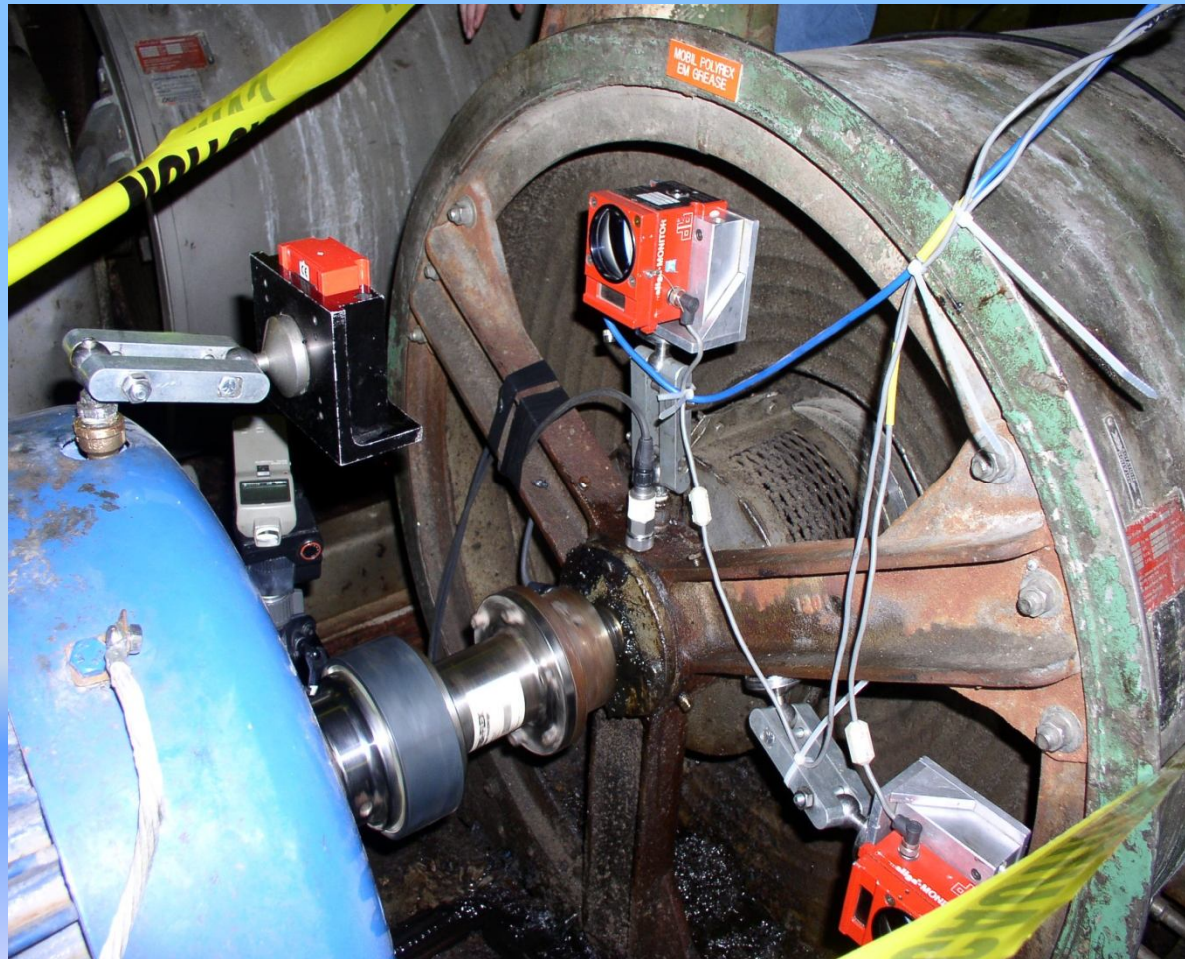
**Figure 14. DB 19 With Laser Alignment and Vibration Sensors Attached.**

A multi-channel spectrum analyzer, IOtech 618E & Tomas software was used to measure vibration data from accelerometers magnetically mounted on the motor and blower bearing housings.

Photo shows Permaalign, an accelerometer, Optical Tachometer, and the Alta-Flex coupling of DB19 Blower.

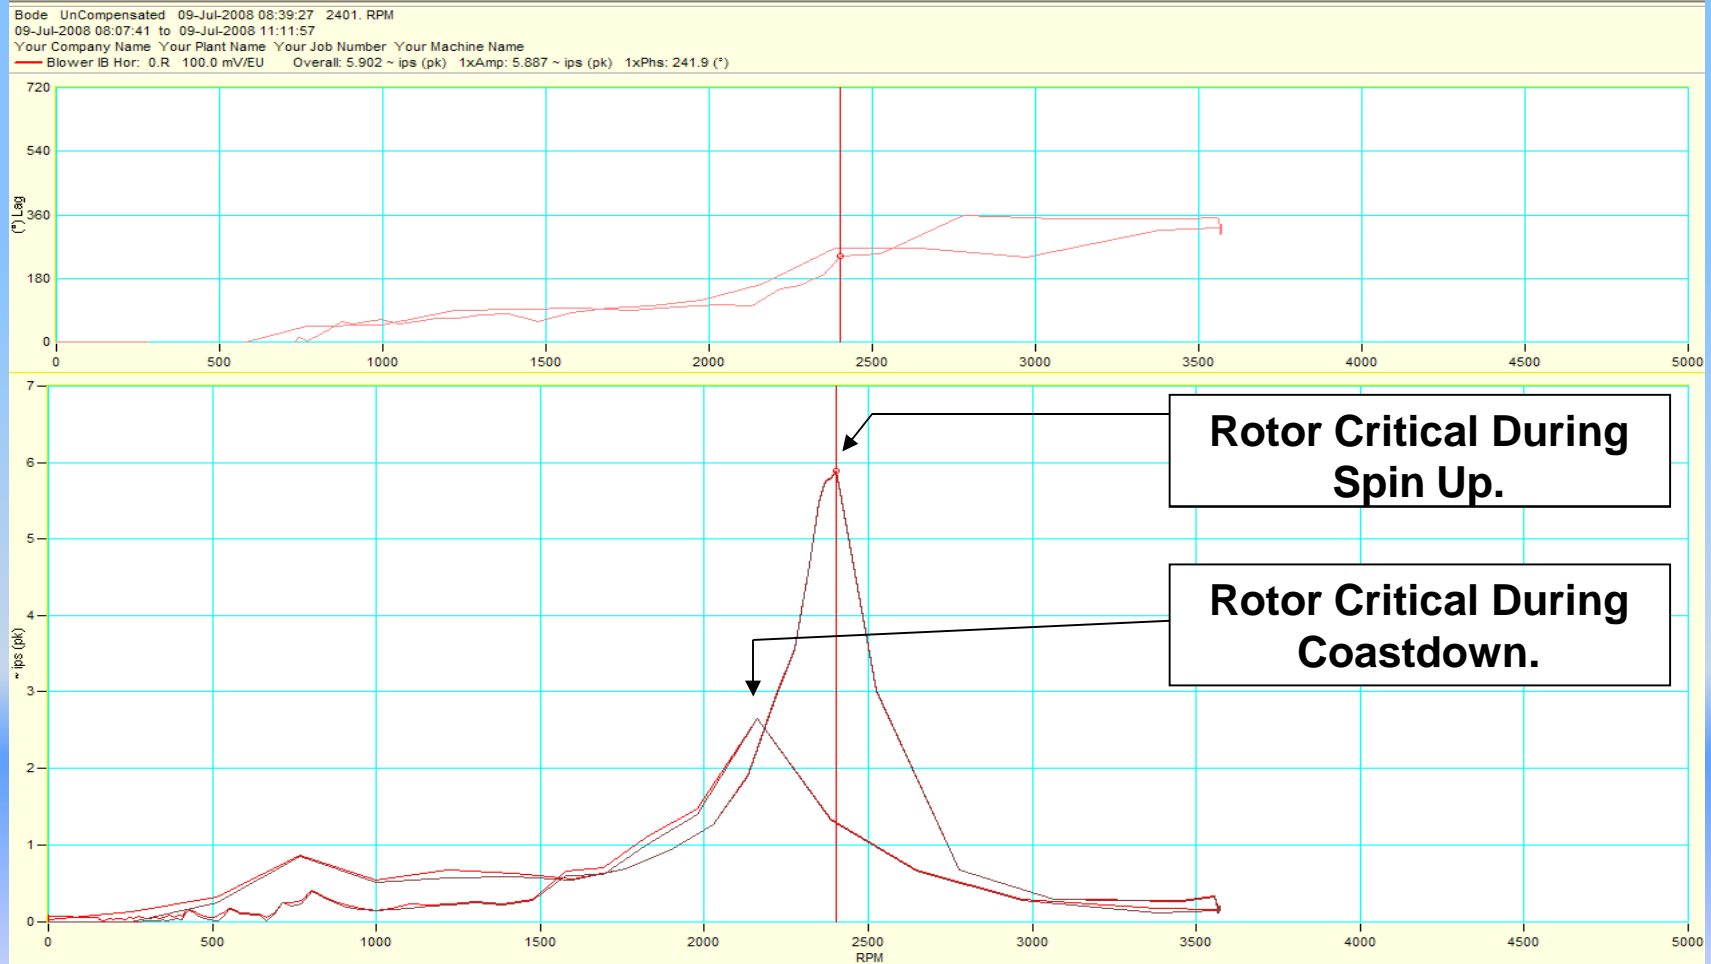
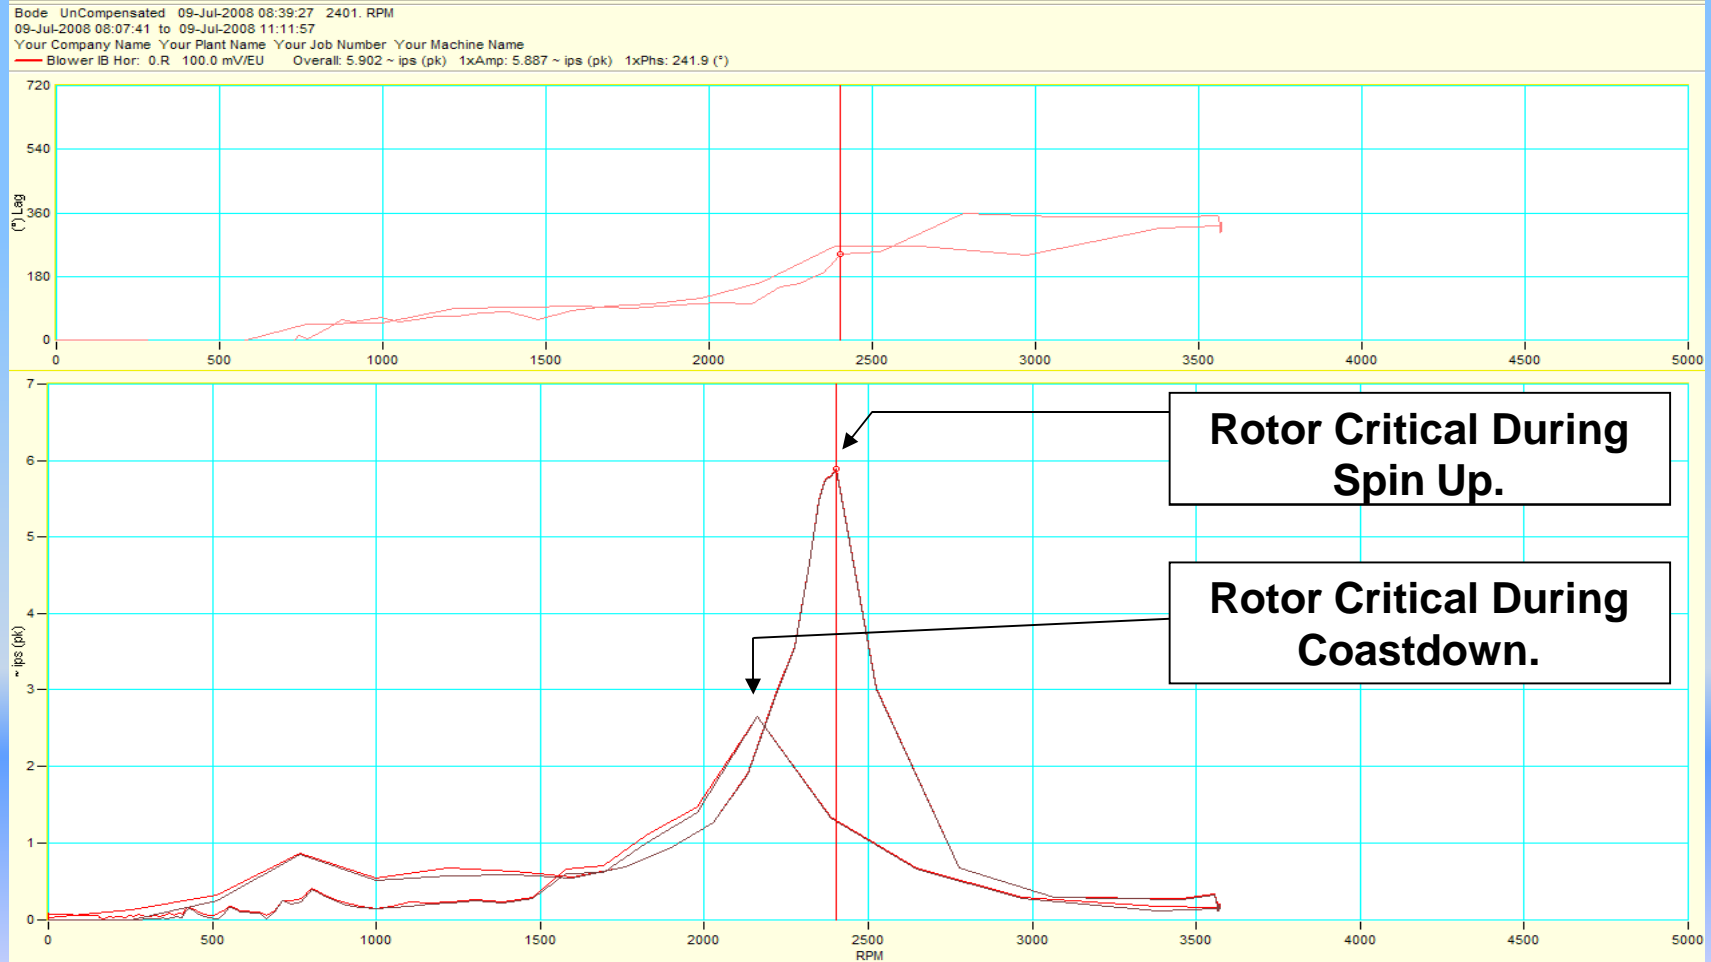
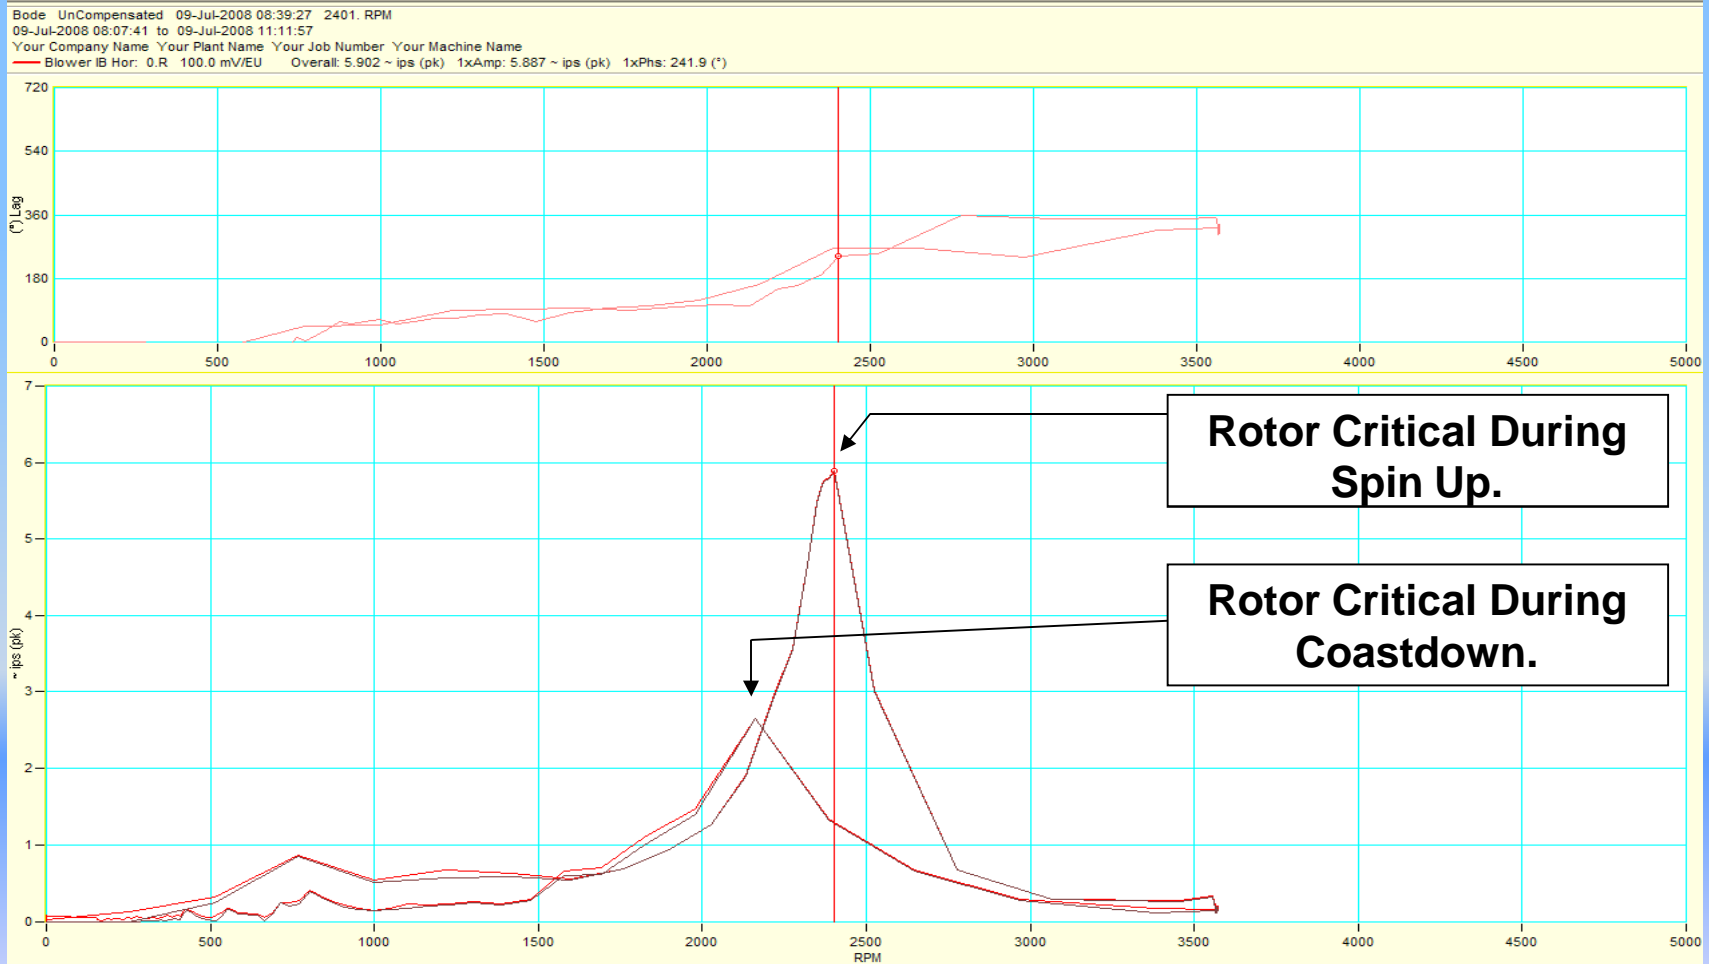
Figure 16: Bode' Plot of Blower IB Hor During 3<sup>rd</sup> Startup and Coastdown. Vibration Amplitude was Very High at About 5.9 in/sec pk.

Data indication of a rotor/bearing critical speed.

The indication of a critical speed much higher than calculated would not become clear until a rotor dynamic analysis was performed.

A rotor rub mid-span (between the bearings) due to high rotor unbalance would raise the critical speed.

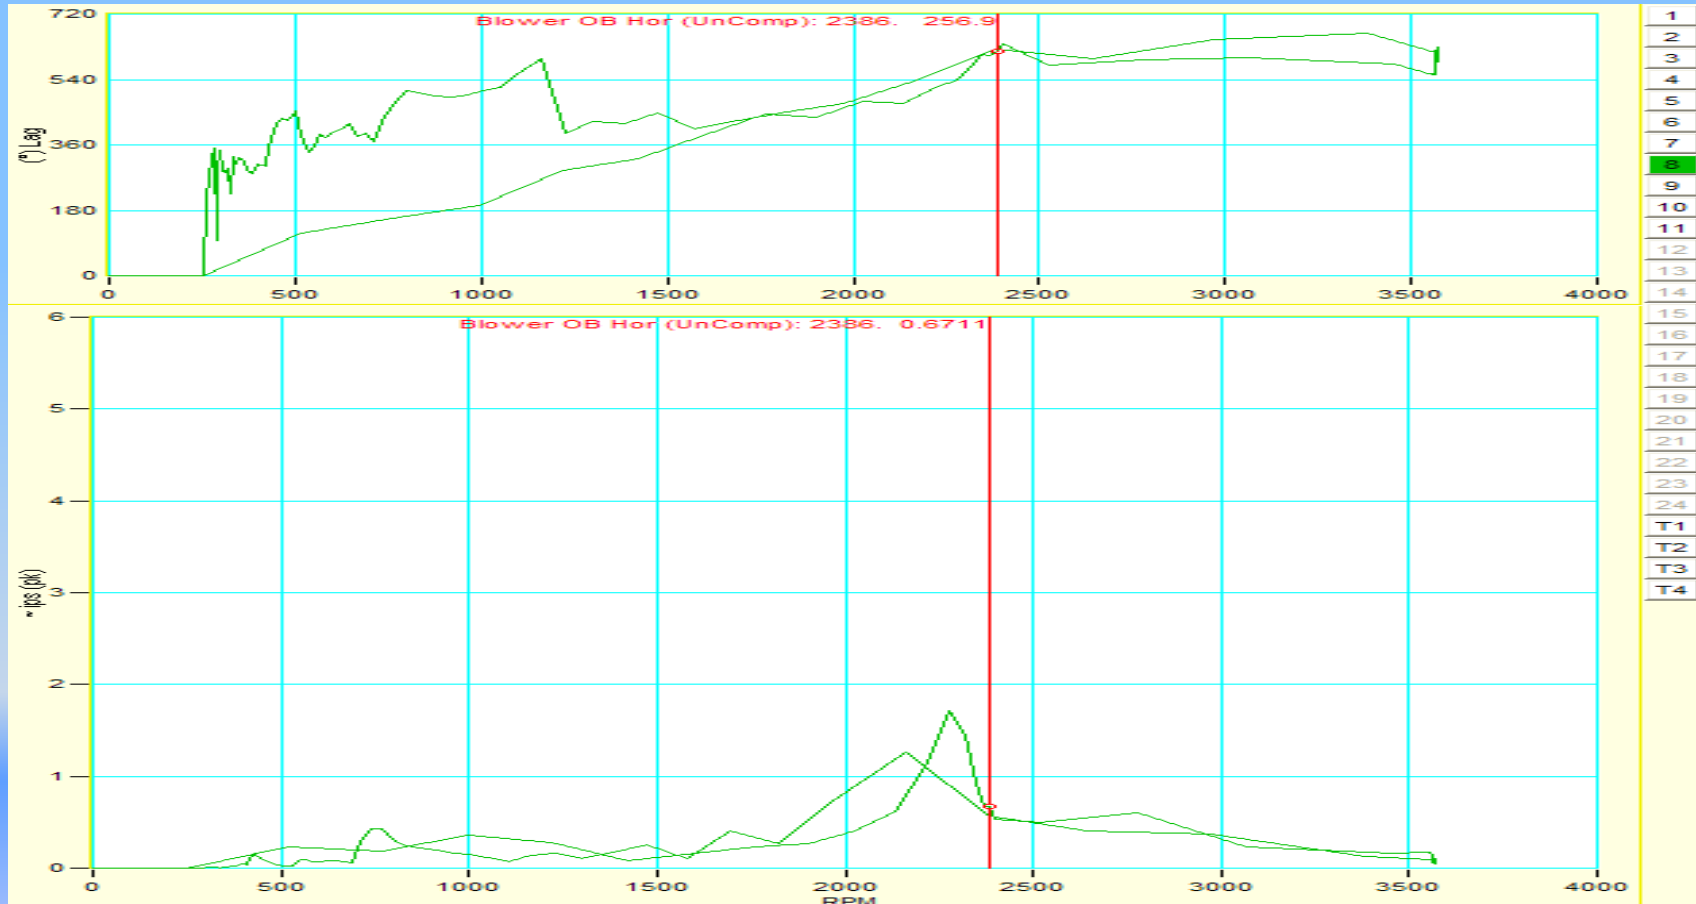
**Figure 17. Bode' Plot of Blower OB Hor During 3<sup>rd</sup> Startup and Coastdown. Vibration Amplitudes Were Much Lower at the OB Bearing Housing and the Critical Speeds Were Also Lower.**

Bode' plot of Blower OB Bearing Housing Horizontal Response During 3<sup>rd</sup> Startup (2271 RPM) & Coastdown (2161 RPM).

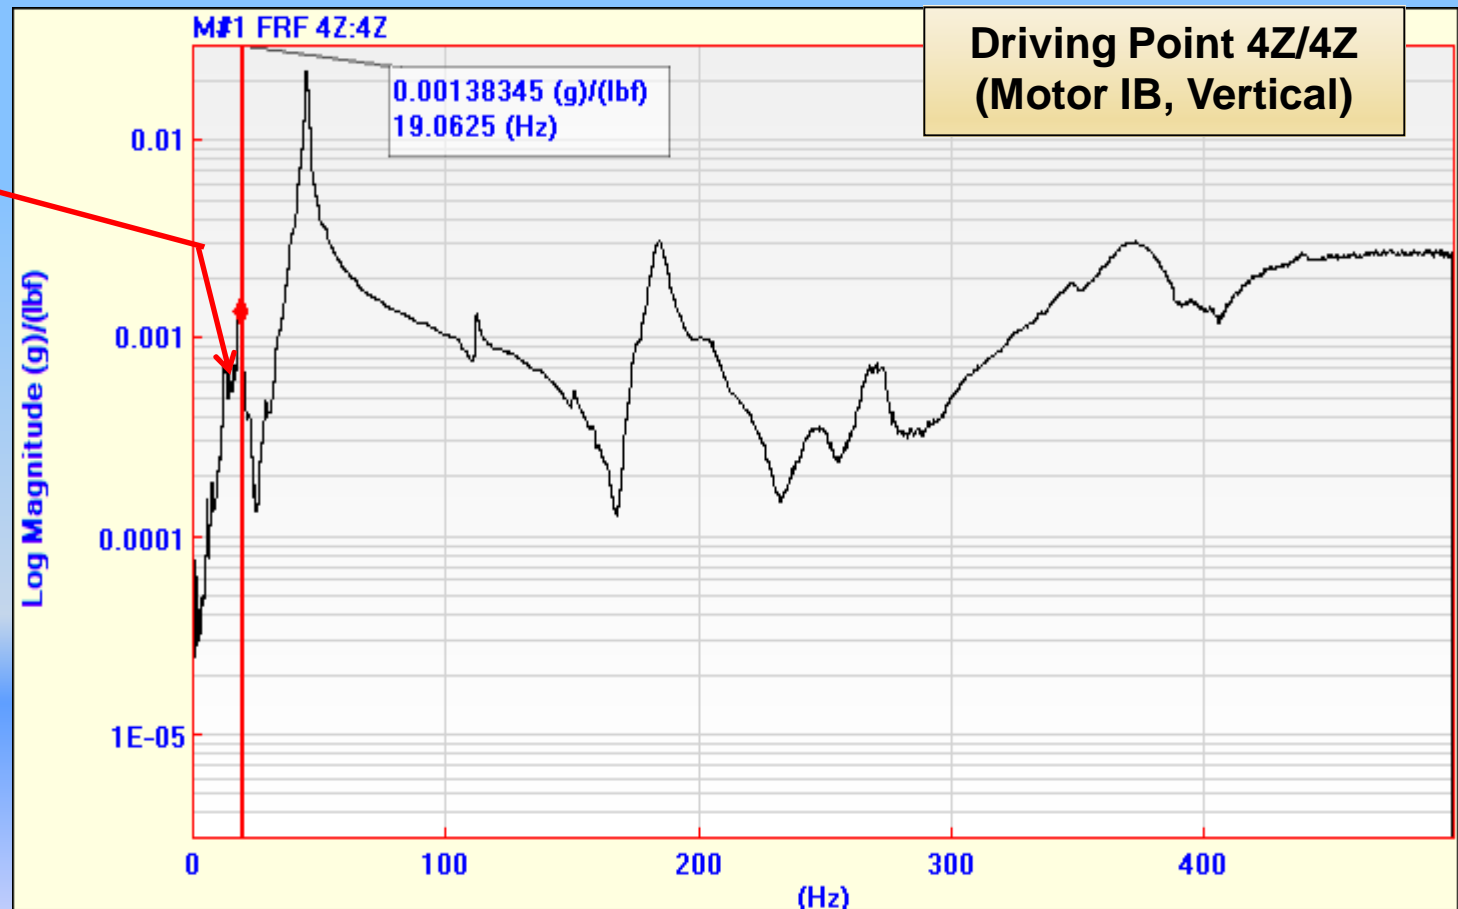
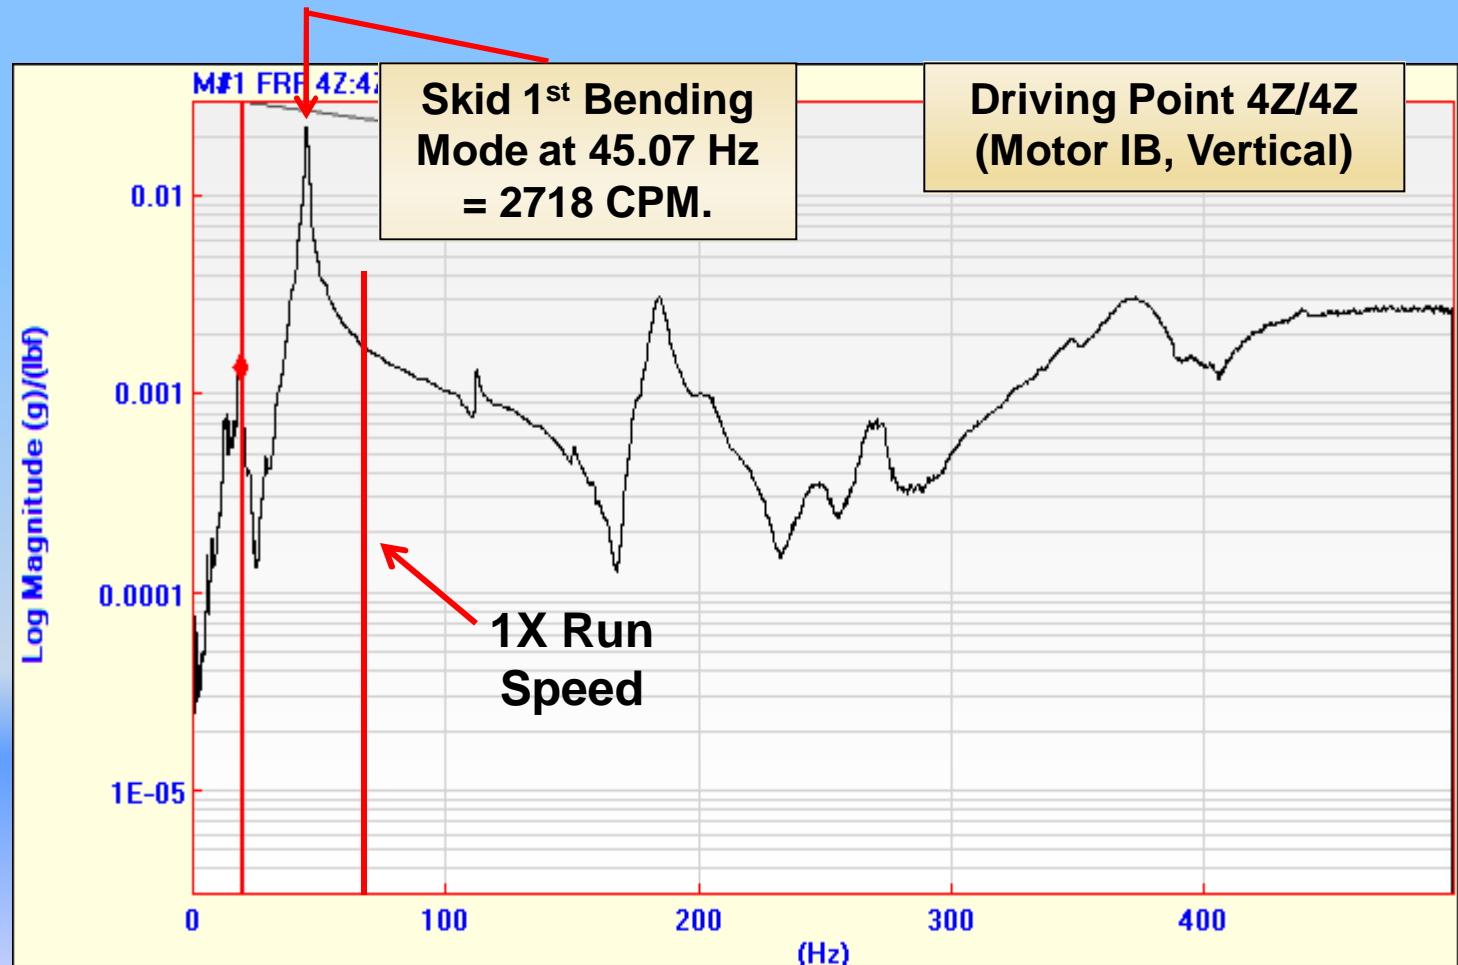
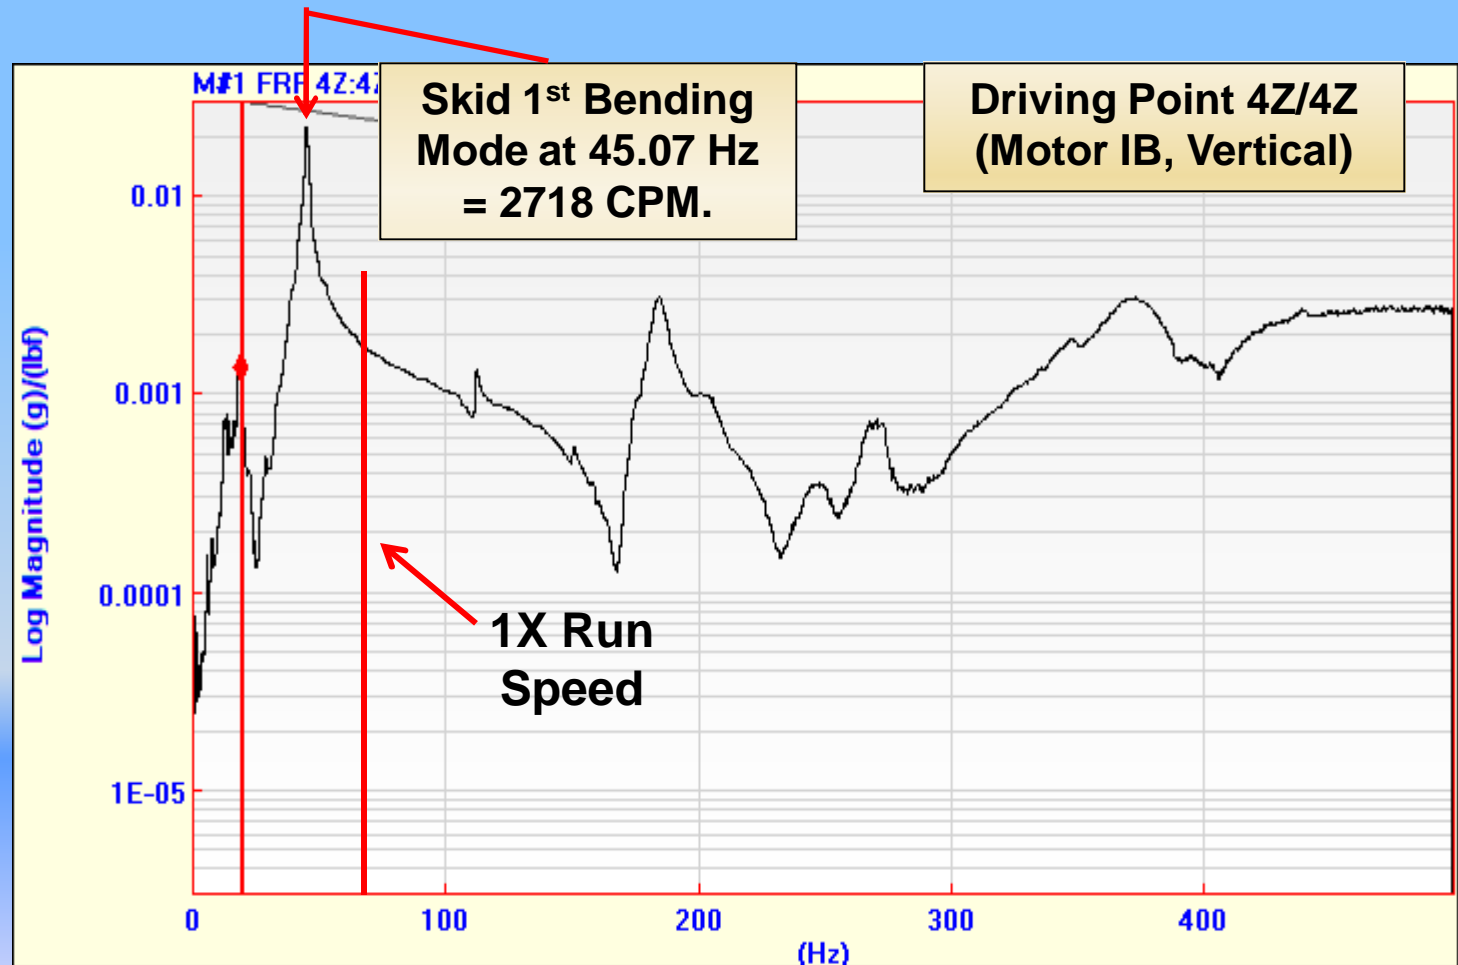
Figure 20: FRF on Motor IB Bearing Housing Showing Natural Frequency Near Running Speed.

The FRF Displays the Damped Natural Frequencies Excited by Impacting the Motor with Modal Hammer.

The mode shape of the 2718 CPM natural frequency was bending of the skid rails in the vertical direction in the section between the motor support rails and the blower inboard feet mounting position.

- ❑ The modal test of the blower and motor frame assembly showed a very responsive bending mode of the frame at the motor end within the operating speed range. The natural frequency mode shape was rocking of the motor in the vertical and axial directions. All five blowers tested had high amplitude motor vibration in the axial and vertical directions. It was discovered that stiffener plates/gussets originally provided by the OEM had been removed by maintenance personnel to gain access to hold down bolts. These gussets had not been replaced.**

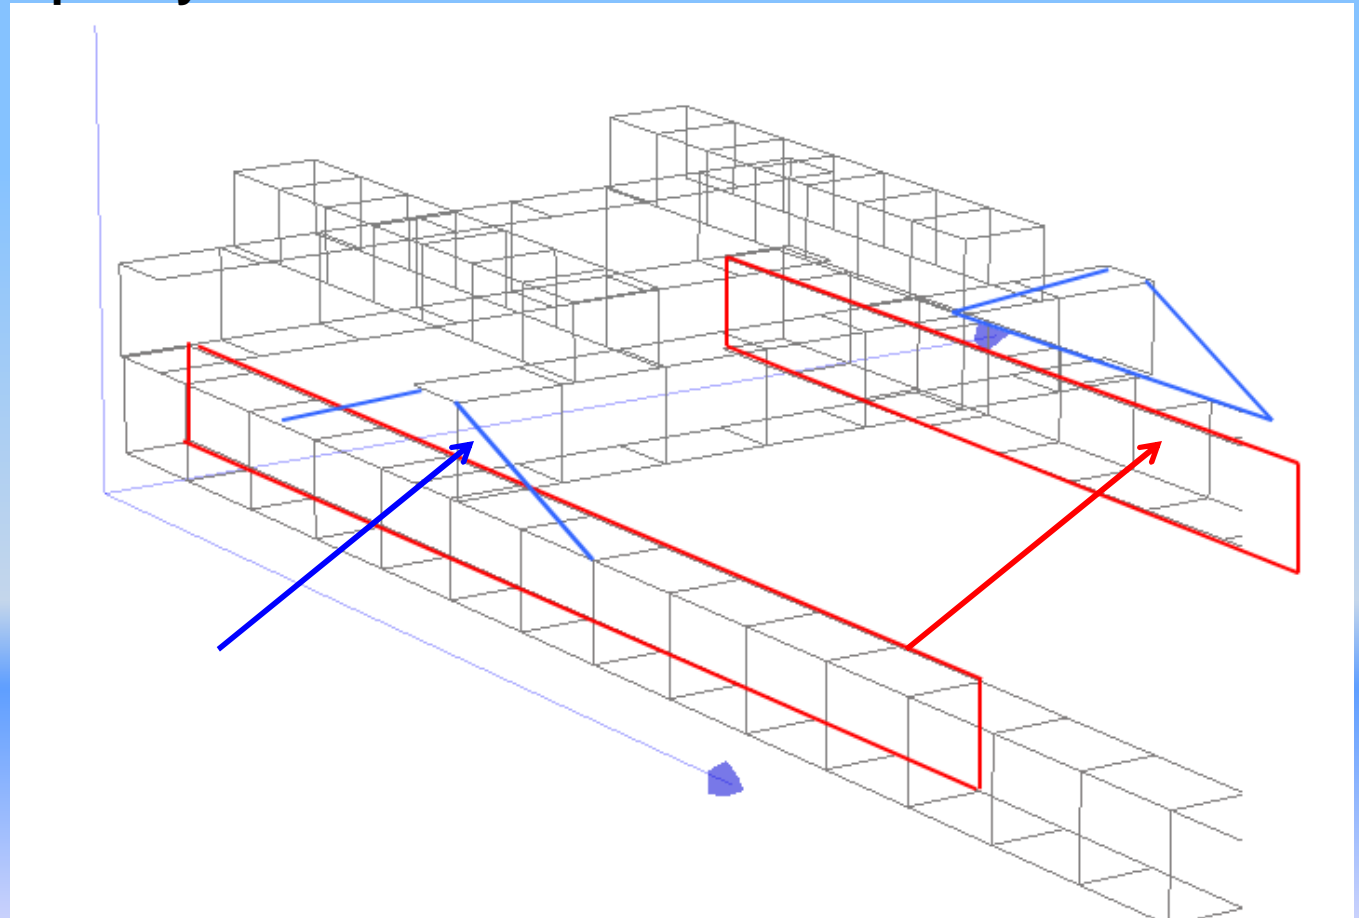
Figure 21: Suggested Stiffen Of the Skid Frame Rails Based on the Modal Test Results.

Stiffening the Existing Skid Was Recommended by Welding Plate to the Channel (making the channel a rectangular tube) and also Adding plate Stiffeners.

Intent was to Move the Motor-Support Skid Frame Bending Mode Well Above The Run Speed Frequency.

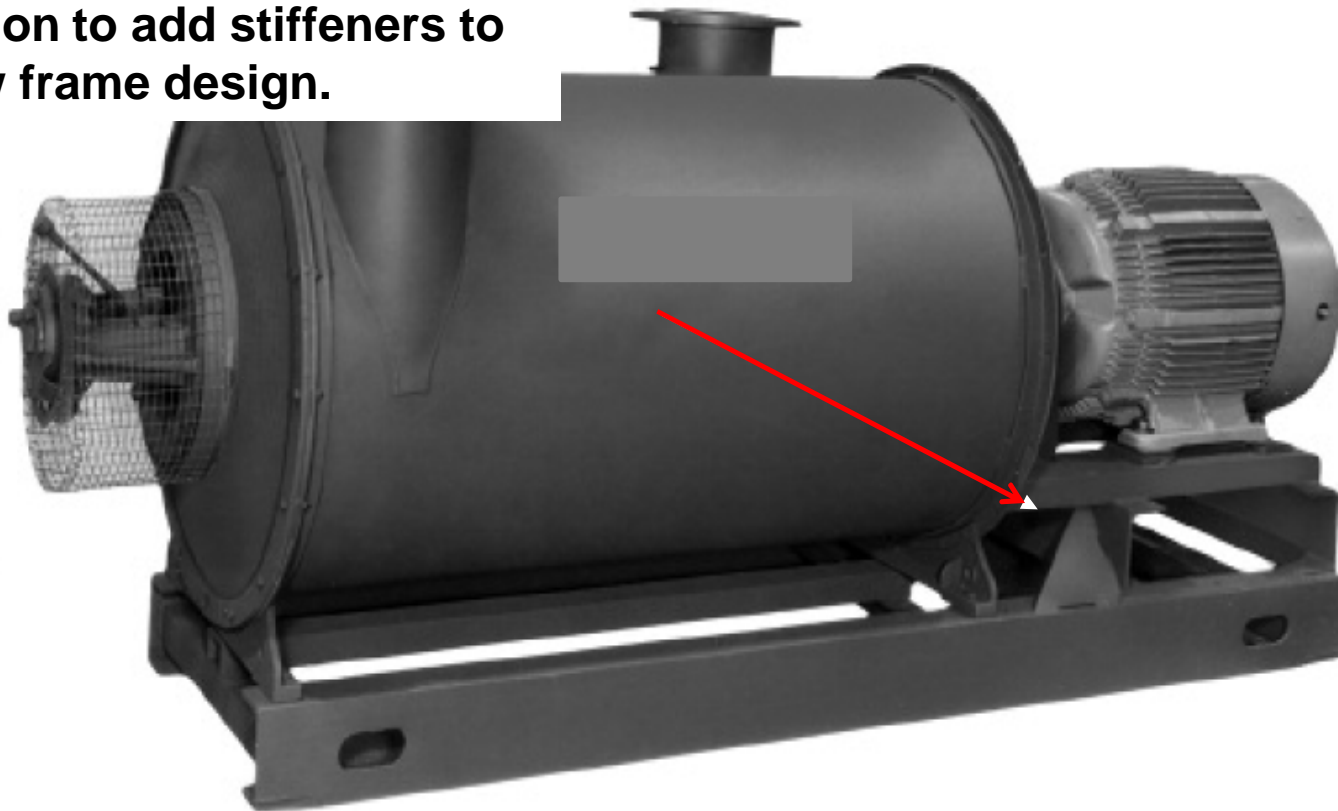
**Figure 22. Stiffeners Originally Included in the Blower Design.**

**It Turned Out that the Blower OEM Design Incorporated Stiffeners in this Area. During maintenance, the OEM Stiffeners had been Removed to Gain Access to Bolts but they had not been replaced.**

**The equipment owner used this information to add stiffeners to their new frame design.**
