# Reliability Improvement Project Multi-Stage Centrifugal Blowers

For  
Piedmont Chapter  
Vibration Institute  
Charleston, SC Sept 9, 2011

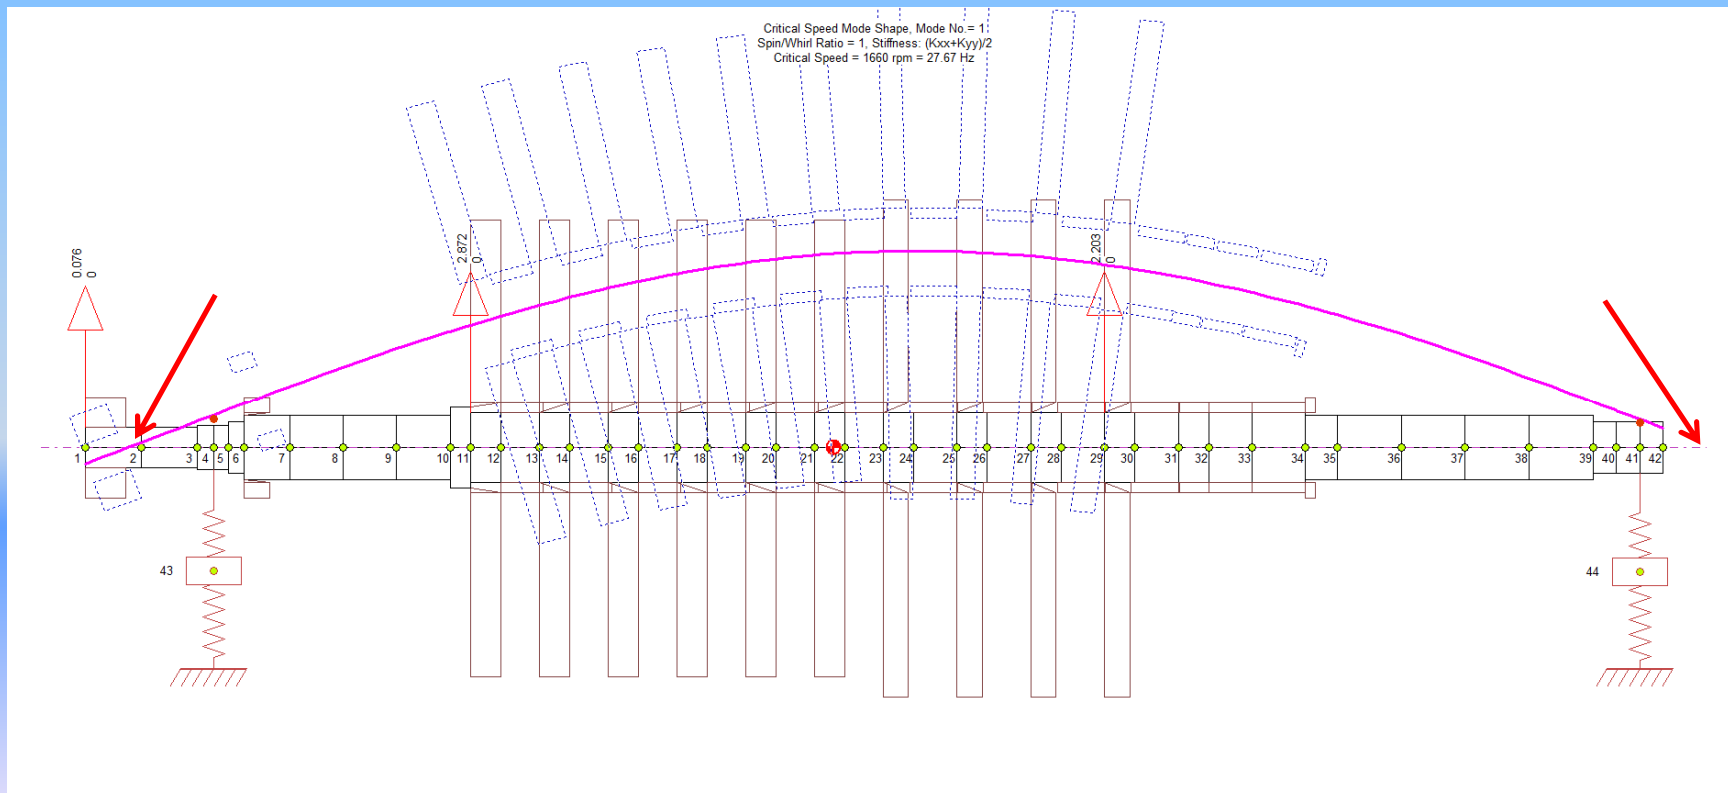
Figure 24. Rotor 1<sup>st</sup> Mode. Nodal Points are About 4" Outside Each Bearing.

Very important that the nodal points of a critical are not at the bearings. If this happens, the bearings provide very little control of the rotor vibration at the critical speed.

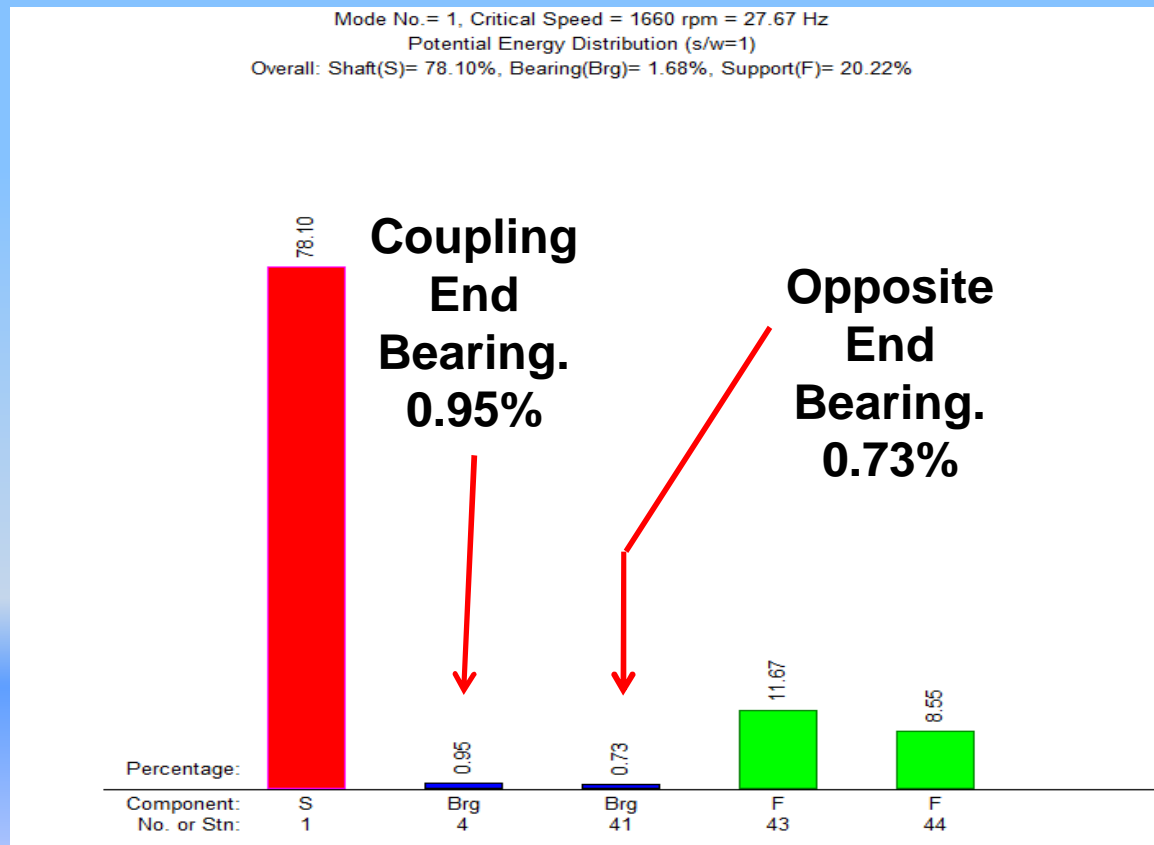
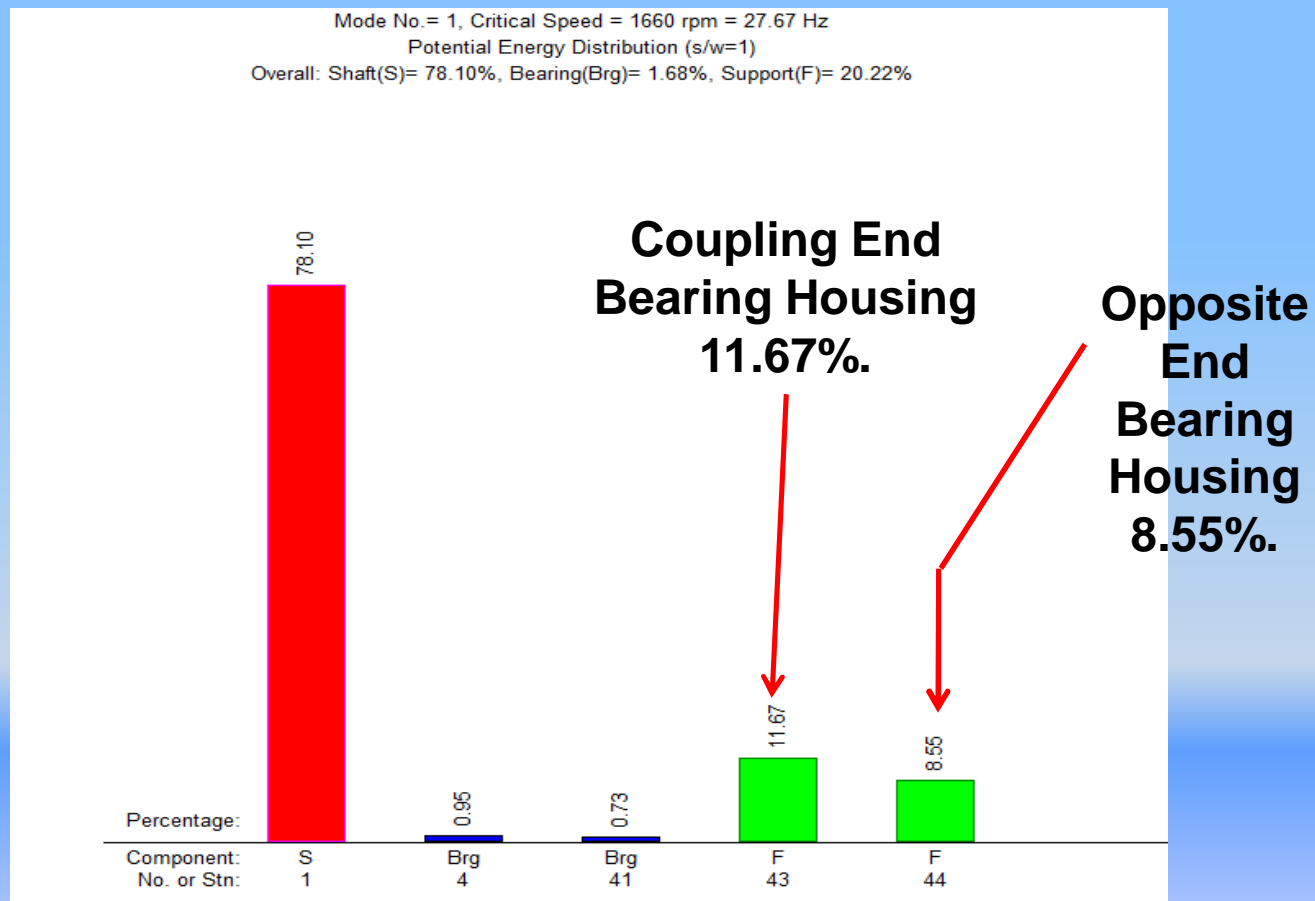
Figure 25. Potential Energy Distribution Showing Most Energy in the Shaft but the Bearings Have Very Low Participation in the Mode.

Dr Gunter Recommends the bearings have at Least 20% Strain Energy .  
The Bearings Calculated to Have Less than 1% Strain Energy Which Means the bearings will not contribute to overall system damping. The rotor will be Very Sensitive to Unbalance and Expected to Have High Vibration at the 1<sup>st</sup> Critical.

The Shaft is the Primary Component Controlling Critical Speed Response.

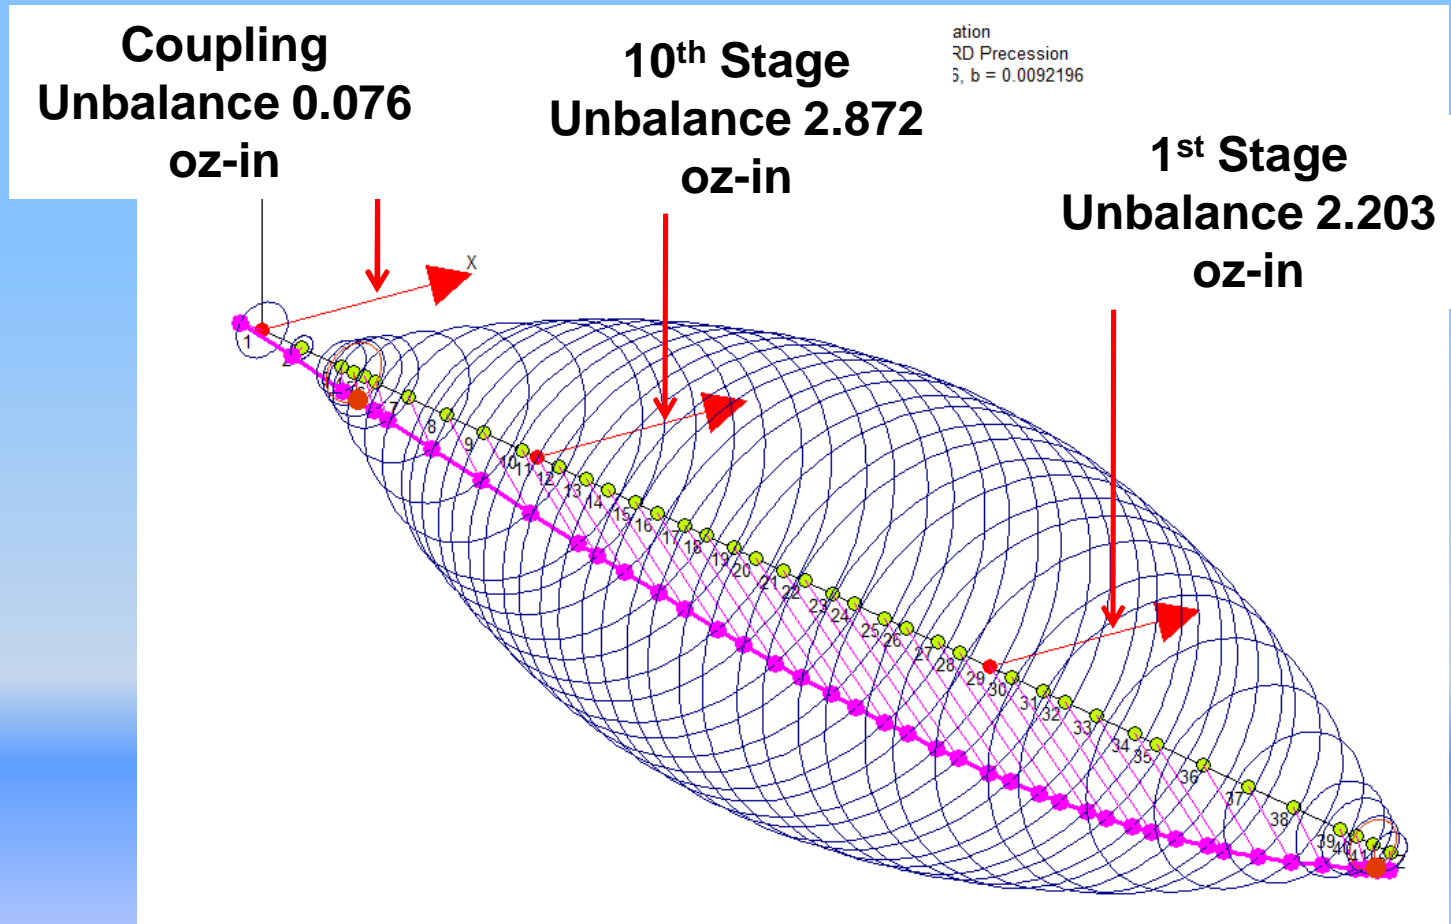
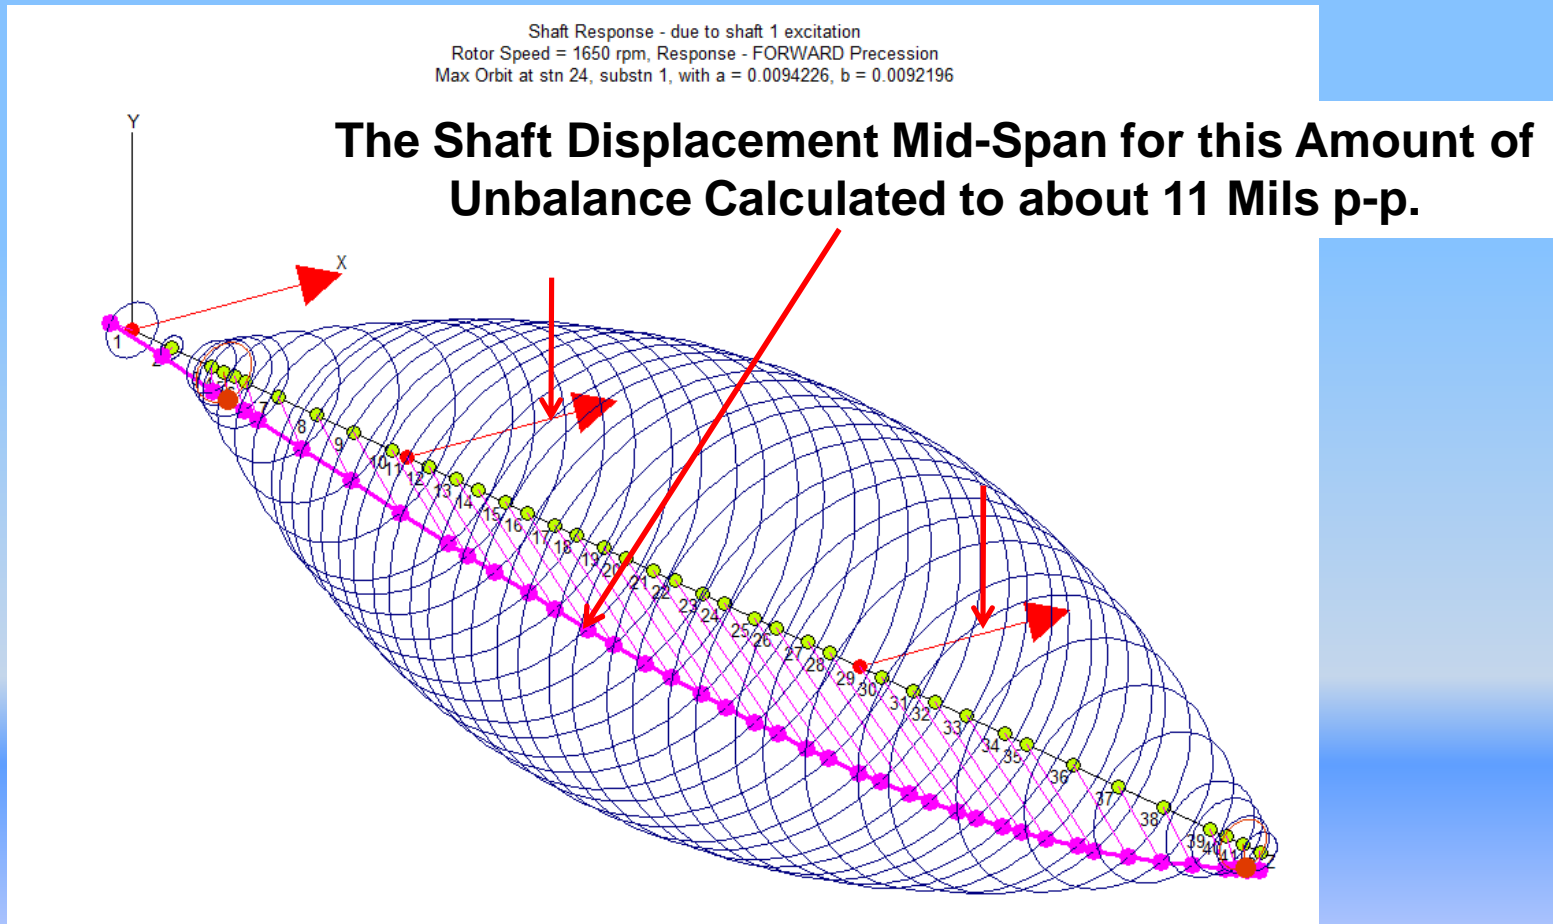
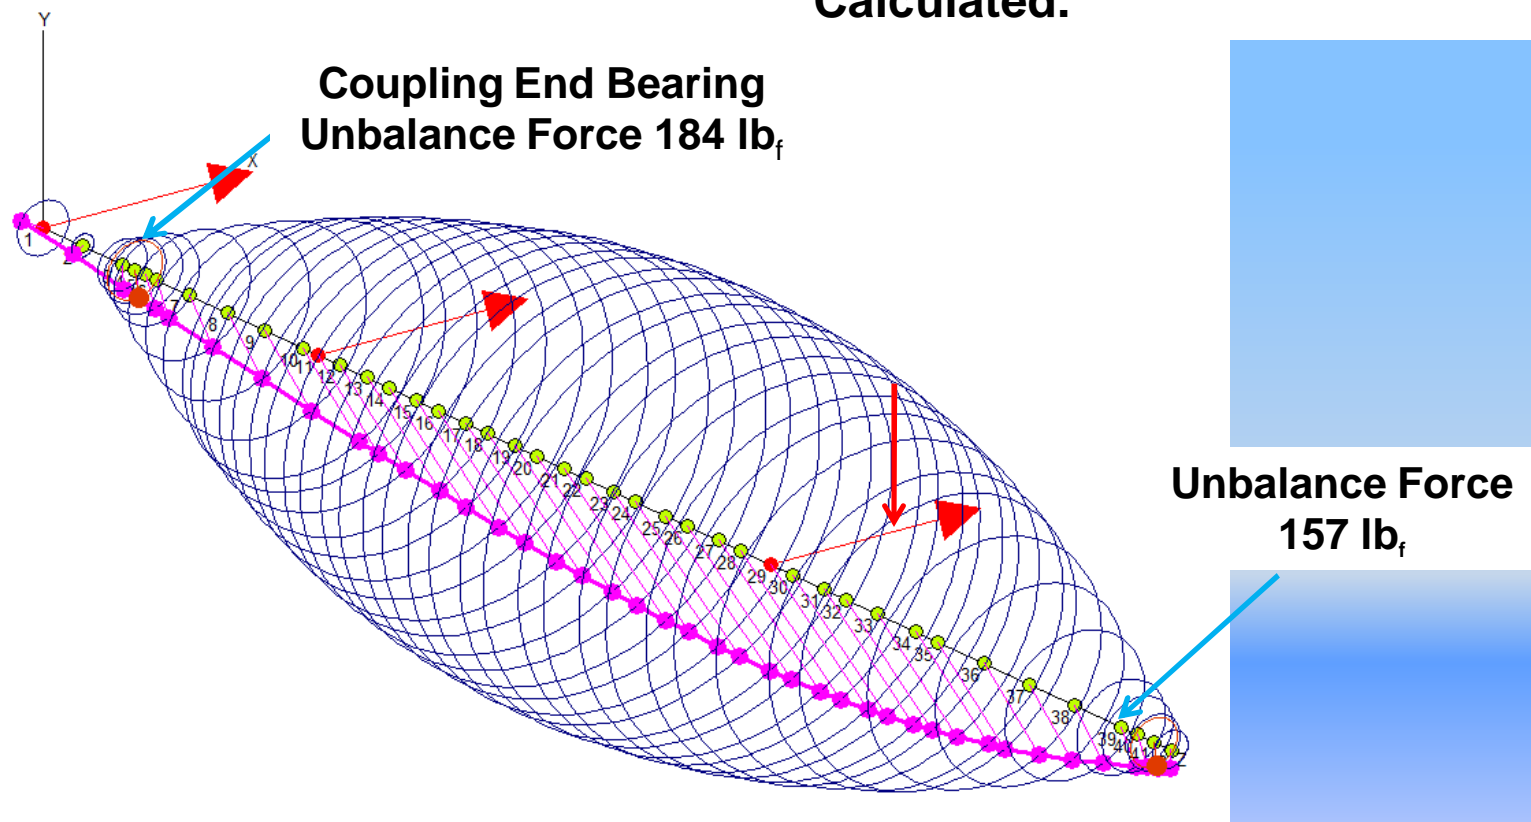
Figure 27: Rotor Response at 1<sup>st</sup> Critical to G 6.3 Unbalance in the 1<sup>st</sup> and 10<sup>th</sup> Stage Impellers. Maximum Orbit Mid-Span Calculated to About 11 mils pp.

Unbalance = to ISO G 6.3 Was Placed in the Model.

The Unbalance Force at the Bearings was Calculated.

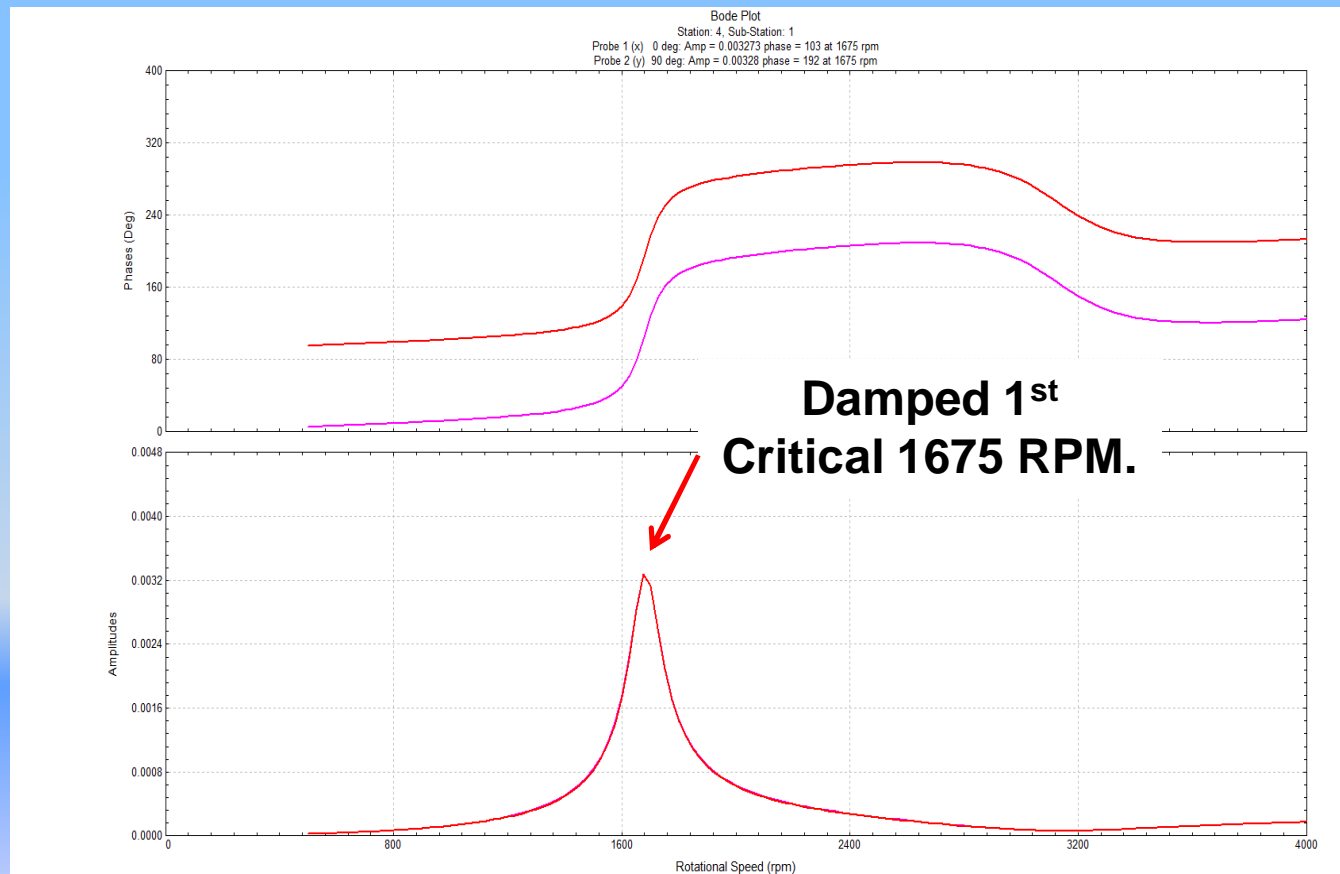
Figure 28. Bode' Plot of Damped Unbalanced Response at the Drive End Bearing to G6.3 Unbalance in 1<sup>st</sup> and 10<sup>th</sup> Stage Impellers.

Response from X Probe 0 Deg and Y Probe 90 Deg is Plotted for Response to ISO G 6.3 Unbalance.

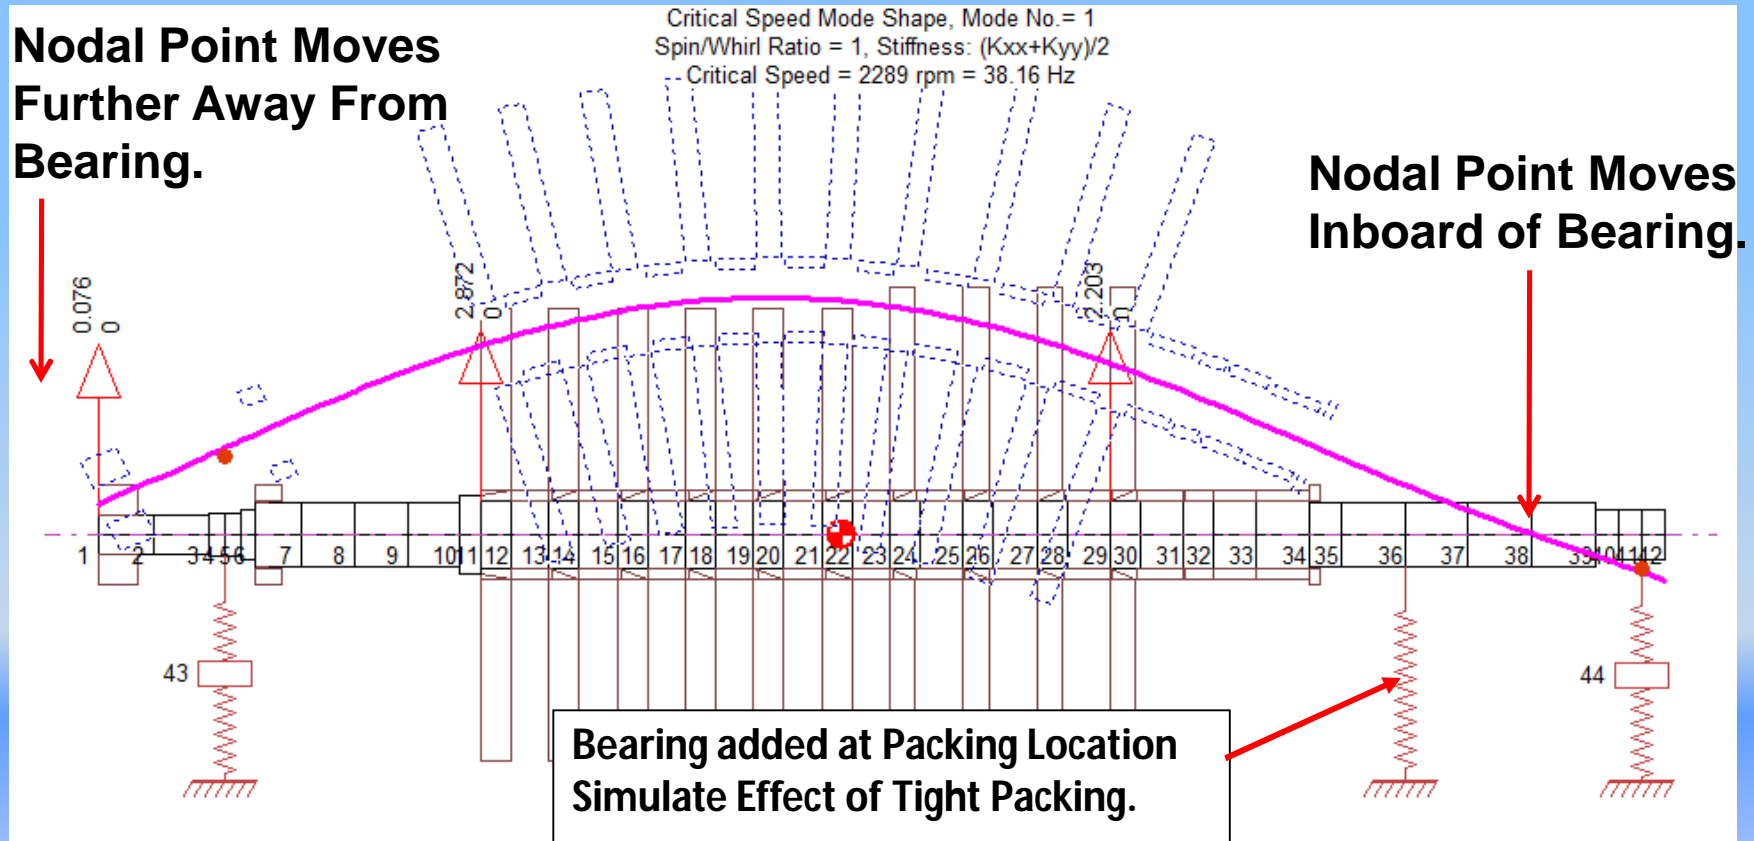
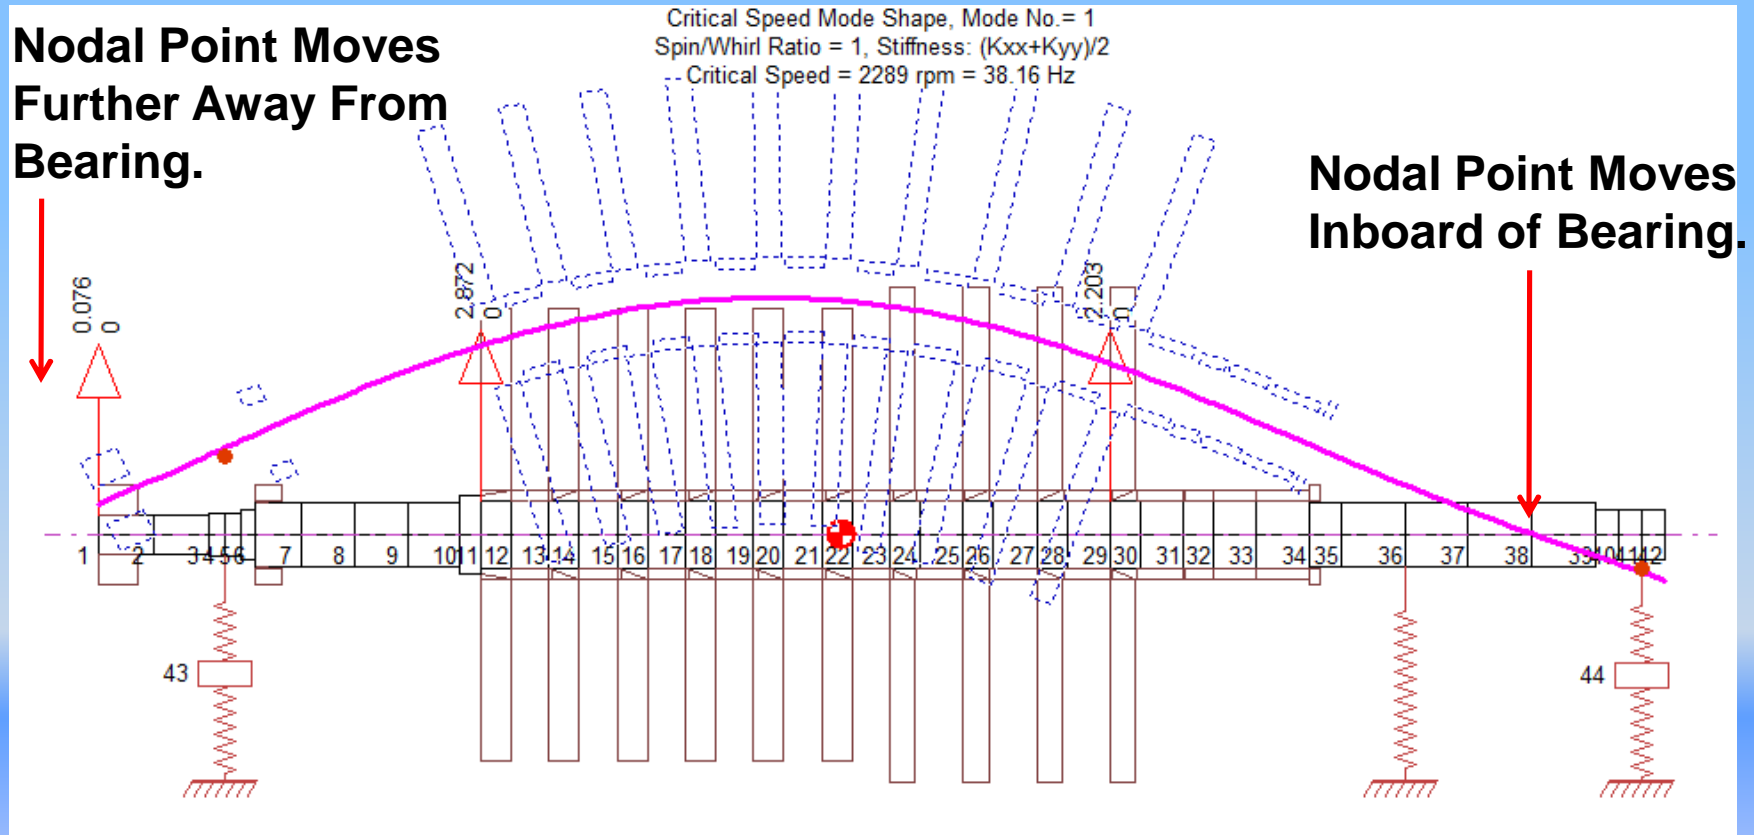
Figure 30. Blower Rotor Model with Bearing Added at the Packing Location to Simulate the Stiffening Effect of the Packing.

Different Stiffness Values were Tested to Find that 200,000 lb<sub>f</sub> Moved the 1<sup>st</sup> Critical to About 2400 RPM – Agreeing with the Field Vibration Data.

Animation of Damped 1<sup>st</sup> Forward Mode 2377 RPM

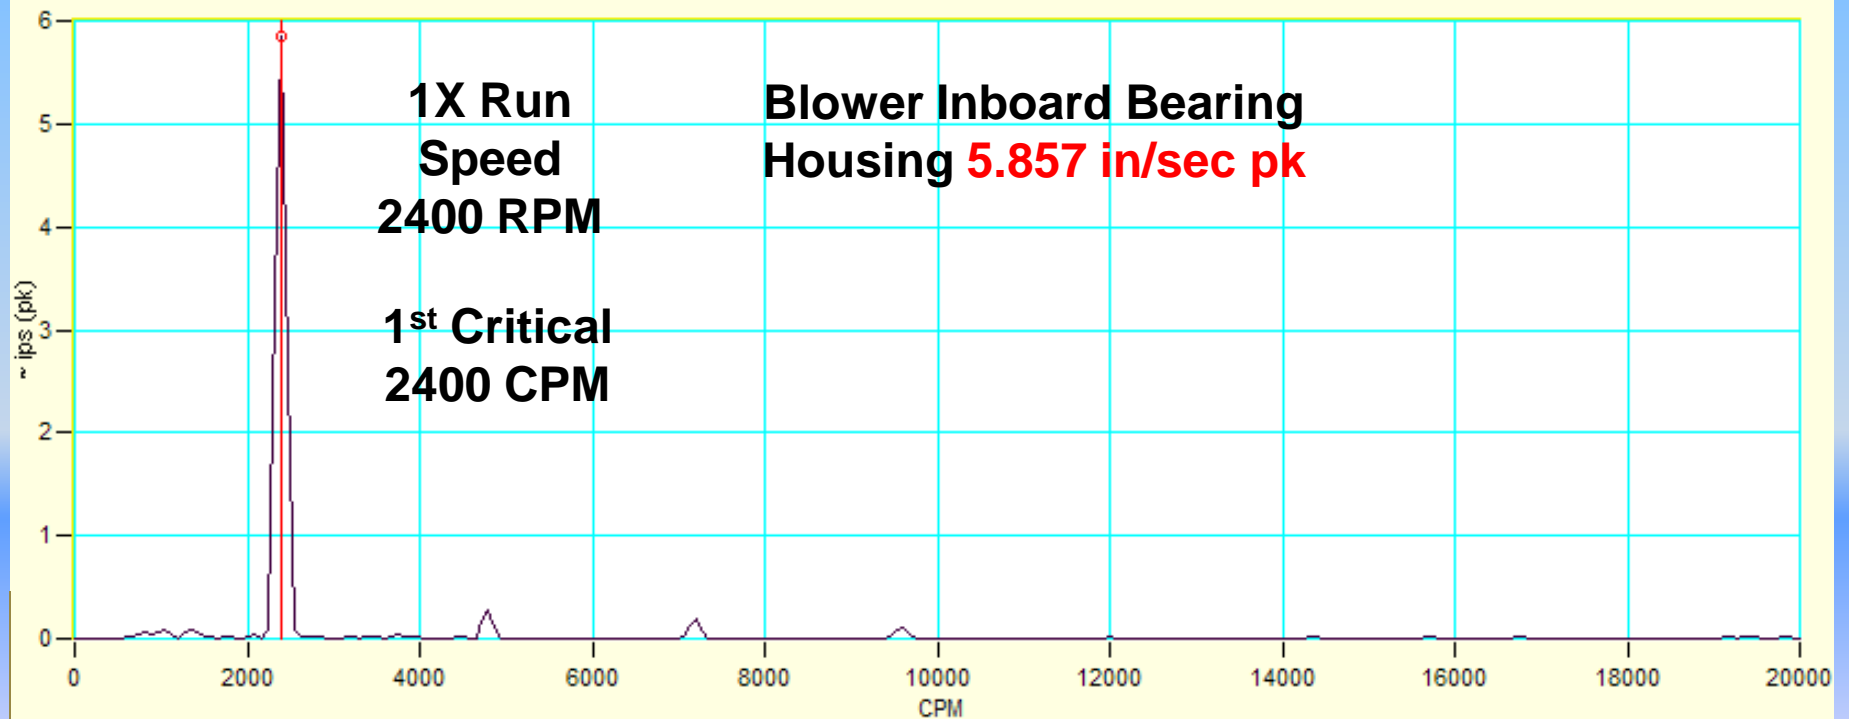
— Blower IB Hor Csr: 2400. CPM, 5.857 ~ ips (pk) (OA: 5.902)

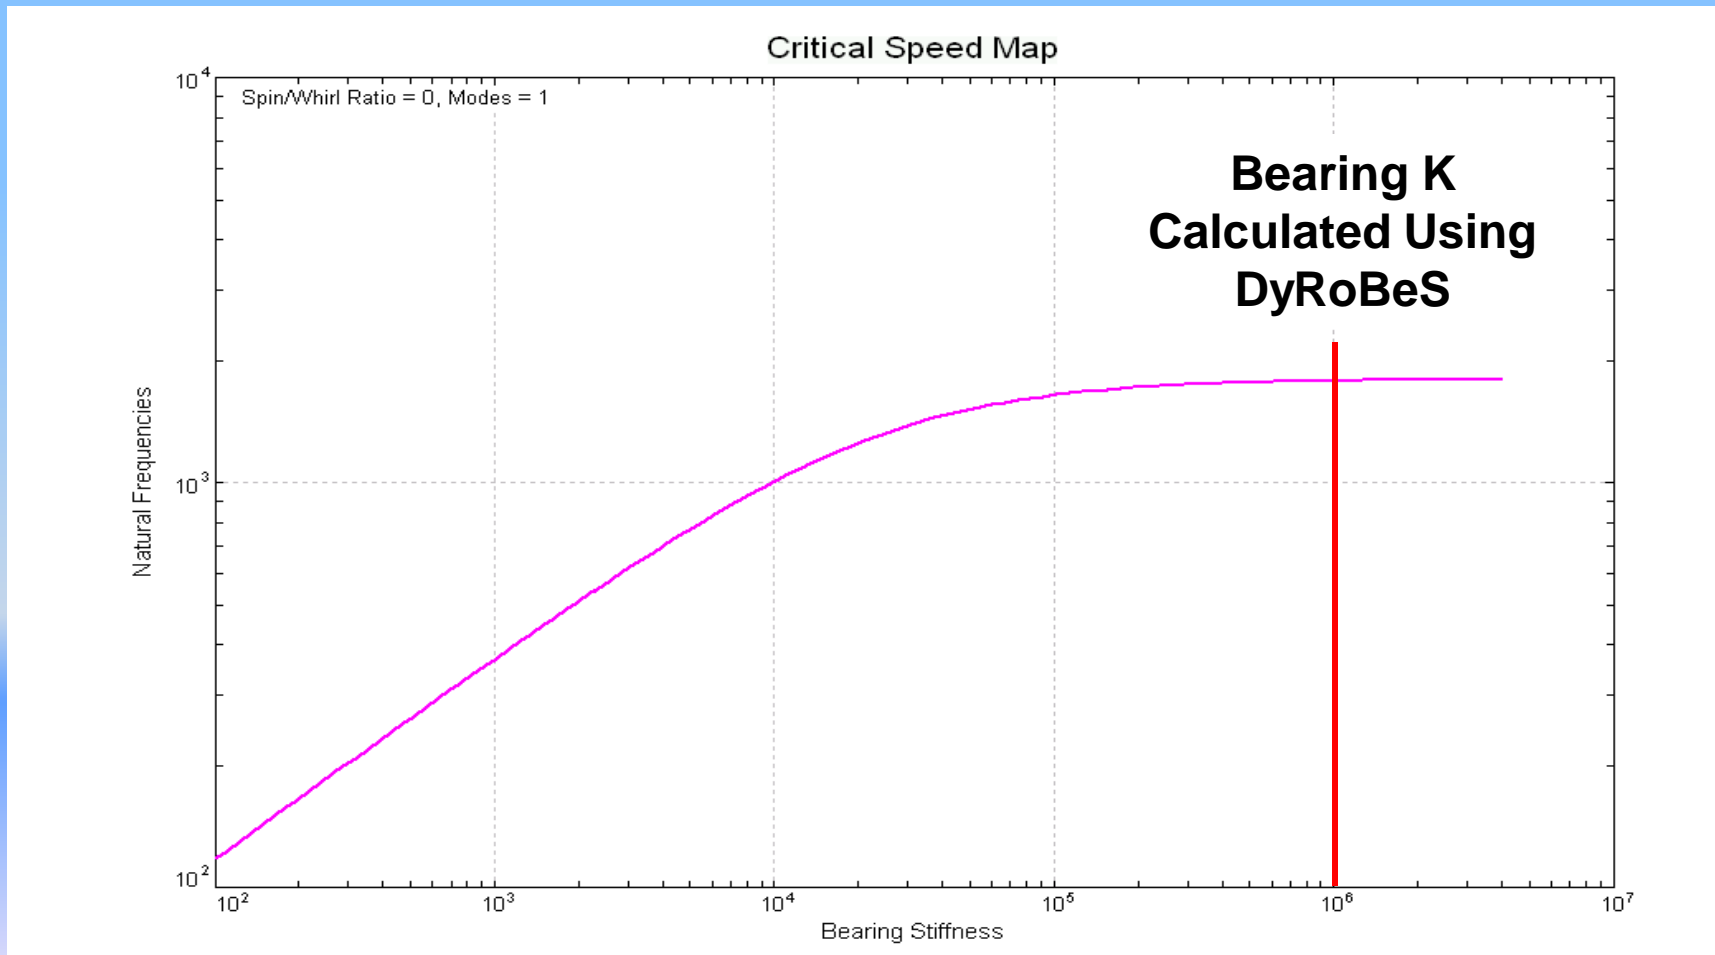
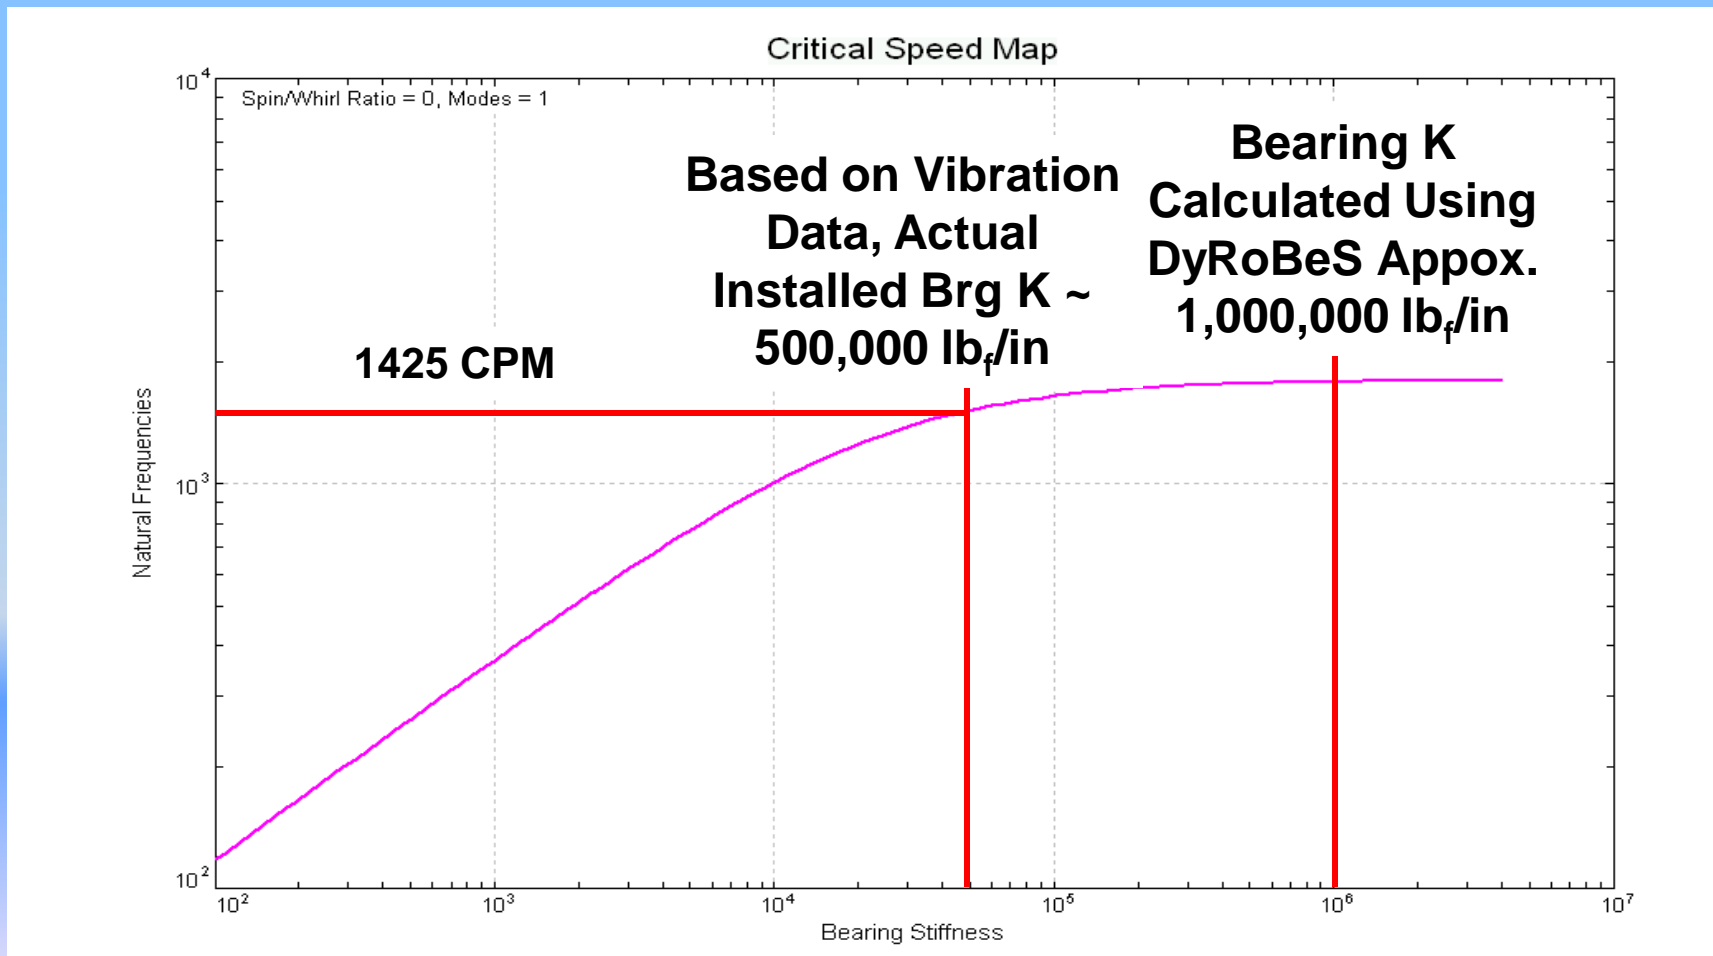
The Blower 1<sup>st</sup> Critical Speed Calculated to 1660 (Packing adding no support stiffness). The bearing stiffness calculated using DyRoBeS was approx 1,000,000 lb<sub>f</sub>/in.

It would be found at disassembly that the shaft bearing fits were undersize and the bearing housing bores were oversize thus providing lower support stiffness than calculated (~500,000 lb<sub>f</sub>/in).

The model represented a new condition blower.

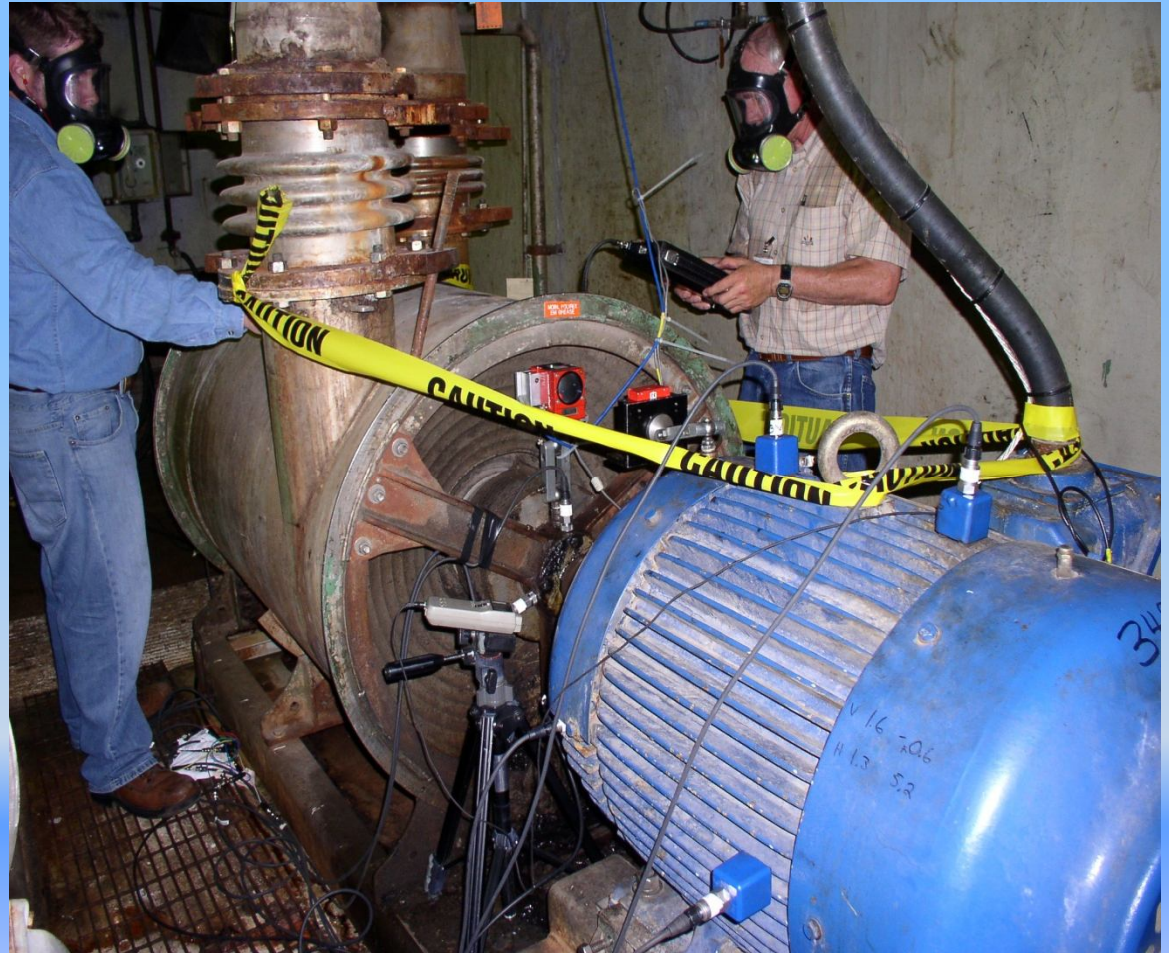
Figure 33. Laser Alignment Equipment, Ludeca Permalign,<sup>Ref 7</sup> Installed on the Motor and Blower.

The Blower was Shutdown and Allowed to Cool Overnight.

Permalign Was Installed After Shutdown.

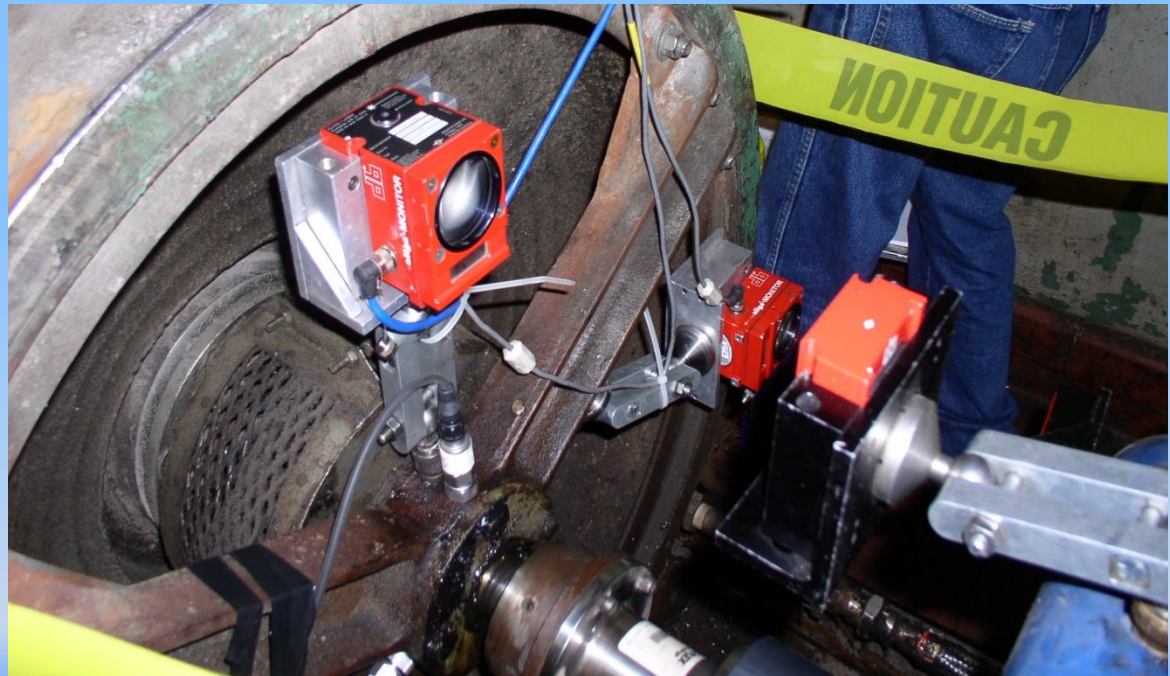
Figure 34. Permalign Setup on Blower and Motor. <sup>Ref 7</sup>

Permalign Was Installed After Shutdown.

At Startup, Permalign Laser and Accelerometers Moved due to High Vibration.

Blower was Shutdown, Adjustments made & Blower restarted.

Cool Down Data Indicated Severe Pipe Stain in the Horizontal Direction.

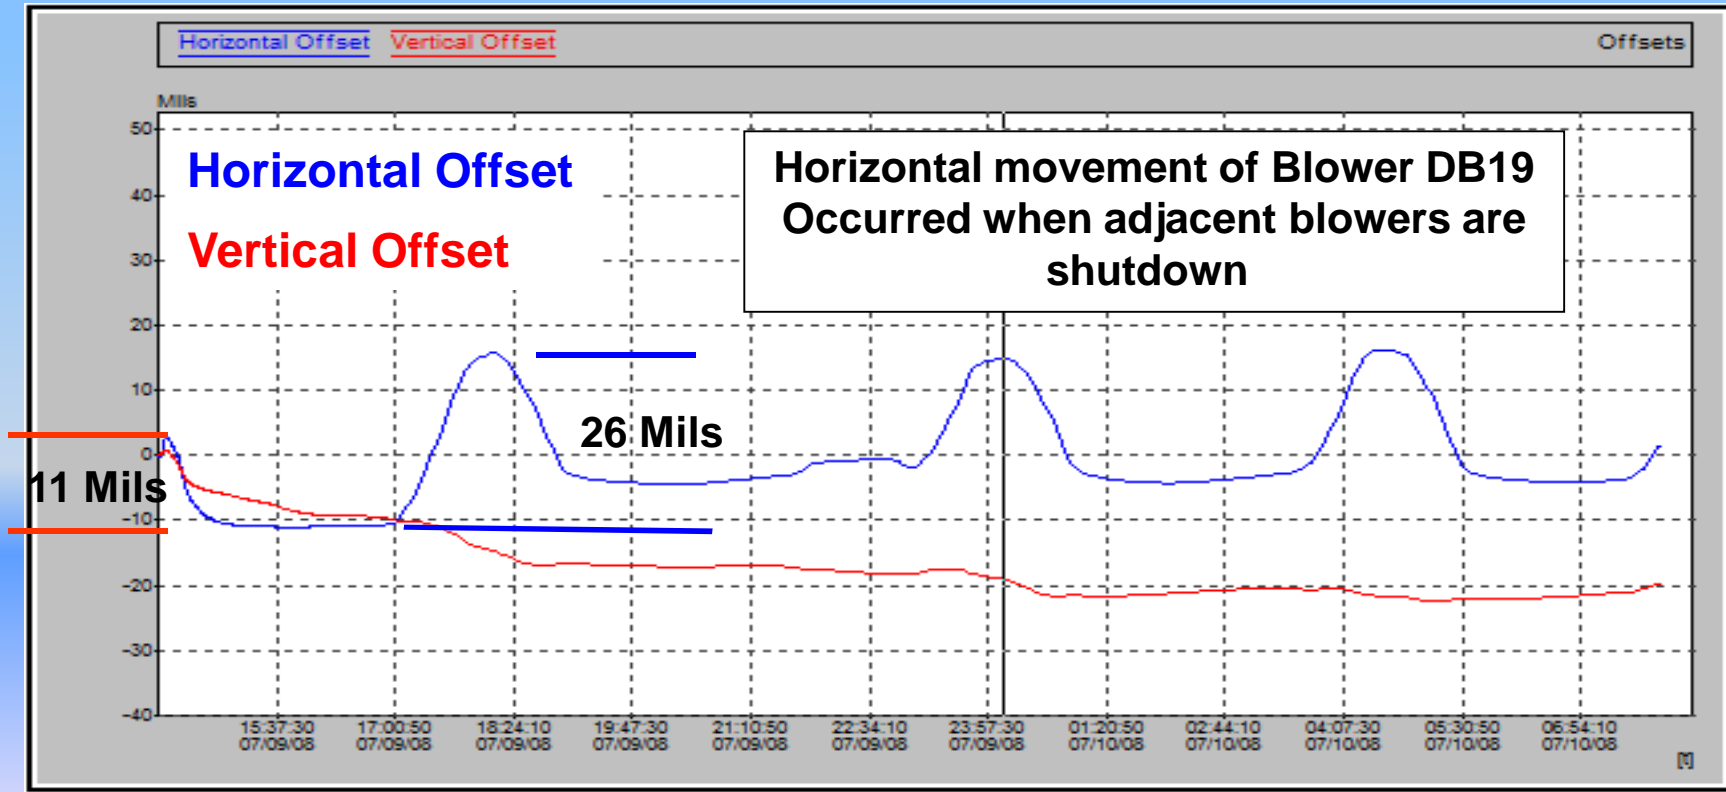
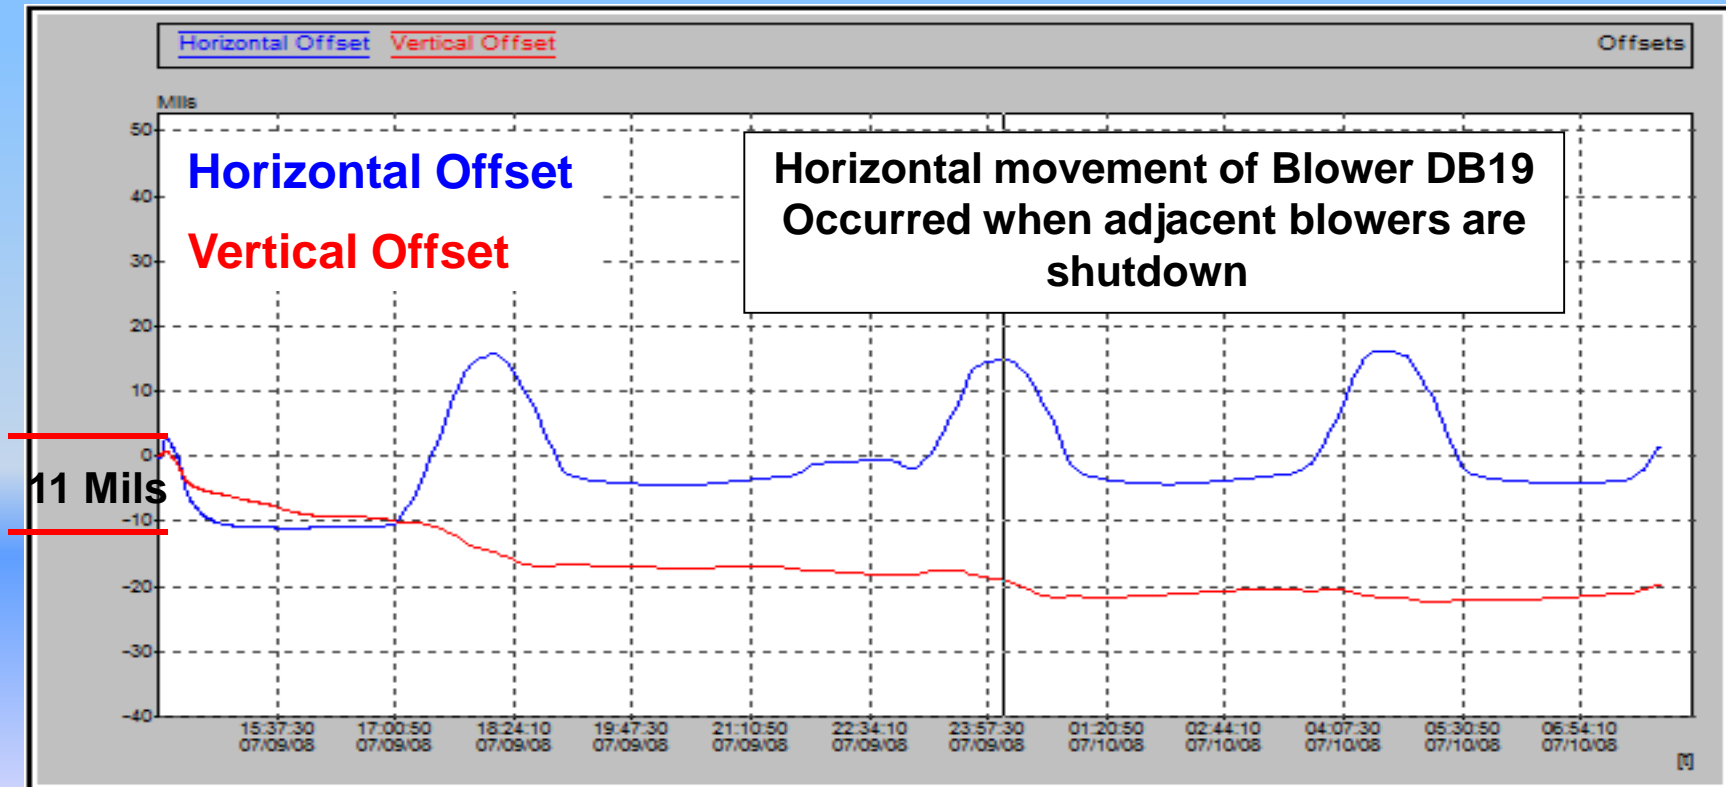
Figure 35. Blower DB19 Cool Down Alignment Data.

The Pipe Strain Forces the Blowers Out of Alignment as Much as 20 mils during Each Blower Startup.

- ❑ Permalign data measured on DB18 and DB19 showed over 20 mils relative horizontal movement of the motor and blower during shutdown and cooling to ambient temperature. There were also excessive alignment changes when adjacent blowers cycled on and off caused by thermal growth of the piping pushing/pulling the blowers.**
