# Reliability Improvement Project Multi-Stage Centrifugal Blowers

For  
Piedmont Chapter  
Vibration Institute  
Charleston, SC Sept 9, 2011

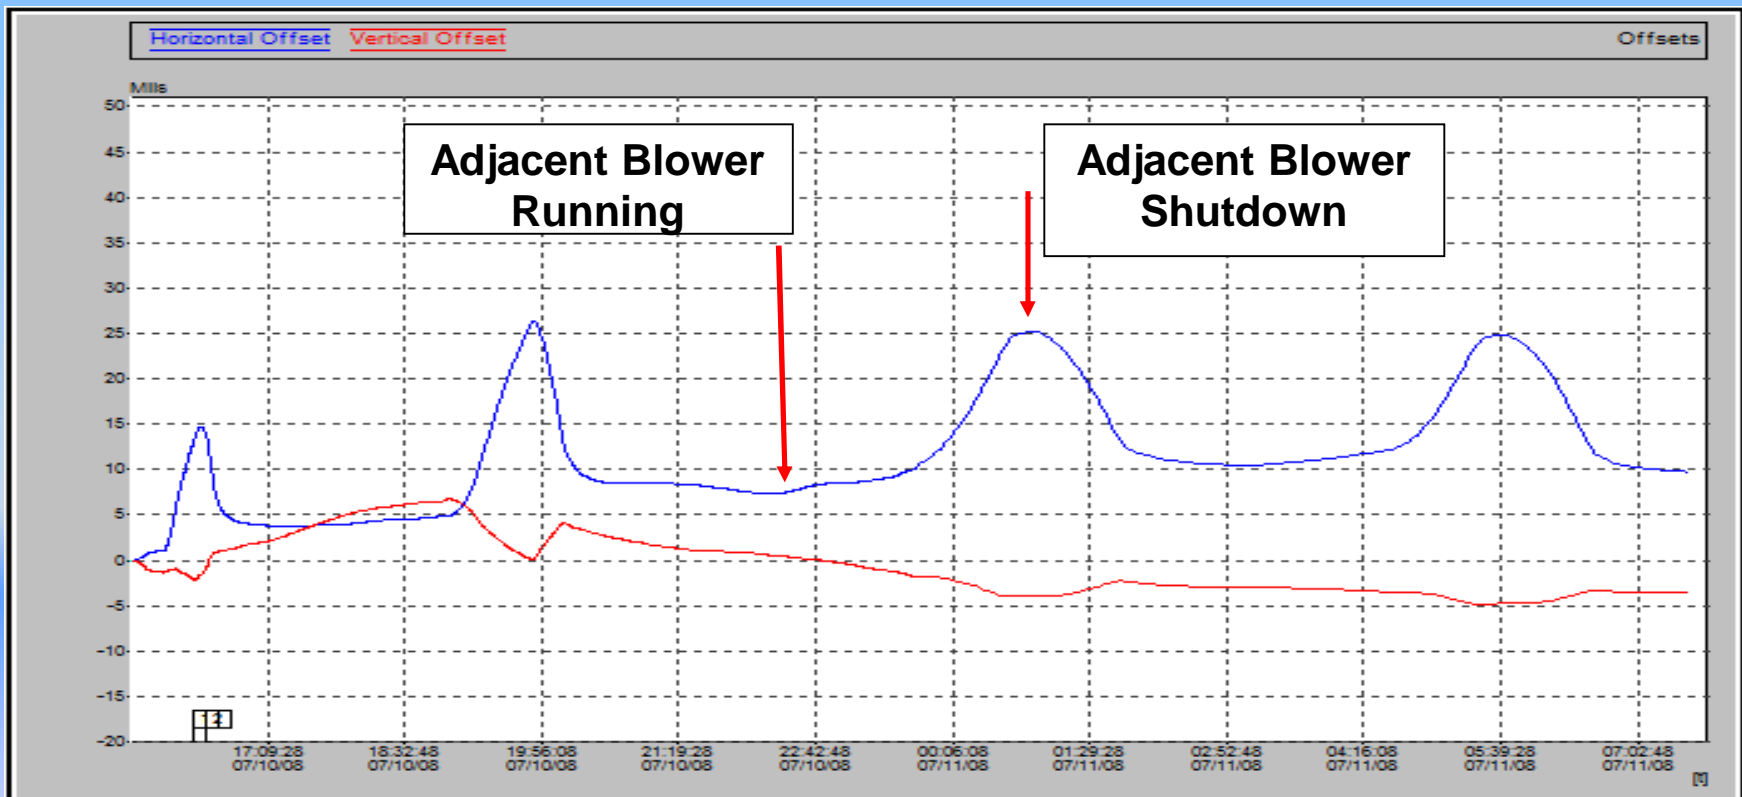
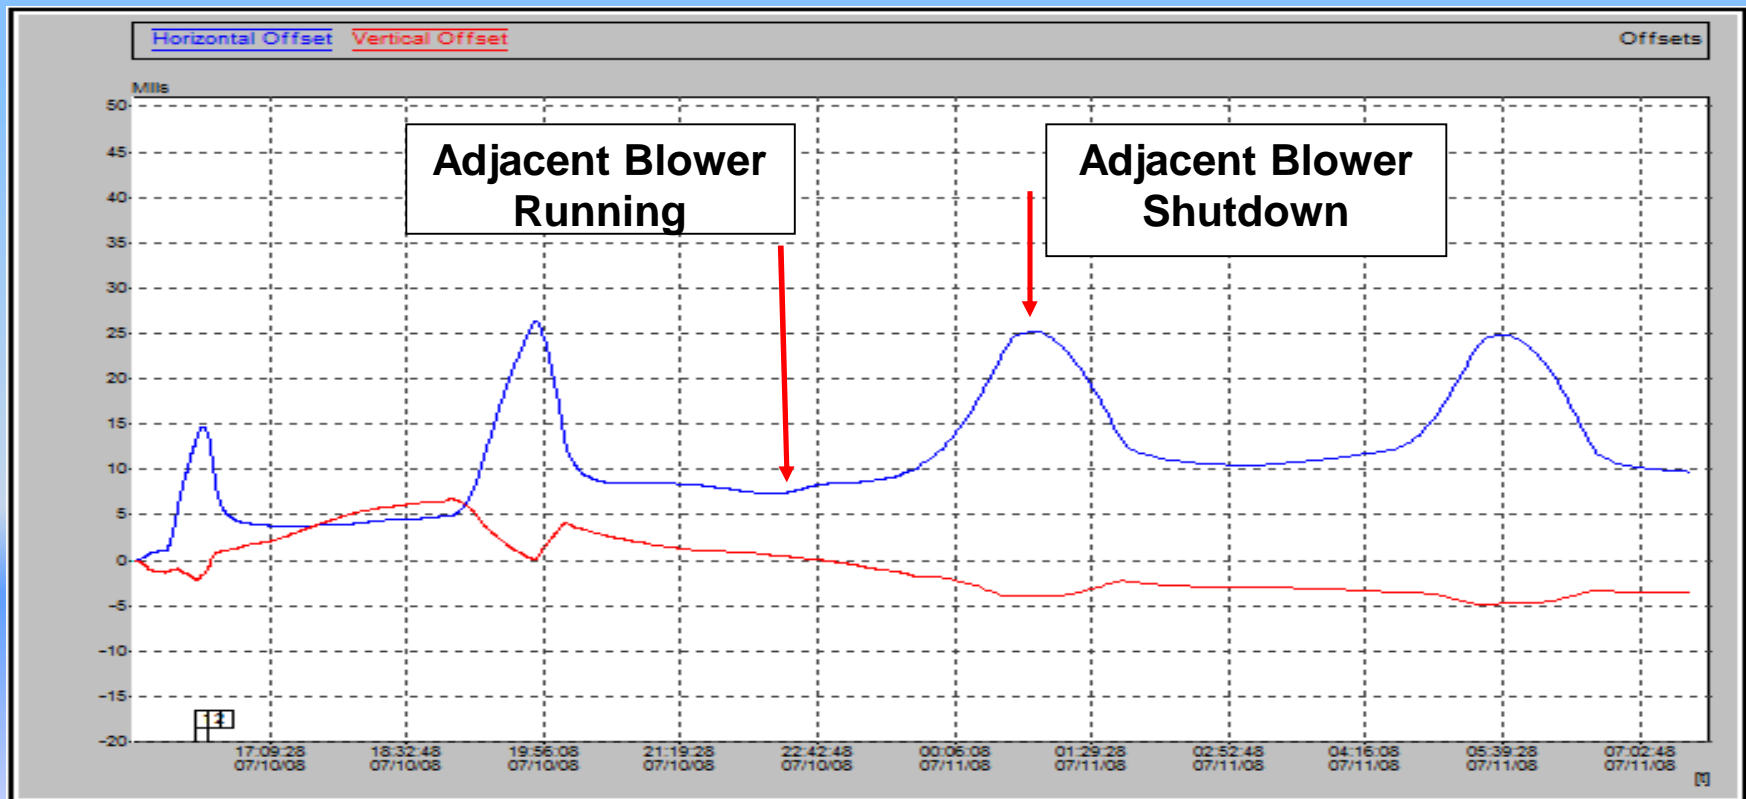
Figure 3. Permalign Data File for DB18 Blower. Horizontal Movement Occurs When Adjacent Blower Shutdown.

Permalign Was Installed on DB18 After DB19 Was Re-Aligned and Started. DB18 Was Started and Allowed to Reach Operating Temperature for About 5 Hours, Then Shutdown and Allowed to Cool Overnight.

Results were Similar to DB19. Blower Was Pushed/Pulled When Other Blowers Shutdown.

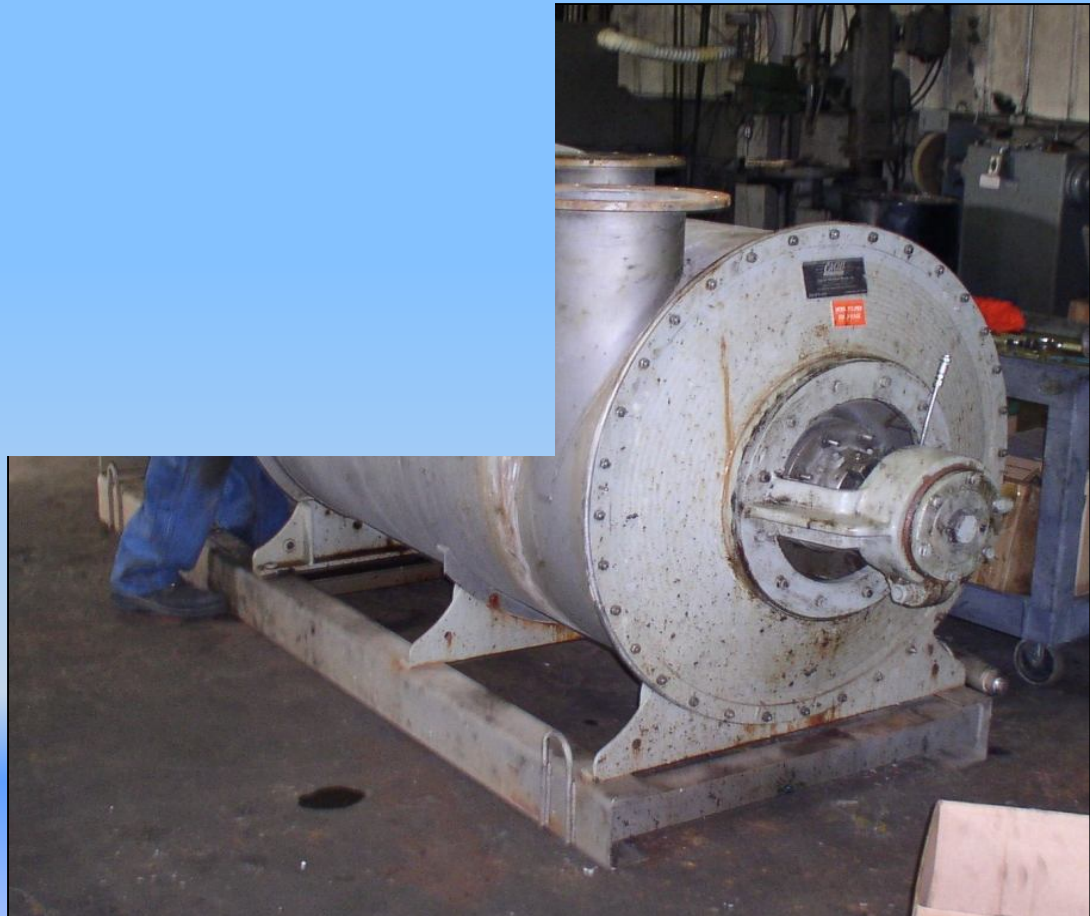
**Figure 37. Blower DB 19 As Received at Factory  
Authorized Repair Facility.**

**DB19 Sent to Blower Authorized Repair Facility.**

- **Disassembled**
- **Inspected**
- **Repaired**
- **Balanced**
- **Re-assembled**
- **Run Tested.**

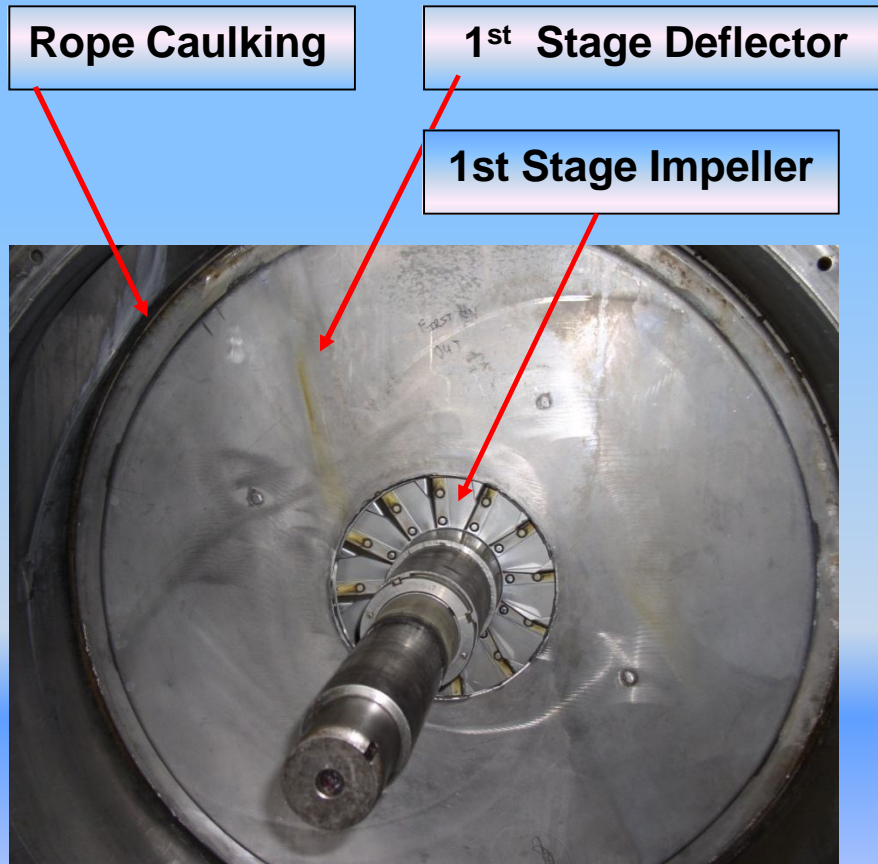
Figure 38. 1<sup>st</sup> Stage Impeller With Deflector and Rope Caulking at the OD.

The shaft packing area had over 30 mils wear. Blower OEM allows up to 30 mils shaft wear.

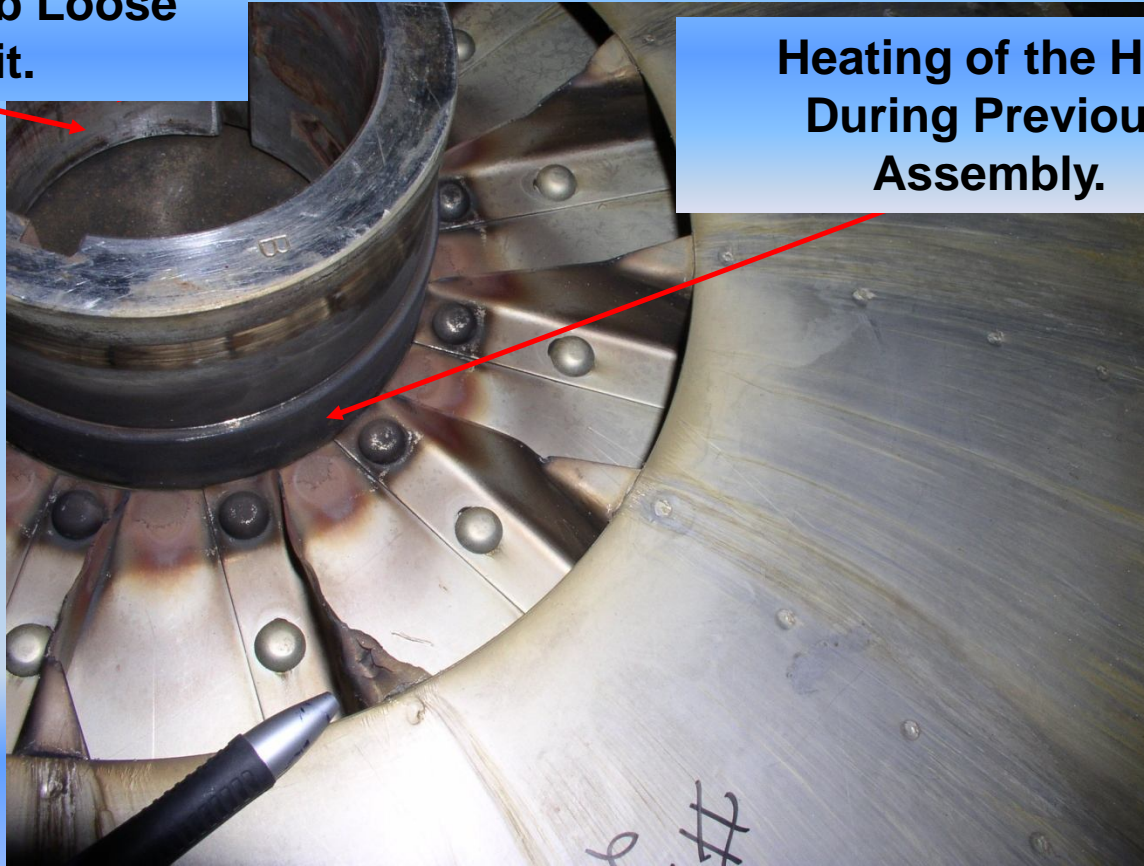
Figure 40. Impeller #2 Blade Damage. Note Heating of the Hub Which Occurred During Previous Assembly.

Fretting in Bore –  
Indication Hub Loose  
Shaft Fit.

Heating of the Hub  
During Previous  
Assembly.

**Shaft was replaced due to undersized fits.**

Drive End Shaft Bearing Fit	<b>Undersized 0.0062 inch</b>
Drive End Shaft Housing Bore	<b>Oversized</b> (no measurement on report)
Non Drive End Shaft Bearing Fit	<b>Undersized 0.0064 inch</b>
Non Drive End Housing Bore	<b>Over sized</b> (no measurement on report)
Max Shaft Wear @ Packing 0.030 in	<b>Undersized</b> (no measurement on report)
Impeller shaft fits	<b>0.010 inch variation in fit diameters.</b>
