# Improvement or degradation of water quality? A field visit to forest reserves near Kampala Uganda 5-years after initial survey

## ABSTRACT

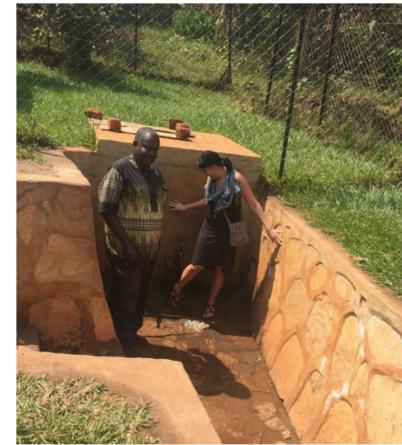
Photograph 4. A. Dr. Jovanelly uses the water with non-profit organizer for clean water near Mabira Forest Reserve. B. The women pictured here are some of the 500 community members who use the water source daily.

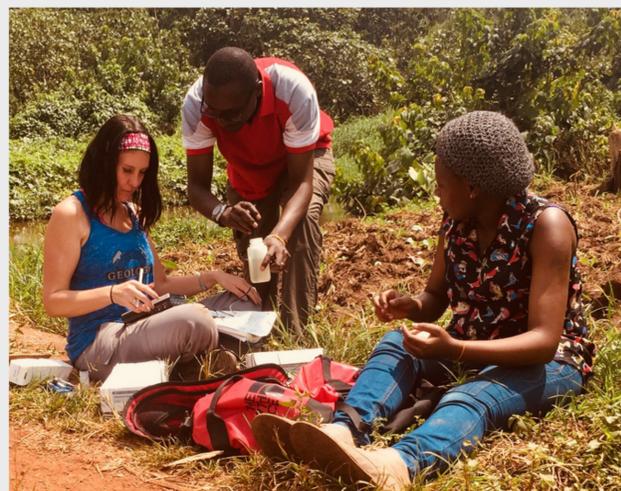
Photograph 3. Dr. Jovanelly introduces the field equipment for the water quality assessment at Mabira Forest. The equipment remained at the Uganda Wildlife Center for weekly sampling throughout the 2018/2019 year.
