## EXISTING BUILDING

# EXISTING STRUCTURE REPORT

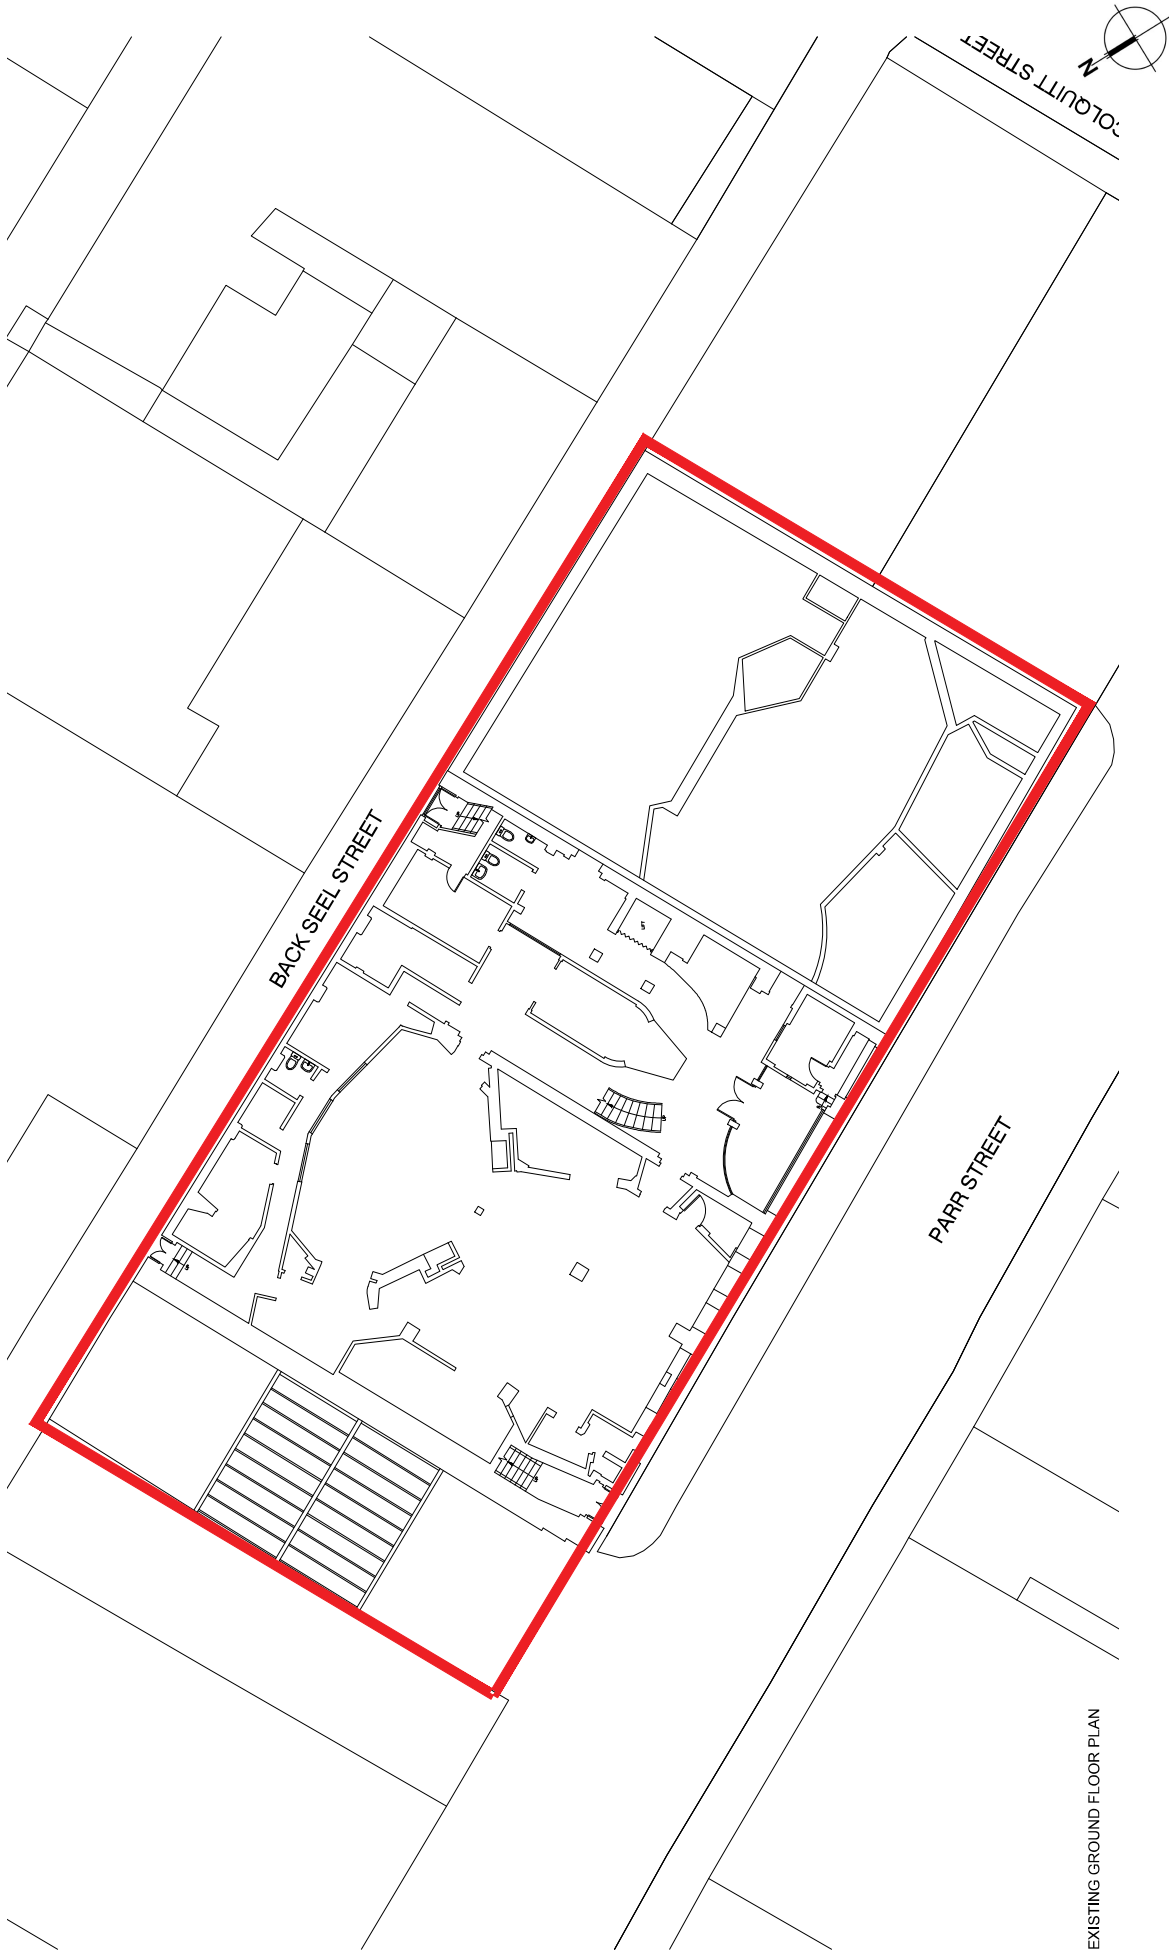
EXISTING GROUND FLOOR PLAN

**EXISTING BUILDING.**  
GROUND FLOOR PLAN
