COMPLEX NONCONTACT PIPELINES INSPECTION

OM TECHNICAL
SOLUTIONS

OM TECHNICAL SOLUTIONS has developed a magnetometric inspection system for the non-contact inspection of steel pipelines.

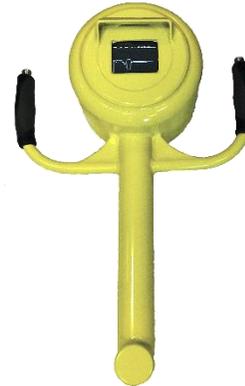
KMD-02D-Octopus is a diver-operated system for underwater pipelines non-contact magnetometric inspection at the depth of 20 – 60 m.

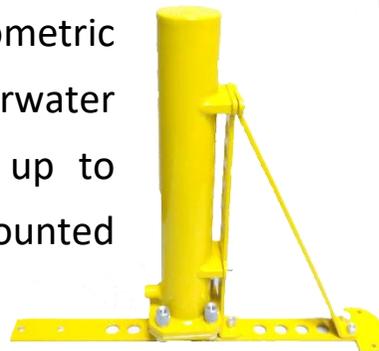
KMD-02GR-Dolphin and **KMD-02R-Barracuda** are systems for non-contact magnetometric inspection of underwater pipelines at the depth up to 300 m/2000 m, to be mounted on ROV.

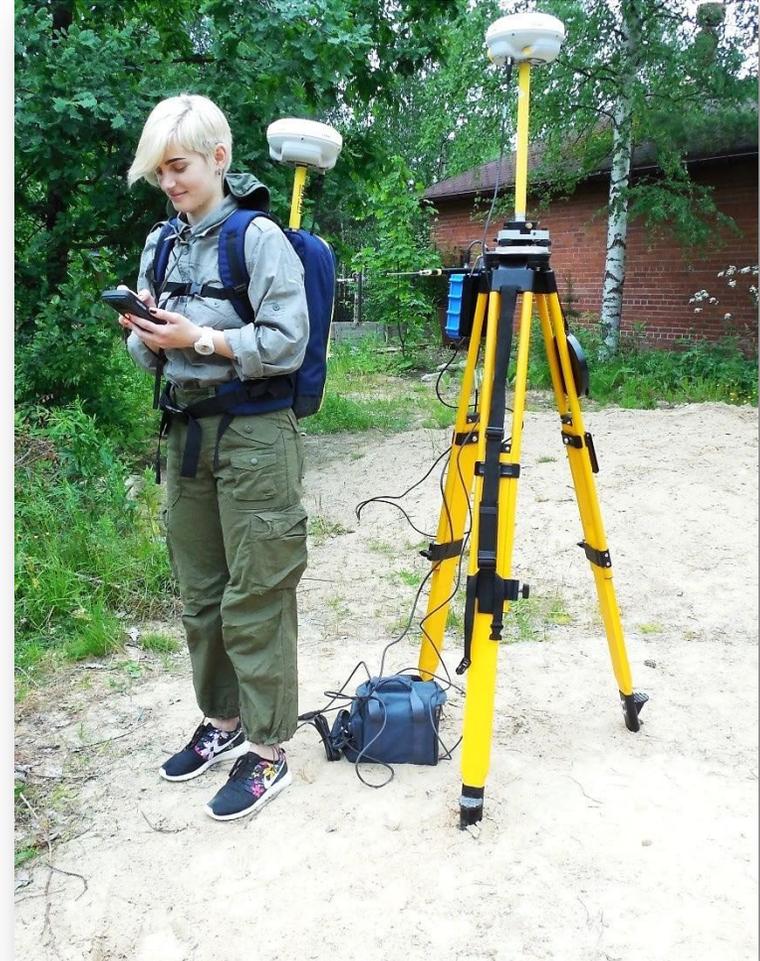
For defining of each measurement
GPS coordinates the high-accuracy
geo-positioning system

TRIMBLE R10 is used.

- *High accuracy of inspected objects' coordinates binding,*
- *Automatic tracing of pipelines.*

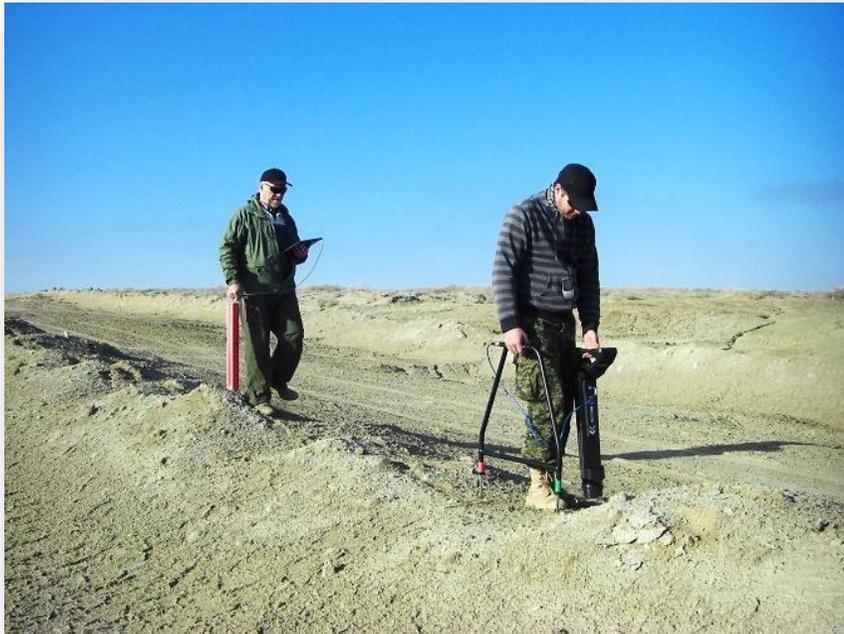
1. Non-Contact and Remote Inspection with NMC

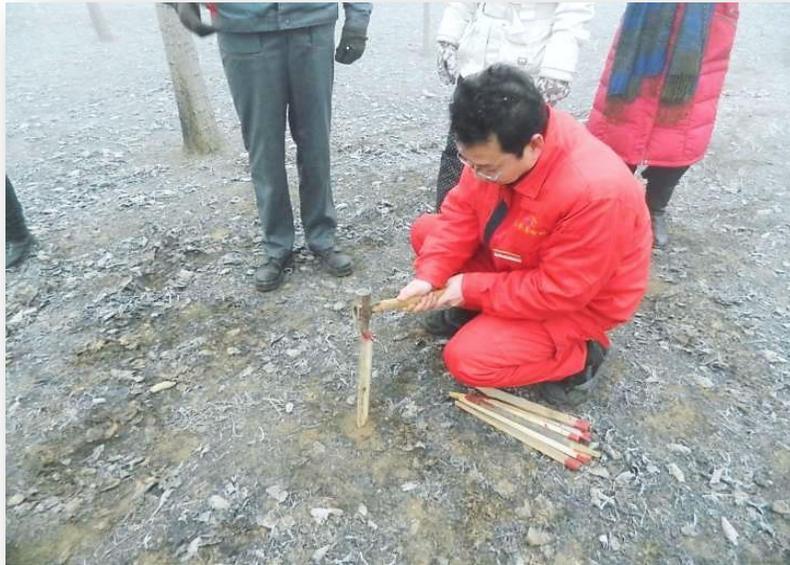
3. Marking of the magnetic anomaly's center at the site.

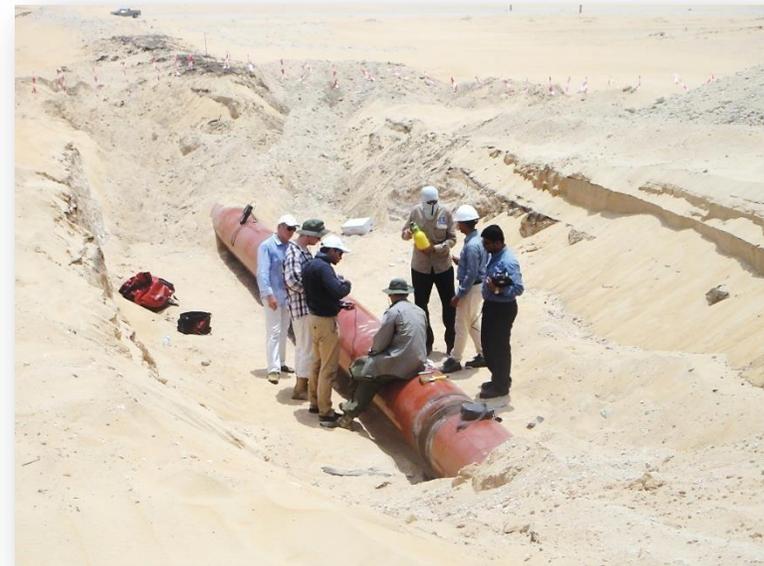
4. Additional control measuring in the test pit.

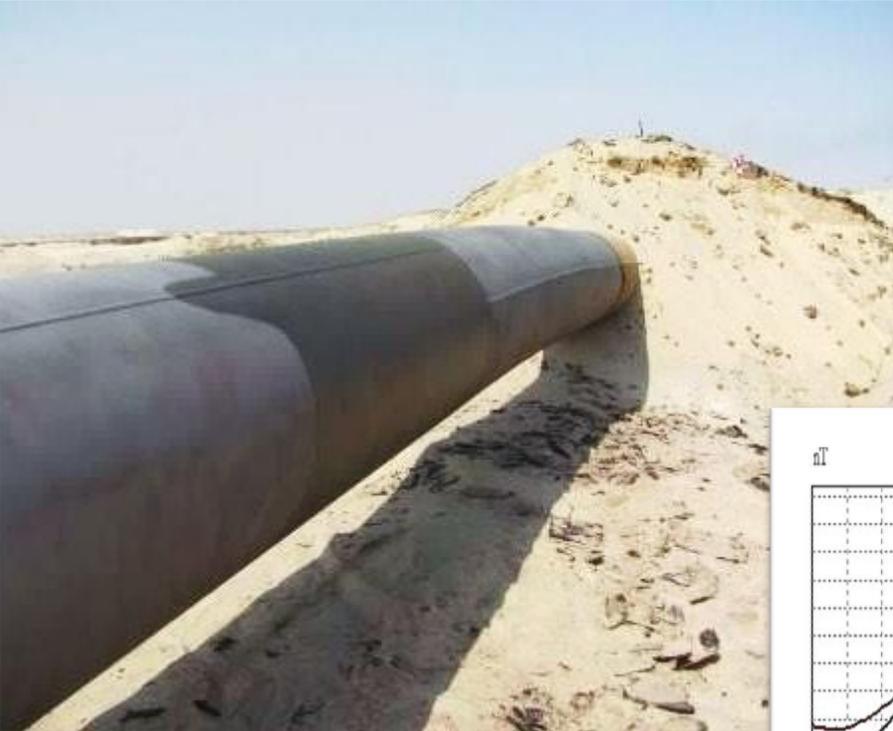
The magnetogram of changing of the full vector of magnetic induction shows significant stress (bending moment), caused by curving of the pipeline due to the pressure of sand. ILI made a few months before defined the pipeline as “no problems”.

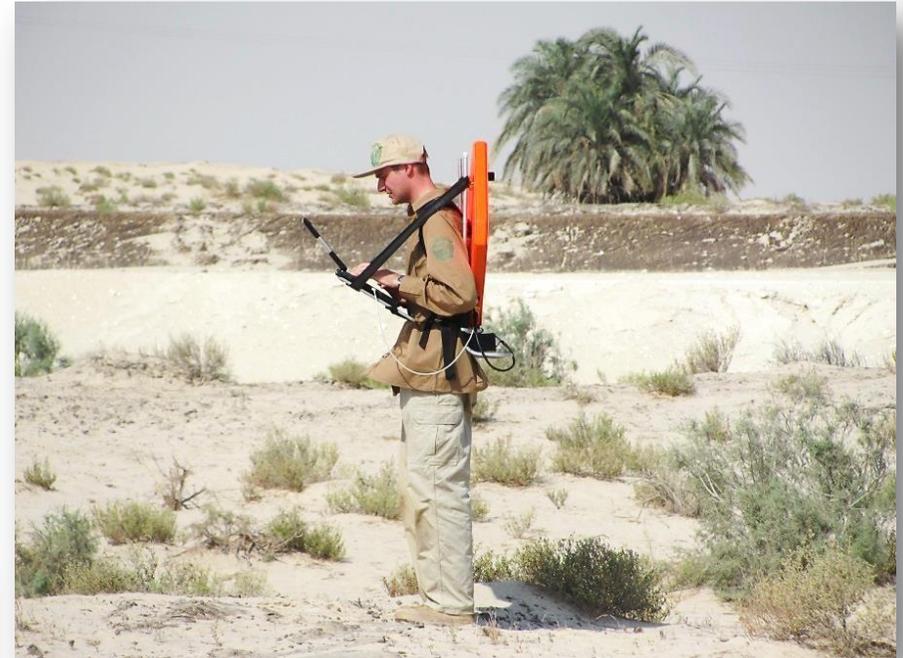
The magnetogram shows the changing of the full vector of magnetic induction of the pipeline, covered by the sand dune.

At 118 meters long section the high of the dune is more than 10 diameters of the pipe, so the data of the pipeline can not be read.

At places where the pipeline enters and exits the dune the stressed-deformed state of high level are detected, caused by the pressure of large amount of sand.

No local defects associated with the loss of metal were detected at the inspected area.

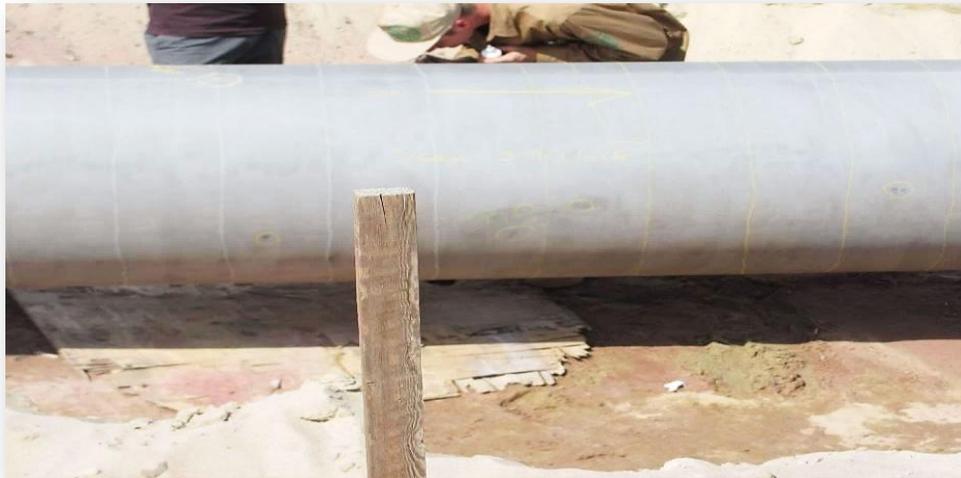
- Corrosion of underground pipeline was detected and marked,
- Excavation confirmed precise location of the anomaly within ± 0.5 m.

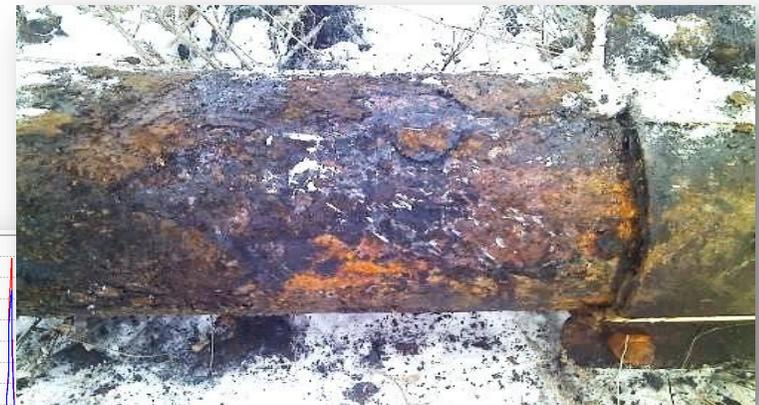
The damaged part of the pipeline and corresponding magnetogram.
The loss of metal - over 50%.

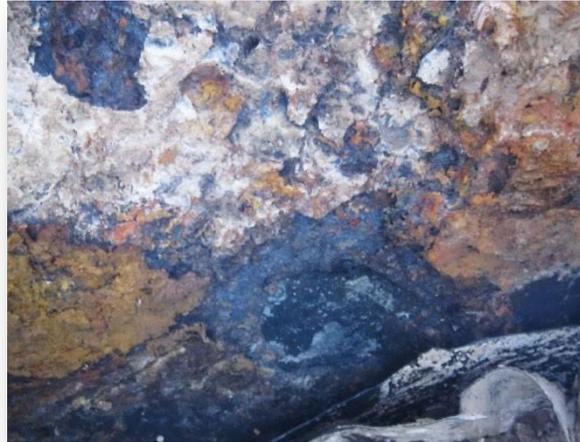
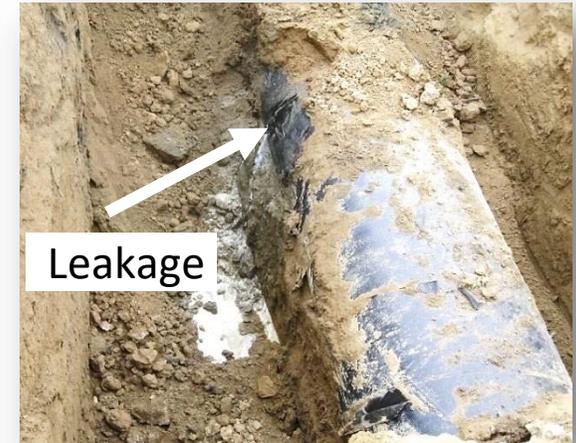
- Pit #2 finding: the loss of metal 100% - hole,
- Pits #1 and #3 finding: lots of corrosion over 70%

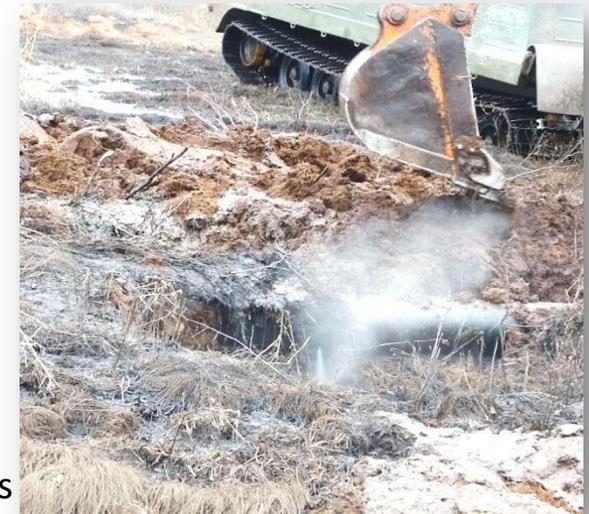
- The loss of metal 100% - hole

The fragment of the magnetogram at the part of the pipeline that has metal loss

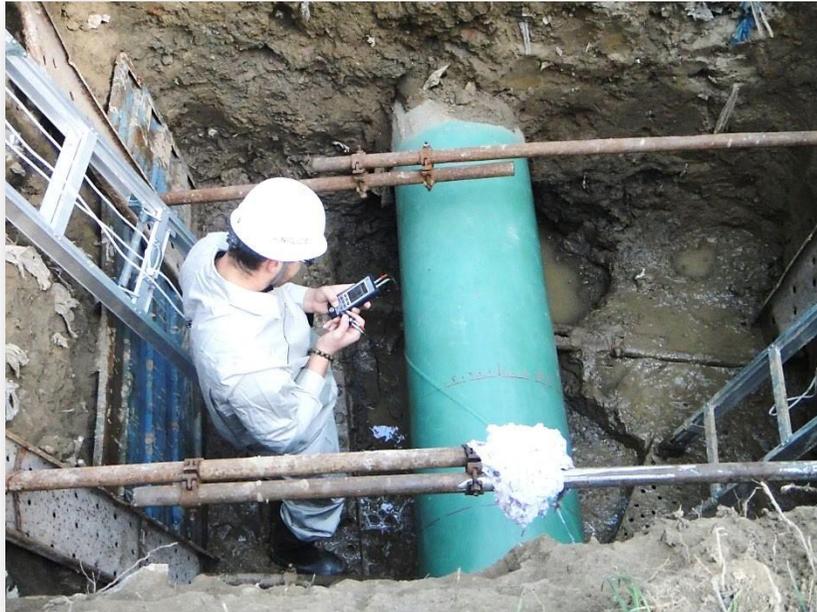
Excavation at the location of the magnetic anomaly.

ADDITIONAL FLAW DETECTING TESTS (AFDT) – ultrasonic thickness and eddy-current tests.

FINDING: stress corrosion cracking.

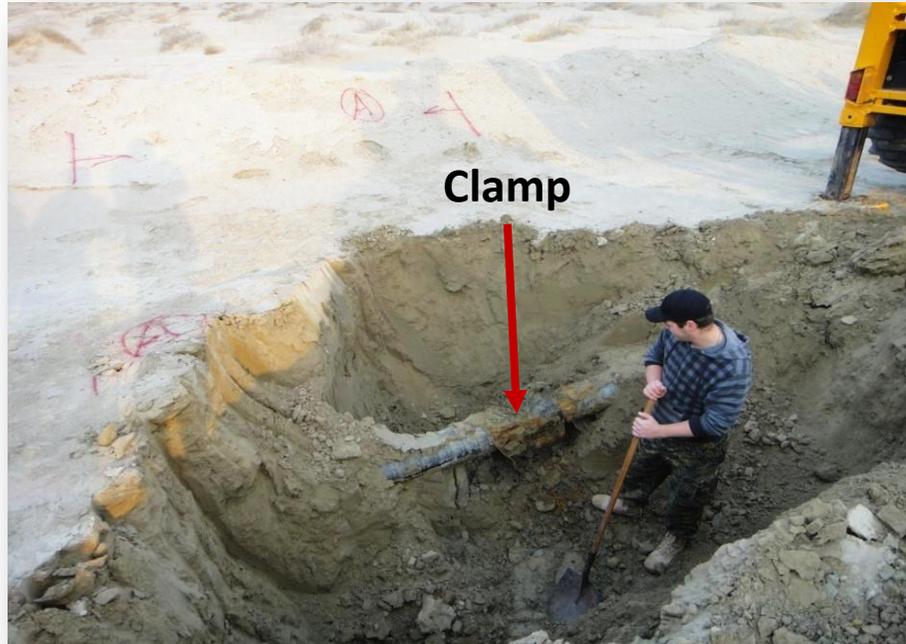
The excavated clamp located at the point, marked according to the results of the contactless inspection.

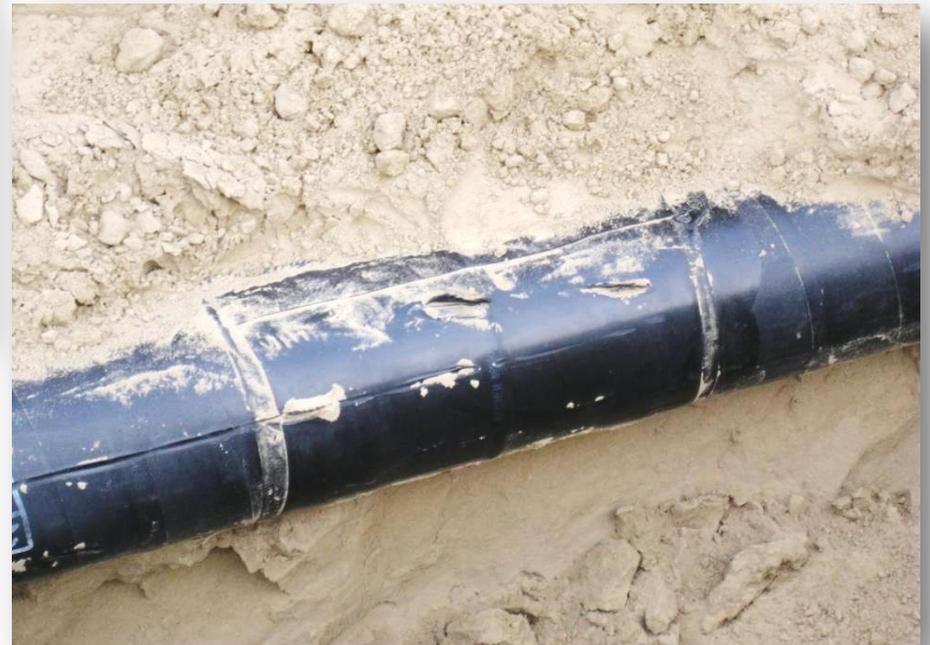
The excavated pit, made at the location of the magnetic anomaly the concentrator of the tensions (repair construction) was found.

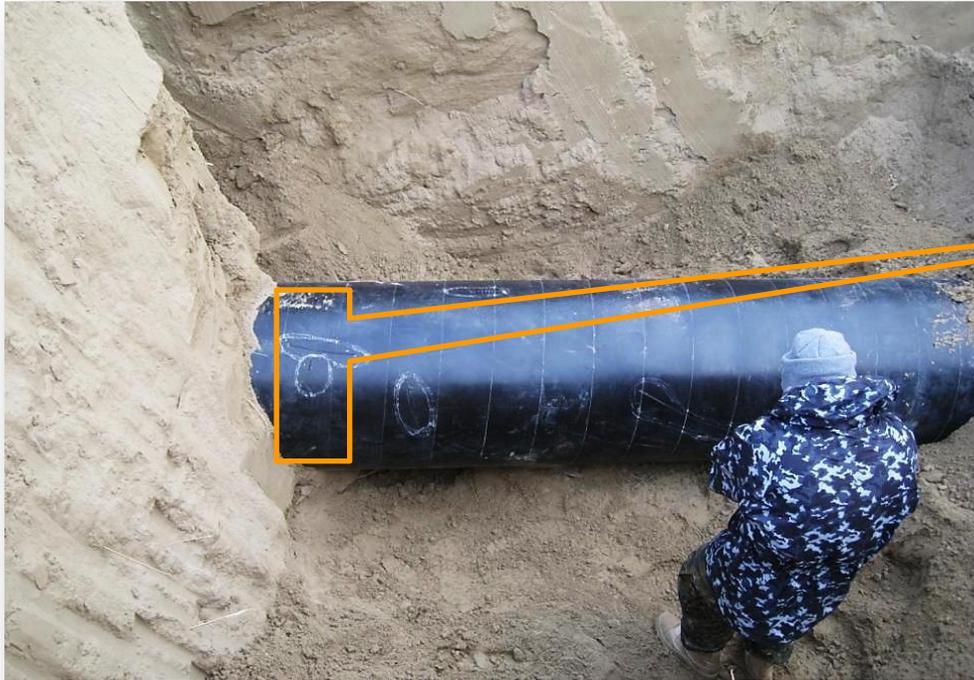
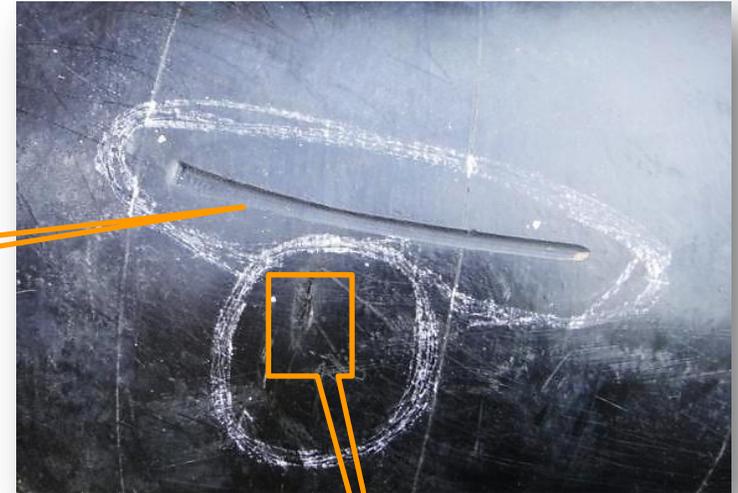
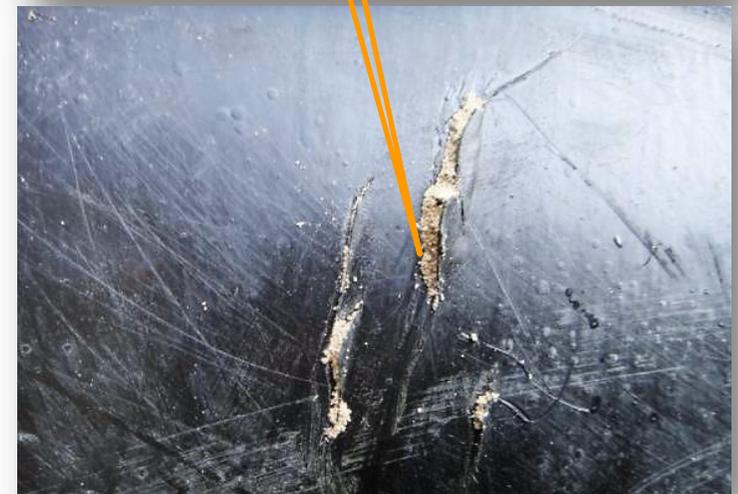
The excavated pit made at the location of the isolation cover damage, detected according to the results of the contactless inspection.

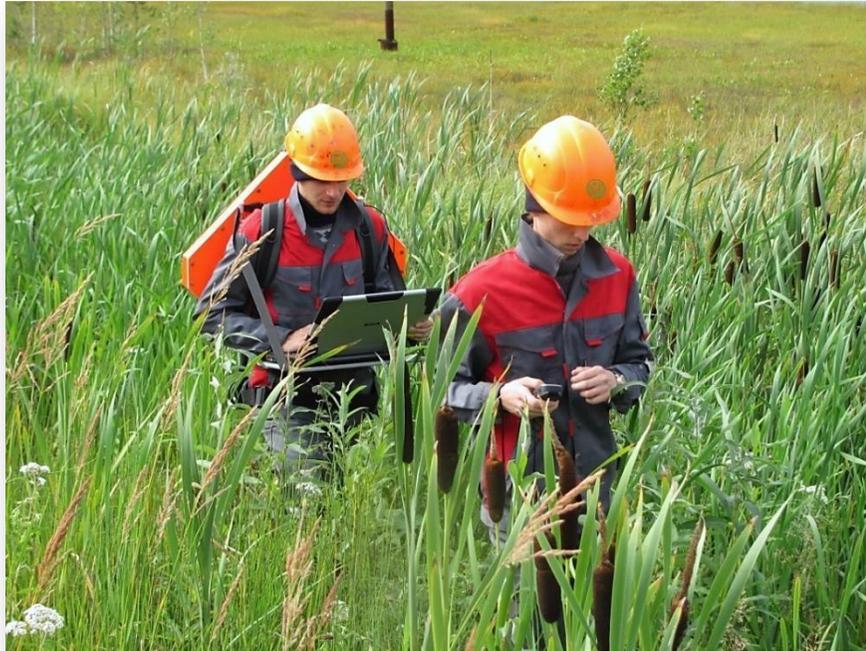
**OBJECT: «PT CHEVRON PACIFIC»
(Indonesia), 2015**
main gas pipeline (ø 12 mm)

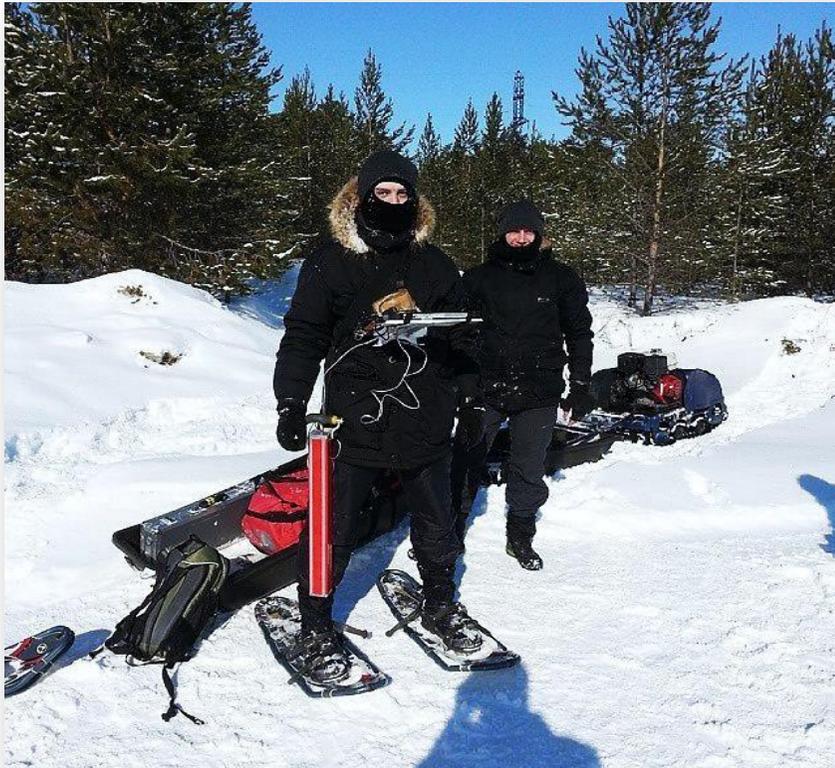
Using of the snowmobile for diagnostic.
The speed - 20 km/h.

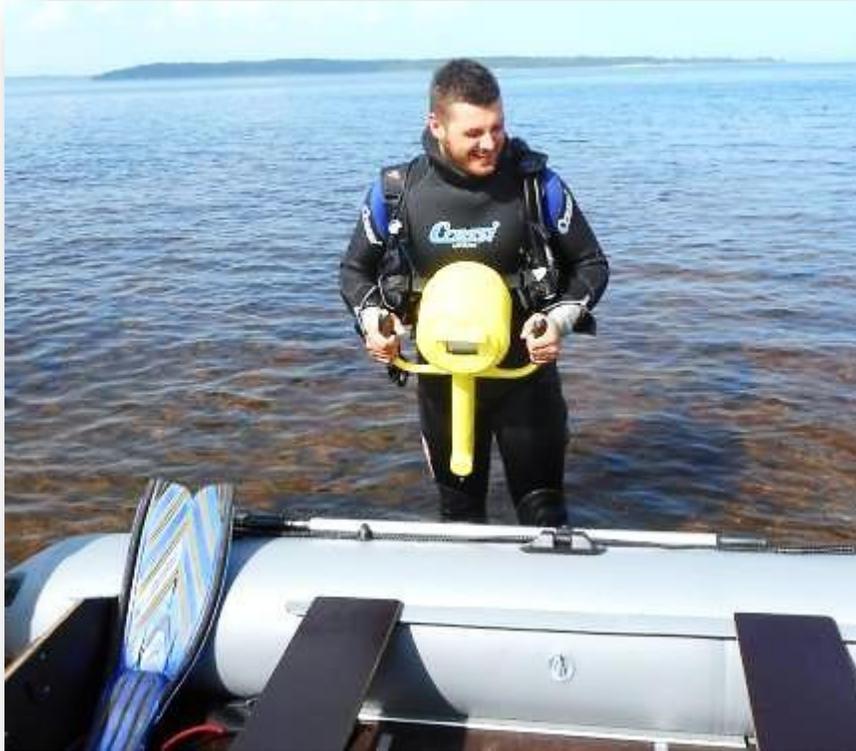
Waterproof display allows the operator to monitor anomalies in real time.

The device operated by a diver allows inspection at the depth of up to 40-60 m. The received data is written to the flash memory for further processing.

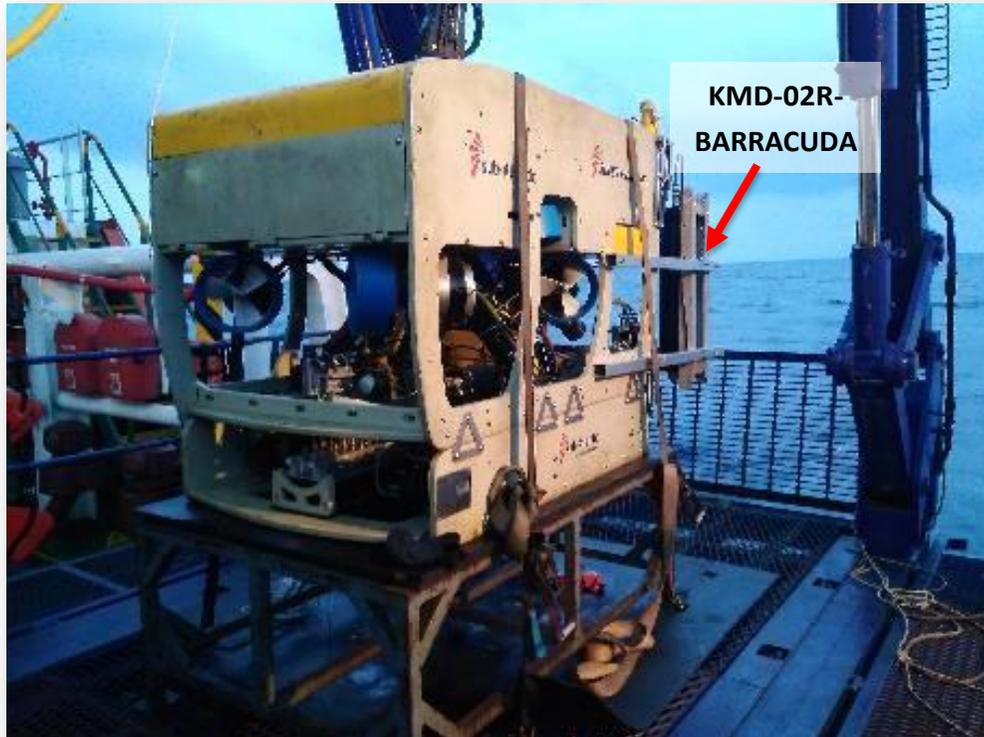
The device is designed for the non-contact inspection of subsea pipelines at the depth up to 2000 m

The data from KMD-02R-Barracuda is sent by the cable of ROV to the computer of the operator in the real time, it's also recorded into the computer memory.

KMD-02R-Barracuda is mounted on an ROV.

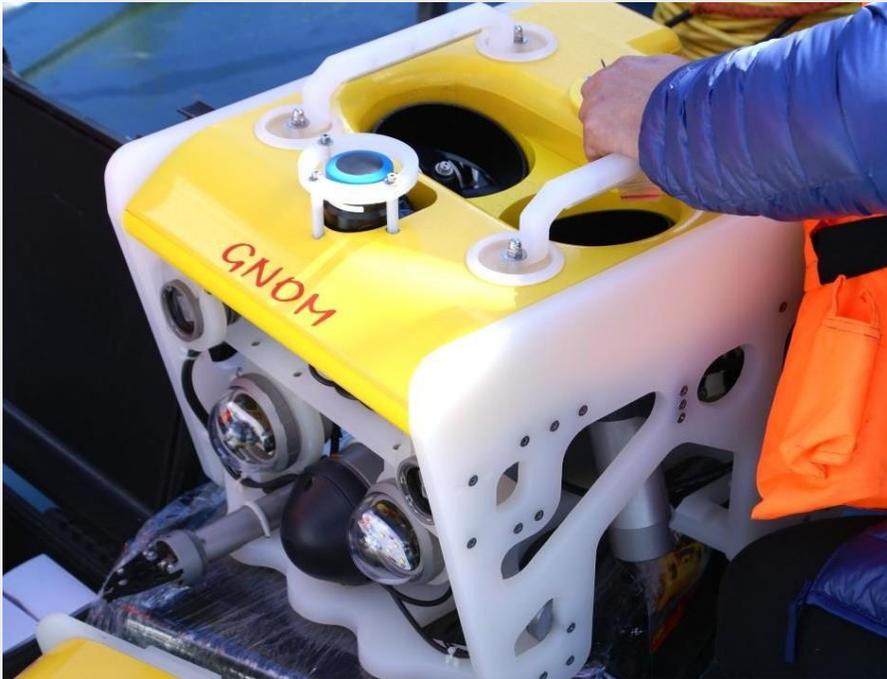
KMD-02GR-Dolphin mounted on SuperGnom ROV and ready for the operation.

The device is designed for the non-contact magnetometric pipelines inspection at the depth of up to 300 m.

KMD-02GR-Dolphin should be mounted on an ROV SuperGnom type.

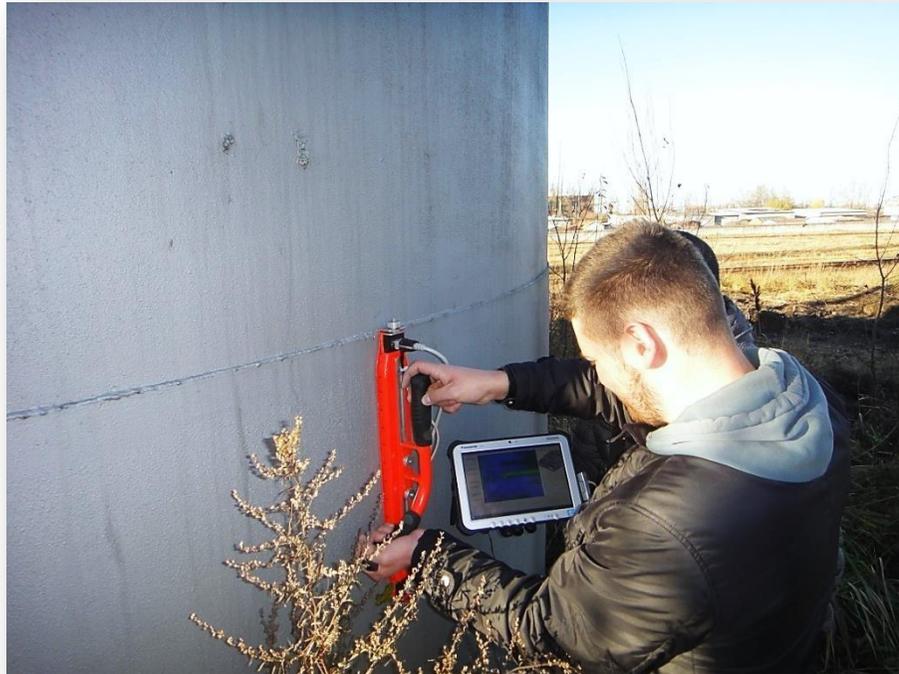
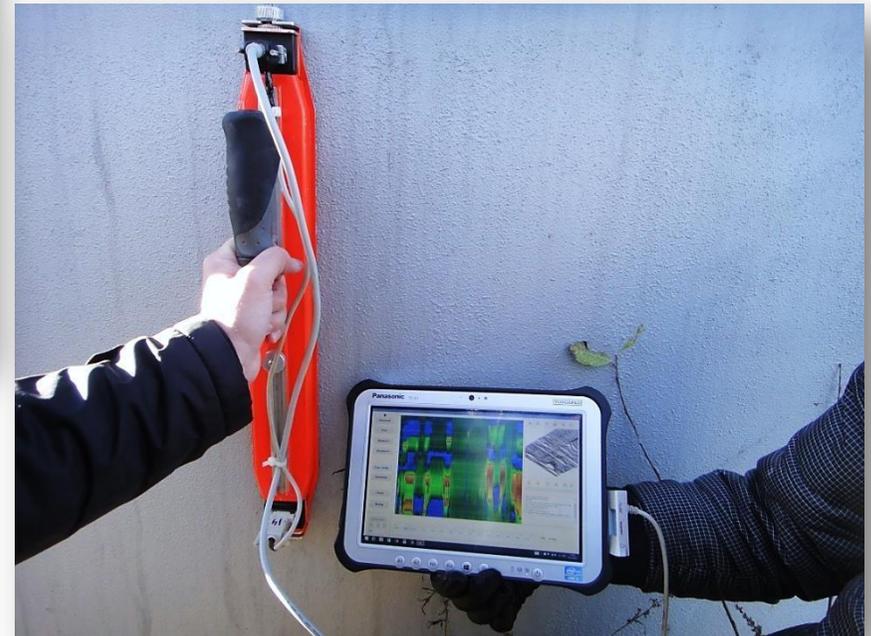
The system allows inspection of tanks even without a pressure.

Sub-contact (without insulation removing) inspection system allows location of the stress concentrators, appeared due to various flaw.
