G. BATISTA
ENGINEERING & CONSTRUCTION

STRUCTURAL INTEGRITY RESERVE STUDY

The Bay House Tower Condominium Association, Inc.

17878 N Bay Rd, Sunny Isles Beach, FL 33160

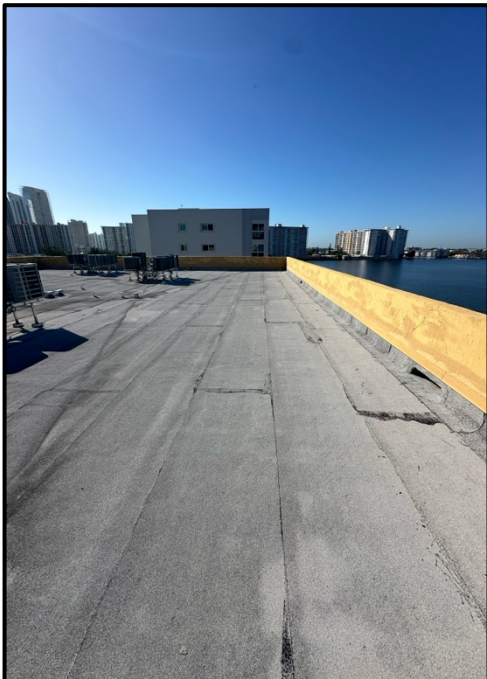
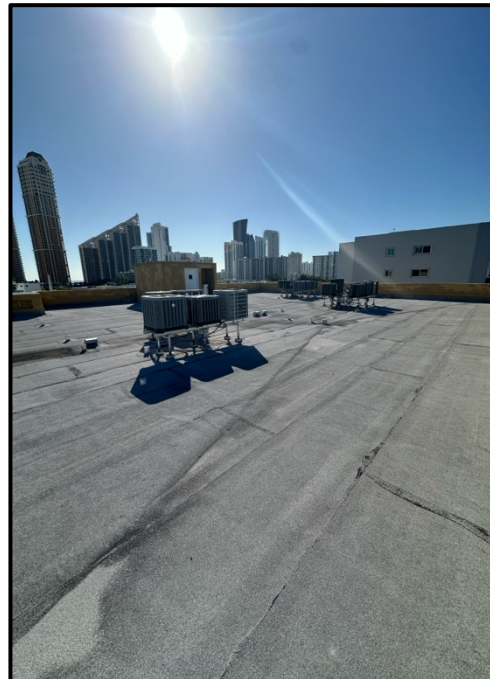
Condition: The roof is in good conditions.

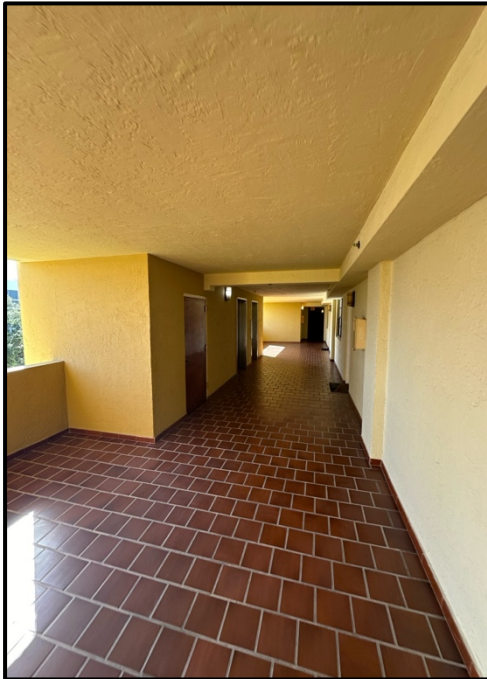
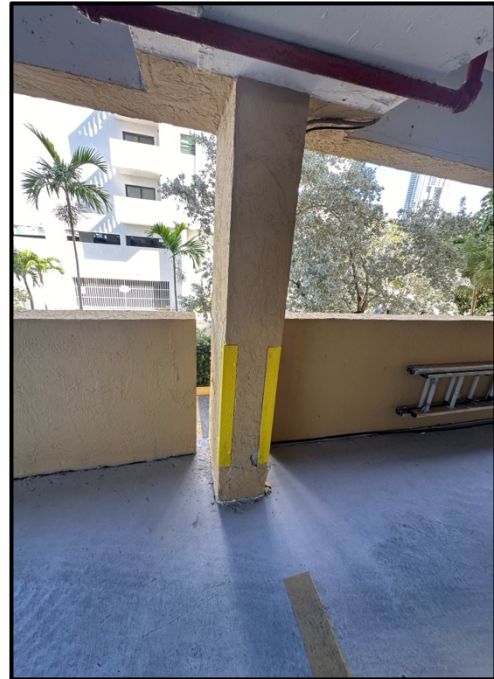
Condition: The concrete framing and floor systems is in unsatisfactory condition. Concrete repairs will be performed as per the information provided by the association during our inspection. We will consider this information in our executive summary.

Remaining Lifespan: Although concrete is a very durable material, due to the location's proximity to the coast, spalling due to rebar corrosion usually manifests before the concrete naturally deteriorates. It is important to note that it is rarely possible to visually inspect and examine all the concealed construction, nor should be generally necessary. Our conclusions are based upon our experience and conditions examined in the exterior typical structural members of the building. Refer to the table presented at the end of this report. Concrete repairs will be performed as per the information provided by the association during our inspection. We will consider this information in our executive summary.

Estimated Cost of Replacement: Concrete repairs are typically done on a unit-price basis and should be repaired as damages appear. Refer to the table presented at the end of this report for our recommendation based on our experience and the size of the building.

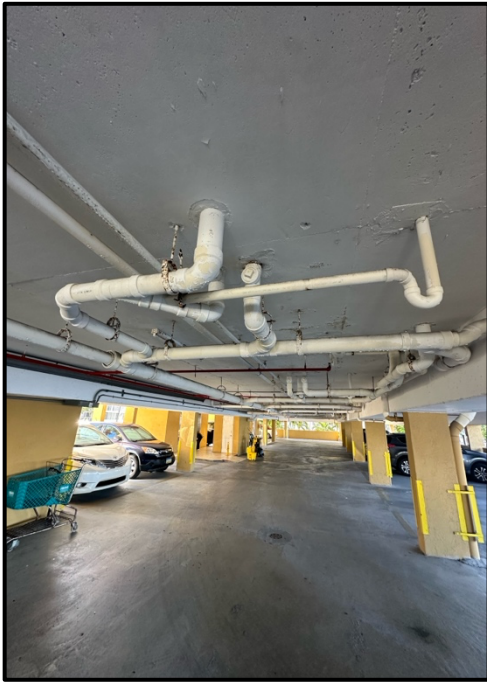
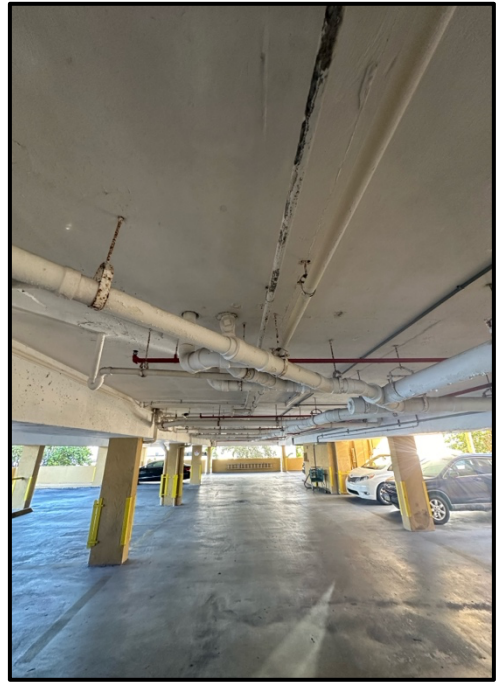
Condition: The plumbing system is in satisfactory condition. It is important to note that it is rarely possible to visually inspect and examine all the concealed construction, nor should be generally necessary. Our conclusions are based upon our experience and deficiencies found in the visible and readily accessible areas.

Estimated Cost of Replacement: Plumbing lines and systems are typically not replaced in their totality but are repaired as items appear. See the table presented at the end of this report for our recommendation based on our experience and the size of the building.

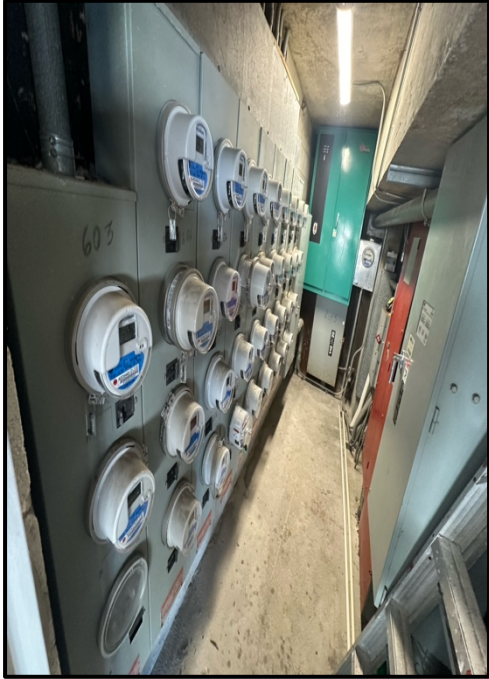
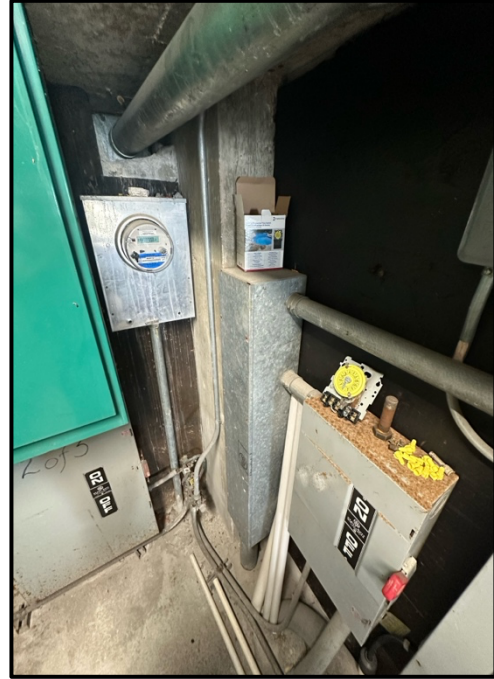
Condition: The electrical system(s) is in good condition.

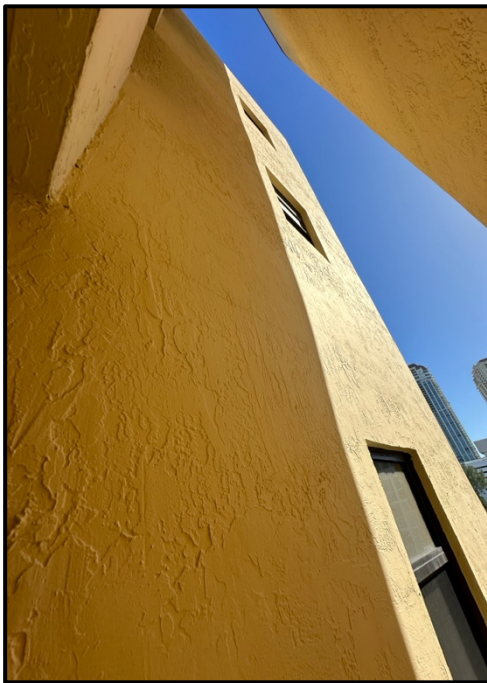
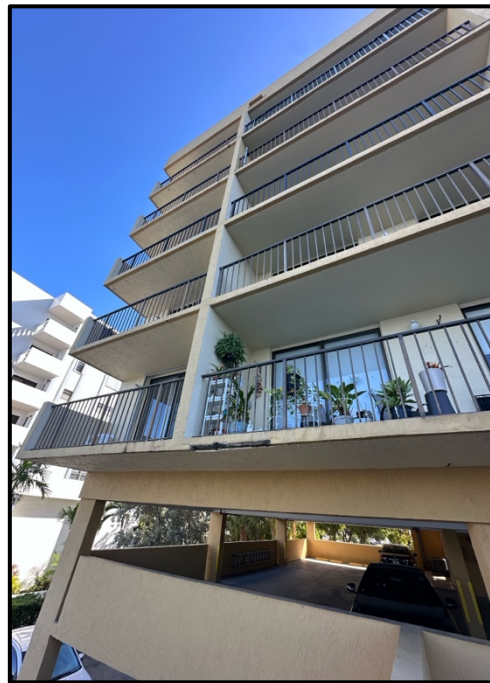
Condition: The exterior stucco is in satisfactory condition. It is important to note that our conclusions are based upon our experience and deficiencies found in the visible and readily accessible areas. Concrete repairs will be performed as per the information provided by the association during our inspection. We will consider this information in our executive summary.

Remaining Lifespan: Although the stucco is a very durable material, due to the location's proximity to the shore, spalling due to rebar corrosion usually manifests before the stucco naturally deteriorates. Refer to the table presented at the end of this report. Concrete

Estimated Cost of Replacement: The removal and replacement of all the stucco finish is rarely required. It is typically repaired as required in the building for general maintenance. Therefore, we assume that 20% of all exterior surfaces are required to be replaced at once. See the table presented at the end of this report for our recommendation based on our experience and the size of the building. (The exact amount of area needing replacement will be discretionary based on the actual future conditions and the desired appearance).

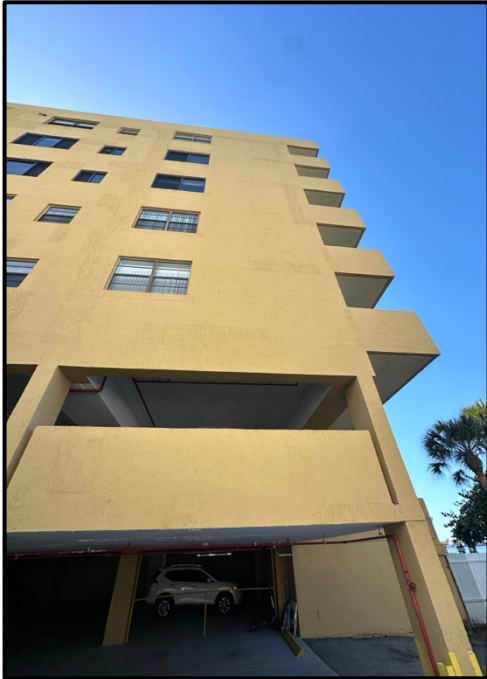
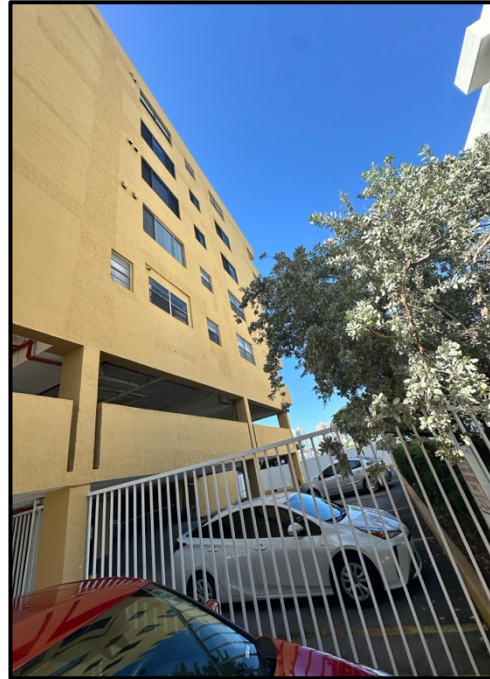
Condition: The surfaces appear to be in satisfactory condition.

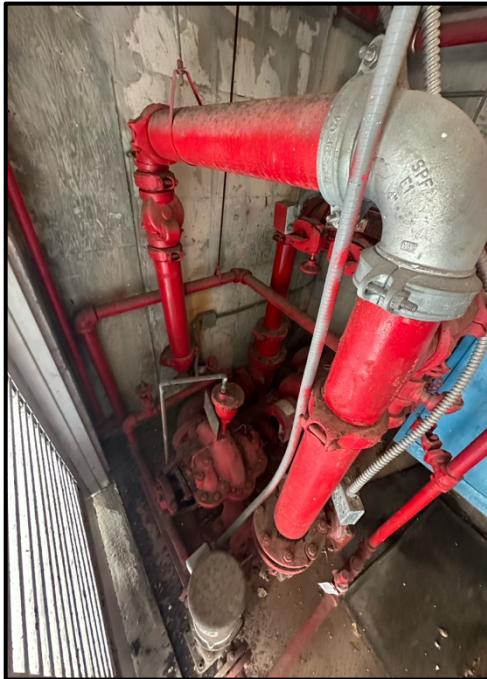
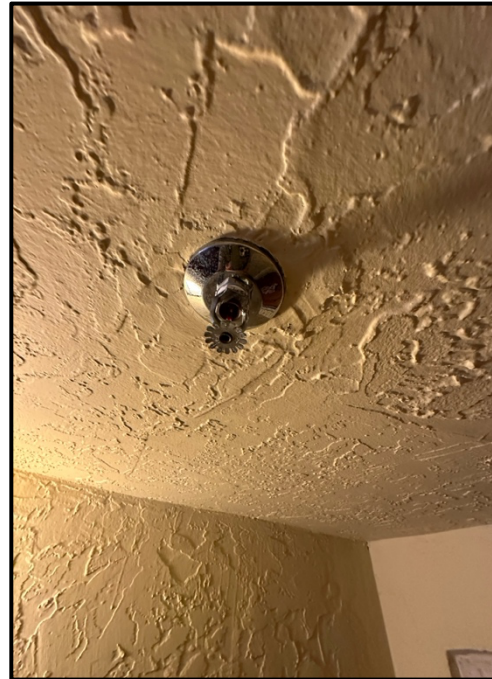
Condition: The fire protection systems appear to be in satisfactory condition.

Estimated Cost of Replacement: Fire protection systems such as the ones observed in the building are typically not replaced in their totality but are replaced as required. See the table presented at the end of this report for our recommendation based on our experience and the size of the building.

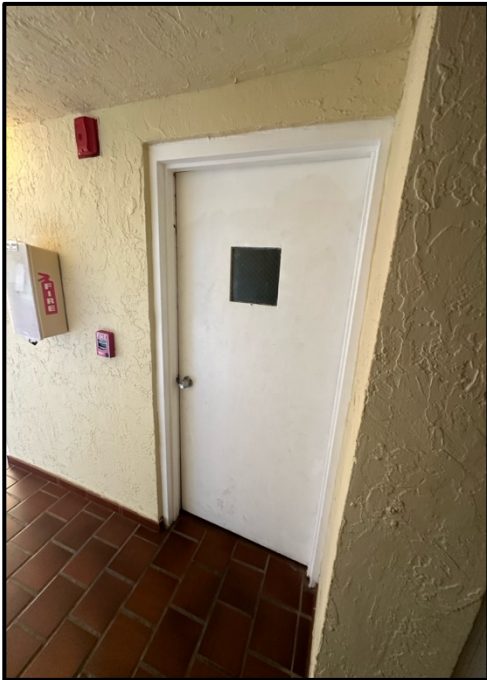
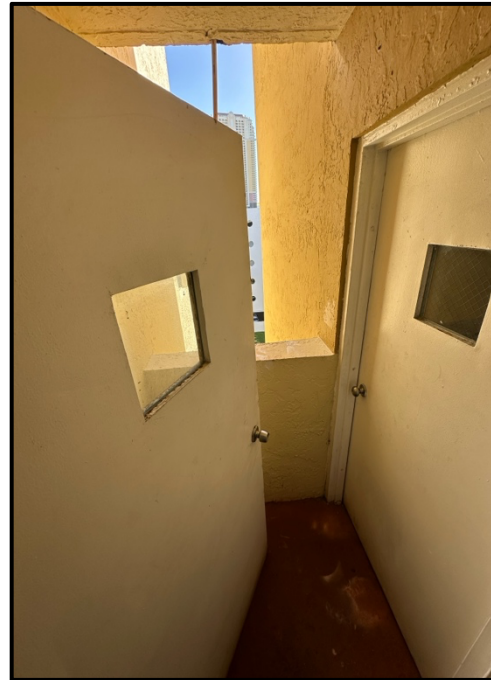
Condition: The common area windows and doors appear to be in satisfactory condition. The association is only responsible for the common areas. The units' windows and doors are the unit owner's responsibility. At the time of our inspection, no common area windows were noted.
