**RE: Phase II Subsurface Investigations & UST Removal Report
2210 Providence Highway, Walpole, MA
GEC Project No. 1936-0010**

Goldman Environmental Consultants, Inc. (GEC) of Braintree, Massachusetts has completed a limited follow-up investigation and closure assessment of a #2 fuel oil underground storage tank (UST) at the property addressed under 2210 Providence Highway, Walpole, Massachusetts and presently identified on the Town of Walpole Assessor's Map #54 as Lots 32, 36 and 37 (hereinafter "the Site"). The Site is located south of Providence Highway (a.k.a. Route 1, Boston-Providence Turnpike and General Edwards Highway) and north of Sunset Drive, approximately 165 feet east of Hilltop Drive, in Walpole, Massachusetts. The Site encompasses approximately 1.53 acres and is improved by a one-story commercial structure (the "Site building") and an asphalt-paved parking lot. See Figure 1, the Site Locus.

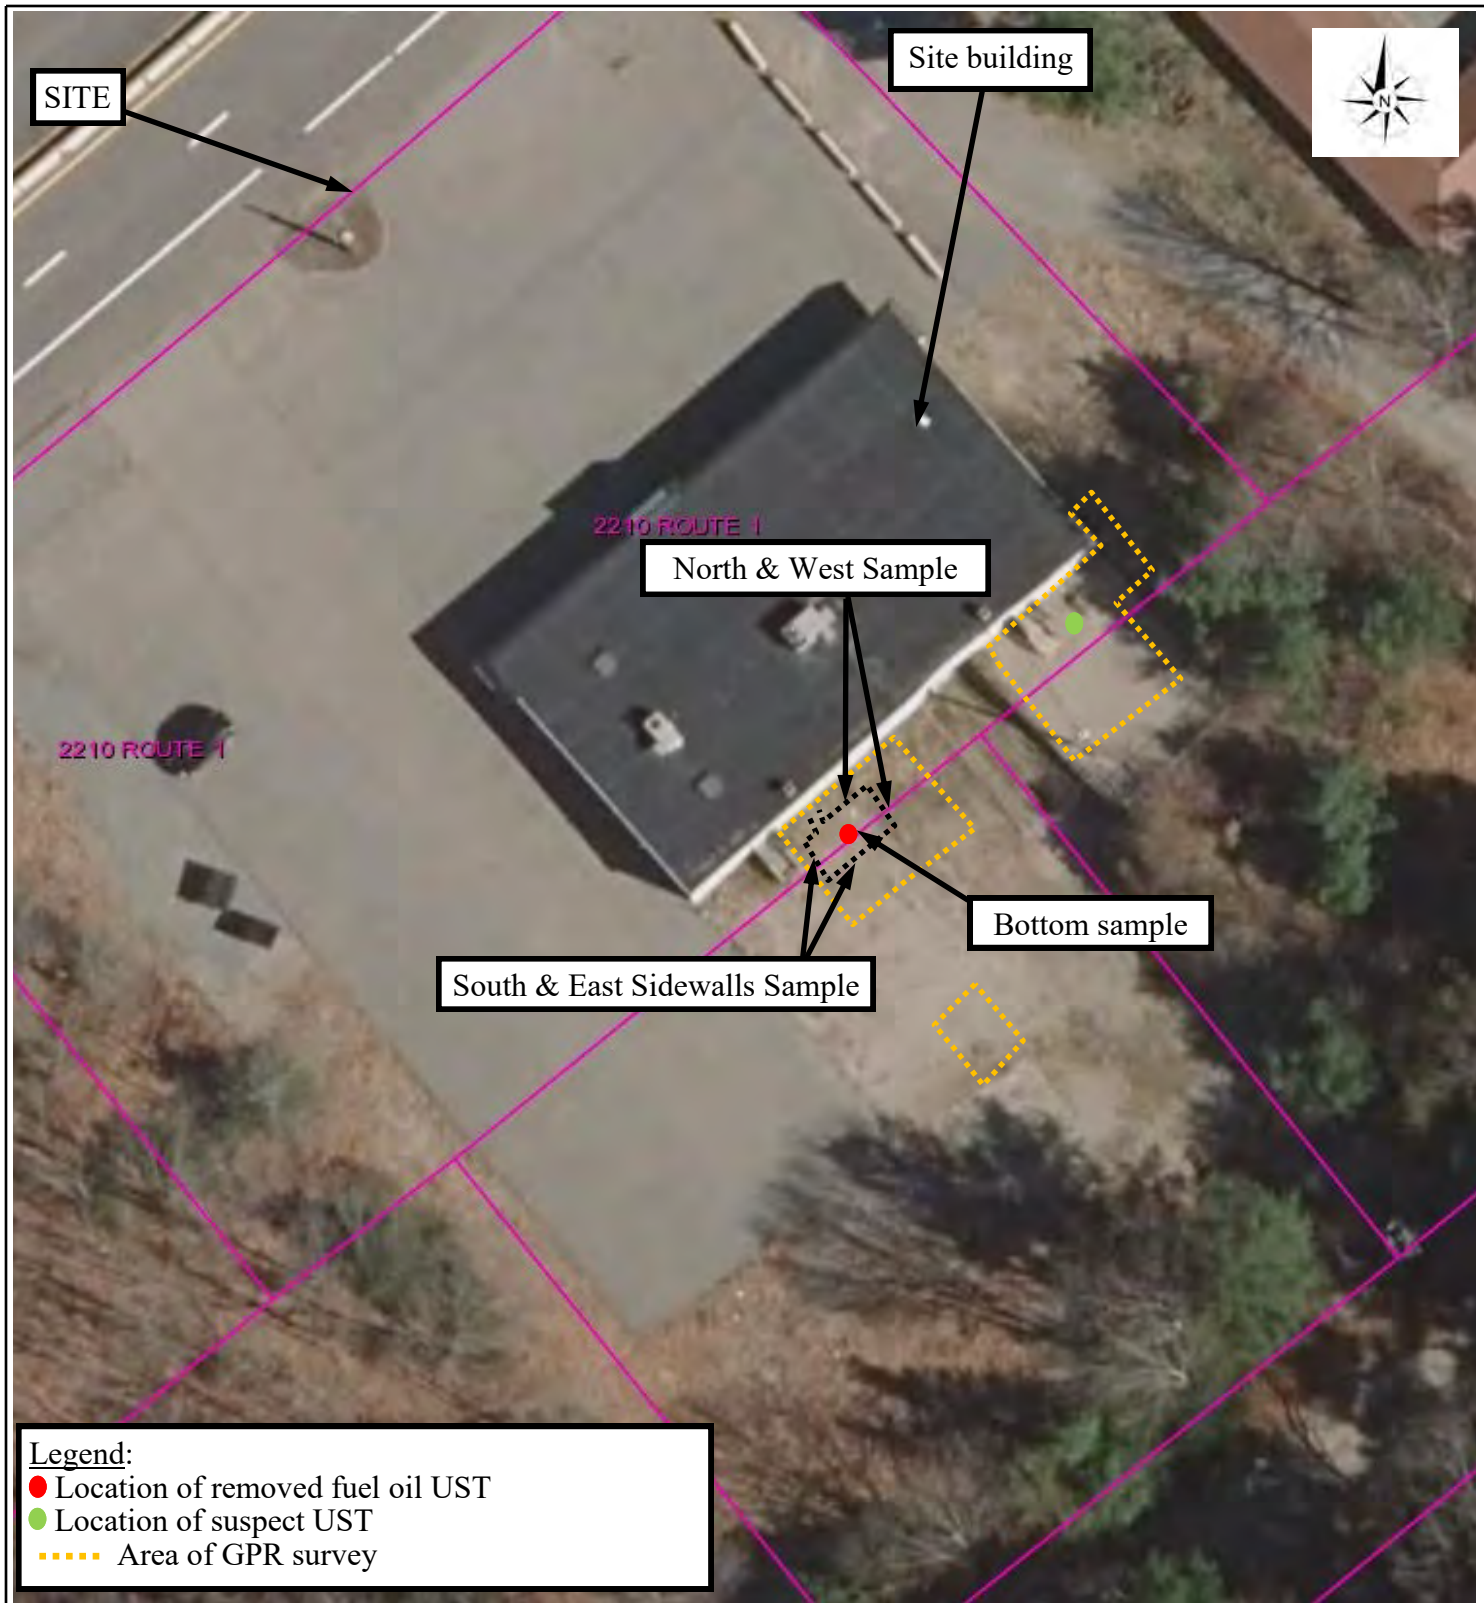
SITE DIAGRAM

Two sides of the tank were subsequently uncovered to ease tank pull and no staining was observed by GEC. At this point, GEC collected one composite soil sample and one grab sample from the south and east exposed sidewalls of the tank grave identified as South & East Sidewall samples (see Figure 2 for sampling location).

GEC subsequently collected additional confirmatory soil samples, specifically two bottom samples (one grab sample and one composite sample) identified as Bottom samples at areas covering each end and the middle at depths between 7-8 feet below grade surface (BGS) and two sidewall samples (one grab sample and one composite sample) identified as North & West samples on the north and west sidewalls of the tank grave at about 5 feet BSG (see Figure 2 for sampling locations).

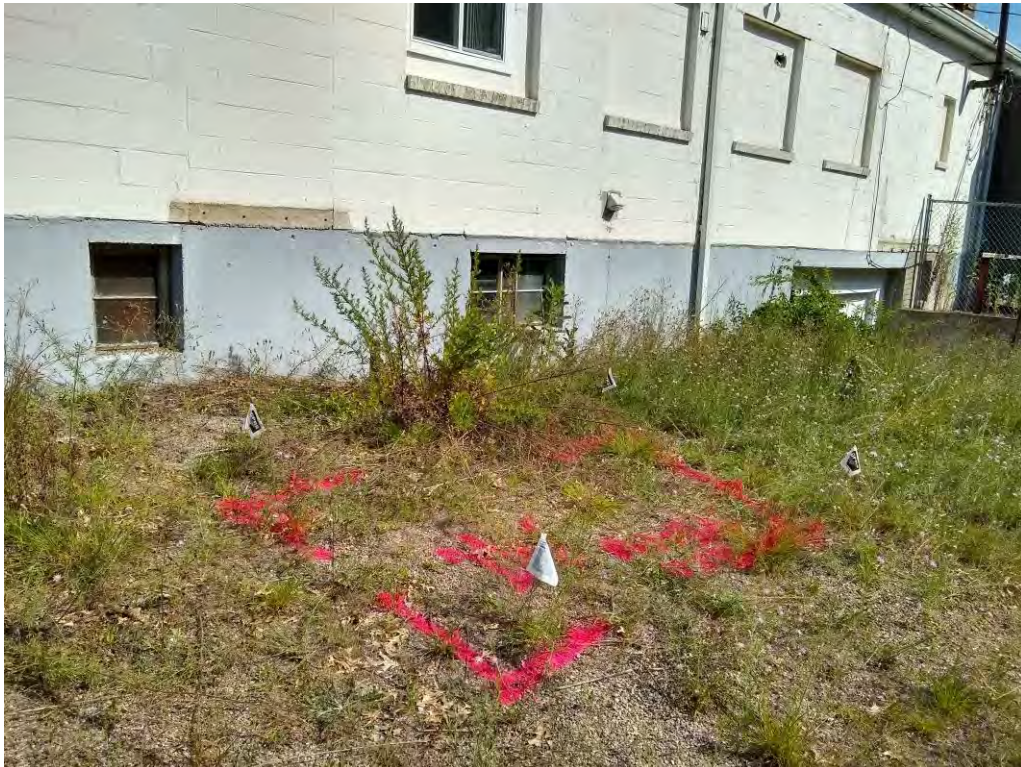
GEC Project No. 1936-0030. July 30, 2020. 2210 Providence Highway, Walpole, MA. Delineation of the UST identified during the geophysical survey.

One (1) UST was identified by GPRS at depth of about 1.5 feet on the southwest side of the Site building, but no suspect UST and no tank grave were detected across the other surveyed area. Refer to the GPRS Geophysical Survey report in Attachment B for additional

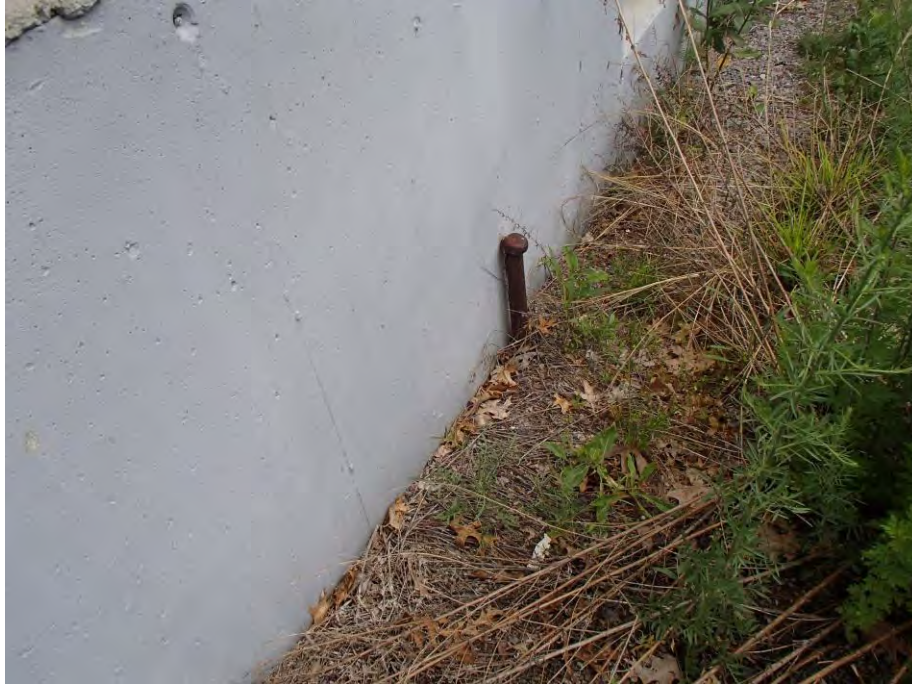
GEC Project No. 1936-0010. June 12, 2020. 2210 Providence Highway, Walpole, MA. View of the UST vent pipe protruding from the ground along the south exterior wall of the Site building prior to excavation

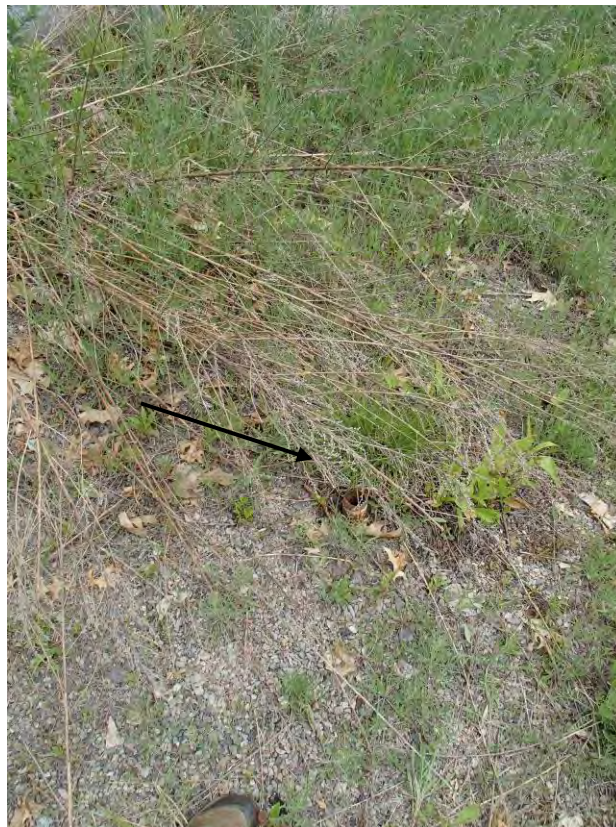
GEC Project No. 1936-0030. June 12, 2020. 2210 Providence Highway, Walpole, MA. View of the uncapped UST fill port present along the south side of the Site building, near the westerly-located vent pipe, prior to excavation.

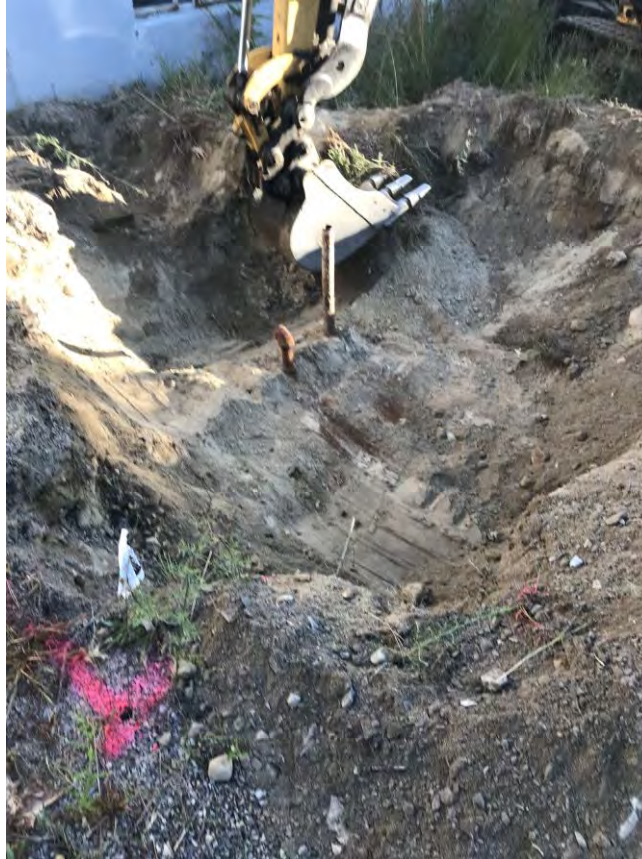
Dowling uncovered the top of the tank using an excavator. The top of the tank was encountered approximately 1.5 feet below grade and was in good condition, with no odors or oily-stained soils observed where feed, fill and vent pipes were located. At this point, soil samples were collected from one foot down each of the tank's sidewalls and GEC performed headspace screenings of these soils for total volatile organic compounds (VOCs) using a photoionization detector (PID) equipped with a 10.6 eV lamp and calibrated to 100 parts per million per volume (ppmv) Isobutylene gas. PID readings of the screened soil samples ranged from none detect to 0.2 ppmv.

GEC Project No. 1936-0030. July 30, 2020. 2210 Providence Highway, Walpole, MA.
Photograph of the uncovering of UST.

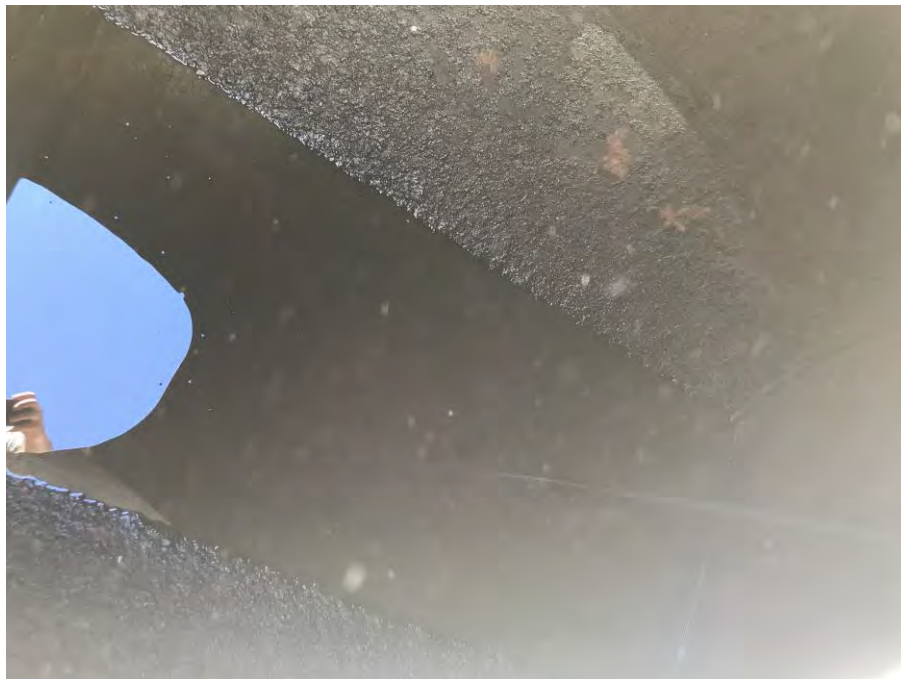
Dowling then cut open a section of the top of tank and visual inspection of the tank revealed that it was a single wall tank of steel construction. GEC noted about six inches of oil/water mixture at the bottom of the tank. US Ecology's vacuum-mounted truck was brought in to pump out residual liquid from the tank. According to the waste manifest approximately 70 gallons of oily water was pumped out and transported off-Site under waste manifest # 021411760 to Trabede T&R of Stoughton, MA on August 21, 2020. A copy of the waste disposal document is included in Attachment C. Dowling employee then accessed the interior of the tank for cleaning operations and resulting oily sludge and oily absorbent pads that were

GEC Project No. 1936-0030. July 30, 2020. 2210 Providence Highway, Walpole, MA.
General view of the inside the tank prior to cleaning operations.

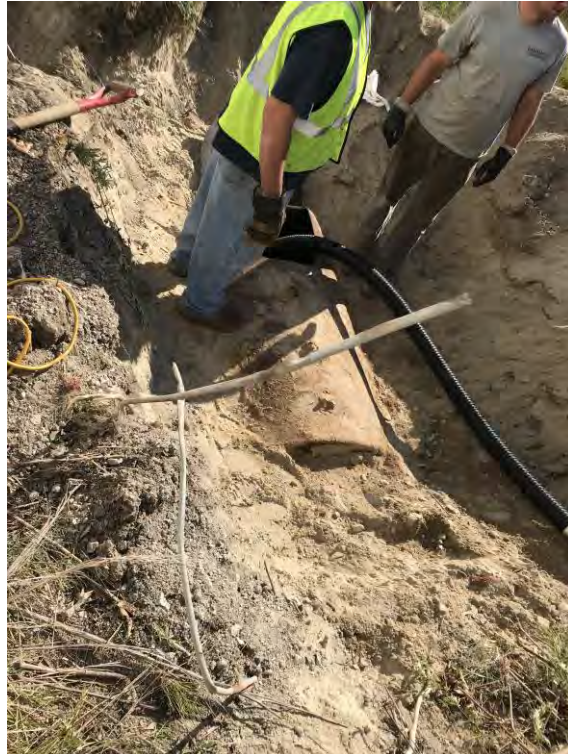
GEC Project No. 1936-0030. June 12, 2020. 2210 Providence Highway, Walpole, MA.
View of the residual oil/water mixture being pumped out from the UST.

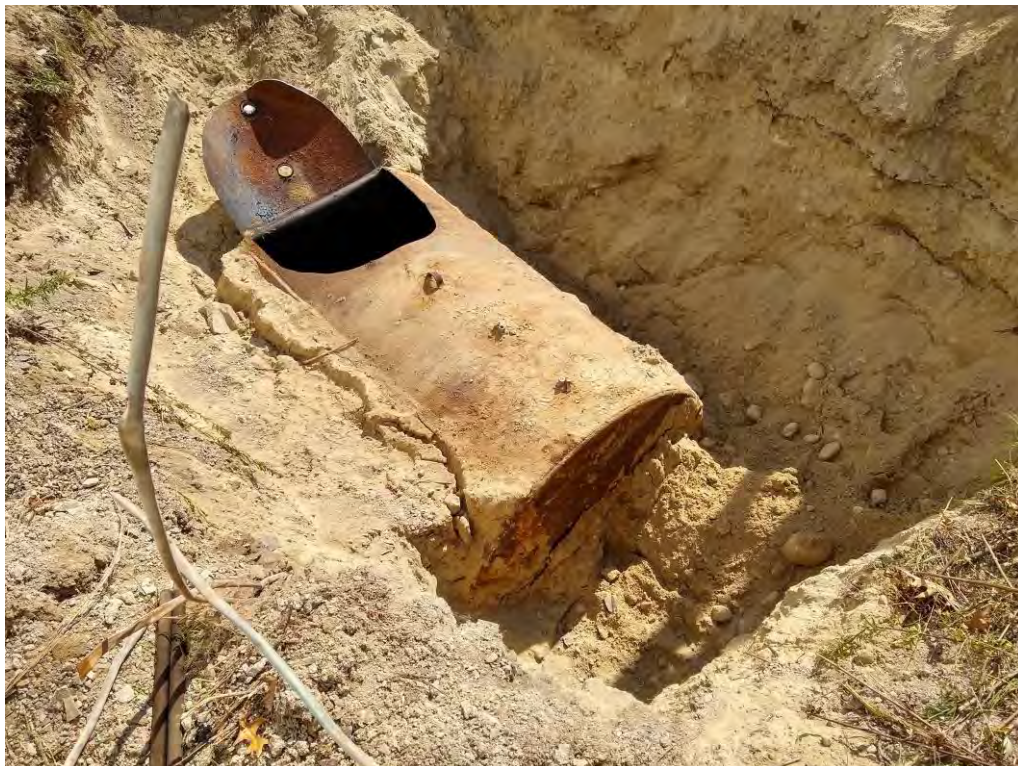
GEC Project No. 1936-0030. July 30, 2020. 2210 Providence Highway, Walpole, MA.
Photograph of the exposed UST and soil conditions along its south and east sides.

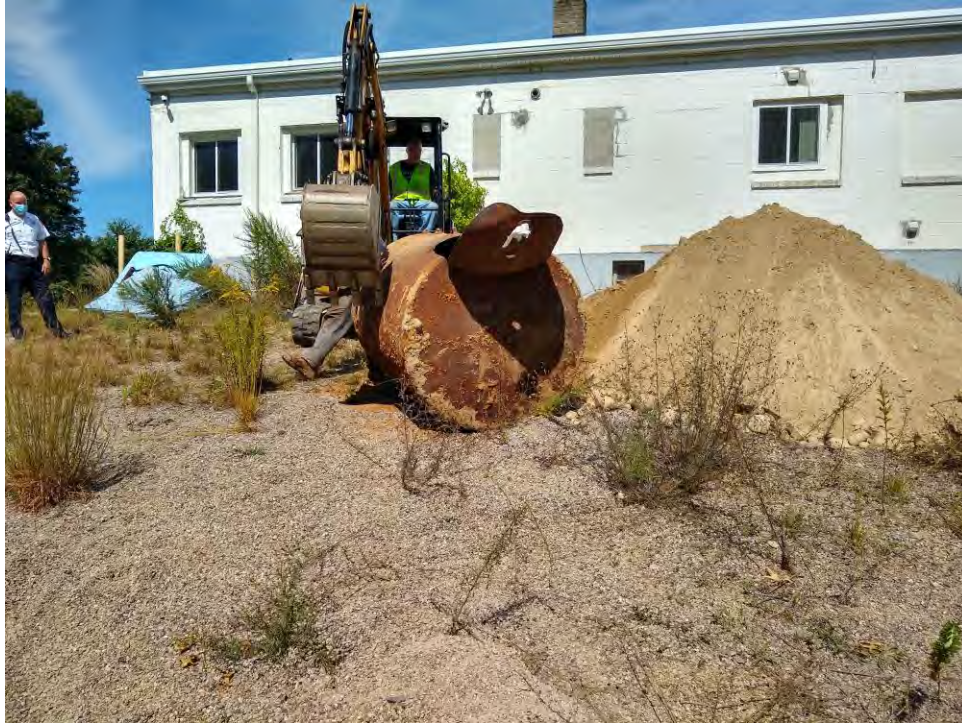
At approximately 11:00 a.m., Captain Paul Carter of the Walpole Fire Department arrived on-Site and observed the UST as it was pulled from the excavation by a Dowling excavator operator. Satisfied by soil and tank conditions, Captain Paul Carter granted Dowling to backfill the excavation and reported that he would sign the tank removal permit once he returned at the office.

GEC Project No. 1936-0030. June 12, 2020. 2210 Providence Highway, Walpole, MA.
View of the UST being pulled out from the ground under the witness of the Dire Department.

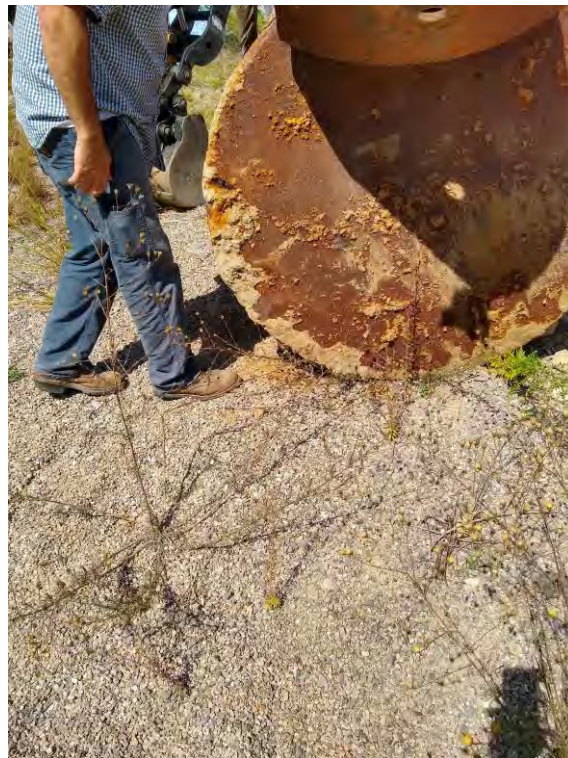
Once excavated, GEC visually inspected the estimated 750-gallon fuel oil UST and observed slight rusting and some minor pitting/scaling on its northern end. The overall condition of the tank was good with no apparent holes or cracks. The tank was then loaded onto a flatbed trailer truck, secured and transported to an approved tank yard #15 operated by Allied Recycling Center Inc. of Walpole, Massachusetts. A copy of Form FP 291 - Receipt of Disposal of Underground Steel Storage Tank – documenting proper disposition of the tank, and Form FP 290R – Application and Permit for storage tank removal - are attached in Attachment C.

GEC Project No. 1936-0030. June 12, 2020. 2210 Providence Highway, Walpole, MA.
View of the mild rusting and pitting observed on the exterior steel wall of the tank.

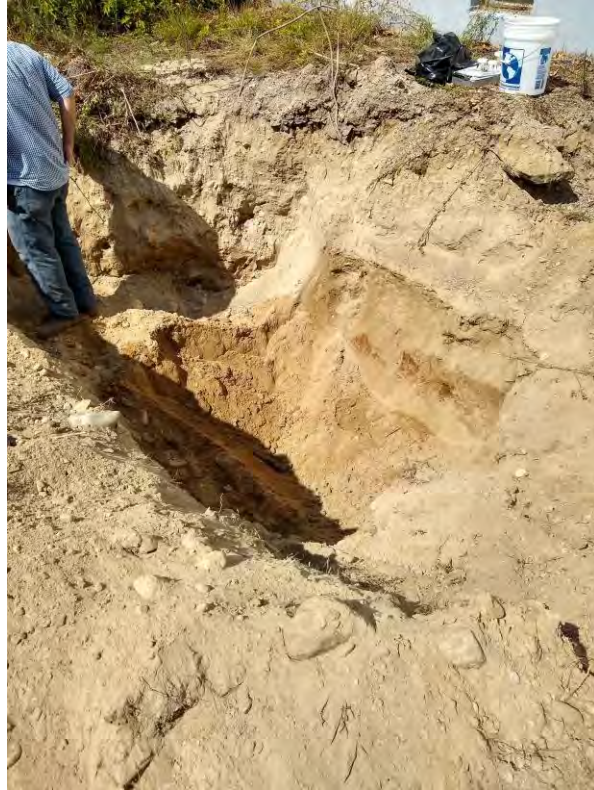
GEC also inspected the tank grave and noted no visual or olfactory evidence of a petroleum release. Soil profile consisted of brown sand overlain by a layer of gravel and sandy loam with material debris. GEC observed wood planks that had been installed below the UST serving as supports. At no time throughout the excavation process was groundwater encountered. GEC also collected soil samples from each tank grave sidewalls and bottom that were field screened using the PID. PID readings ranged between 0.0 and 0.2 ppm.

GEC Project No. 1936-0030. July 30, 2020. 2210 Providence Highway, Walpole, MA.
General view of the soil conditions in the tank grave following removal of the UST.

After the collection of confirmatory soil sampling, the feed and return lines were pulled out and the tank grave was backfilled with the excavated material that had shown no evidence of fuel release. No fill material was needed to bring the excavation to grade. See Attachment A for Site Photographs.

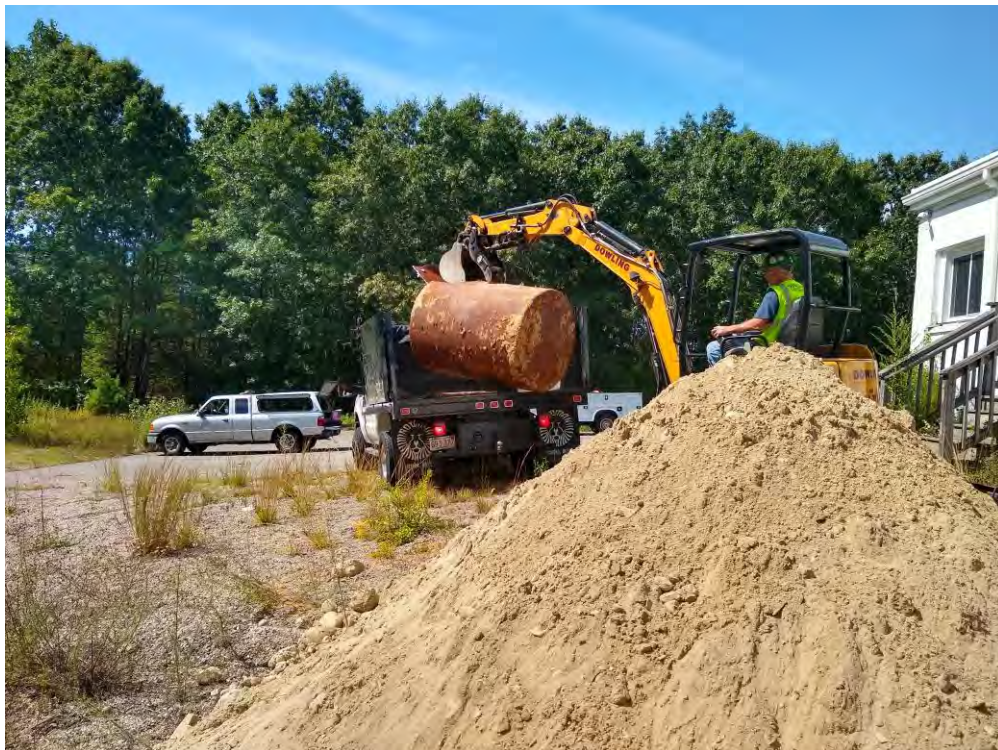
GEC Project No. 1936-0030. July 30, 2020. 2210 Providence Highway, Walpole, MA.
General view of the tank being placed on the truck for off-Site disposal.

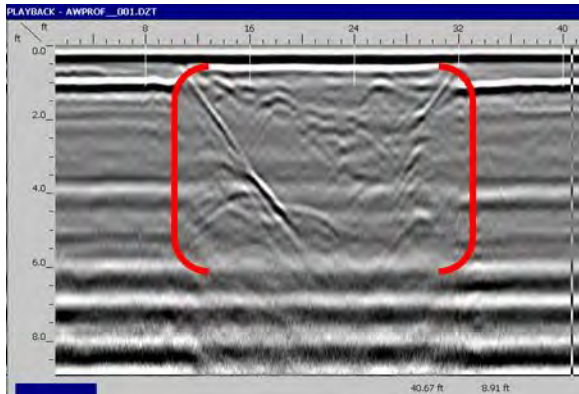
Sample GPR data screenshot showing a possible former tank pit or excavation. The change in the data from the excavation is apparent but GPR cannot determine whether this is due to a tank removal or whether tanks may still exist beyond the maximum depth of the GPR signal.

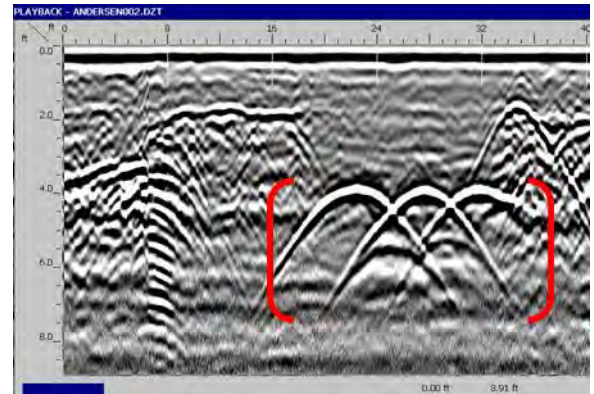
Sample GPR data screenshot showing three reactions from probable USTs. The diameters cannot be determined from these hyperbolas but they can be seen to be larger than a reaction from a typical utility.

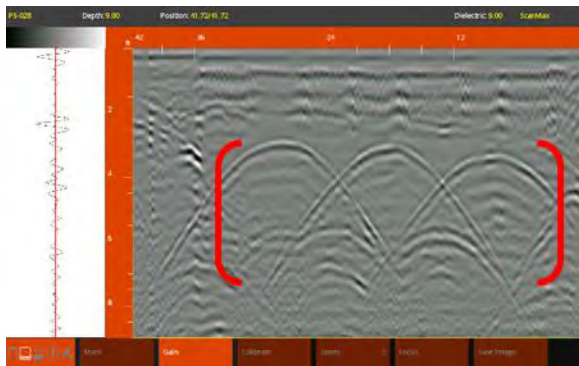
Sample GPR data screenshot showing three reactions from known USTs at an active fueling station. The concrete above the USTs is reinforced with wire mesh.

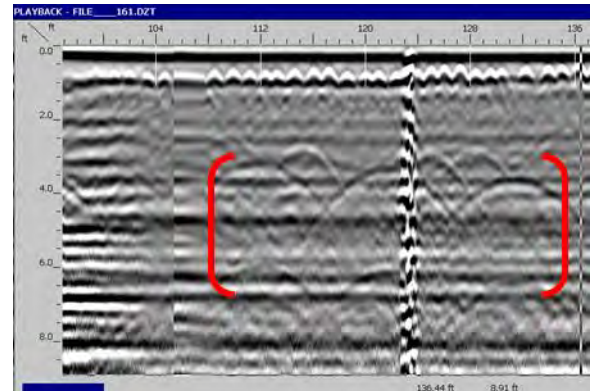
Sample GPR data screenshot showing three reactions from known USTs at an active fueling station. These USTs are non-metallic and therefore have a weaker reflection that is more difficult and sometimes impossible to identify in the GPR data.

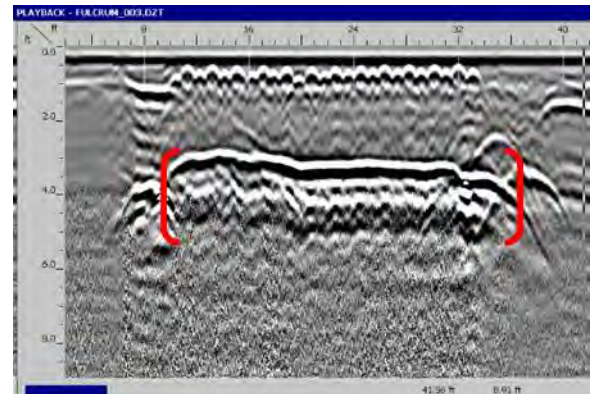
Sample GPR data screenshot showing a scan collected parallel along the top one of the suspected USTs shown in the data to the left. A parallel scan is used to determine a clear beginning and end to the reaction to the reaction which is an indicator of a UST and to determine an approximate length.
