Stormwater Construction Site Inspection Report

Rattlesnake Creek

CWS-201802602

Substation: Steel Erection. T-line: polebase setting

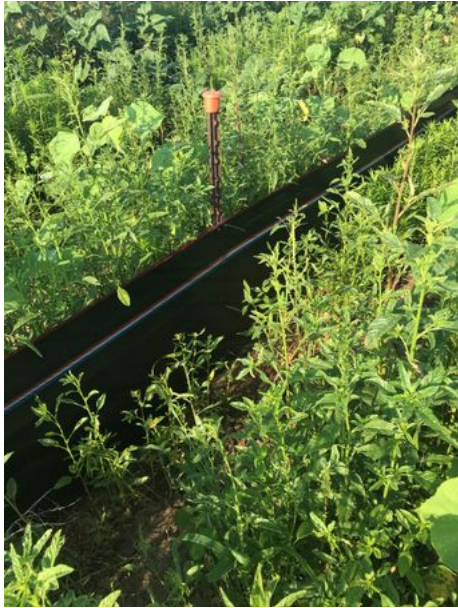
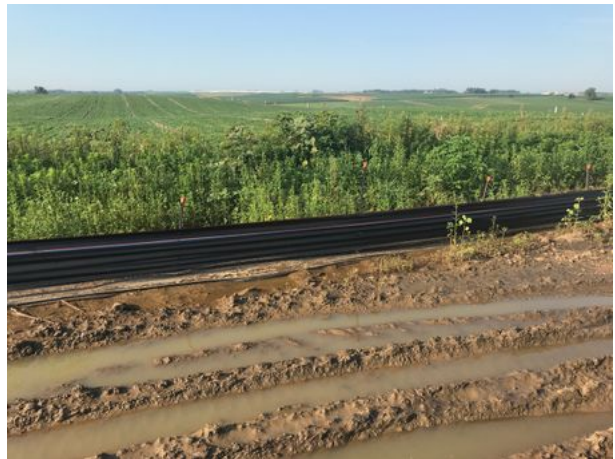
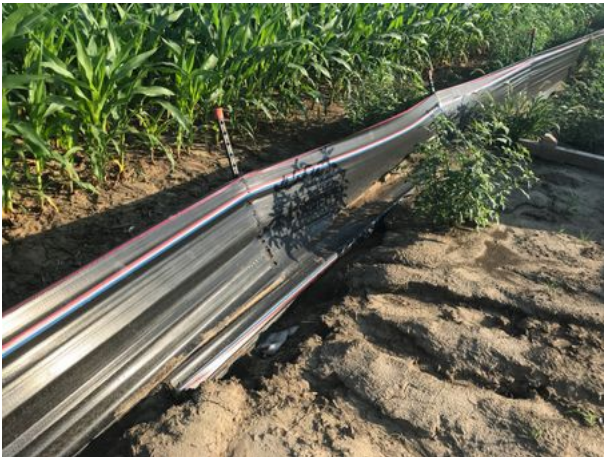
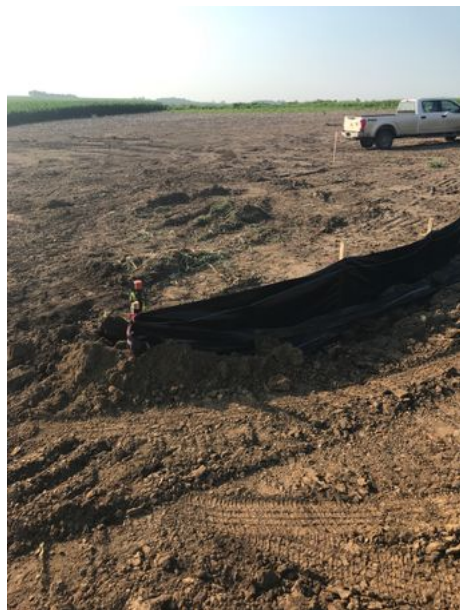
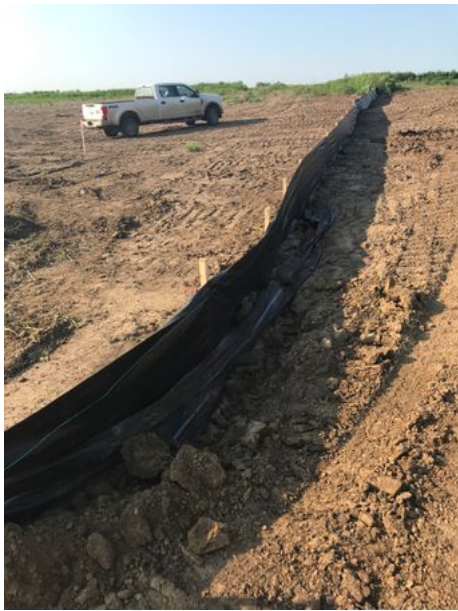
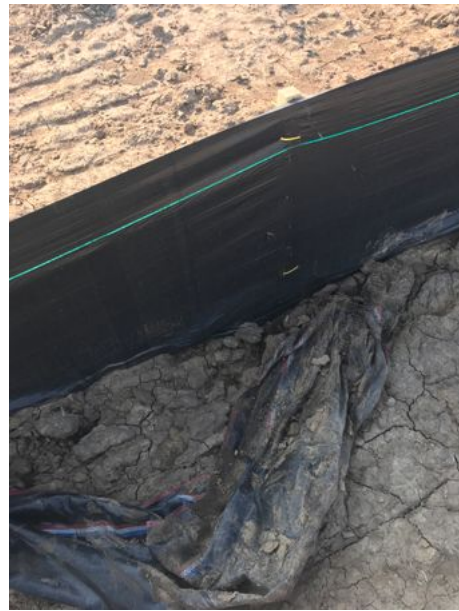
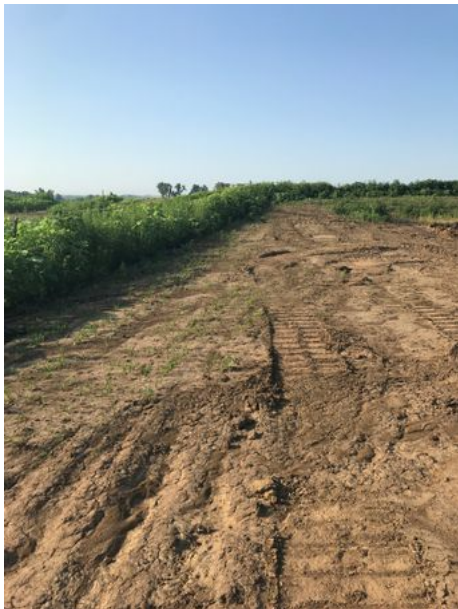
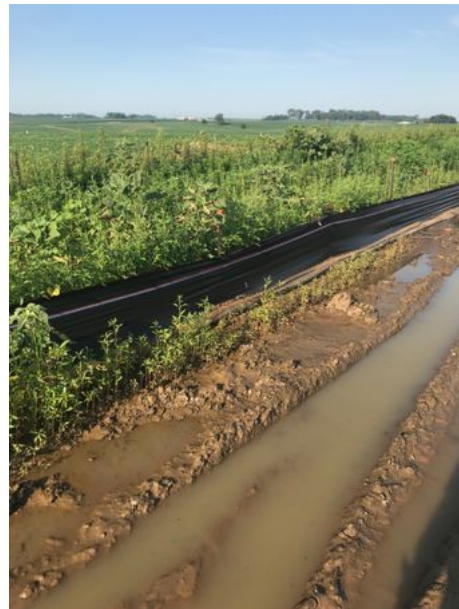
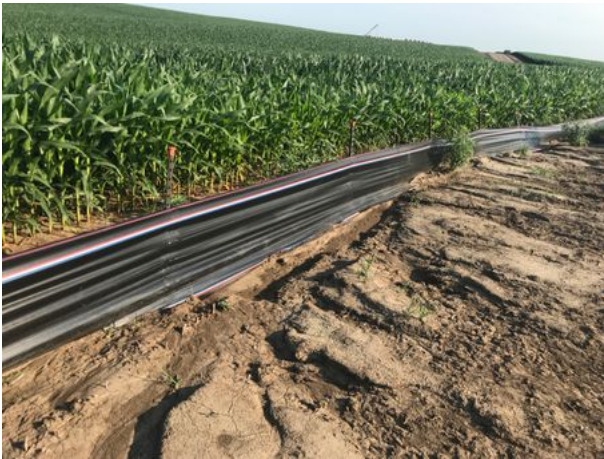
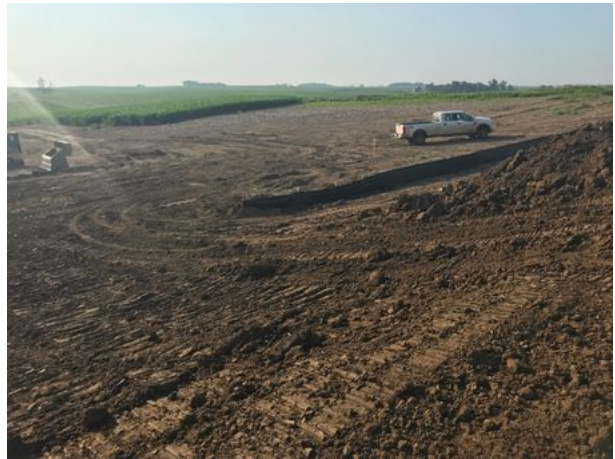
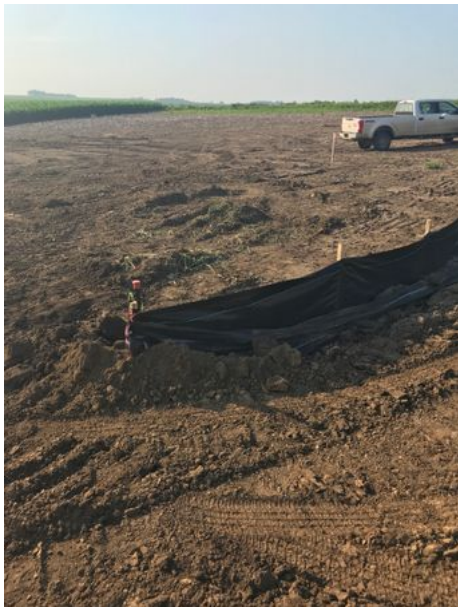
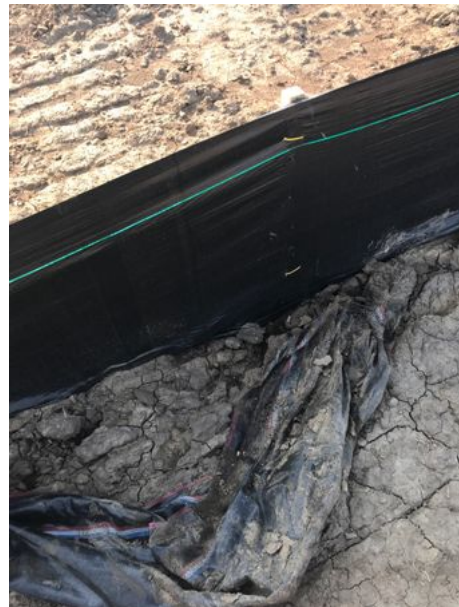
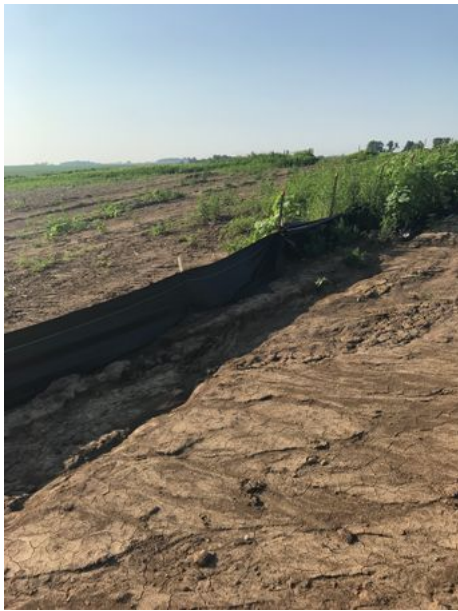
Question	Response	Details
Add BMP		
BMP 1		
BMP Number	Silt fence	
Is BMP Installed?	Yes	
BMP Maintenance Required?	Yes	
<div style="display: flex; flex-wrap: wrap; justify-content: space-around;"> <div style="text-align: center;">   <p>Appendix 1</p> </div> <div style="text-align: center;">   <p>Appendix 2</p> </div> <div style="text-align: center;">

Corrective action needed, Notes	Repair silt fence approximately 200 ft north of the substation entrance on the west side.	
BMP 2		
BMP Number	Temporary seeding	
Is BMP Installed?	Yes

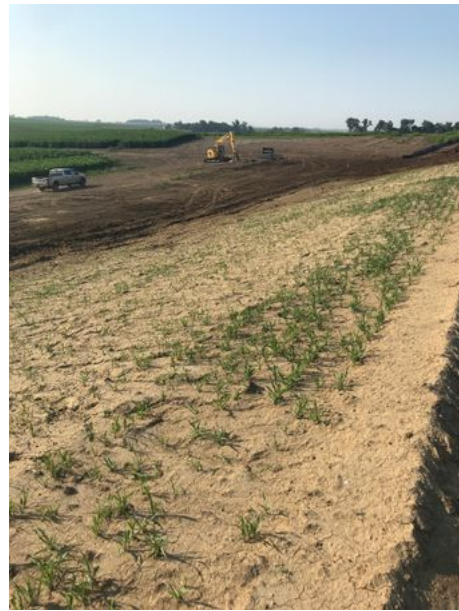
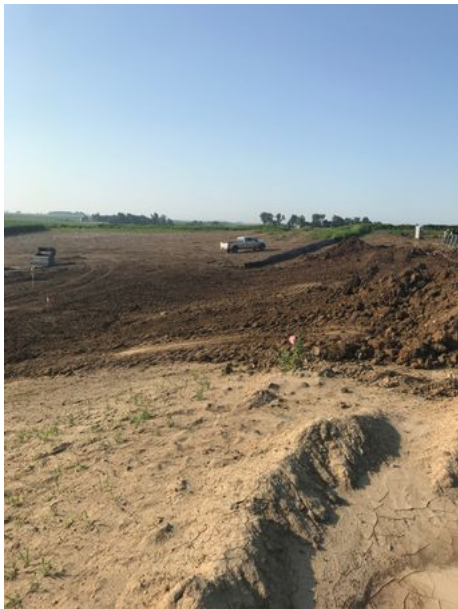
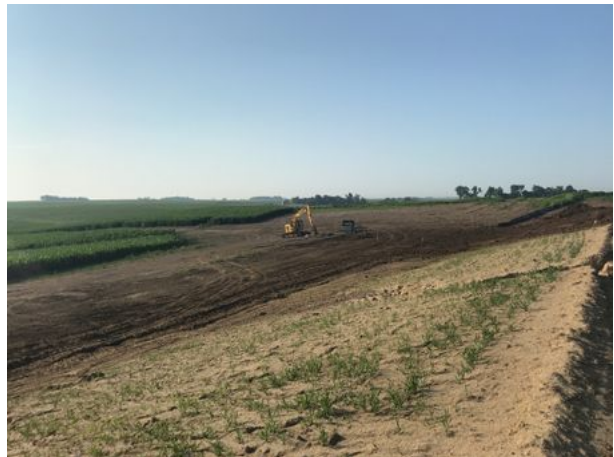
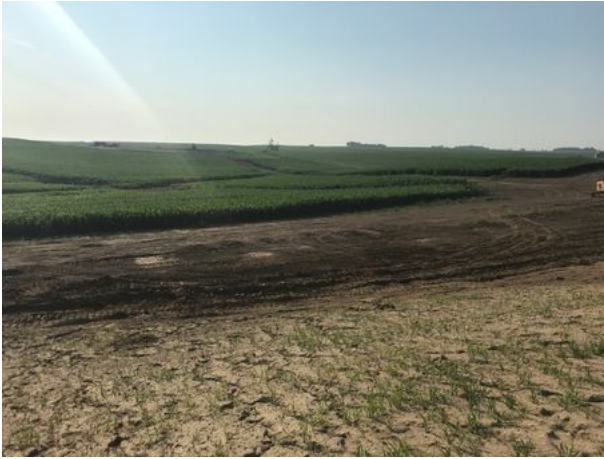
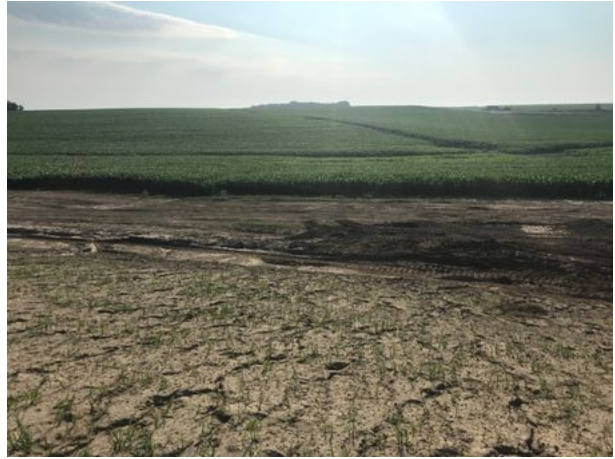
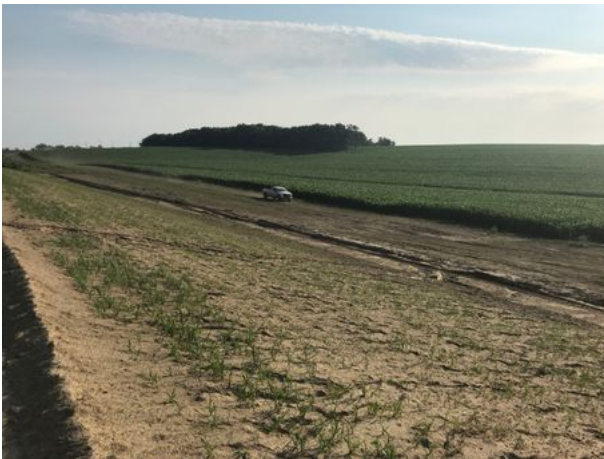
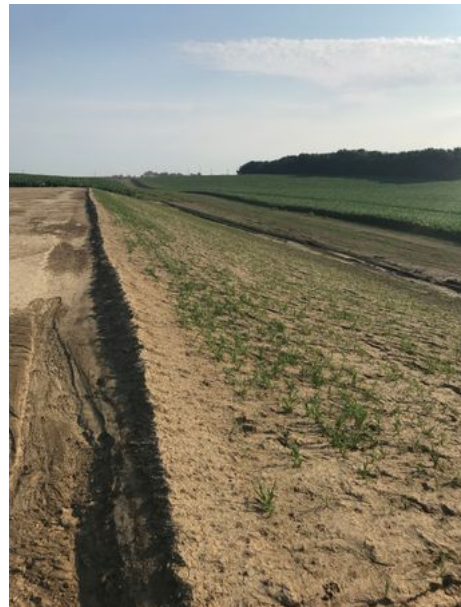
Question		Response	Details	
BMP Maintenance Required?		Yes		
<div><div>

<p>Appendix 20</p></div></div>				
Corrective action needed, Notes		Seeding on the east side of the substation that was previously sprouting has been trenched over and destroyed. Re-seeding is required.		
BMP 3				
BMP Number		Substation: Wattles		
Is BMP Installed?		Yes		
<div><div>

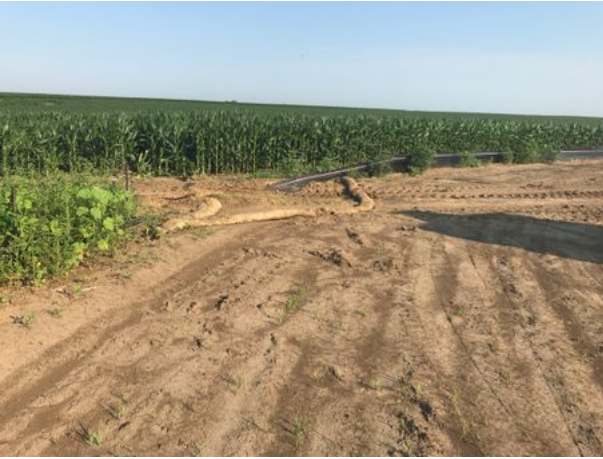
Appendix 21

<p>Appendix 21</p></div></div>				
BMP Maintenance Required?		Yes		
Corrective action needed, Notes		Traffic has gone over the wattles on the southwest corner of the substation. Replacement is required.
