Keeping your Li'l Red in the Black

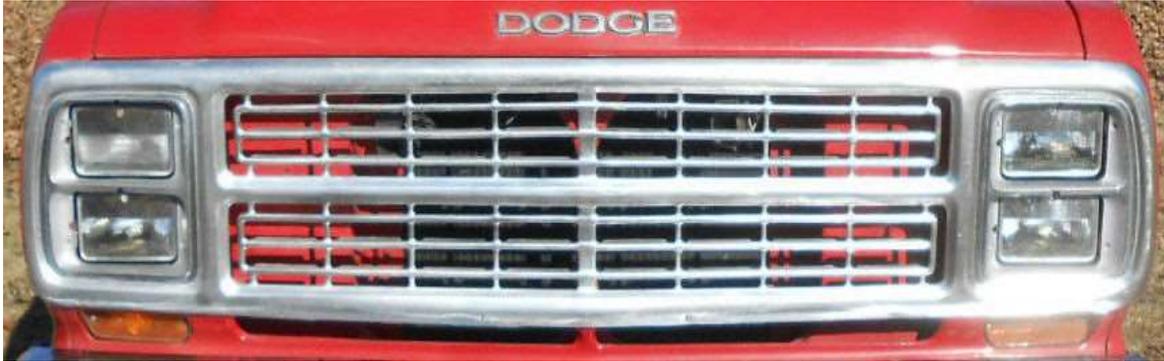
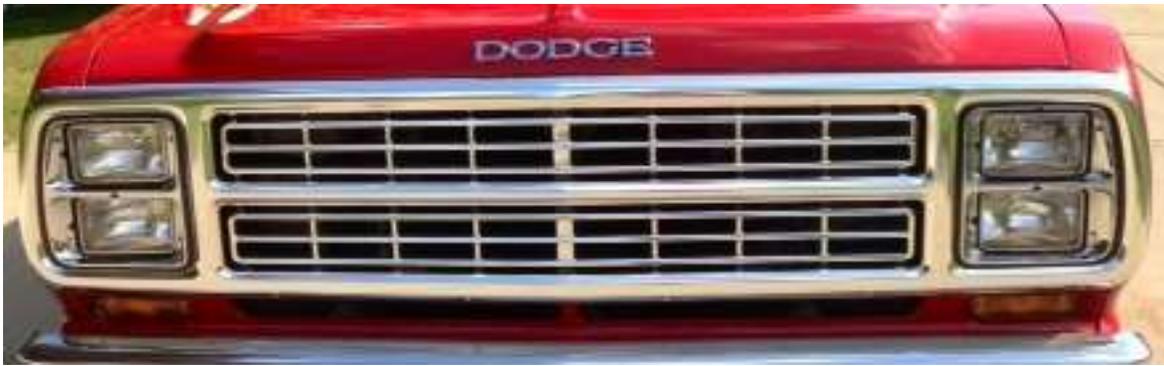
Which looks better to you?

behind the grille, supporting all the front-end equipment. Chrysler always had the vendor that supplied the radiators and A/C condensers, paint them black before shipment, so they did not show through the grille. I see so many “Restored” Li'l reds, that have the red paint on the front of the core support, aluminum radiators and A/C condensers, glaring through the grille work. It really distracts from the beauty of the front of the truck.

You can always tell when a Mopar has been “restored” or repainted, most body shops just leave the color on the front of the radiator core and it sticks out like a sore thumb!! I have seen this done, by so called expert Mopar restoration shops and back yard painters. You can tell when a true Mopar restorer paints a vehicle, such as Legendary Motor Cars, in Canada and Graveyard Cars in Oregon; they always paint these areas a satin black, as the factory had done.
