The dangers of exposure to asbestos in vermiculite attic insulation

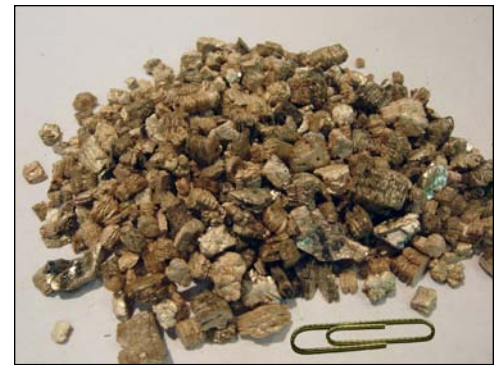
Vermiculite insulation

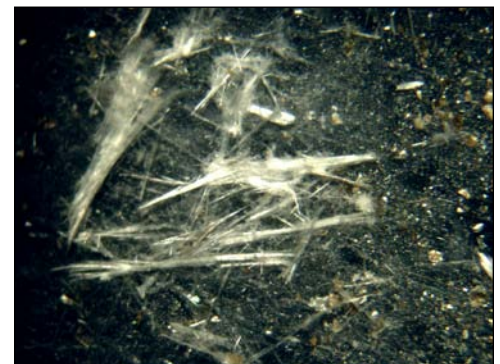
Asbestos fibres from vermiculite insulation

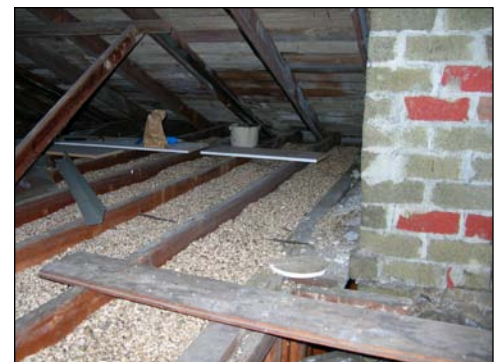
Typical vermiculite insulation in an attic

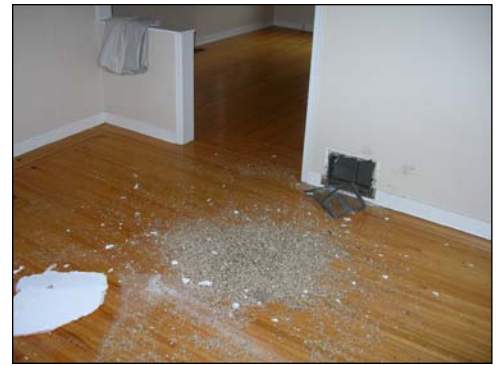
Vermiculite insulation spilled from an attic during a renovation

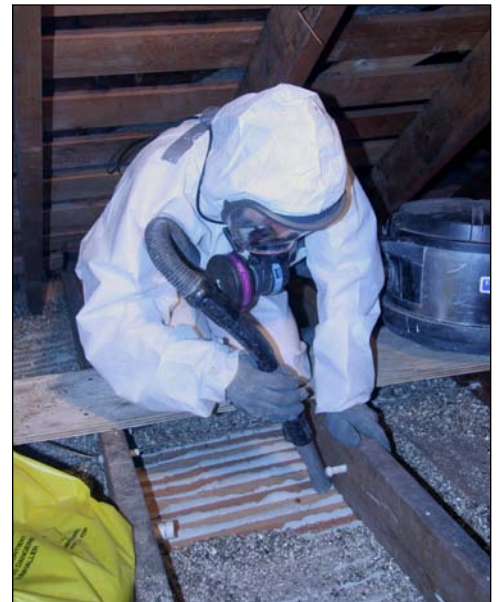
Protected asbestos worker removing vermiculite insulation from an attic

Vermiculite insulation containing asbestos must be removed by experienced asbestos abatement contractors before any renovations or demolition takes place. You are responsible if unprotected workers are exposed to asbestos-containing building materials (including vermiculite) while working in your home or on your worksite.
