LAKE BROWNWOOD STATE PARK  
 ROOF REPLACEMENT  
 PROJECT NUMBER: 1110153

OAK LODGE - ROOF PLAN & ELEVATIONS

100% SET - CONSTRUCTION DOCUMENTS

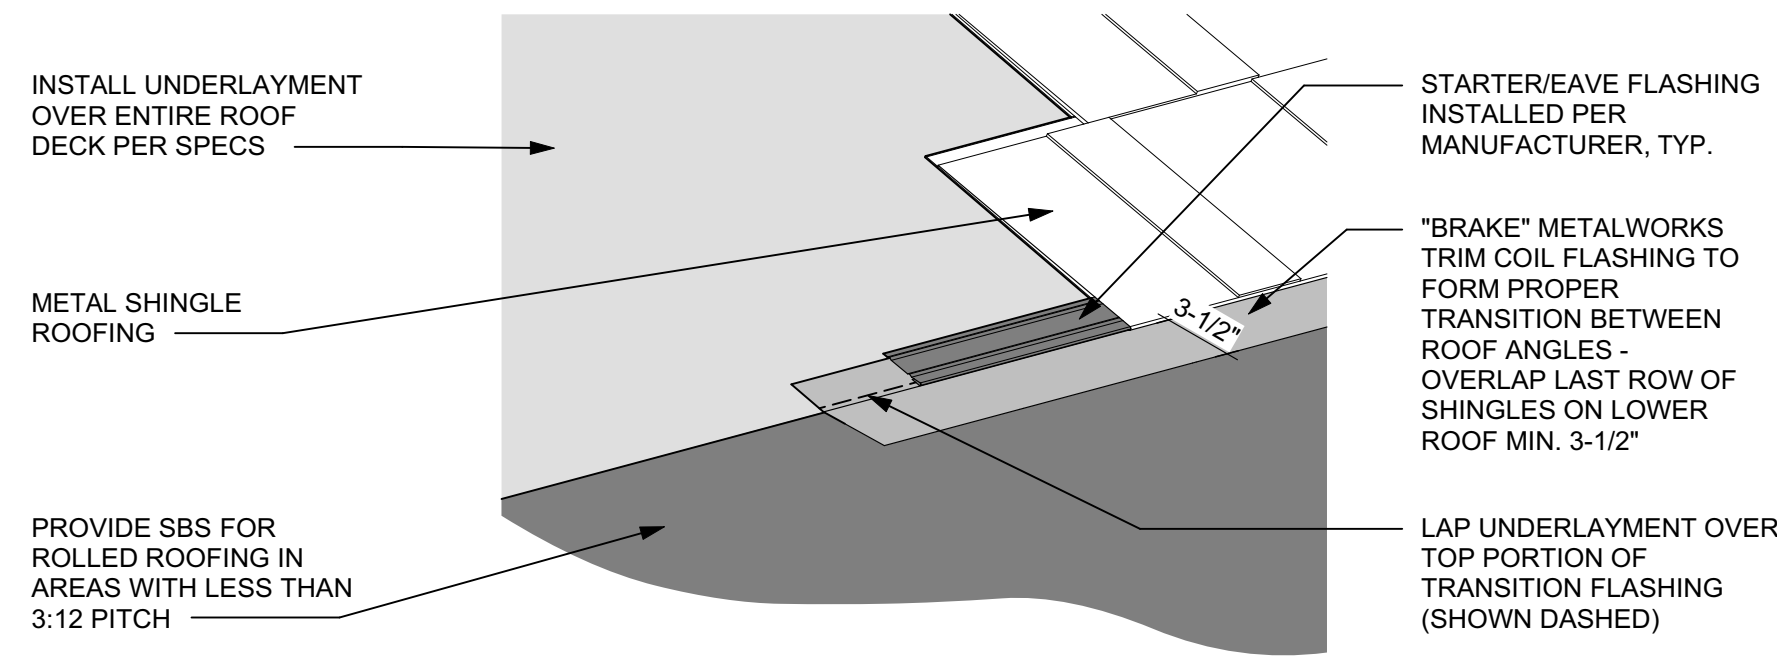
**C1** DETAIL VIEW - ROOF PITCH TRANSITION (DO NOT BEND SHINGLES)  
NOT TO SCALE

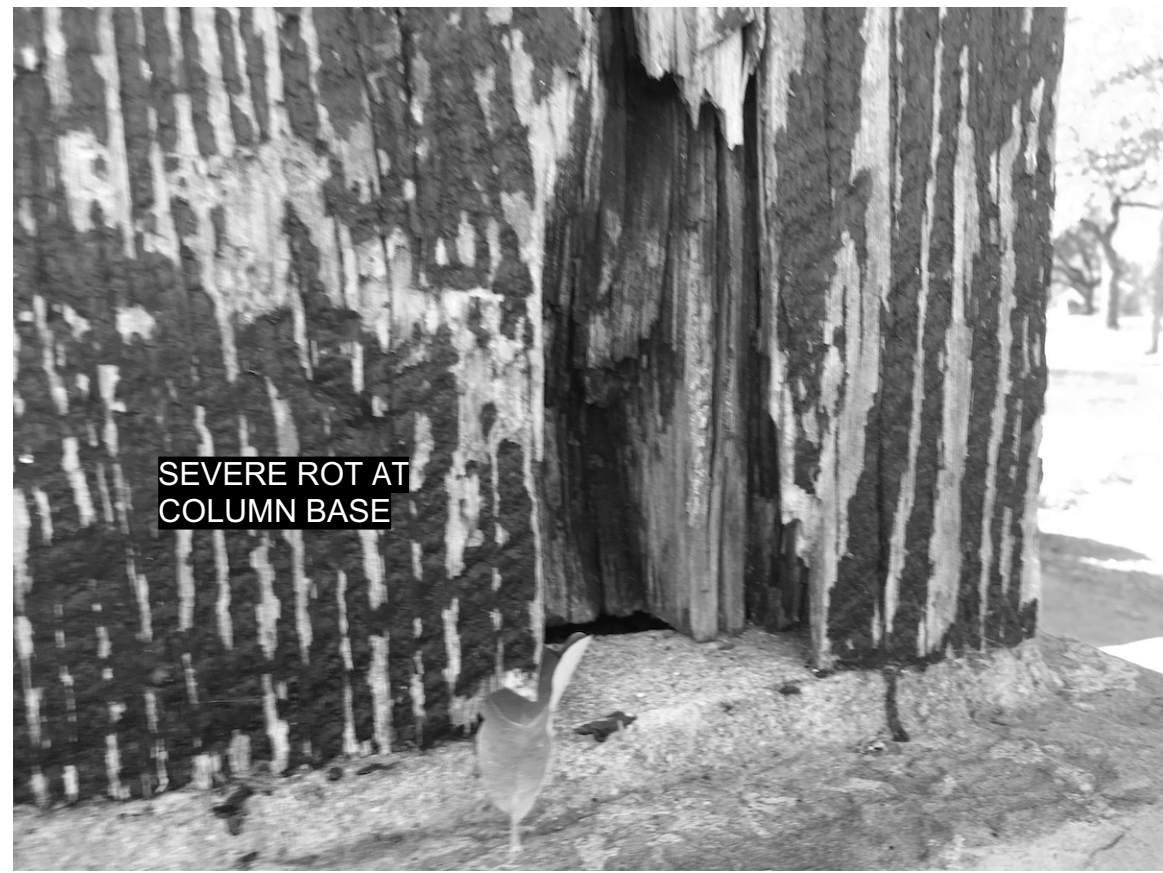
PHOTO 3 SEVERE ROT AT COLUMN BASE

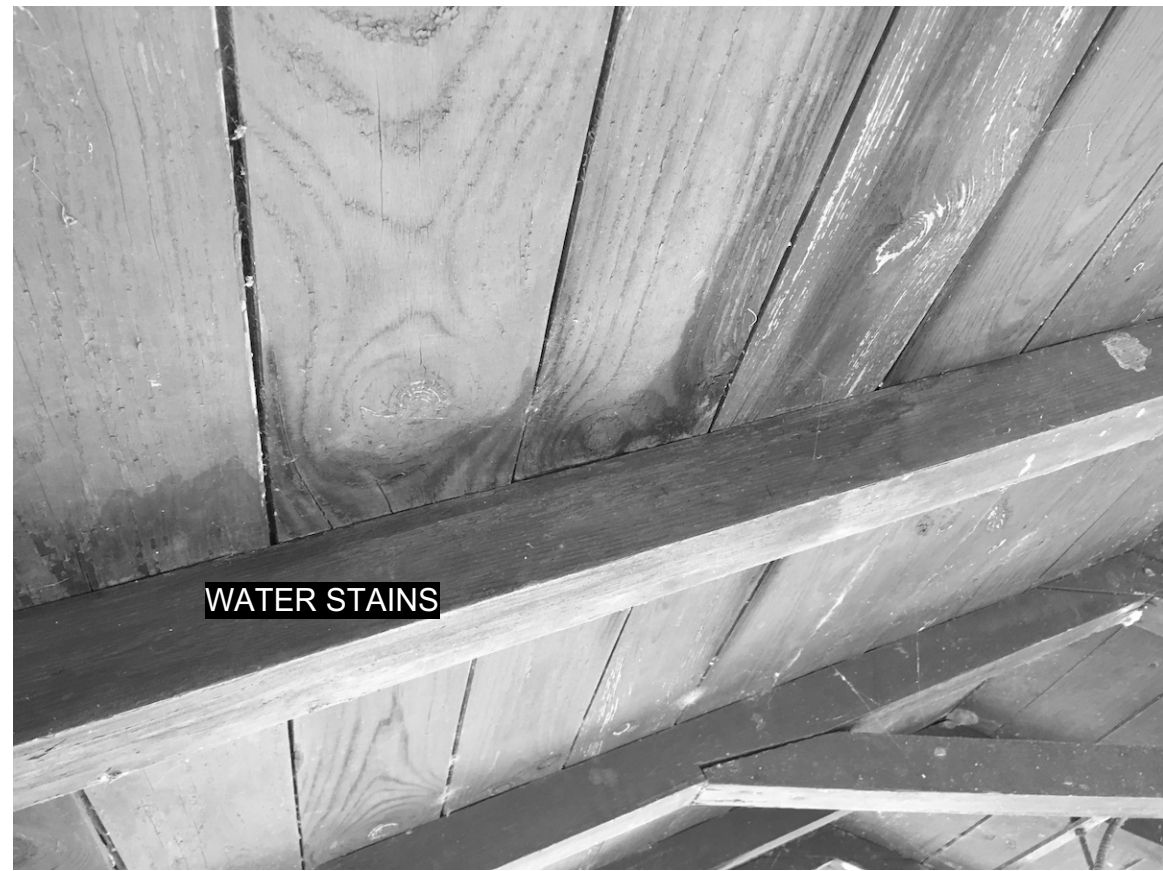
PHOTO 5 WATER STAINS AT DECK UNDERSIDE

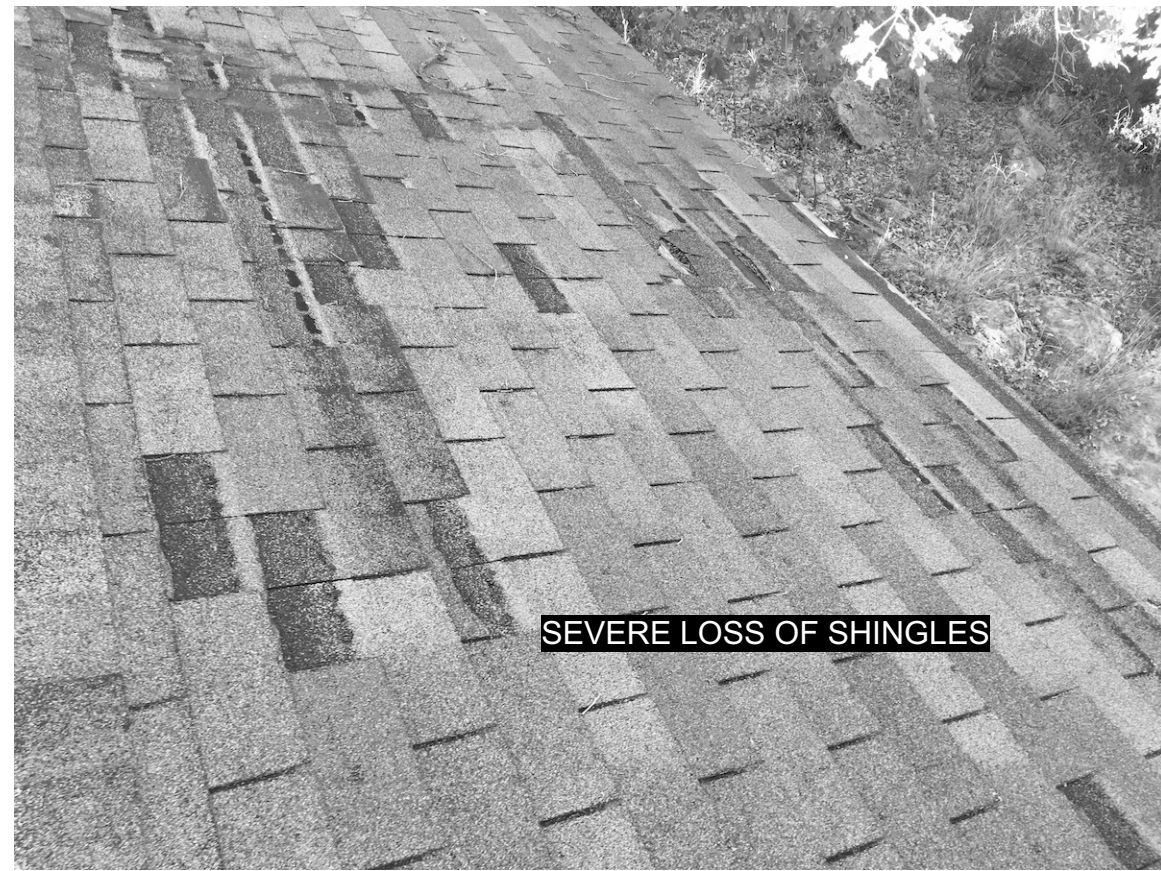
PHOTO 6 SEVERE LOSS OF SHINGLES ROOF LOOKING NORTH

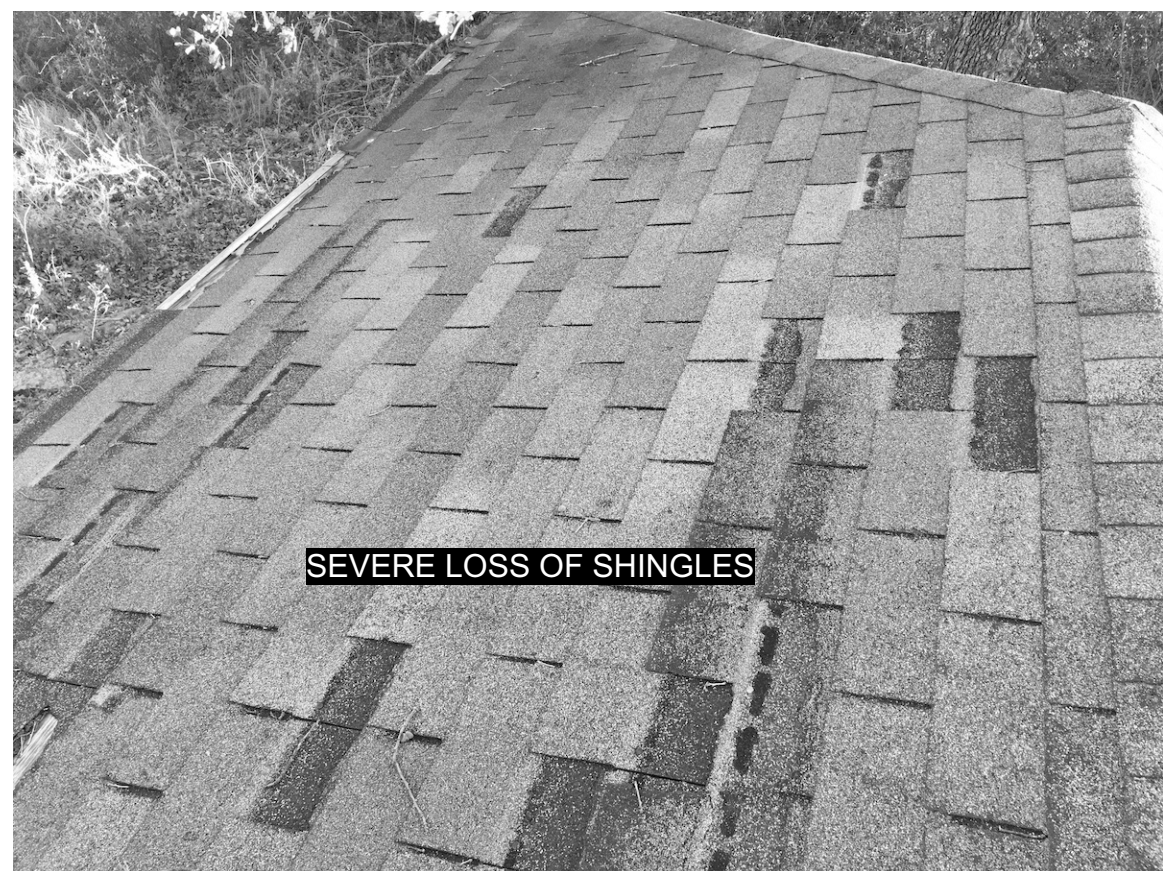
PHOTO 7 SEVERE LOSS OF SHINGLES ROOF LOOKING SOUTH

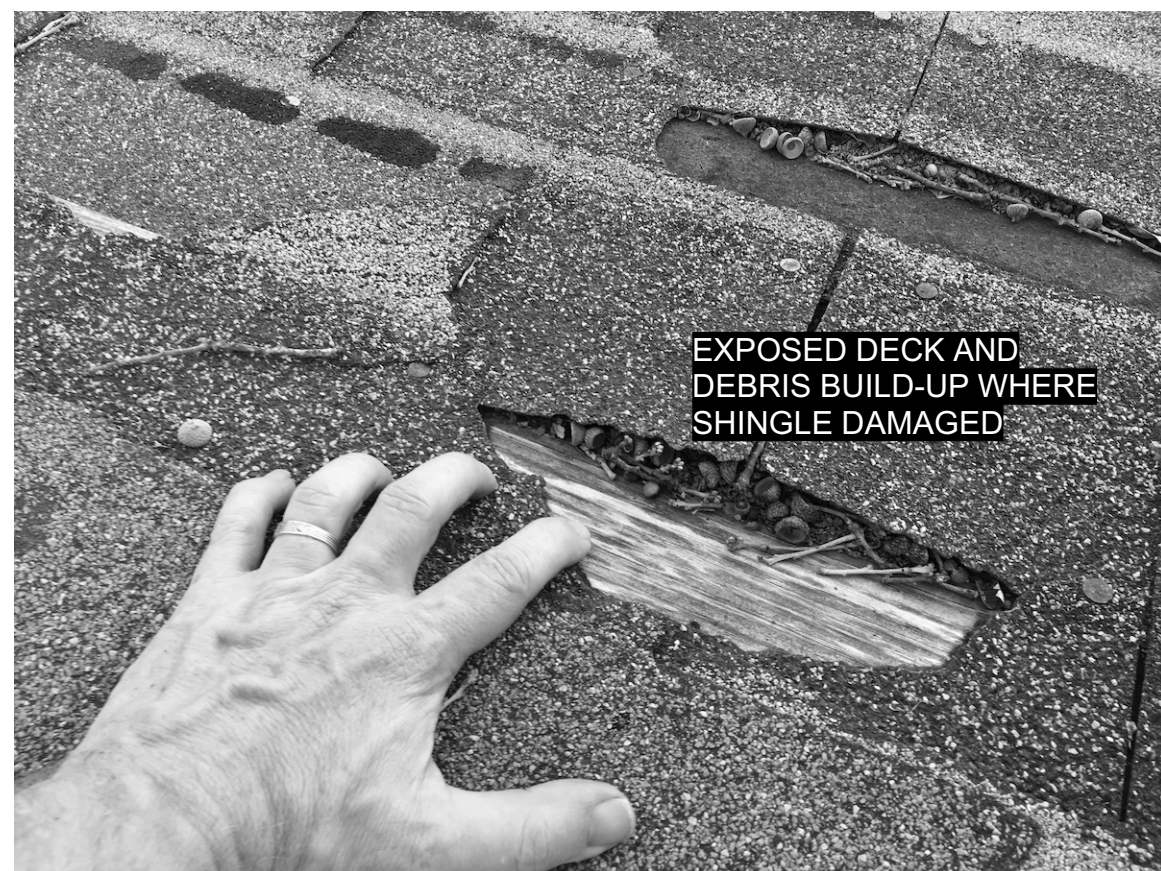
PHOTO 8 EXPOSED DECK AND DEBRIS BUILD-UP WHERE SHINGLE DAMAGED

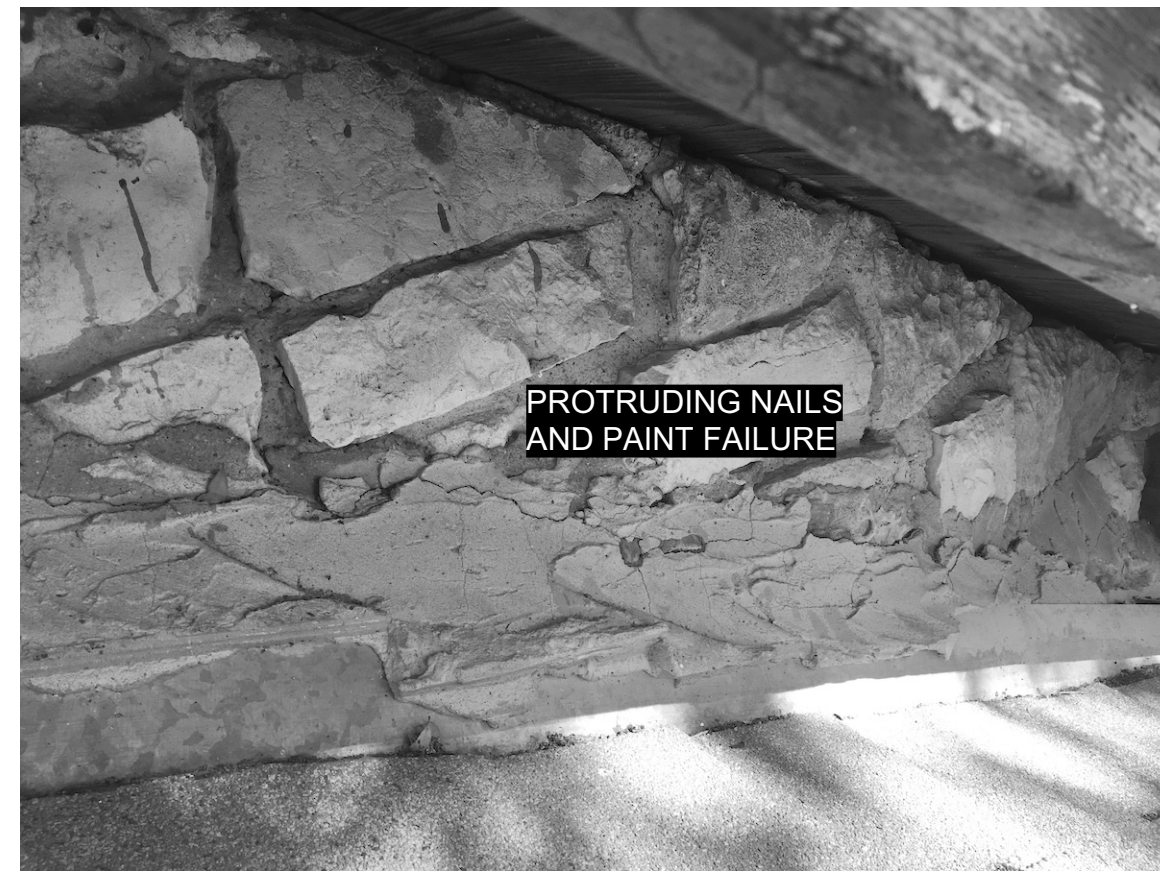
PHOTO 4 MORTARED FLASHING AT NORTH GABLE

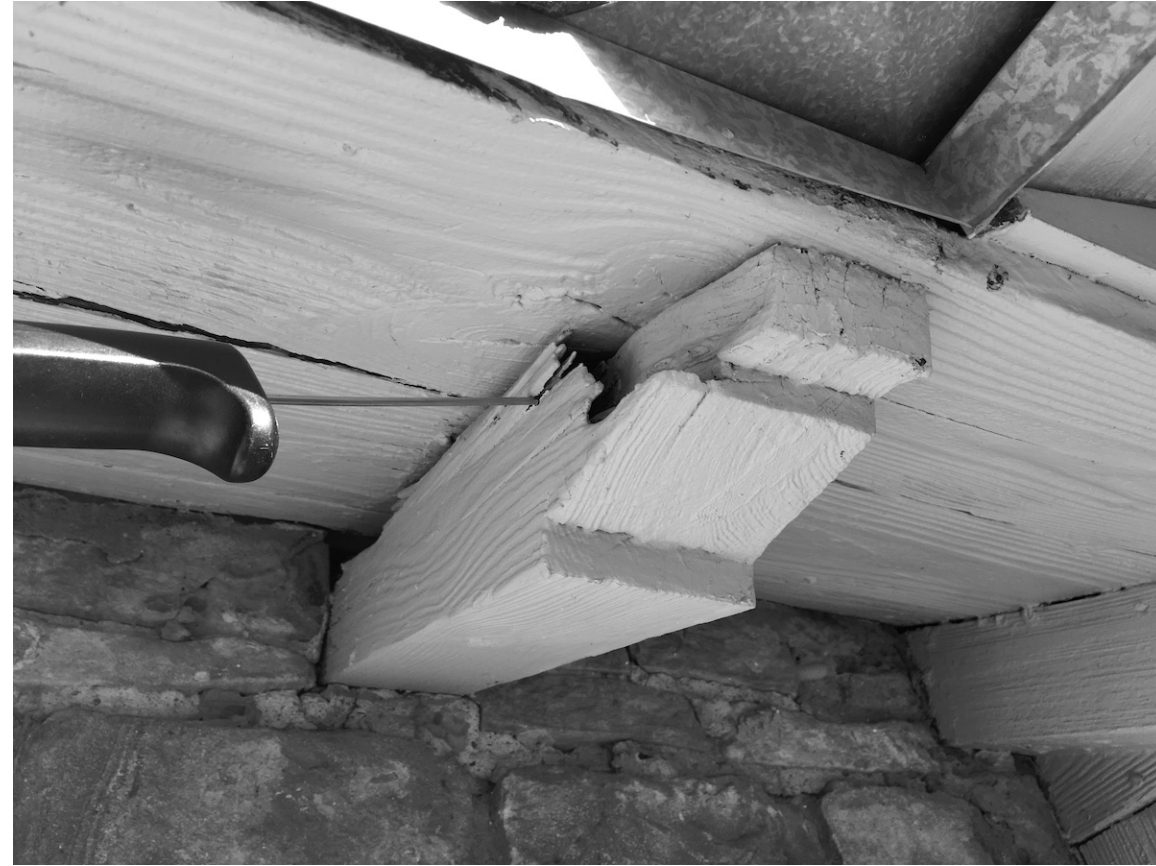
PHOTO 5 ROTTED RAFTER END
