Inspection Report

Main Street USA NJ

Homes Inspections LLC

Date: 11/16/2016	Time: 12:00 AM	Report ID: homes-11.16.16_b35
Property: Main Street USA NJ	Customer: John Doe	Real Estate Professional:

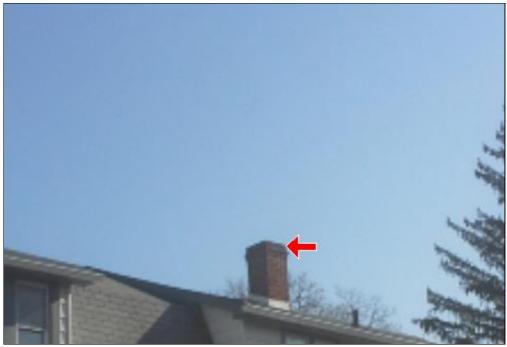
Safety issue:Chimney not lined, some loose bricks noted, repairs needed..Have one installed and all repairs completed by a qualified chimney contractor prior to use.

1.2 Item 1(Picture) Chimney Unlines

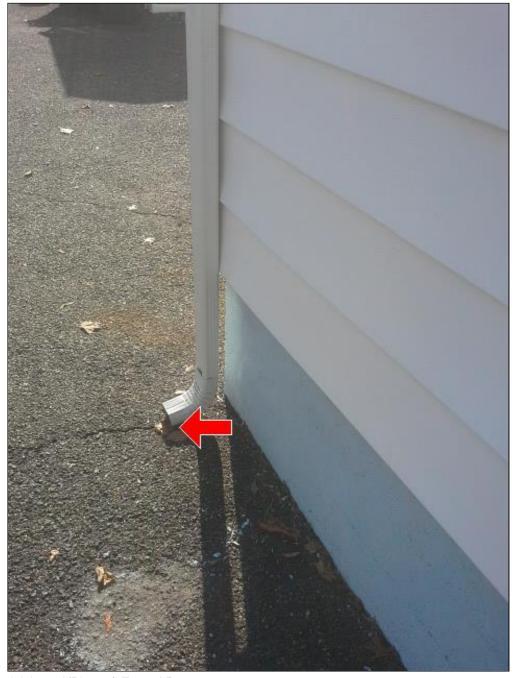
1.3 Item 1(Picture) Extend Downspouts

Suggest extending all downspouts away from foundation.

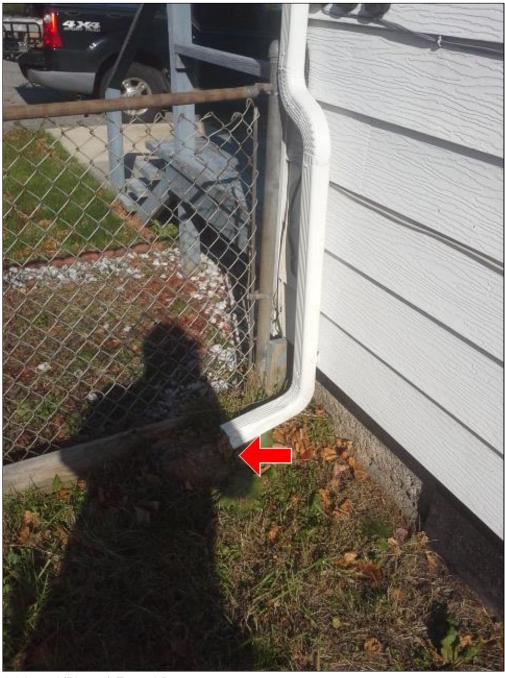
1.3 Item 2(Picture) Extend Downspouts

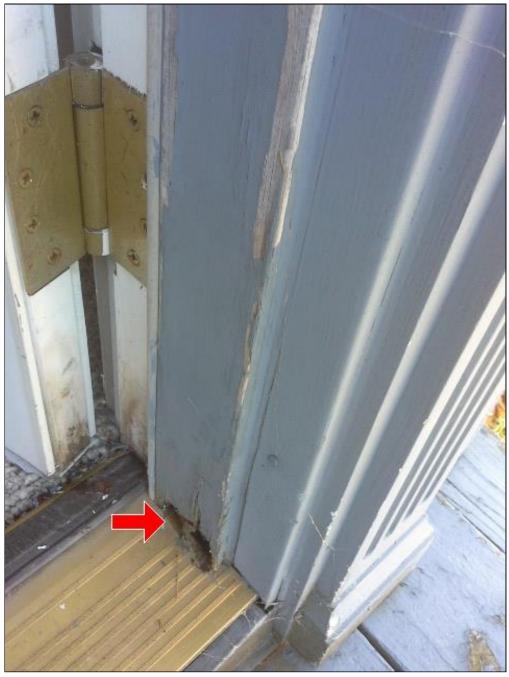
Termite damage noted to exterior wood trim, base of front door.Suggest having all water & termite damage repairs made by a qualified contractor, have him check for any hidden water and insect damage at time of repairs and make all repairs needed.

2.0 Item 1(Picture) Termite damage

Have house treated for termites by a qualified exterminator.

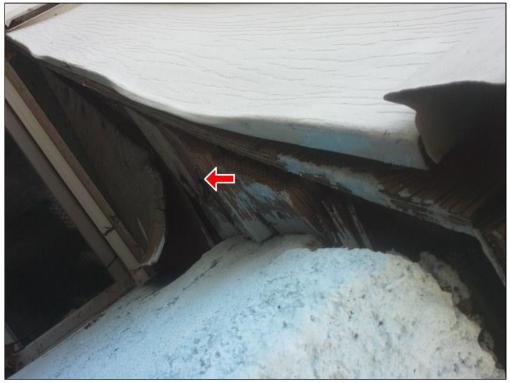
Wood fascia under house by left rear basement window rotted, replacement needed, repairs needed.

2.4 Item 1(Picture) Plywood Rotted

Suggest having all water & termite damage repairs made by a qualified contractor, have him check for any hidden water and insect damage at time of repairs and make all repairs needed.

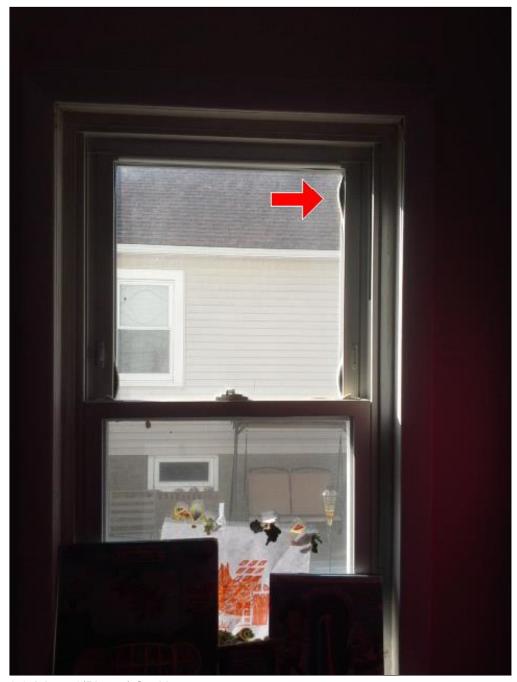
Seal loose in bedroom window across from living room, repairs needed. Suggest further evaluation by a qualified contractor to make all repairs needed.

3.6.A Item 1(Picture) Seal Loose

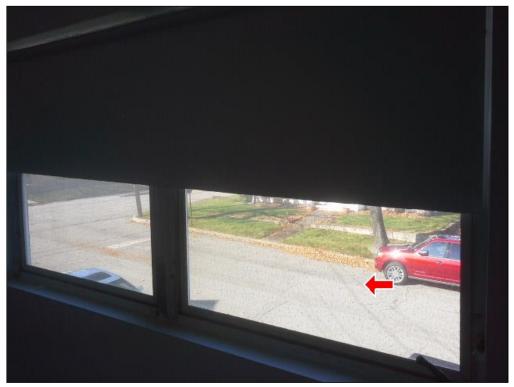
Suggest replacing all single pane to double pane, to increase energy efficiency. Window pane broken in bedroom by living room, repairs needed. Suggest further evaluation by a qualified contractor to make all repairs needed.

3.6.B Item 1(Picture) Single Pane Windows

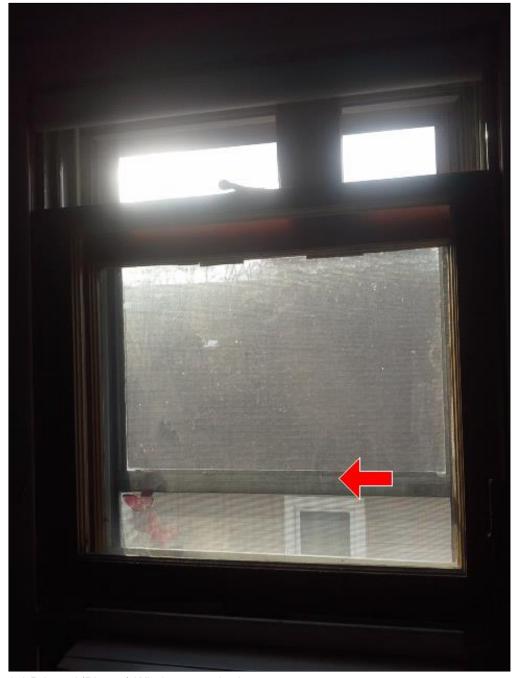
3.6.B Item 2(Picture) Window pane broken

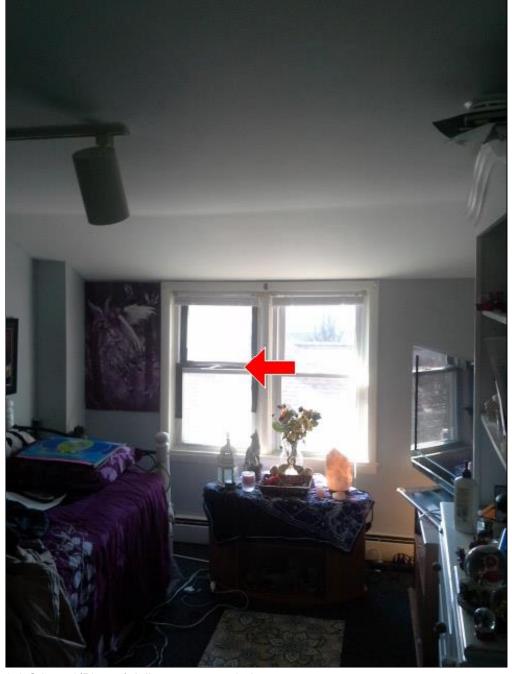
3.6.C Window in bedroom doesn't stay open, adjustments needed. Window pane broken by 3rd floor stairs, repairs needed. Suggest further evaluation by a qualified contractor to make all repairs needed.

3.6.C Item 1(Picture) Adjustments needed

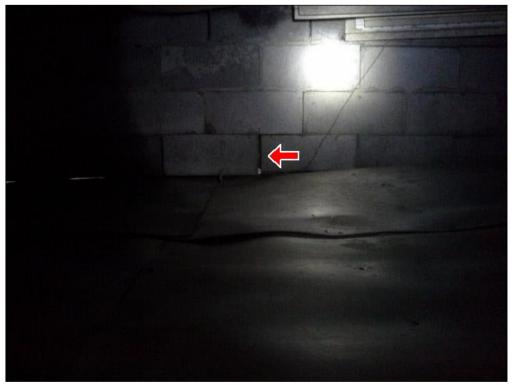
Some cinder blocks for crawl space need re-pointing, void noted in foundation. Suggest further evaluation by a qualified masonry contractor to make all repairs needed.

4.0 Item 1(Picture) Re-Point Block

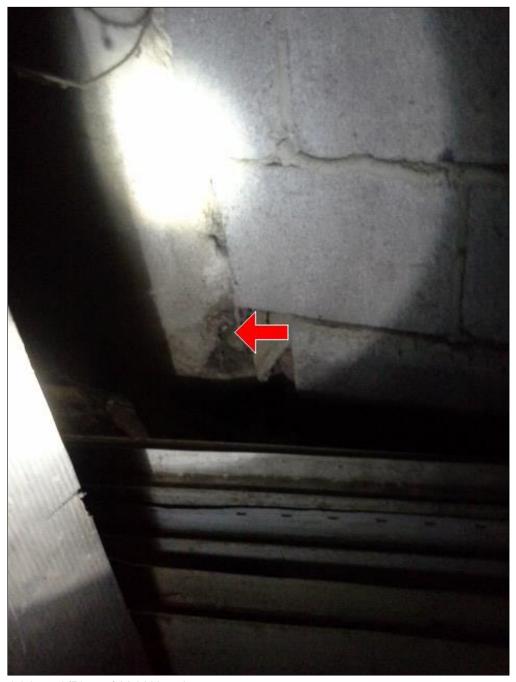
4.0 Item 2(Picture) Void Noted

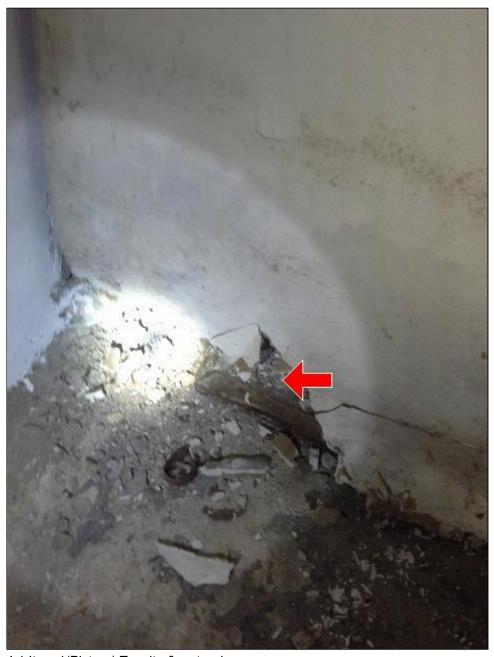
- **4.0** Some cinder blocks for crawl space need re-pointing, void noted in foundation. Suggest further evaluation by a qualified masonry contractor to make all repairs needed.
- 4.1 Water stains noted on sheetrock in basement. Termite damage noted to base of interior wall.

4.1 Item 1(Picture) Termite & water damage

Suggest further evaluation by a qualified water proofing contractor to make all repairs needed to mitigate water.

Suggest having all water & termite damage repairs made by a qualified contractor, have him check for any hidden water and insect damage at time of repairs and make all repairs needed.

Have house treated for termites by a qualified exterminator.

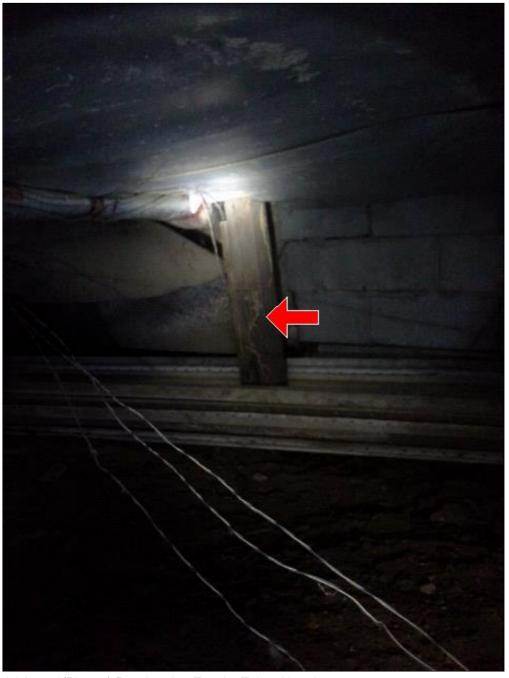
4.2 Wood pier in crawl space leaning not on footing, possible sag issue Termite tubes noted on wood pier.Unable to view floor joist & sill plate in crawl space, sheet metal installed on floor joists. Sheet rock installed on basement ceiling, unable to view sill plates & floor joists.

4.2 Item 1(Picture) Post leaning-Termite Tubes Noted

Suggest having a qualified contractor remove all sheet metal on floor joists in crawl space prior to contingency. To assess any hidden termite damage in crawl space and give a quote to shore up house and repair all hidden termite damage prior to contingency.

Have a qualified exterminator treat house for termites.

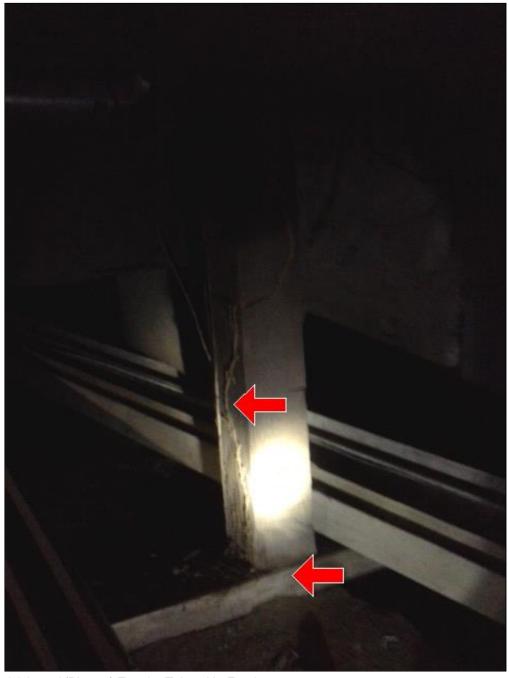
4.2 Item 2(Picture) Termite Tubes-No Footing

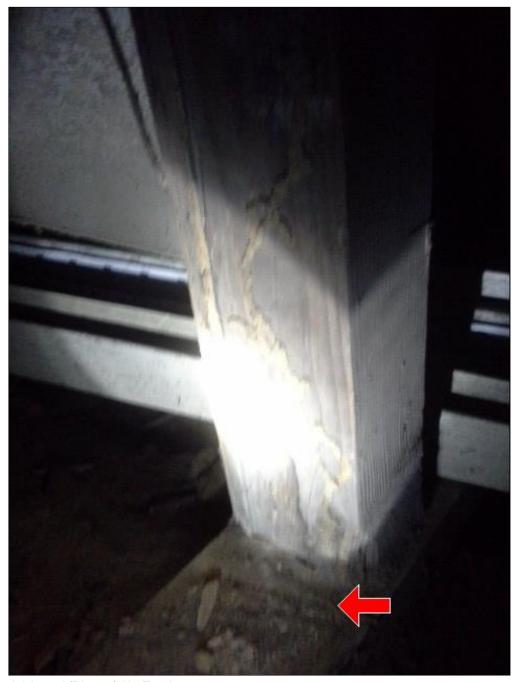
4.2 Item 3(Picture) No Footing

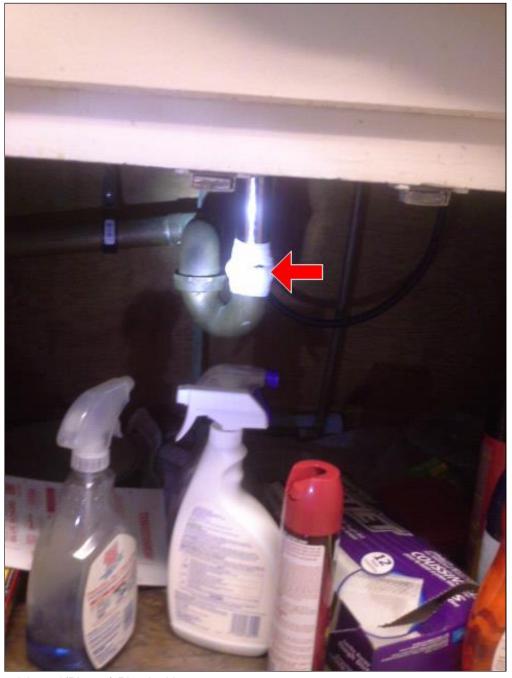
5.0 Leak noted under 3rd floor kitchen sink. Corrosion noted on cast iron waste pipe, not leaking at time of inspection, repairs needed.

5.0 Item 1(Picture) Pipe leaking

Suggest further evaluation by a licensed plumber to make all repairs needed.

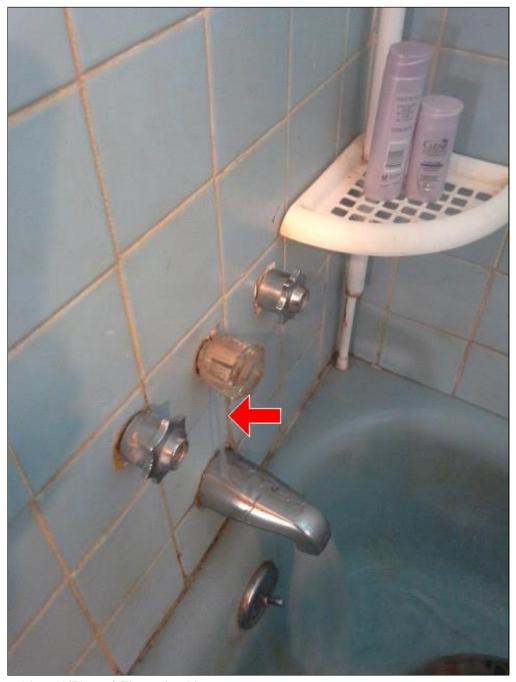
Fixture in bathroom leaking, repairs needed. Suggest further evaluation by a licensed plumber to make all repairs needed.

5.1 Item 1(Picture) Fixture Leaking

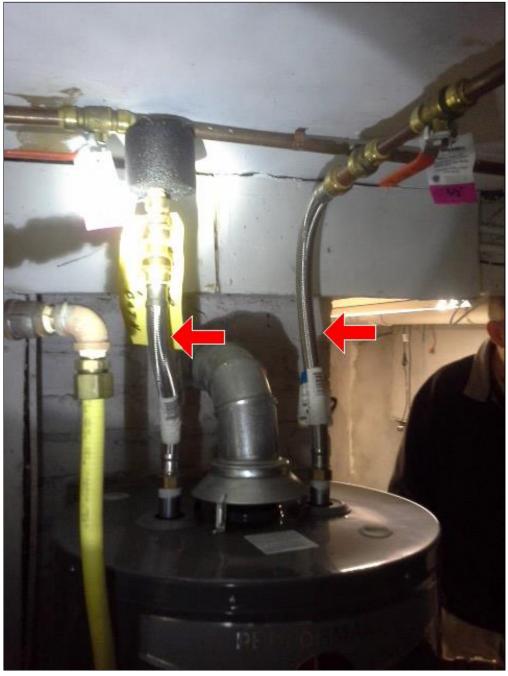
5.2 No bond noted on Rheem, approx 1 year old. AO Smith approx 10 years old, install bond. 30 gallon rheem brand new, install bond. Have a licensed plumber make all repairs needed.

5.2 Item 1(Picture) Install Bond

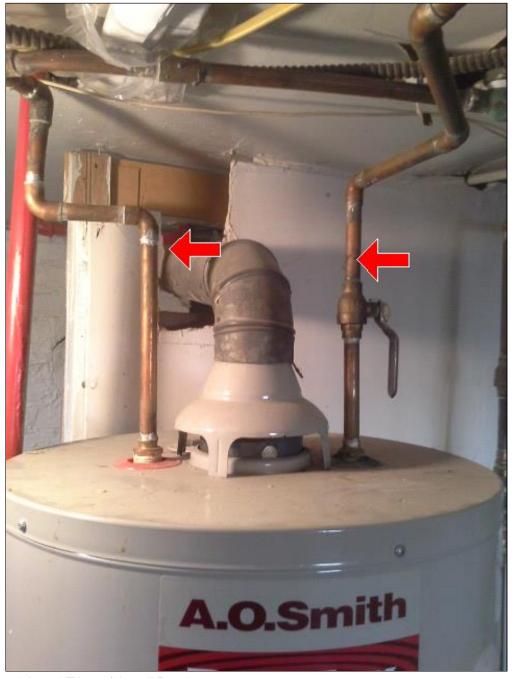
5.2 Item 2(Picture) Install Bond

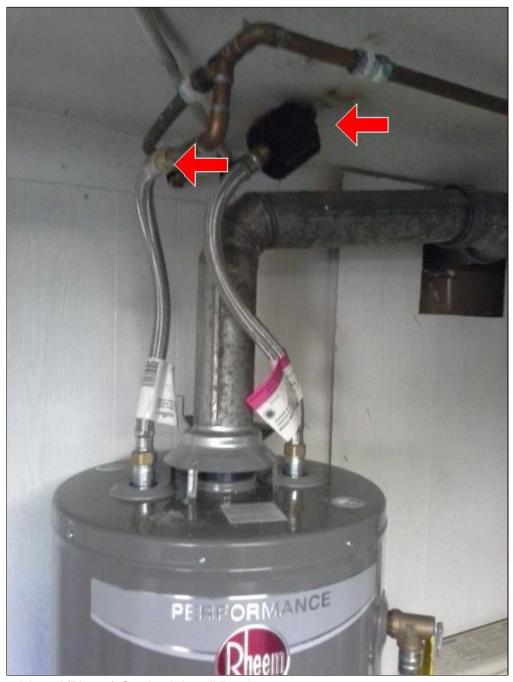
Safety Issue: Gas leak detected on 30 gallon unit. Notified listing agent at time of inspection to inform owner, for PSE&G to make repairs ASAP.

5.2 Item 3(Picture) Gas Leak-Install Bond

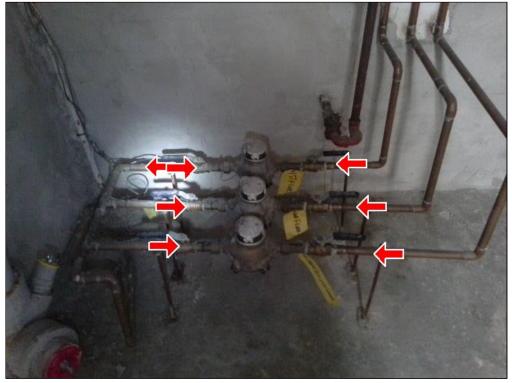
Reattach main ground and install bonds on all 3 meters. Suggest further evaluation by a licensed electrician to make all repairs needed.

5.3 Item 1(Picture) Ground not attached-bonds missing

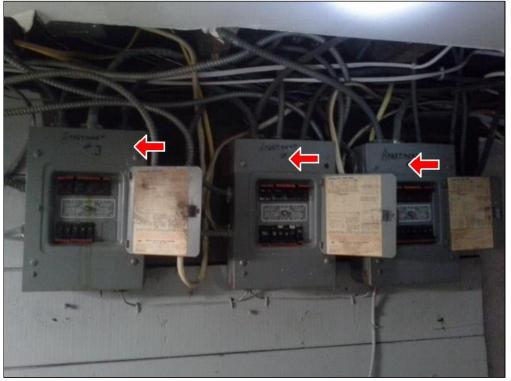
3 Federal Pacific panels in basement need replacing. Suggest upgrading Federal pacific fuse panel to breaker panel. Fire Hazard: Federal Pacific breaker panels have a history of not always tripping due to over current, which can lead to a fire in the panel. Get a quote from a licensed electrician to replace all 3 panels and fuse panel, prior to contingency.

6.1 Item 1(Picture) Federal Pacific

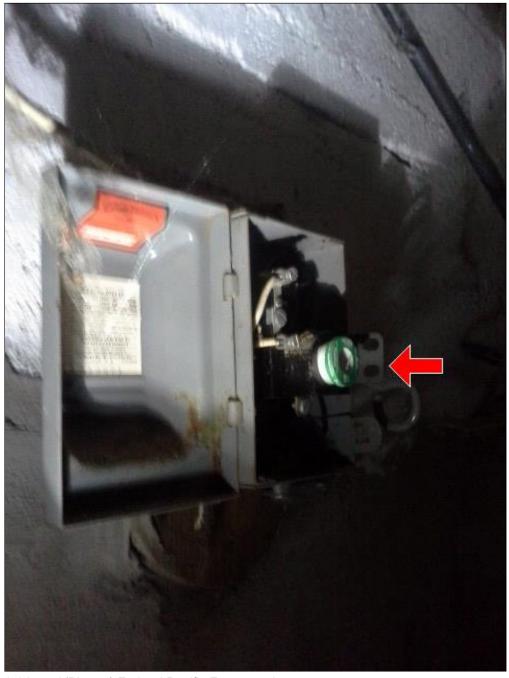
6.1 Item 2(Picture) Federal Pacific Fuse panel

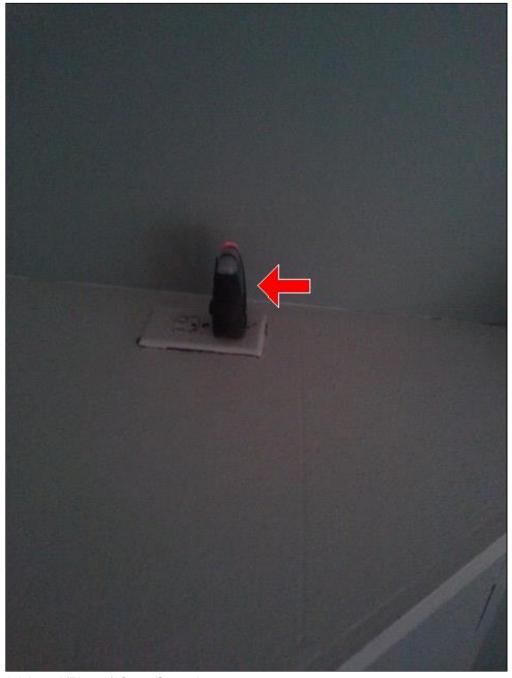
6.3 Item 2(Picture) Open Ground

Suggest further evaluation by a licensed electrician to make all repairs needed.

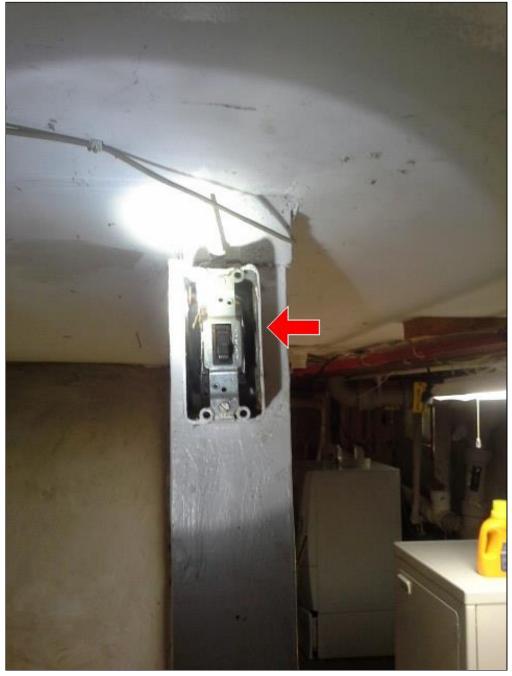
6.3 Item 3(Picture) Replace Cover

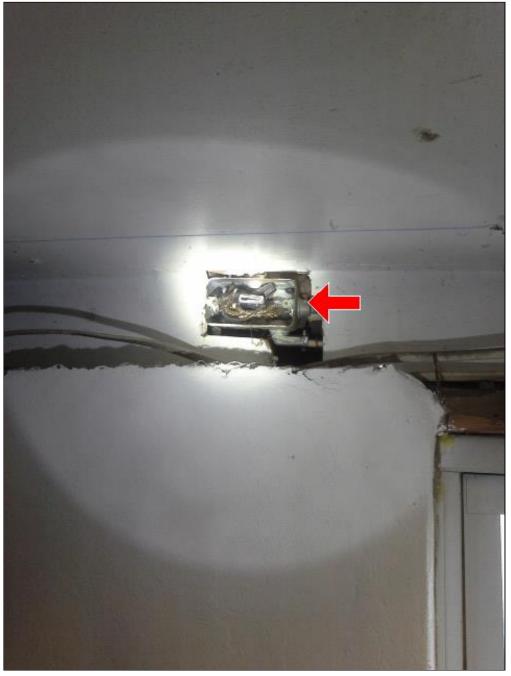
6.3 Item 4(Picture) Replace Cover

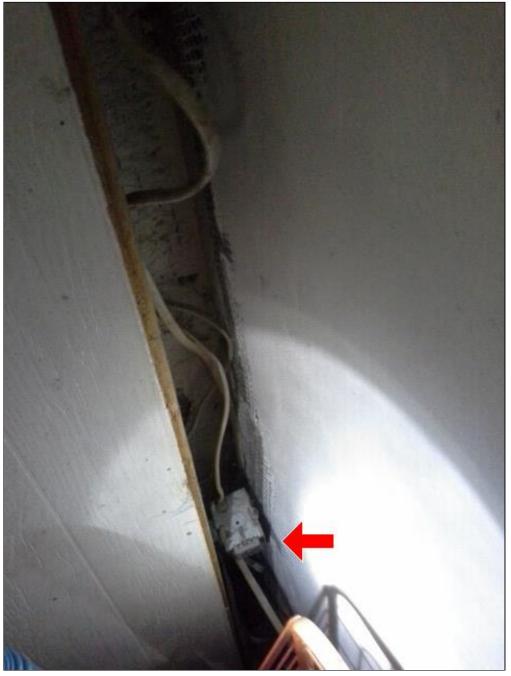
6.3 Item 5(Picture) Replace Cover

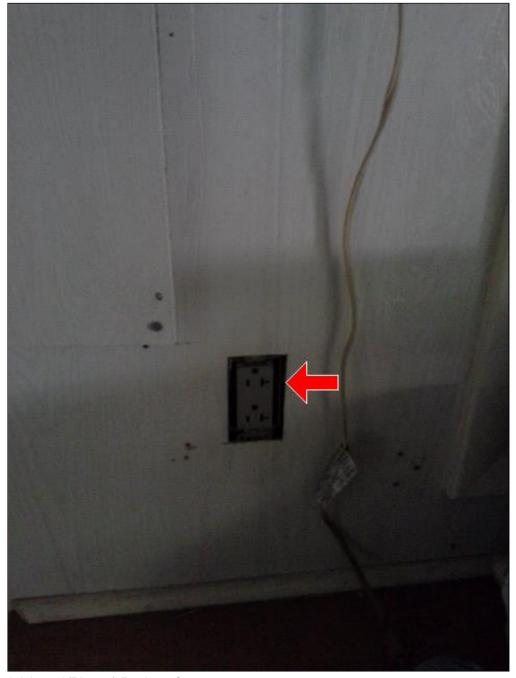
6.3 Item 6(Picture) Replace Cover

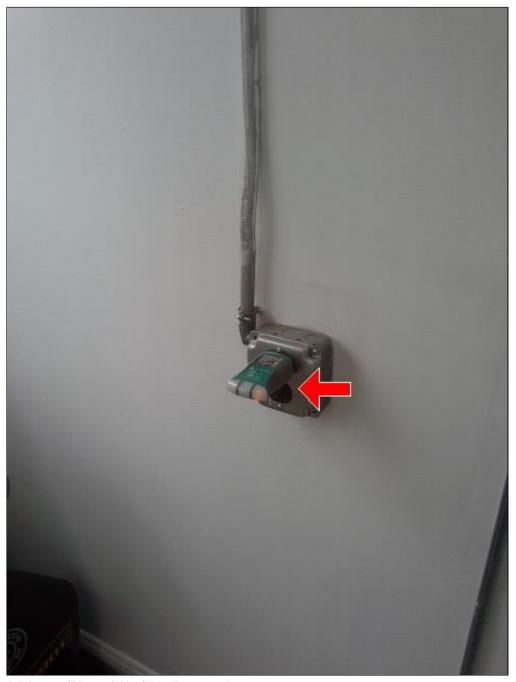
6.3 Item 7(Picture) Hot/Neu Reversed

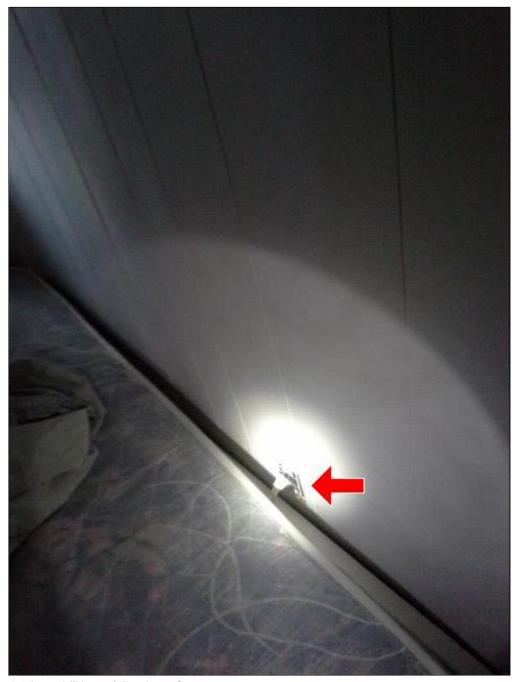
6.3 Item 8(Picture) Replace Cover

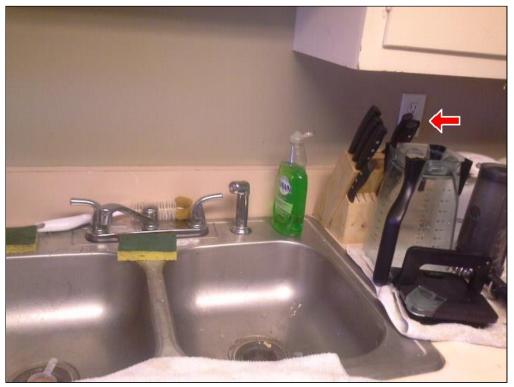
6.4 Item 1(Picture) Kitchen

6.4 Suggest upgrading all outlets within 6 feet of water to GFCI.Hot/Neu reversed in 2nd floor bathroom, repairs needed.

Suggest further evaluation by a licensed electrician to make all repairs needed.
