# Supporting Document 7-1 Before and After Photos for 2022 BMP Treatments in the UCRWG ETF Project Area

Prepared for the Upper Colorado River Watershed Group  
Under CDPHE Grant #2000-3746  
And Fire on the Mountain, Inc. Grant 2022  
December 2022

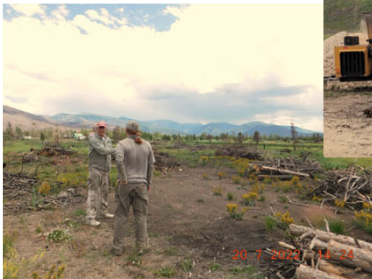
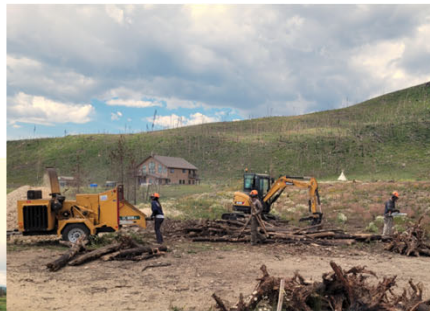
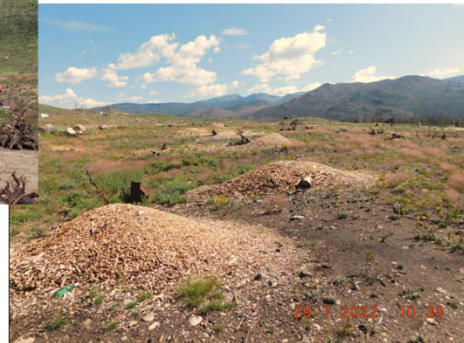
## Before and After Photos of the Aspen Pines Subdivision BMP Treatment Area – NFCR Tributary

UCRWG rented chipper and mini-Excavator for the APE HOA, then helped chip hundreds of logs. The wood chips are being used throughout the HOA for soil stabilization and landscaping. Area benefiting ~10acres.

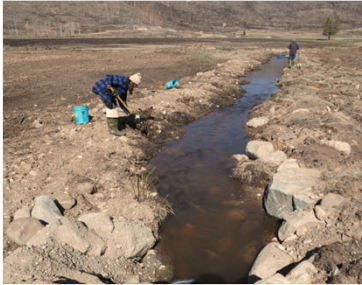
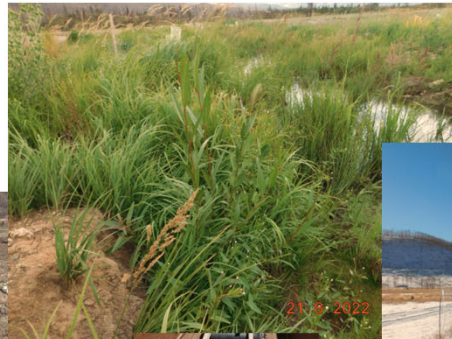
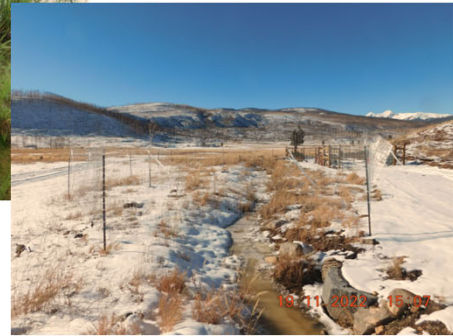
## Before and After Photos of the Mulford Ditch BMP Treatment Area

UCRWG field team planted willow sprigs early in the 2022 season. The willows grow abundantly up to ~18inches high when they were heavily browsed by elk. We then installed a 0.1 acre enclosure and planted cottonwoods.

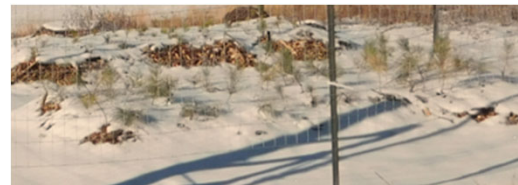
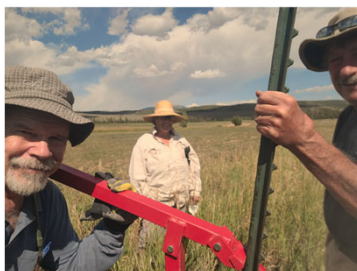
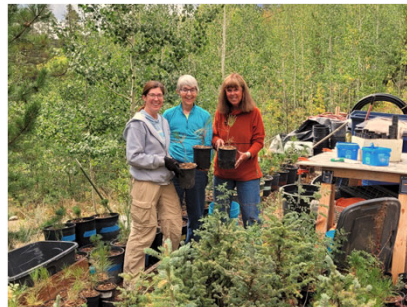
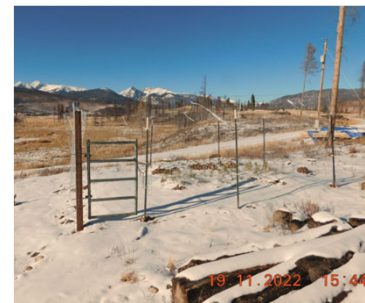
## Before and After Photos of the King Property BMP Treatment Slope above NFCR

UCRWG field team planted conifer seedlings in 1gal pots to prepare for extensive reforestation, we re-used TPosts from an old wildlife fence + new hogwire fencing to create a ~320 ft<sup>2</sup> enclosure. 130 seedlings will ~2.5 acres above NFCR.

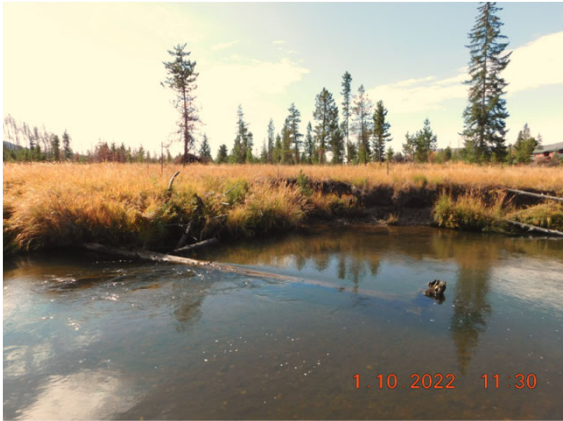
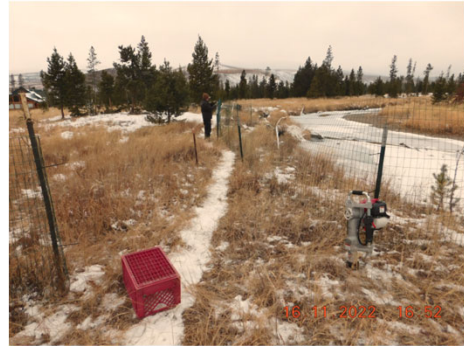
## Before and After Photos of the Kaback Riverbank BMP Treatment

UCRWG field team installed exclusion fencing along ~60ft of NFCR riverbank to promote willow growth, also several smaller enclosures within 30ft of the bank. Area to benefit ~0.1 acres along NFCR.

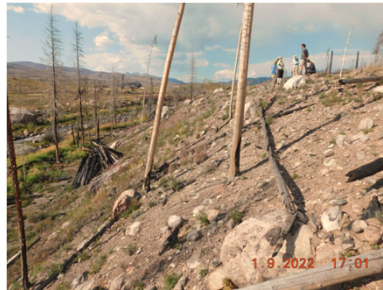
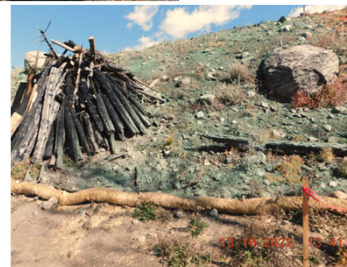
## Before and After Photos of the GLMRD Hydromulching BMP Treatment Site

UCRWG field team worked with hydromulch contractor ECCO LLC to stabilize a steep slope above the NFCR on Grand Lake Metro Recreation District property. Mix included mycellium inoculant from Boulder Mushroom to replace chemicals. t of the bank. Area to benefit ~0.25 acres along NFCR.

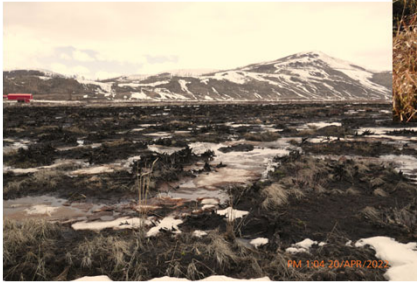
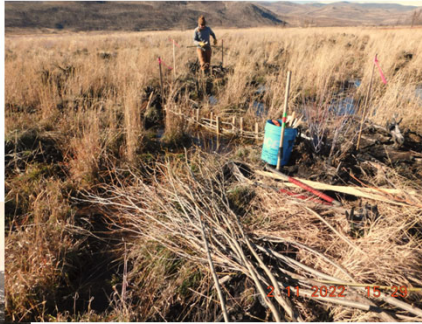
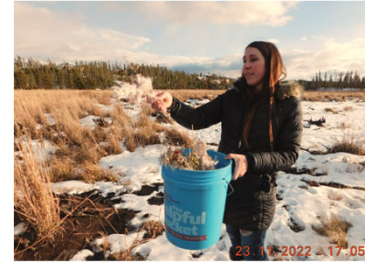
## Before and After Photos of the Best-Keller-Rounds BMP Treatment Area

UCRWG field team installed Zeedyk picket-wicker weirs in a decimated willow area to restore wetland hydrology and willow community on the Best-Rounds-Keller properties, then seeded with hand collected fireweed. Area to benefit ~3 acres in floodplain upstream from Supply Creek.
