Inspection Report

Timely Inspections

1234 Main St, Burke, Va 22015
Inspection prepared for: John Doe
Date of Inspection: 4/2/2022

Report Summary

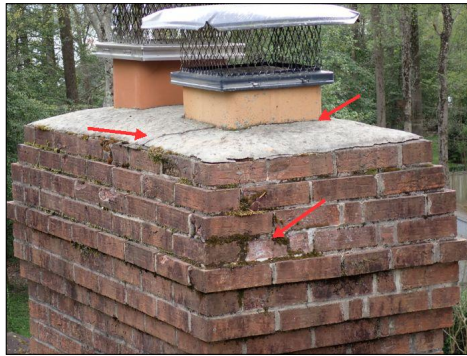
| Page 13 Item: 3 | SKYLIGHTS, CHIMNEYS AND ROOF PENETRATIONS | • Chimney Inspected - Repair / Replace - Both chimneys had cracking in the mortar on top. Have a qualified chimney contractor repair the cracks and clean off the moss around the tops. |

Chimney - Cracked Brick / Mortar

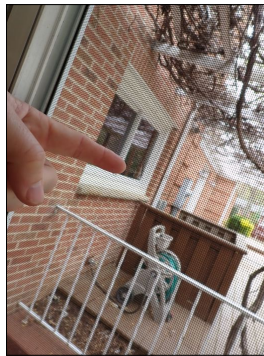
• Inspected - Repair / Replace - One of the window screens in the sun room had a small hole in it. Have a qualified contractor repair or replace the screen.

Damaged Window Screen

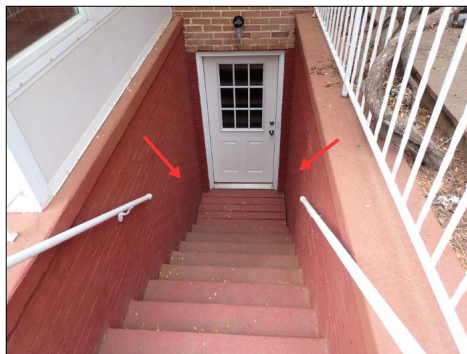
• Inspected - Safety Item - The stairwell on the back of the house has railings that don't go all the way down. This is a fall hazard. Have a qualified contractor add the necessary railings.

Missing Railing

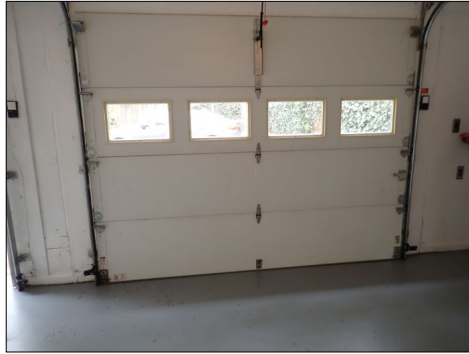
| Page 17 Item: 6 | GARAGE DOOR OPERATORS | <ul style="list-style-type: none"> • The automatic reversal system was tested and does not activate anytime the door encounters excessive resistance. (~3-5 lbs of force) Have a qualified contractor adjust the sensor or replace the opener. |

Garage Door

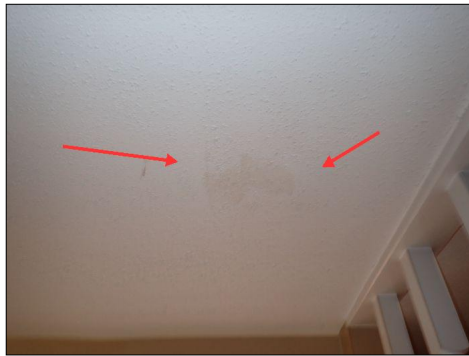
| Page 19 Item: 1 | CEILINGS | <ul style="list-style-type: none"> • Inspected - Repair / Replace - There is some staining on the ceiling in the basement from a previous leak. I tested the area with a moisture meter and it was dry. Have a qualified contractor spot seal the stain and repaint the ceiling. The ceilings in the basement are a textured finish, because of the age of the house it is recommended to have an asbestos test done to the ceiling if you plan to remove them or do any sanding. |

Water Staining

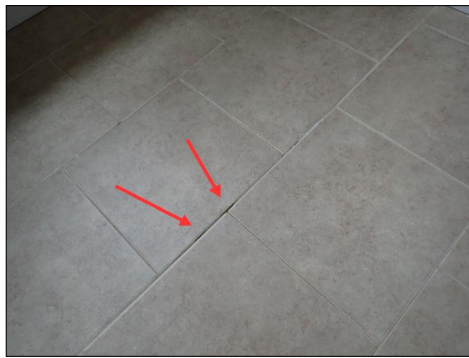
| Page 19 Item: 3 | FLOORS | <ul style="list-style-type: none"> • Inspected - Repair / Replace - There was some missing grout in the upstairs hall bathroom. Replace it to prevent any water leaking into the ceiling below. |

Missing Grout

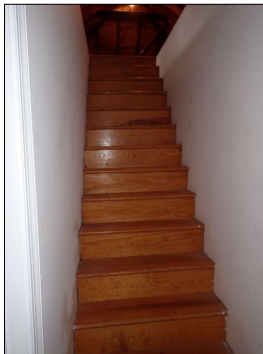
• Inspected - Safety Item - In the stairwell leading up to the attic there are no handrails, also there are no walls or railings around the opening from the top. This is a fall hazard. Have a qualified contractor add the railings and either walls or railings at the top.

Missing Railing

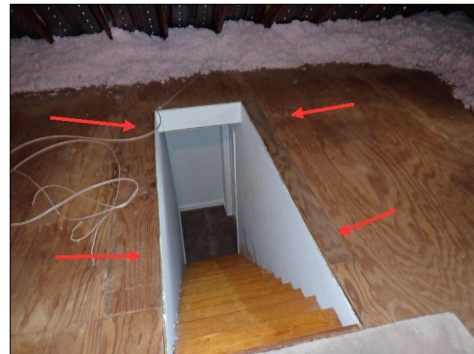
Open Area

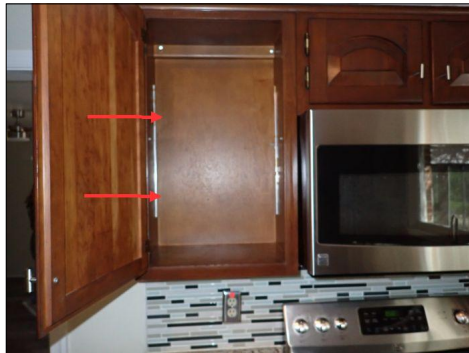
• Inspected - Repair / Replace - The cabinet to the left of the microwave is missing shelves.

Kitchen Cabinet

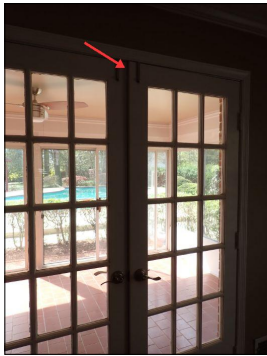
| <p>Page 21 Item: 6</p> | <p>DOORS</p> | <ul style="list-style-type: none"> • Inspected - Repair / Replace - The right door leading out to the sun room sticks, Have a qualified contractor adjust the door so that it closes properly. • Inspected - Repair / Replace - The door in the owner suite sticks at the top. Have a qualified contractor adjust the door so that it works properly. • Inspected - Repair / Replace - The shower door in the owners suite bathroom does not slide very well. It seems to be installed incorrectly. Have a qualified contractor repair or replace the door. |

Door Sticks

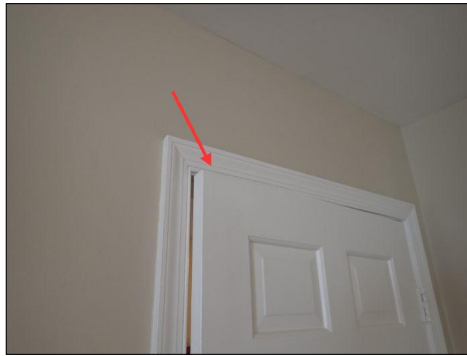
Door Sticks

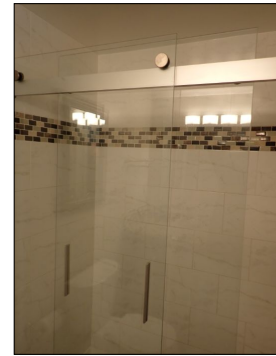
Shower Door

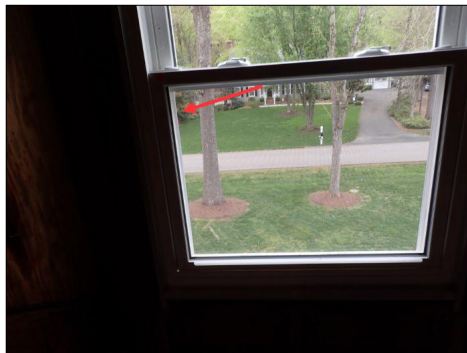
| <p>Page 21 Item: 7</p> | <p>WINDOWS</p> | <ul style="list-style-type: none"> • Inspected - Repair / Replace - The window on the right in the attic has a failed counterbalance. This means that the window will fall back down when opened and will not stay open. Have a qualified window contractor repair or replace the window. |

Failed Counterbalance -

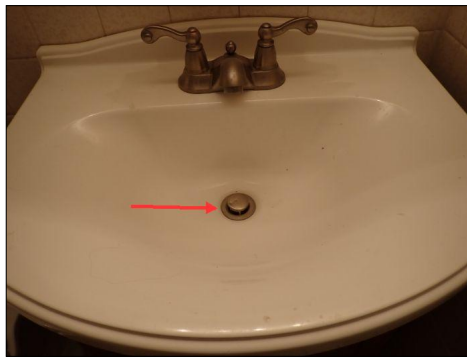
| <p>Page 23 Item: 1</p> | <p>PLUMBING DRAIN, WASTE AND VENT SYSTEMS</p> | <ul style="list-style-type: none"> • Inspected - Repair / Replace -The sink drain stopper in the basement bathroom is broken. Have a qualified contractor repair or replace the stopper. |

Bathroom Sink Drain

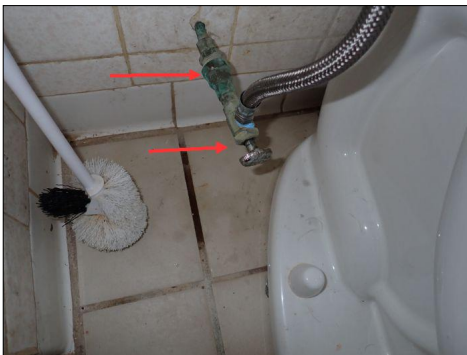
- Inspected - Repair / Replace - The shut off valve for the toilet in the basement bathroom leaked when I turned it off. Have a qualified plumber replace the valve.
- Inspected - Repair / Replace - There is evidence of a previous leak under the bar sink. Have a qualified plumber check the faucet and bar sink drain and replace what is needed.

Toilet Supply Valve

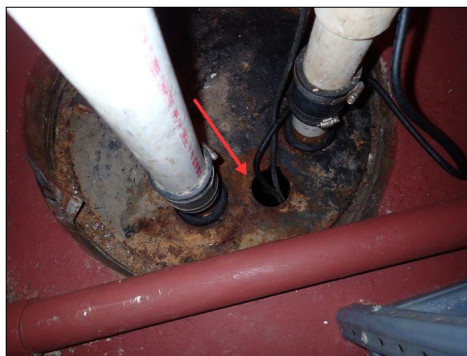
- Inspected - Repair / Replace - The ejection pump is not sealed. Have a qualified contractor seal the hole in the ejection pump area.

Ejection Pump

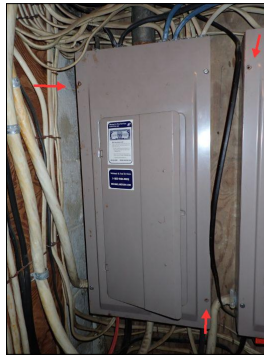
- Inspected - Safety Item - Both Panel covers were missing screws. Have a qualified contractor replace the screws with flat-backed panel screws.

Main Electrical Panel

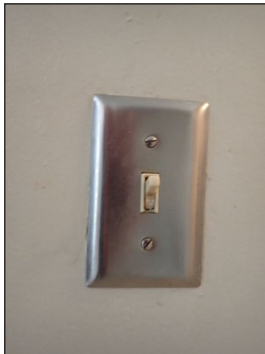
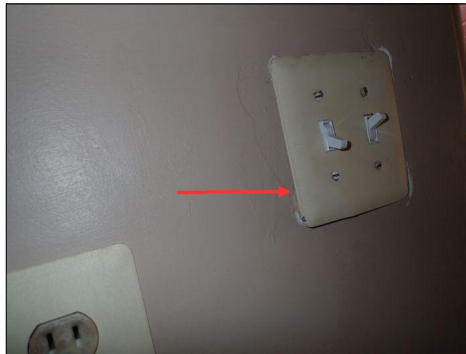
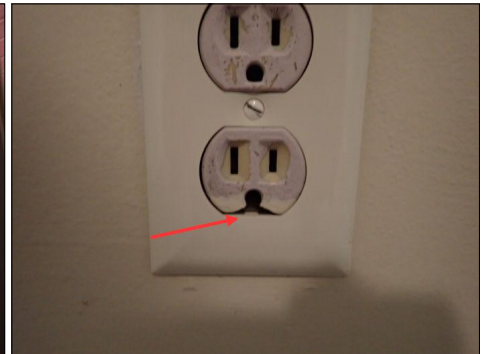
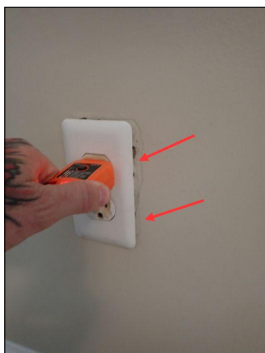
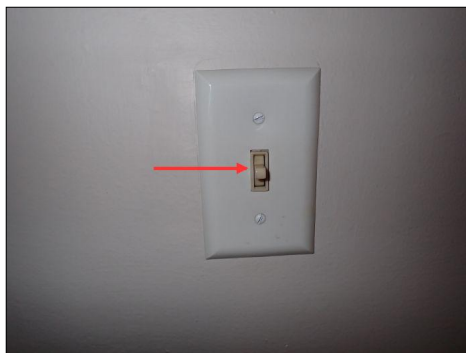
- Inspected - Repair / Replace - There are some broken/loose switches and outlets throughout the house. Have a qualified electrician replace all damaged switches and outlets.
- Inspected - Safety Item -There is open electrical in the attic by the fan, in the basement near the sump pump, and in the basement near the ejector pump. Have a qualified electrician make repairs as needed to make it safe.
- Inspected - Safety Item -There are missing **GFCI** outlets in the kitchen, main level bathroom, basement bar area, basement kitchen area, both sump pumps, the ejector pump, garage, and the exterior outlets. Any area that is around water needs to have GFCI outlets. Have a qualified electrician add all necessary GFCI outlets.

Loose Switch

Light Switch Cover

Cracked Outlet

Loose Outlet

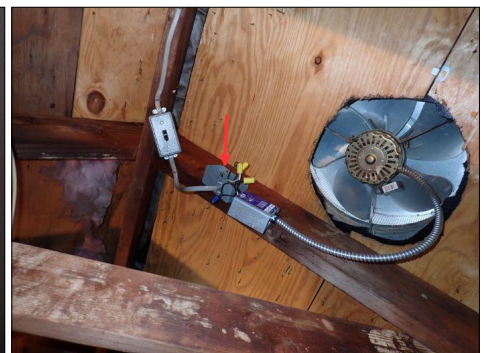
Open Electrical - Attic

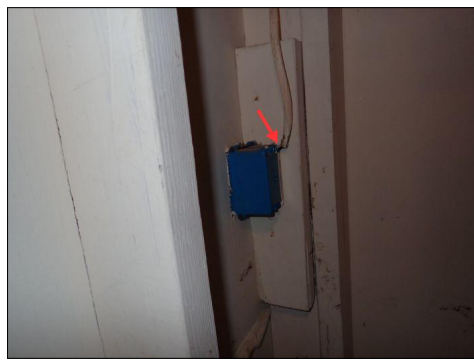
Open Electrical - Basement

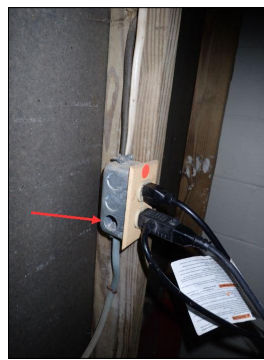
Open Electrical - Basement

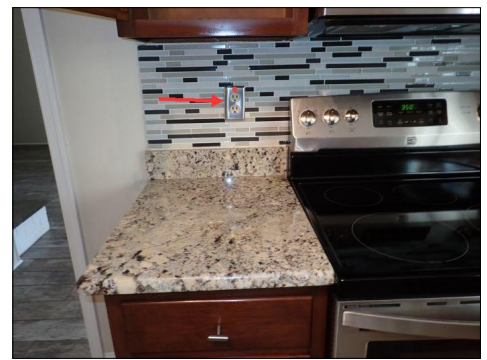
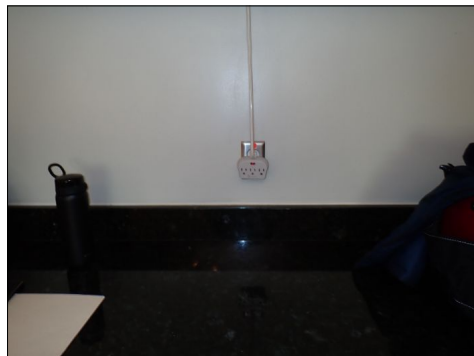
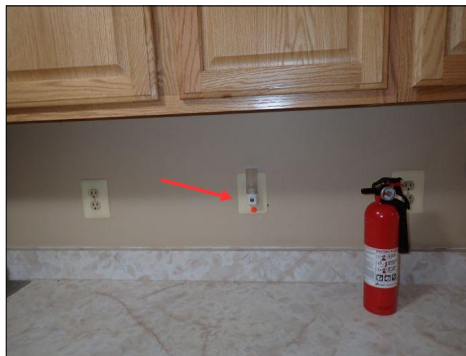
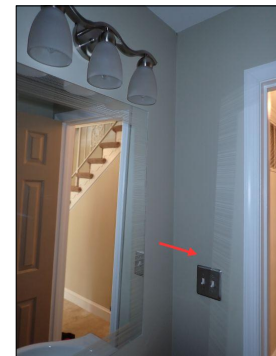
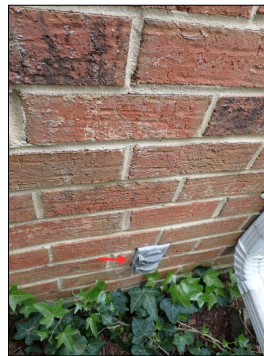
Missing GFCI Outlet

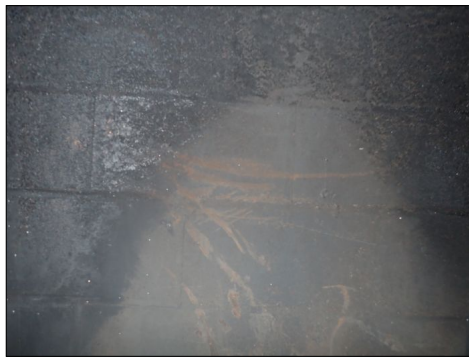
- Inspected - Repair / Replace - The fireplace needs to be cleaned before use. Have a qualified chimney contractor clean the chimney before use.

Fireplace

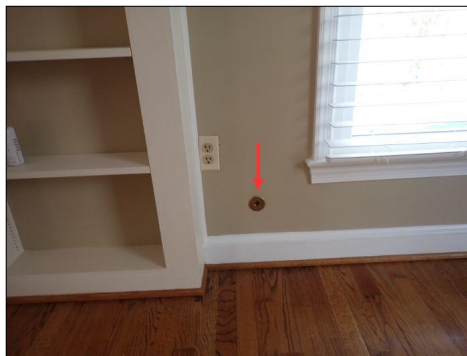
• Inspected - Repair / Replace - Ask the sellers if they have the Dante Valve Key. It was not there at the time of the inspection.

Missing Dante Valve Key

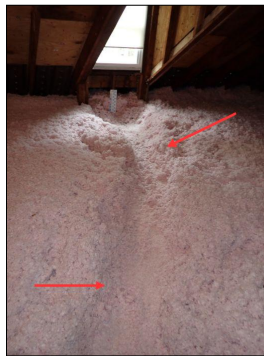
• Inspected - Repair / Replace - The insulation in some areas is trampled down from when they replaced the window. It was also missing by the hvac unit. Have a qualified insulation contractor replace where needed.

Missing Attic Insulation

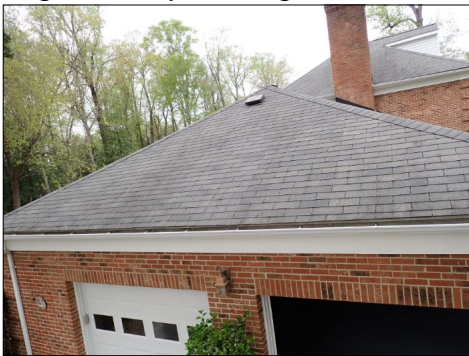
- Inspected- The roof was installed in 2010 so it is roughly 13 years old. It appears to be a 20-25 year shingle and is in good shape. The plywood was also changed with the roof so there were no signs of any leaking in the attic.

Asphalt Shingles

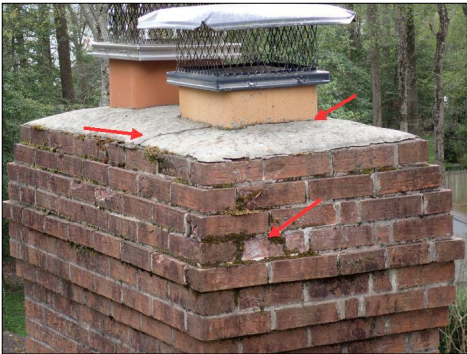
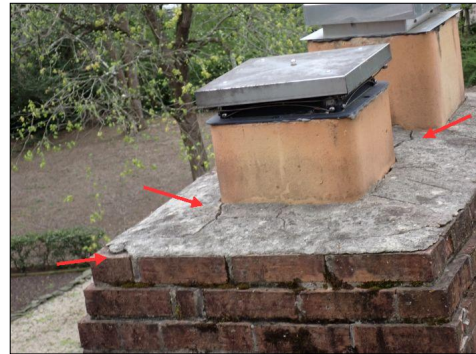
• Chimney Inspected - Repair / Replace - Both chimneys had cracking in the mortar on top. Have a qualified chimney contractor repair the cracks and clean off the moss around the tops.

Chimney - Cracked Brick / Mortar

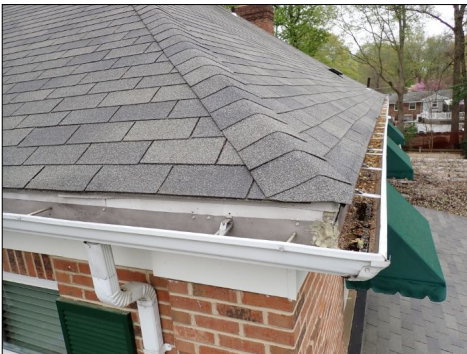
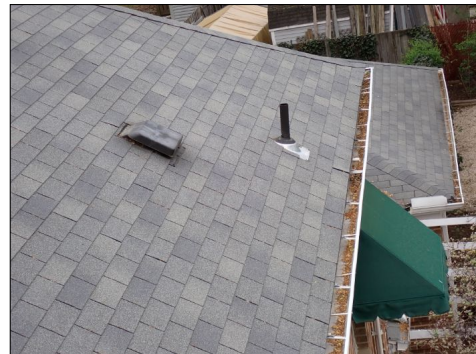
• Inspected- There was some debris in the gutters, but they were not clogged. Make sure to have them cleaned occasionally to prevent clogging.

Gutters

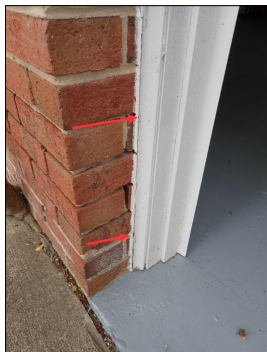
• **Maintenance Item - Check the caulking and paint on all the outside trim yearly to make sure the wood does not rot.**

Wood Trim

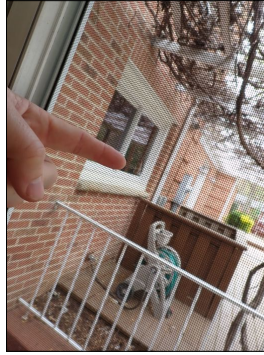
• **Inspected - Repair / Replace - One of the window screens in the sun room had a small hole in it. Have a qualified contractor repair or replace the screen.**

Damaged Window Screen

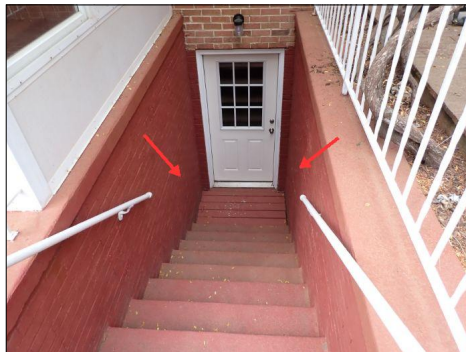
- Not Inspected- The pool was not inspected, I would recommend having a pool company do an inspection before use.
- Inspected - Safety Item - The stairwell on the back of the house has railings that don't go all the way down. This is a fall hazard. Have a qualified contractor add the necessary railings.

Missing Railing

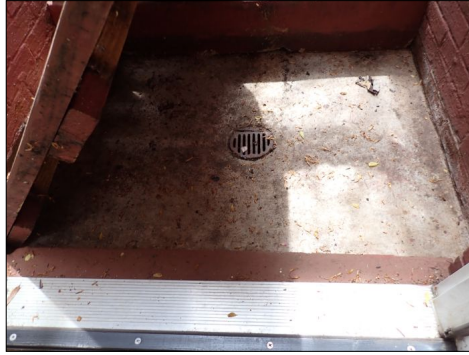
- Maintenance Item - There is a drain at the bottom of the stairway by the back door underneath some removable wood decking. Check the drain occasionally to make sure it is free of debris.

Stairwell Drain

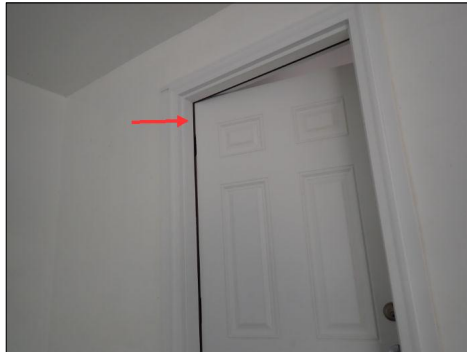
- Inspected- I recommend installing self-closing hinges on the door going from the garage into the home. There is a chance of carbon monoxide gases entering the home if the door is not closed.

Garage to Home Door

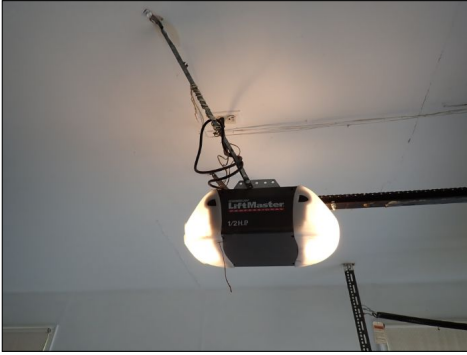
• The automatic reversal system was tested and does not activate anytime the door encounters excessive resistance. (~3-5 lbs of force) Have a qualified contractor adjust the sensor or replace the opener.

Garage Door Opener

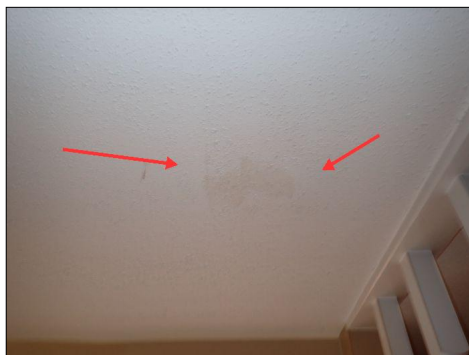
- Inspected - Repair / Replace - There is some staining on the ceiling in the basement from a previous leak. I tested the area with a moisture meter and it was dry. Have a qualified contractor spot seal the stain and repaint the ceiling. The ceilings in the basement are a textured finish, because of the age of the house it is recommended to have an asbestos test done to the ceiling if you plan to remove them or do any sanding.

Water Staining

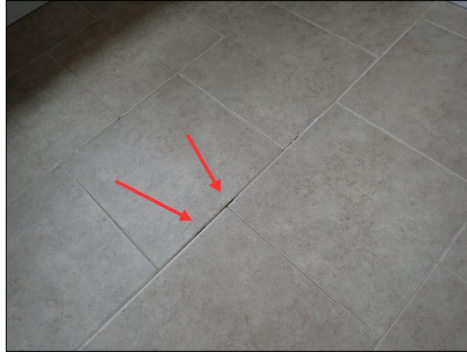
- Inspected
- Inspected - Repair / Replace - There was some missing grout in the upstairs hall bathroom. Replace it to prevent any water leaking into the ceiling below.

Missing Grout

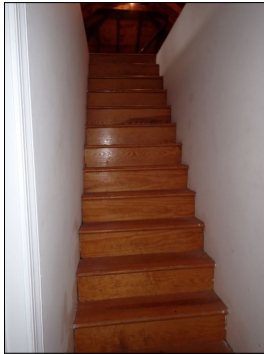
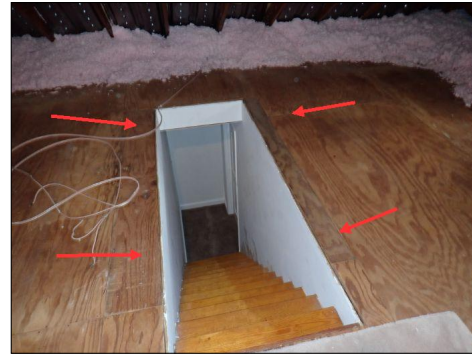
- Inspected - Safety Item - In the stairwell leading up to the attic there are no handrails, also there are no walls or railings around the opening from the top. This is a fall hazard. Have a qualified contractor add the railings and either walls or railings at the top.

Missing Railing

Open Area

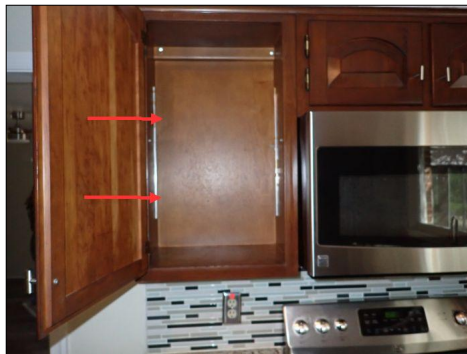
- Inspected - Repair / Replace - The cabinet to the left of the microwave is missing shelves.

Kitchen Cabinet

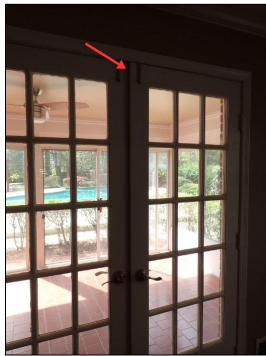
- Inspected - Repair / Replace - The right door leading out to the sun room sticks, Have a qualified contractor adjust the door so that it closes properly.
- Inspected - Repair / Replace - The door in the owner suite sticks at the top. Have a qualified contractor adjust the door so that it works properly.
- Inspected - Repair / Replace - The shower door in the owners suite bathroom does not slide very well. It seems to be installed incorrectly. Have a qualified contractor repair or replace the door.

Door Sticks

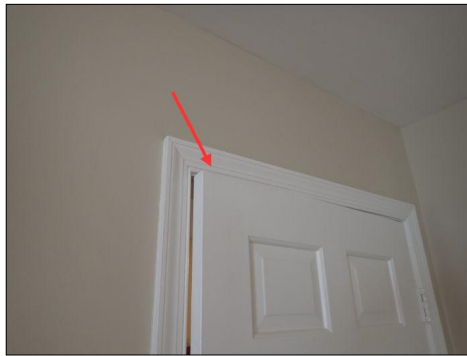
Door Sticks

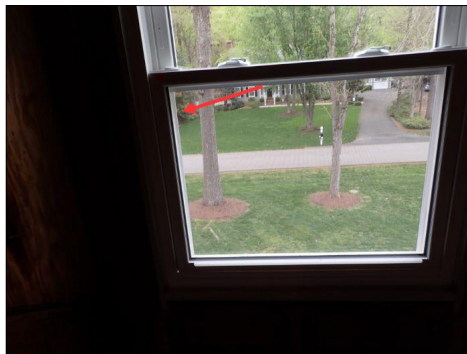
- Inspected - Repair / Replace - The window on the right in the attic has a failed counterbalance. This means that the window will fall back down when opened and will not stay open. Have a qualified window contractor repair or replace the window.

Failed Counterbalance -

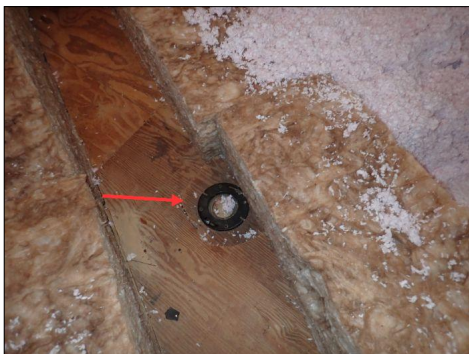
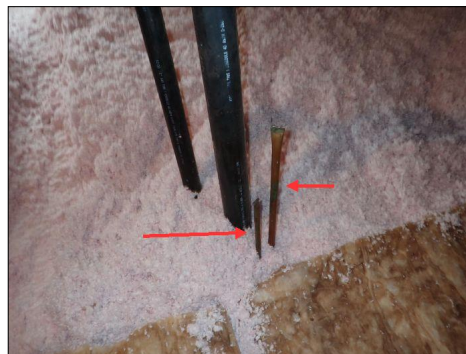
- Inspected- There are plumbing rough ins in the attic, so it can be remodeled in to another room in the future.

Toilet Rough In

Plumbing Rough In

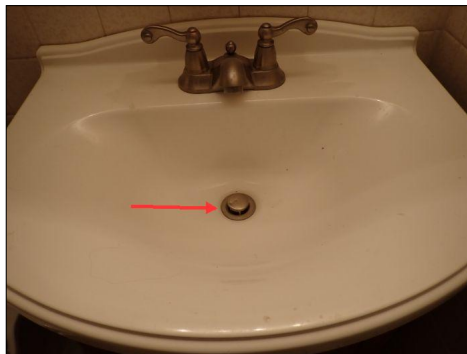
- Inspected - Repair / Replace -The sink drain stopper in the basement bathroom is broken. Have a qualified contractor repair or replace the stopper.

Bathroom Sink Drain

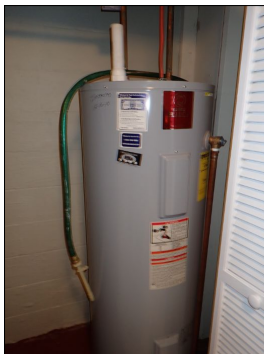
- Budget for Replacement - The water heater is 12-13 years old, it was working properly at the time of the inspection but it is a good idea to budget for a new one.

Electric Water Heater

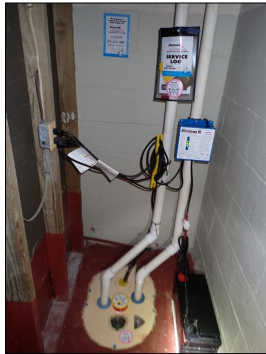
- Inspected - Repair / Replace - The ejection pump is not sealed. Have a qualified contractor seal the hole in the ejection pump area.

Sump Pump

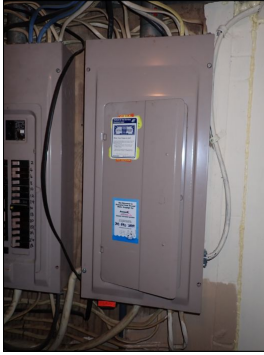
- Inspected- The panels look good and were labeled. You may want to check that the labels are correct.
- Inspected - Safety Item - Both Panel covers were missing screws. Have a qualified contractor replace the screws with flat-backed panel screws.

Main Electrical Panel

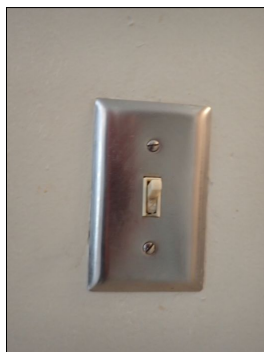
- Inspected- There are two switchable outlets in the front family room because there are no overhead lights. They are both on the wall opposite of the gas fireplace.
- Inspected - Repair / Replace - There are some broken/loose switches and outlets throughout the house. Have a qualified electrician replace all damaged switches and outlets.
- Inspected - Safety Item -There is open electrical in the attic by the fan, in the basement near the sump pump, and in the basement near the ejector pump. Have a qualified electrician make repairs as needed to make it safe.
- Inspected - Safety Item -There are missing **GFCI** outlets in the kitchen, main level bathroom, basement bar area, basement kitchen area, both sump pumps, the ejector pump, garage, and the exterior outlets. Any area that is around water needs to have GFCI outlets. Have a qualified electrician add all necessary GFCI outlets.

Loose Switch

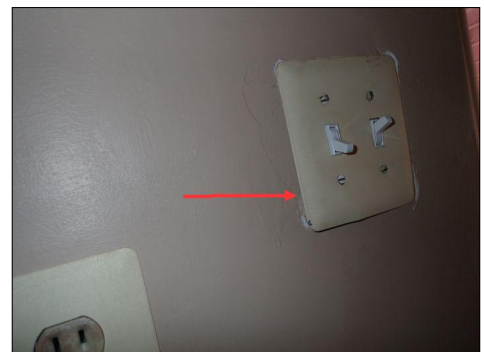
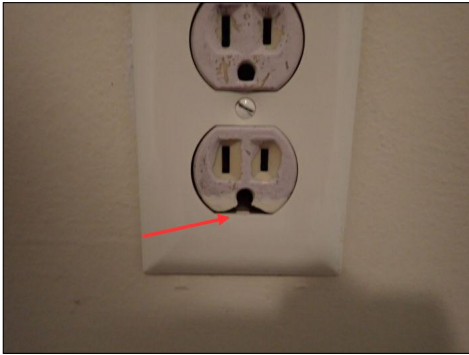
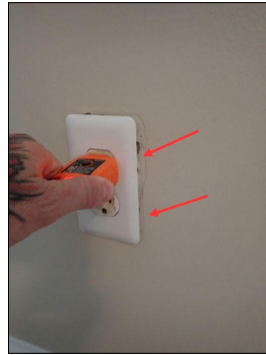
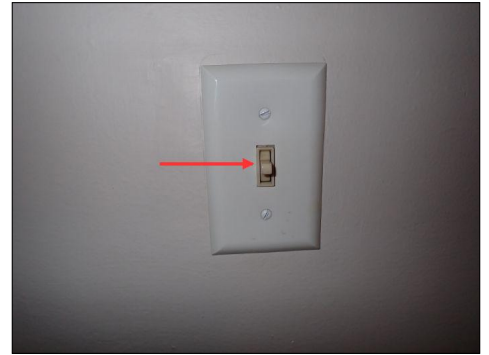
Light Switch Cover

Cracked Outlet

Loose Outlet

Loose Switch

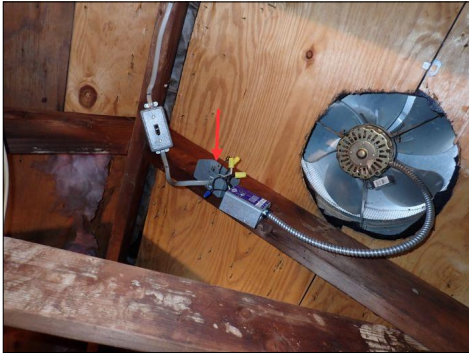
Open Electrical - Attic

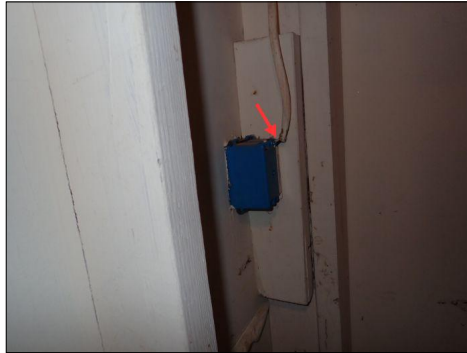
Open Electrical - Basement

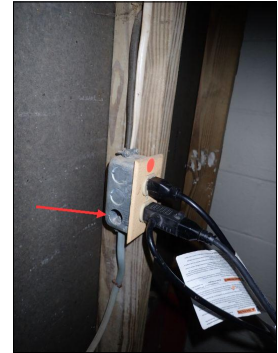
Open Electrical - Basement

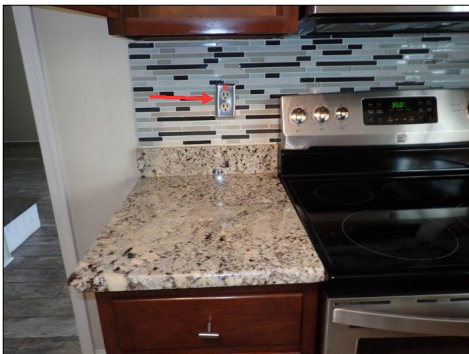
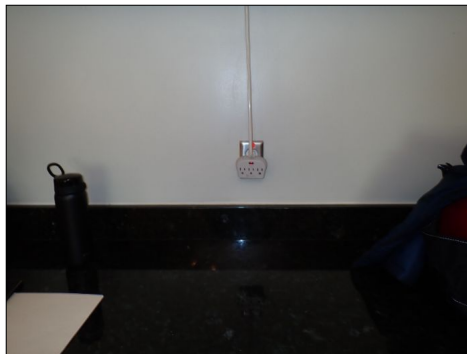
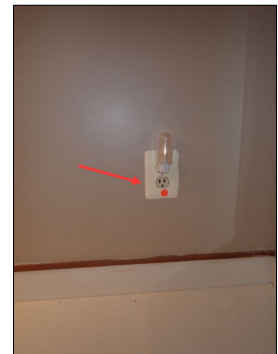
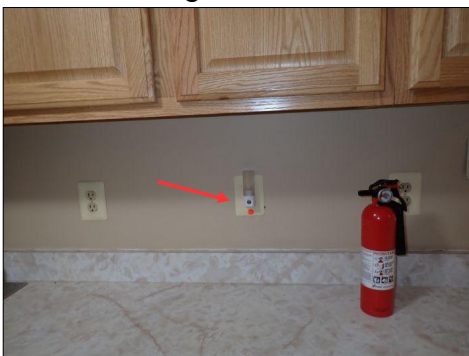
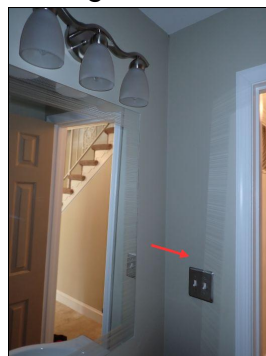
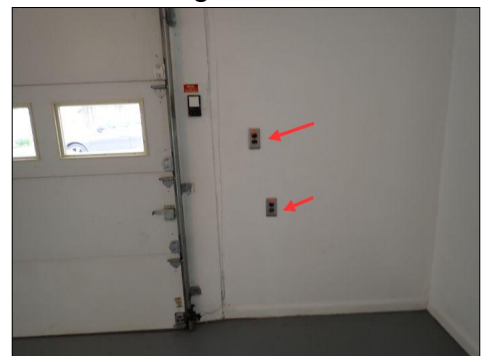
Missing GFCI Outlet

Missing GFCI Outlets

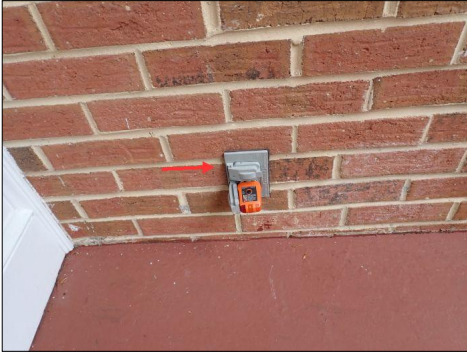
Missing GFCI Outlet

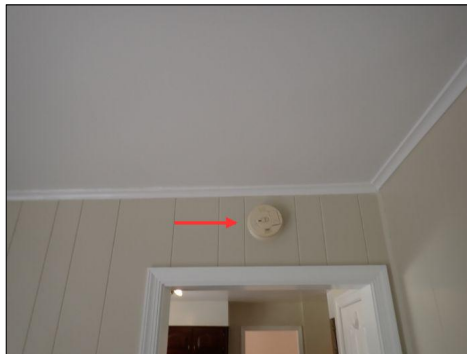
- **Recommended Upgrade** - Older smoke detectors were observed in the home. I recommend installing new smoke detectors in all bedrooms and hallways to ensure safe notification in the event of a fire.

Old Smoke Detectors

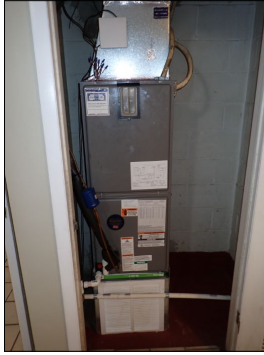
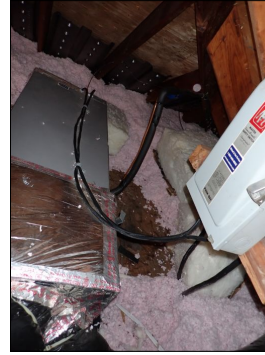
- The System heat, which was measured with thermometers on a 2 degree rise at thermostat from room temperature was 98 degrees under normal heat pump operations. The auxiliary heat function engaged when a 3 degree or greater heating call was made at the thermostat. The heat measured 137 degrees. All the heat strips responded. These results indicate the unit is operating in normal ranges.

Heat Pump

Heat Pump - Unit #2

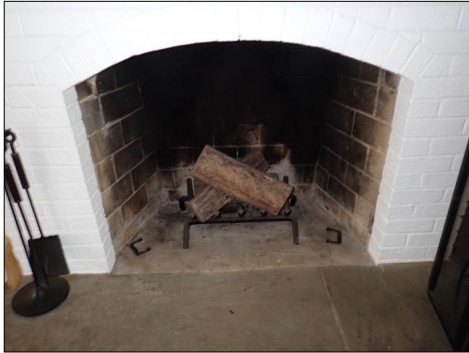
- **Inspected - Repair / Replace** - The fireplace needs to be cleaned before use. Have a qualified chimney contractor clean the chimney before use.

Fireplace

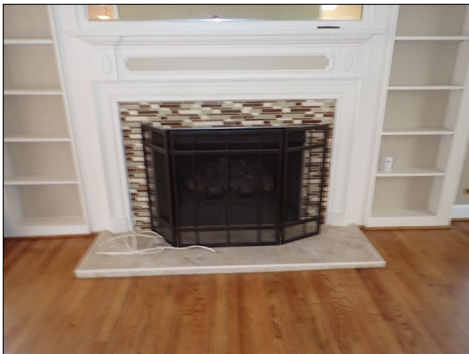
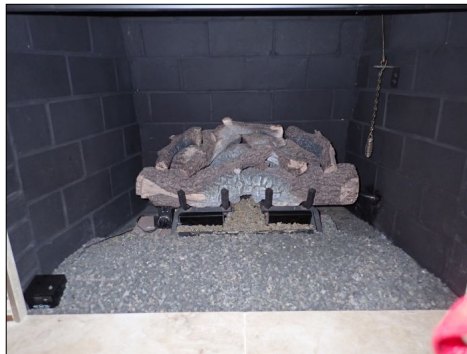
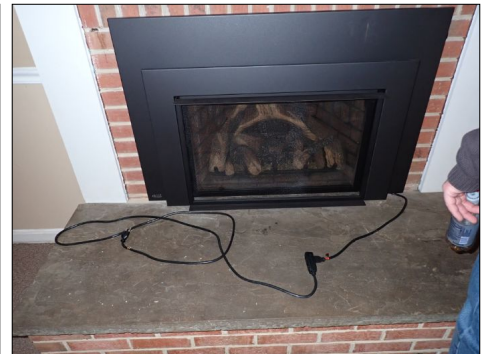
- **Inspected - Repair / Replace** - Ask the sellers if they have the Dante Valve Key. It was not there at the time of the inspection.

Gas Fireplace

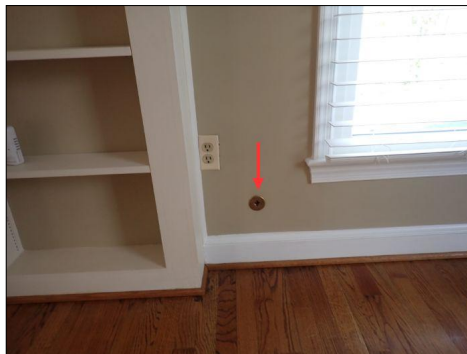
Missing Dante Valve Key

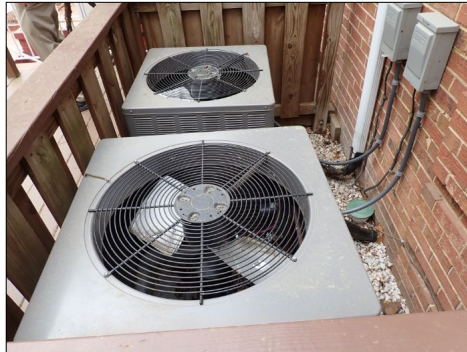
- Not Inspected- The temperature was too cold to run the air conditioning, but the heat pump was working so that means the fans turn.

A/C Units

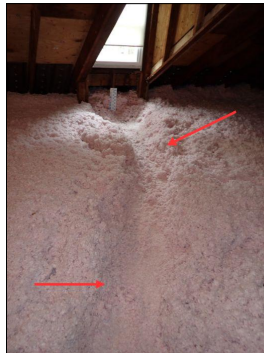
- Inspected - Repair / Replace - The insulation in some areas is trampled down from when they replaced the window. It was also missing by the hvac unit. Have a qualified insulation contractor replace where needed.

Missing Attic Insulation

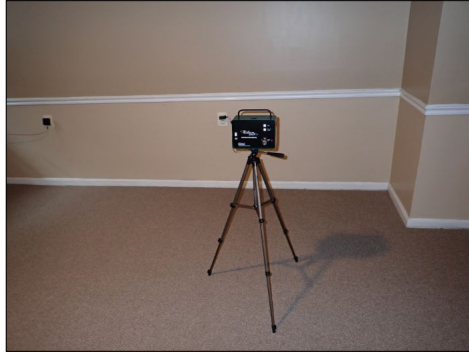
Active Radon Test

- https://www.epa.gov/sites/production/files/2016-02/documents/2012_a_citizens_guide_to_radon.pdf
