# Attic Ventilation and Moisture Research Study

FINAL REPORT | JUNE 2014

Homeowner  
Protection Office  
Branch of BC Housing

MORRISON HERSHFIELD

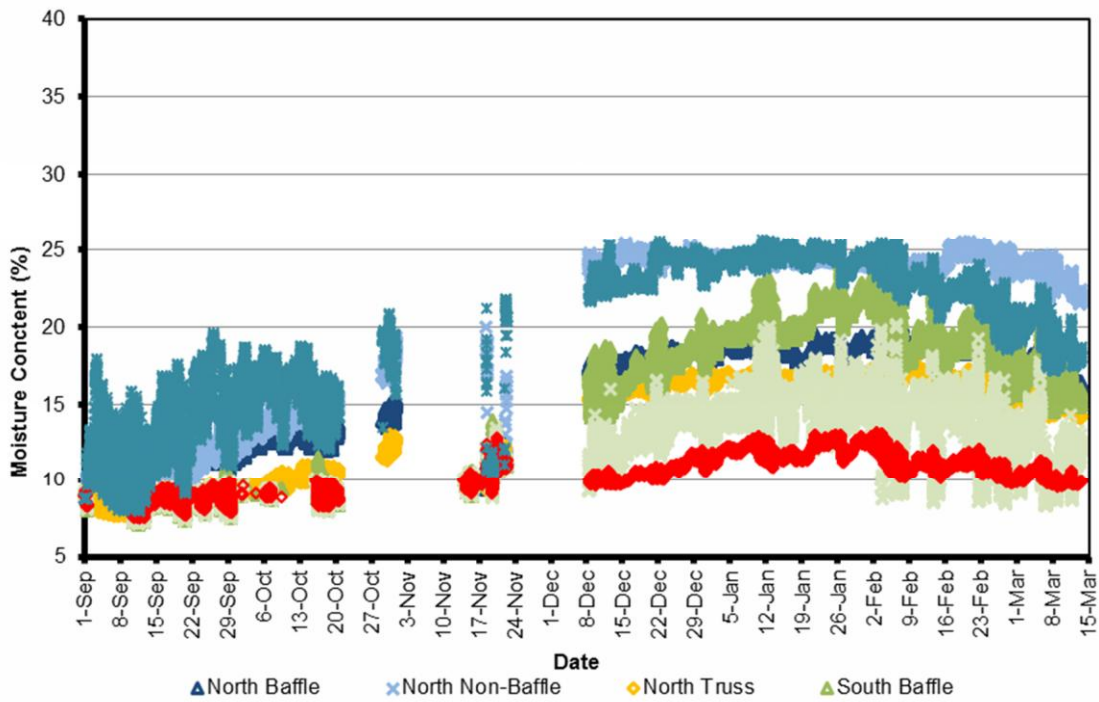
Figure B.31: Unit 4 long term wood moisture content

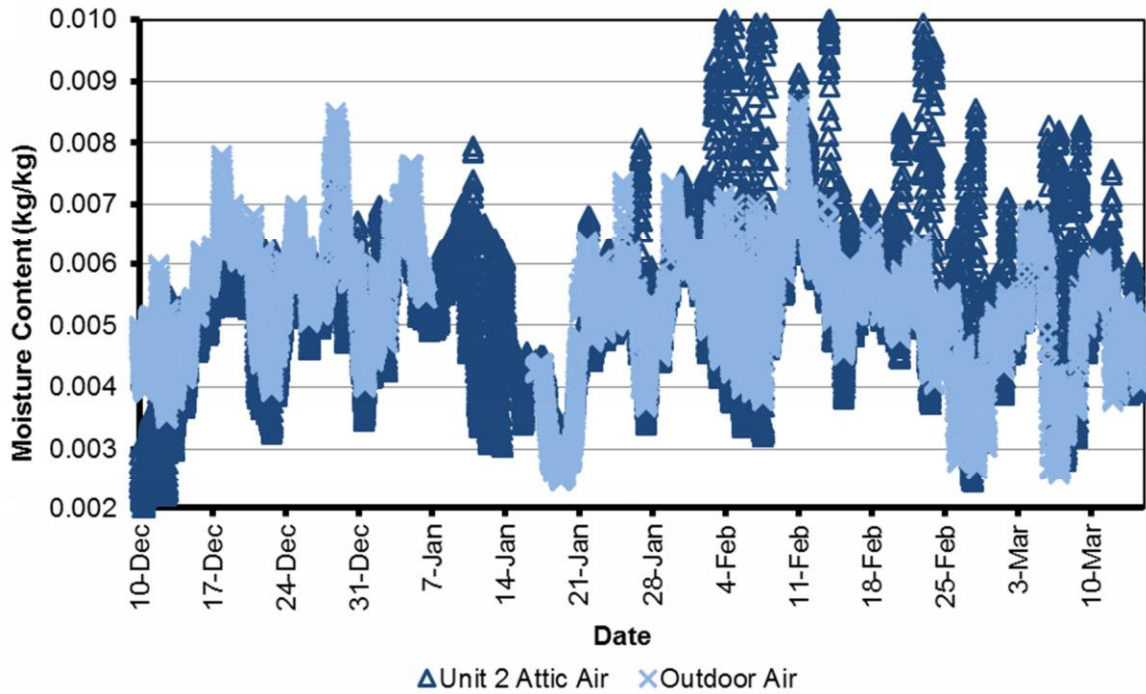
Figure B.49: Unit 2 Attic Air and Outdoor Air Moisture Content

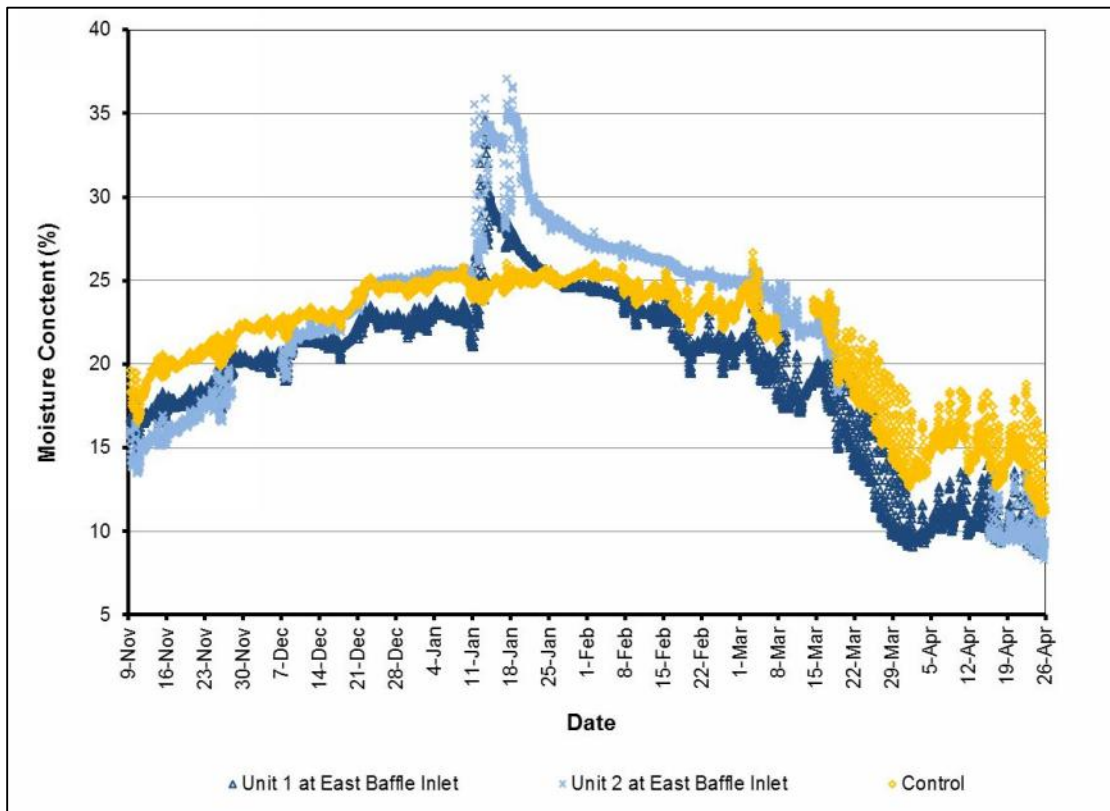
Monitoring continued in units 1 and 2 at the beginning of November 2012. The soffit venting was blocked in unit 2 by filling the voids with plastic bags filled with loose fill insulation. This work was done in-conjunction with servicing the monitoring equipment and continuation of the monitoring program. A button vent was added near the ridge of unit 1 at the middle of December 2012. Graphs showing the monitoring data for the period of November 2012 to the spring of 2013 can be found in Appendix A. The key findings related to changes made to the venting areas and how it relates to the effectiveness of ventilation follow.

Figure 2: Moisture Content of Sheathings with Changes to Venting Area

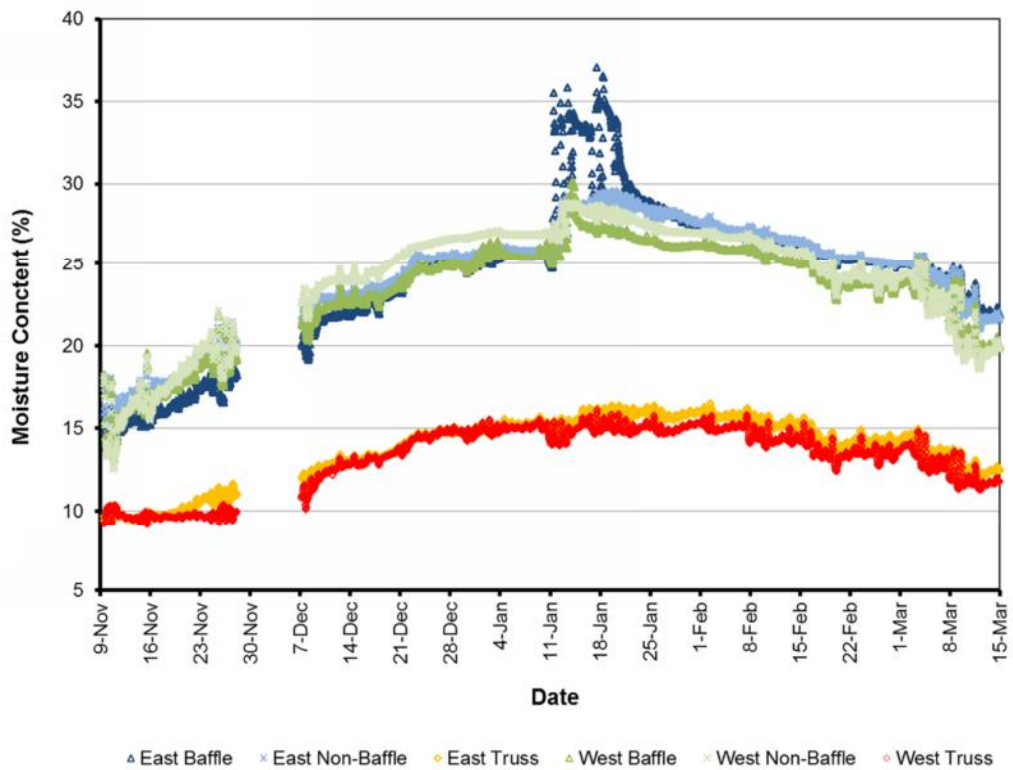
Figure A.8: Unit 2 Wood Moisture Content for 2012 - 2013

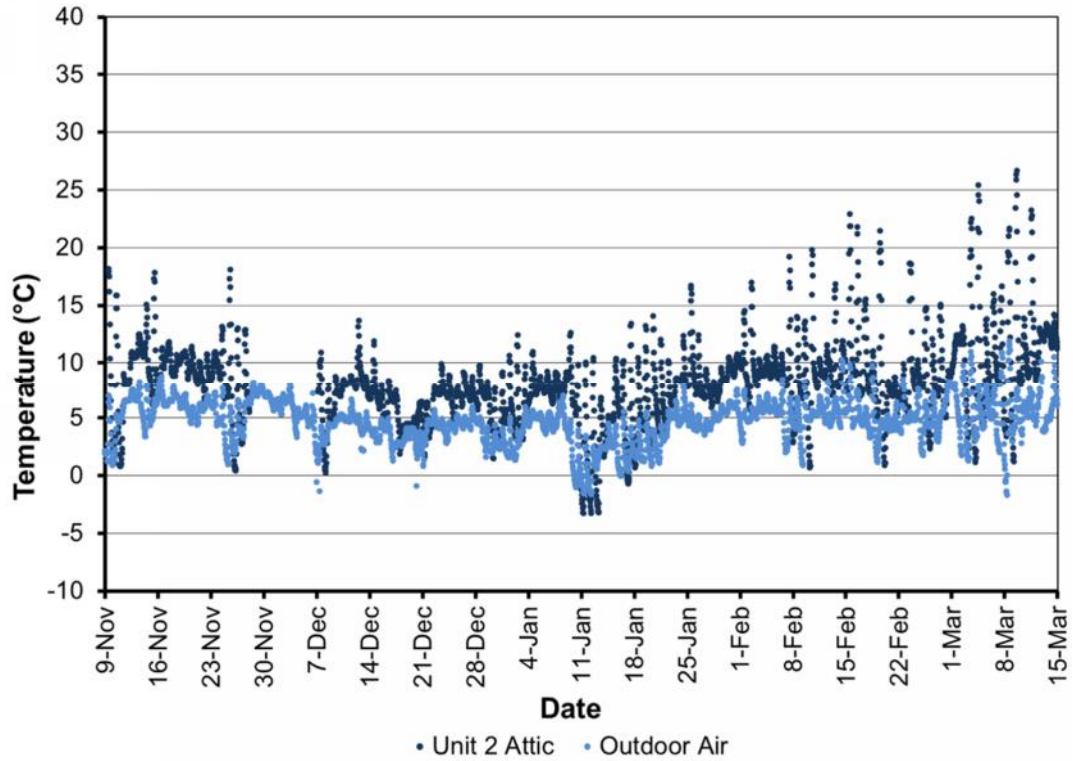
Figure A.11: Unit 2 Attic and Outdoor Air Temperatures for 2012 – 2013

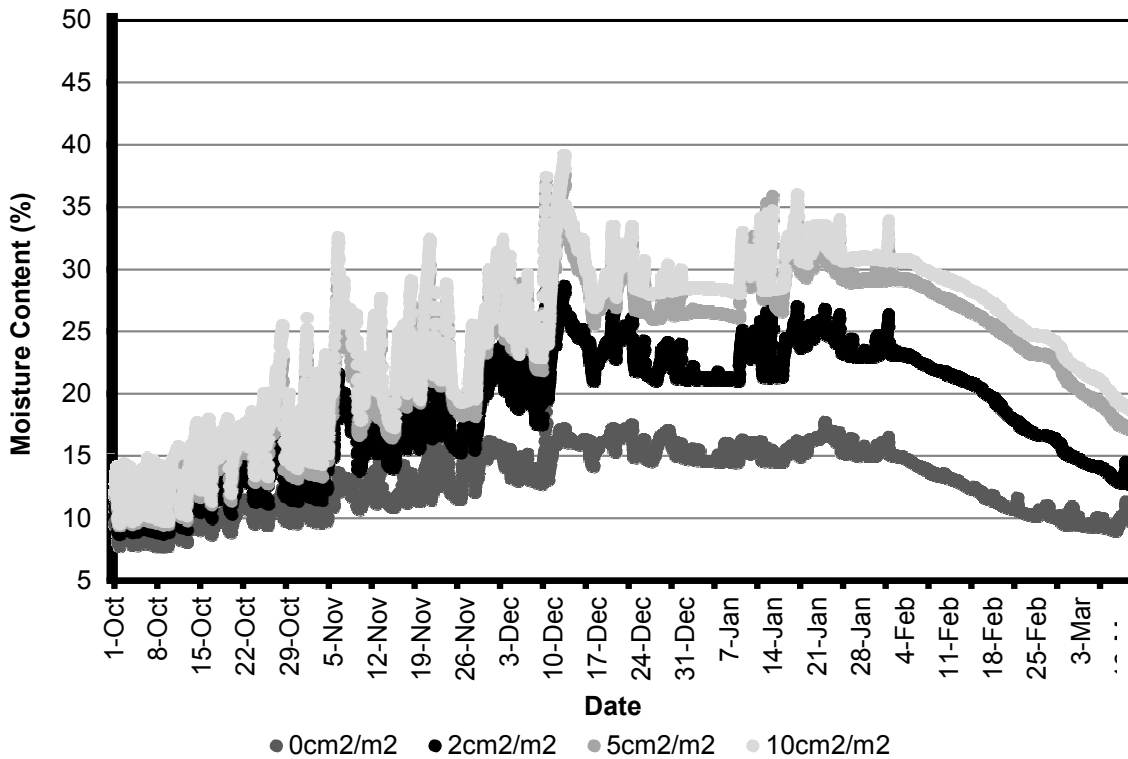
**Figure B.6:** West Roof Sheathing Moisture Content for Different Rates of Interface Leakage (Case ID 1, 2, 3, 4)

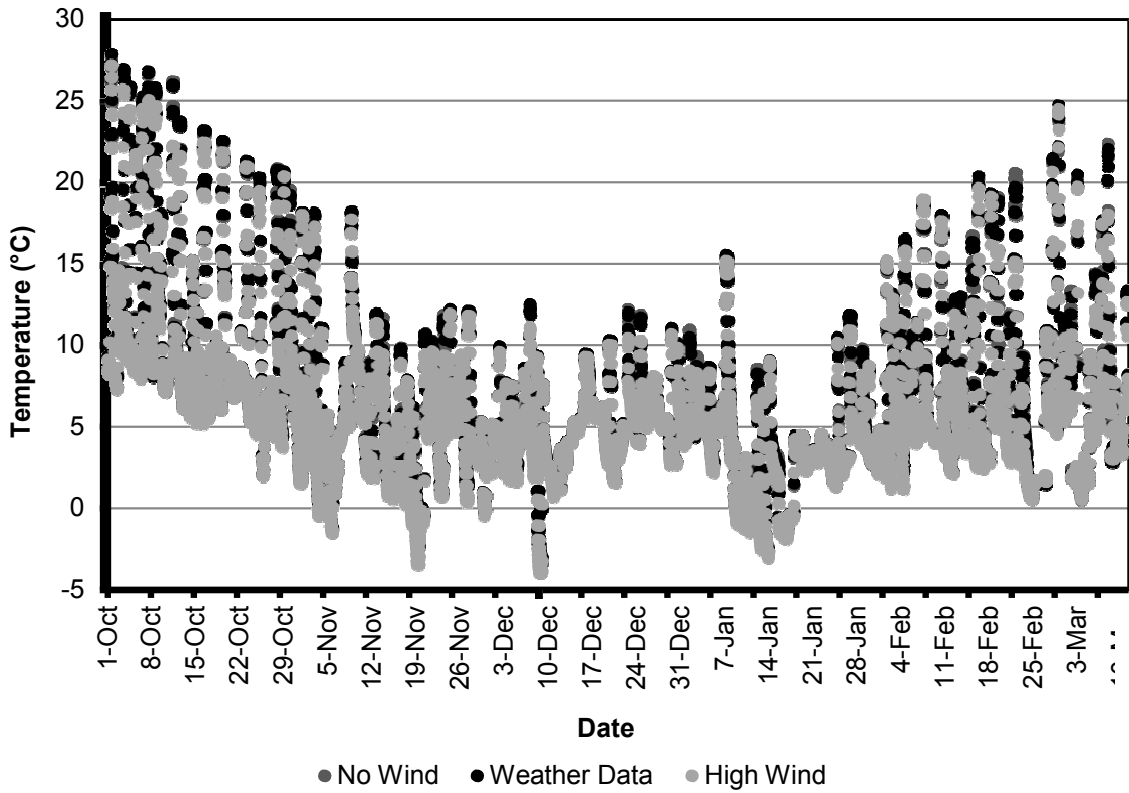
Figure B.23: East Roof Sheathing Surface Temperature for Different Wind Speeds (Case ID 14, 2, 15)

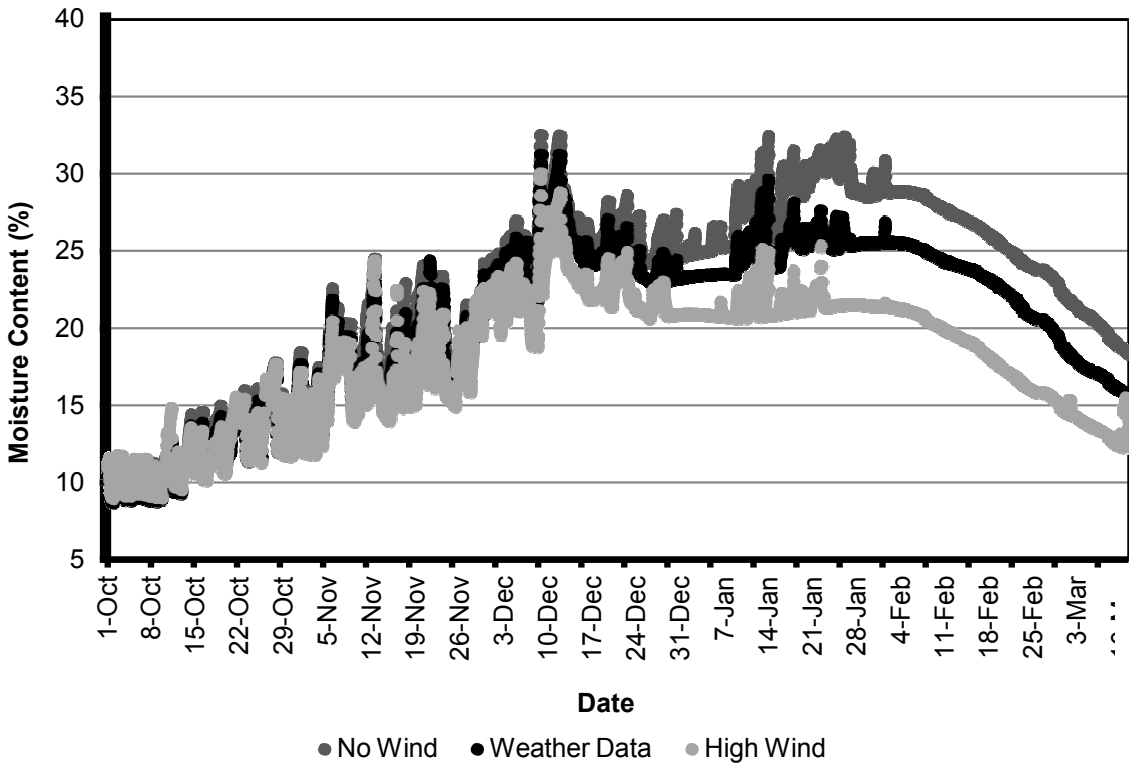
Figure B.24: East Roof Sheathing Moisture Content for Different Wind Speeds (Case ID 14, 2, 15)

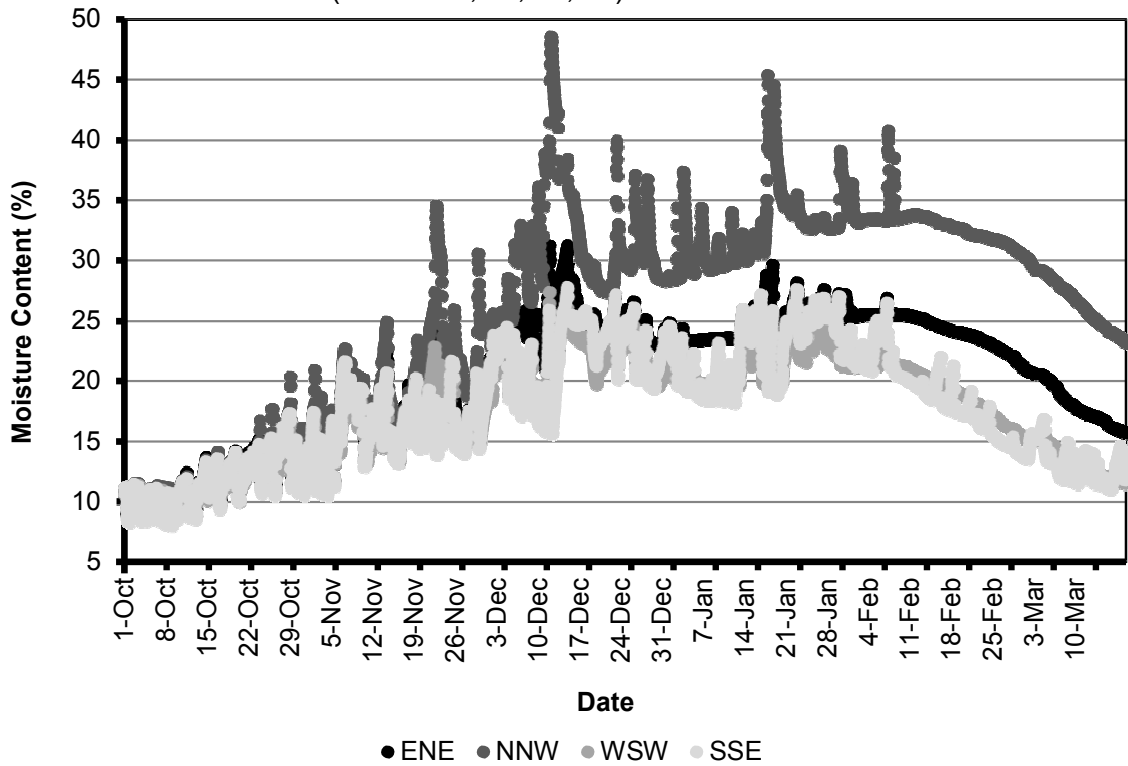
Figure B.28: East Roof Sheathing Moisture Content for Different Building Orientations (Case ID 2, 16, 17, 18)

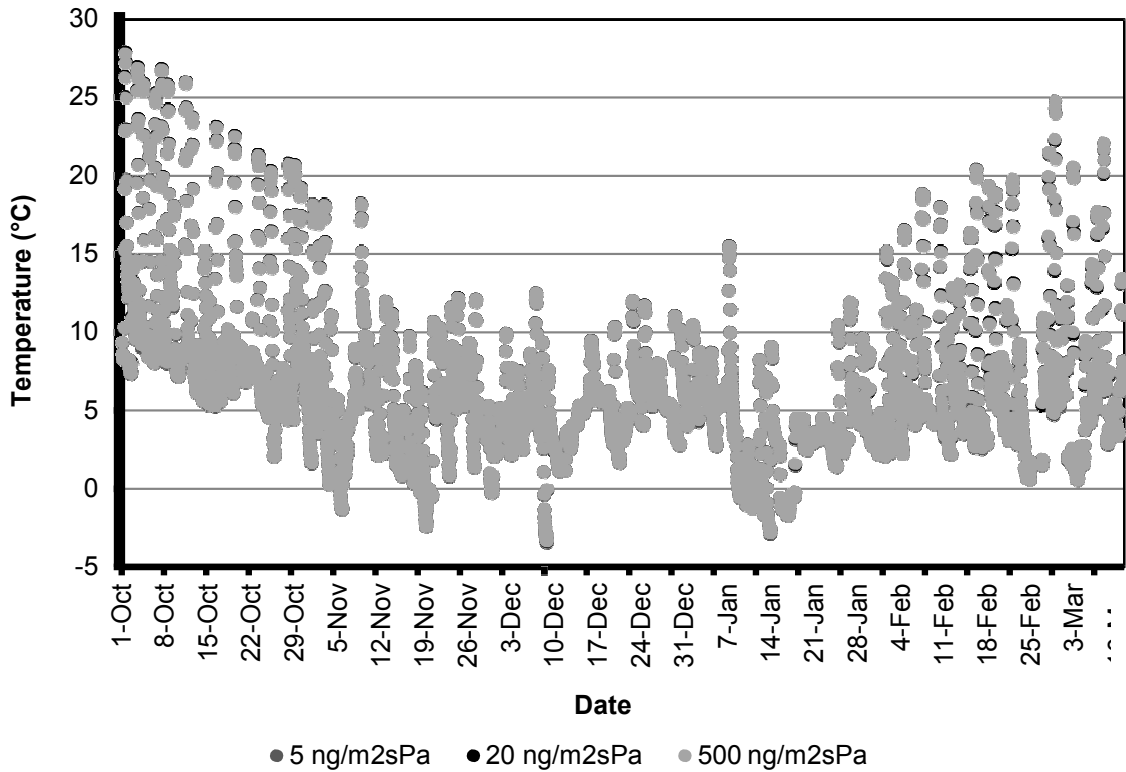
Figure B.29: East Roof Sheathing Surface Temperature for Different Shingle Permeability (Case ID 19, 2, 20)

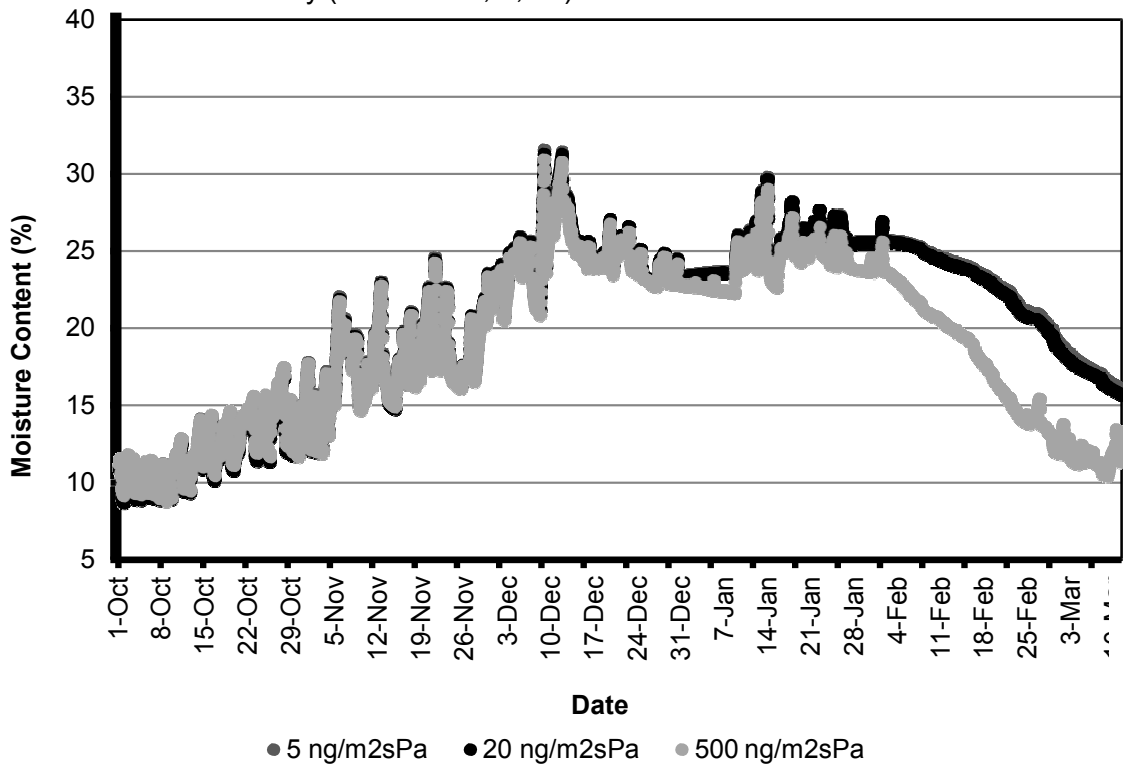
Figure B.30: East Roof Sheathing Moisture Content for Different Shingle Permeability (Case ID 19, 2, 20)

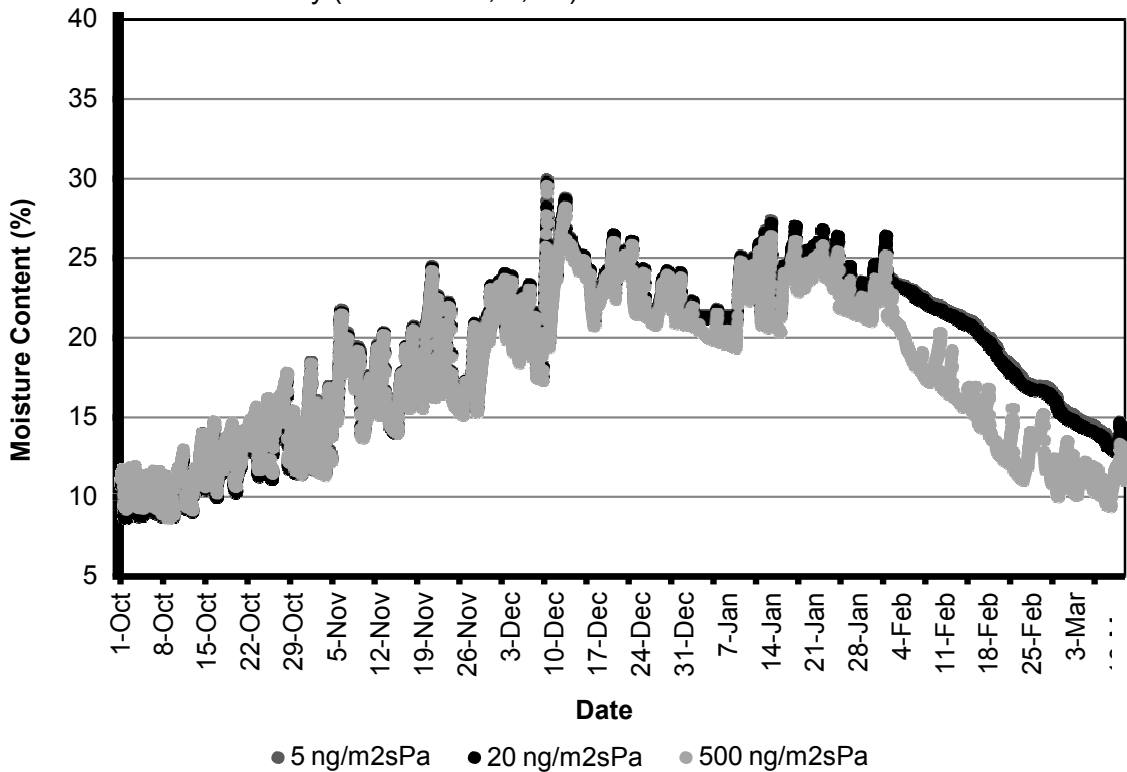
Figure B.32: West Roof Sheathing Moisture Content for Different Shingle Permeability (Case ID 19, 2, 20)

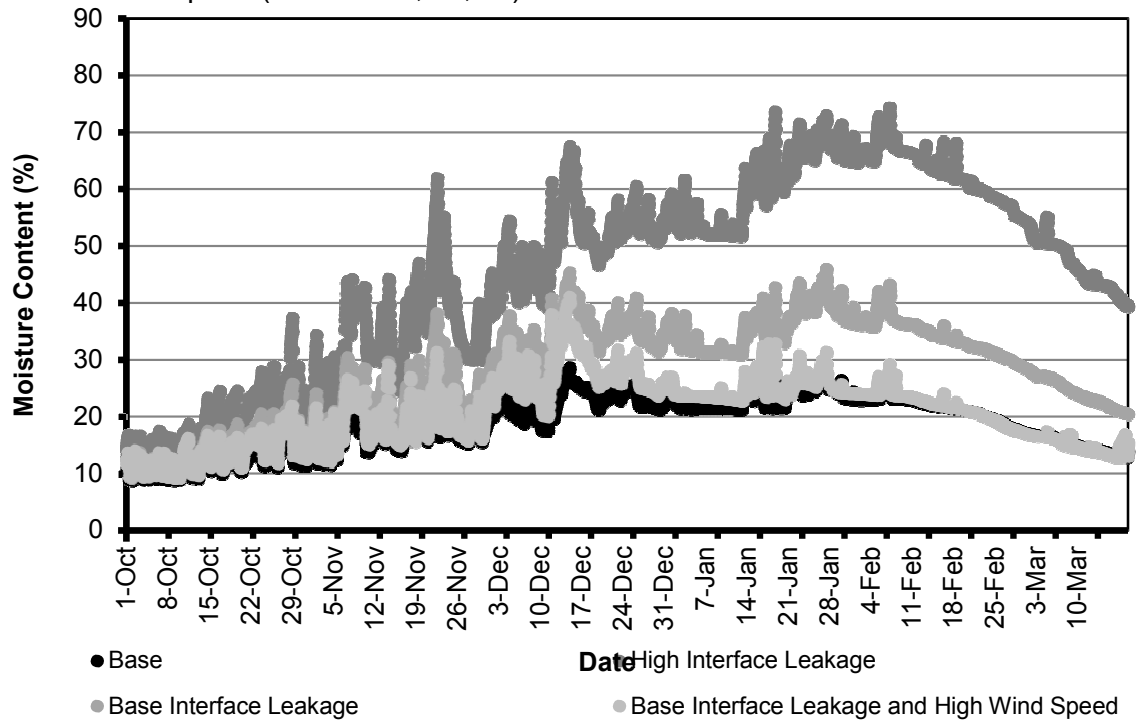
**Figure B.40:** West Roof Sheathing Moisture Content with High Venting Area, High Indoor Humidity and Permutations of Interface Leakage Area and Wind Speed (Case ID 24, 25, 26)
