Maintenance Department Report

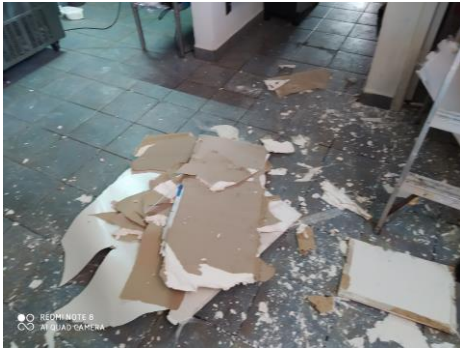
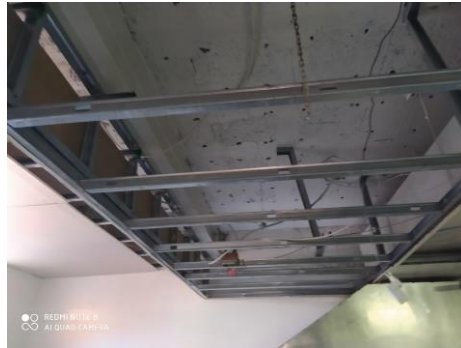
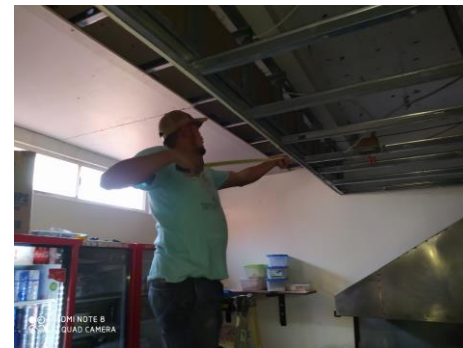
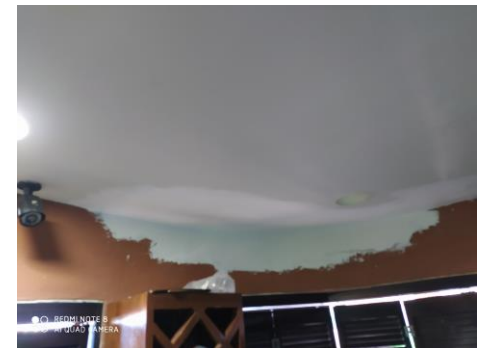
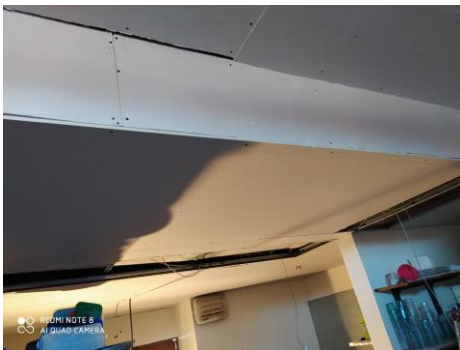
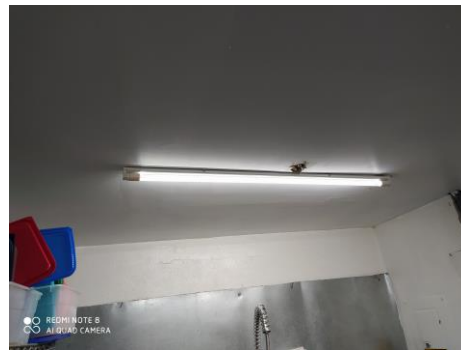
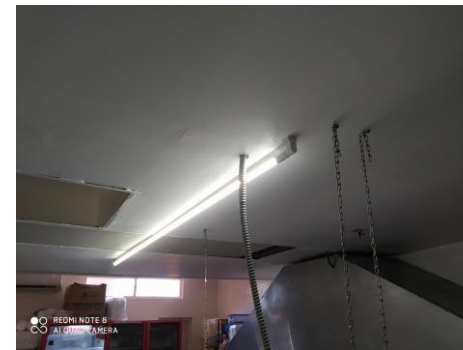
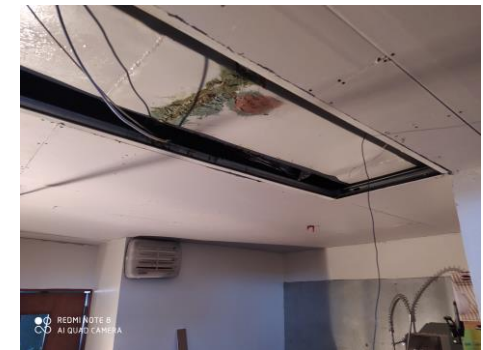
* Kitchen roof has been repair

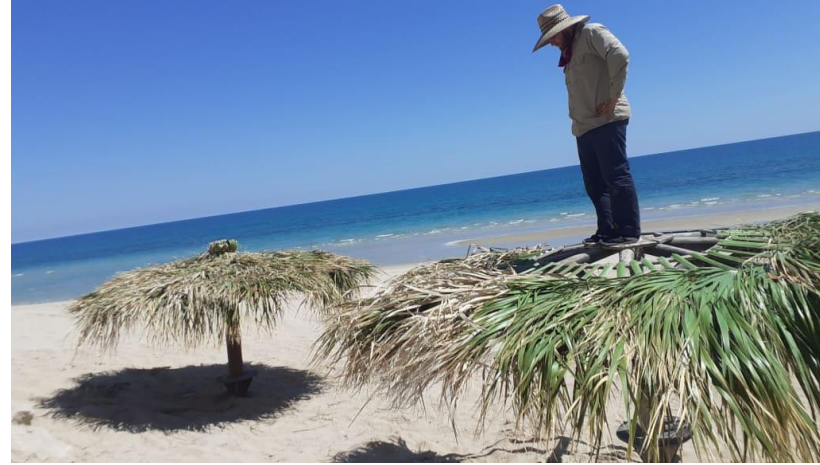
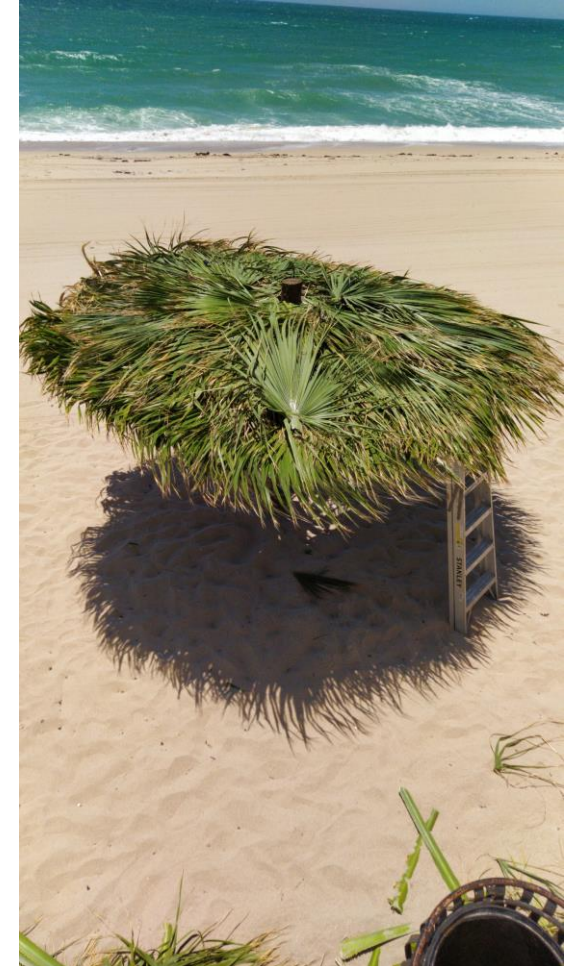
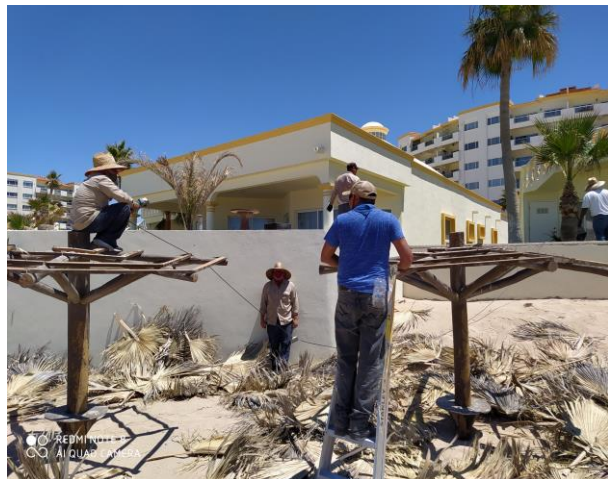
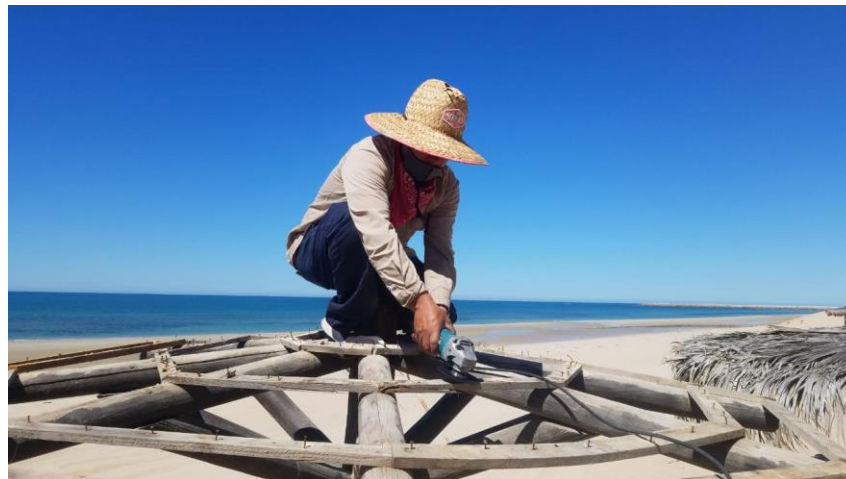
We change four palm leaf of palapas and move tow of the right side, but now we must move all at 25 feet's between them

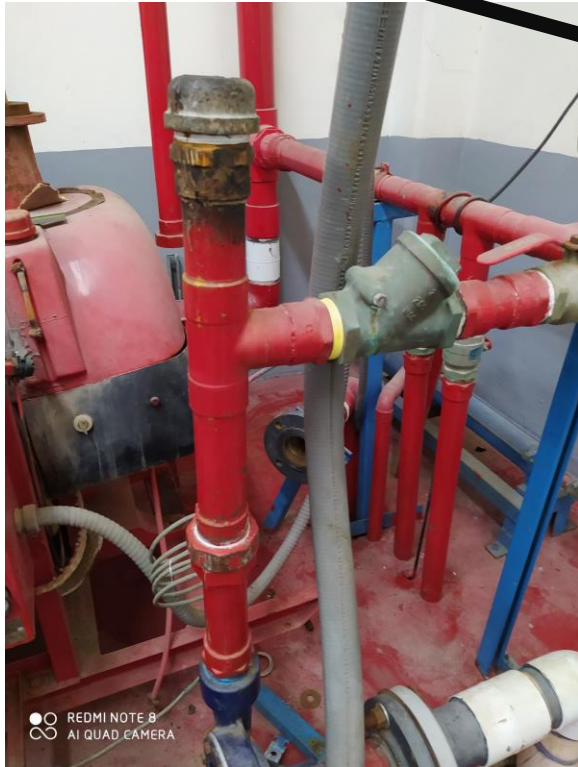
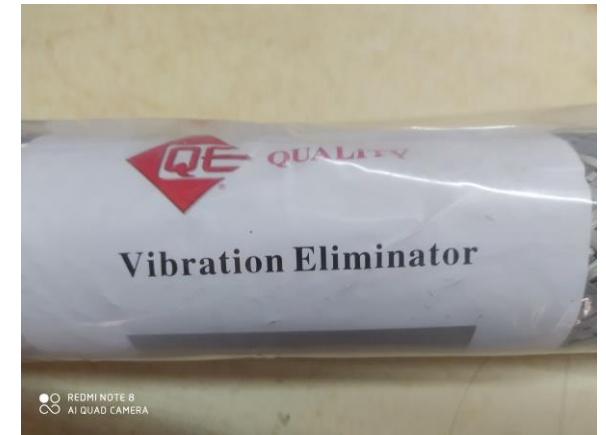
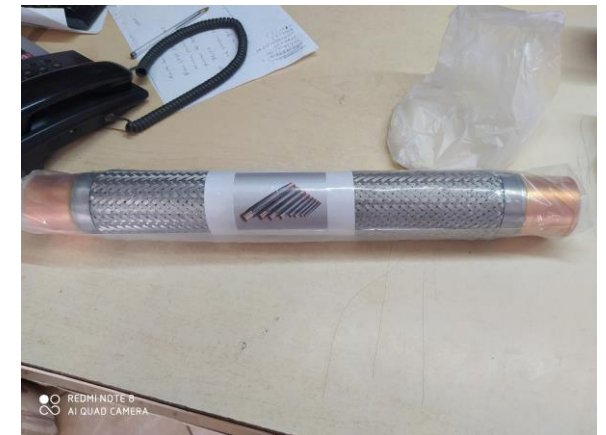
*Fire System Upgrade

This section is a PVC and copper joint and that's why we added the vibration eliminator.

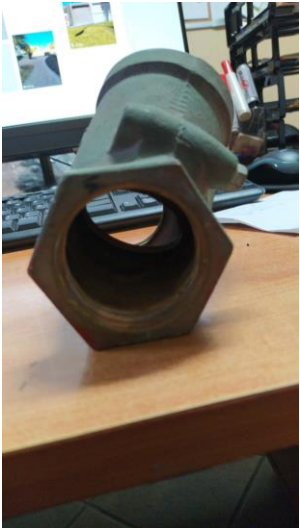
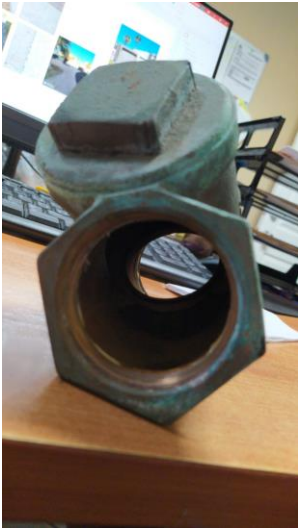
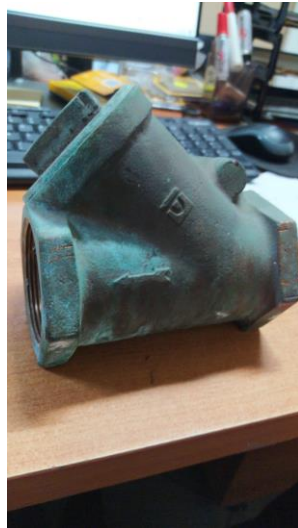
Horizontal Check Valve Broke

We have been re-enabling the system, it had been neglected for a long time, by the time we repaired the electric motor and anti-vibration system, but as we went along we noticed more malfunctions due these the check valves are still not working

when we start the system pressure reaches 120 psi, but then it drops. We proceeded to check the system for water leaks and we found that the check valve had no gate and neither does the check valve on the suction part.

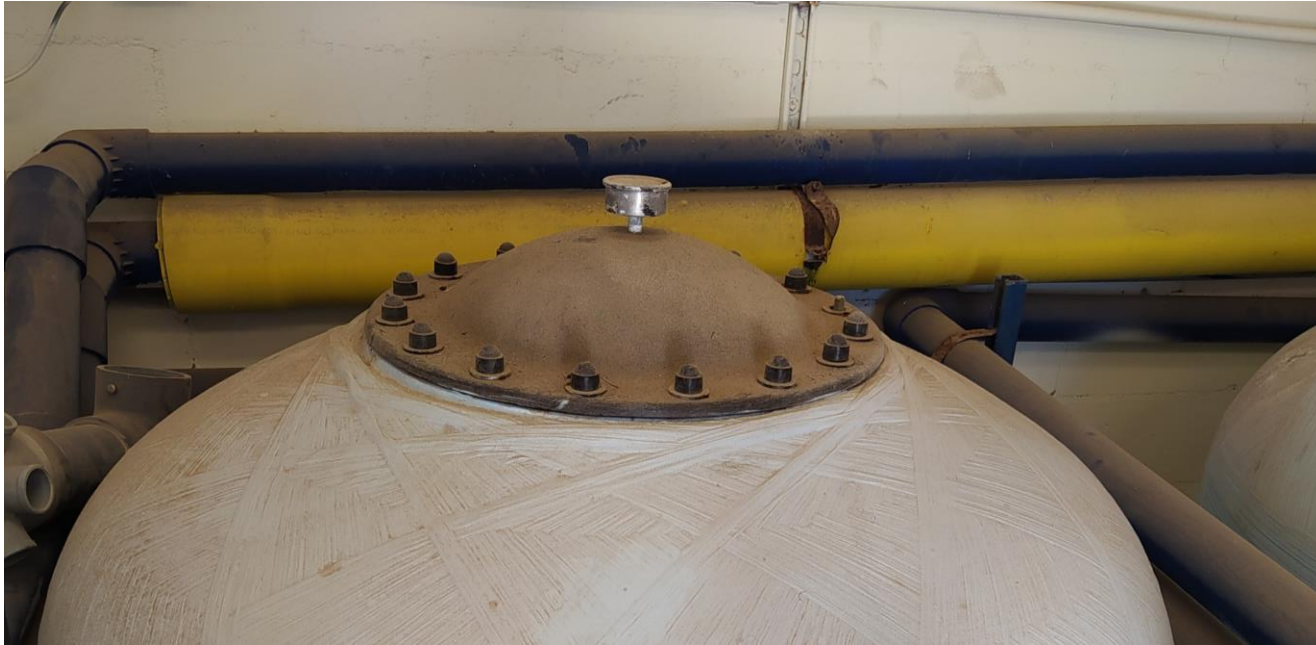
- The Sand Filter of the Slide pool is incomplete, the internal pipes are broken and those are very expensive, the drain valve is broken as well. That's why we purchased a new one for cheaper than purchasing separate parts to fix it.
- (Brand ASTRALPOOL)

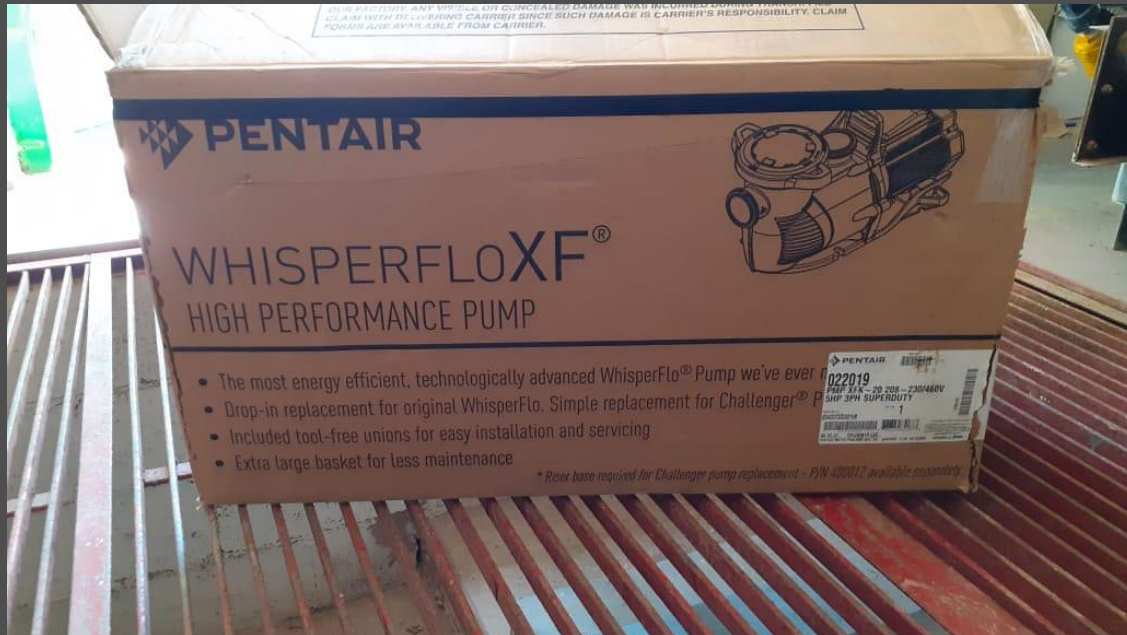
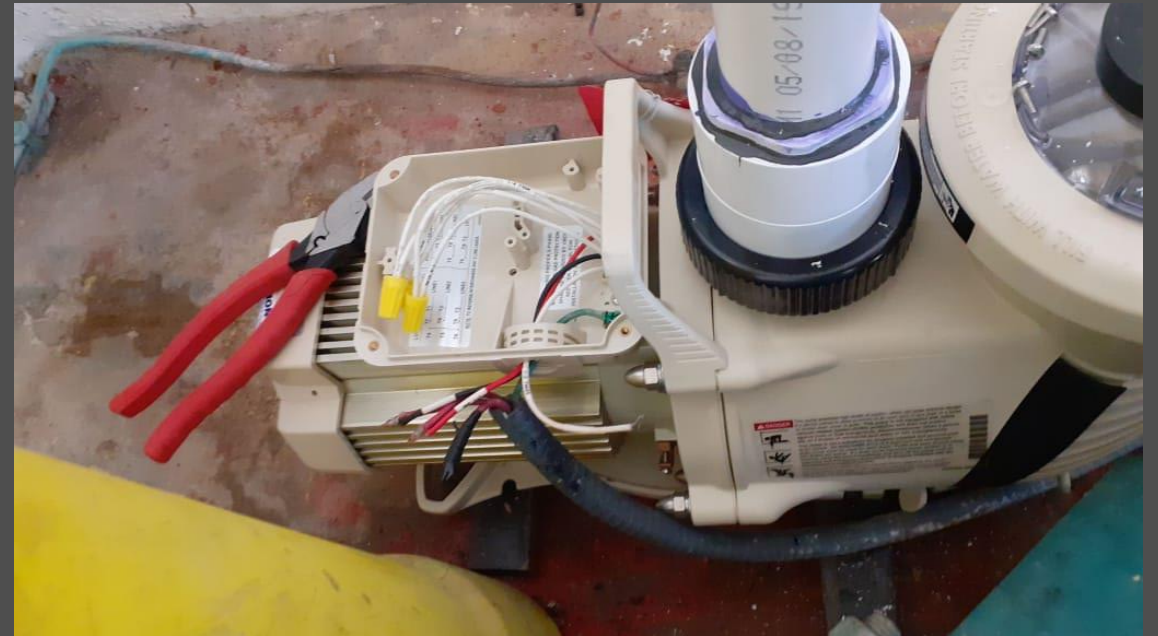
New Pump Installation

Pump was installed in the slide Pool
