Las Palmas Maintenance Report

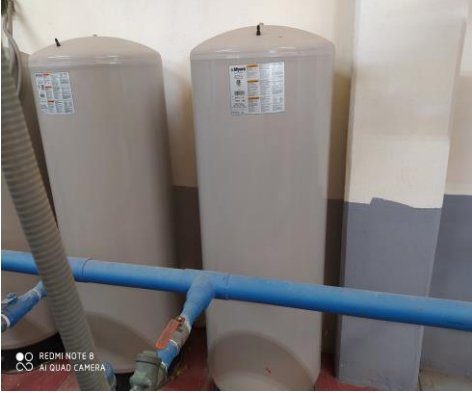
We need to replace one Hydropneumatics cylinder due the bladder is ripped off.

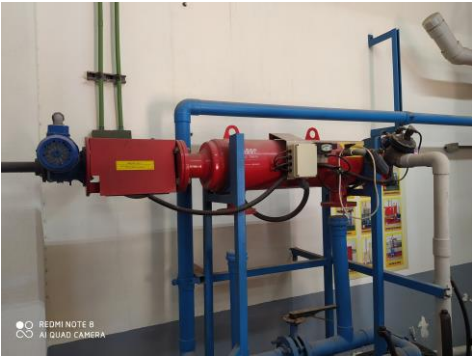
AMIAD filter is unplugged, we need to replace some components inside like the membrane and electric motor. These filter is important to remove sand and Stone particles from the Water pipes and those particles can damage all kind of valves.

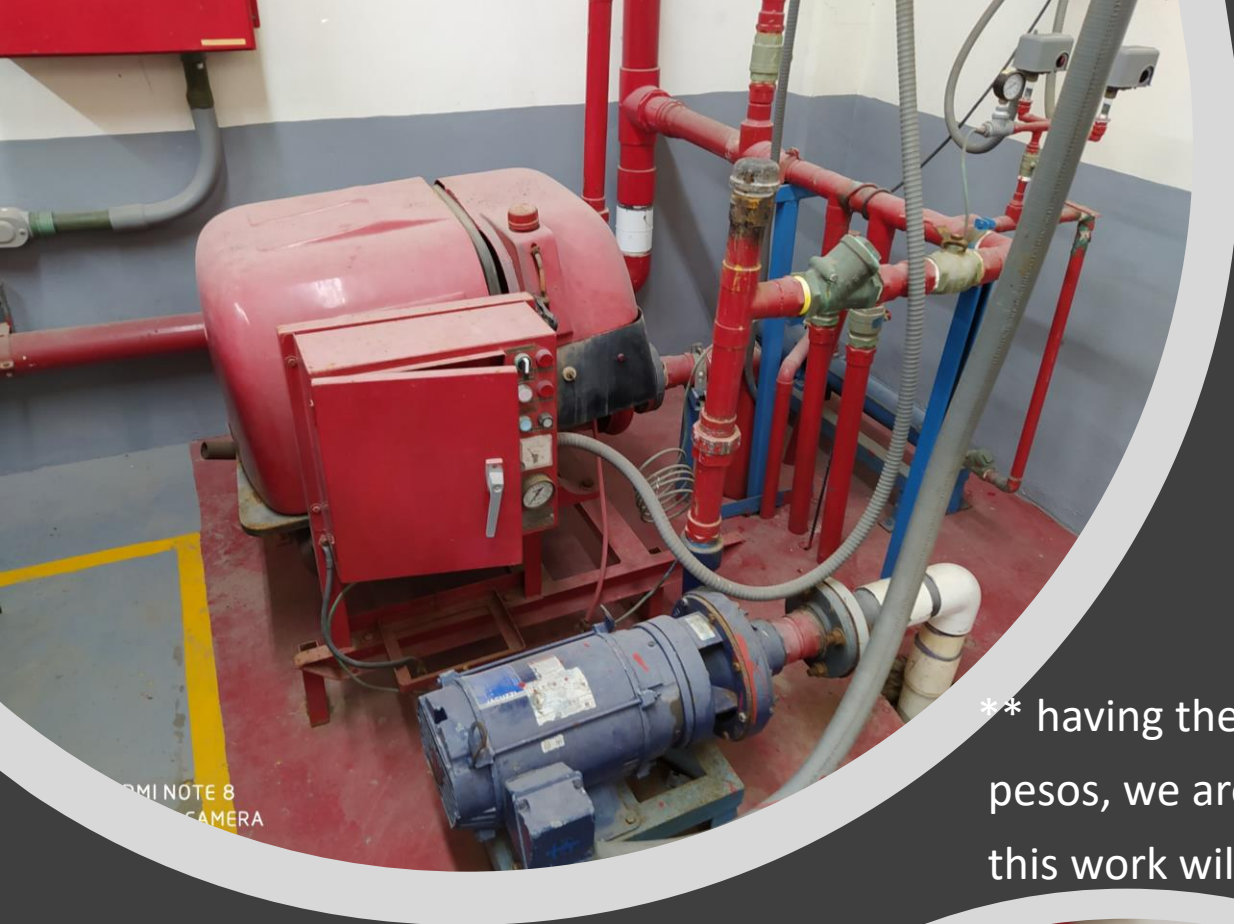
Mechanical Room

- Fire System
- It doesn't work, we need to buy a power battery and a new propeller and make a full
- service, Oil change, Spark plugs, etc..
- The electrical motor is not working, so we don't have a water pressure on the fire
- system pipes

** having the system shut down can make us accountable for a fine of 2 million pesos, we are running the risk of not controlling a fire in the complex, therefore, this work will be taken as a priority **

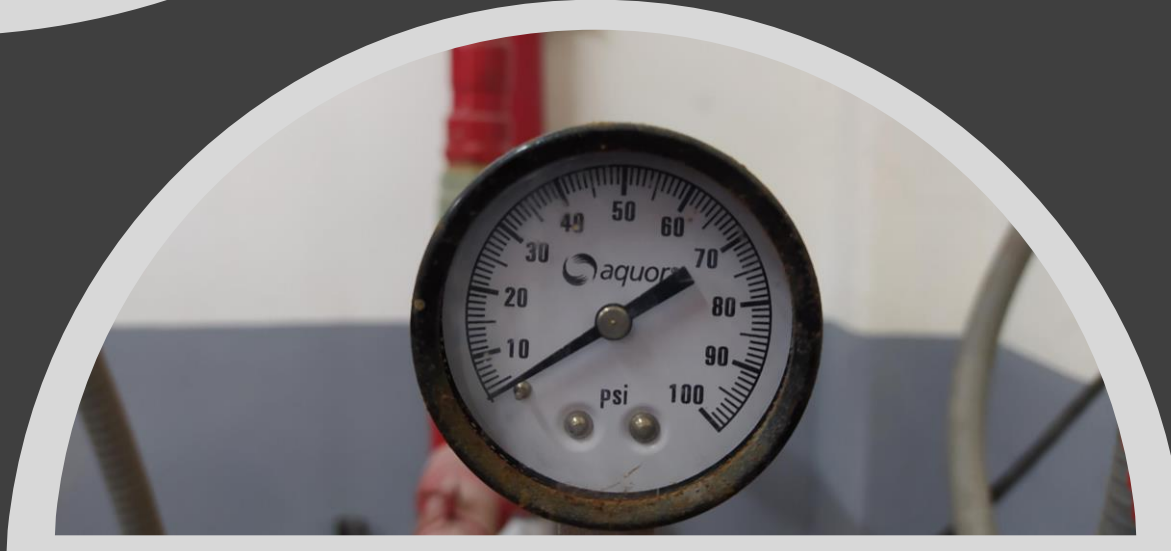
Mechanical Room

- The electric motor was put into operation, the fire line was pressurized and
- we are seeing where to quote the parts that are needed for the combustion
- engine

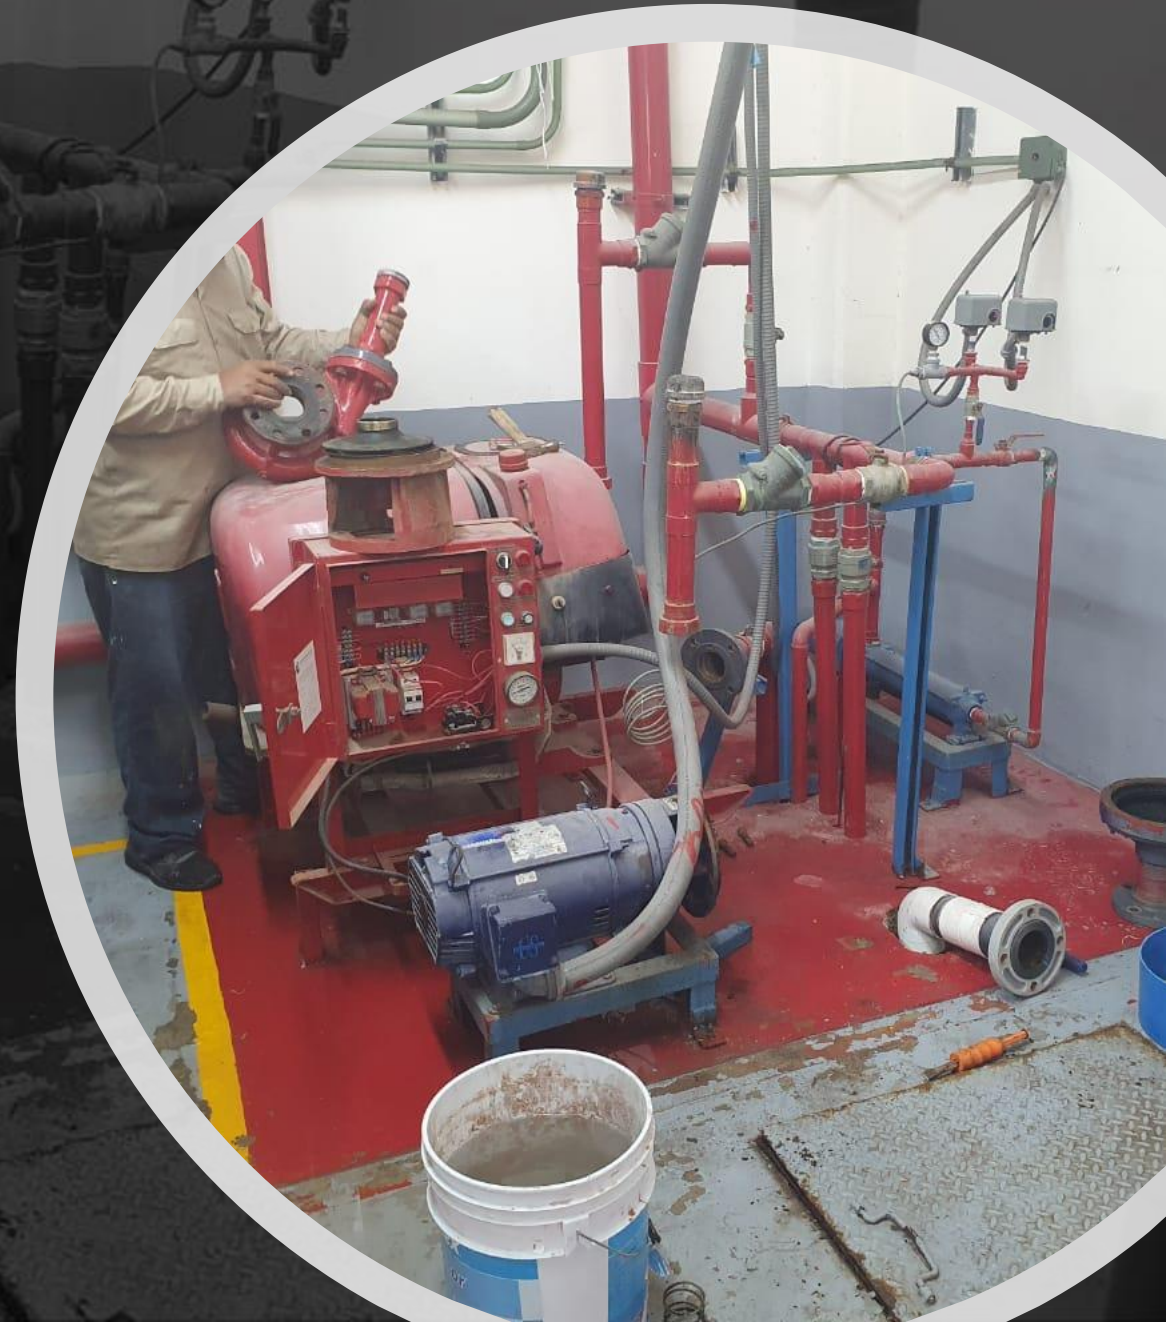
Mechanical Room

Salt Filters

Is not working and the valves are stuck

Its necessary to remove the valves and service them or see what conditions they are in, it is also necessary to change the resin and activated cabon for filtering

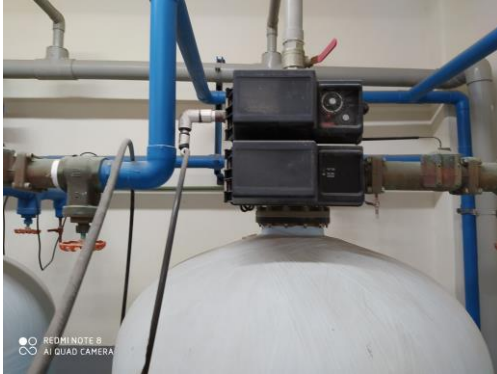
There is not Salt in the thanks

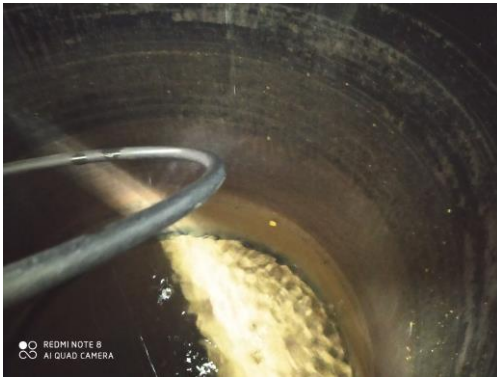
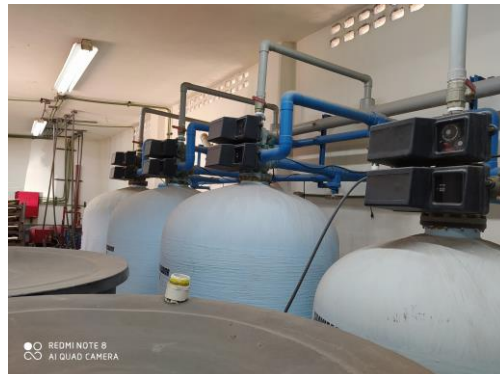
Activated carbon filters are not working, it is necessary to change the activated carbon and see the condition of the internal pipes.

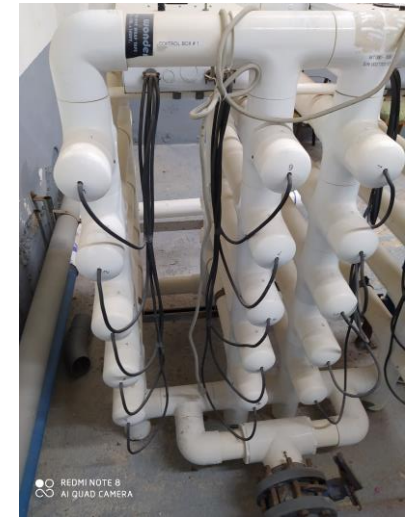
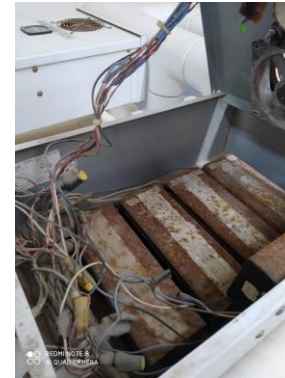
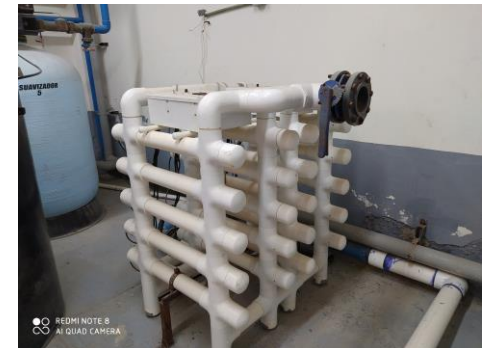
Mechanical Room

- UV system is necessary to eliminate bacteria and currently it is not working, ballasts are not working, uv lamps are burnt out due to electricity variations and it will also be necessary to replace some Crystals.

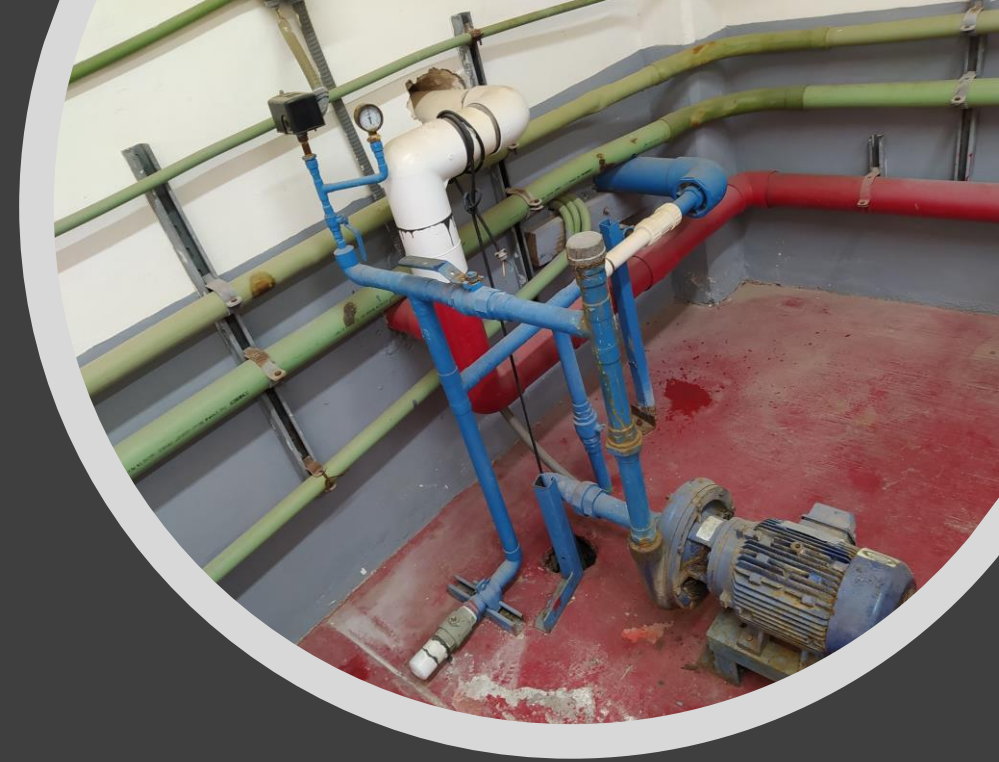
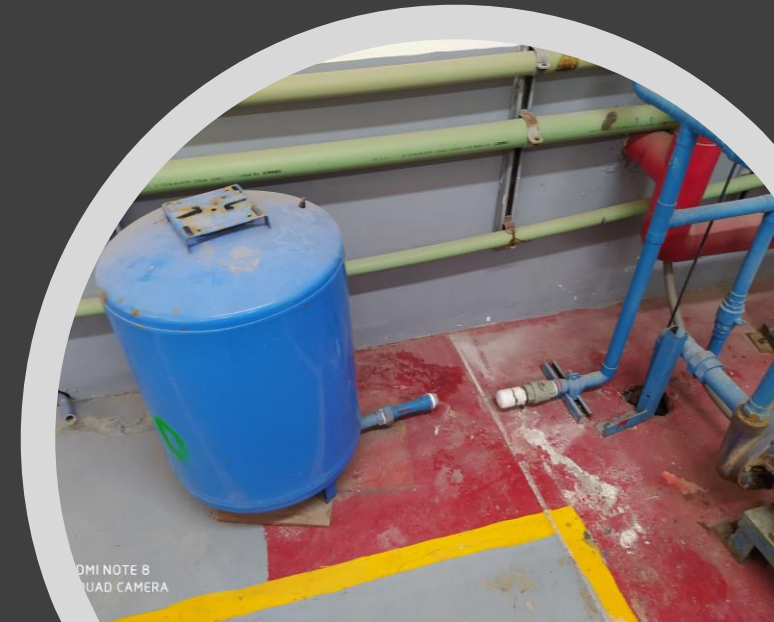
Mechanical Room

- the irrigation system when it is in use the pump is always on due to the fact that it does not have a tank that pressurizes the system and that generates more electricity expenditure, this can cause more wear and tear on the equipment.

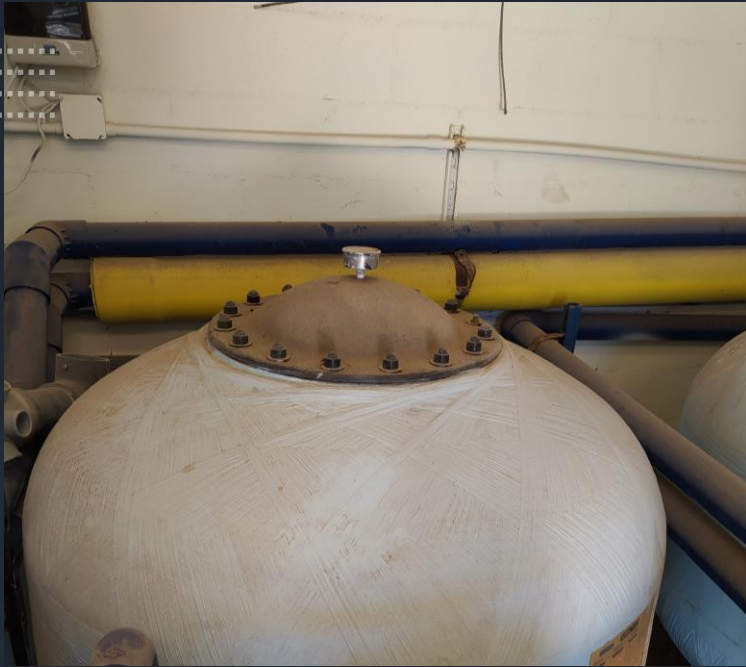
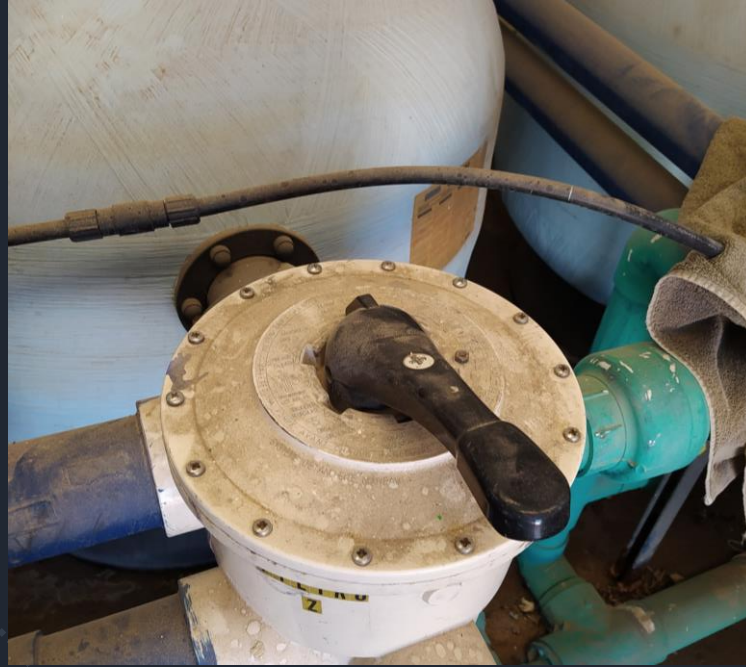
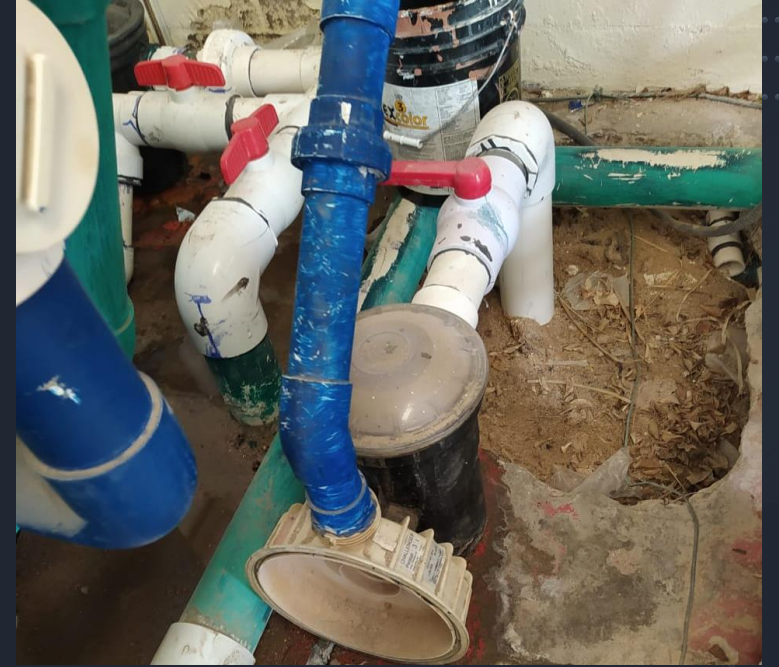
Pool Filter Rooms

- This filter does not have sand and the valve is damaged and it is necessary to change it, the motor of this pump stopped working and that is why it was removed, currently we need 9 motors for the filter rooms, either for waterfalls or for filtering

Currently only one filter and one pump are operating for this "slide" pool and it is insufficient to maintain good water standards, we run the risk of raising bacteria when the pool comes into operation.

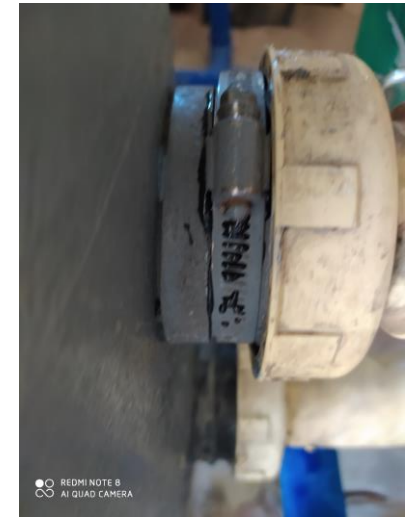
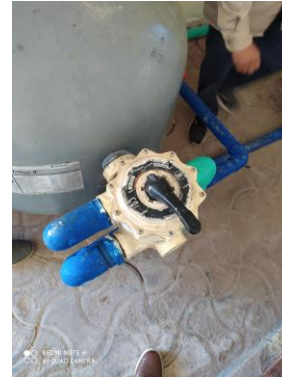
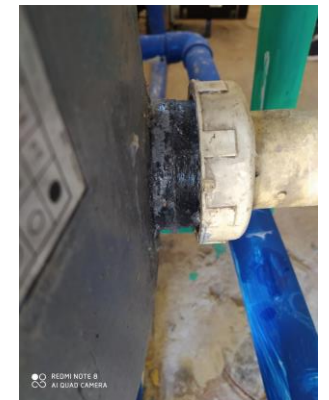
Pool Filter Rooms

- The valve needs to be replaced, it has leaks, the water is going to drain instead of following the flow of filtrate due to internal damage.
- The pool supervisor put that clamp with some glue to stop the leaks

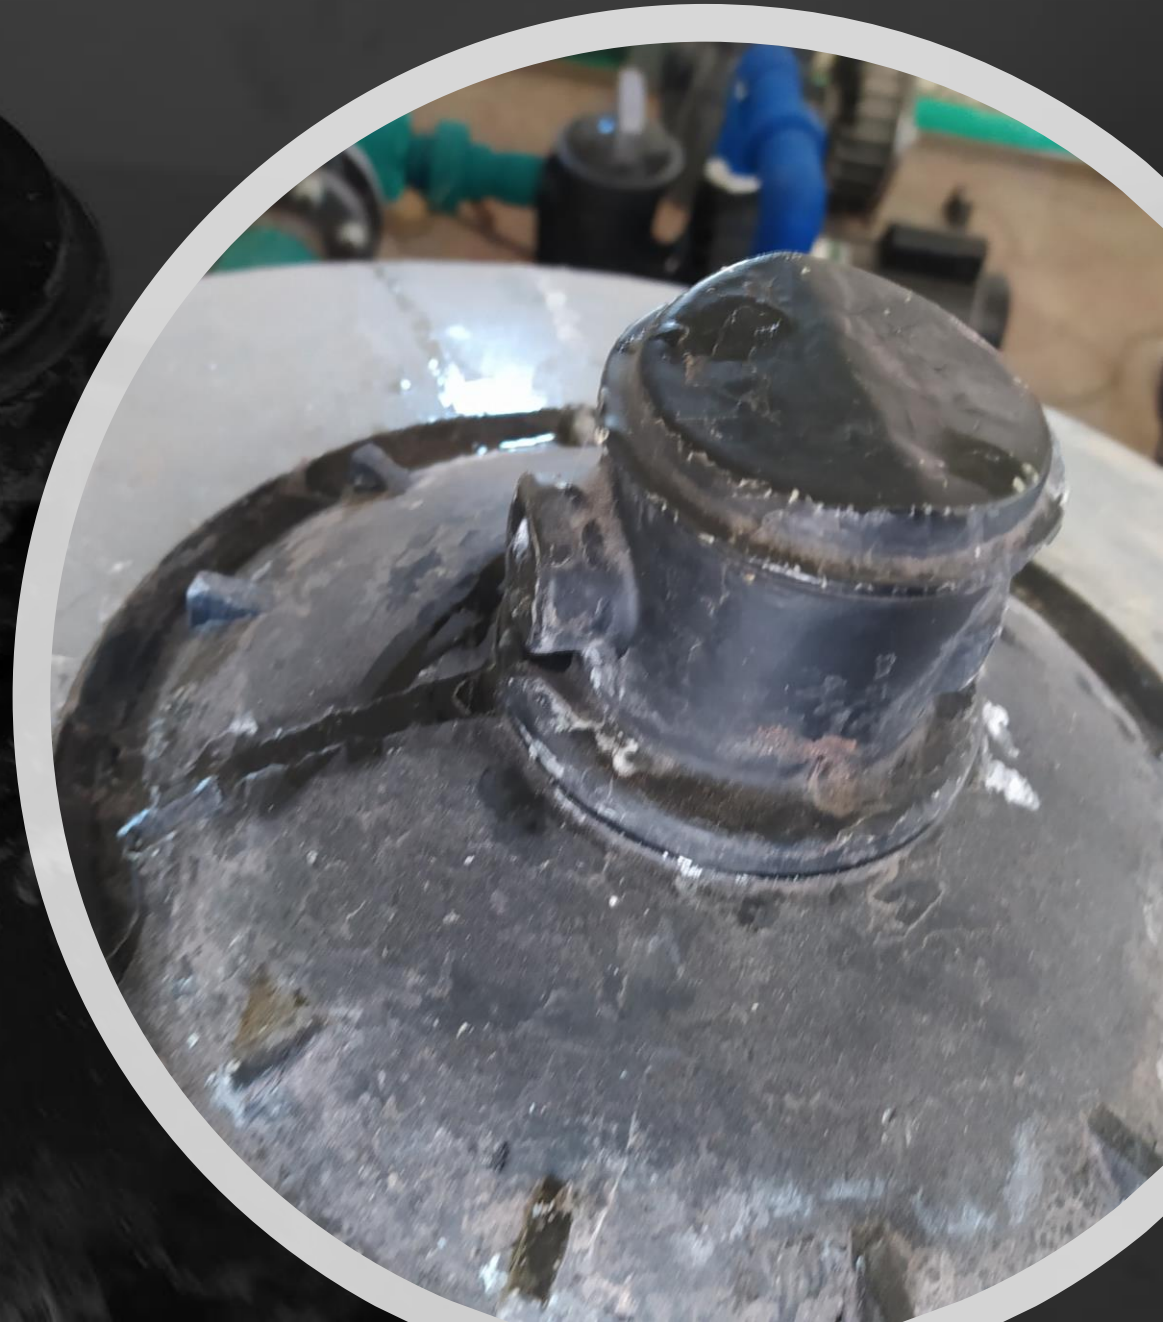
Pool Filter Rooms

- The valve is broken and was repaired with glue only, this takes several years like this.

- There is no key to open the filters.

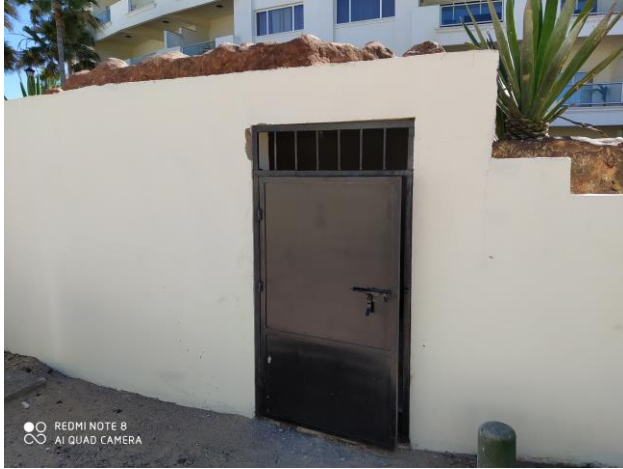
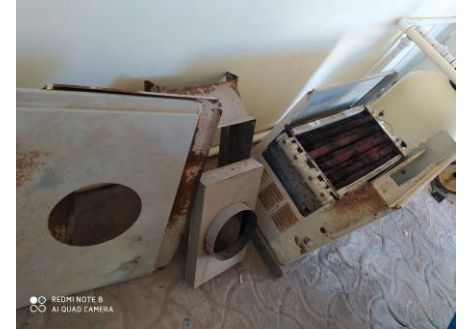
Most of the boilers are damaged and we have to replace them, some lack the pilot or are aberrated by the time of use, the heater pipes are pitted

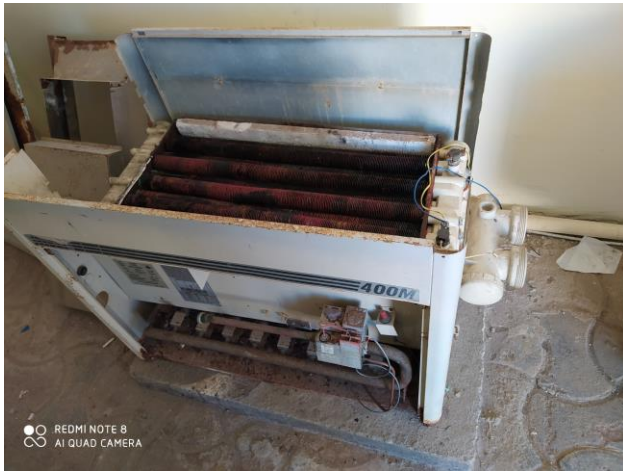
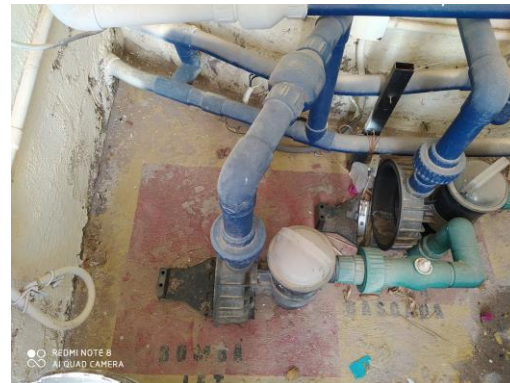
We need around 9 motors for filtering or cascades, many pumps had smart cards and these were damaged so they do not work without it.

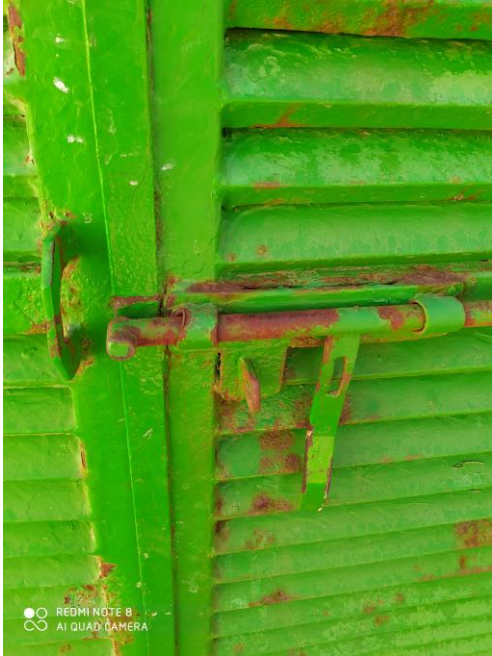
Pool Filter Rooms locks

No filtering room was locked

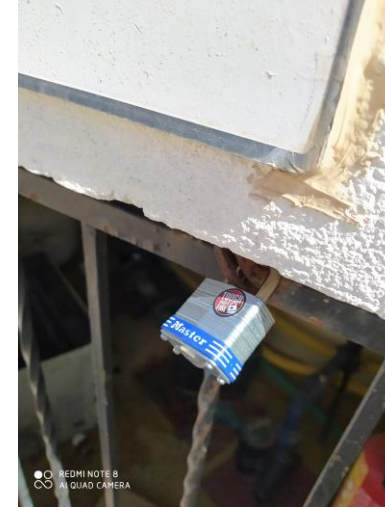
No filtering room was locked, now we already locked them all

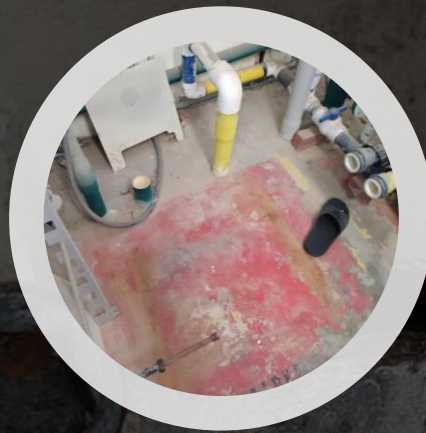
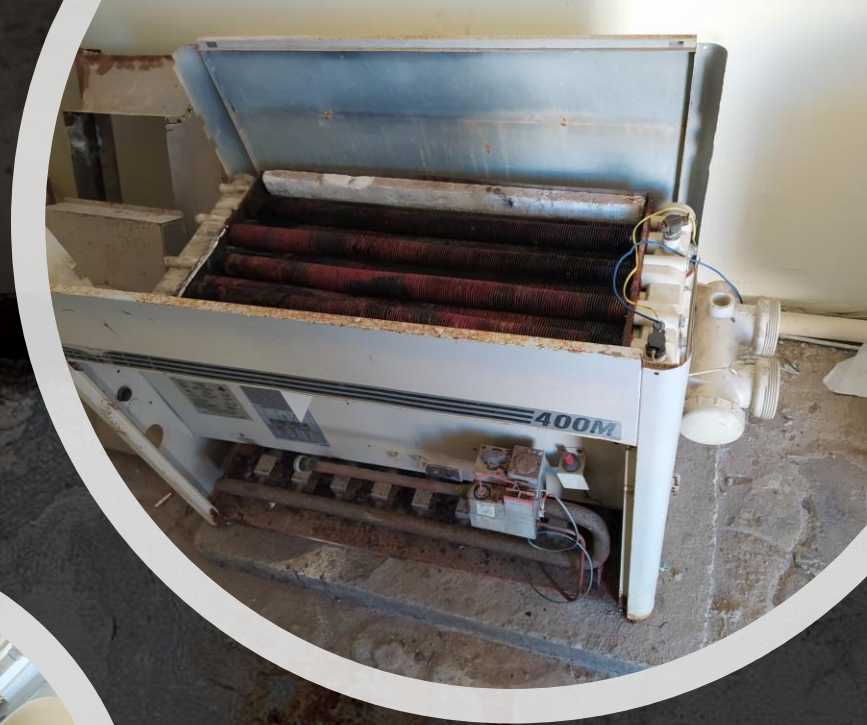
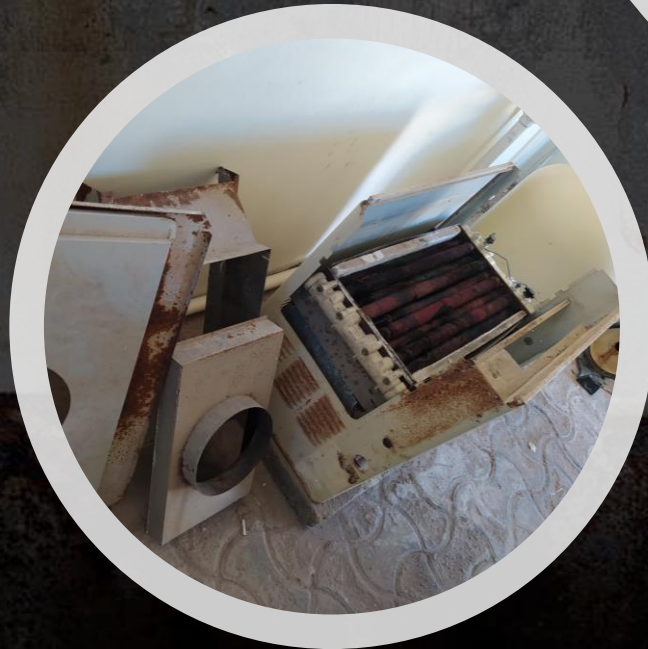
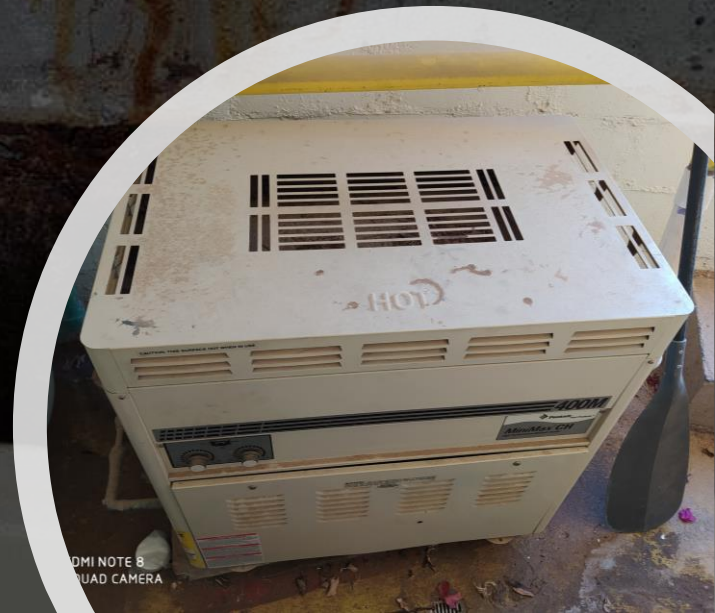
Pool Filter Rooms

- Currently we have 8 water heaters, either for jacuzzi or pool of which only 3 are those that turn on but are in poor condition but continue to operate in some detail such as leaks.

These are the three boilers that we have in operation

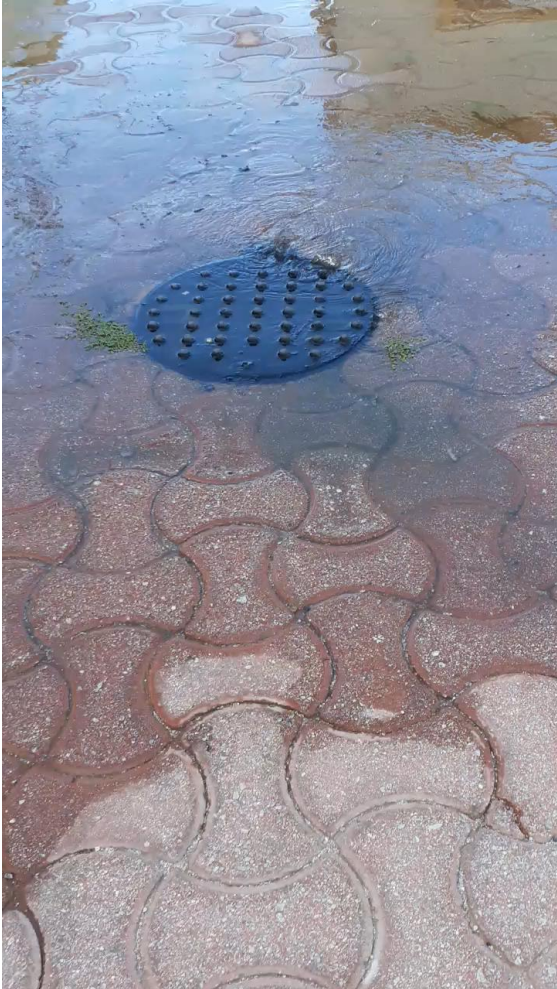
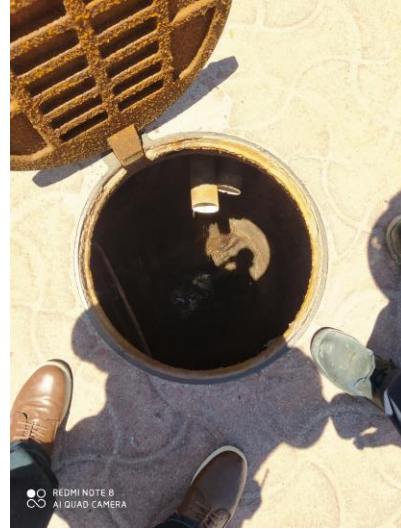
Common Areas

Common areas is severely affected by a problem in the main drainpipe on the left side of the complex

This sewer is in the first villa on the left side of the complex

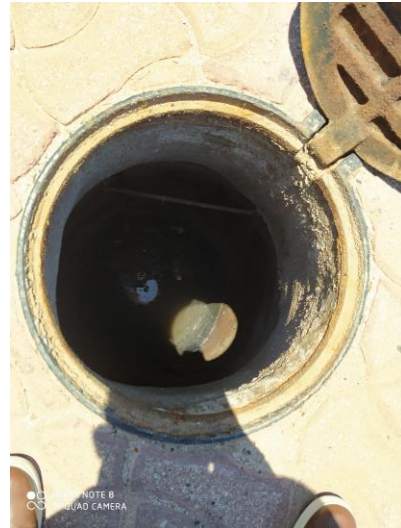
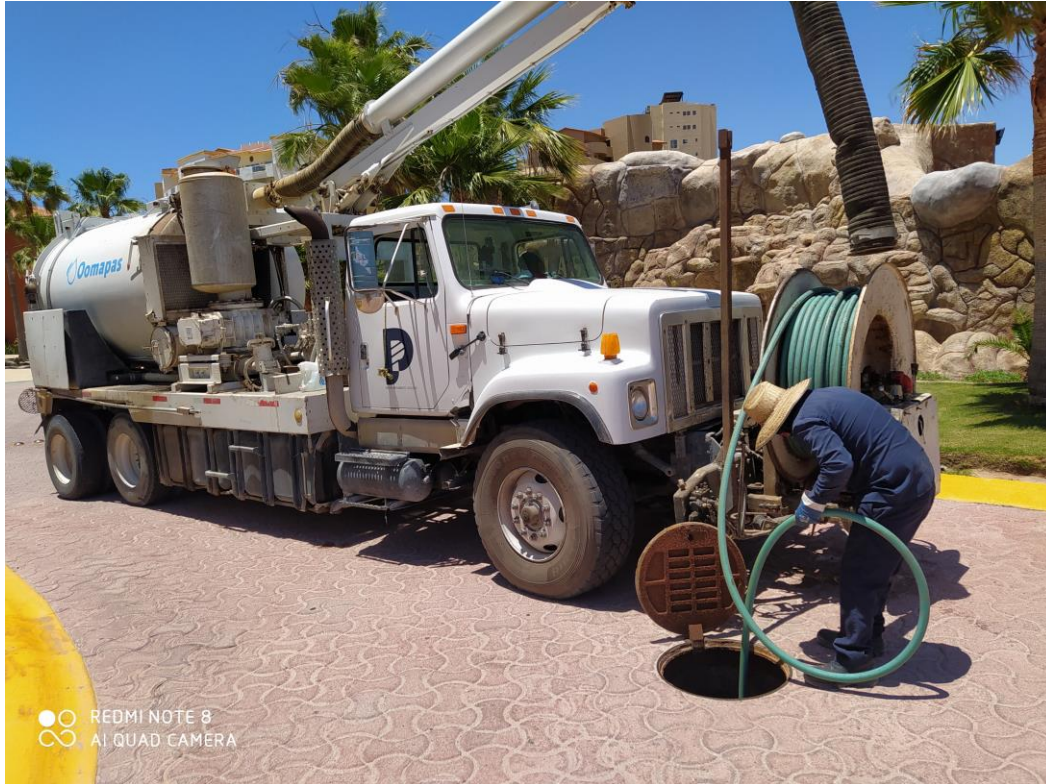
Common Areas

The problem was solved but we must enter the sewer and remove the roots of the palms, apart from this problem.

In three months they will come to clean the main pipes of the entire complex and be ready for the high season.

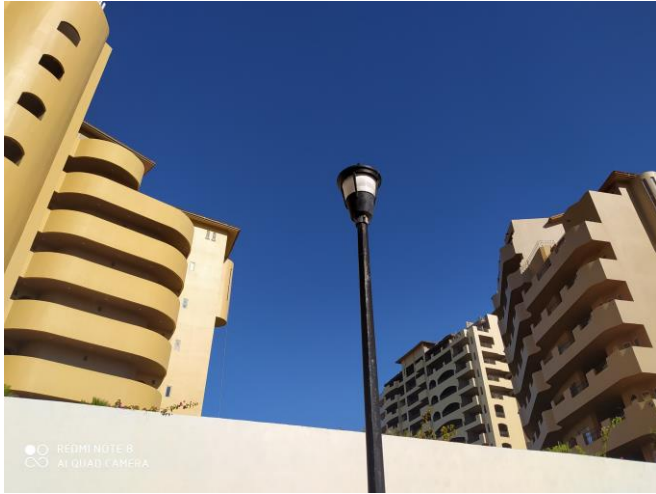
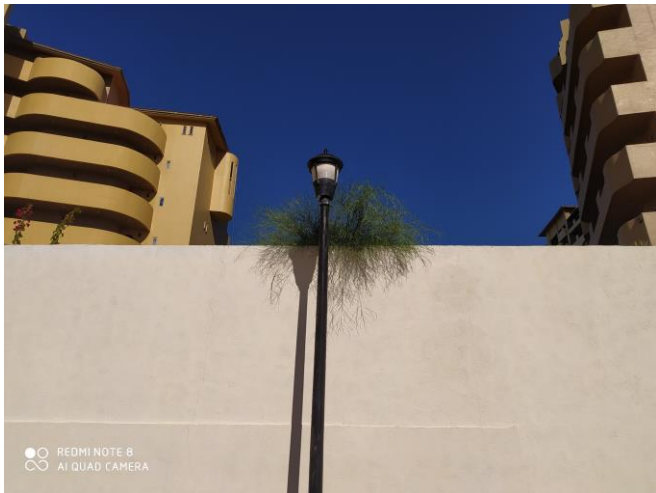
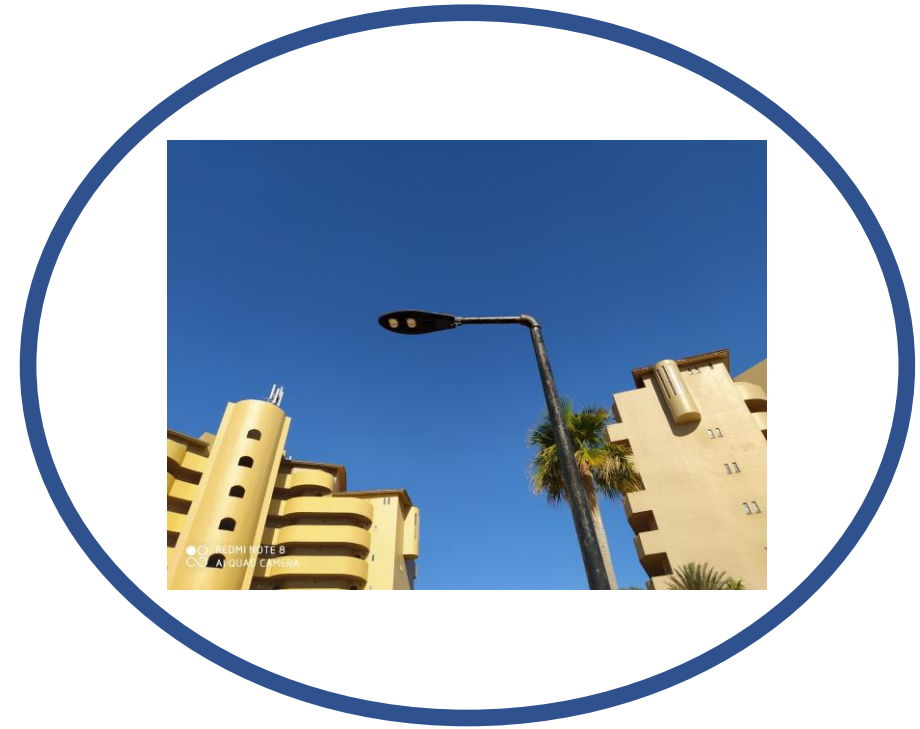
Common Areas

We need to change 5 lamps equal to this since in the warehouse we have 5 LED type

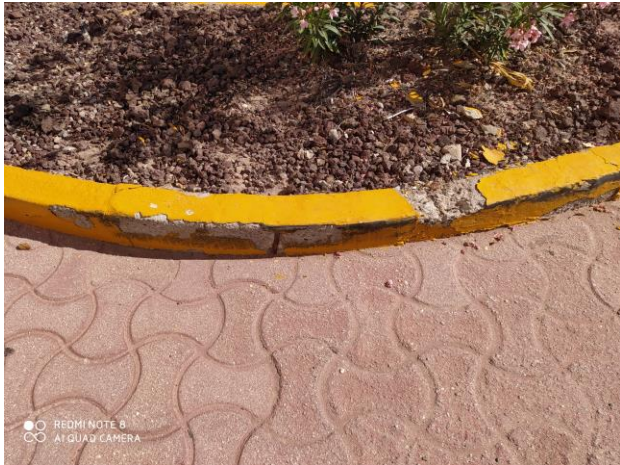
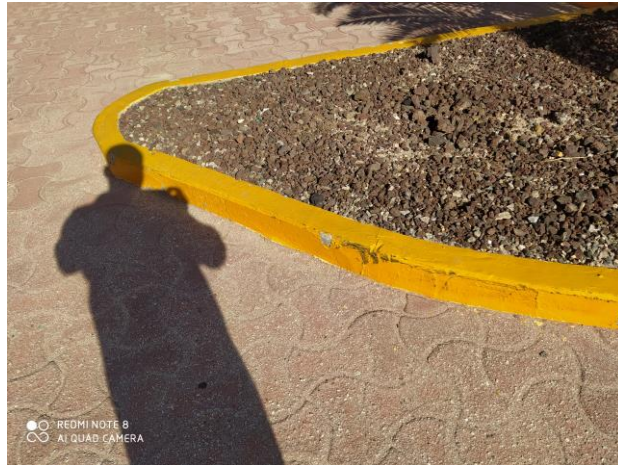
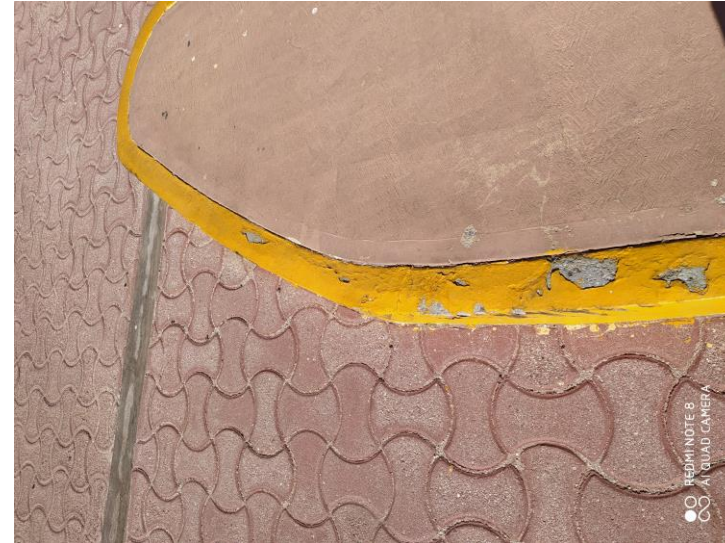
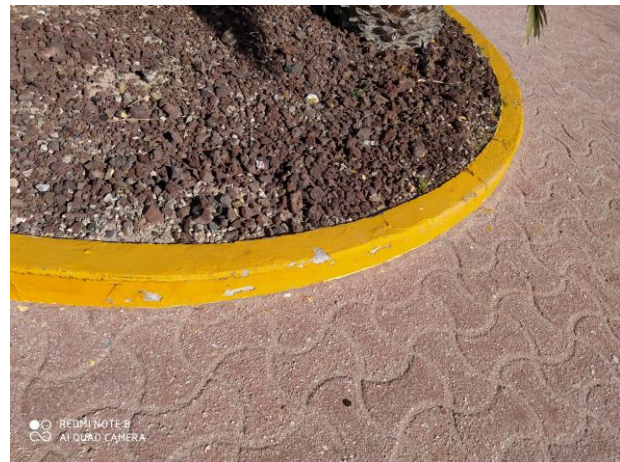
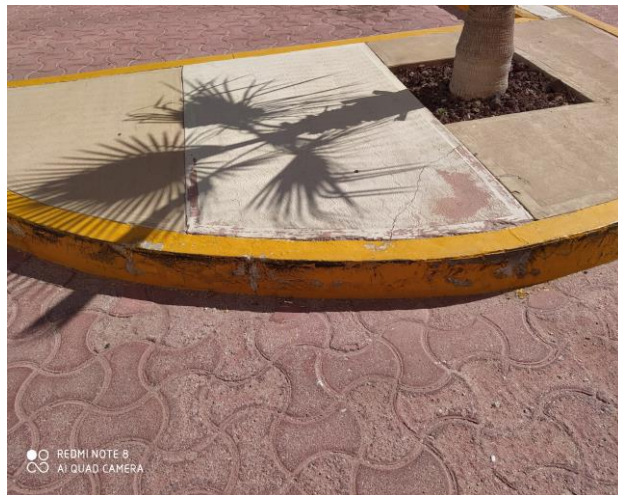
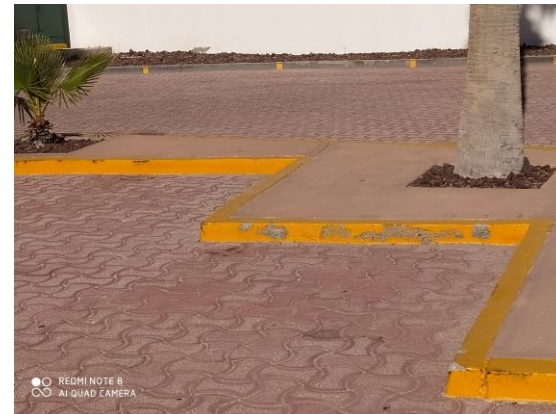
Common Areas

All of the parking fittings are damaged and look bad

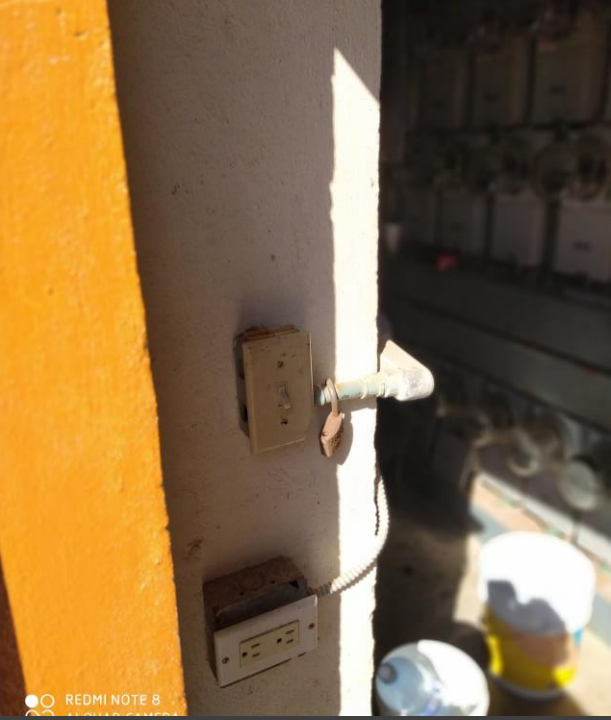
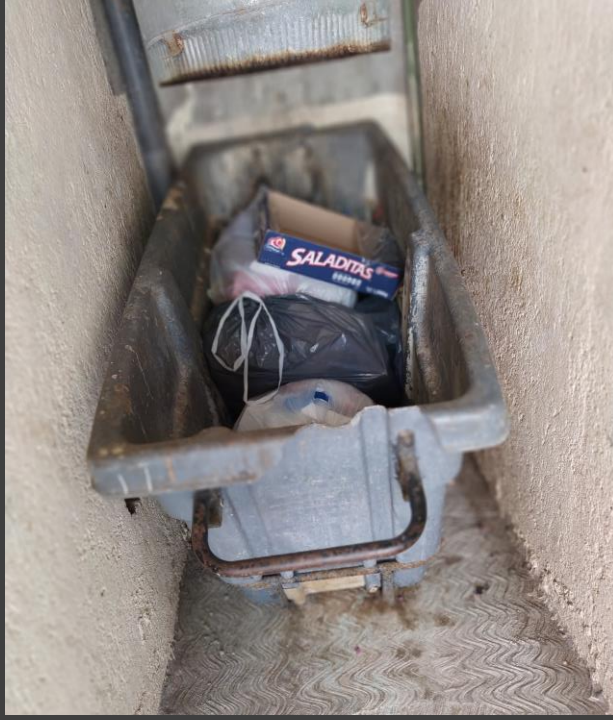
Common Areas

- The cleaning staff of common areas have the work material in the garbage shut room.
- They do not have lighting, the garbage carts are broken or in poor condition

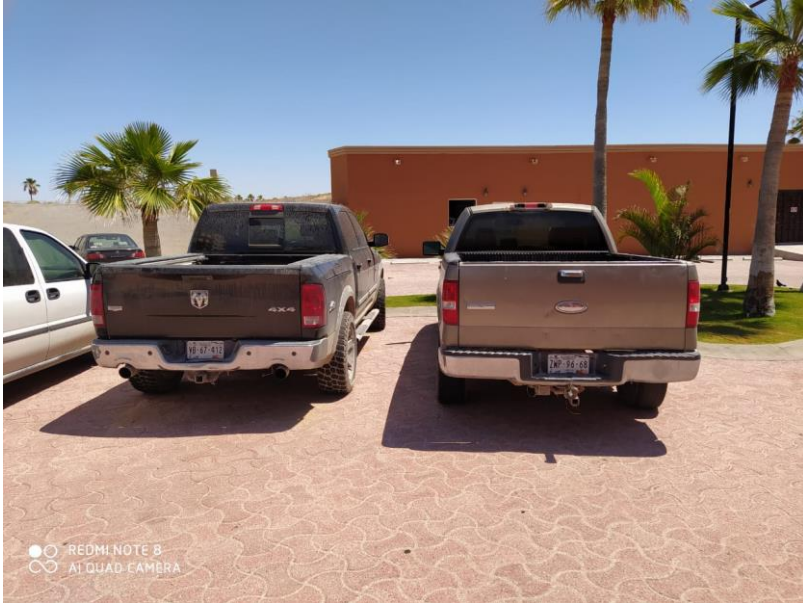
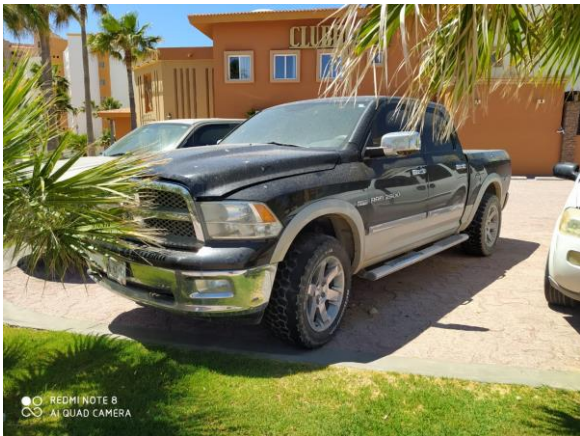
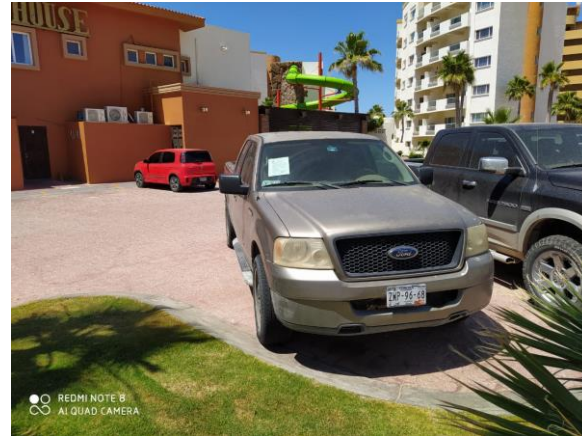
Pick up Trucks

Ford F150 needs service, engine sounds good and runs well, A / C does not work, interiors are in poor condition

The engine has a mayor damage and needs to be rebuilt.
